Corrosion Atlas

THIRD, EXPANDED AND REVISED EDITION

A Collection of Illustrated Case Histories

Evert D.D. During

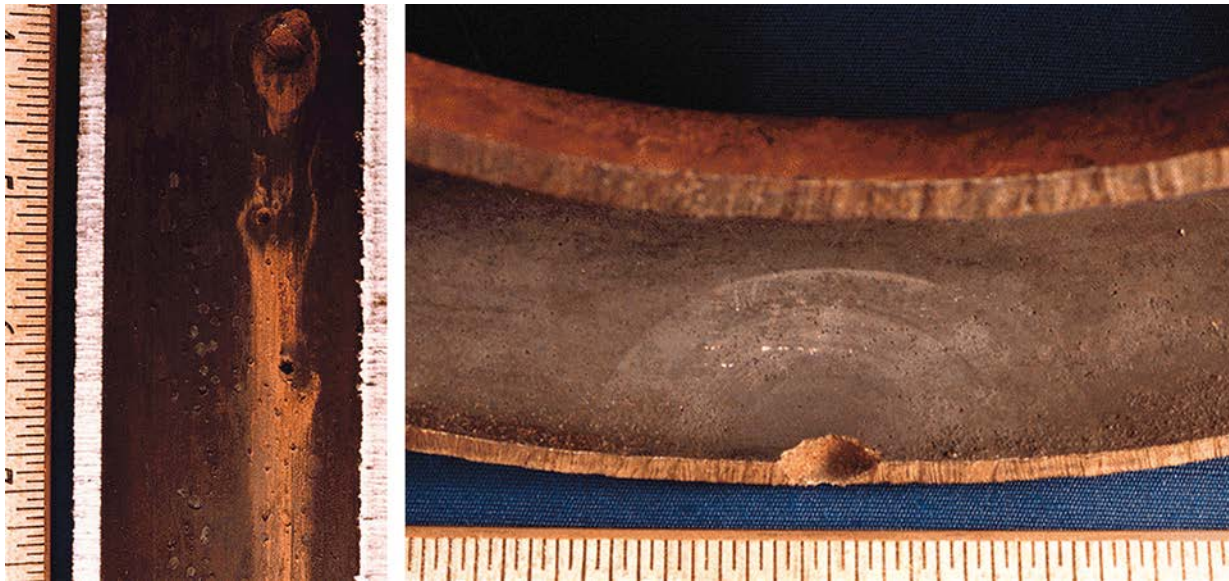
PHENOMENON Oxygen corrosion.

APPEARANCE Pitting with gravity-induced drainage of corrosion products on the vertical section (left). Elliptical water rings surrounding the pit on the horizontal U-bend section (right).

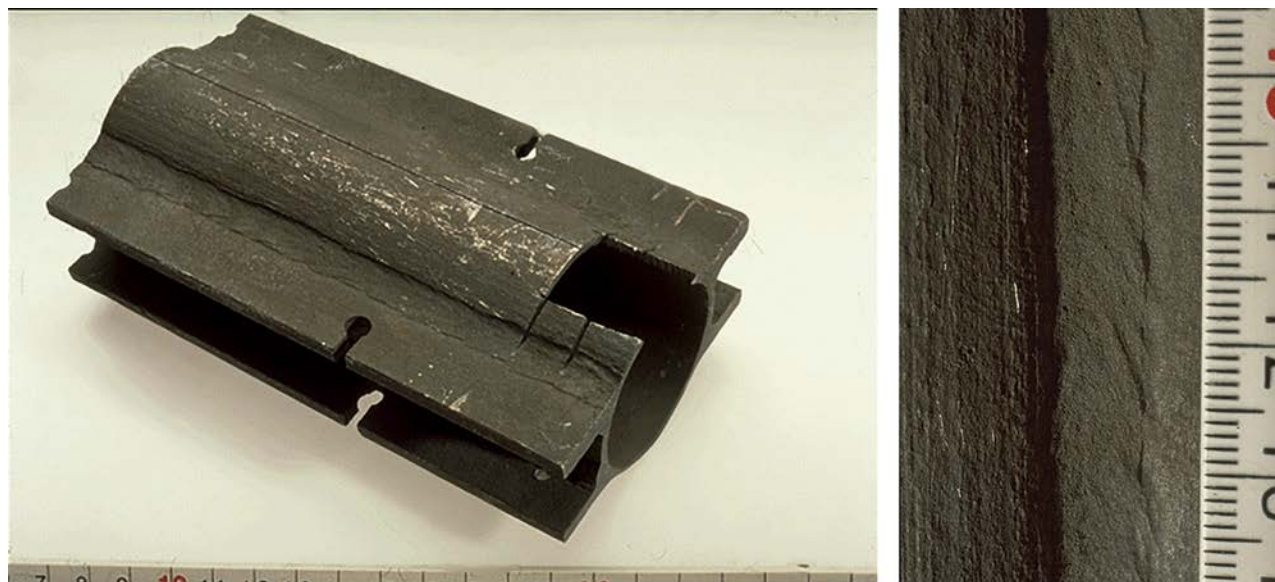
MATERIAL	Carbon steel.
SYSTEM	Refuse incinerator.
PART	Electric resistance welded furnace tube.
PHENOMENON	Acid corrosion (dew-point corrosion).

APPEARANCE	Severe attack to the longitudinal seam weld.
TIME IN SERVICE	Unknown.
ENVIRONMENT	Flue gases contaminated with HCl originating from the combustion of plastics (polyvinyl chloride etc.).
CAUSE	As a result of a difference in structure between the weld and the base material, partly caused by welding at low frequency, the weld seam is selectively attacked by the HCl (at temperatures below the dew point). This dew-point corrosion during service is also called cold-end corrosion (for selective attack of the weld, see also Case History 01.11.04.01).
REMEDY	<ul style="list-style-type: none"> • Use a seamless tube; or • Higher frequency welding; or • Application of postweld heat treatment for normalizing the welds.

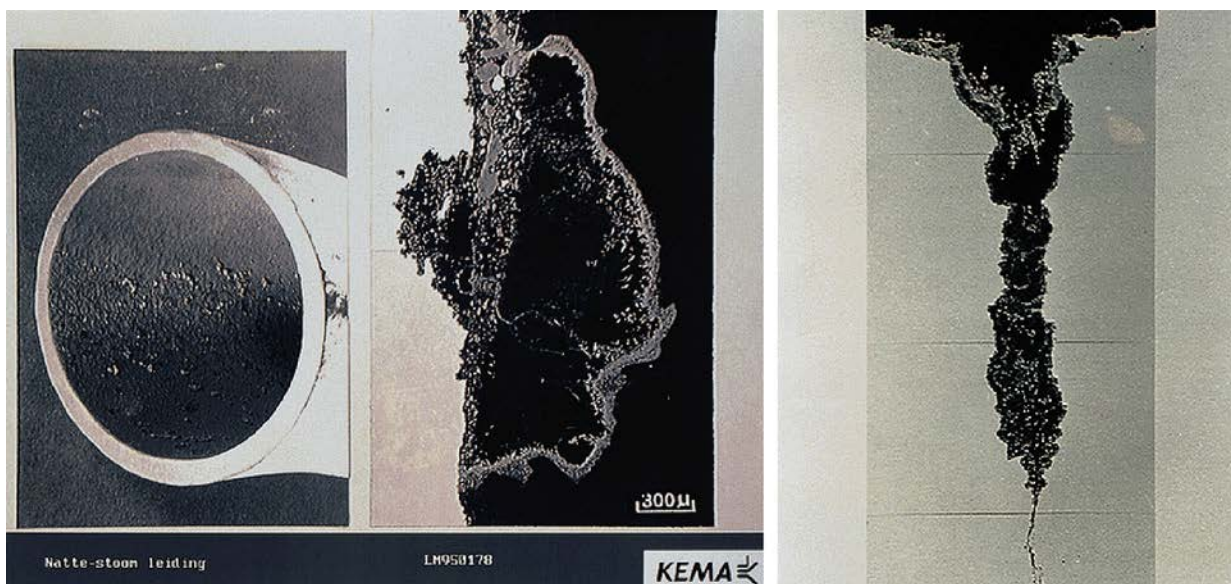
PHENOMENON Stress-corrosion cracking.

APPEARANCE Pitting and stress-corrosion cracks. The cracks started at the pits transgranularly changing to intergranularly near the crack tips.

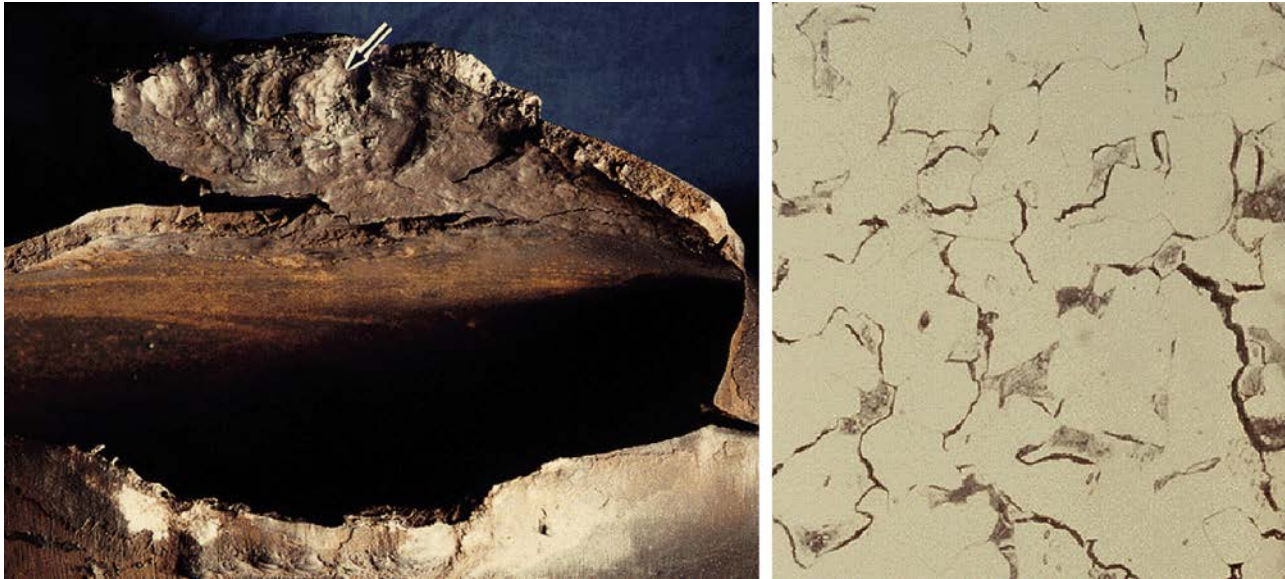
MATERIAL	Carbon steel.
SYSTEM	Utility boiler (13.8MPa).
PART	Water wall tube above the burners.
PHENOMENON	Hydrogen damage (high-temperature hydrogen attack).

APPEARANCE	Brittle rupture. Internal corrosion gouging in areas of thick deposit.
TIME IN SERVICE	In service for 32 years.
ENVIRONMENT	Boiler water, coordinated phosphate program.
CAUSE	Localized build-up of internal deposit and underdeposit corrosion. Hydrogen generated at the base of corrosion gouge diffused into steel and reacted with iron carbide (Fe_3C) to form methane gas (CH_4). Intergranular cracking led to brittle fracture of tube.
REMEDY	Chemically clean boiler. Ultrasonic testing to identify and replace other damaged areas.

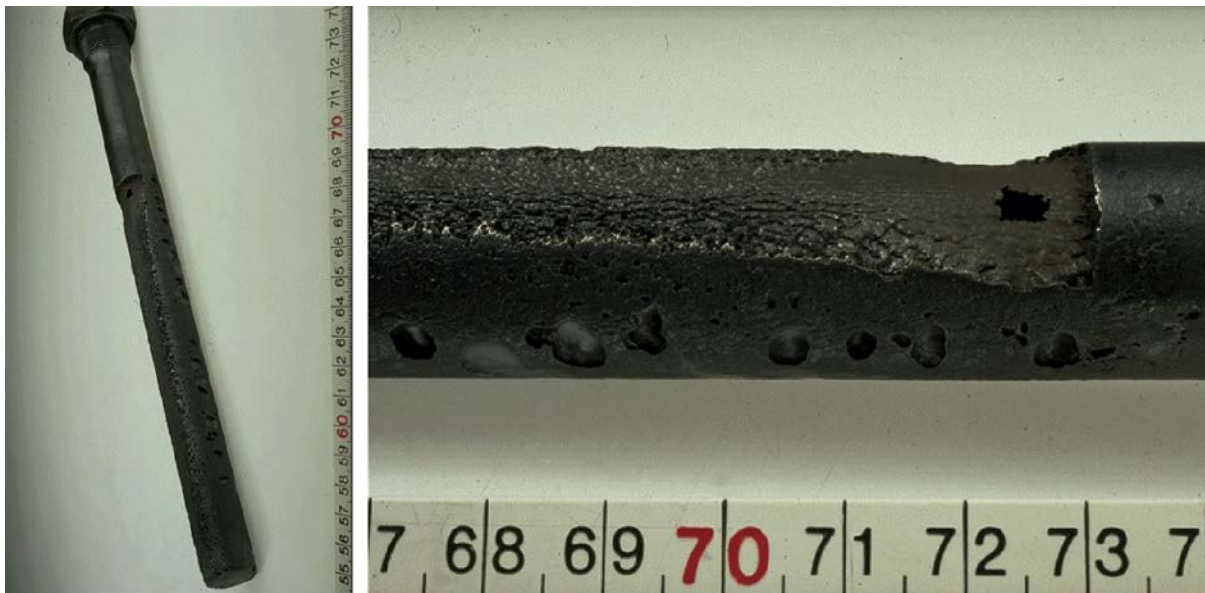
MATERIAL	Low-alloyed steel (13 CrMo 44).
SYSTEM	Steam system.
PART	Thermometer bulb from turbine steam supply line.
PHENOMENON	Erosion (water-droplet impingement).

APPEARANCE	Material is uniformly eroded to the point of leakage perpendicular to the direction of flow, while the material is locally eroded at the sides.
TIME IN SERVICE	15 years.
ENVIRONMENT	Superheated steam. Temperature: 495°C; pressure: 10 MPa; velocity: 37 m/s.
CAUSE	The thermometer was positioned immediately downstream from the injection cooler. Water droplets still present in the steam caused the erosion (see also Case History 01.01.32.04).
REMEDY	Thermometer bulb replaced and relocated, further away from the injection cooler.

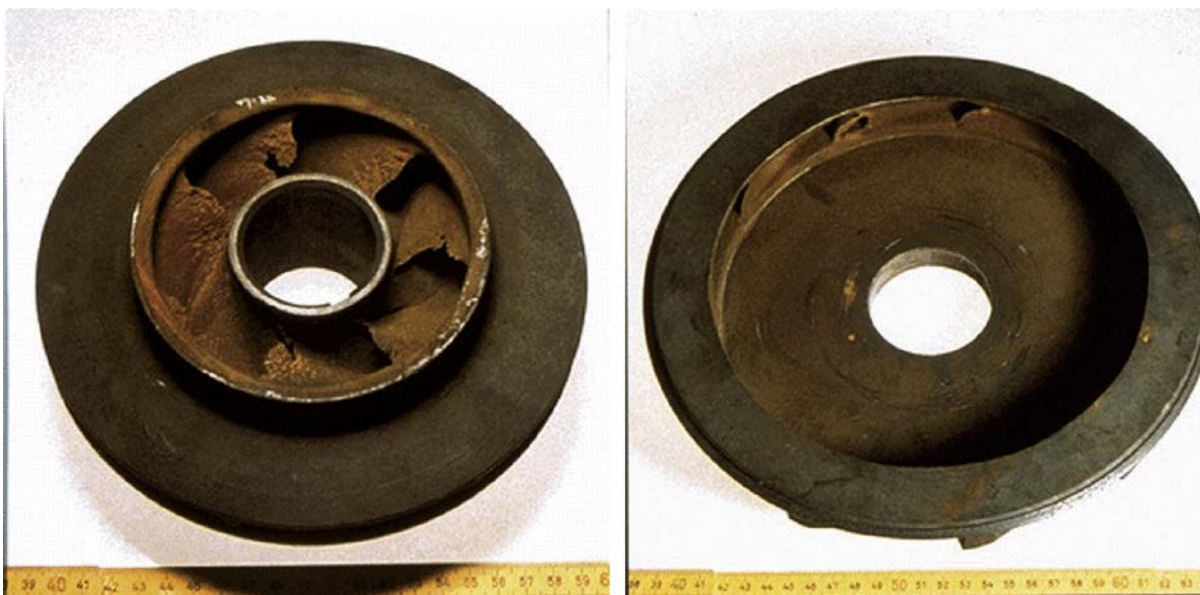
MATERIAL	Impeller: nickel- and chromium-alloy cast iron. Diffuser ring (guide vane): cast iron.
SYSTEM	Boiler feedwater system.
PART	First impeller and diffuser ring of boiler feedwater pump (65 m ³ /h, 5.1 MPa back pressure).
PHENOMENON	Cavitation erosion.

APPEARANCE	Material worn away locally.
TIME IN SERVICE	5 years.
ENVIRONMENT	Deaerated demineralized feedwater; temperature 105°C.

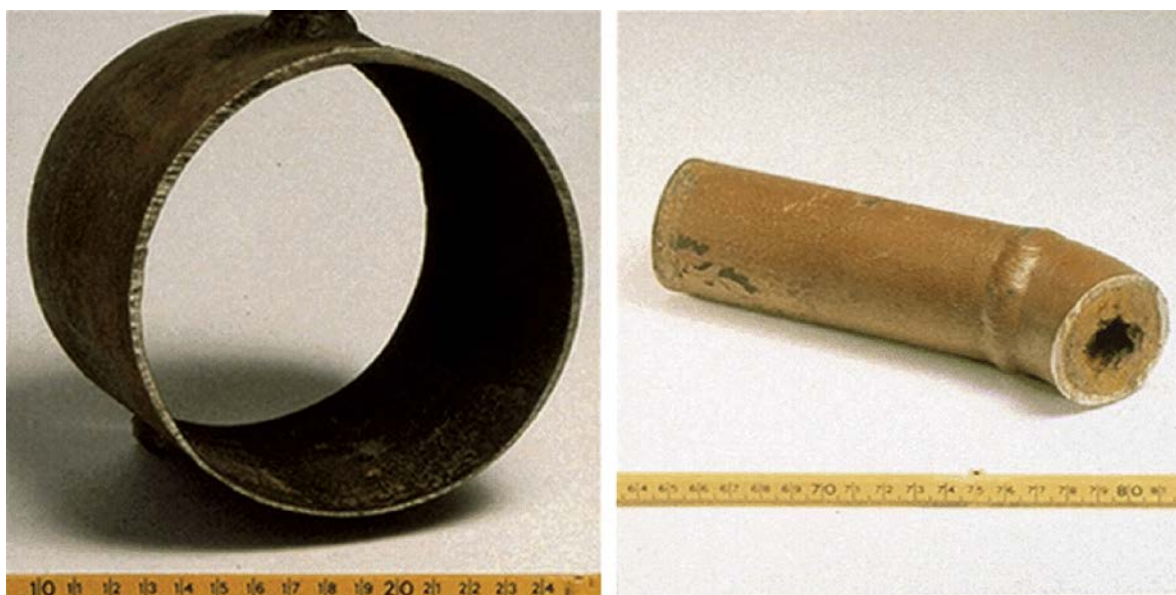
MATERIAL	Carbon steel.
SYSTEM	Steam condensate system.
PART	Horizontal condensate pipe and deposits in a condensate pipe.
PHENOMENON	Carbonic acid corrosion.

APPEARANCE	Uniform attack at the lower side. Remaining corrosion products in another line.
TIME IN SERVICE	12 years.
ENVIRONMENT	Corrosive condensate; temperature 90–100°C.
CAUSE	Attack by carbonic acid-containing condensate; corrosion products are not only fed to the boiler but can also cause local blockage of the condensate line.
REMEDY	Alkalinity reduction of the makeup water, thereby minimizing the carbonic acid content of the condensate.

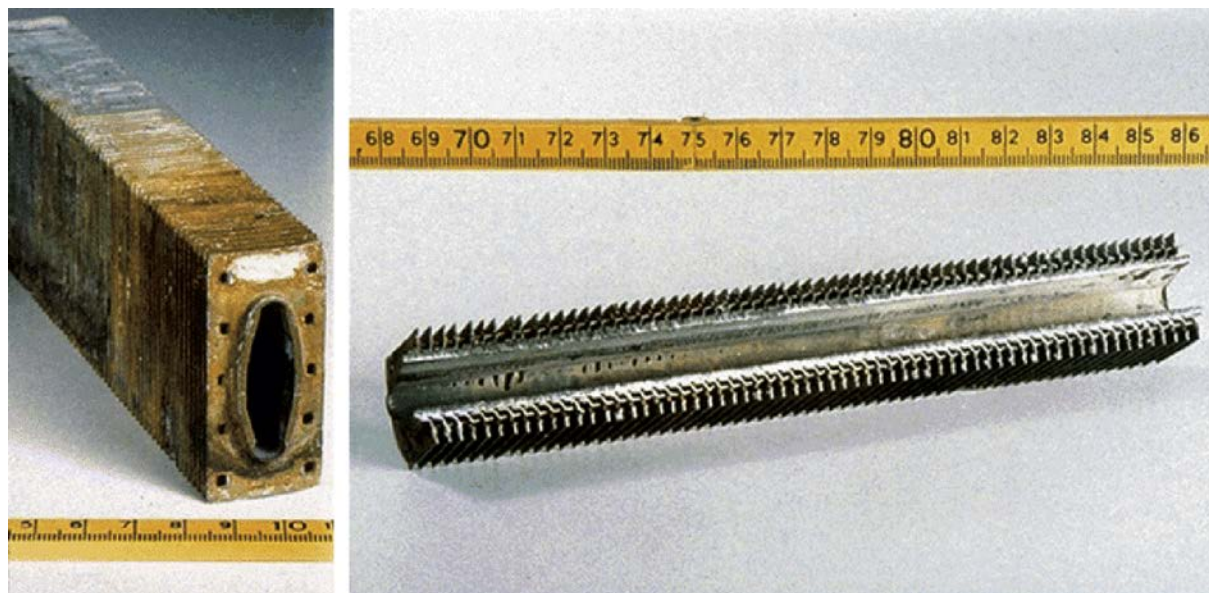
MATERIAL	Carbon steel.
SYSTEM	Steam condensate system.
PART	Vertical element from air heater (before and after sawing through).
PHENOMENON	Carbonic acid corrosion.

APPEARANCE	Uniformly grooved at one side.
TIME IN SERVICE	Unknown.
ENVIRONMENT	Corrosive condensate due to the presence of a large quantity of carbonic acid originating from the decomposition of bicarbonate in the boiler; temperature 100°C.
CAUSE	Steel corroded by carbonic acid-containing condensate, grooved attack of the side exposed to the fan (where most condensation occurs).
REMEDY	<ul style="list-style-type: none"> • Alkalinity reduction of the makeup water; in view of the nature of the plant, it was not possible to dose chemicals into the steam. • Alternative option: construction of the air heater from AISI 304 stainless steel.

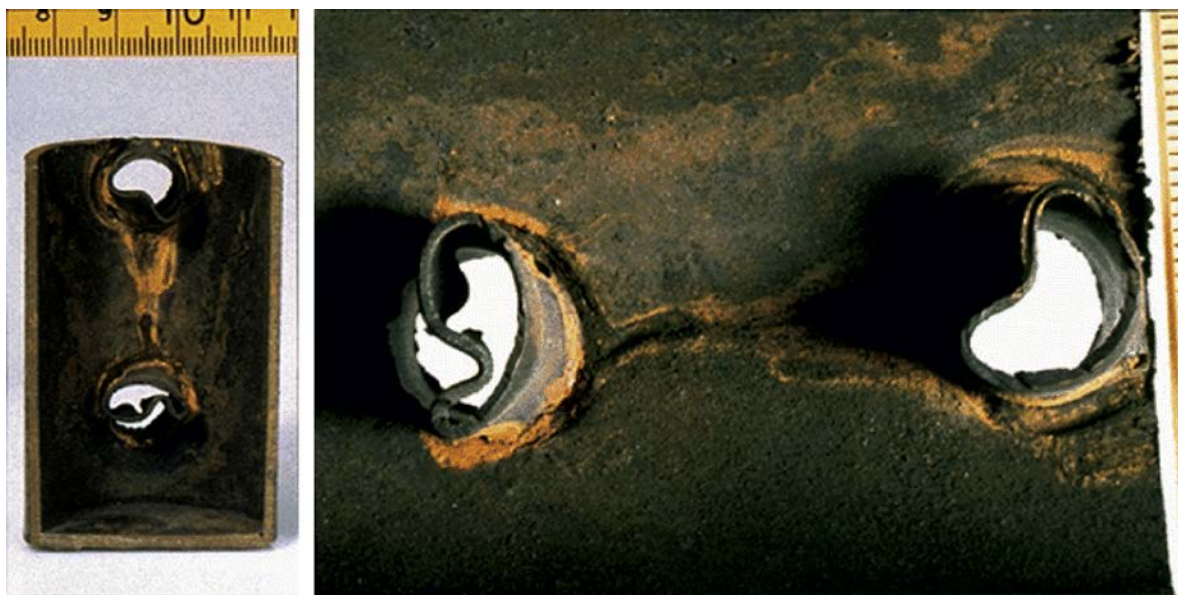
PHENOMENON Galvanic corrosion.

APPEARANCE Grooved attack of the header where the tubes are attached and deformation of the tubes.

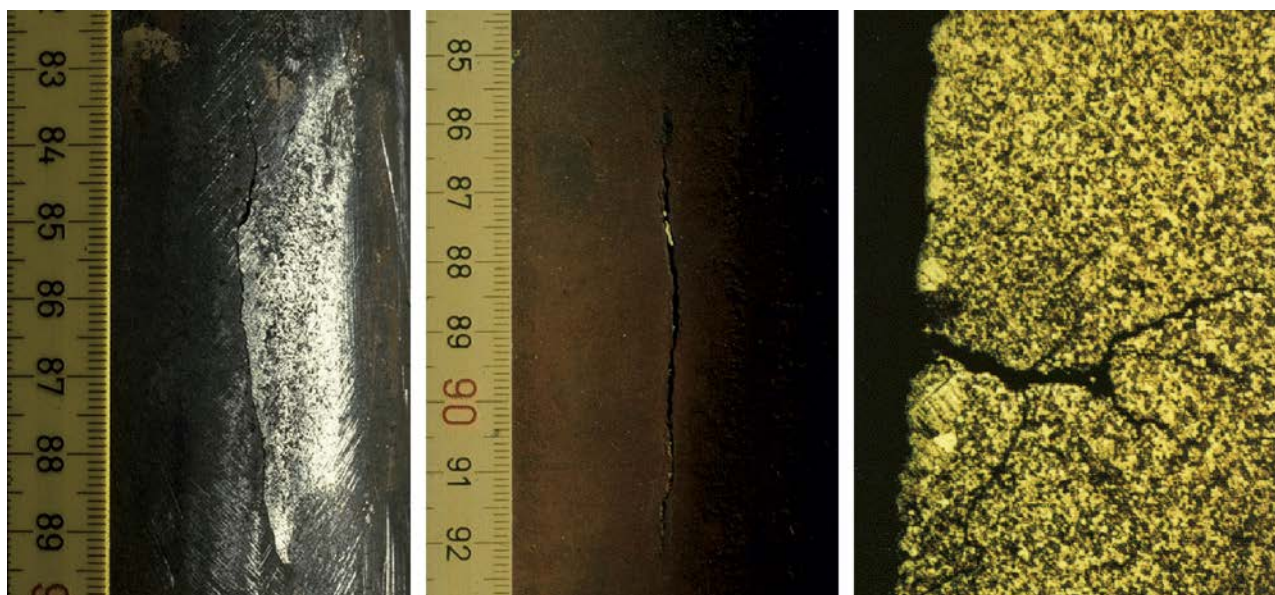
PHENOMENON Thermomechanical fatigue.

APPEARANCE 6 cm long fracture 4 cm away from the weld, with branches at the fracture tip. On the left external, internal at the center.

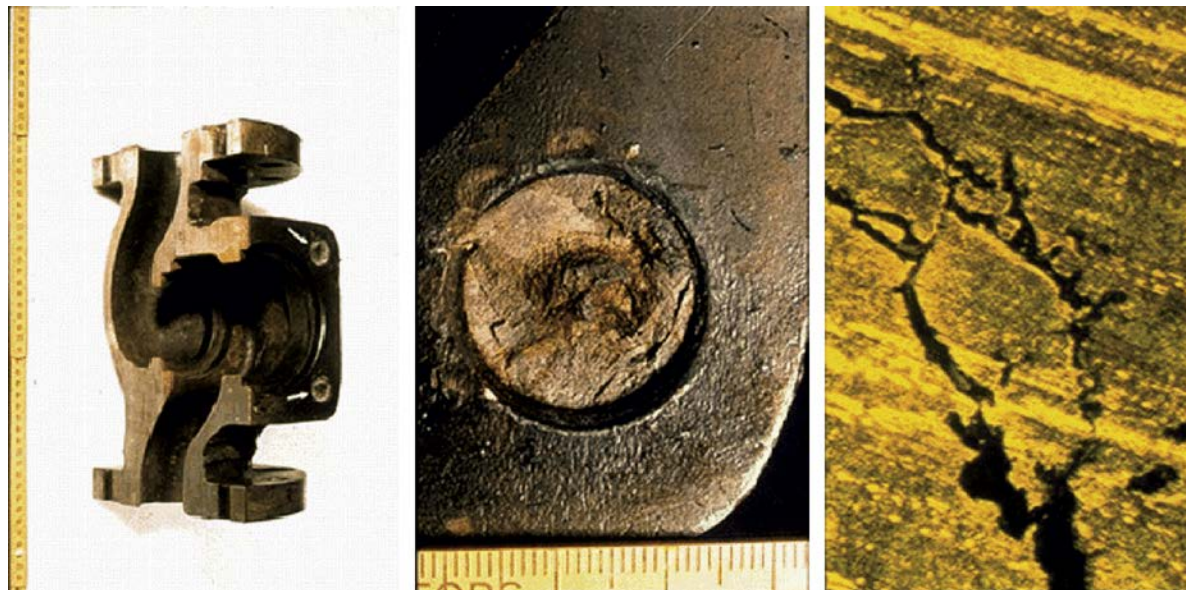
PHENOMENON Liquid metal embrittlement.

APPEARANCE Brittle fracture of the bolts.

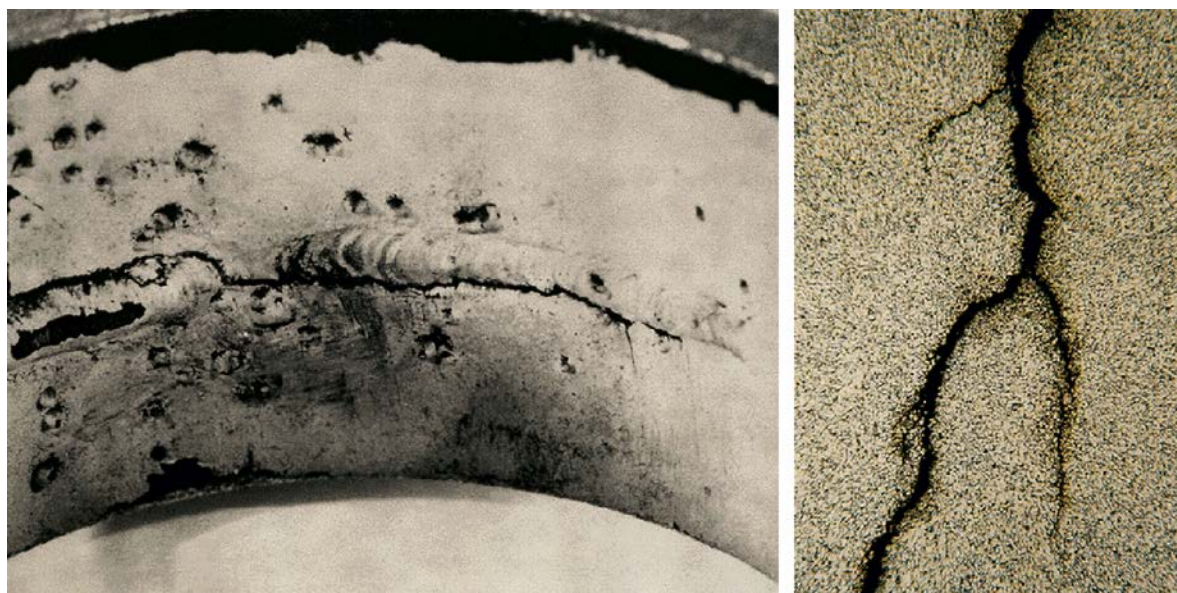
APPEARANCE	Left photograph: Inner view of the round weld after magnetic testing. Right photograph: Branched intergranular cracks initiated at the fusion line of the root weld leading to leakage.
TIME IN SERVICE	The leak was discovered during hydrostatic pressure testing.
ENVIRONMENT	The pipeline was degreased by purging with a solution of sodium carbonate (3%) in water (60ppm Cl) at a temperature of about 80°C. Hydrostatic pressure testing was performed at 6–7bar and 120°C, about 0.5 years after purging of the pipeline.
CAUSE	Carbon steel is known to be subject to carbonate stress corrosion at temperatures above about 100°C. Weld thermal stresses and stress concentration at the root fusion line caused initiation (see also Case History 04.11.18.10).
REMEDY	Use carbonate-free detergent or keep the temperature (even during purging or pressure testing) well below 100°C.

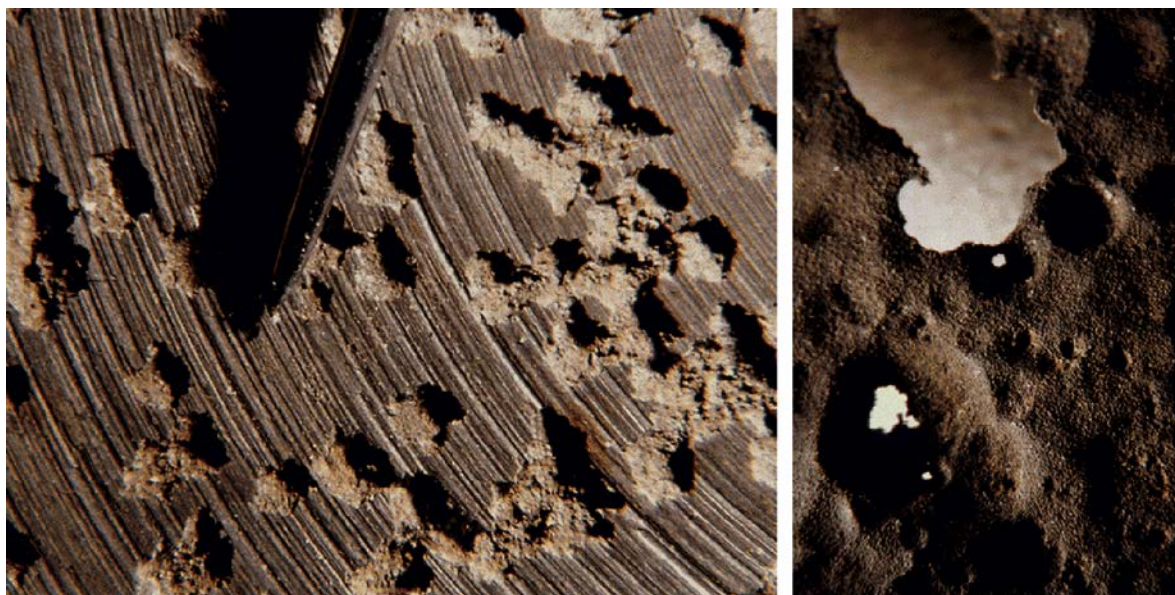
APPEARANCE	Valve: Heavy pitting. Bracket: General wastage with superimposed pitting.
TIME IN SERVICE	8 years in service; corrosion took place in several weeks.
ENVIRONMENT	Mill coolant (\approx 5% oil, 95% demineralized water), temperature 60°C.
CAUSE	An upset that permitted hydrochloric acid to mix with the mill coolant, which caused a pH drop from 5 to 2. Because demineralized water was used, even small amounts of acid contamination caused severe pH upset.
REMEDY	Continuous control of the pH of the mill coolant so that timely measures can be taken (alkalizing or freshening the coolant).

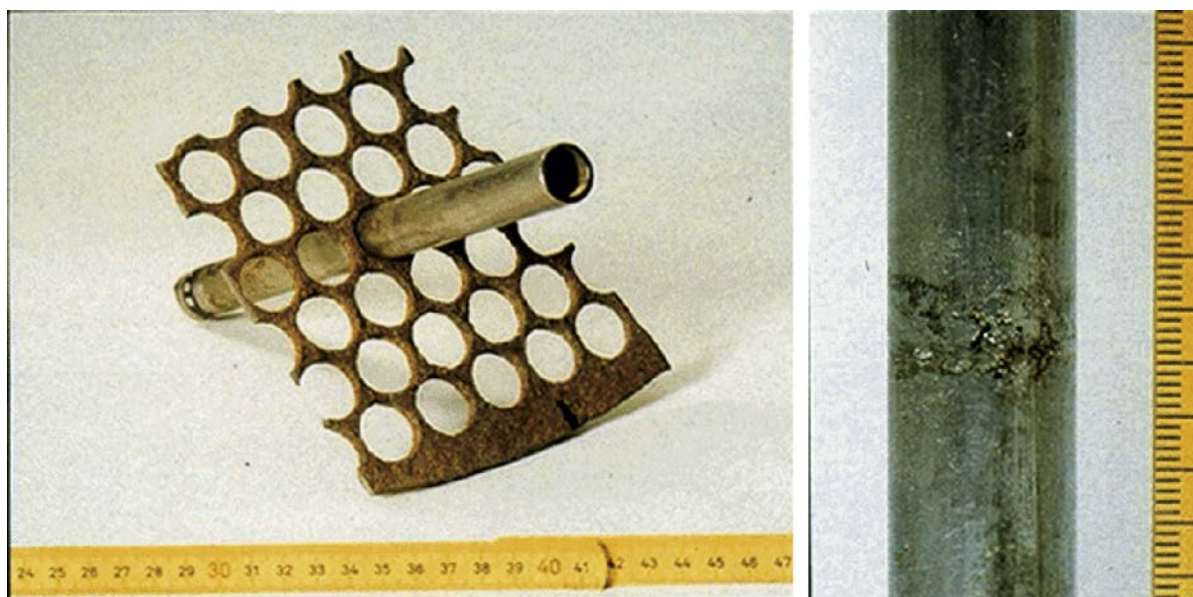
APPEARANCE Uniform attack to baffle, pitting to tubes in crevices.

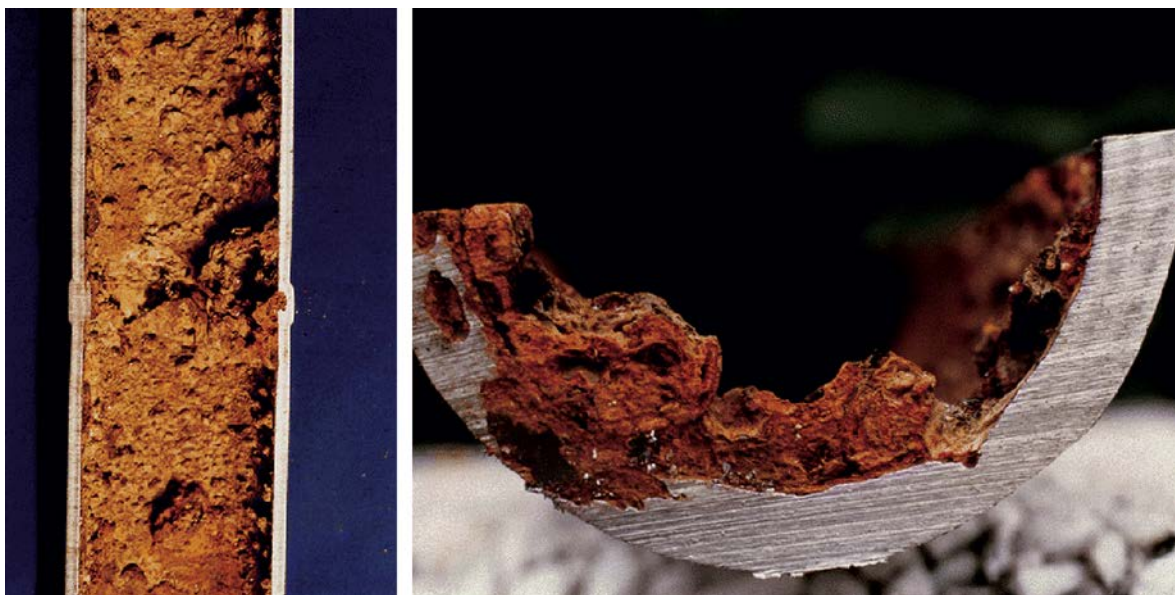
APPEARANCE	Heavy tuberculation on pipe interior. The circumferential weld-backing ring was heavily corroded. The weld was riddled with mildly undercut, gaping pits, confined to fused and heat-affected zones.
------------	--

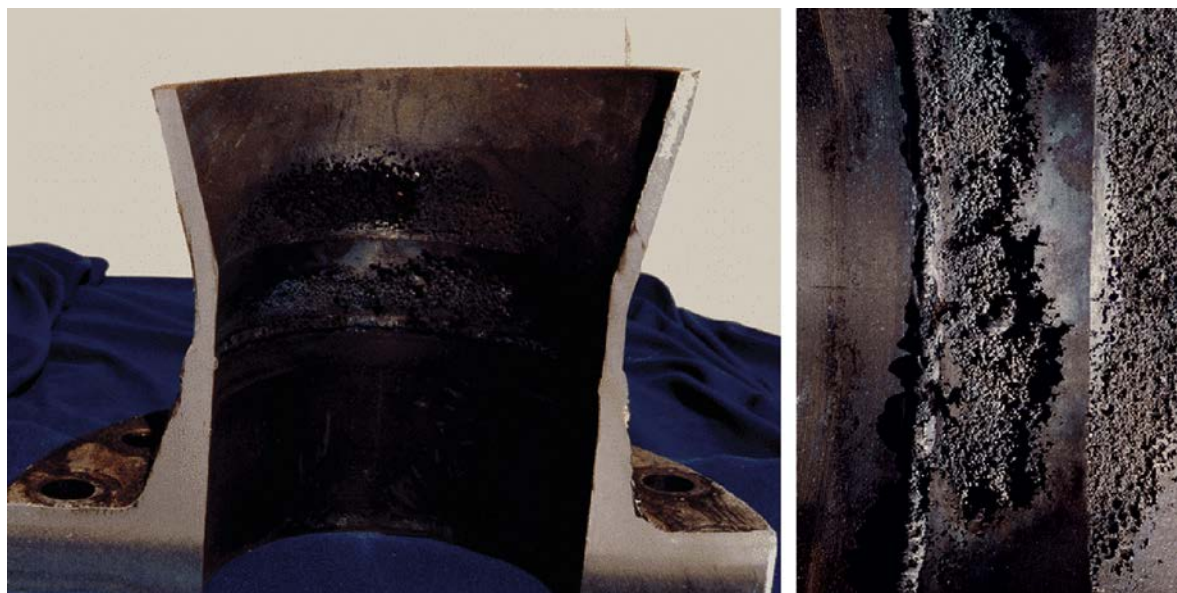
APPEARANCE	Jagged, spongelike metal loss downstream of protruding weld bead and again in the region of diameter increase.
TIME IN SERVICE	6 years.
ENVIRONMENT	Internal: Untreated lake water intermittently chlorinated. External: air.
CAUSE	The damage was apparently due to severely turbulent flow past a partially closed valve, coupled with flow disruption across the weld bead and pressure reduction in the region of diameter increase (see Case History 01.01.33.03).
REMEDY	<ul style="list-style-type: none"> • Operate the valve in the fully open position. • Specify a cavitation-resistant material such as hardened carbon steel, hardened stainless steel, or carbon steel overlaid with a cavitation-resistant material.

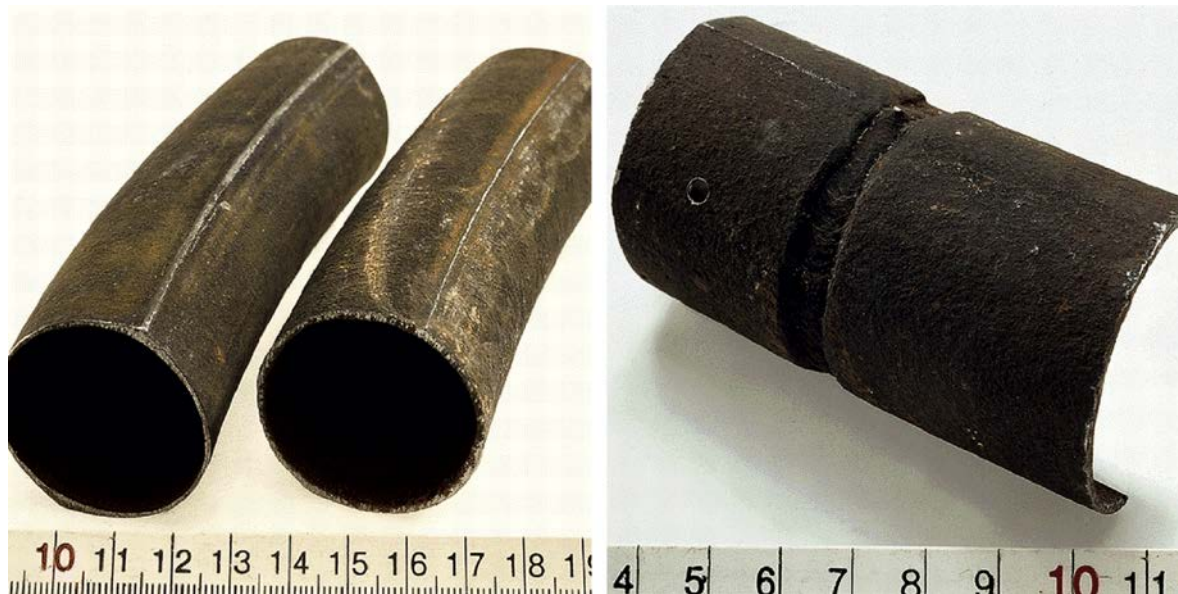
APPEARANCE	The tubes show a pickled surface, caused by uniform corrosion from outside. The wall thickness has been reduced from 2.6 to 1.1 mm. The weld even shows a preferential attack to 0.5 mm thickness.
------------	--

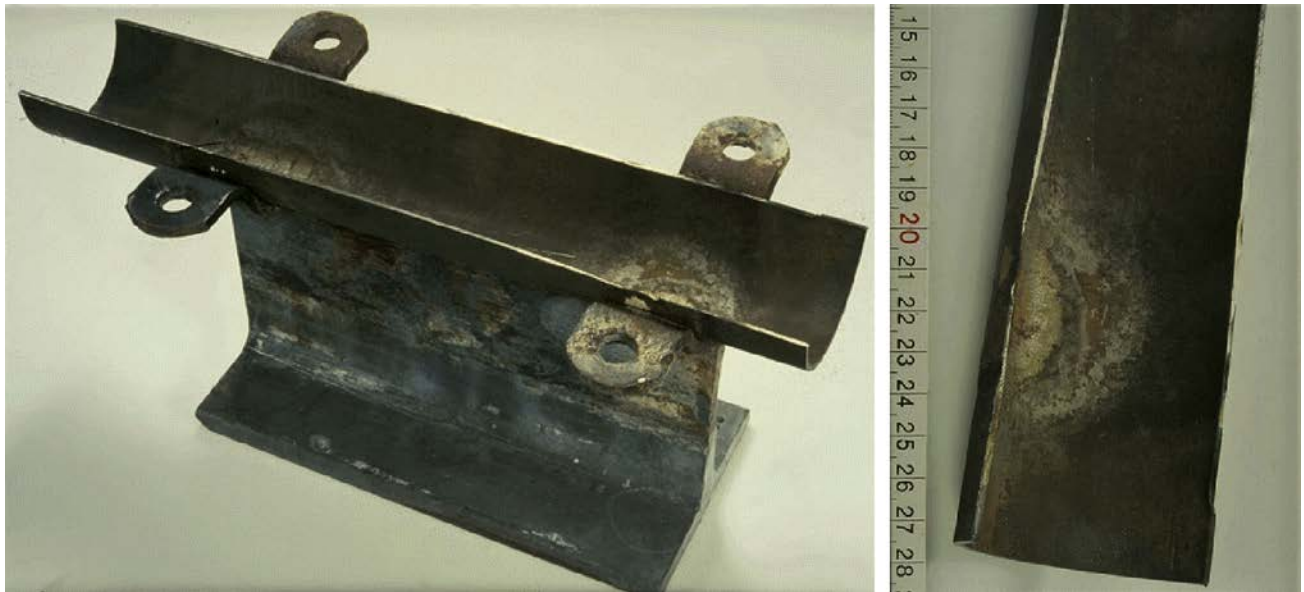
APPEARANCE	Internal uniform corrosion with a pickled metallic blank appearance exactly where the line rests on the support, while the 2-mm-thick wall eroded through locally.
TIME IN SERVICE	Several years.
ENVIRONMENT	For 1 to 1½ hours a day, palm oil stearin, temperature 100–110°C and containing 0.5–1% fatty acid, is pumped through the line after it has been preheated with hot air for half an hour. Afterward the line is purged with cold air.
CAUSE	Condensation of moisture from the hot air, and condensation of volatile fatty acids from the product, selective to the uninsulated contact points with the support, forming a “cold bridge.” As a result of accumulation of the fatty acids, the pH can fall to around 5. It may be that polymerization is also involved in the formation of acids.
REMEDY	<ul style="list-style-type: none"> • Eliminate the cold bridge by applying insulation between the line and support. • Prevent condensation by first conditioning the hot air by drying it or by keeping the line in continuous operation by recirculation of the oil (the latter solution is more expensive of energy than drying the air).

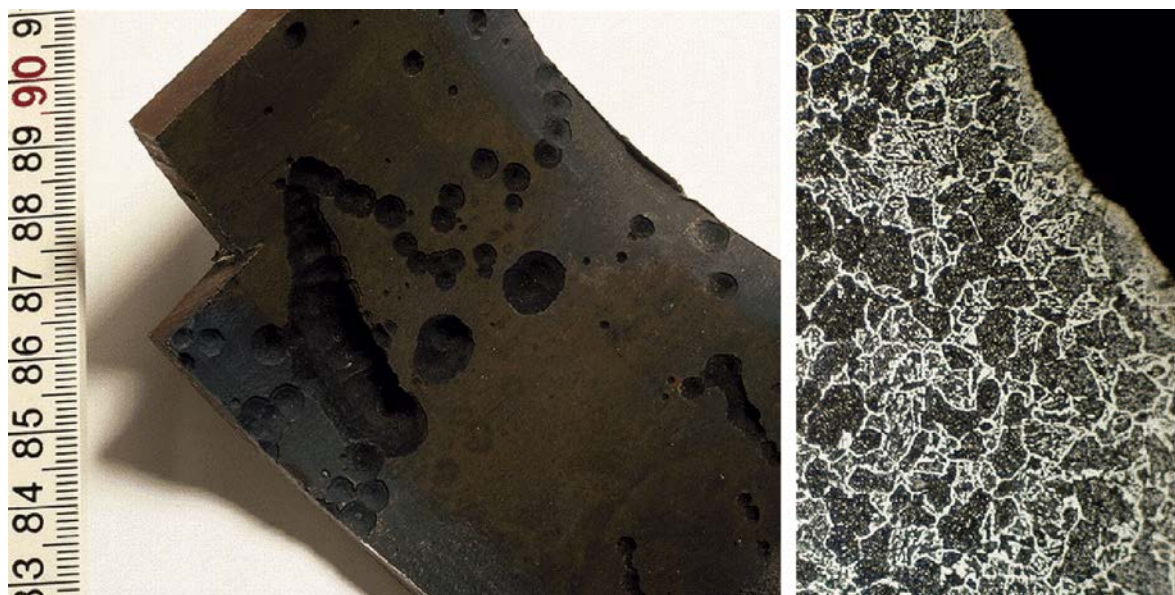
PHENOMENON High-temperature corrosion (metal dusting).

APPEARANCE Pitted surface with various types of pits. Absence of scale or deposits.

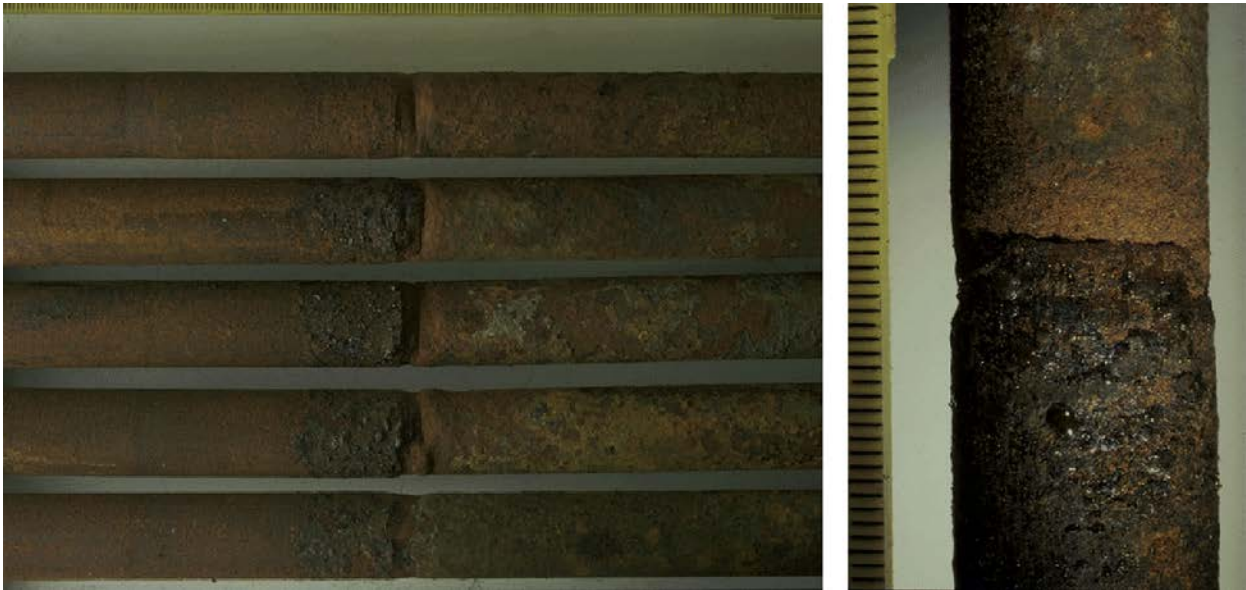
APPEARANCE	Just behind the pipe plate, the wall thickness of the pipes in the upper part of the horizontal bundle has decreased from 2.25 to 1.2–1.5 mm. The left-hand part is fitted in the pipe plate (200 mm).
TIME IN SERVICE	2.5 years.
ENVIRONMENT	Around the pipes: sulfur-containing oil (0.24% S, >0.1% H ₂) which is heated from 35 to 155°C. Through the pipes: desulfurized oil fed at a temperature of 235°C (according to specification!).
CAUSE	As a result of overloading of the plant in response to the large demand for low-sulfur oil and also because of the deposition of sludge, the local wall temperature considerably exceeded the design temperature of 235°C. Attack took place at a temperature >250°C at the hottest place (immediately after the pipe plate) by hydrogen sulfide present in the oil, originating from decomposition of the organic sulfur compounds during distillation. The presence of H ₂ promoted this attack because hydrogen converts organic sulfur compounds to hydrogen sulfide. The corrosion rate depends on the partial pressure of H ₂ S.

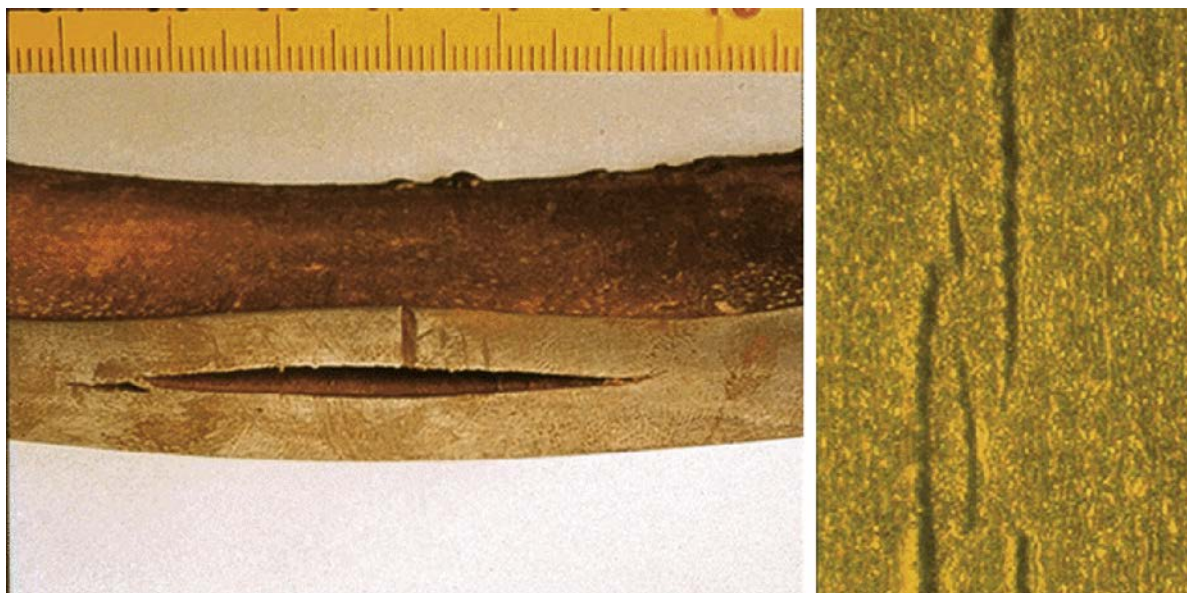
APPEARANCE Blistering.

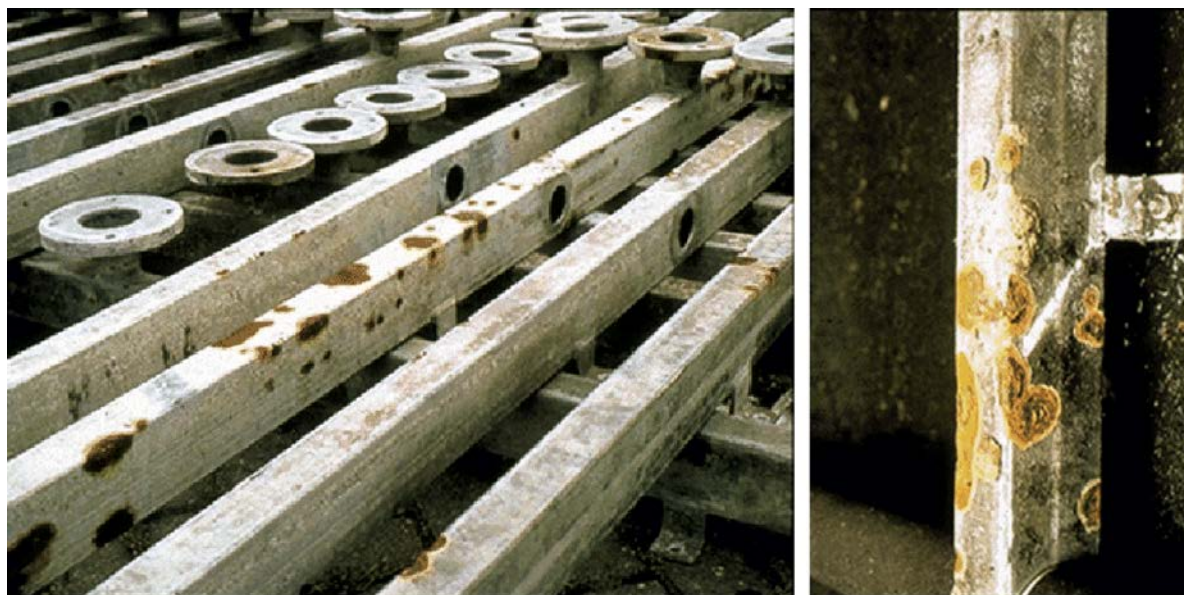
APPEARANCE Pitting underneath crusts of sludge deposit.

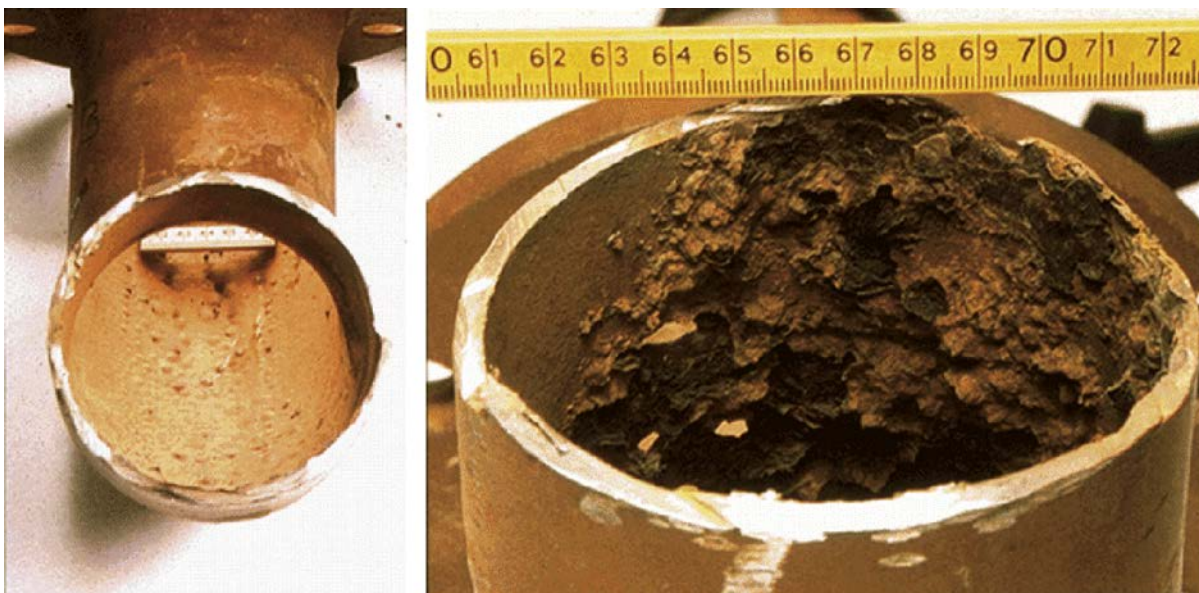
APPEARANCE Blisters in coating and pitting underneath corrosion nodules.

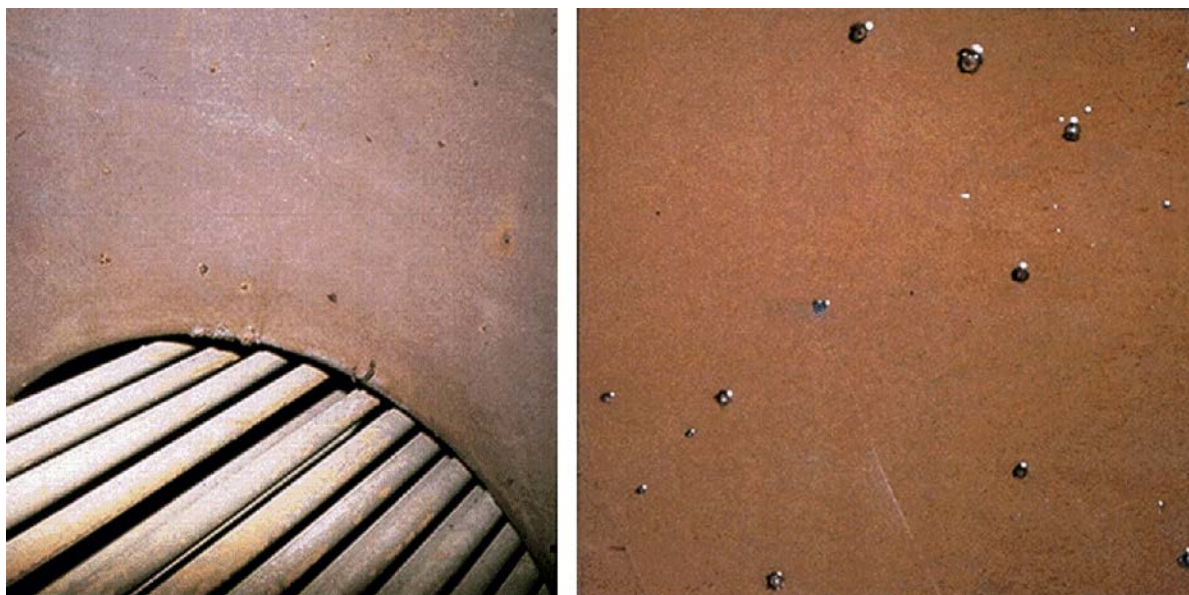
APPEARANCE Pitting with corrosion blisters.

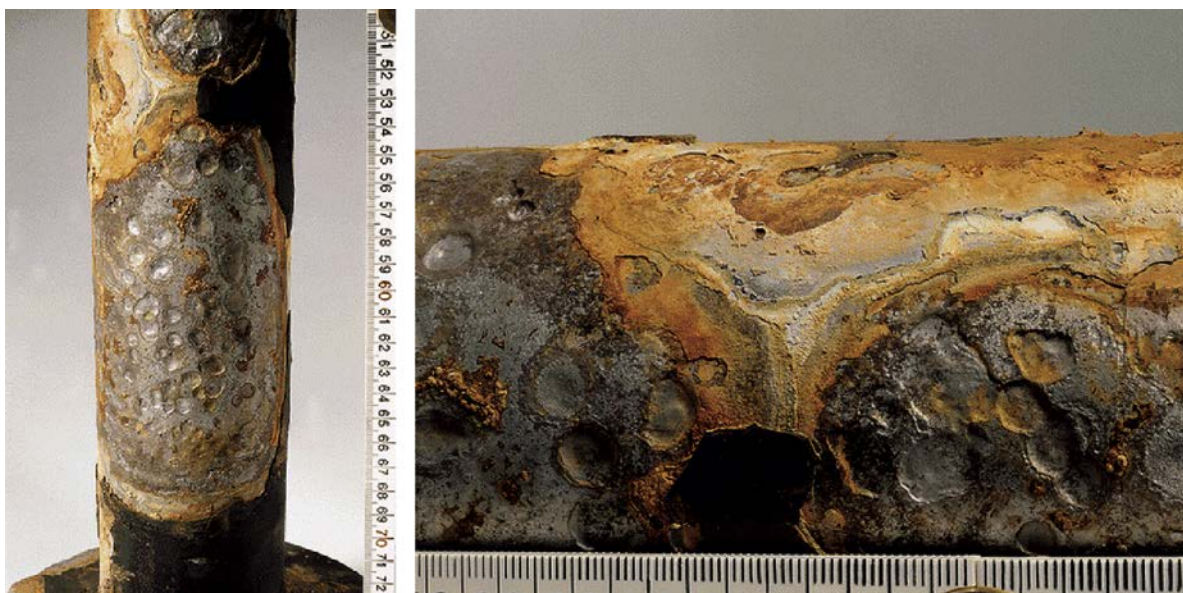
APPEARANCE Flaked-off bitumen coating, shiny metallic steel surface with extensive pitting.

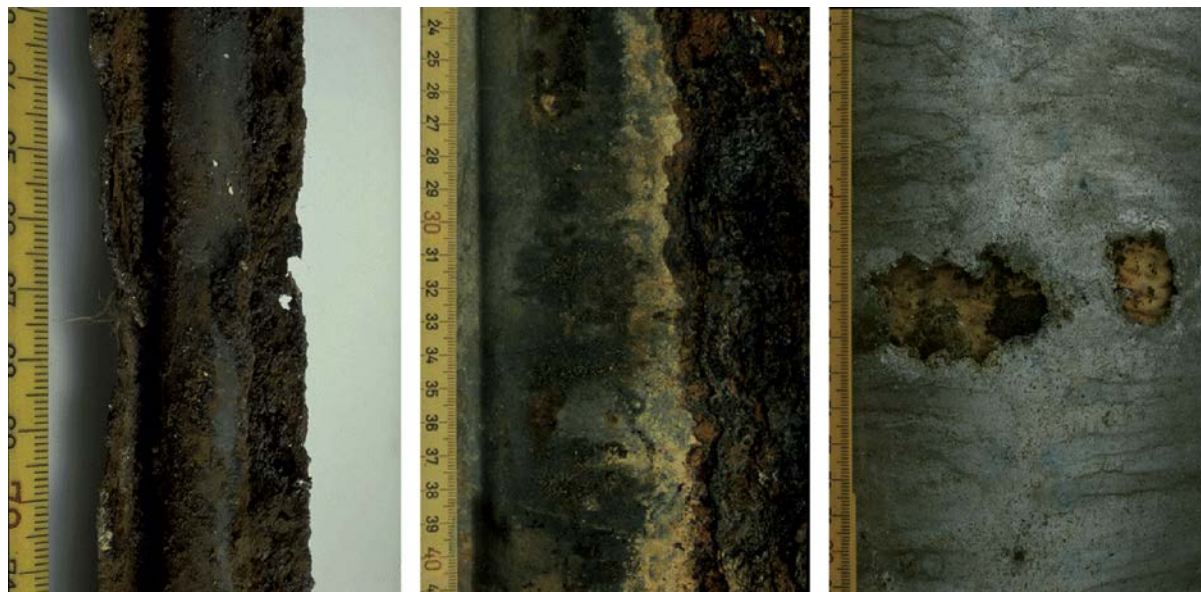
APPEARANCE	Left: Angle steel with tracing, severely attacked and locally eroded. Center: Transport pipeline, severely attacked at the base. Right: Plating, locally eroded at the base.
------------	--

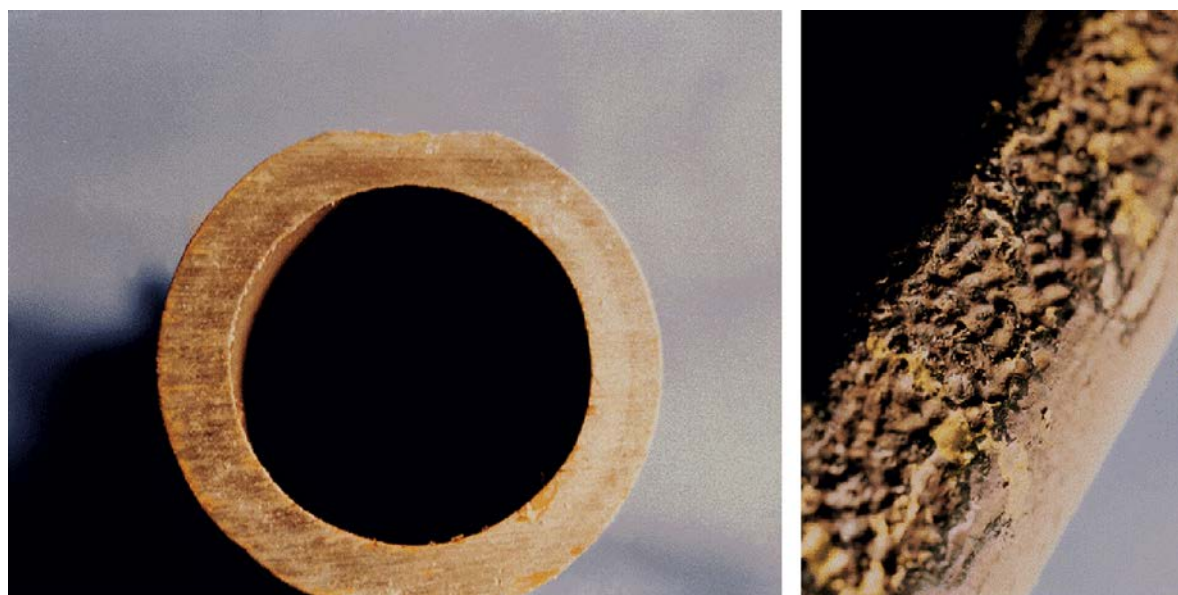
APPEARANCE Pock-marked surface in a 2.5cm-wide band as a result of severe corrosion along one side of the tube. The tube-wall thickness had been reduced by 2.2 mm.

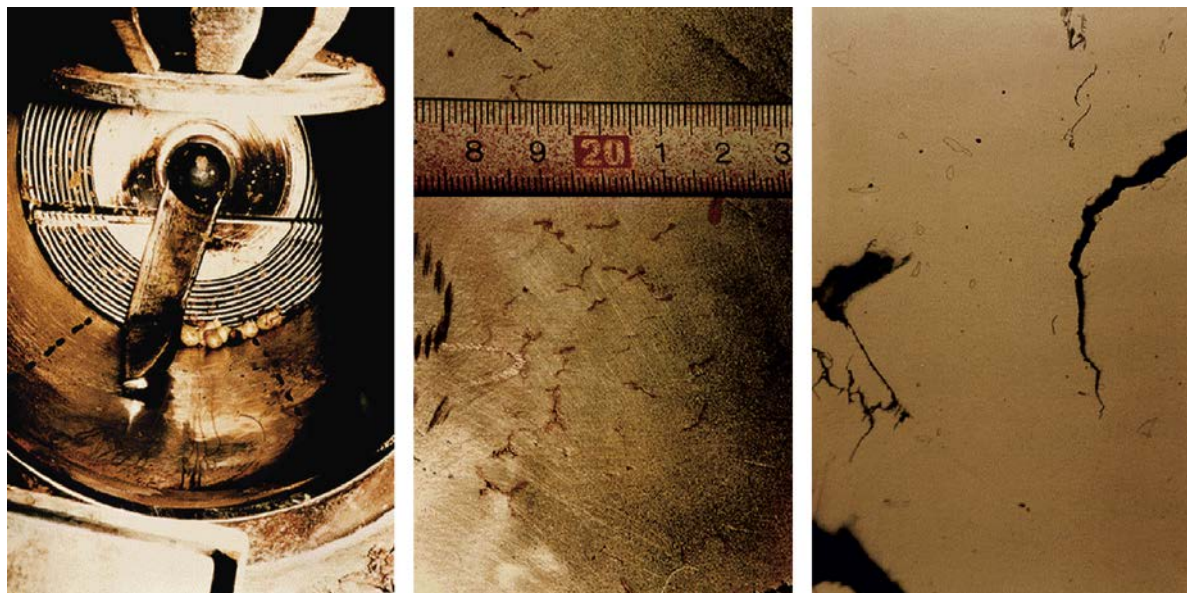
APPEARANCE Randomly oriented short surface cracks filled with corrosion products.
