Corrosion Atlas

THIRD, EXPANDED AND REVISED EDITION

A Collection of Illustrated Case Histories

Evert D.D. During

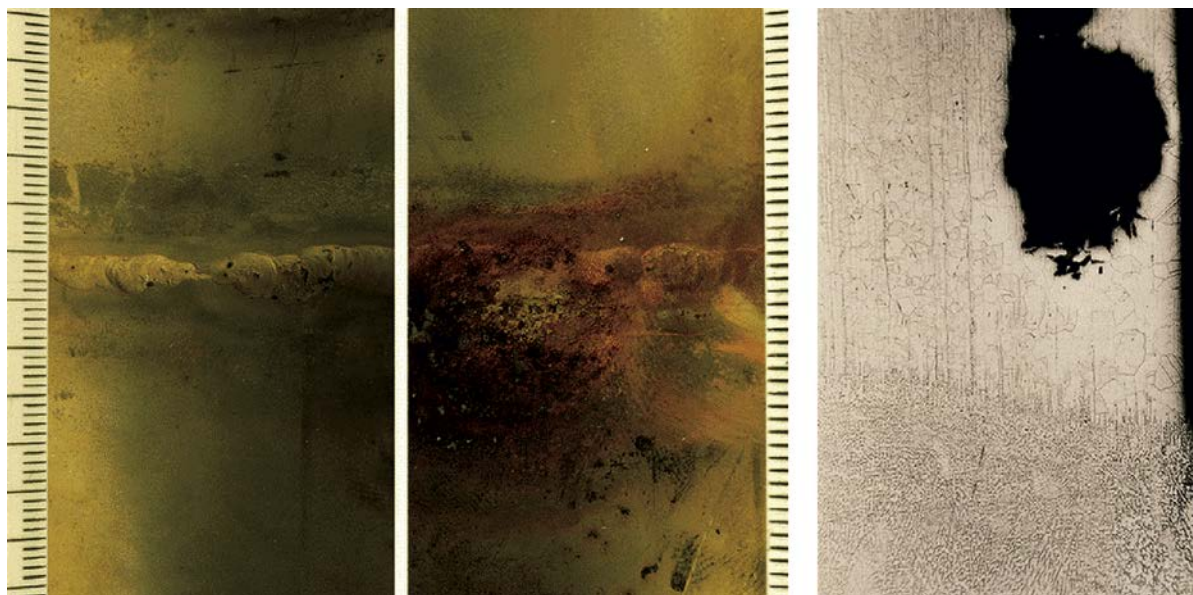
APPEARANCE	Macro: small black tinted pits and brown modules on the weld seam and in the HAZ. Micro: small penetration leading to larger cavity with tunneling.
------------	--

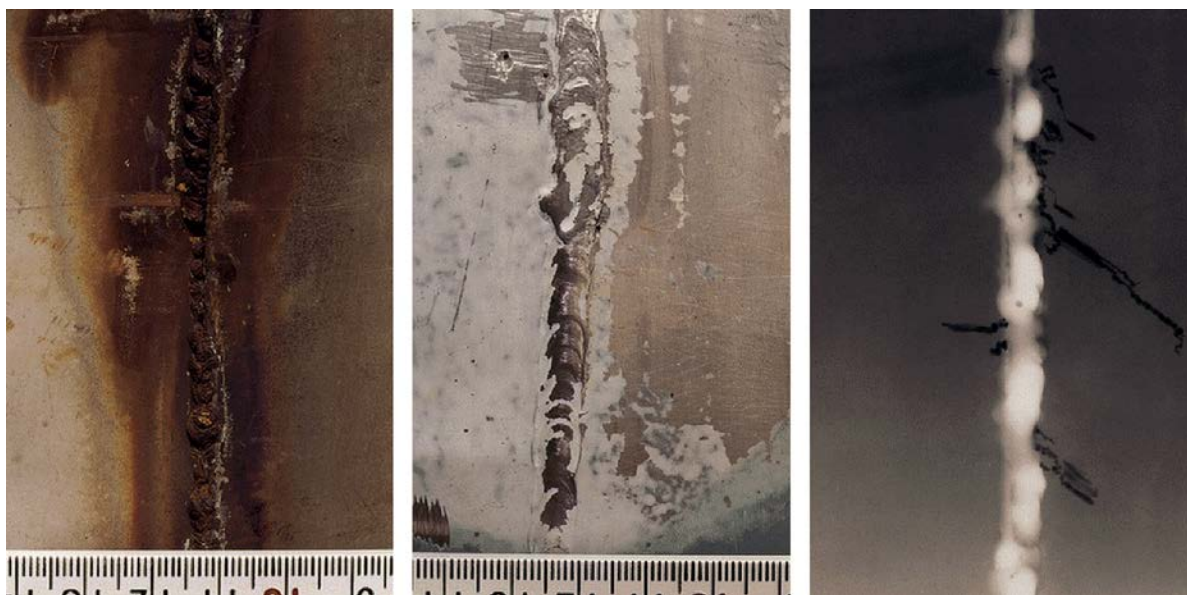
APPEARANCE	Red-brown corrosion products at both sides of the weld. Pinholes through pipe wall near weld, tunneling in pipe wall (see X-ray print).
TIME IN SERVICE	A few months to a year.
ENVIRONMENT	Iron traces containing drinking water made from well water. Temperature: 15–18°C.
CAUSE	Iron bacteria colonized weld surface and induced pitting attack and typical tunneling through pipe wall (see also Case Histories 04.05.17.01 and 04.08.17.01).
REMEDY	<ul style="list-style-type: none"> • Repair of the system where necessary and clean with nitrite acid, improve operation of the deferrization installation, and prevent biological deposits by increasing the water velocity, or • Replace the stainless steel pipes by glass-fiber reinforced epoxy pipes.

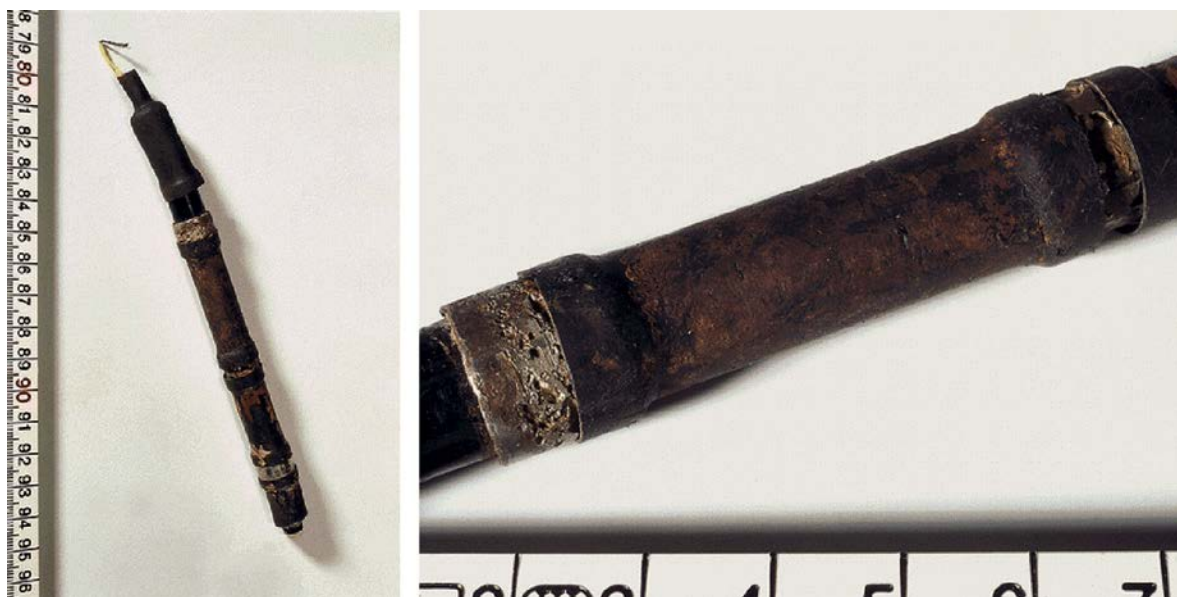
APPEARANCE Severe attack of electrode.

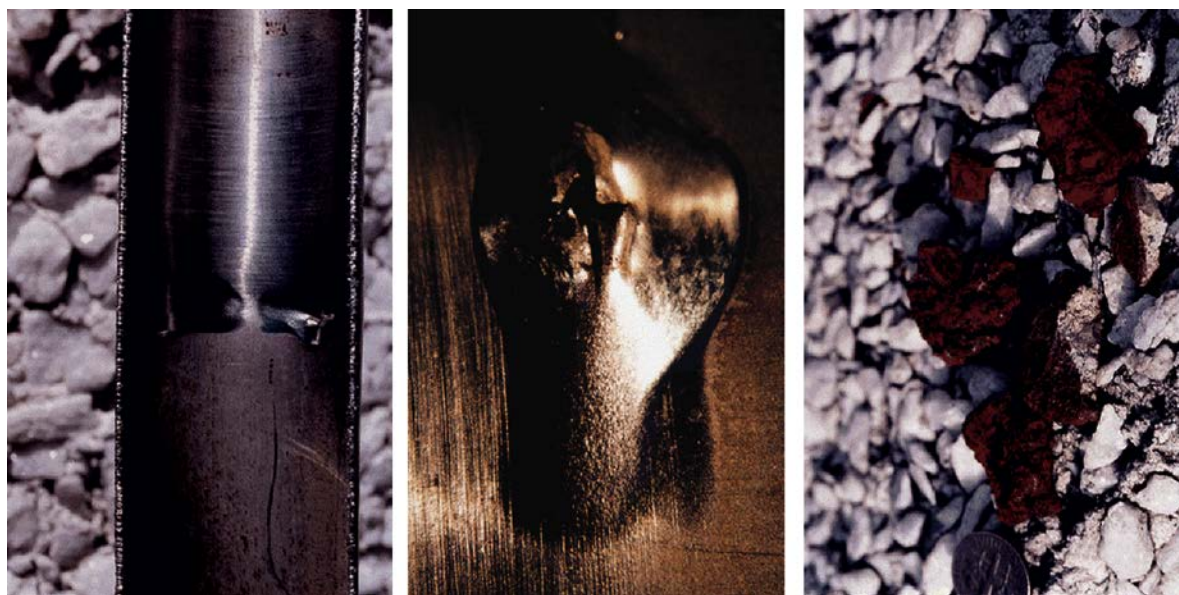
APPEARANCE	Severe gouging on internal surface with close-up of perforated gouge (magnification $\times 7.5$). Concrete chips covered with orange iron oxide (tubes and chips are placed on gravel).
------------	---

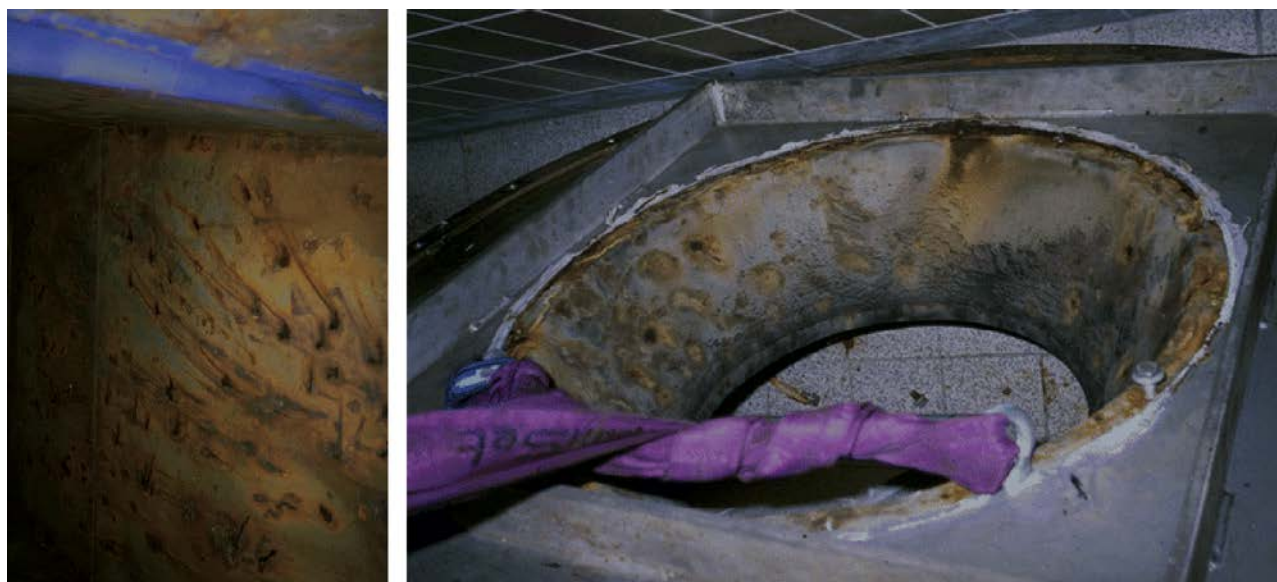
APPEARANCE	Pitting attack with corrosion nodules and fanned-out corrosion products.
TIME IN SERVICE	2 years.
ENVIRONMENT	Humid air contaminated with chloride, H ₂ S, and other gases of putrefaction. Temperature 5–20°C. Successive condensation and evaporation.
CAUSE	Pitting due to rising chloride content caused by evaporation, in a reducing atmosphere.
REMEDY	The extractor system was constructed of plastic (see also Case History 04.08.12.04).

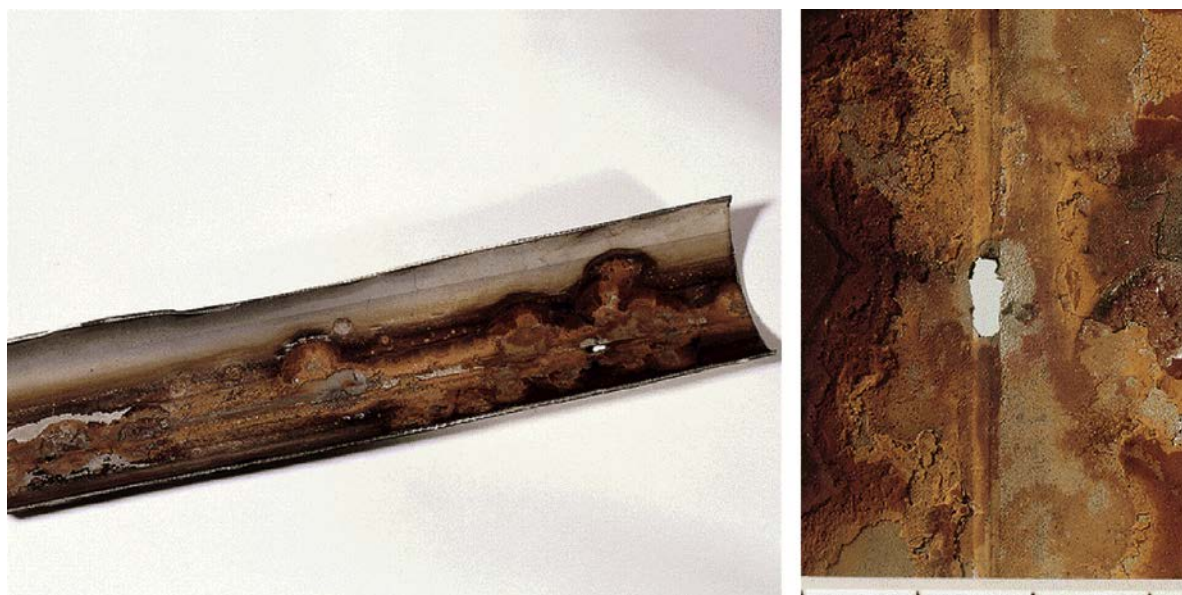
APPEARANCE General corrosion and pitting.

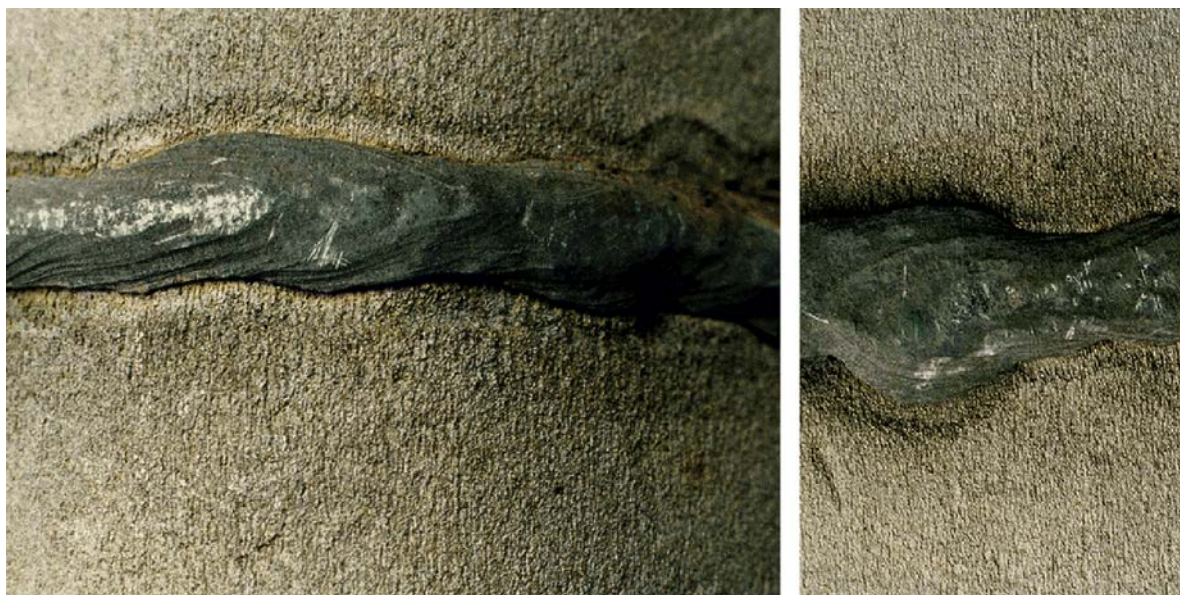
APPEARANCE Severe corrosion along the weld in the HAZ and etching of the base metal.

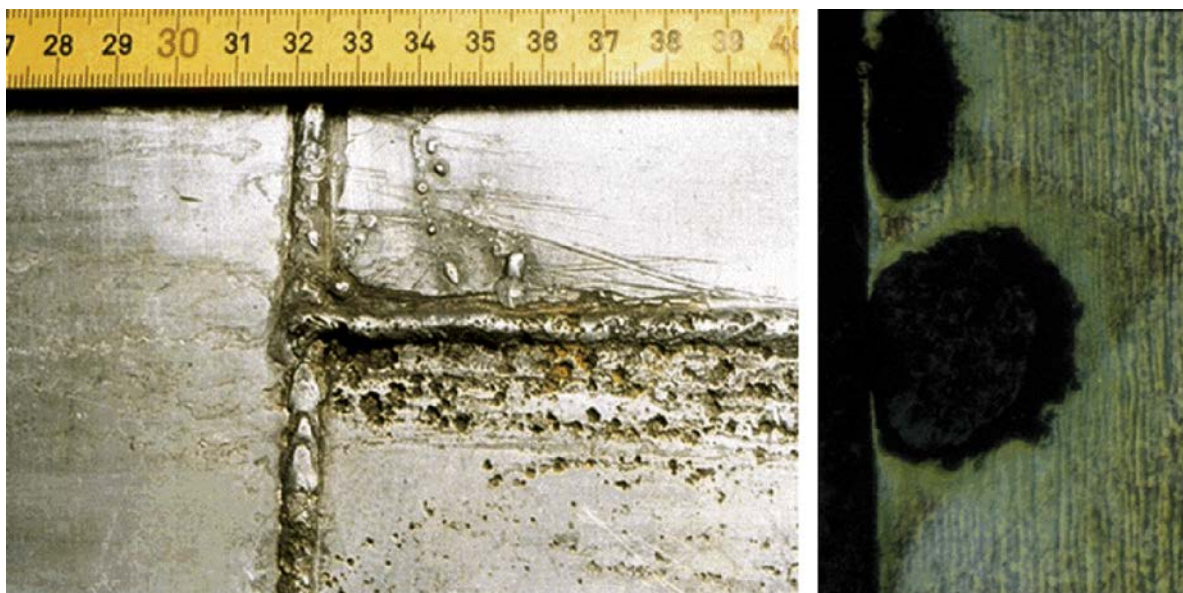
APPEARANCE	Internal pitting attack of the plate, lower right.
TIME IN SERVICE	6 years.
ENVIRONMENT	Benzene-containing organic compound with a small quantity of water and traces of SO ₂ . Temperature 50°C.
CAUSE	Under the prevailing conditions (reducing chloride-containing environment at 50°C), stainless steel AISI 304 is susceptible to chloride particularly in the neighborhood of the welds. The pitting attack only appeared, however, at some places in the plant, constructed completely in stainless steel 304. Systematic analysis of a great number of metal samples showed that all the attacked plates had a Mo-content of <0.1% (which is normal for AISI 304). The plates with some tenths of 1% Mo (as contaminant) showed no pitting (see also Case History 04.05.12.01).
REMEDY	Construct tank from AISI 316 stainless steel.

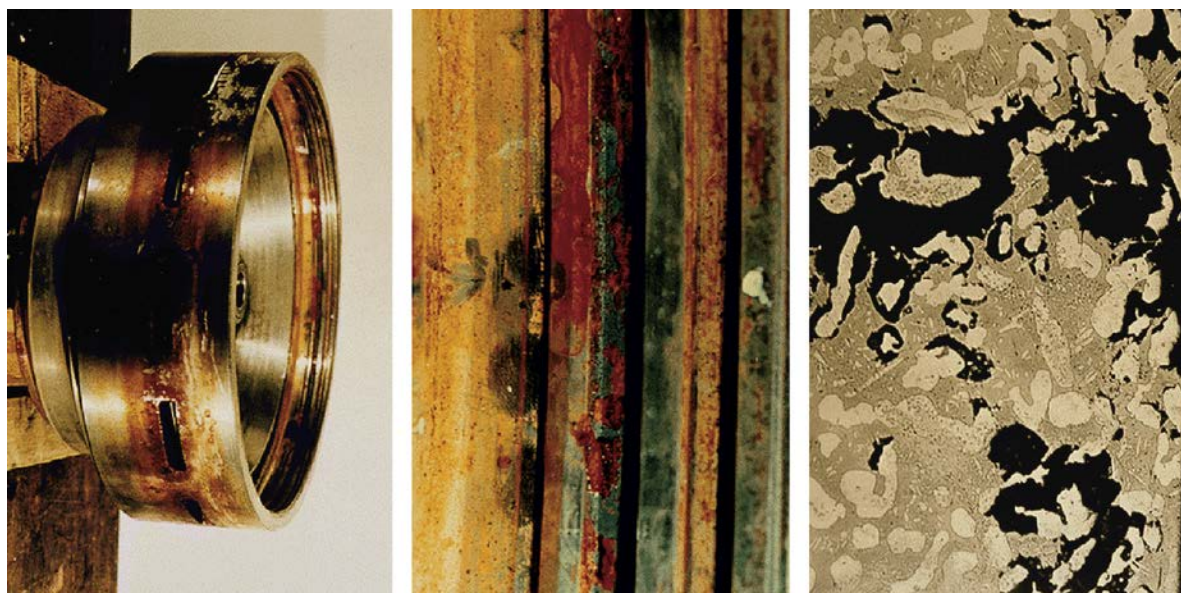
APPEARANCE Small pinhole defects.

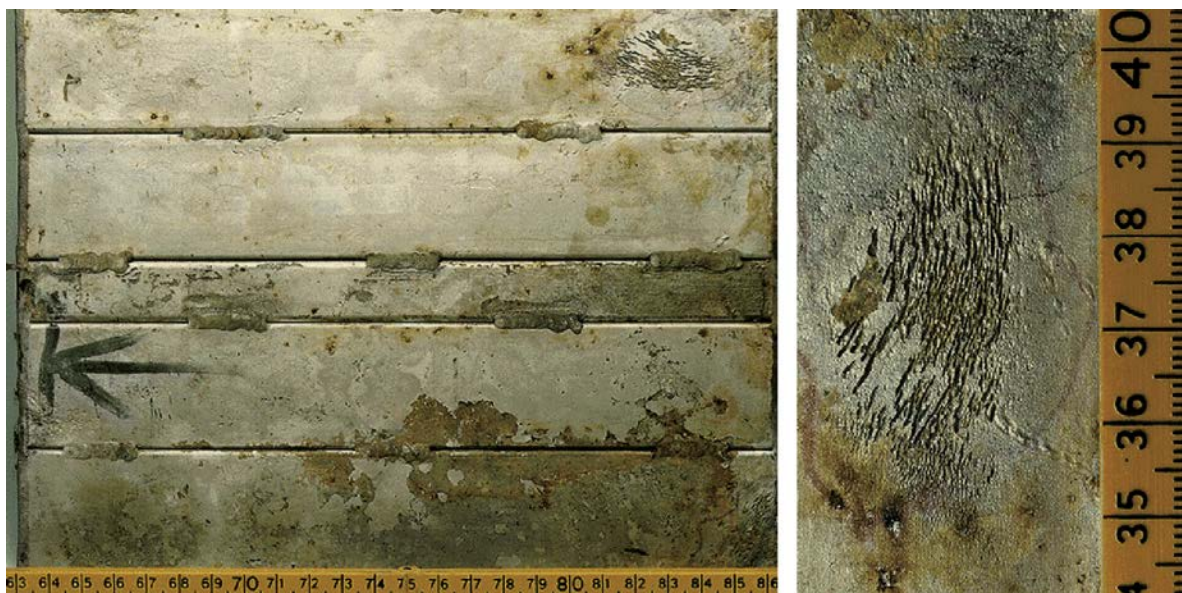
APPEARANCE	Pitting attack; attack more severe at the damaged oxide skin.
TIME IN SERVICE	Unknown.
ENVIRONMENT	Hydrofluoric acid vapors in a moist environment (relative humidity 75%–80%).
CAUSE	Stainless steel AISI 304 has poor HF resistance. As a result of condensation, the shields were etched by dilute HF.
REMEDY	Shields were constructed of stainless steel AISI 316, which has a serviceable HF resistance at room temperature in concentrations <10%.

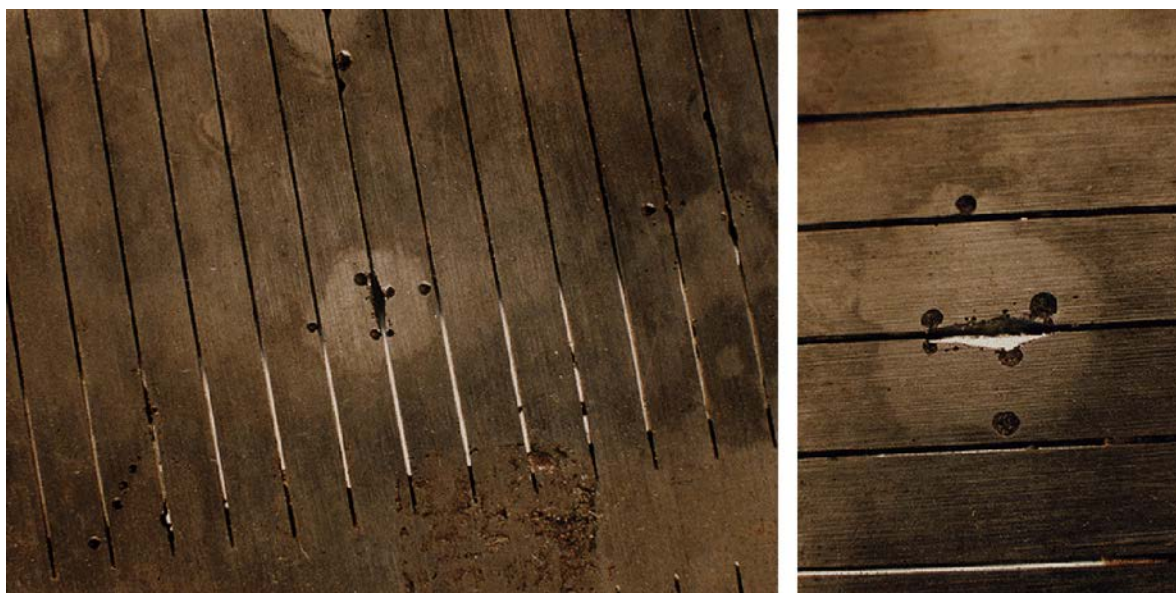
APPEARANCE Pitting under deposits.

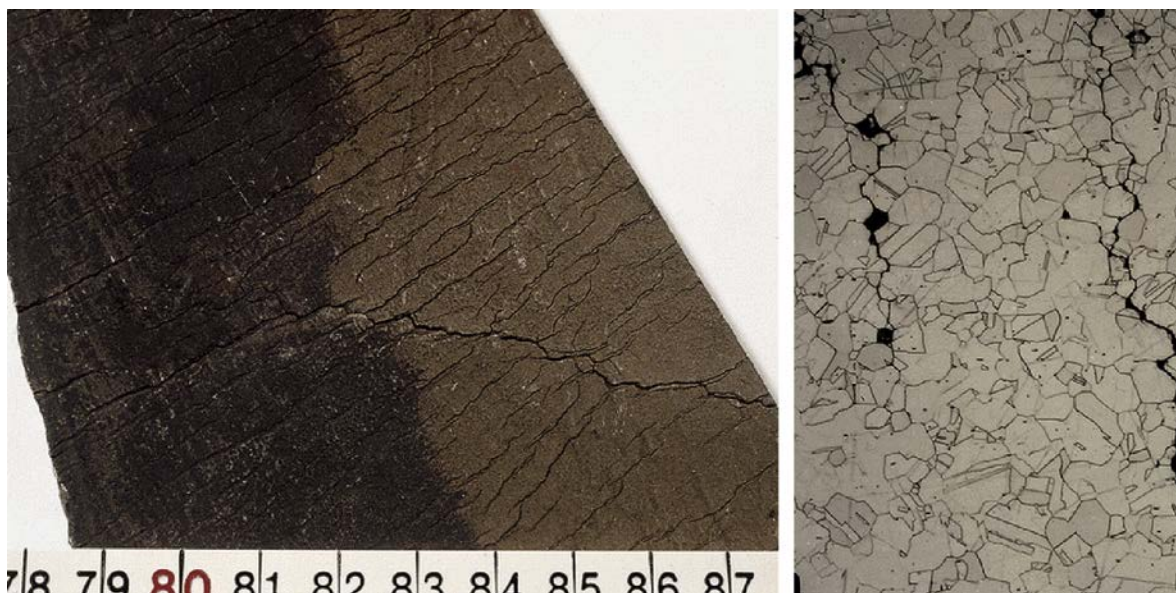
APPEARANCE Intergranular cracking.

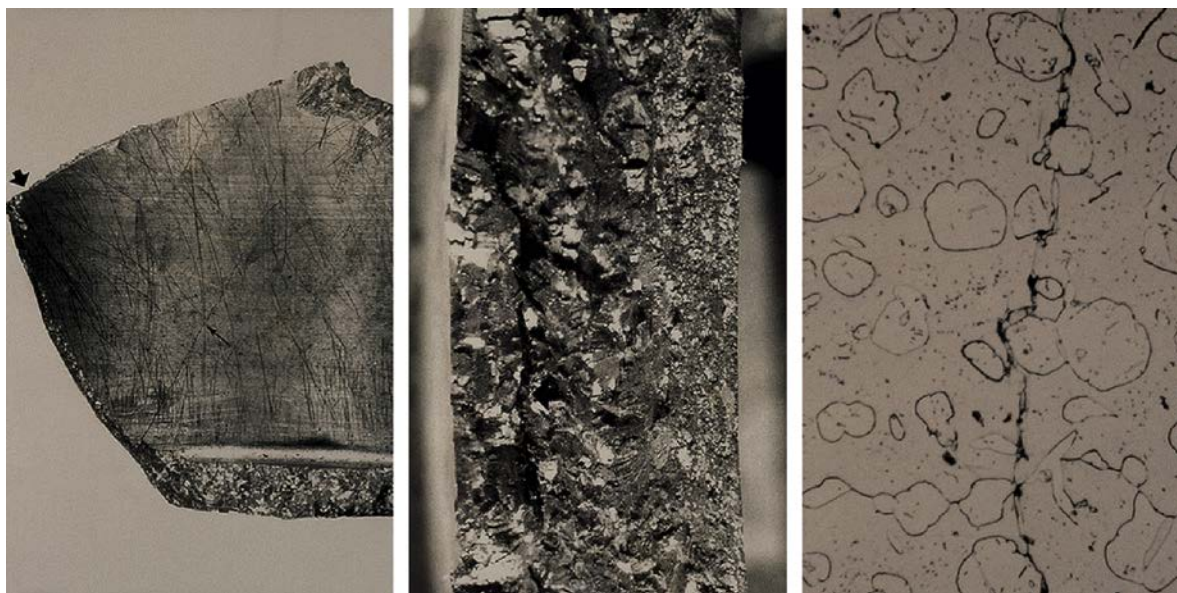
APPEARANCE Left photograph: a piece from the underside of the bowl.
Middle photograph: detail of the fraction at the arrow showing a crack parallel to the surface.

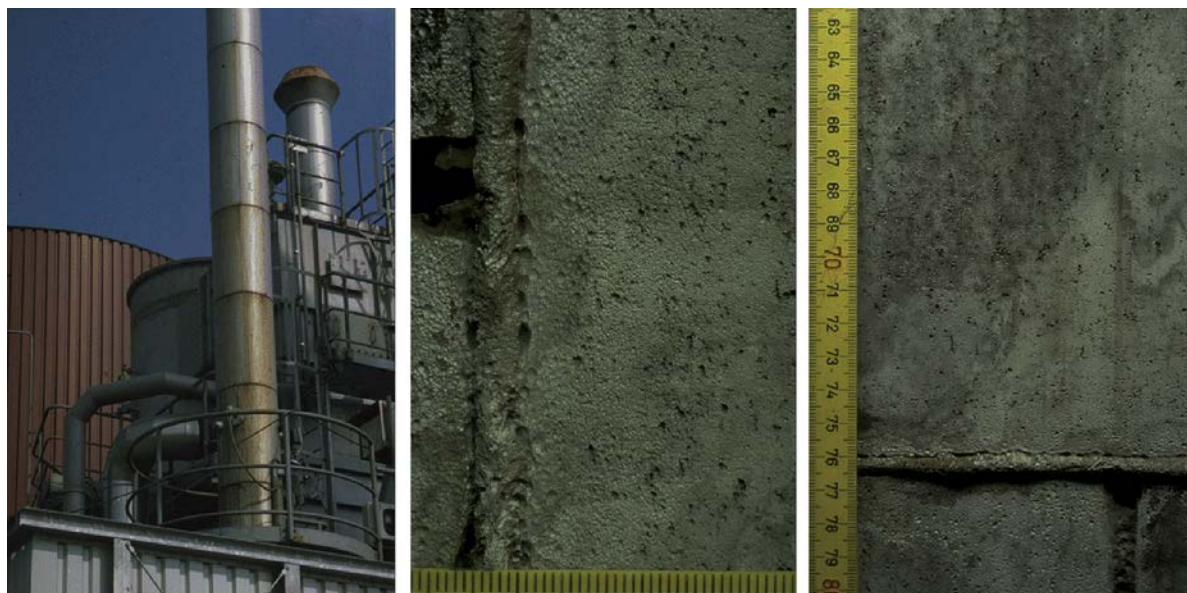
APPEARANCE	Left-hand photograph: external corrosion of aluminum plating. Center photo: severe pitting attack, most severe in the vicinity of the welds. Right-hand photograph: razor-sharp attack directly alongside the weld.
------------	---

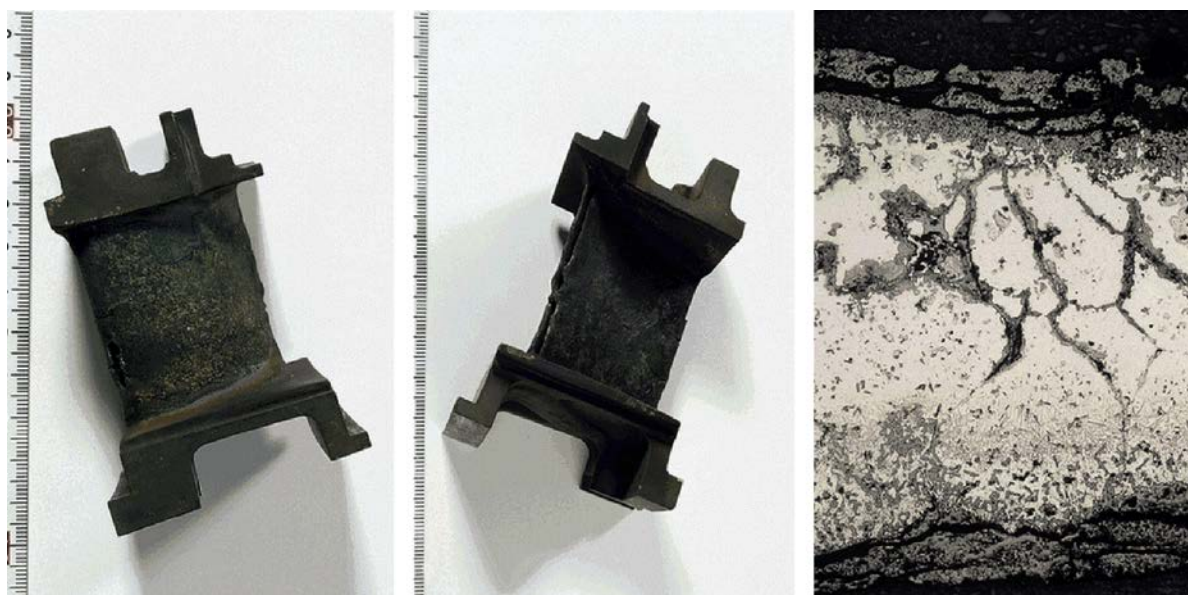
APPEARANCE Uniform attack with dark-green corrosion products.

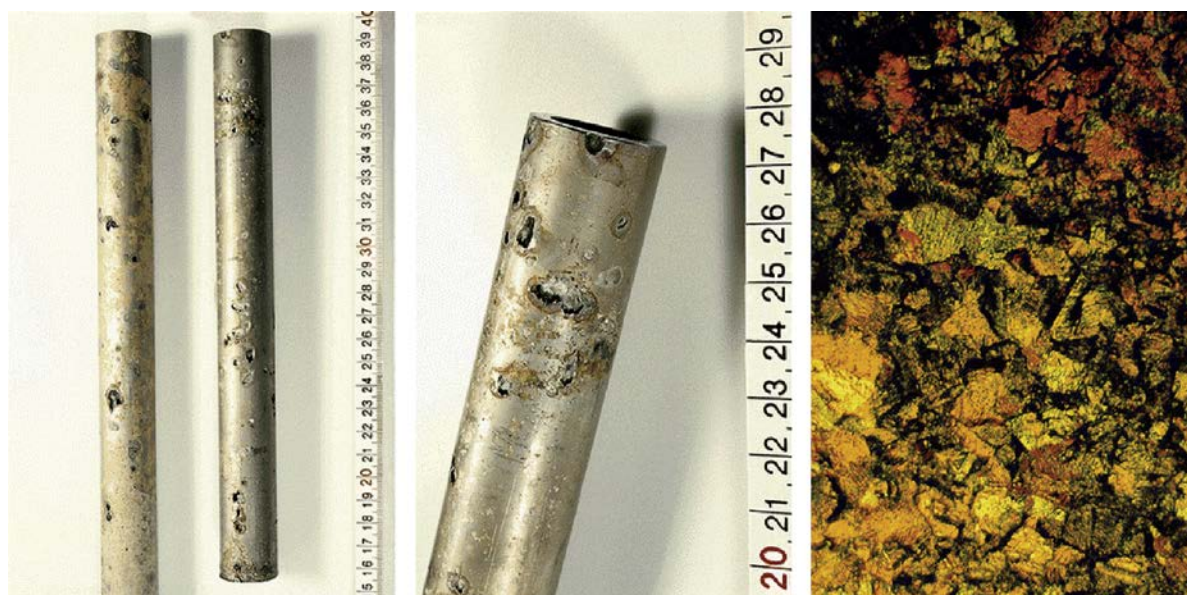
APPEARANCE Wide, deep pitting attack to leakage.

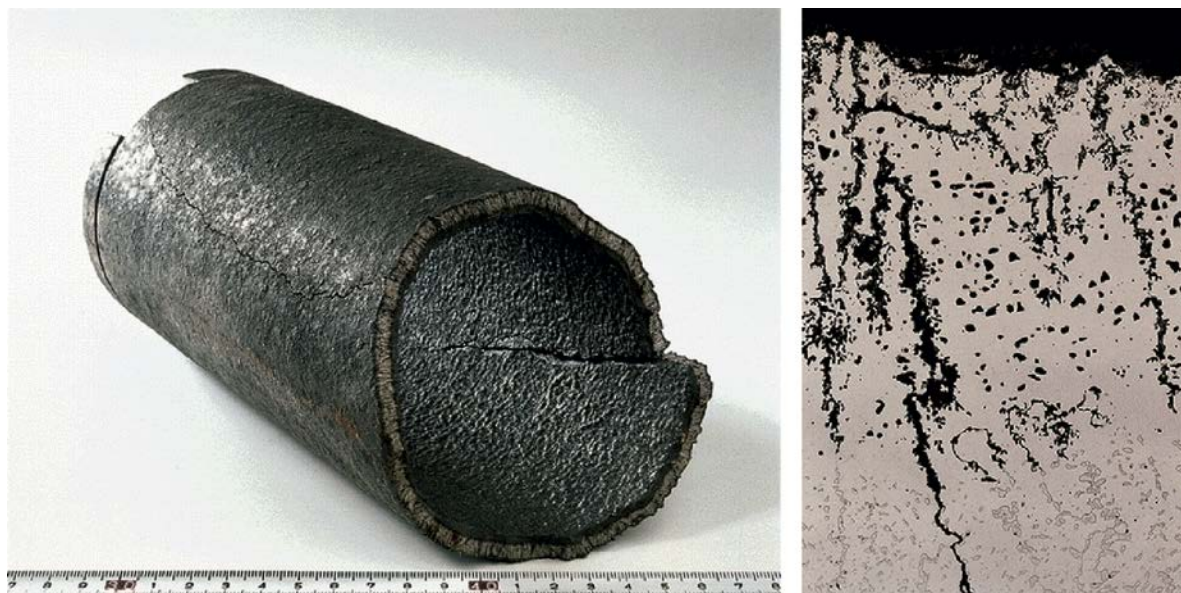
APPEARANCE Uniform attack with cracking; reduction of wall thickness by 3–5 mm.

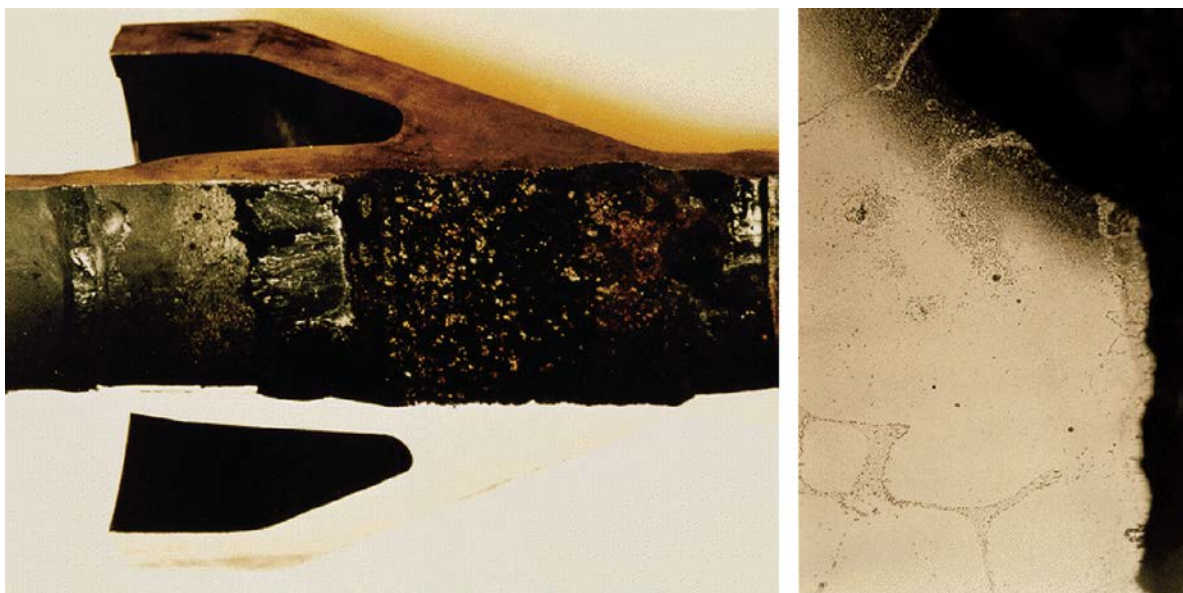
APPEARANCE Local pitting attack.

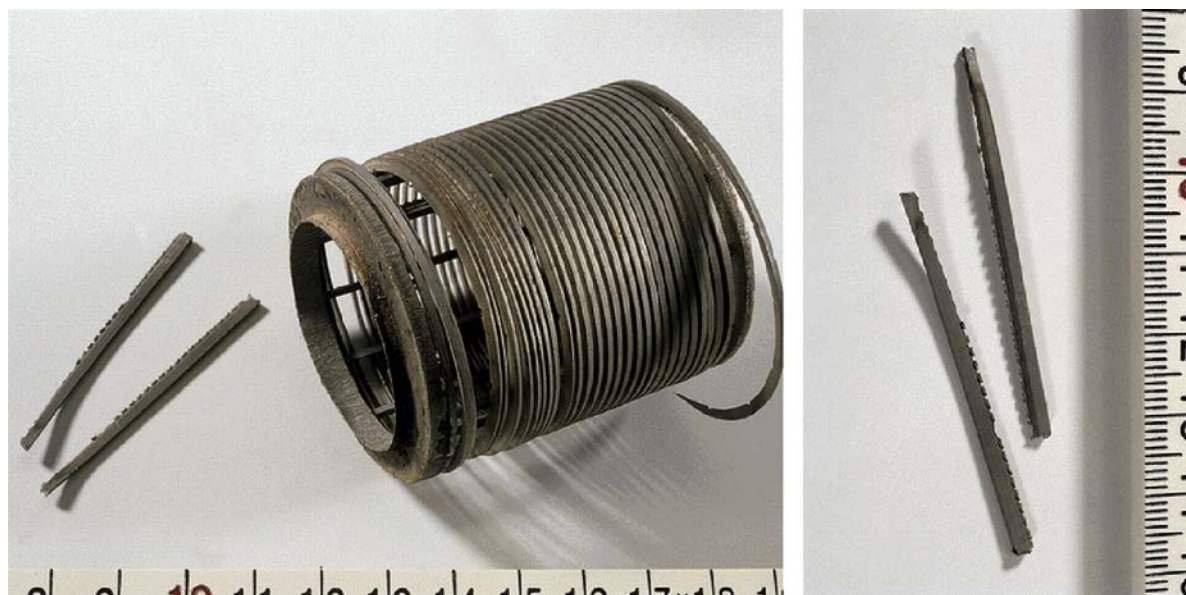
APPEARANCE	Severe uniform corrosion, mainly at the vessel side of the strainer. The opening of the strainer has widened and the friction weldments of the rods and the wire are also corroded.
TIME IN SERVICE	6 months.
ENVIRONMENT	Sulfuric acid 90% at 95 °C.
CAUSE	The strainer was mounted in a Hastelloy C276 vessel and both end parts of the strainer were made of C276. The wire and rods were made of Hastelloy C22. Both materials have a good corrosion resistance in sulfuric acid. In combination, however, there will be galvanic corrosion of Hastelloy C22.
REMEDY	<ul style="list-style-type: none"> • Use one single material for the strainer: Hastelloy 276. • Solution annealing followed by water quench of the strainer after fabrication will enlarge the corrosion resistance of the friction weldments.

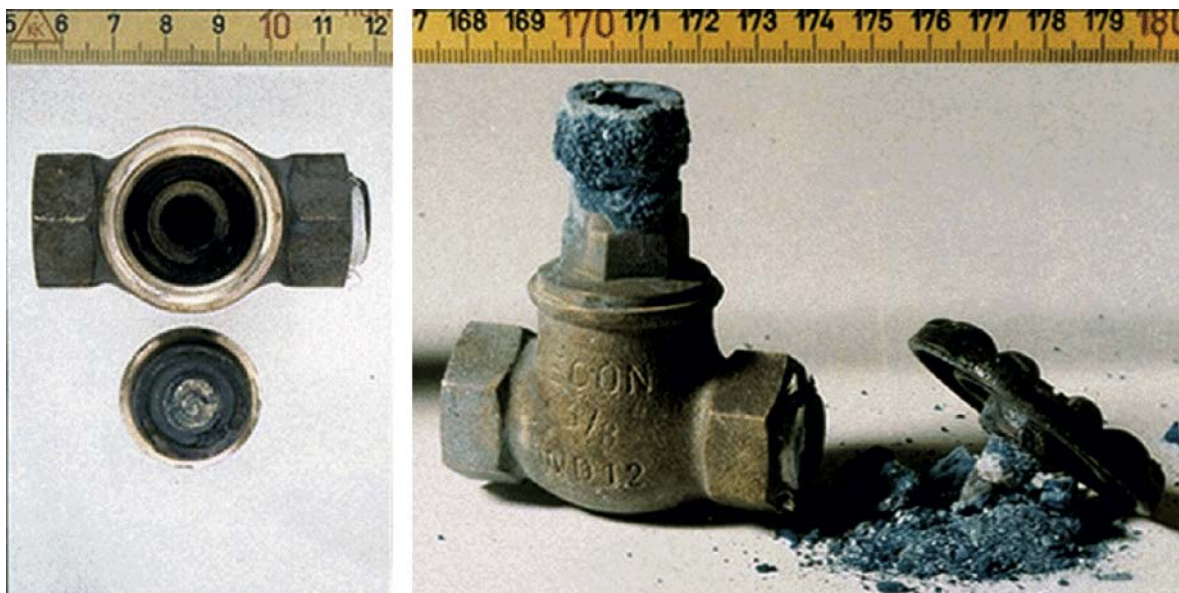
APPEARANCE Internal: erosion corrosion to the point of leakage; external: uniform attack; with blue corrosion products (see also Case History 06.13.10.01).

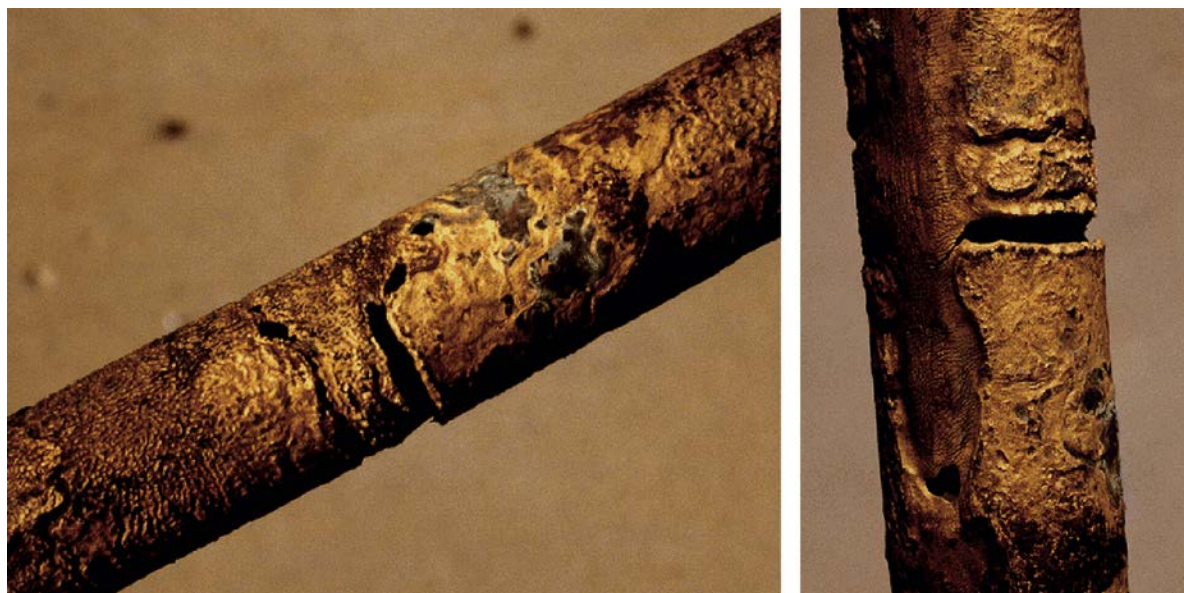
APPEARANCE	General attack with fine grooves.
TIME IN SERVICE	18 months since last inspection, which found no significant damage.
ENVIRONMENT	Ammonia-containing steam.
CAUSE	Wastage took place by condensing ammonia-containing steam. The ammonia was produced by breakdown of hydrazine and carry-over in steam (see also next Case History).
REMEDY	Start-up procedures were improved and gas venting increased in air removal section of exchangers.

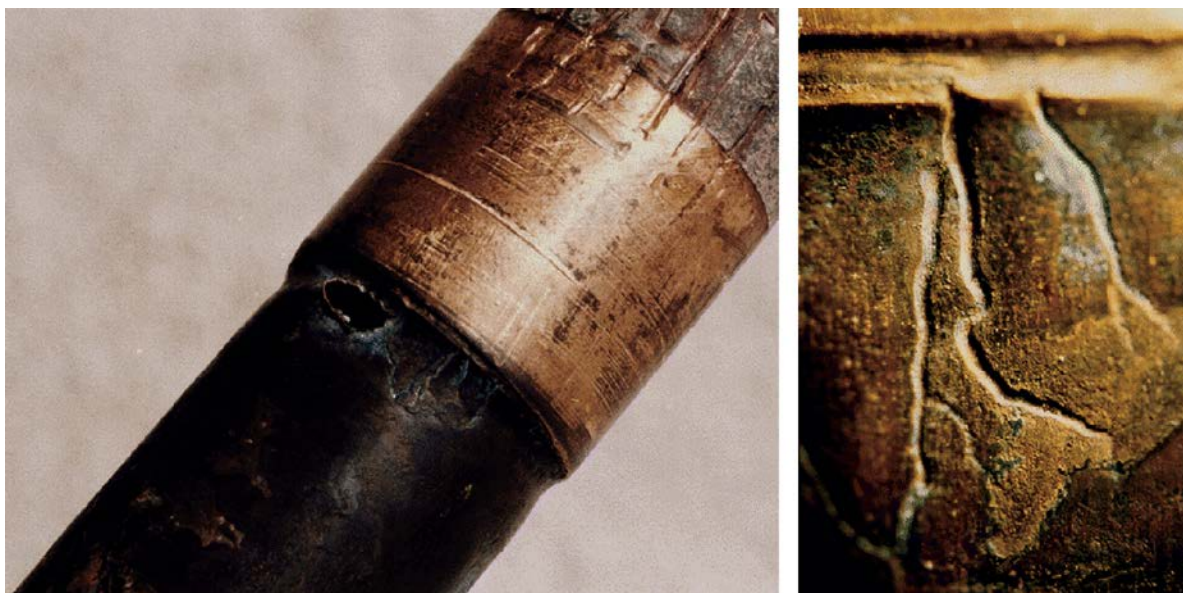
APPEARANCE	Severe grooving in the direction of gravity. A thin dark oxide layer, replaced in places by a dark green patina.
TIME IN SERVICE	14 years.
ENVIRONMENT	Saturated steam 41–54 °C. Analysis: During normal service: NH_3 <0.3 ppm, pH 8.7–9.0, dissolved oxygen 10–20 ppb; during start-up (once or twice a year): NH_3 up to 75 ppm, pH 8.7–9.4, dissolved oxygen up to 3500 ppb, hydrazine 10–20 ppb.
CAUSE	Wastage was caused by condensate containing high concentrations of ammonia, carried over in steam from boiler-water treatment. The ammonia-rich condensate ran down the tube sheet and collected at tube ends, causing pronounced localized wastage.
REMEDY	Basically, improve gas removal during start-ups. Much damage is caused during start-ups, when NH_3 concentrations may exceed several hundred parts per billion.

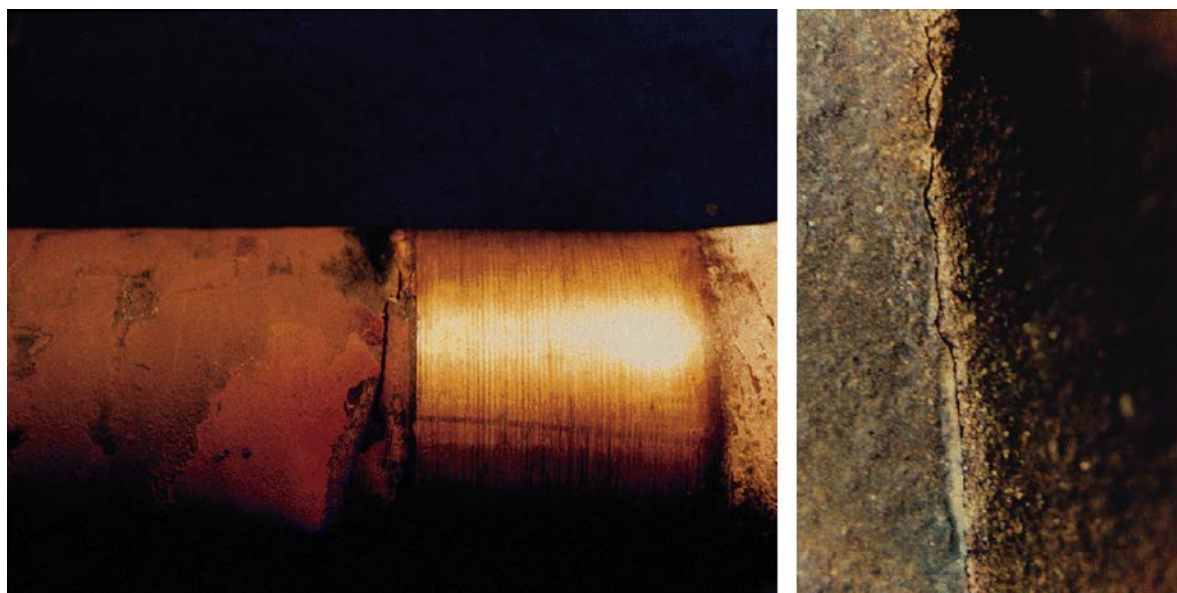
APPEARANCE	Circumferential crack adjacent to location of tube sheet. Microprint (magnification $\times 33$) shows straight unbranched crack.
TIME IN SERVICE	25 years (the failure had occurred in a much shorter time).
ENVIRONMENT	Internal: circulating cooling water pH 7.8–8.2. External: Steam and condensate treated with an oxygen scavenger and ammonia, pH 7.8–9.2, temperature ambient to 66 °C.
CAUSE	The condenser had lastly been in cyclic service. Microstructural examinations revealed straight, unbranched transgranular cracks, typical of corrosion fatigue. The cracks originated on the external surface where the corrosion was superficial. In view of the circumferential appearance of the crack, the cyclic stresses responsible for this failure were apparently bending stresses, associated with cyclic thermal expansion and contraction (for longitudinal fatigue crack in copper, see Case History 06.06.28.01).

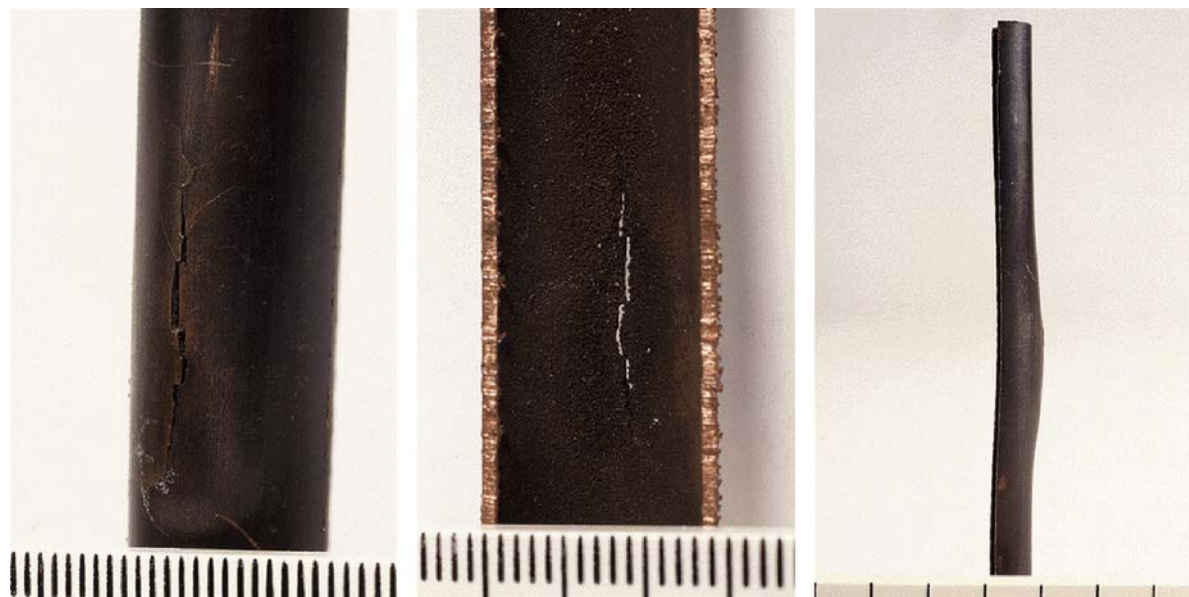
APPEARANCE	Bulging with cracking starting from inside; photographs on the left and in the middle: cracking outside and inside; photograph on the right: bulging outside.
------------	---

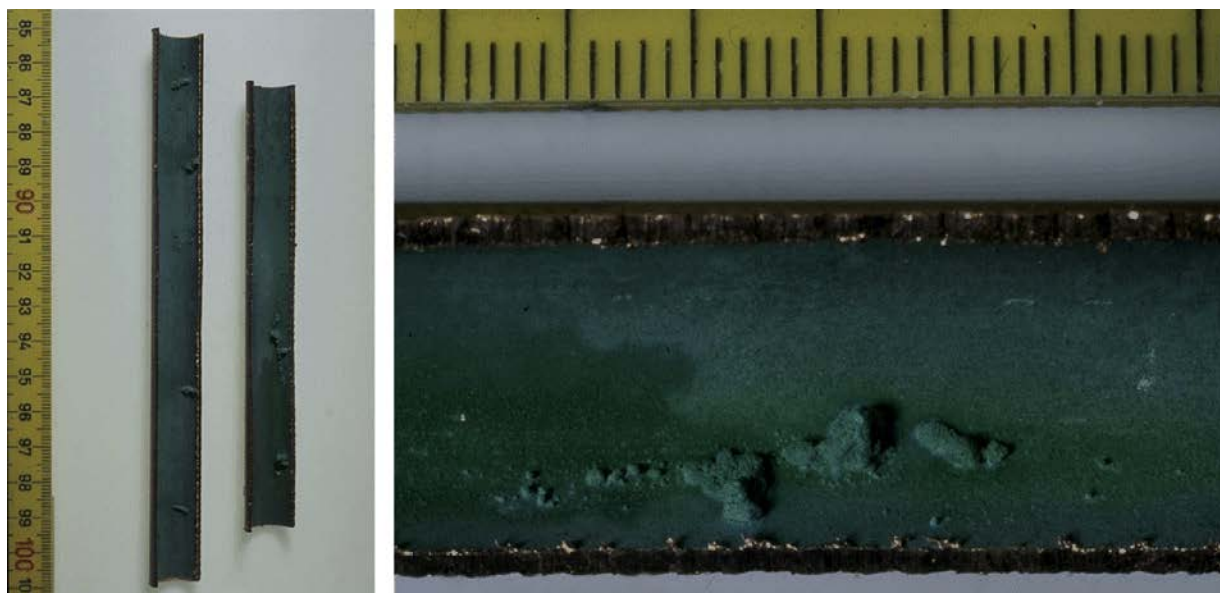
APPEARANCE	Pitting corrosion underneath corrosion nodules only at the upper side in pipes often containing standing water.
------------	---

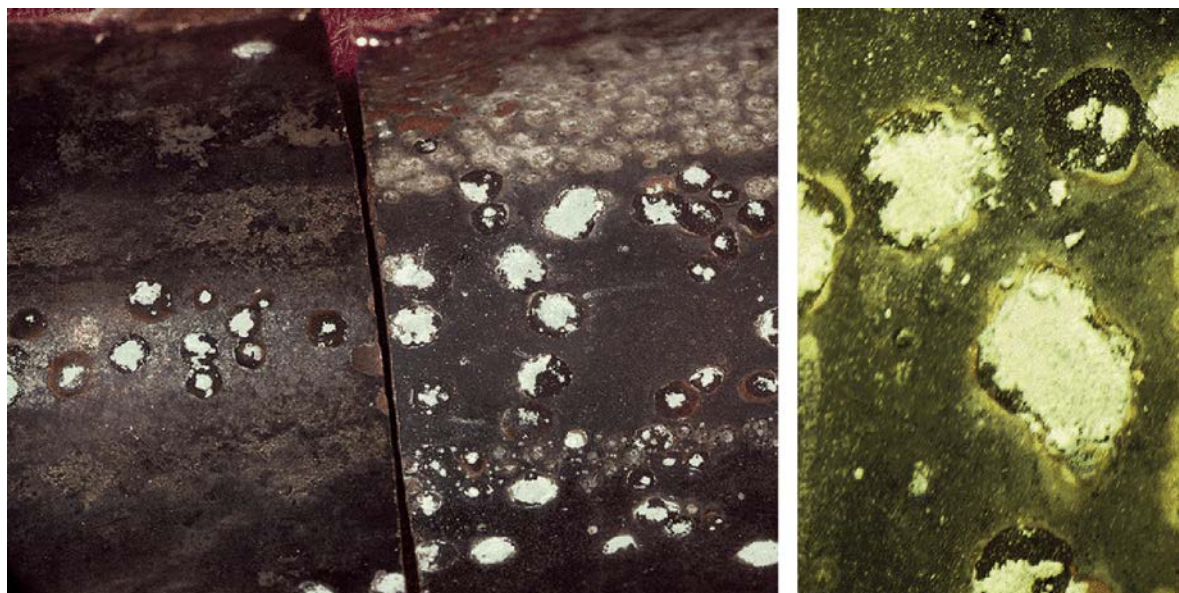
APPEARANCE Little pits covered with black, green, and blue white deposits and corrosion products.

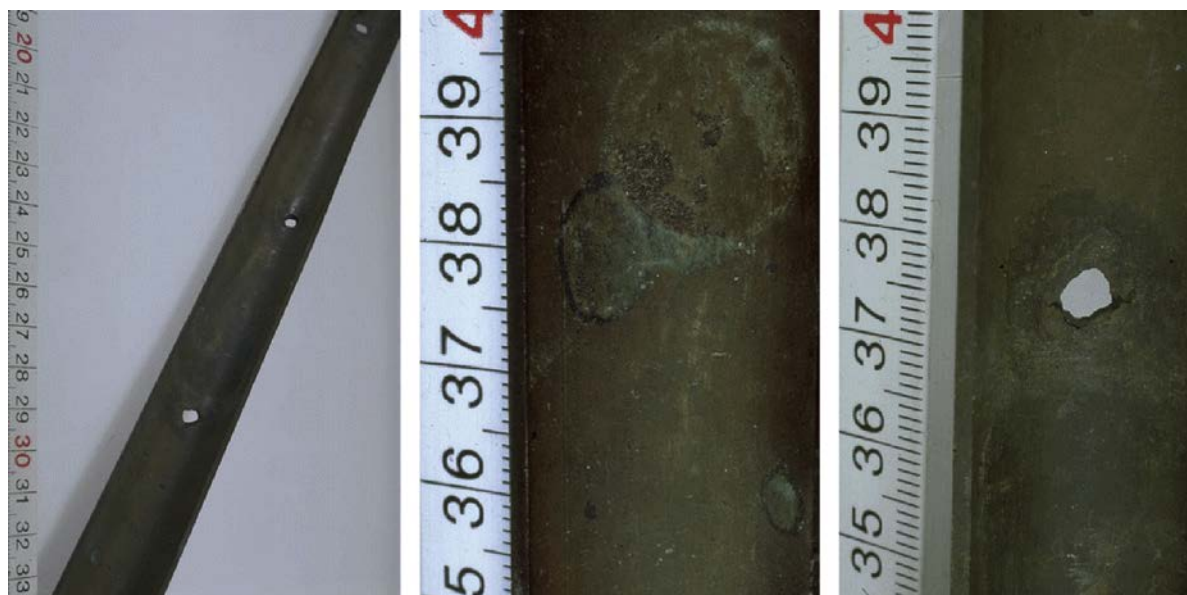
APPEARANCE Pitting attack.

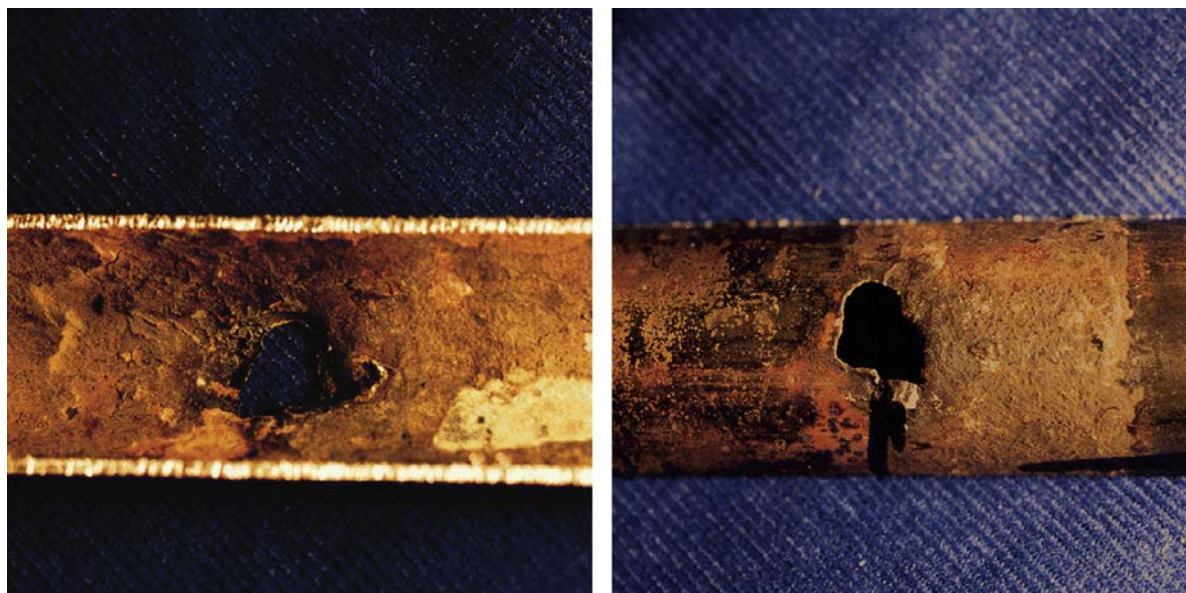
APPEARANCE	Perforation originating from the internal surface along the bottom of the tube where it rested on the steel baffle.
TIME IN SERVICE	Unknown.
ENVIRONMENT	Internal: cooling water. External: steam and condensate.
CAUSE	Tube metal temperatures were higher in the area of contact with the baffle than at adjacent locations. The hotter tube metal at the baffle established a thermogalvanic cell with the surrounding cooler metal, causing metal wastage in the hotter region.
REMEDY	Thermally isolate tube from baffle.

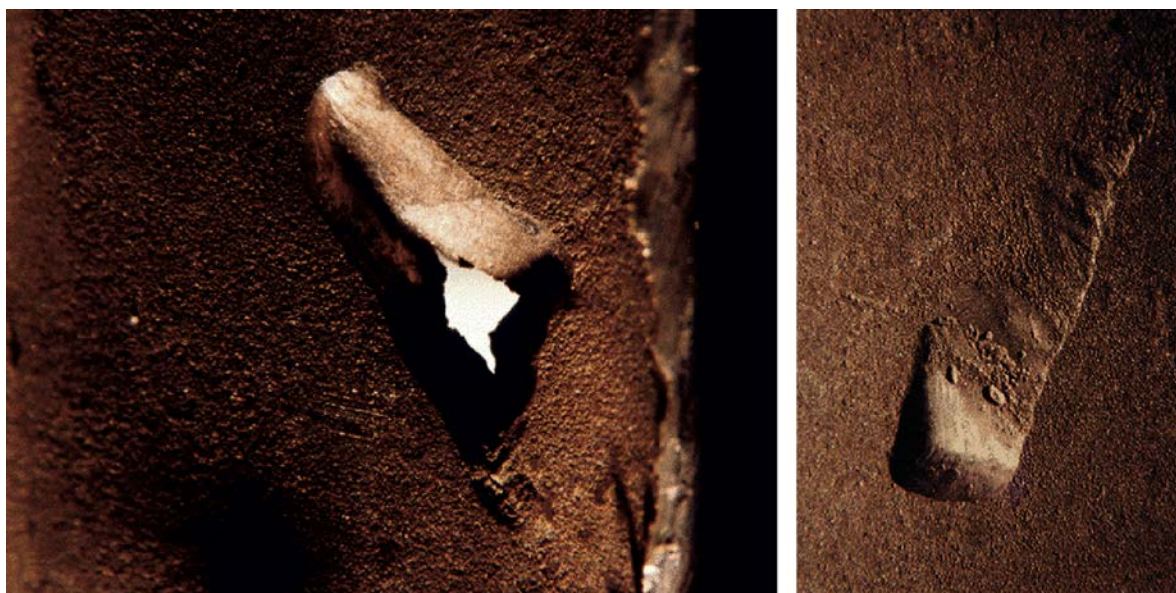
APPEARANCE Irregularly shaped patterns of highly localized metal loss.
