Corrosion Atlas

THIRD, EXPANDED AND REVISED EDITION

A Collection of Illustrated Case Histories

Evert D.D. During

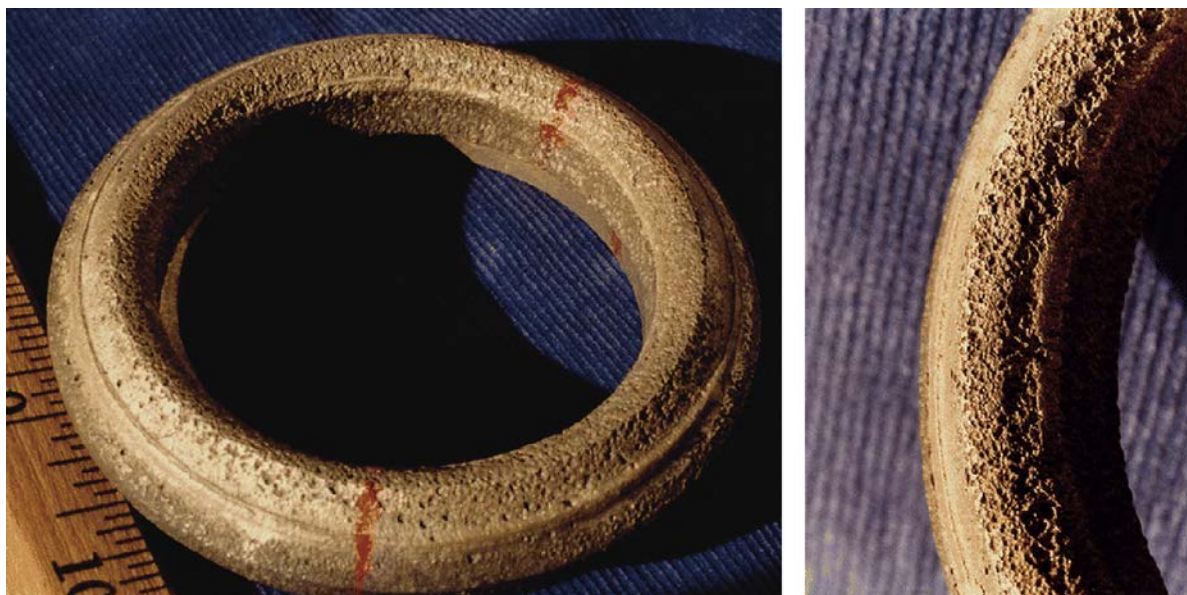
APPEARANCE Pitting (red marks were drawn on the surfaces to assist metallographic preparation).

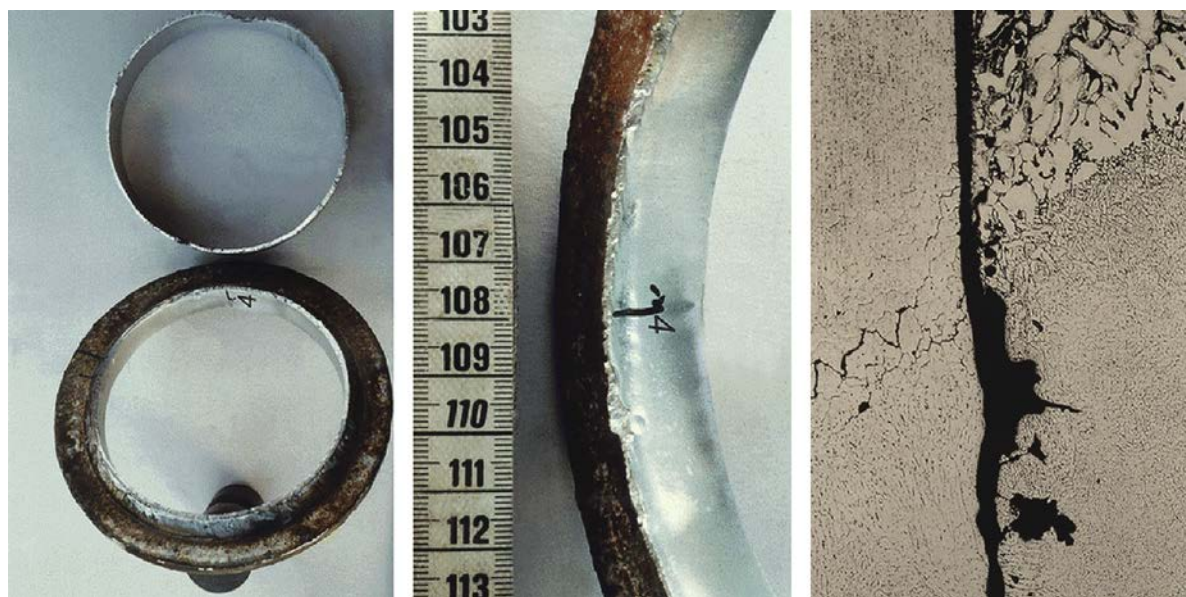
APPEARANCE Intergranular cracking in weld Heat Affected Zone (HAZ) (melt cracks).

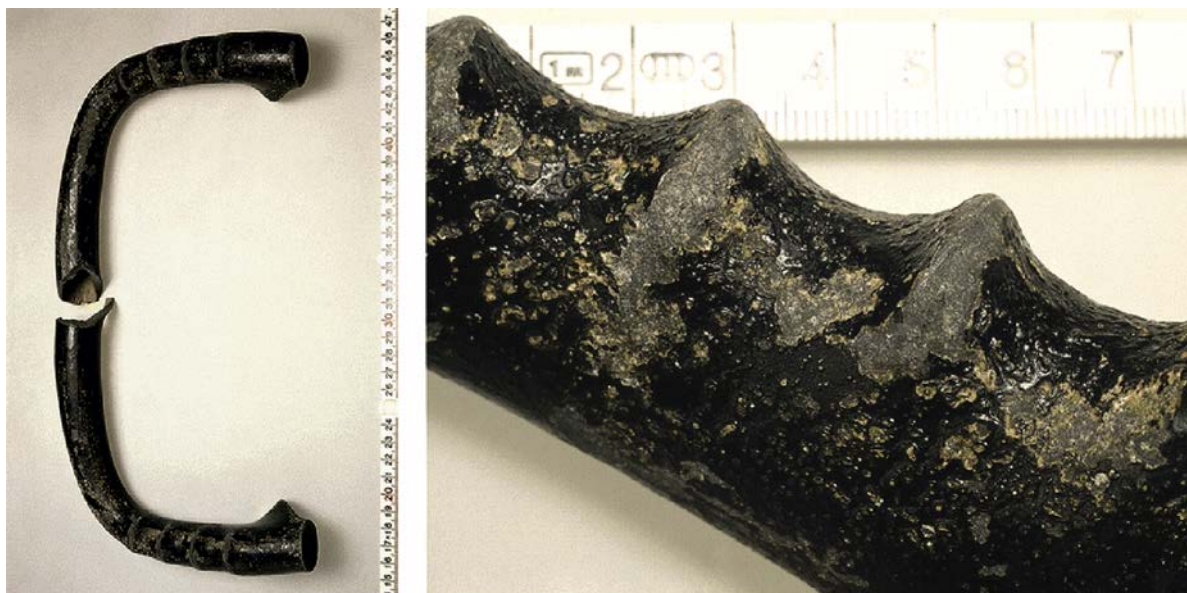
APPEARANCE General attack.

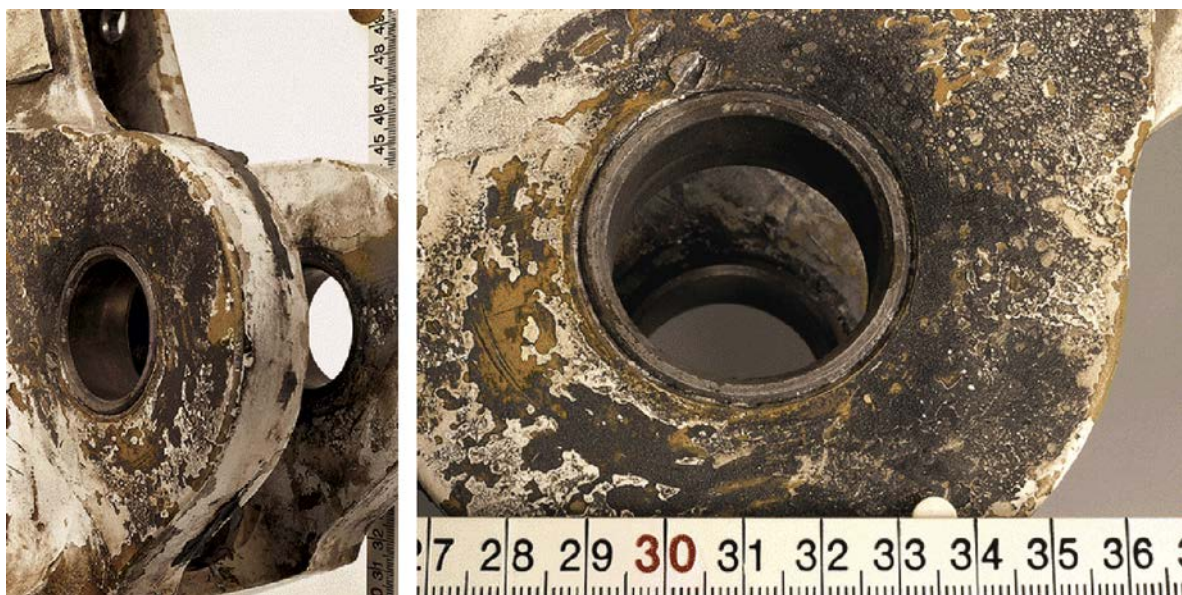
APPEARANCE Exfoliation of the side stay bracket surface around the bush hole.

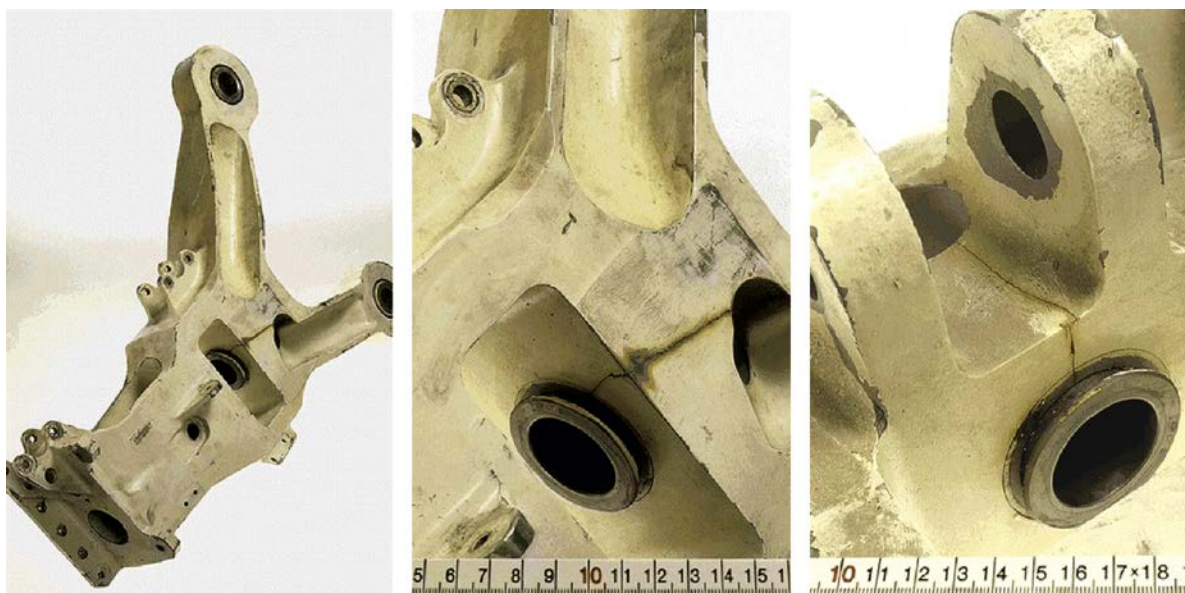
APPEARANCE Through crack.

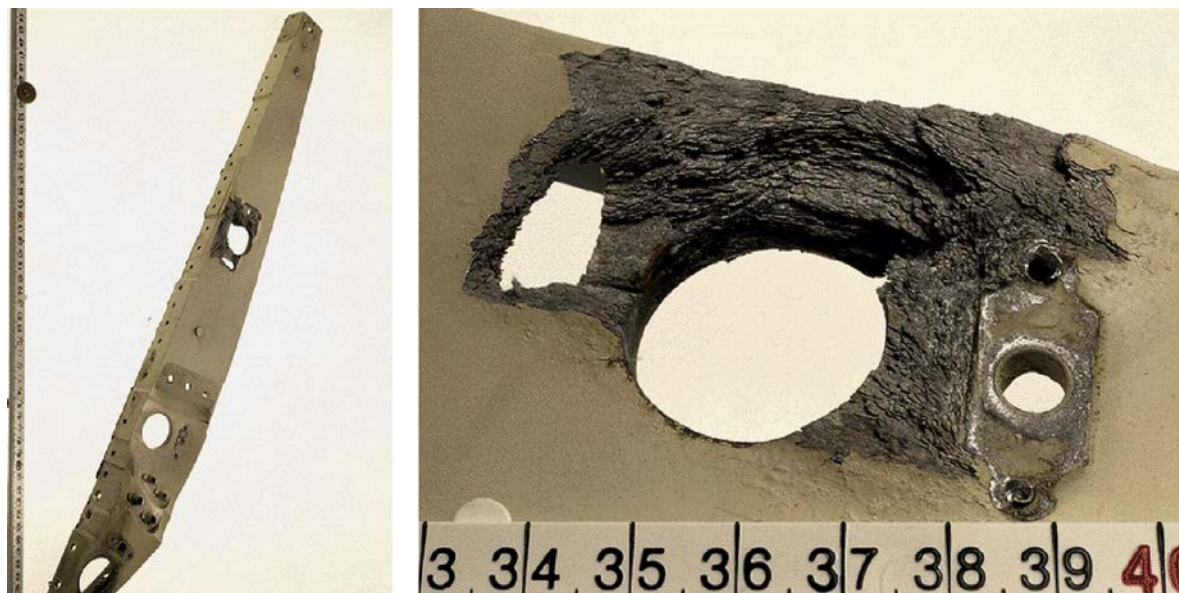
APPEARANCE Layered corrosion around the bush hole.

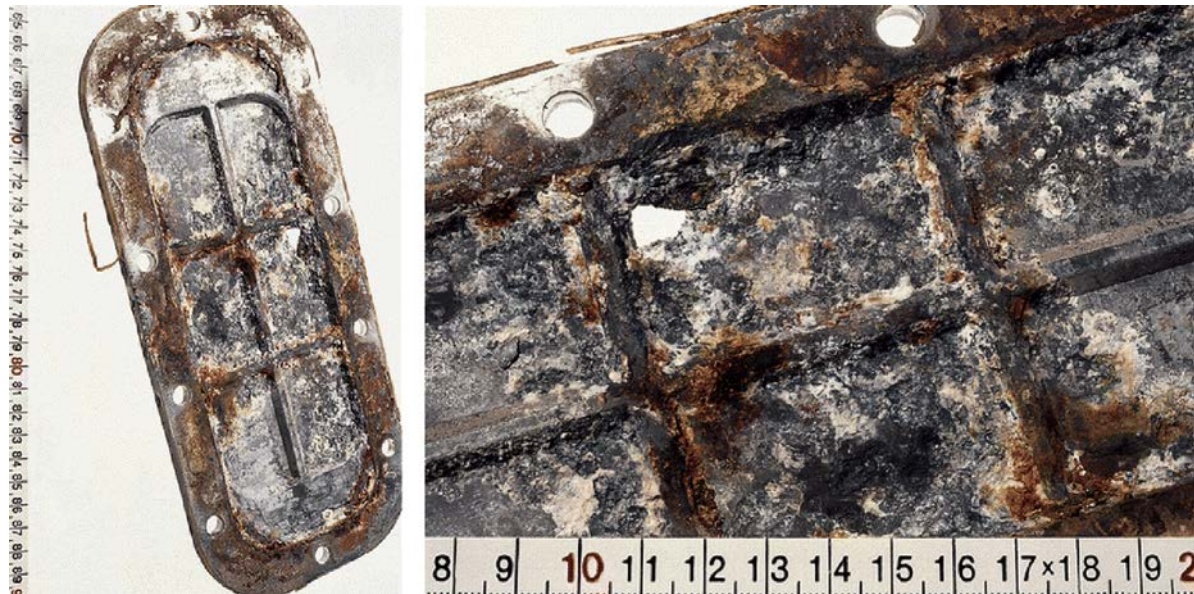
APPEARANCE Pitting and overall corrosion with deposits.

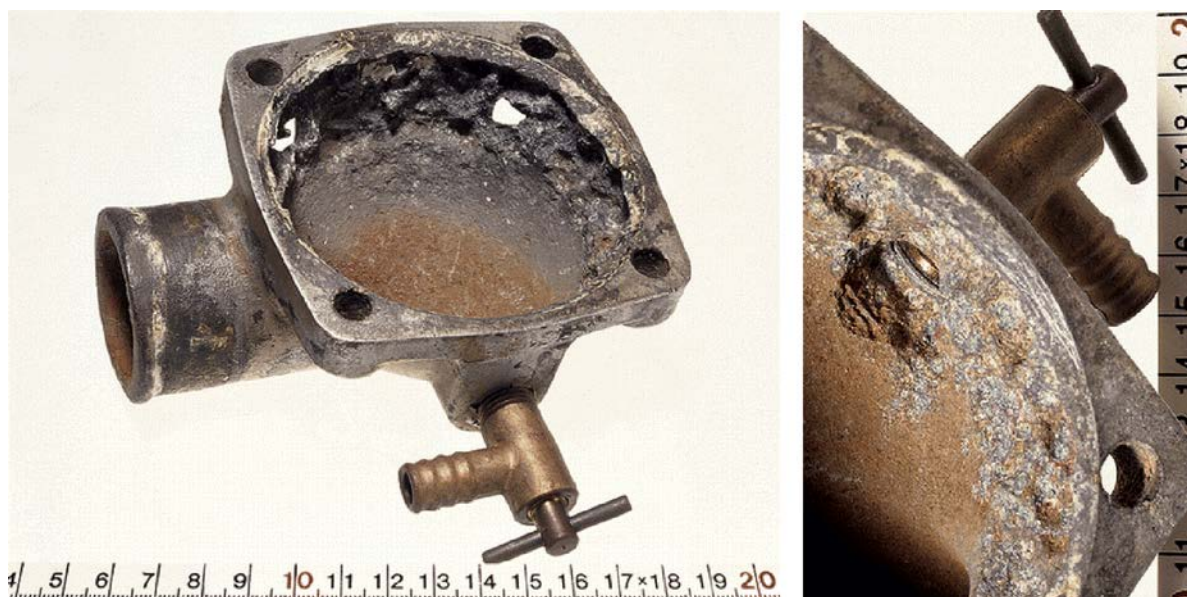
APPEARANCE Severe corrosion near the connection with the brass tap. The lowest part of the lid (upside down on the left photo) shows very severe corrosion all around, with holes.

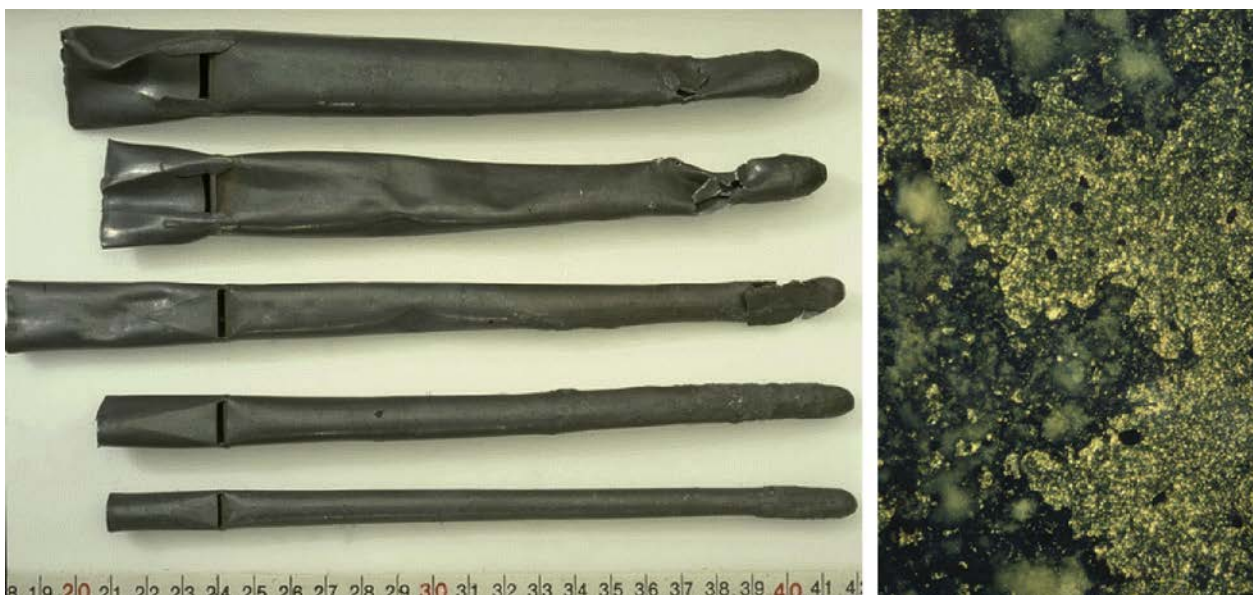
APPEARANCE At the right-hand extremities, the pipes exhibit spots of grey tin, formation of white powder, and an uneven surface and have fractured locally.

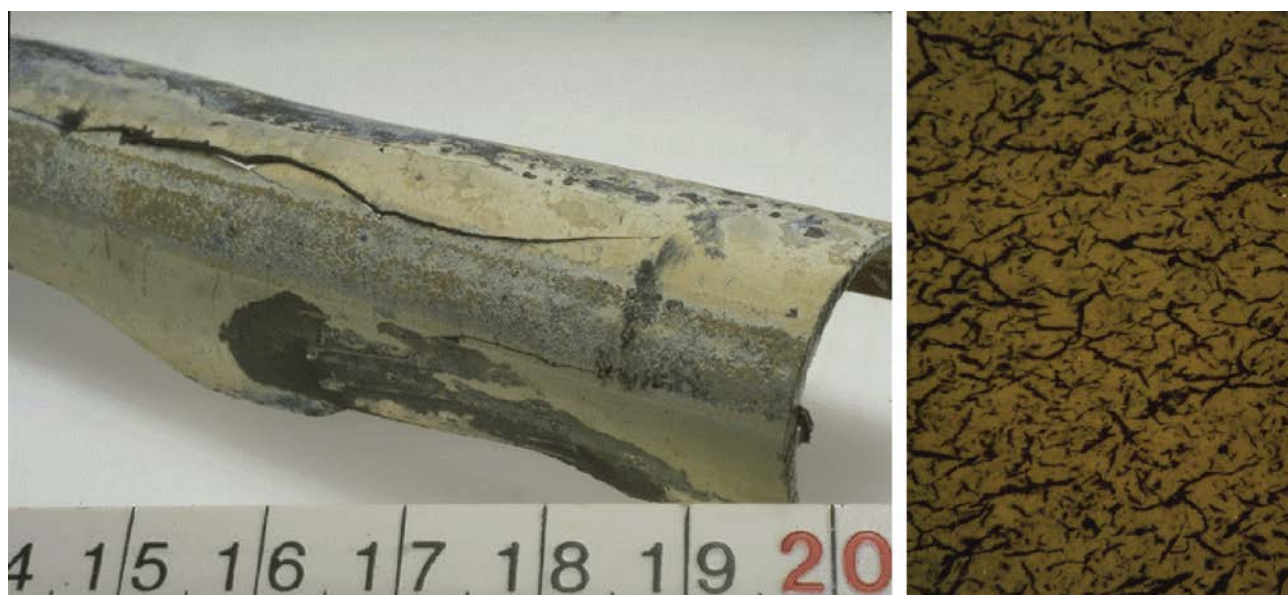
APPEARANCE Cracking and uniform corrosion, the wall thickness being reduced from 3 to 1 mm.

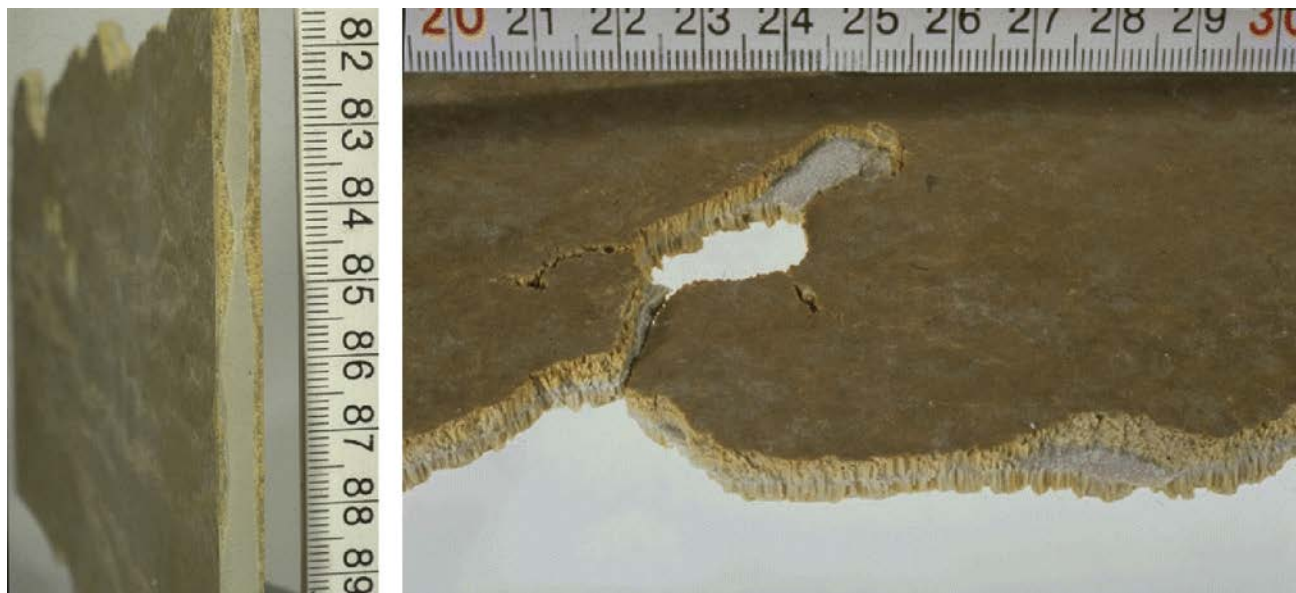
APPEARANCE Fractured.
Material exhibits two-sided discoloration from gray to yellow, with needle structure.
