Corrosion Atlas

THIRD, EXPANDED AND REVISED EDITION

A Collection of Illustrated Case Histories

Evert D.D. During

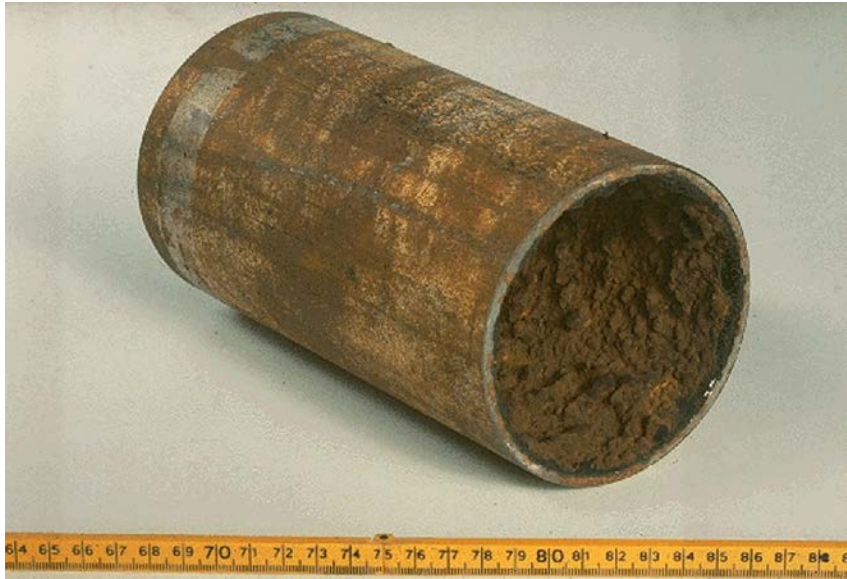
01.01.01.01

MATERIAL	Carbon steel.
SYSTEM	Boiler feed system.
PART	Feed line from deaerator to boiler.
PHENOMENON	Oxygen corrosion.

APPEARANCE	Many pits covered with knob-like mounds of iron oxide corrosion products (tubercles; see also Case Histories 01.05.01.01 , 01.06.01.01 , and 01.06.01.02).
TIME IN SERVICE	About 2 years.
ENVIRONMENT	Deaerated feedwater is a mixture of steam condensate and dealkalized and softened makeup water; pH 5; chloride (Cl ⁻) 10 p.p.m.; temperature 105°C.
CAUSE	Excessive oxygen in the feedwater owing to malfunctioning deaerator.
REMEDY	<ul style="list-style-type: none"> • Improve deaerator operation: identify the cause of the malfunctioning by internal inspection to examine atomizers and steam injection nozzles and by measurement of the residual oxygen content under various loads. • Improve the boiler feedwater composition, keeping it alkaline.

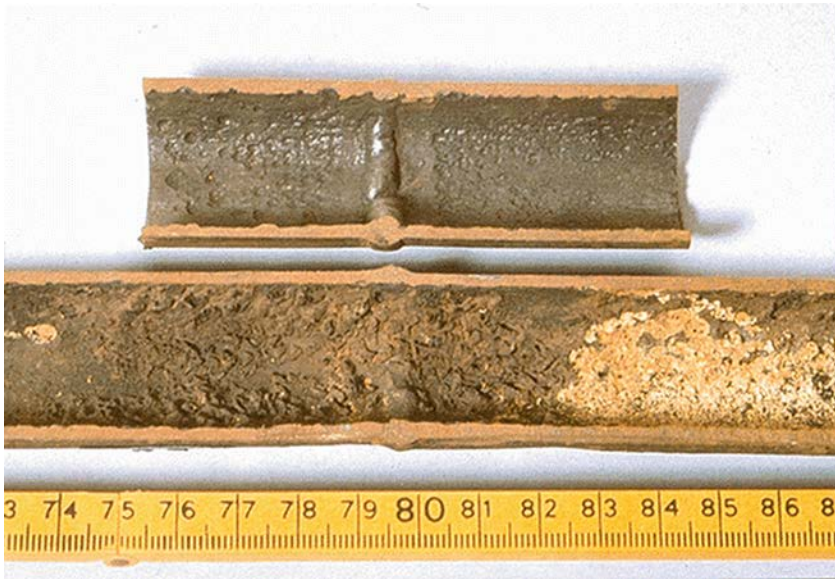
PART Economizer pipe (before and after laboratory cleaning).

PHENOMENON Oxygen corrosion.

APPEARANCE The upper pipe, cleaned with acid, shows pitting. In the lowest (not cleaned) pipe, the pits are covered with caps of iron oxide.

TIME IN SERVICE About 2 years.

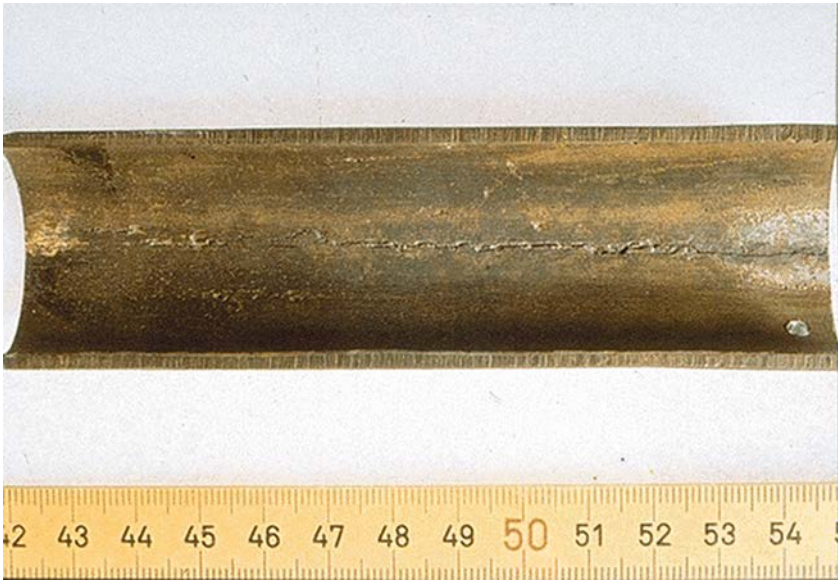
01.01.01.03

MATERIAL	Carbon steel.
SYSTEM	High-pressure water-tube boiler.
PART	Economizer pipe.
PHENOMENON	Oxygen corrosion.

APPEARANCE	Longitudinal crack.
TIME IN SERVICE	Unknown.
ENVIRONMENT	Boiler feedwater in the pipe; flue gases around the pipe.
CAUSE	The application of periodical shot-peening, to clean the flue gas side of the economizer, led to regular disturbance of the magnetite layer inside. The damaged spot is sensitive to further attack by traces of oxygen in the boiler feedwater.
REMEDY	<ul style="list-style-type: none"> • Regular inspection of the setting of the distributor pivot in the shot-peening unit. • Alternative: change to ultrasonic cleaning.

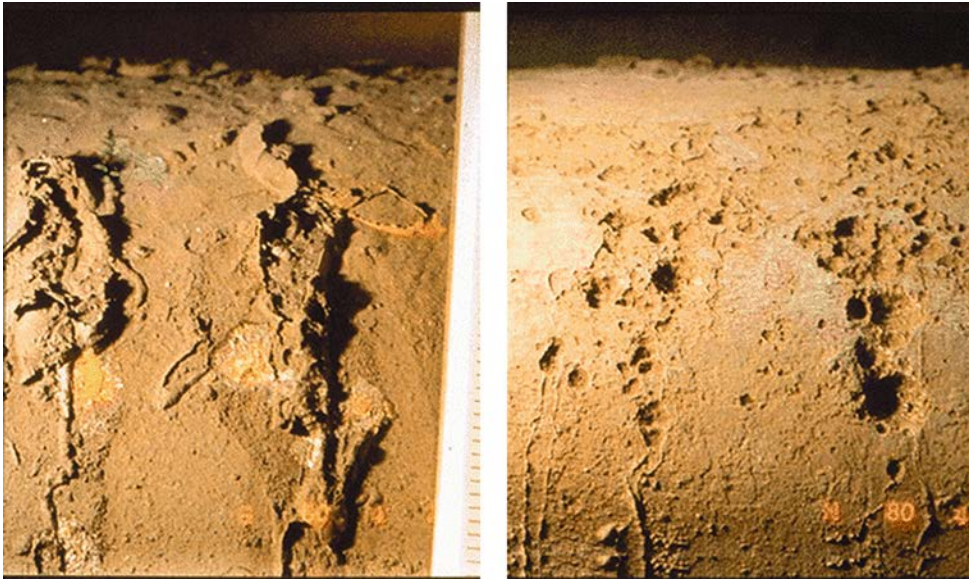
PART Fire tube (before and after cleaning).

PHENOMENON Oxygen corrosion.

APPEARANCE Pitting covered with blisters; pits about 2 mm in depth. The right-hand photo shows the tube after the corrosion products were brushed away.

TIME IN SERVICE 13 years.

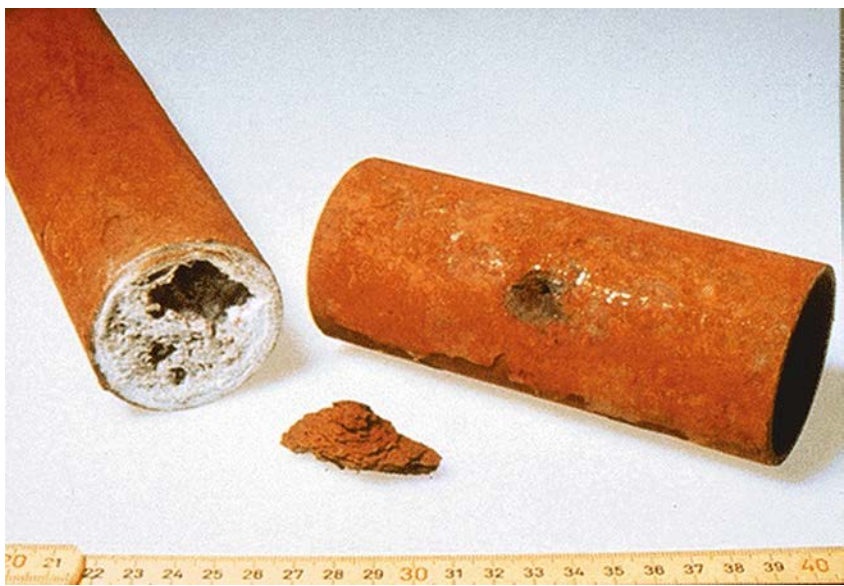
01.01.01.05

MATERIAL	Carbon steel (35.8).
SYSTEM	Shell-type fire-tube boiler (1.9 MPa).
PART	Fire tubes.
PHENOMENON	Oxygen corrosion.

APPEARANCE	Pitting attack underneath corrosion nodules at the bottom of the fire tubes.
TIME IN SERVICE	Approximately 10 years.
ENVIRONMENT	Boiler water; p alkalinity 12–20 meq/l (600–1000 p.p.m. CaCO ₃); chloride (Cl ⁻) 130–220 p.p.m.; phosphate (PO ₄ ³⁻) 50–70 p.p.m.; iron (Fe ²⁺) 15–50 p.p.m.
CAUSE	Malfunctioning deaerator: as the deaerator was being charged, the pressure fell below 1.25 bar and the temperature below 105°C because of excessive over-capacity of the makeup water pump. As a result of the leak, blockage with boiler water salts had occurred elsewhere in the fire tubes.
REMEDY	The makeup water pump should be throttled in such a way that the volume of feedwater is in accordance with the capacity of the steam pressure regulator in the steam supply line.

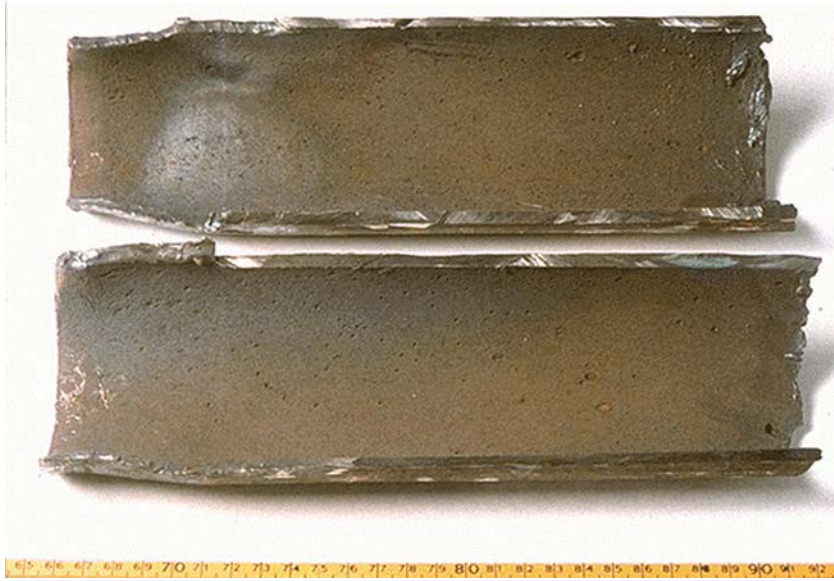
PART Downcomer tube from drum.

PHENOMENON Oxygen corrosion.

APPEARANCE Small clean pits in the upper part of the downcomer tubes below the drum.

TIME IN SERVICE 11 years.

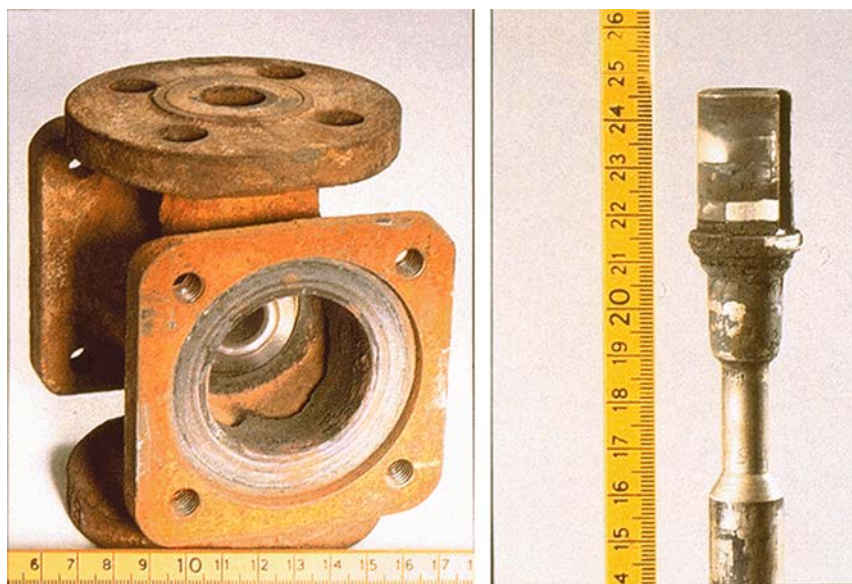
PART Steam control valve.

PHENOMENON Oxygen corrosion.

APPEARANCE Magnetite deposits in the valve.

TIME IN SERVICE The valve seized up after a few months.

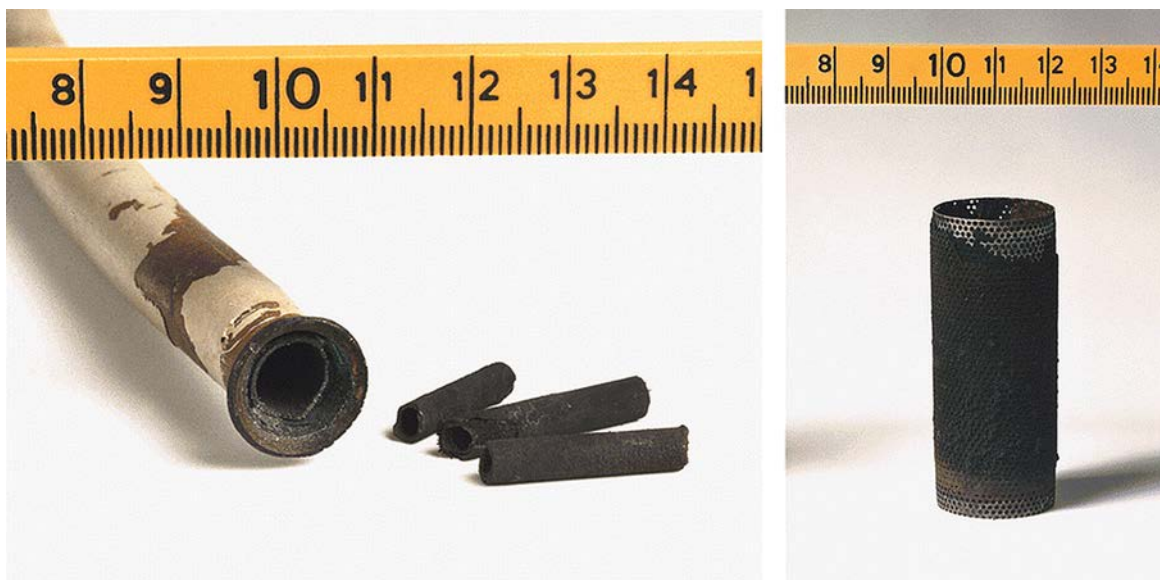
01.01.01.09

MATERIAL	Carbon steel.
SYSTEM	Steam system.
PART	Siphon of a condensate drain (left) and a steam sieve (right).
PHENOMENON	Oxygen corrosion.

APPEARANCE Blockage due to magnetite deposition.

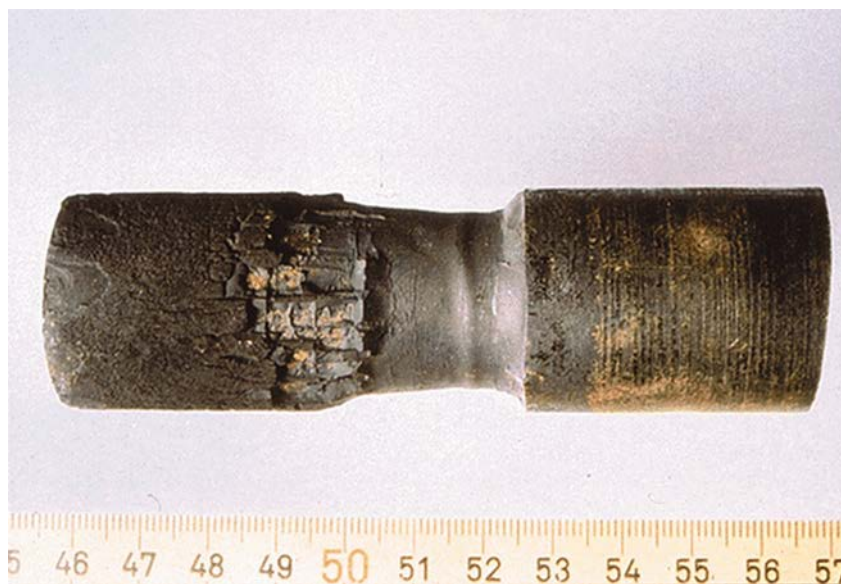
PART Quench cooler pipe section.

PHENOMENON Caustic corrosion.

APPEARANCE Uniform attack with cracking.

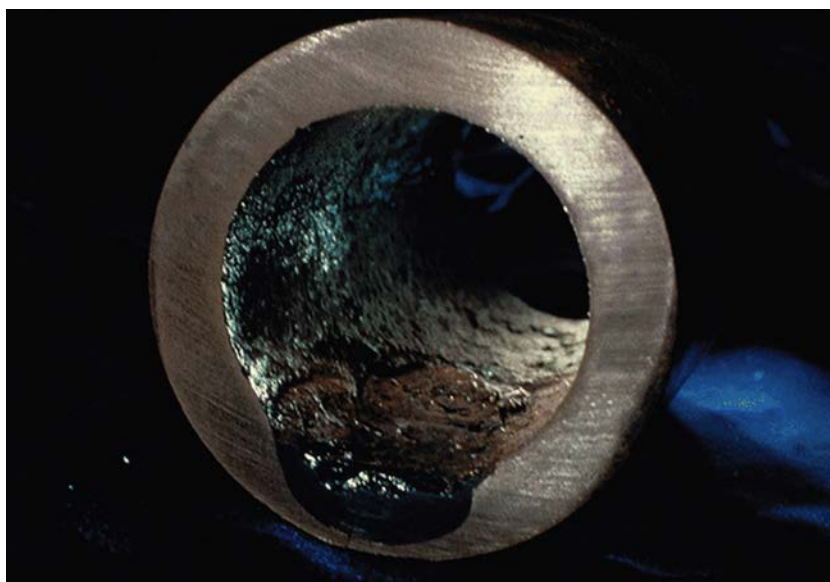
PART Wall tube.

PHENOMENON Caustic corrosion (high pH gouging).

APPEARANCE Deep gouging beneath insulating internal deposits.

TIME IN SERVICE 13 years.

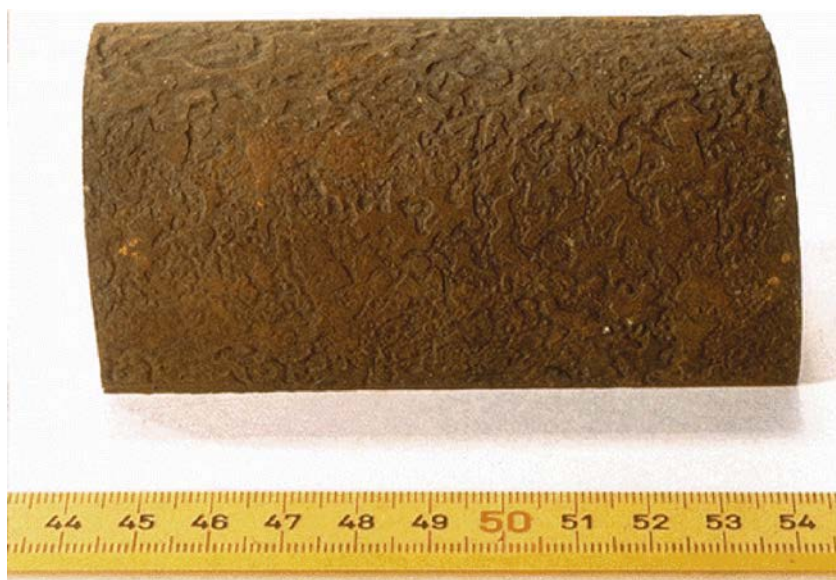
PART Fire tube.

PHENOMENON Acid corrosion.

APPEARANCE Grooved attack over the entire surface.

TIME IN SERVICE Corrosion took place in 3 h.

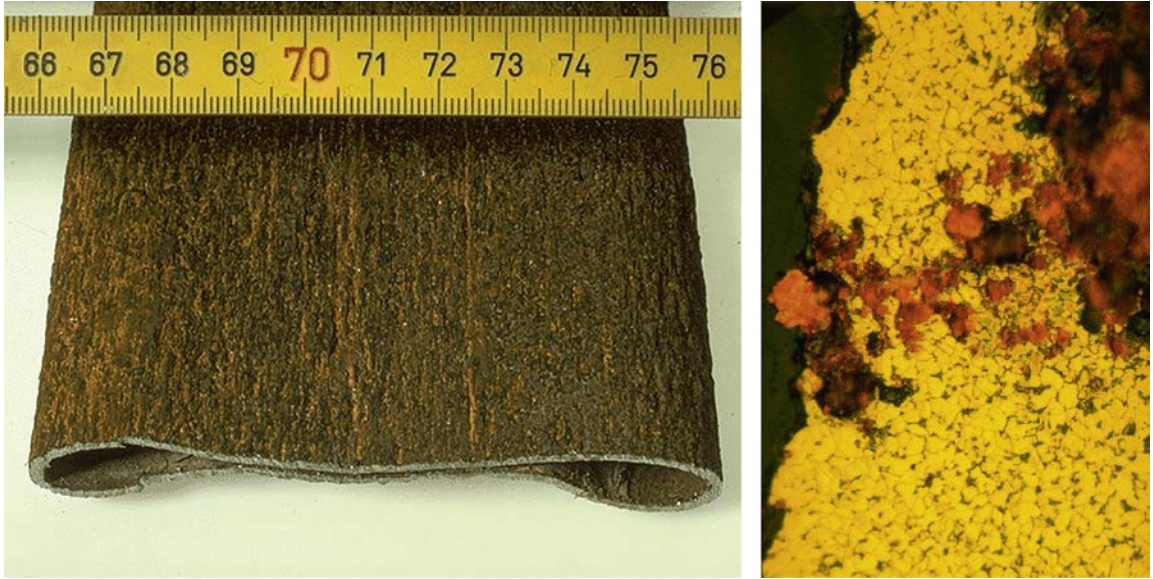
01.01.04.04

MATERIAL	Carbon steel.
SYSTEM	Shell-type fire-tube boiler (1.6 MPa).
PART	Fire tube.
PHENOMENON	Acid corrosion.

APPEARANCE	Grooved attack, tube imploded under pressure testing at 11 bar after cleaning.
TIME IN SERVICE	About 40 h (duration of the cleaning operation).
ENVIRONMENT	Cleaning acid (inhibited HCl 6%); average temperature (calculated subsequently) about 90°C. The boiler was chemically cleaned in view of the presence of organic contamination entrained with the condensate.
CAUSE	<p>Errors made during the cleaning operation:</p> <ul style="list-style-type: none"> • Firing the boiler filled with cleaning acid, allowing the wall temperature of the flame pipes to rise to excessive levels. • Using an inhibitor unsuitable for industrial cleaning purposes. • The lack of any monitoring during cleaning, as a result of which among other things the formation of FeCl_3 was not detected in time and additional attack took place. This case also is the result of poor workmanship (see also Case History 01.01.04.01).

REMEDY	The boiler had to be renewed; total damage \$300,000. Note: chemical cleaning should be performed by specialized firms.

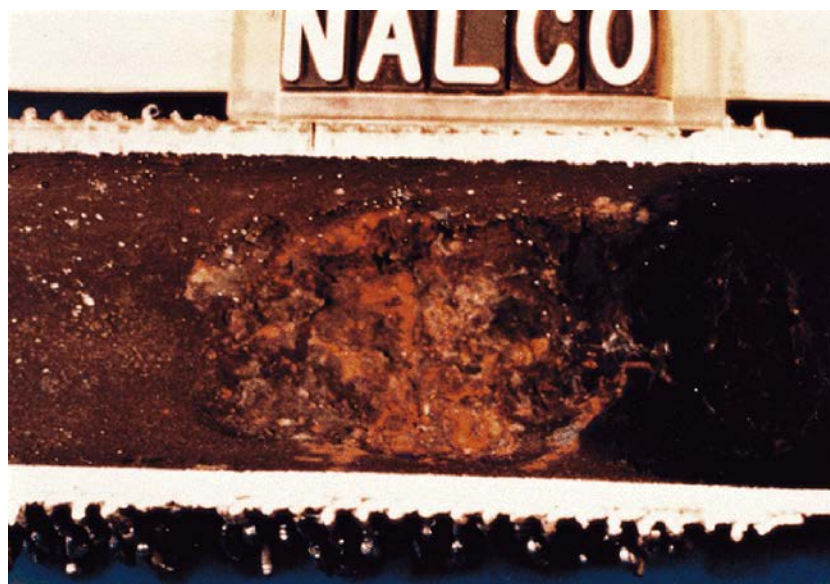
PART Horizontal economizer tube (diameter: 6.0 cm).

PHENOMENON Acid corrosion (low pH gouging).

APPEARANCE A large elliptically shaped gouge covered with a thick, irregular layer of hard dark iron oxides with a laminated structure.

TIME IN SERVICE 7 years.

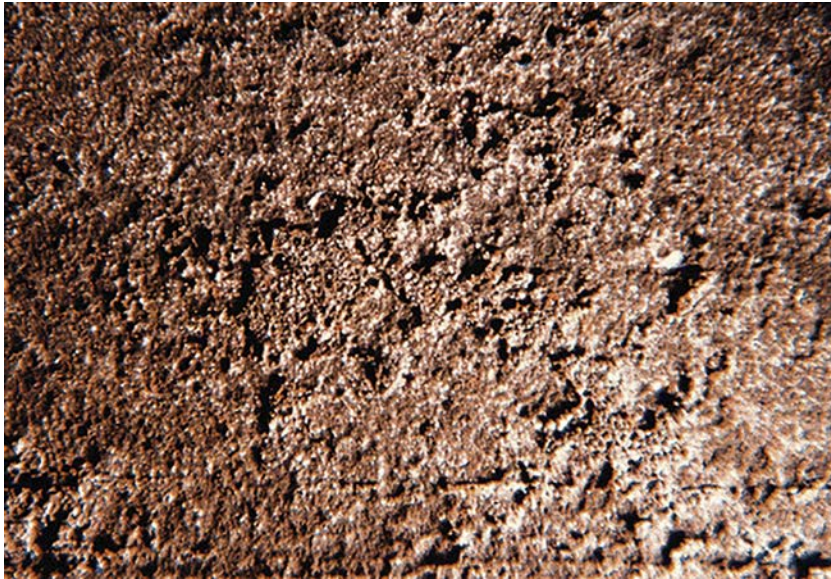
01.01.04.06

MATERIAL	Carbon steel (ASME 210, similar to AISI 1020).
SYSTEM	Water-tube boiler (pressure 13.5 MPa).
PART	Vertical wall tube (OD: 6.3 cm).
PHENOMENON	Acid corrosion.

APPEARANCE	Etched, bright metallic. The photo, taken at 7.5 magnification, reveals irregular islands of uncorroded metal standing 0.12 mm above the surrounding corroded surface.
TIME IN SERVICE	15 years. Corrosion took place in 24 h.
ENVIRONMENT	Citric acid during cleaning.
CAUSE	It is suspected that a combination of thermal decomposition of the inhibitor and lack of proper monitoring was responsible for the corrosion, i.e., poor workmanship (see also Case Histories 01.01.04.01 and 01.01.04.04).
REMEDY	During acid cleaning, give careful attention to cleaning solution temperatures, exposure time, and frequent monitoring of solution chemistry.

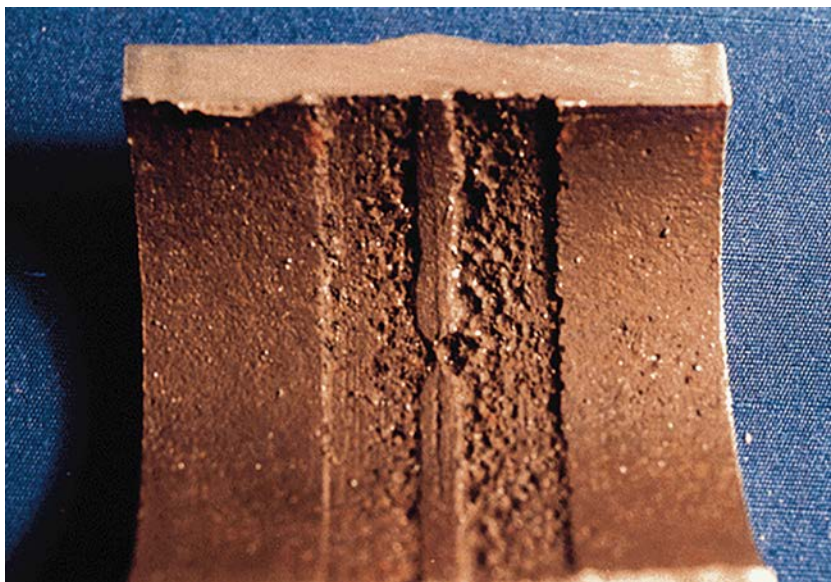
PART Vertical wall tube (outer diameter: 7.6 cm).

PHENOMENON Acid corrosion.

APPEARANCE Strong grooved attack of the internal surfaces of wall tubes opposite external circumferential welds.

TIME IN SERVICE 30 years. Corrosion took place over numerous, successive acid cleanings.

CAUSE Residual stresses remaining from the weld make the heat-affected zones subject to preferential corrosion when exposed to strong acid (see also Case History [01.01.04.03](#)).

REMEDY Damage of this type may be minimized by careful attention to cleaning solution temperature, exposure time, and frequent monitoring of solution chemistry during acid cleaning.

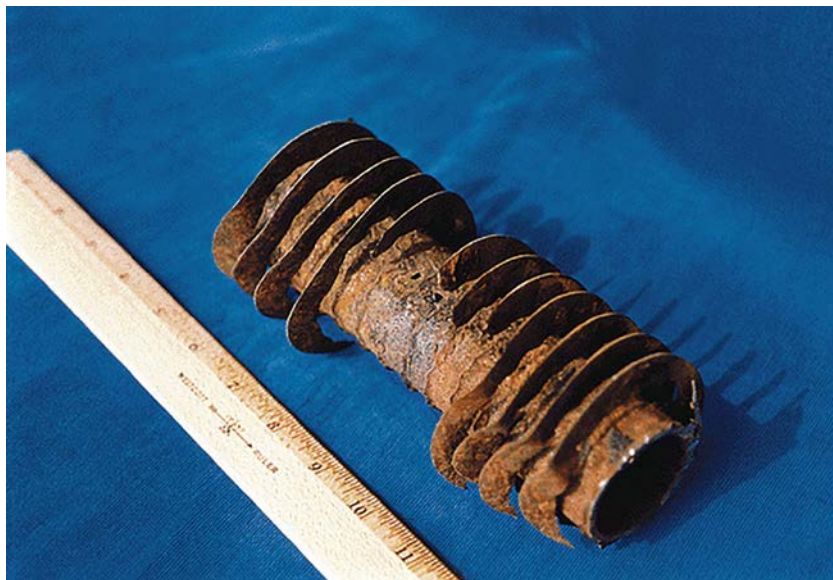
01.01.04.08

MATERIAL	Carbon steel (ASME SA-106-B, similar to AISI 1030).
SYSTEM	Oil-fired water-tube boiler.
PART	Horizontal economizer tube (OD: 4.8 cm).
PHENOMENON	Acid corrosion (cold-end corrosion).

APPEARANCE	The external surface, including fin surfaces, exhibited smooth, general metal loss.
TIME IN SERVICE	Unknown.
ENVIRONMENT	SO ₂ and SO ₃ -containing flue gases. Temperature: entry: 300°C; exit: 185°C.
CAUSE	Condensation of sulfuric acid at the cold end of the boiler, the economizer, where the temperature of the metal drops below the sulfuric acid dew point of the flue gas. The sulfuric acid attacks the steel (dew-point corrosion). The oil contained 1.9% S. The pH of a 1% slurry of the corrosion products was measured at 2.3 (see also Case History 01.01.04.03).
REMEDY	<ul style="list-style-type: none"> • Specify fuel with low sulfur and low moisture content. • Operating the boiler at or below 5% excess air will keep the SO₃ percentage as low as possible. • Substantial design changes are often required to eliminate metals with surface temperatures below the sulfuric acid dew point. • Feed fuel additives as a chemical solution of the problem.

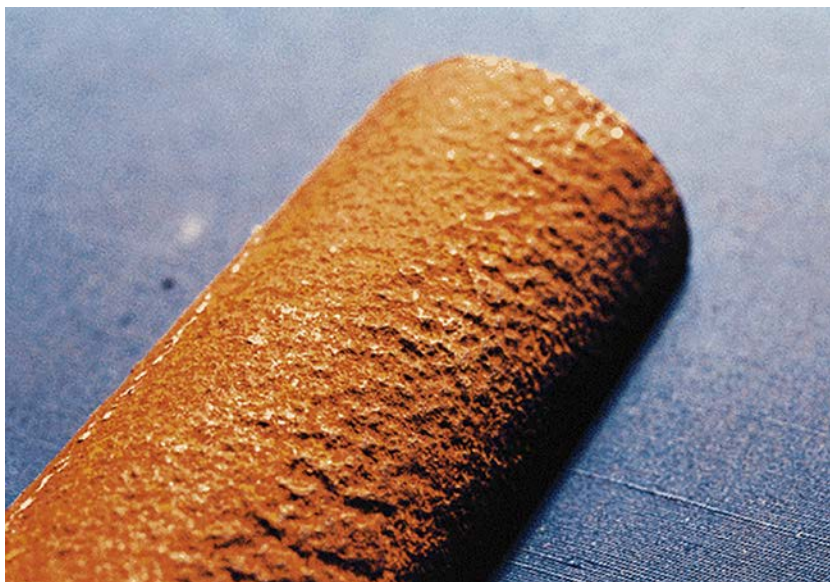
PART Vertical screen tube (OD: 5.1 cm).

PHENOMENON Acid corrosion (dew-point corrosion).

APPEARANCE General metal loss with an irregular surface contour.

TIME IN SERVICE 10 years.

CAUSE Combustion of black liquor gives sulfurous ash deposits covering the tubes. As the boiler cools during idle periods, the temperature of its external surface may drop below the dew point, allowing moisture to form on the tube surface. The acidic solution formed attacks the steel (see also Case History [01.01.04.02](#)).

- Remove the fire-side deposition from metal surfaces immediately after boiler shutdown using high-pressure water sprays, followed by a lime wash to neutralize remaining acidic substances.
- Keep the boiler fire side dry, by circulation of warm boiler water (by means of a heat exchanger and another boiler), or by circulation of dried air.
- In general, specify fuels with lower sulfur content to prevent dew-point corrosion.

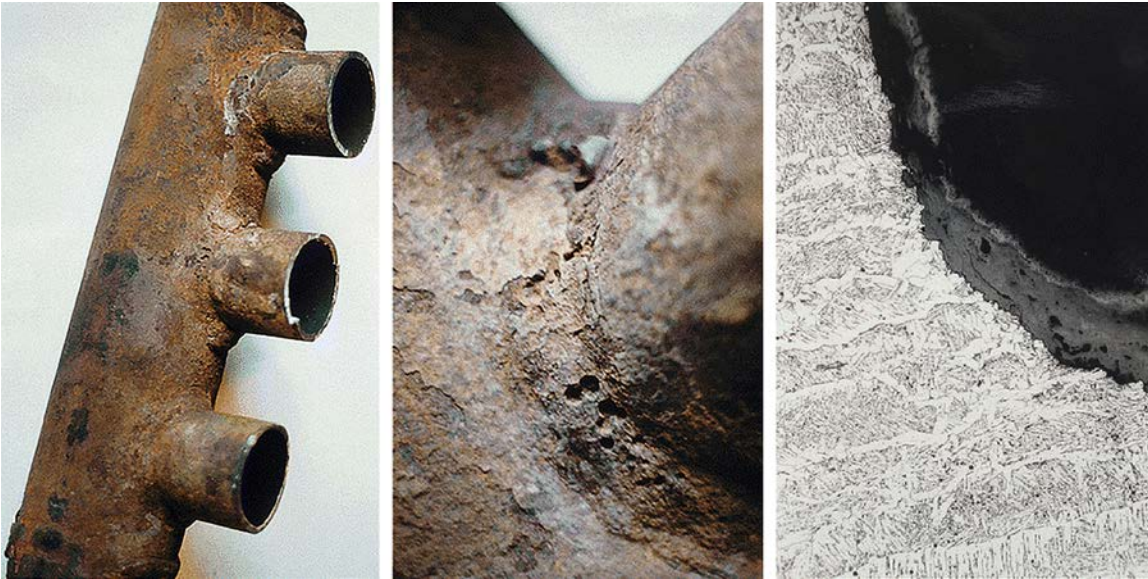
01.01.04.10

MATERIAL	Carbon steel (35.8).
SYSTEM	Waste-incineration boiler.
PART	Header of the vaporizer section of the rotating drum furnace.
PHENOMENON	Dew-point corrosion.

APPEARANCE	Pitting attack to the welds, which form the connection between the header and the vaporizer tubes. More specifically in the weld zone with a characteristic cast structure (stalk-shaped crystals).
TIME IN SERVICE	8 years (during which leakages occurred regularly).
ENVIRONMENT	Acid off-gases condensing in boiler feedwater (demineralized makeup water + recycled condensate). Acid deposits consisting of silicates, iron oxide, and chlorides.
CAUSE	Because of leaking economizer tubes, part of the vaporizer section was regularly hosed with water, resulting in local dew-point corrosion due to contact with the acid off-gases. This caused pitting attack to the welds as these are partly less corrosion resistant because as weld metal hardens a coarse cast structure is formed with segregation phenomena (see micro-photo), which makes these parts less homogeneous and hence more sensitive to corrosion.

REMEDY	Partial replacement of the economizer.

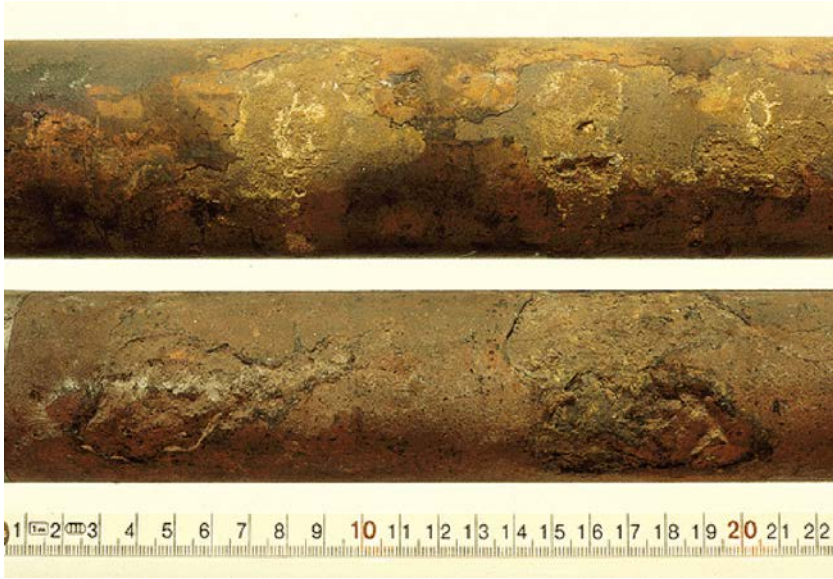
01.01.04.11

MATERIAL	Carbon steel (35.8).
SYSTEM	Shell-type boiler; 0.15 MPa.
PART	Fire tubes.
PHENOMENON	Acid corrosion.

APPEARANCE	Severe localized uniform corrosion with a yellow and red corrosion scale.
TIME IN SERVICE	3 months (upper tube) to 2 years (lower tube).
ENVIRONMENT	Boiler water (P-alkalinity: 10–20 meq/L; chloride: 100–400 ppm Cl; phosphate; 25–50 ppm P ₂ O ₅ ; sulfite: 50–100 ppm Na ₂ SO ₃ ; sulfate: 5000–10,000 ppm Na ₂ SO ₄).
CAUSE	<p>This was suspected to be a form of acid corrosion by the sulfite (sulfurous acid). Investigation by Kema (see next page) led to the following conclusions:</p> <p>In view of the uniform attack, the presence of the sulfur-rich compound on the oxide-metal interface, and the local pits underneath the oxide layer where the sulfur-rich compound was found, the corrosion is believed very probably to be a consequence of an acid sulfur compound.</p> <p>It may be that the heat load coupled with high sulfite dosages enables an acid to form, such as sulfuric acid, sulfurous acid, or polythionic acid.</p>

REMEDY	<ul style="list-style-type: none"> • Replace the sulfite by another oxygen scavenger. • Change to thermal deaeration of the feedwater. • Use a calmed steel (with higher Si-content) which is more resistant to acids.

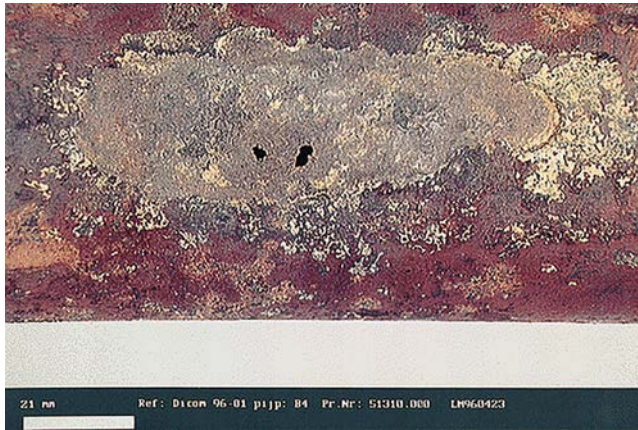
Fig. 1 Close-up of one of the pipes.

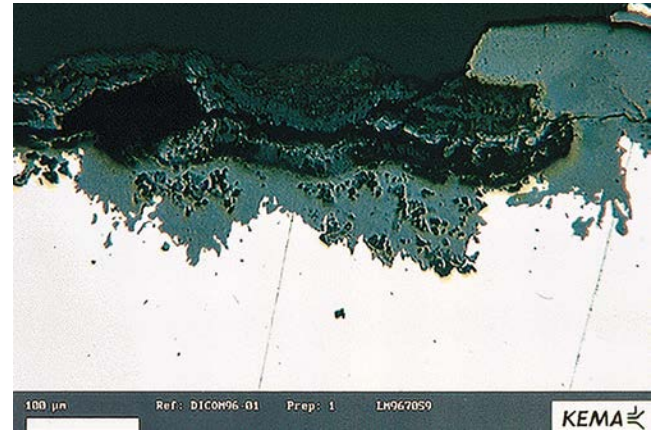
Fig. 2 Photograph taken with incident light.

Various photomicrography techniques were applied: normal incident light, polarized light, and the DICOM imaging technique (Figs. 2, 3, and 4). In the polarized light photograph (Fig. 3), a yellowish-orange corrosion product is found. Electron microscopy and EDS analyses were used to analyze the phases at various locations. In all the specimens, a sulfur-rich compound is found on the oxide-metal interface. The phase which reflects orange in polarized light is also found to contain much sulfur. Note the skeleton structure in the oxide and the pits on the oxide-metal interface, where a clear sulfur enrichment is found. In the electron microscopy image (not reproduced here), even small intergranular sites of attack are visible.

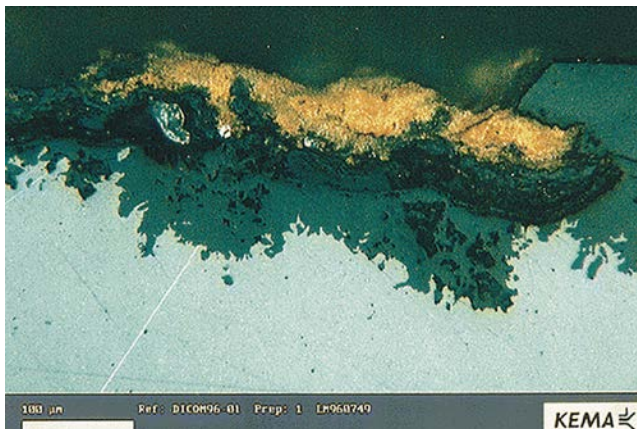
Fig. 3 Photograph taken with polarized light.

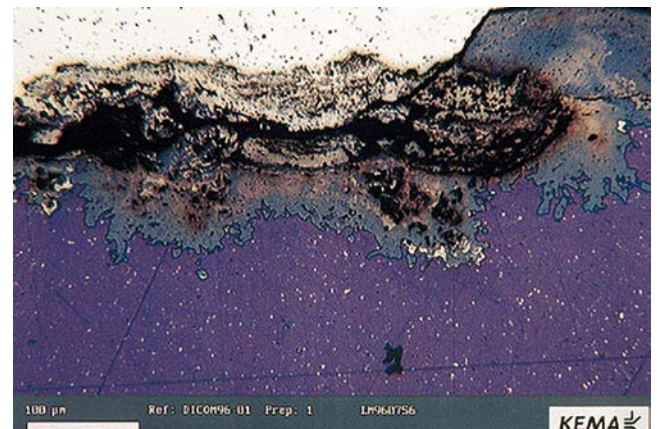
Fig. 4 DICOM image.

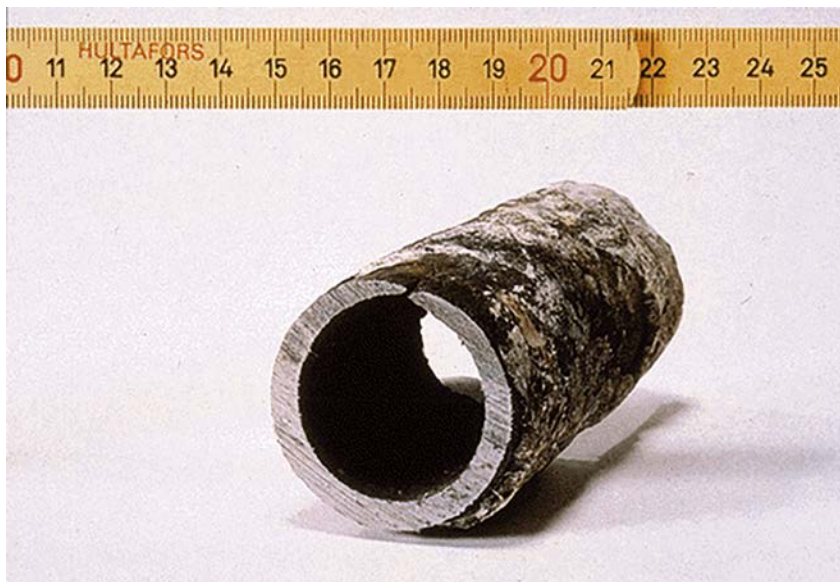
PART Superheating tube.

PHENOMENON High-temperature corrosion (oxidation).

APPEARANCE External uniform attack leading to cracking by superheating.

TIME IN SERVICE 5 years.

CAUSE The presence of oxides of heavy metals (V,W,Nb) catalyzes the oxidation at high temperature. Heavy oil contains sulfur, vanadium, and sodium. At wall temperatures above 600°C, vanadium oxide and sodium sulfate melts occur on the superheater tubes, leading to corrosion of the steel. This phenomenon is also known as hot corrosion or in oil-fired boilers oil-ash corrosion.

REMEDY Initially, dosing of various oil additives proved ineffective; subsequently, for other reasons as well, switched to firing sulfur-free natural gas; the entire superheater was replaced.

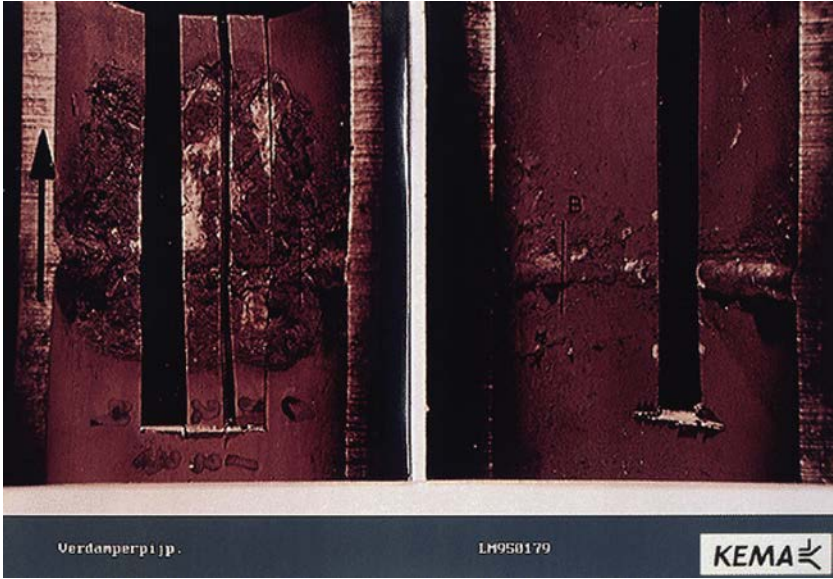
01.01.07.01

MATERIAL	Carbon steel.
SYSTEM	Forced circulation water-tube boiler (pressure 10 MPa).
PART	Evaporator tube.
PHENOMENON	Heat-flux corrosion (chloride induced).

APPEARANCE	The weld and the surrounding pipe surface was corroded.
TIME IN SERVICE	5 years.
ENVIRONMENT	Inside: ammonia-conditioned boiler water.
CAUSE	Condenser inleakages resulted in chloride-containing boiler water. The present laminated oxide layers are typical of Cl-induced corrosion under heat-flux conditions. The corrosion started from the weld and expanded over the pipe surface. The weld material has too low corrosion resistance for application in evaporators. The critical FeCl_2 value was only 15, whereas the recommended selection criterion is 35. (Ref. Huijbregts, W.M.M.: "Corrosion in Power Stations," paper presented at VGB conference: Chemistry at Power Stations, Essen, 1994.)
REMEDY	<ul style="list-style-type: none"> • More attention was given to boiler water quality, and the condenser inleakages were prevented. • In this case, the tube was replaced without paying attention to the composition of the steel and welding material. • To prevent chloride-induced heat-flux corrosion: specify the acid-corrosion resistance of carbon steel (tube and welding material) for evaporators. A critical FeCl_2 value of at least more than 35 mmol is recommended.

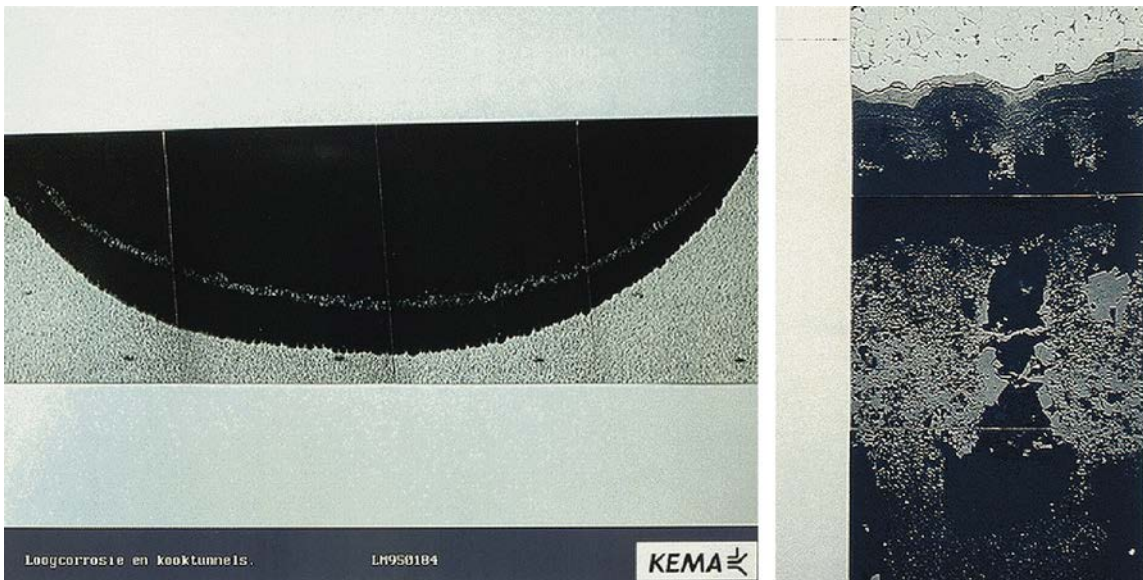
PART Evaporator tube.

PHENOMENON Heat-flux corrosion (alkali-induced).

APPEARANCE A thick porous oxide layer with pitting underneath the oxide scale. The topotactically grown oxide is very porous. The epitactical oxide layer on the outside consists of coarse crystalline magnetite octahedra.

TIME IN SERVICE 2 weeks.

CAUSE Water conditioning with non-volatile NaOH and presence of a fouling layer of iron oxides. Because of high heat flux under the deposit layer, the NaOH concentrates to high values, resulting in corrosion of the carbon steel.

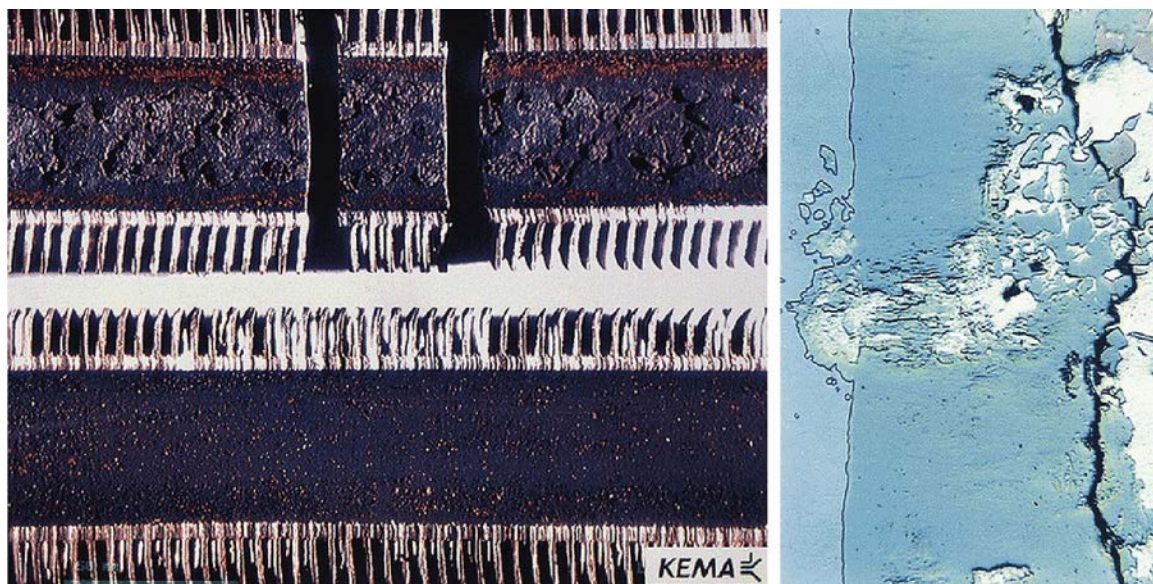
PART Evaporator tube.

PHENOMENON Heat-flux corrosion (induced by nucleate boiling).

APPEARANCE Thick corrosion scale at the heat-flux side. Only slight deposits on the nonheated side. Pitting corrosion on the boundary of the thick corrosion scale.

TIME IN SERVICE Unknown.

CAUSE Contamination of the boiler water with a sulfur-containing chemical (S was demonstrated at the pits). In the pits, ferrous oxide was tangled, and occasional intergranular corrosion was found. At the inlet of the evaporator, there was very high heat flux, so that severe nucleate boiling (columnar boiling) took place. The resultant steam bubbles caused the formation of oxide-free tunnels, as can be seen on the microprint.

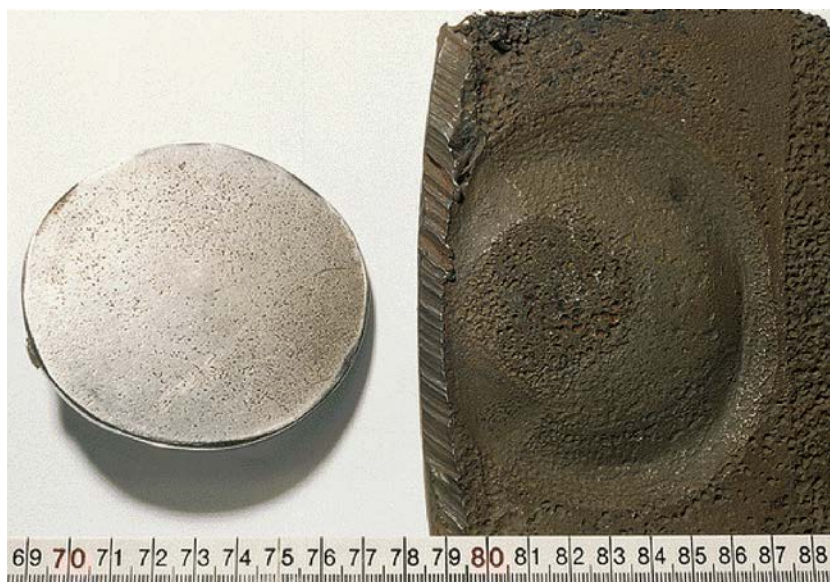
MATERIAL	Carbon steel.
SYSTEM	Boiler feedwater system.
PART	Condensate tank bottom.

PHENOMENON Galvanic corrosion with oxygen corrosion.

APPEARANCE Ring-shaped overall attack under the stainless steel plate; pitting attack outside it.

TIME IN SERVICE At least 6 years.

CAUSE A stainless steel plate was left behind, causing local galvanic corrosion of the carbon steel tank bottom. The presence of oxygen resulted in pitting attack.

- Apply effective inspection procedures before start-up to ensure no alien objects are left behind.
- Prevent oxygen corrosion by coating the tank or constructing it of stainless steel AISI 316 L.

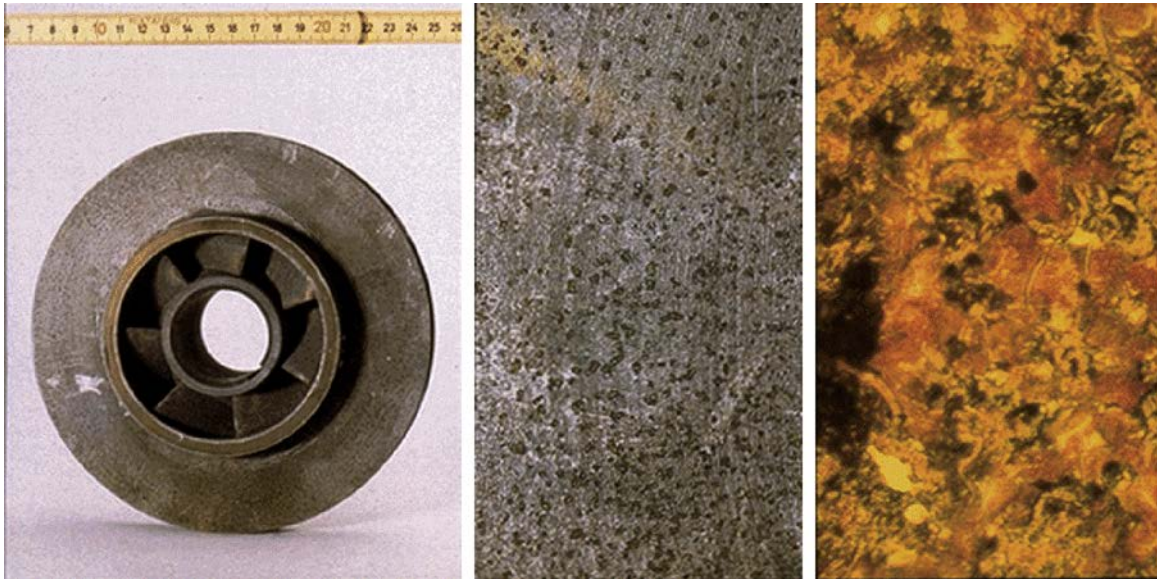
01.01.16.01

MATERIAL	CrNi cast iron.
SYSTEM	Boiler feedwater system.
PART	Boiler feed pump impeller.
PHENOMENON	Selective leaching (graphitic corrosion).

APPEARANCE Soft granular surface which gives off black powder; material receded about 1 mm.

TIME IN SERVICE 1½ year (6000 operating hours).

CAUSE The cast iron is attacked as a result of the low pH of the feedwater, the iron being dissolved and the carbon remaining (see also Case Histories 01.06.16.01 and 01.06.16.02).

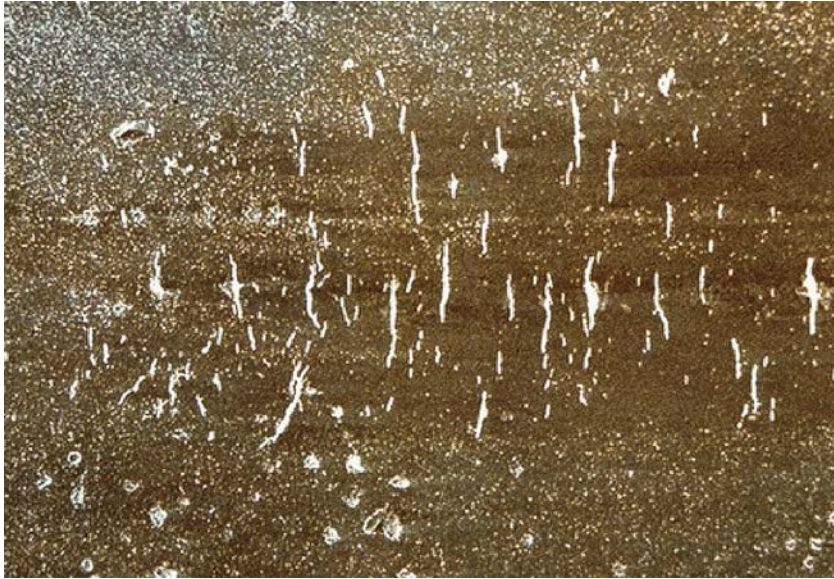
01.01.18.01

MATERIAL	Carbon steel (DIN 17155).
SYSTEM	Boiler feedwater system.
PART	Deaerator (design pressure 0.25 MPa, design temperature 134°C).
PHENOMENON	Stress-corrosion cracking (environmentally induced cracking).

APPEARANCE	Cracking in an alongside weld seams (shown by magnetic particle fluorescent examination).
TIME IN SERVICE	15 years.
ENVIRONMENT	Feedwater (demineralized makeup and condensate); temperature 105°C; pressure 0.15 MPa.
CAUSE	The corrosion mechanism has not yet been definitely established. Presumably, it is a combination of residual stresses present at the welds and oxygen attack; in addition, fatigue due to vibrations may play a part.
REMEDY	<ul style="list-style-type: none"> • Grind away cracks, build up material if necessary, then anneal deaerator at 550°C, repeat magnetic particle fluorescent examination after repair. • In serious cases, re-weld or replace deaerator. • New deaerator to be annealed with postweld heat treatment.

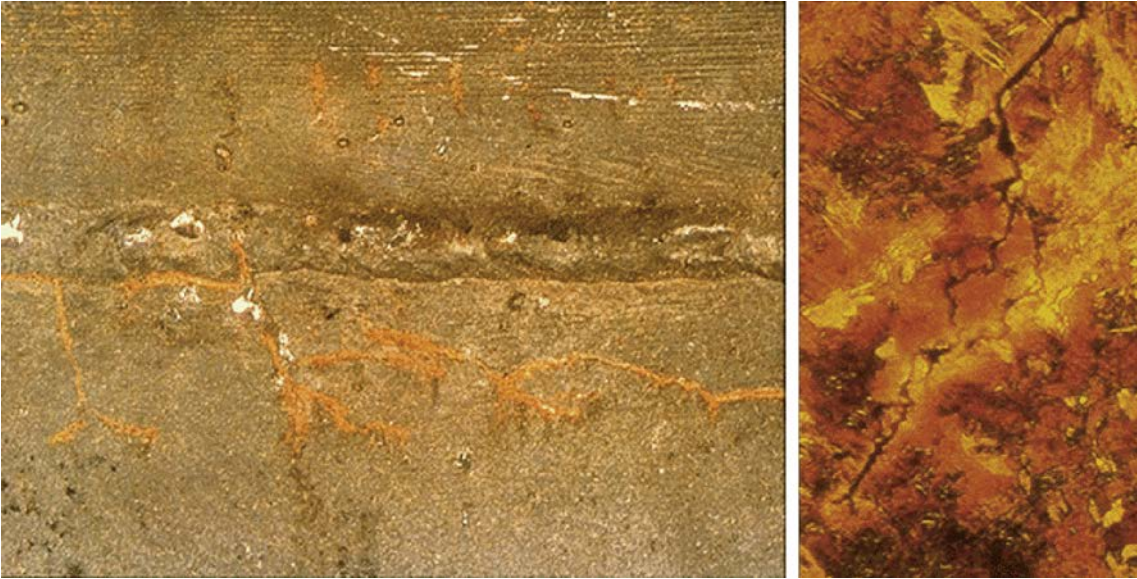
01.01.18.02

MATERIAL	Carbon steel (35.8).
SYSTEM	Steam system (low pressure).
PART	Steam pipe section.
PHENOMENON	Intergranular stress-corrosion cracking (caustic stress-corrosion cracking).

APPEARANCE	Crack at weld.
TIME IN SERVICE	Unknown.
ENVIRONMENT	Low-pressure steam (0.35 MPa).
CAUSE	Because of a leak in the production process, 50% caustic soda entered the low-pressure steam system via the injection condensate for desuperheating. Under these circumstances, normally, harmless tensile stresses near welds led to caustic stress-corrosion cracking (see also Case Histories 01.01.18.05 and 01.11.18.01).
REMEDY	<ul style="list-style-type: none"> • Improve the quality control of the condensate by means of conductivity monitoring; or • Inject demineralized water.

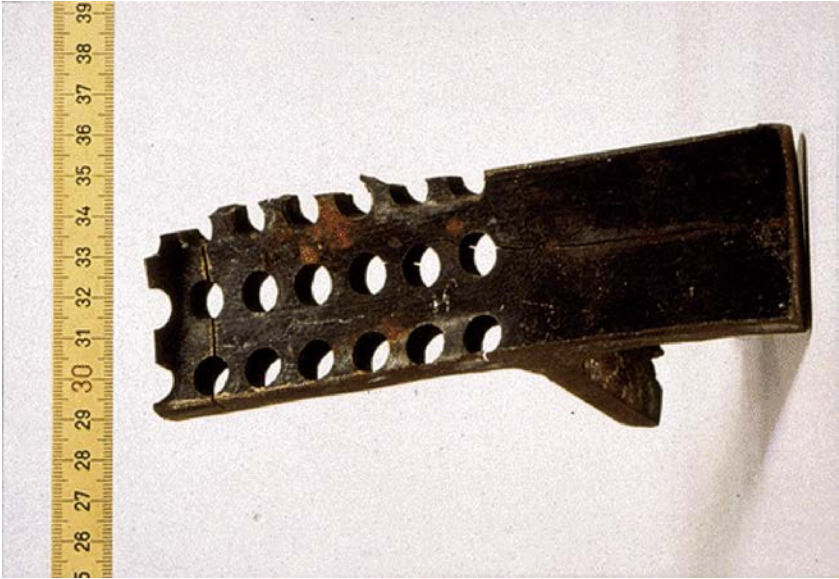
01.01.18.03

MATERIAL	Carbon steel.
SYSTEM	Stripper steam system.
PART	Distributor pipe.
PHENOMENON	Intergranular stress-corrosion cracking (caustic stress-corrosion cracking).

APPEARANCE	Cracks running from hole to hole.
TIME IN SERVICE	10 years.
ENVIRONMENT	Steam and aqueous environment with a high pH (11–12); temperature 140°C.
CAUSE	At the high temperature, the alkaline solution causes stress corrosion in carbon steel.
REMEDY	Normalize the steel.

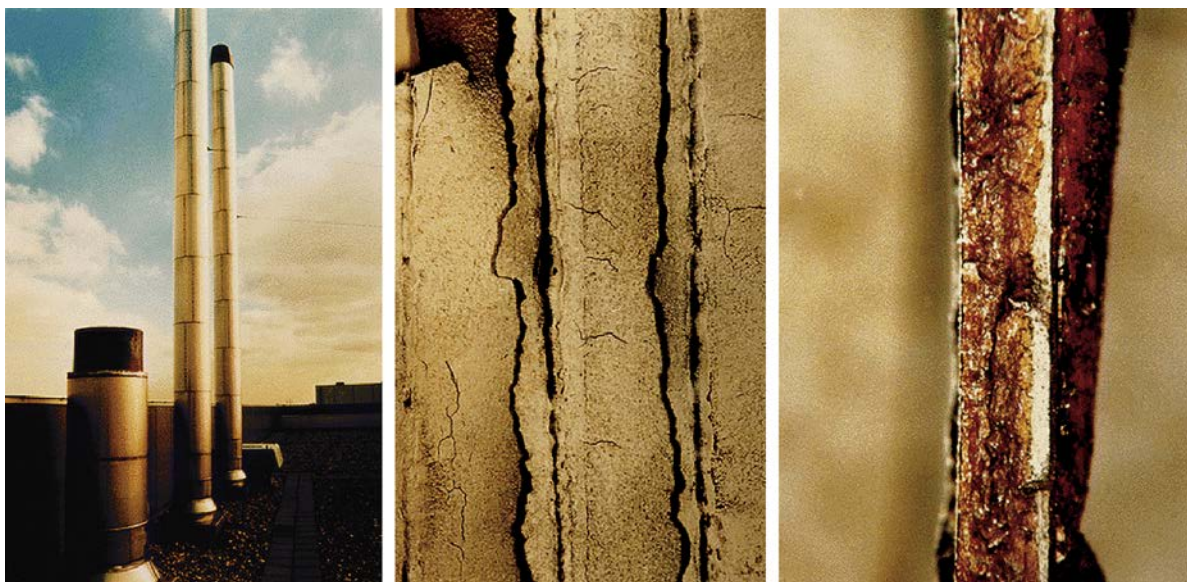
PART Chimney.

PHENOMENON Nitrate stress-corrosion cracking (intergranular).

APPEARANCE Multiple branched cracks near welds.

TIME IN SERVICE 2.5 years.

CAUSE Intermittent use of the boiler caused condensation of the exhaust gas in the chimney. The formed solution caused intergranular cracking of the weld area because of the presence of internal stresses (see also Case History [01.11.18.02](#)).
