Corrosion Atlas

THIRD, EXPANDED AND REVISED EDITION

A Collection of Illustrated Case Histories

Evert D.D. During

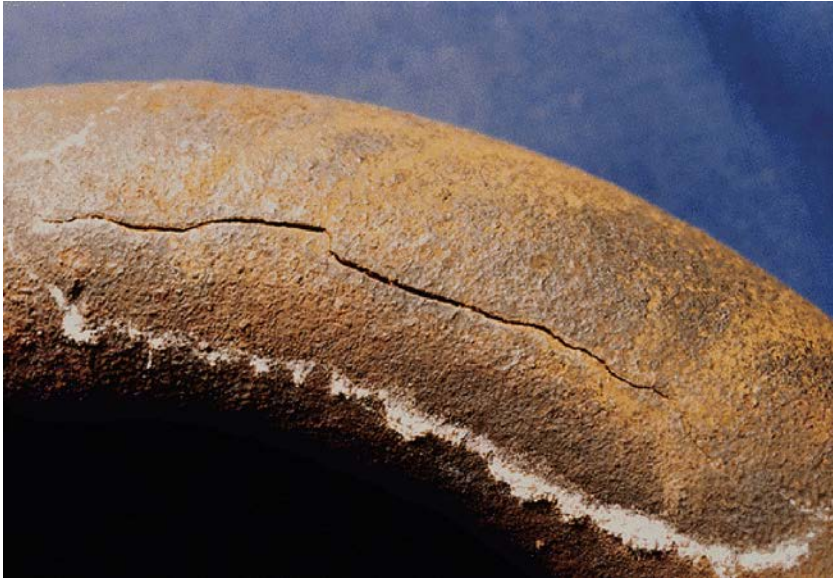
01.01.18.05

MATERIAL	Carbon steel (ASME SA-192, similar to AISI 1012).
SYSTEM	Water-tube boiler (pressure 5.5 MPa).
PART	Economizer tube bend (OD 5.1 cm).
PHENOMENON	Intergranular stress corrosion (caustic stress-corrosion cracking).

APPEARANCE	A pair of thick-walled cracks on opposite sides of the 90 degrees bend, located at opposite ends of the long axis of the oval cross-section of the bend.
TIME IN SERVICE	15 years.
ENVIRONMENT	Boiling water. Water treatment: phosphate.
CAUSE	The joint action of concentrated sodium hydroxide and tensile stresses: <ul style="list-style-type: none"> • The sodium hydroxide apparently concentrated beneath porous iron oxide deposits and led to shallow general metal loss and formation of crystalline magnetite. • The cracks originated at the bottom of shallow pits, which acted as stress concentrators, elevating the normal stress level. The longitudinal orientation of the cracks reveals that internal pressure provided the stresses necessary for stress-corrosion cracking.

REMEDY	<ul style="list-style-type: none"> • Keep internal surfaces sufficiently free of deposits. • Prevent pitting of internal surfaces through proper control of dissolved oxygen. • Avoid use of out-of-round tubes to prevent elevated stresses inherent in oval-shaped tubes.

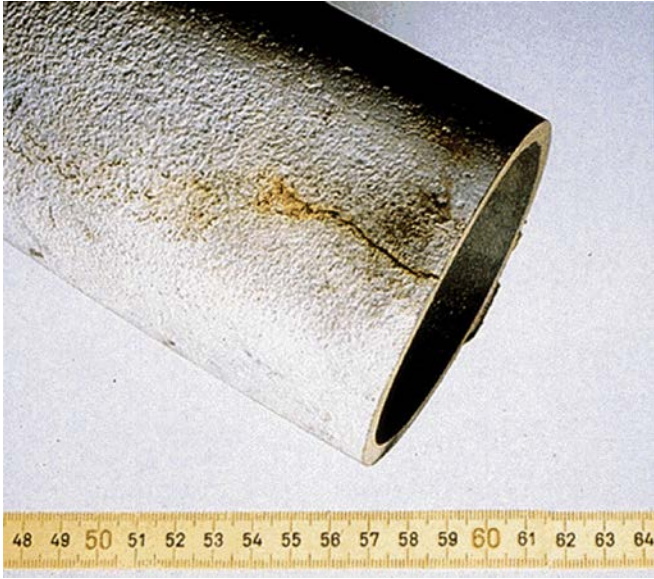
01.01.20.01

MATERIAL	Carbon steel.
SYSTEM	High-pressure boiler.
PART	Evaporator tube.
PHENOMENON	Hydrogen damage (intergranular hydrogen stress cracking).

APPEARANCE	Longitudinal cracks in cold-bent bend.
TIME IN SERVICE	Over 10 years.
ENVIRONMENT	Flue gas deposits with sulfuric acid compounds.
CAUSE	During the first stage of the neutralization process at the flue gas side (applied at shutdown), an acidic environment is created on the pipes as a result of the sulfur deposits present. Reaction between the resultant sulfuric acid and the steel forms hydrogen, thereby attacking the cold-bent steel and allowing fractures to occur (see also Case Histories 01.01.20.07 , 01.11.20.06 , and 01.11.20.07).
REMEDY	Use low-alloyed (hydrogen-resistant) steel.

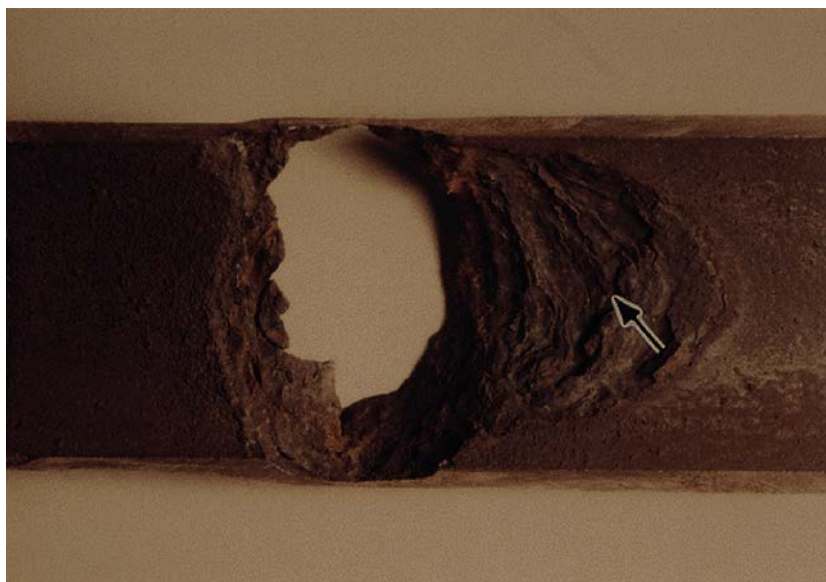
PART Water wall roof tube.

PHENOMENON Hydrogen damage (high-temperature hydrogen attack).

APPEARANCE Brittle “window” rupture. Internal corrosion gouging.

TIME IN SERVICE Not known.

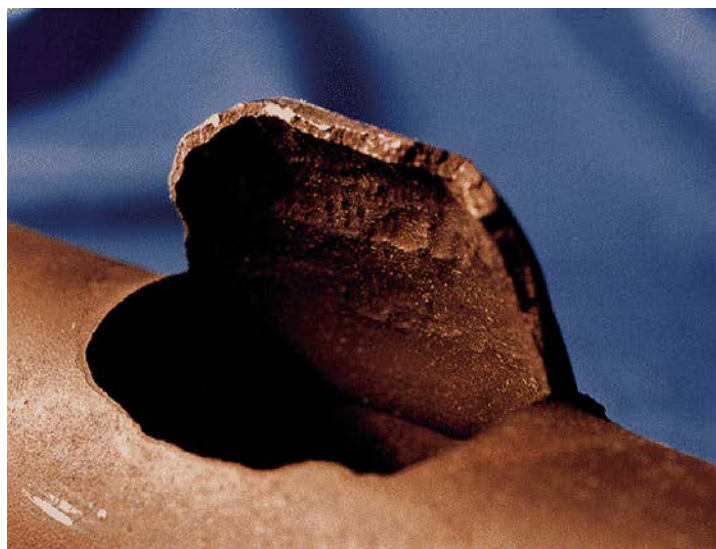
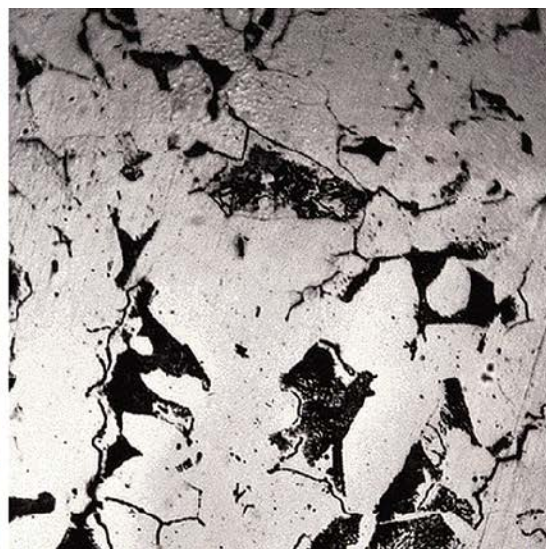
PART Vertical water wall tube (OD 6.3 cm).

PHENOMENON Hydrogen damage (high-temperature hydrogen attack [decarburization]).

APPEARANCE A thick-walled burst with blunt fracture edge. Shallow gouging along the internal surface, free of deposits. Microstructure: intergranular microcracks with dark islands of pearlite.

TIME IN SERVICE 17 years.

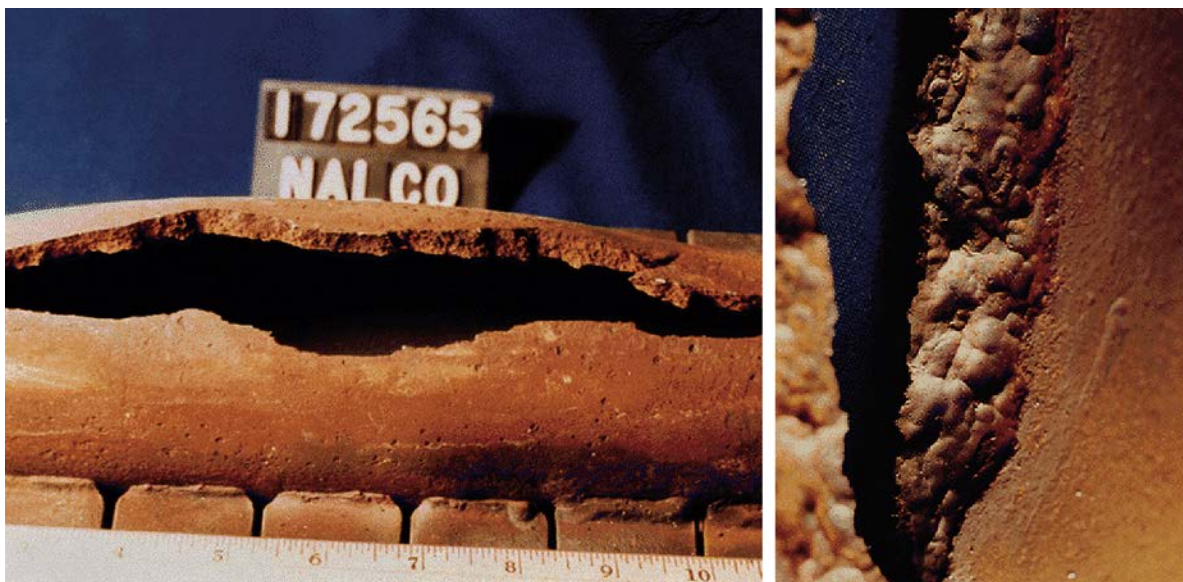
01.01.20.05

MATERIAL	Carbon steel (ASME SA-210, similar to AISI 1020).
SYSTEM	Water-tube boiler (pressure 13.8 MPa).
PART	Nose slope water-wall tube (OD: 7.6 cm).
PHENOMENON	Hydrogen damage (high-temperature hydrogen attack [decarburization]).

APPEARANCE	A thick-walled rupture. The smooth wavelike contours of the internally corroded surface are covered with black iron oxide. Intergranular microcracks were present below the corroded region.
TIME IN SERVICE	25 years.
ENVIRONMENT	Boiler water. Water treatment: co-ordinated phosphate.
CAUSE	Localized departure from nucleate boiling (DNB) in high heat flux areas resulted in concentration of sodium hydroxide, which caused deep caustic gouging. This phenomenon may also be regarded as heat-flux corrosion. The atomic hydrogen formed at the corrosion diffuses into the steel, causing decarburization. The hydrogen damage and resulting fracture were a direct consequence of the caustic gouging. The boiler is in peaking service.
REMEDY	Prevent DNB by elimination of hot spots.

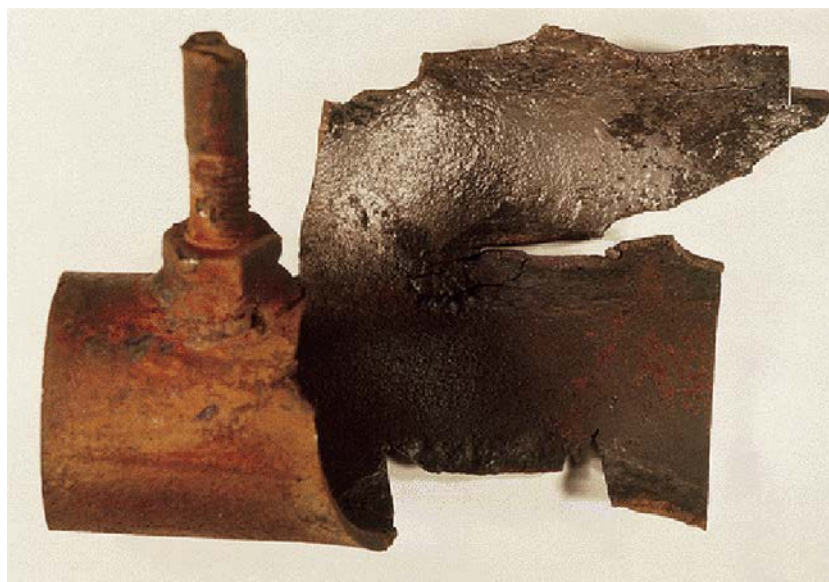
PART Water wall tube between upper and lower burners.

PHENOMENON Hydrogen damage (high-temperature hydrogen attack).

APPEARANCE Brittle “window” rupture at butt weld. Internal corrosion gouging in areas of heavy deposit.

TIME IN SERVICE Boiler had been in service 19 years.

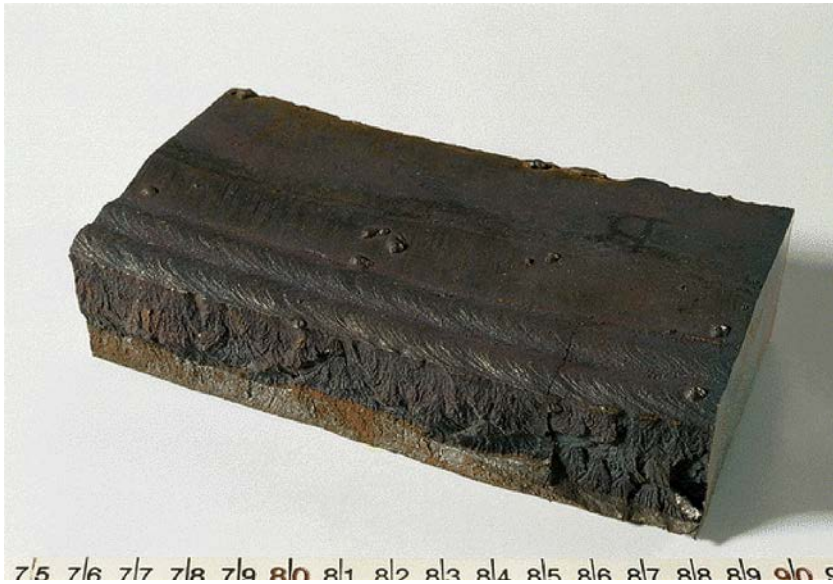
01.01.20.07

MATERIAL	Carbon steel (HSB 55 C; W.-Nr. 1.9877).
SYSTEM	Reactor with evaporating coils for producing steam (4 MPa, 250°C) and steam drum for separating the steam from the circulating boiler water.
PART	Wall piece with weld, thickness 27 mm.
PHENOMENON	Hydrogen damage (hydrogen-induced stress-corrosion cracking [HISCC]).

APPEARANCE	Intergranular fracture along the weld with transverse crack in the weld, brittle end fracture.
TIME IN SERVICE	15 years.
ENVIRONMENT	Boiler water and steam; water treatment: phosphate trisodium dosing for pH adjustment 9.0–9.5.
CAUSE	Acidic components in the boiler feedwater and too low level or absence of phosphate in the boiler water causes too low pH values (about 4). The formed atomic hydrogen diffuses into the steel to places with elevated stress conditioning. This results in HISCC caused by acid corrosion.
REMEDY	<ul style="list-style-type: none"> • Effective conditioning of the boiler water by means of trisodium phosphate dosing with careful monitoring. • Using lesser steel with adjusted processing techniques to reduce the hardness of the welds. • Annealing with postweld heat treatment to reduce the hardness and the stress level.

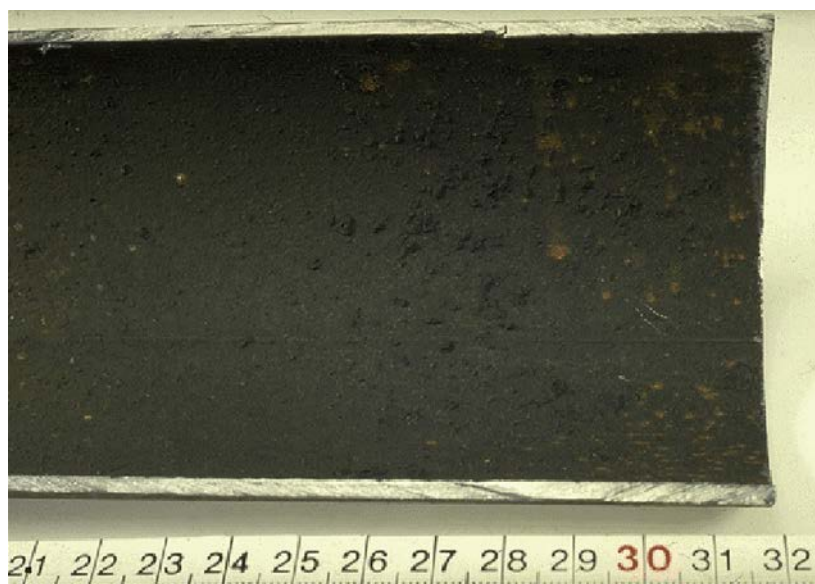
01.01.21.01

MATERIAL	Carbon steel.
SYSTEM	Boiler feedwater system.
PART	70 mm diameter boiler feedwater line with deaerator to boiler.
PHENOMENON	Chelant corrosion.

APPEARANCE Uniform decrease of 60% of the original wall thickness of the line.

TIME IN SERVICE 1.5 years.

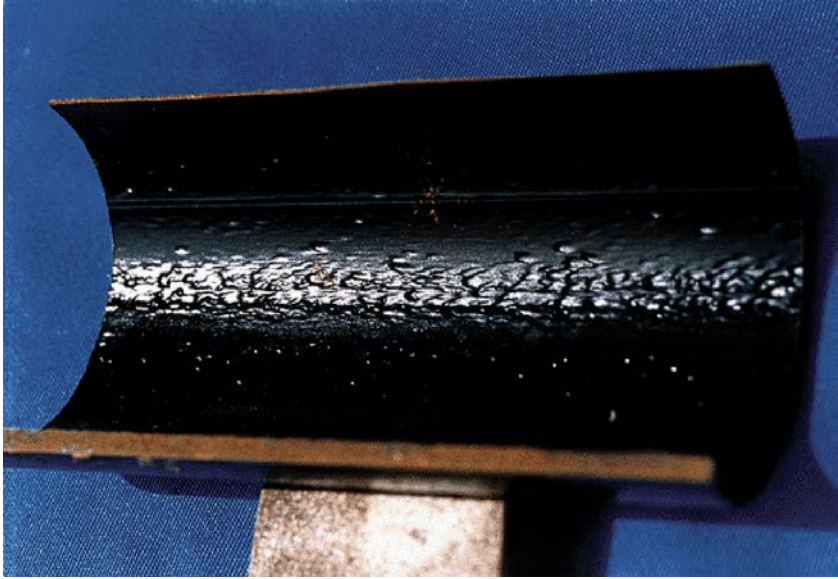
01.01.21.02

MATERIAL	Carbon steel (ASME SA-178, similar to AISI 1012).
SYSTEM	Water-tube boiler (pressure 6.2MPa).
PART	Wall tube (OD 6.3 cm).
PHENOMENON	Chelant corrosion.

APPEARANCE	Comet-tail and horseshoe-shaped depressions.
TIME IN SERVICE	2 years.
ENVIRONMENT	Boiler water. Water treatment: scale control agents, oxygen scavengers, chelant.
CAUSE	High concentrations of chelants by overfeeding or by evaporation will attack magnetite according to the following reaction: $\text{Fe}_3\text{O}_4 + \text{Fe} + 8\text{H}^+ + 4 \text{ chelants} \rightarrow 4\text{Fe (II) chelant} + 4\text{H}_2\text{O}$. Excessive levels of dissolved oxygen synergize with excessive levels of chelant to produce jagged metal-surface contours.
REMEDY	<ul style="list-style-type: none"> • Close control of chelant and dissolved oxygen levels in the feedwater is imperative. • Take special care in case of inconsistent feedwater quality and when chelants are used in a dirty boiler. • Elimination of hot spots will prevent chelant corrosion. • Reducing fluid velocity and eliminating turbulent flow will also help to reduce chelant corrosion.

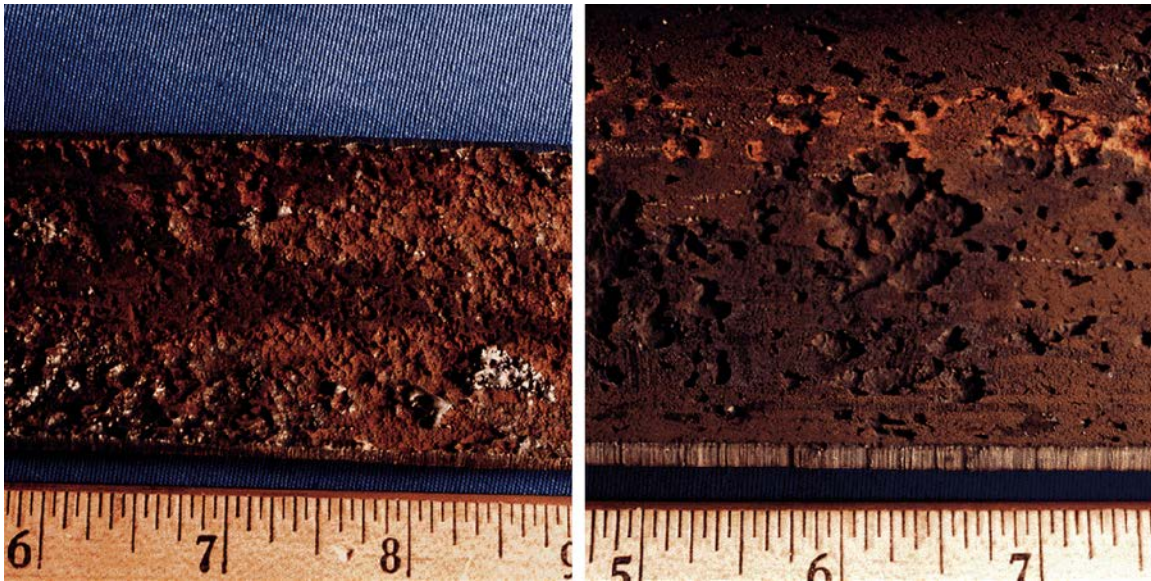
PART Steam drum end of downcomer tubes (OD: 6.3 cm).

PHENOMENON Chelant corrosion

APPEARANCE Smooth, rolling, wavelike surface contours and islands of intact metal in affected areas. The entire internal surface was lightly covered with deposits and iron oxides.

TIME IN SERVICE 35 years; the corrosion occurred within a period of 7 months.

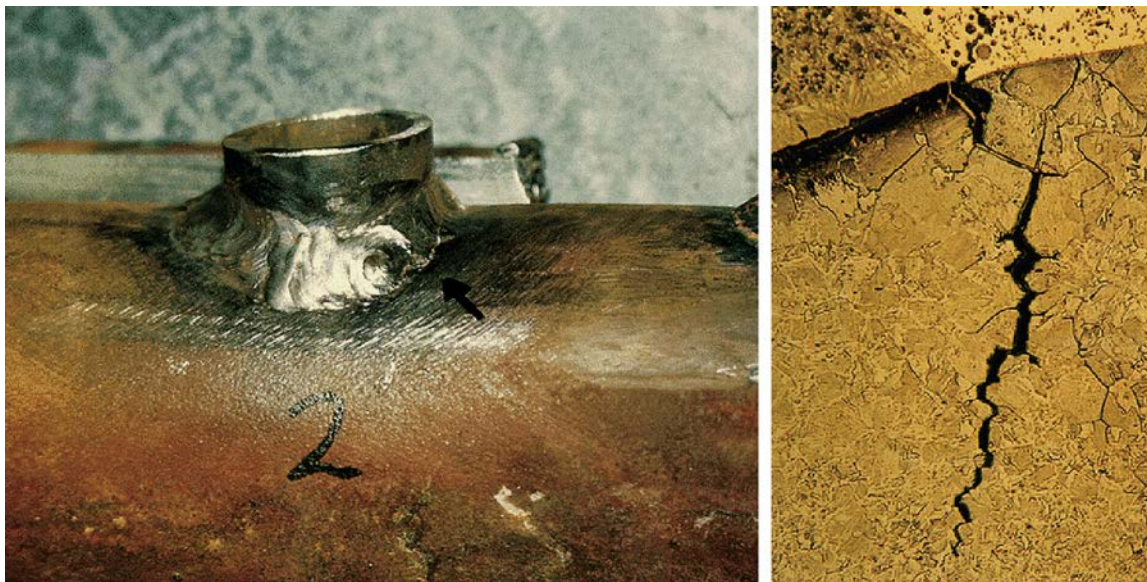
PART Riser tube.

PHENOMENON Liquid metal embrittlement.

APPEARANCE Intergranular cracking in HAZ and weld (root section) after overhaul. The cracks are covered with metallic copper.

TIME IN SERVICE The boiler had been in service for several decades. The cracks appeared during pressure-testing after overhaul.

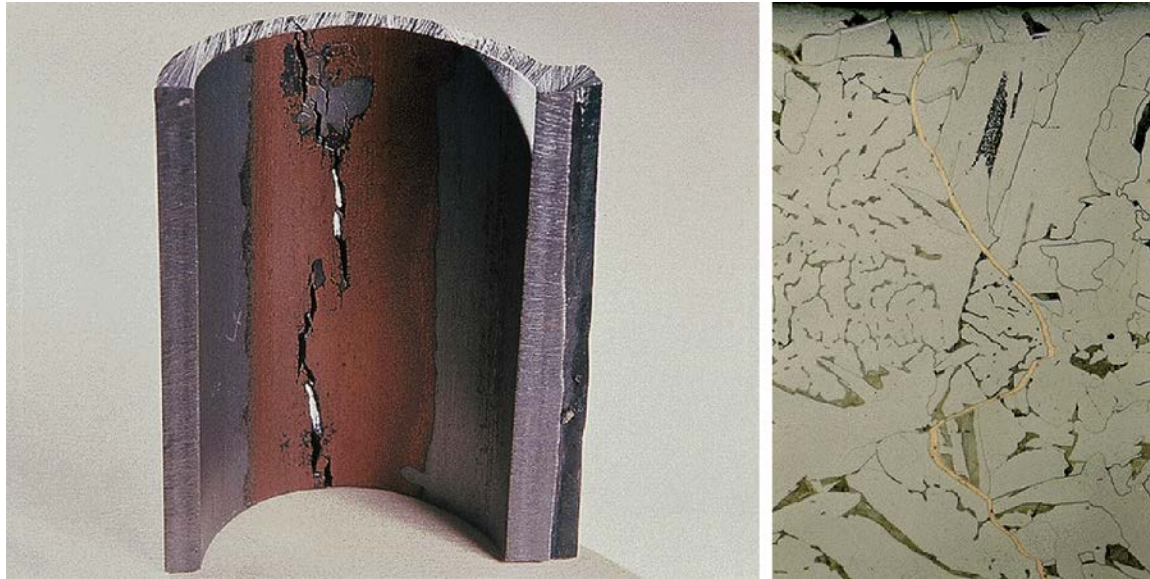
01.01.22.02

MATERIAL	Carbon steel.
SYSTEM	Utility boiler (14MPa).
PART	Water wall tube, third burner level.
PHENOMENON	Liquid metal embrittlement.

APPEARANCE Longitudinal through-wall cracks initiating on internal surface in region of metallic copper plating on hot side of tube. There was only minor wall thinning at the fracture lip, and some necking was apparent.

TIME IN SERVICE Boiler had been in service for 20 years. Cracking occurred in less than 20 min during the overheating event.

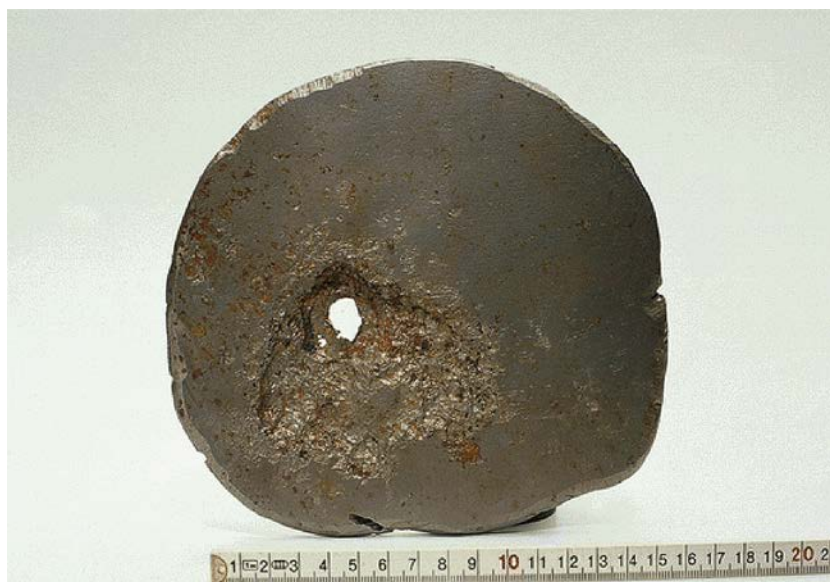
PART Section from the bottom of the outdoor boiler feedwater tank.

PHENOMENON Corrosion under insulation.

APPEARANCE Severe pitting corrosion over a large area at the underside of the tank.

TIME IN SERVICE 23 years.

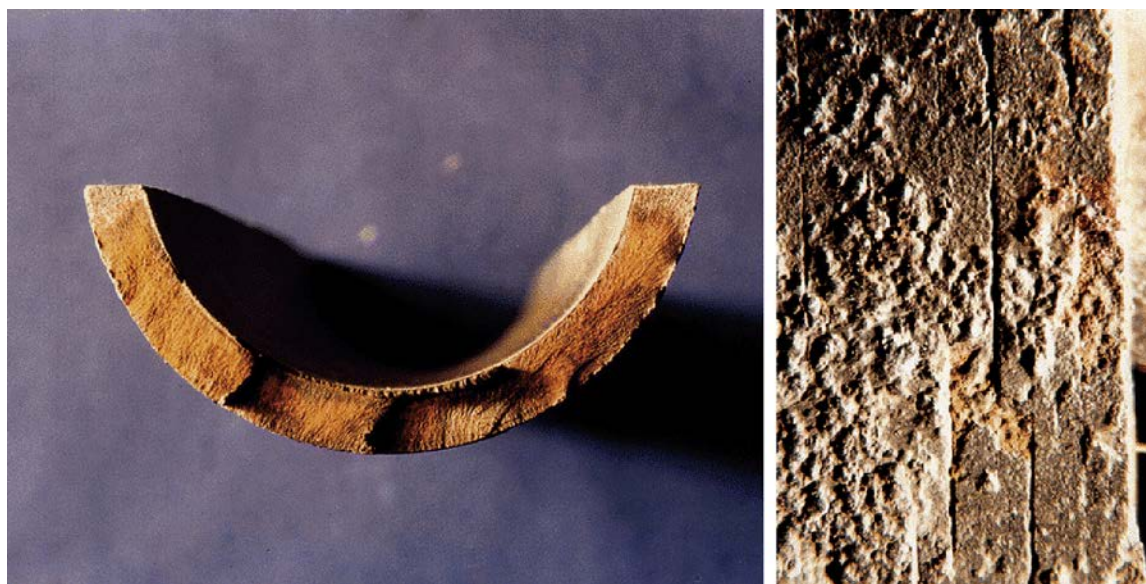
PART Vertical superheater tube near outlet header (OD: 4.4 cm).

PHENOMENON Corrosion fatigue.

APPEARANCE A thick-walled circumferential fracture with secondary unbranched transgranular cracks adjacent to the brittle fracture.

CAUSE The circumferential orientation of the cracks reveals that the stresses responsible were cyclic bending stresses, possibly caused by thermal expansion and contraction of the tube (see also Case Histories [01.21.28.01](#) and [04.11.28.02/03](#)).

- Elimination or reduction of corrosion-fatigue cracking is realized by controlling cyclic tensile stresses, controlling environmental factors, and boiler redesign.
- Reducing or eliminating cyclic operation of the boiler as well as extending startup and shutdown times may help eliminate or reduce corrosion-fatigue cracking.

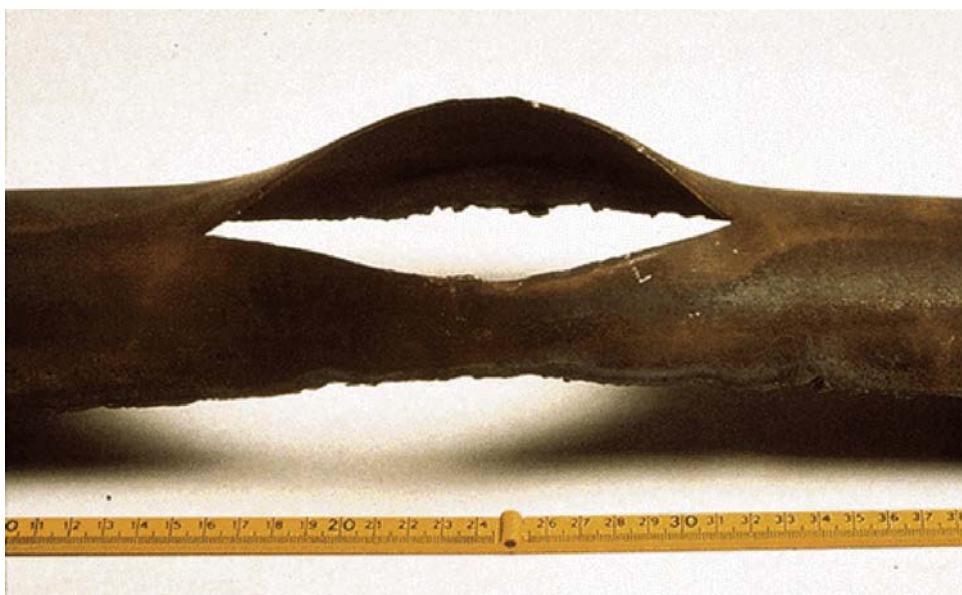
01.01.30.01

MATERIAL	Carbon steel (35.8).
SYSTEM	Vertical water-tube boiler (7.1 MPa).
PART	Water tube.
PHENOMENON	Creep rupture caused by overheating.

APPEARANCE	Fractured water tube.
TIME IN SERVICE	2 years.
ENVIRONMENT	Boiler water formed from steam condensate (98%) and demineralized water (2%), no chemical dosing.
CAUSE	Oxygen corrosion of the fire tube passing through this water tube (pipe-in-pipe system) caused water loss; the capacity of the makeup pump installed was insufficient; the low-water level safety device had been “bypassed” because it did not function owing to the low conductivity of the boiler water (constant alarm). As the water level fell, the burner was therefore not shut down; overheating caused a water tube to fracture after bulging and the boiler exploded.
REMEDY	<ul style="list-style-type: none"> • Dose hydrazine to prevent corrosion. • Dose trisodium phosphate in order to maintain sufficient alkalinity and conductivity, and • Regular checks of the low-water level safety device and the boiler water composition.

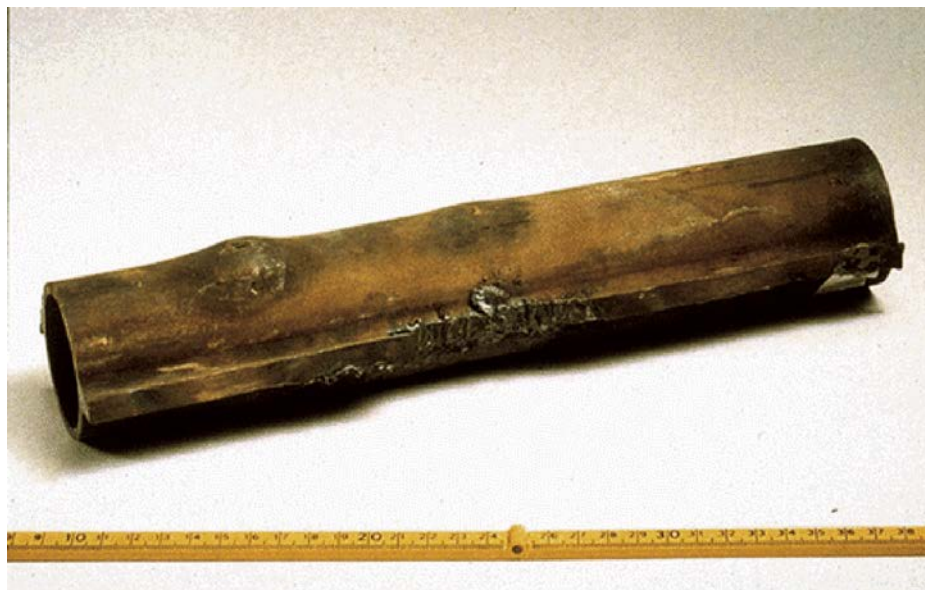
PART Furnace tube.

PHENOMENON Creep caused by overheating.

APPEARANCE Local bulging of tube.

CAUSE Poor water circulation owing to blockage in headers caused by deposition of impurities (zinc and iron oxide) from the condensate.

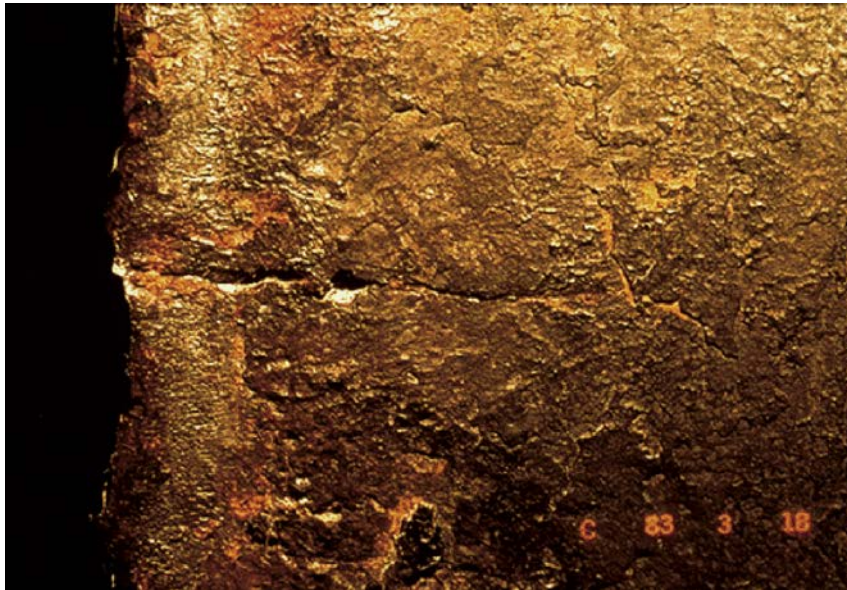
01.01.30.03

MATERIAL	Carbon steel (35.8).
SYSTEM	Gas-fired shell-type fire-tube boiler (0.7–0.8 MPa).
PART	Fire tube extremity of second pass.
PHENOMENON	Cracking caused by overheating.

APPEARANCE	Incipient cracks at protruding tube extremities.
TIME IN SERVICE	10 years.
ENVIRONMENT	Flue gases; 191°C.
CAUSE	Pipe extremities (second pass entry) extending from the tube plate into the combustion chamber were insufficiently cooled, allowing overheating to occur so that the tubes fracture and begin to leak.
REMEDY	Removal of protruding parts and securing of the tubes in the tube plate by means of a U-weld.

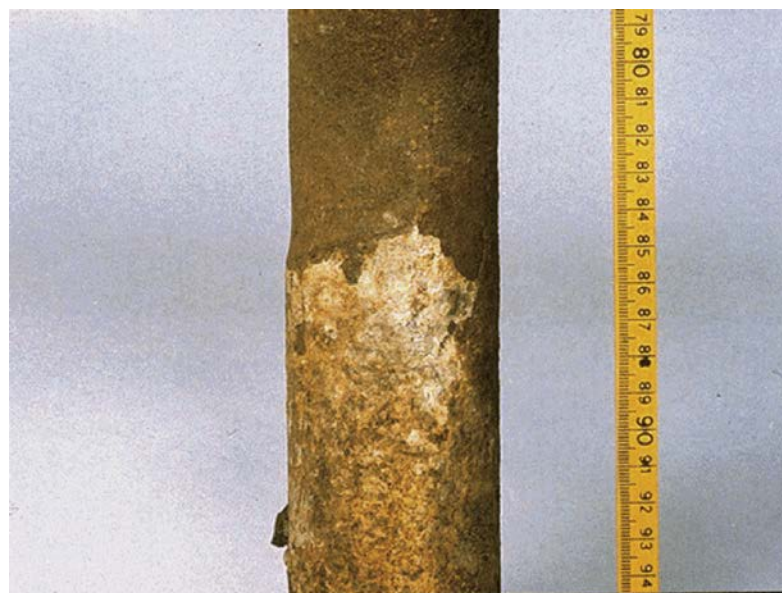
PART Furnace wall tube.

PHENOMENON Erosion.

APPEARANCE Evenly worn surface (upper left-hand area).

CAUSE Erosion by sand turbulence.

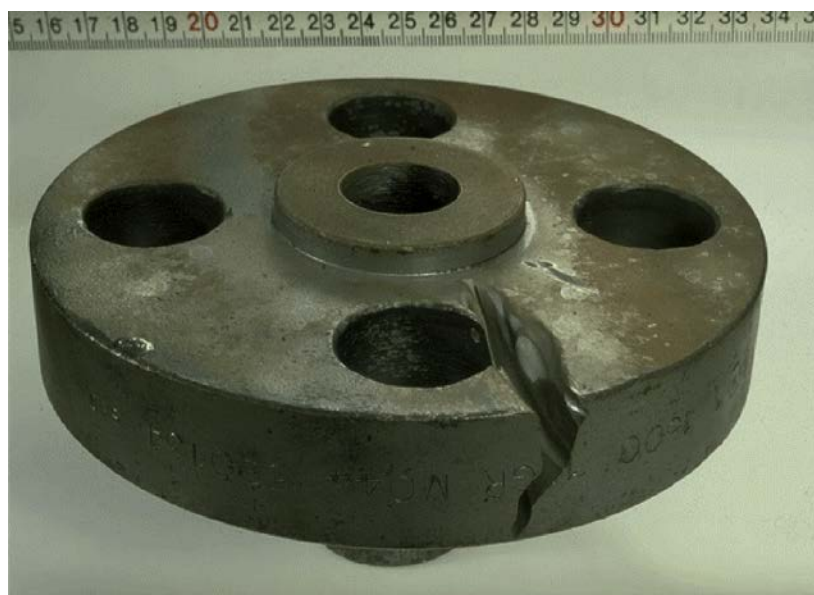
PART Flange from steam line to turbine.

PHENOMENON Erosion (steam cutting).

APPEARANCE Locally worn.

CAUSE Leakage along seal surface, resulting in the superheated steam cutting into the flange. The result of poor workmanship.

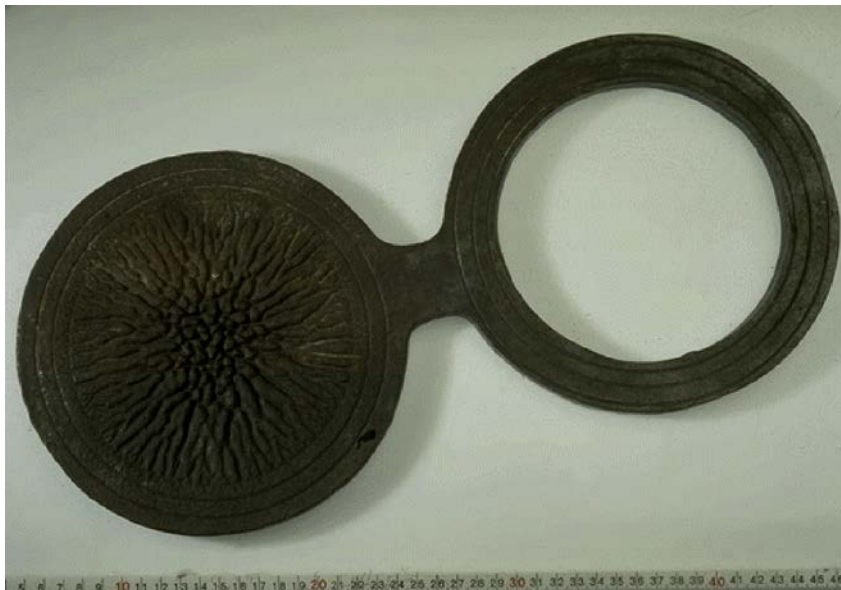
01.01.32.04

MATERIAL	Carbon steel.
SYSTEM	Steam system.
PART	Spectacle flange in 2 MPa steam line.
PHENOMENON	Erosion (water-droplet impingement).

APPEARANCE	Star-shaped erosion picture.
TIME IN SERVICE	Unknown, many years.
ENVIRONMENT	Saturated steam with condensate droplets; 2 MPa.
CAUSE	Impingement by water droplets against closed spectacle flange (see also Case History 01.01.32.02).
REMEDY	Assure proper dewatering of the steam and perform regular inspections on the blind flange.

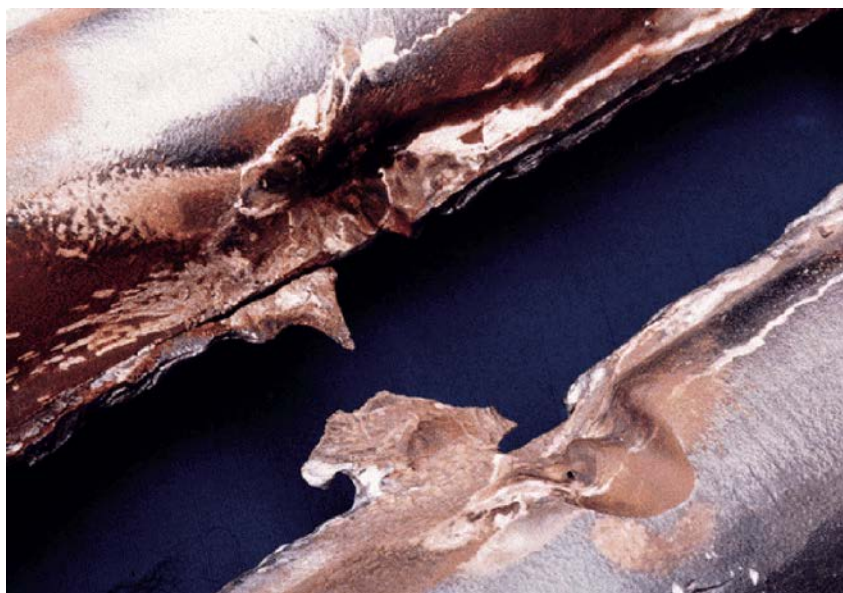
01.01.32.05

MATERIAL	Carbon steel (SA 201 A1).
SYSTEM	Water-tube boiler (pressure: 17.2 MPa).
PART	Vertical front convection wall tube (OD: 7.0 cm).
PHENOMENON	Erosion (steam cutting).

APPEARANCE Severe perforation (cutting) of tube.

CAUSE The original failure occurred at a welded support bracket of another tube and was due to corrosion fatigue. Small corrosion-fatigue cracks were found at poorly fused support welds (poor workmanship!). The adjacent tube was breached by steam escaping from the original failure (see also Case History [01.01.32.03](#)).

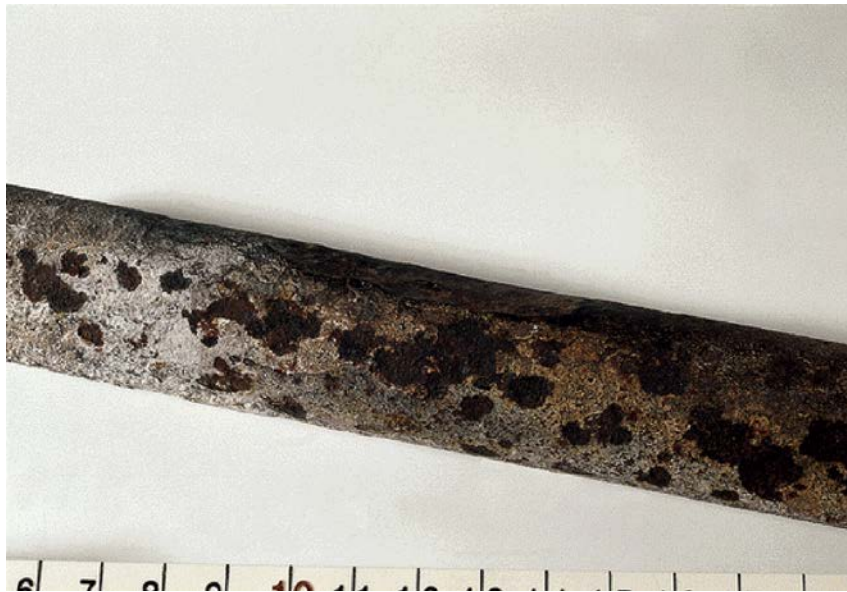
01.01.32.06

MATERIAL	Carbon steel.
SYSTEM	Boiler (2.6 MPa).
PART	Superheater pipe.
PHENOMENON	Erosion.

APPEARANCE Local external wear to the superheater pipe (see upper part).

CAUSE The boiler was fired with rice-chaff which was contaminated with sand. The sand particles caused external erosion of the superheater pipes (see also Case History [01.01.32.07](#)).

- Position wearing plates before the superheater; or
- Apply metal spray coating to the superheater pipes; or
- Remove the sand particles from the rice-chaff before firing.

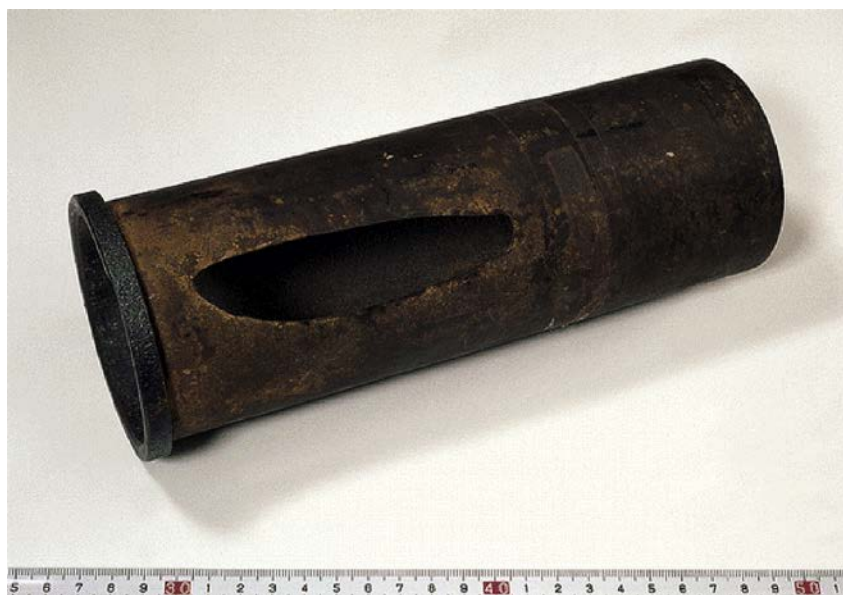
01.01.32.07

MATERIAL	Carbon steel.
SYSTEM	Shell-type fire-tube boiler (2.6 MPa).
PART	Steel insert fire-tube, entrance to third pass.
PHENOMENON	Erosion.

APPEARANCE Insert smoothly worn down from inside to the point of leakage.

CAUSE The boiler was fired with rice-chaff contaminated with sand. The sand particles caused severe erosion in the entrance to the smoke tubes (see also Case History [01.01.32.06](#)).

REMEDY The steel inserts were replaced with ceramic inserts.

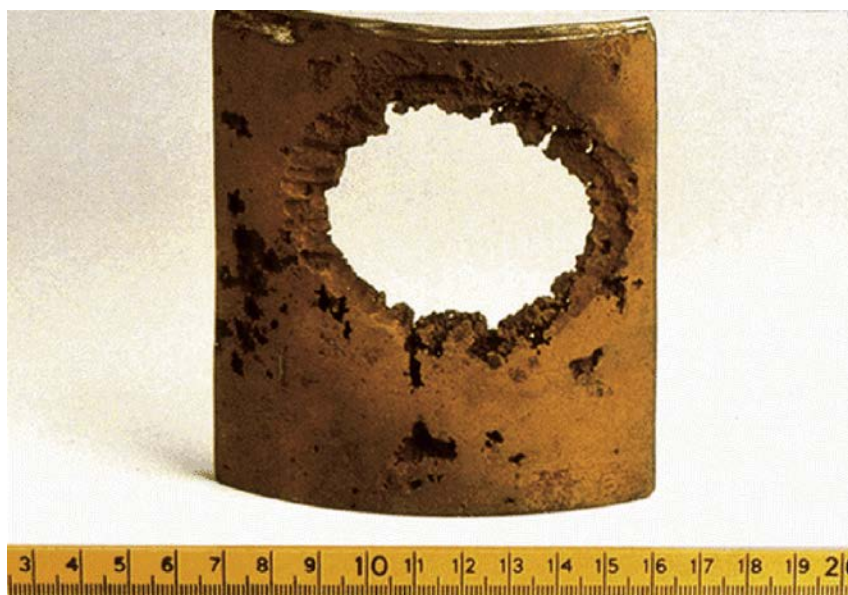
01.01.33.02

MATERIAL	Carbon steel.
SYSTEM	Boiler feedwater system.
PART	Section of steam dome of two-stage deaerator.
PHENOMENON	Cavitation erosion.

APPEARANCE Material with sharp edges worn away to the point of leakage.

CAUSE The steam dome was damaged by cavitation as a result of the steam entering below the surface near the dome.

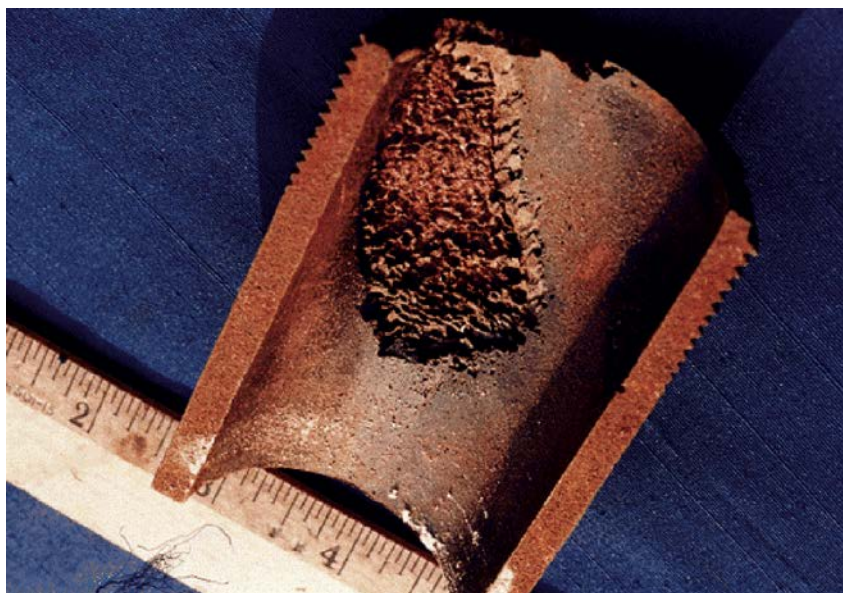
01.01.33.03

MATERIAL	Mild steel.
SYSTEM	Water-tube boiler (pressure: 8.3 MPa).
PART	Horizontal blowdown line threaded into a tee (OD: 6.4 cm).
PHENOMENON	Cavitation damage.

APPEARANCE	Severe localized wastage on internal surface, with perforation near the attachment of the pipe to tee.
TIME IN SERVICE	6 years (only during intermittent manual blowdown).
ENVIRONMENT	Boiler water. Water treatment: coordinated phosphate, oxygen scavenger.
CAUSE	The flow direction is severely changed in the pipe tee, causing strong turbulence and pressure changes leading to vapor bubble formation. The collapsing steam bubbles cause cavitation damage. In this case, the manual blowdown had been increased due to feedwater contamination from the preboiler system.
REMEDY	<ul style="list-style-type: none"> • Construct the blowdown line of a wider straight pipe and minimize manual blowdown by continuous blowdown. • Prevent contamination of the feedwater.

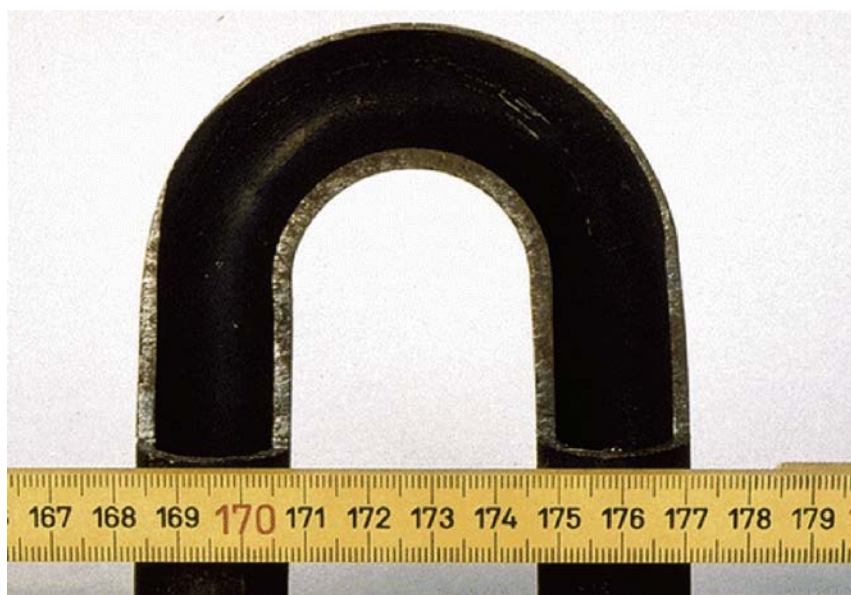
PART Economizer tube.

PHENOMENON Erosion corrosion.

APPEARANCE Material locally worn in the bend pieces.

CAUSE Steam formation in the economizer due to irregular distribution of the flue gases and flue gas temperature. Heat absorption by the economizer was found in practice to exceed the design data (see also Case History [01.01.34.06](#)).

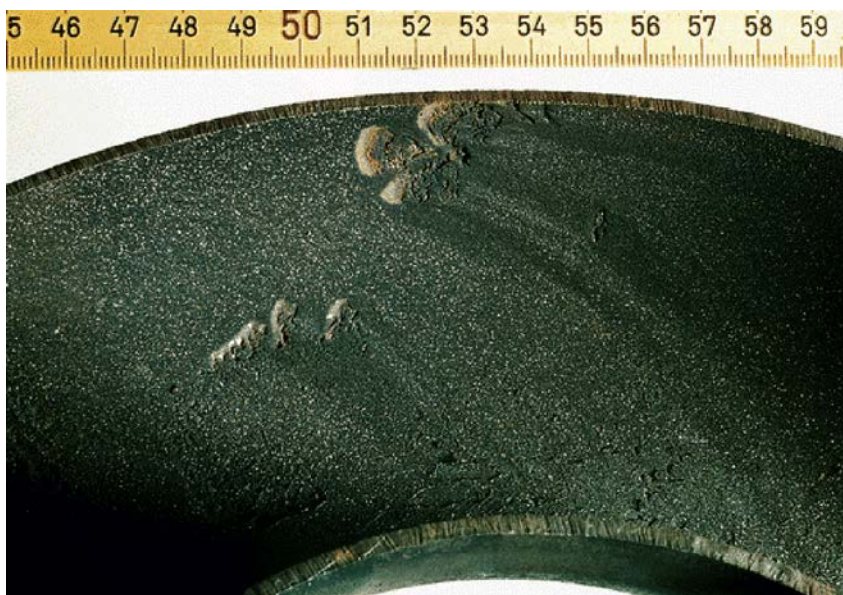
PART Bend in steam pipe.

PHENOMENON Erosion corrosion.

APPEARANCE Here and there the line exhibits a clear flow pattern.

ENVIRONMENT Steam 1.2MPa, occasionally contaminated with boiler water owing to priming of the boiler caused by the high organic matter content (COD 1400 p.p.m.) in the boiler water by feeding with milk-contaminated flash steam condensate (steam velocity: 50 m/s).

CAUSE Turbulence in the bend in addition to the presence of water droplets caused by priming of the boiler, leading to local damage of the magnetite layer.

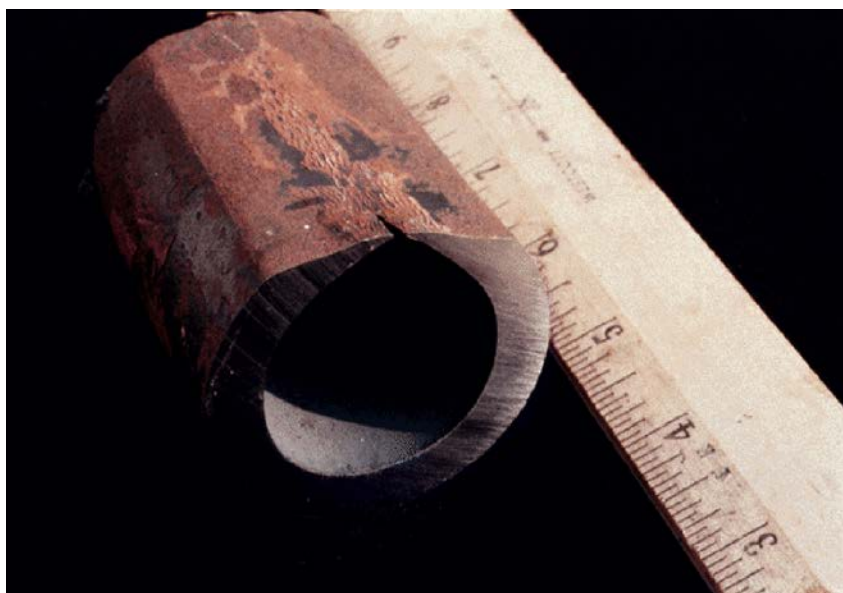
PART Superheater tube (OD: 5.1 cm).

PHENOMENON Erosion corrosion (soot-blower attack).

APPEARANCE The outer surface is partly flattened. The tube bulged and ruptured on the thinned side (see also Case Histories [01.01.06.01](#) and [01.01.32.06](#)).

CAUSE Improperly aligned soot blowers caused near 90° impingement of condensed water droplets on the tube surface.

REMEDY Repair and realignment of soot blower.

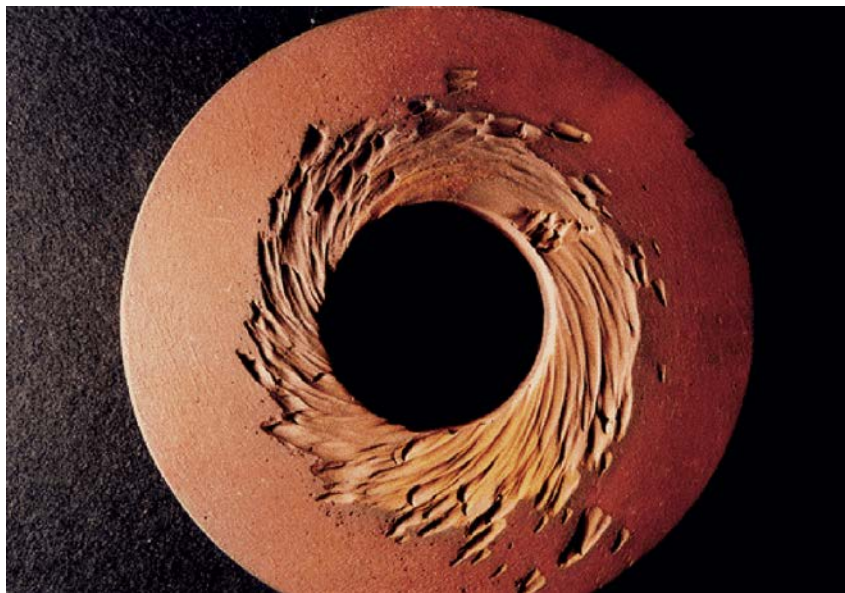
PART Feedwater pump spacer (diameter: 13.3 cm).

PHENOMENON Erosion corrosion.

APPEARANCE Smooth spiral grooves in an obvious flow pattern.

CAUSE Turbulent water flow in pump with relatively high concentration of dissolved oxygen in feedwater.
 The alloy was incorrect for this use.

- Changed to stainless steel American Iron and Steel Institute (AISI) 405.
- Corrected deaerator function in order to reduce dissolved oxygen concentration.

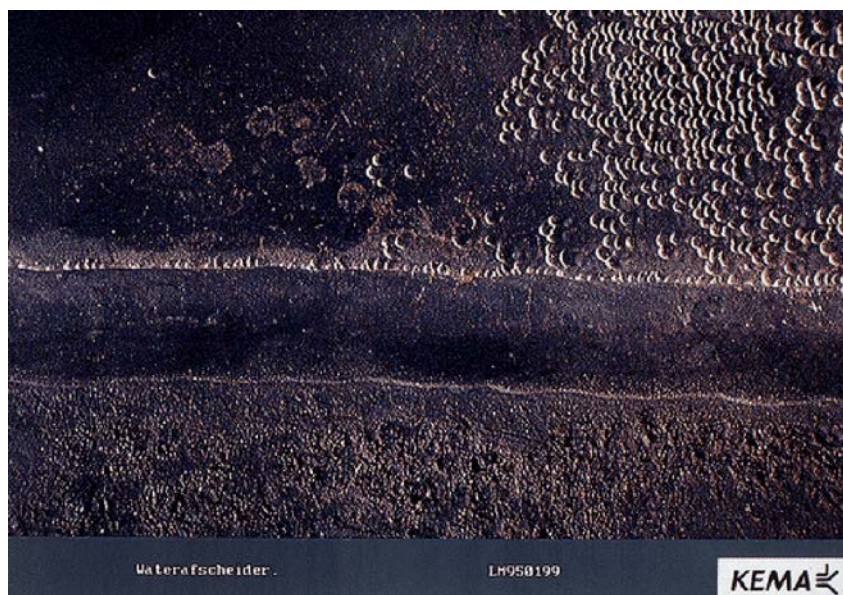
PART Water separator.

PHENOMENON Erosion corrosion.

APPEARANCE One of two welded-together plates showed horseshoe-type erosion corrosion. Iron oxides were deposited on the uncorroded plate. Preferential attack of the weld.

- High turbulence in the water separator.
- Too low resistance of one of the steel plates because of the small amounts of Cu, Cr, and Mo in the steel. The Gkema value of the corroded plate was 87, the value of the uncorroded plate was 53.

- In this case, the steel plates were replaced without giving attention to the steel composition.
- Specify the corrosion resistance of carbon steel (tube and welding material) for erosion-corrosion-sensitive components in the water steam system. A Gkema value of lower than 80 is recommended.

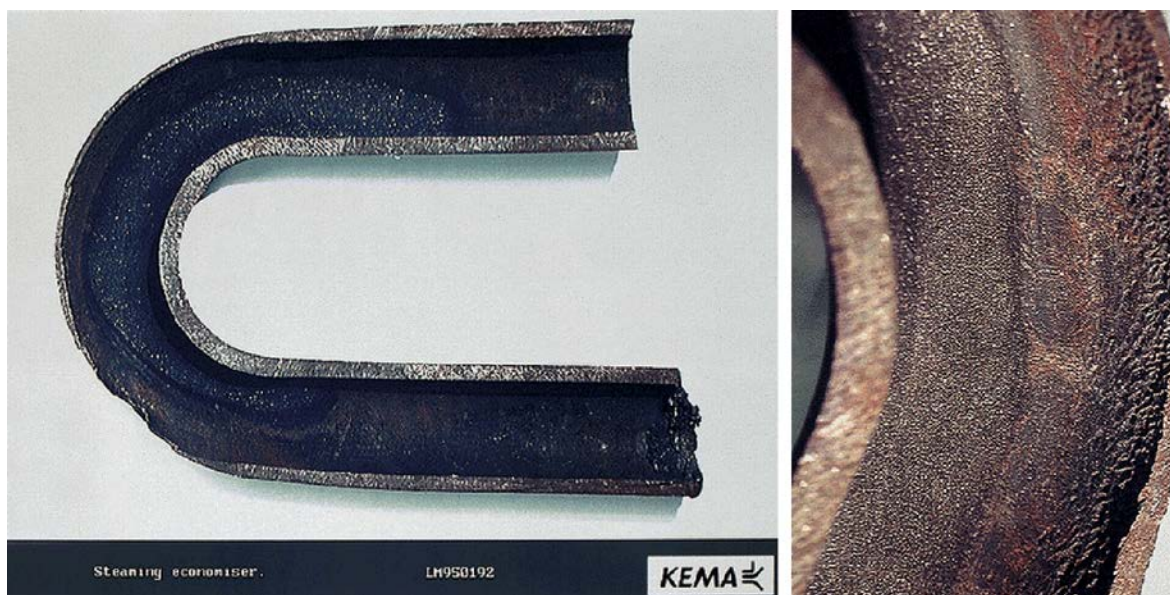
01.01.34.06

MATERIAL	Carbon steel.
SYSTEM	Water-tube boiler.
PART	Steaming economizer tube.
PHENOMENON	Erosion corrosion.

APPEARANCE	At the outer curve side: erosion corrosion (horseshoe-type attack); At the inner curve side: iron oxide deposit as coarse magnetite crystals.
------------	--

CAUSE	In the economizer, steam was formed, and two-phase flow occurred. The water ran at the outside of the bend; steam at the inside. The erosion-corrosion resistance of the steel was too low because of the small amounts of Cu, Cr, and Mo in the steel. Gkema value of the steel was 92 (see also Case History 01.01.34.01).
-------	---

REMEDY	<ul style="list-style-type: none"> • In this case, the bends were replaced with a 1% Cr steel. • Specify the erosion-corrosion resistance of carbon steel (tube and welding material) for erosion-corrosion sensitive components in the water steam system. A Gkema value of lower than 80 is recommended.
--------	--

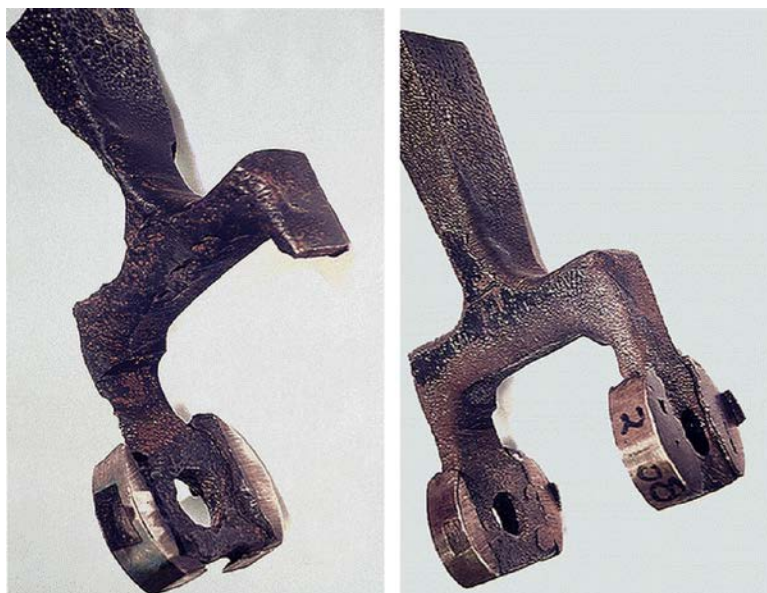
01.01.34.07

MATERIAL	Carbon steel.
SYSTEM	Power station feedwater system.
PART	Switch levers of two water supply pumps in a power station.
PHENOMENON	Erosion corrosion.

APPEARANCE	Horseshoe-type attack on both levers. The lever with the lesser operating time was attacked more. The cladded stainless steel at the lever ends was uncorroded.
TIME IN SERVICE	Lever, left: 10,000 h (1 year). Lever, right: 40,000 h (4 years).
ENVIRONMENT	Demineralized makeup water.
CAUSE	High water turbulence and a carbon steel with too low resistance to erosion corrosion. The lever with an operating time of 10,000 h had a Gkema value equal to 95 because of the very small amounts of Cu, Cr, and Mo in the steel. The lever with the operating time of 40,000 h had a lower Gkema value of 85. This lever was corroded much less.
REMEDY	<ul style="list-style-type: none"> • In this case, the switch levers were replaced without special attention to the steel composition. • Specify the erosion corrosion resistance of carbon steel (tube and welding material) for erosion-corrosion-sensitive components in the water-steam system. A Gkema value of lower than 80 is recommended.
