Corrosion Atlas

THIRD, EXPANDED AND REVISED EDITION

A Collection of Illustrated Case Histories

Evert D.D. During

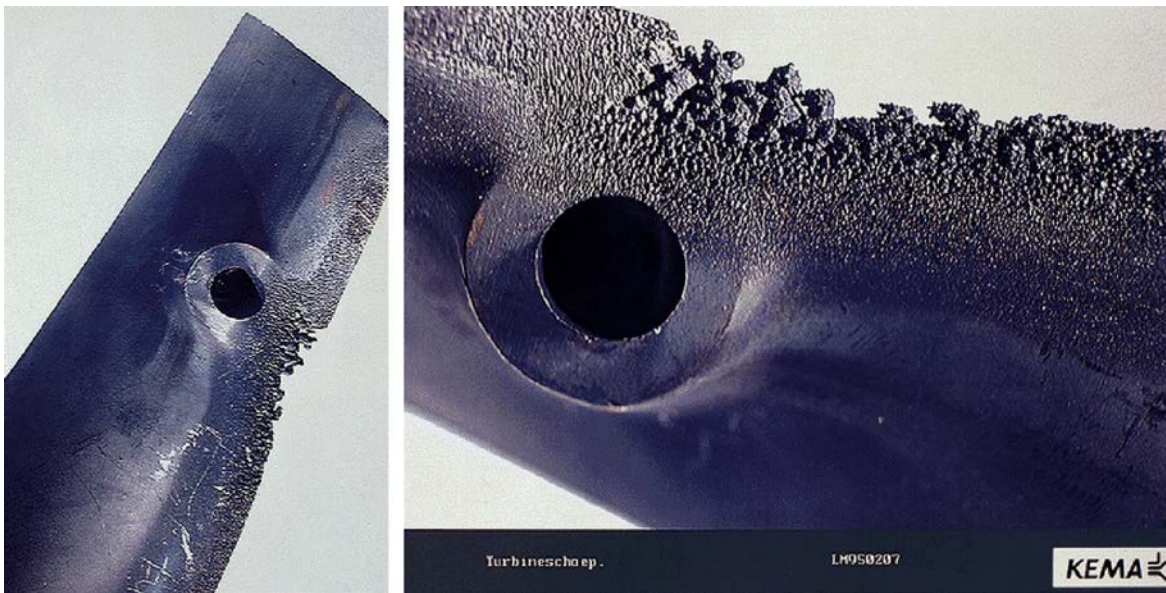
PART Blade of the last row of the running blades.

PHENOMENON Erosion corrosion (impingement).

APPEARANCE The material of the upper part exhibits sponge-type erosion (see also Case History [01.01.32.02](#)).

- The cooling water temperature control system was slow so that large temperature fluctuations occurred in the condenser steam conditions.
- The blades were surface-hardened over a too small length.

REMEDY The replaced blades were surface-hardened over the total length.

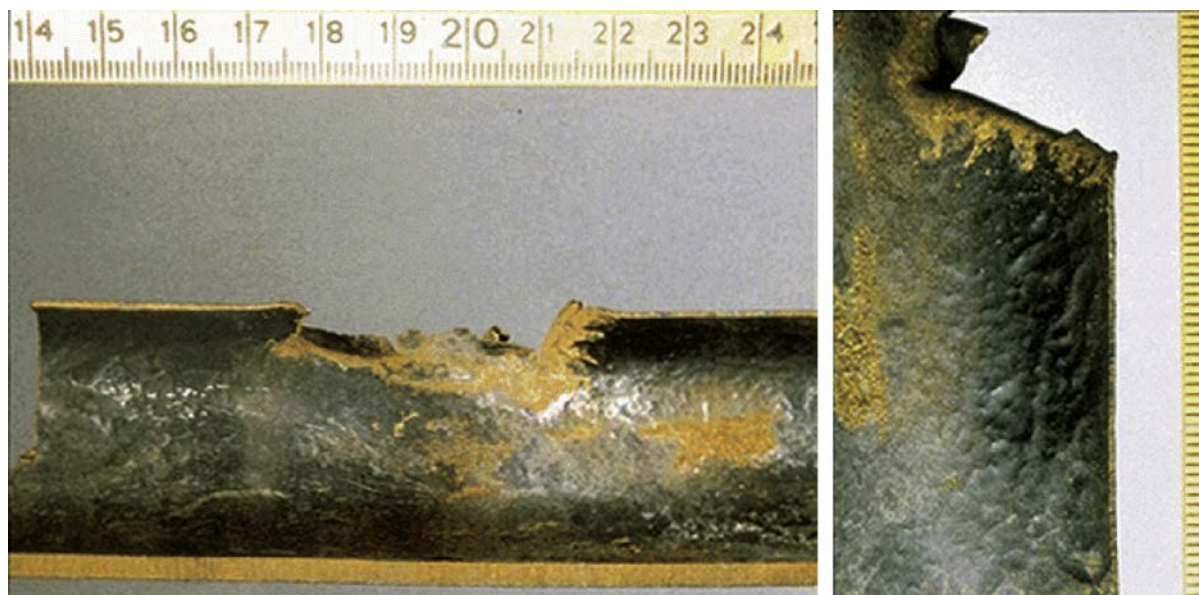
01.01.43.01

MATERIAL	Carbon steel (35.8).
SYSTEM	Corner water-tube boiler (4.1 MPa).
PART	Inclined water tube from convection section.
PHENOMENON	Steam blanketing.

APPEARANCE Internal irregular attack of the material in the upper part of the tube.

CAUSE Excessive steam formation takes place owing to insufficient cooling of the water tubes. Steam bubbles cling to the upper part of the tubes. This causes a strong local decrease in cooling and locally increased magnetite growth takes place. If the bubbles are removed as the result of fluctuating load, the cooling will be temporarily restored, and the oxide formed flakes off. This phenomenon can lead to substantial reduction of wall thickness within a relatively short time.

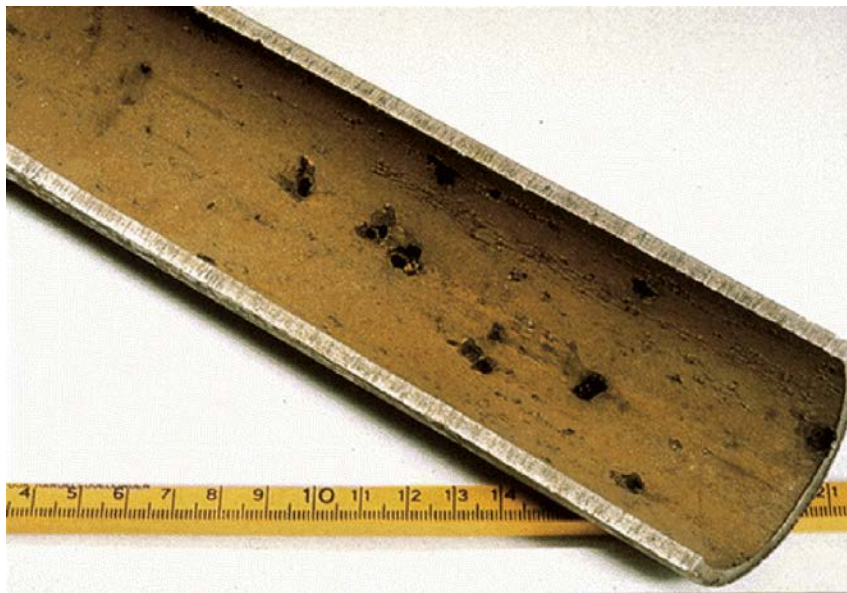
PART Condensate pipe.

PHENOMENON Oxygen corrosion.

APPEARANCE Sharp pitting without corrosion products.

CAUSE The oxygen corrosion occurred because of malfunctioning of the deaerator (steam pressure regulator set too low) and was reinforced by the contamination of the condensate with boiler water (due to malfunctioning of the steam/moisture separator in the boiler).

REMEDY Modification to the deaerator and modification to the steam/moisture separator.

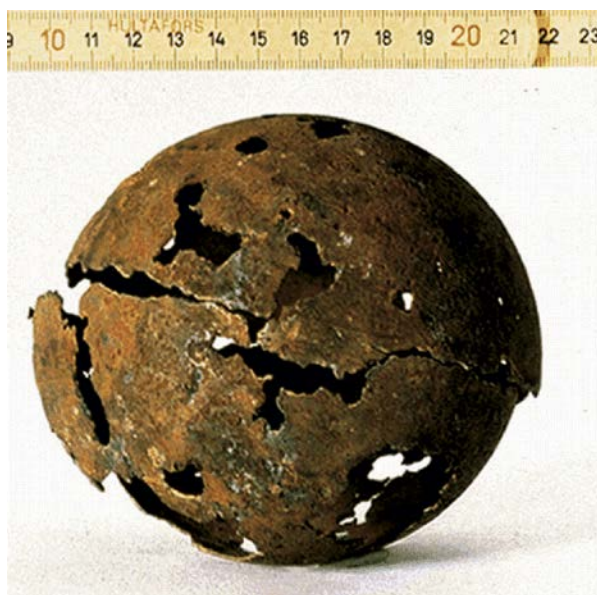
01.02.01.02

MATERIAL	Carbon steel.
SYSTEM	Steam condensate system.
PART	Float ball from heat exchanger steam trap.
PHENOMENON	Oxygen corrosion.

APPEARANCE	Pitting to the point of large holes.
TIME IN SERVICE	7 months.
ENVIRONMENT	Condensate contaminated by aerated dealkalized water due to leakage of the heat exchanger (see Case History 06.01.32.01); temperature approximately 100°C
CAUSE	The contamination with oxygen-containing water caused oxygen attack; because of alkalinity reduction of the makeup water and deaeration of the feedwater, the noncontaminated condensate was of good quality.
REMEDY	After repair of the leakage, for additional certainty, the trap was fitted with an AISI 316 stainless steel float ball.

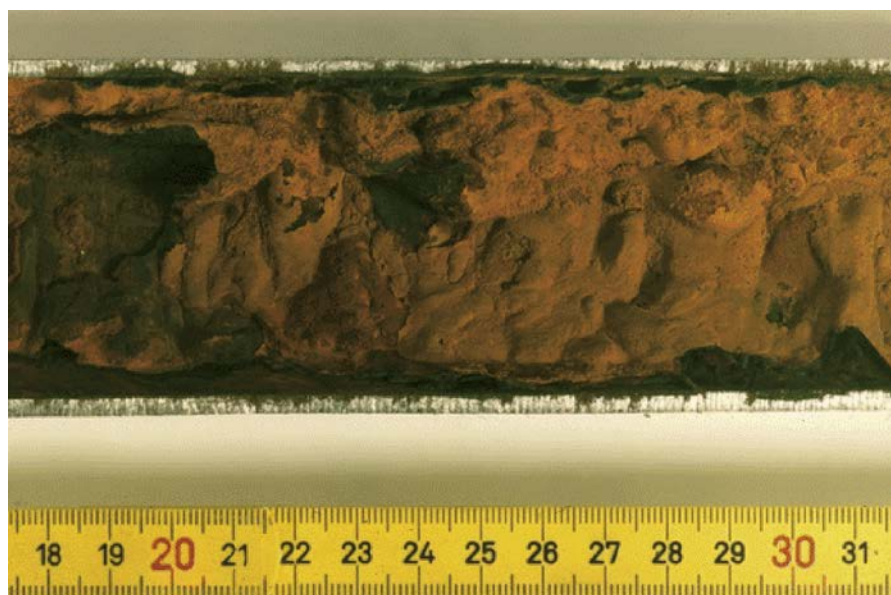
01.02.01.03

MATERIAL	Carbon steel.
SYSTEM	Steam condensate system.
PART	Condensate line.
PHENOMENON	Oxygen corrosion.

APPEARANCE Pipe covered with corrosion products, under which the steel shows pitting attack.

CAUSE Oxygen attack due to the absence of a deaerator; oxygen-binding chemicals were not dosed. The corrosion products remained in the pipe due to the low acidity of the condensate and the low flow rate.

REMEDY In view of the small length of the condensate line, it is constructed of stainless steel. In the case of a large condensate system, it is preferable to apply deaeration of the feedwater or dosing of oxygen-binding chemicals.

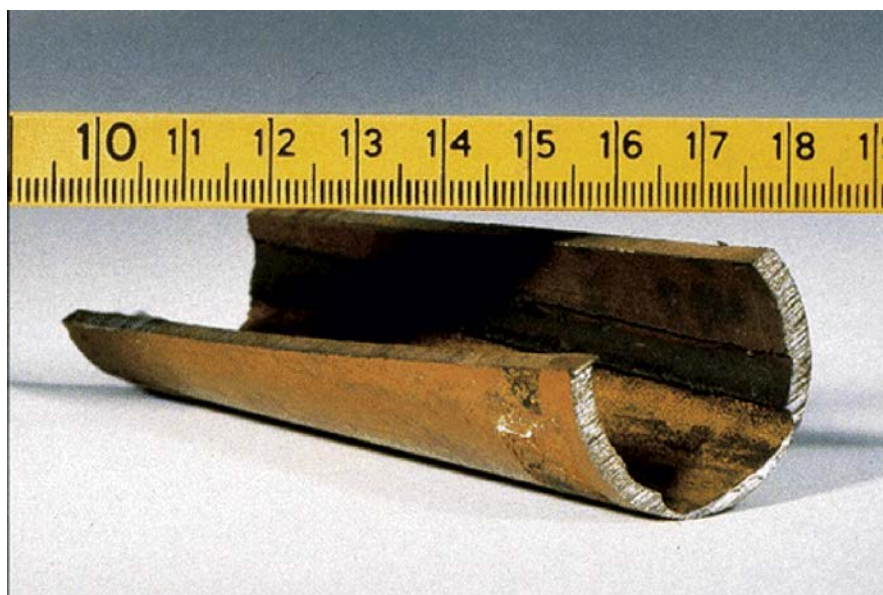
01.02.02.01

MATERIAL	Carbon steel.
SYSTEM	Steam condensate system (of 1.3 MPa steam supply).
PART	Horizontal condensate pipe.
PHENOMENON	Carbonic acid corrosion.

APPEARANCE	One-sided uniform corrosion at two levels, resulting from two different loads (day time and night time).
TIME IN SERVICE	1 year.
ENVIRONMENT	Corrosive condensate (boiler was fed with a mixture of softened makeup water with an alkalinity of 4 meq/L (200 p.p.m. CaCO_3) and 50% condensate; this mixture was deaerated).
CAUSE	Steel attacked by corrosive condensate; the condensate is corrosive because of the presence of carbon dioxide (CO_2), which is formed in the boiler and entrained with the steam.
REMEDY	Alkalinity reduction of the makeup water (in this case, by anion exchanger in chloride cycle). In view of the use of direct steam, it was not possible to dose chemicals into the steam; construction of the condensate system of stainless steel was out of the question for reasons of cost.

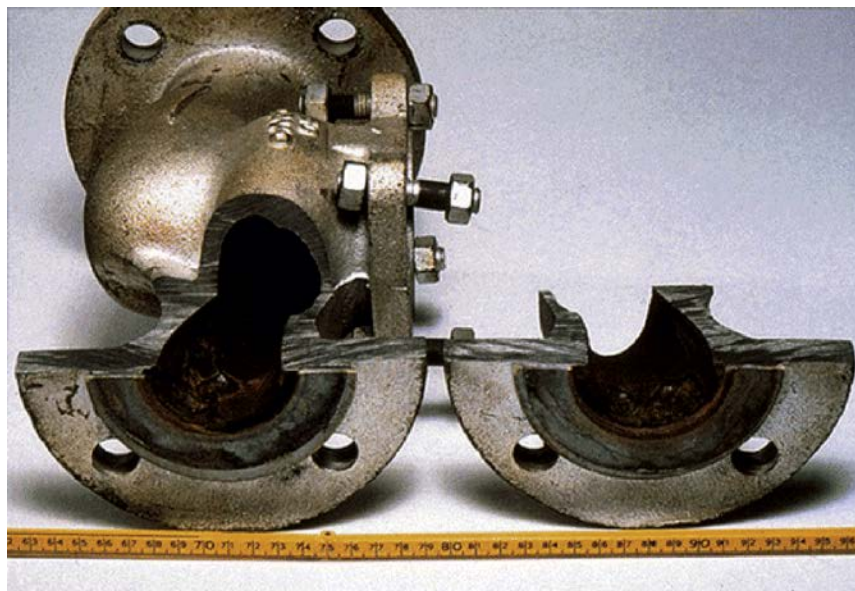
01.02.14.02

MATERIAL	Cast iron.
SYSTEM	Steam condensate system.
PART	Valve from condensate pipe.
PHENOMENON	Galvanic corrosion.

APPEARANCE	Locally severe attack at flange connection.
TIME IN SERVICE	Unknown.
ENVIRONMENT	Moderate corrosive condensate; pH 6.6; temperature approximately 100°C.

CAUSE The cast iron valve was incorporated in an AISI 304 stainless steel condensate pipe of a copper heat exchanger. The potential difference between copper/stainless steel and the cast iron caused galvanic corrosion to the valve.

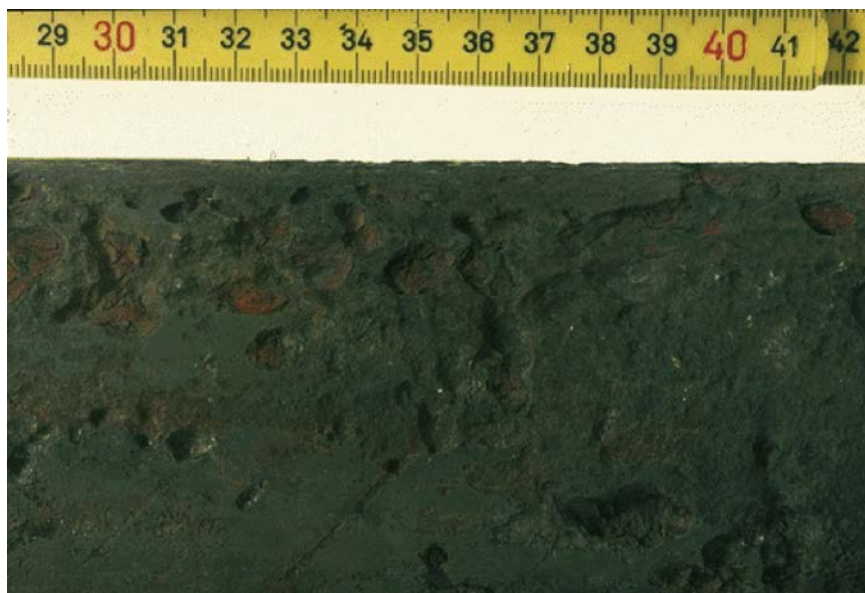
01.02.25.01

MATERIAL	Carbon steel.
SYSTEM	Steam condensate system.
PART	Pipe.
PHENOMENON	Corrosion under insulation.

APPEARANCE	Pitting attack to lower part of pipeline. (The photograph has been placed upside down deliberately to reflect the real situation.)
------------	--

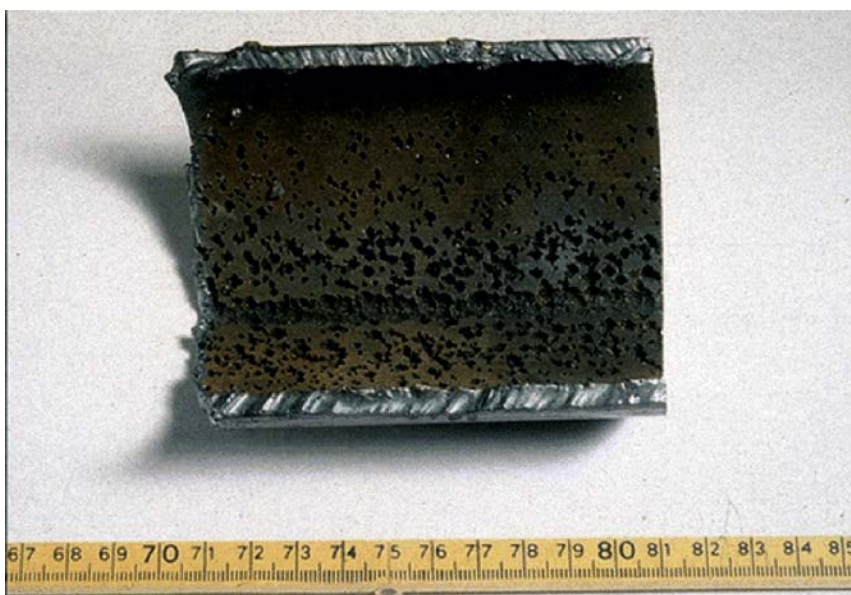
01.02.33.01

MATERIAL	Carbon steel.
SYSTEM	Steam condensate system.
PART	Upper part of horizontal condensate pipe.
PHENOMENON	Cavitation erosion.

APPEARANCE Attack with sharp edges, concentrated at the upper side of the pipe.

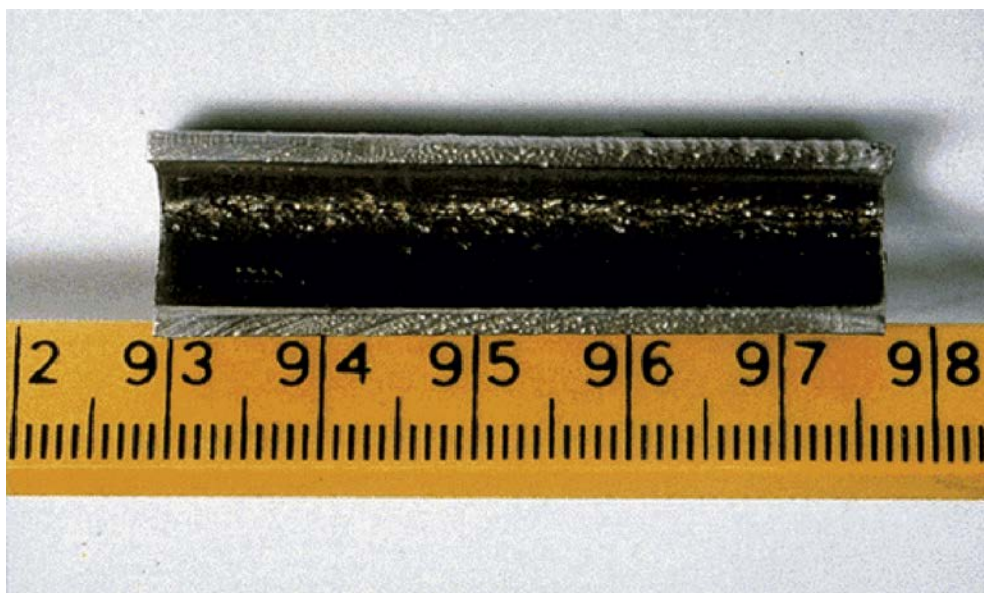
01.02.33.02

MATERIAL	Carbon steel.
SYSTEM	Steam condensate system.
PART	Pipe of air heater used as steam cooler.
PHENOMENON	Cavitation erosion.

APPEARANCE	Local attack with sharp edges on the bottom of the oval pipe.
TIME IN SERVICE	2–3 years.
ENVIRONMENT	Condensate (free of oxygen and carbonic acid owing to properly functioning deaerator and demineralization of the makeup water); temperature 100–120°C.
CAUSE	Condensate accumulation took place due to poor drainage of the horizontally positioned steam cooler so that the feed steam imploded in the cooled condensate, accompanied by loud crackling noises. The sharp bend of the oval pipe was preferentially attacked probably due to the different structure caused by the residual stresses.
REMEDY	In the present case, the rotational speed of the fan positioned underneath the steam cooler was reduced, which yielded improved drainage at the expense of capacity. Replacement of the thermal steam trap by a lower-placed float-type trap can improve drainage without loss of capacity.

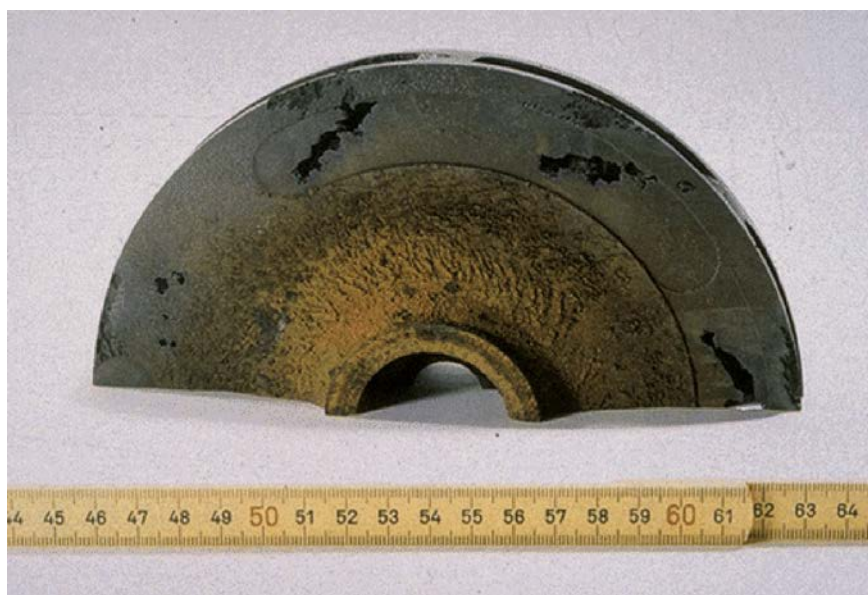
01.02.33.03

MATERIAL	Cast iron.
SYSTEM	Steam condensate system.
PART	Condensate pump impeller.
PHENOMENON	Cavitation erosion.

APPEARANCE	Local wear.
TIME IN SERVICE	6 months.
ENVIRONMENT	Condensate, varying in temperature from 60°C to 90°C.

CAUSE The condensate pump was positioned beside the open condensate tank so that there was insufficient delivery pressure to prevent steam formation in the pump at 90°C. Implosion of the steam bubbles at the discharge side caused the cavitation (see also Case History [04.11.33.01](#)).

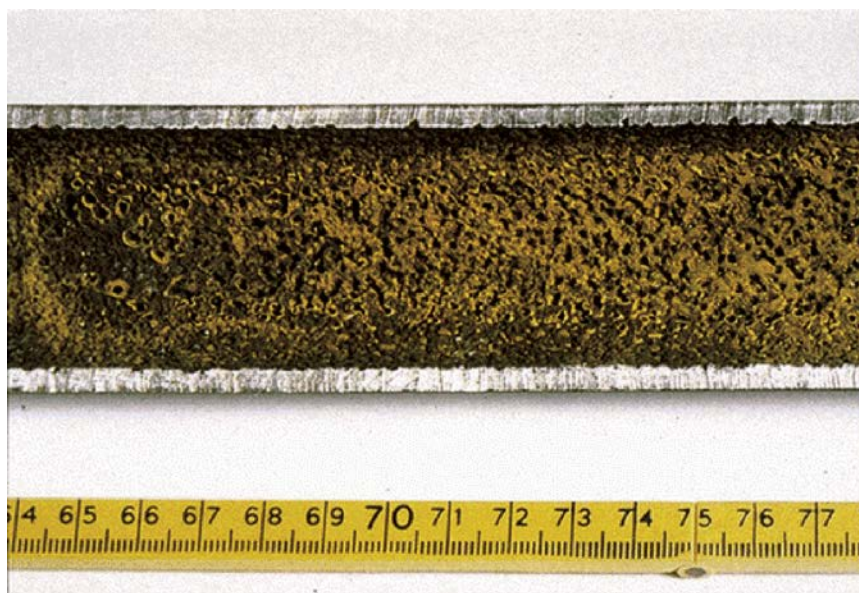
01.02.33.04

MATERIAL	Carbon steel.
SYSTEM	Condensate preheater of a boiler (gas turbine waste-heat boiler, 4.1 MPa). Installed in stack to recover heat from the flue gases.
PART	Pipe from preheater.
PHENOMENON	Cavitation erosion.

APPEARANCE	Pitting.
TIME IN SERVICE	About 3 years.
ENVIRONMENT	Steam condensate low in oxygen and carbonic acid (boiler feed with completely desalted and deaerated water); temperature from 60°C rising to 141°C.
CAUSE	Incorrect positioning of the control valve, namely in the condensate feed line, allowed vacuum to form in the preheater, because of the “hanging” water column, when the valve was closed. The formed steam imploded in the cold condensate when the valve was opened (see also Case History 01.06.33.01).
REMEDY	Relocation of the control valve in the discharge line prevented the formation of vacuum.

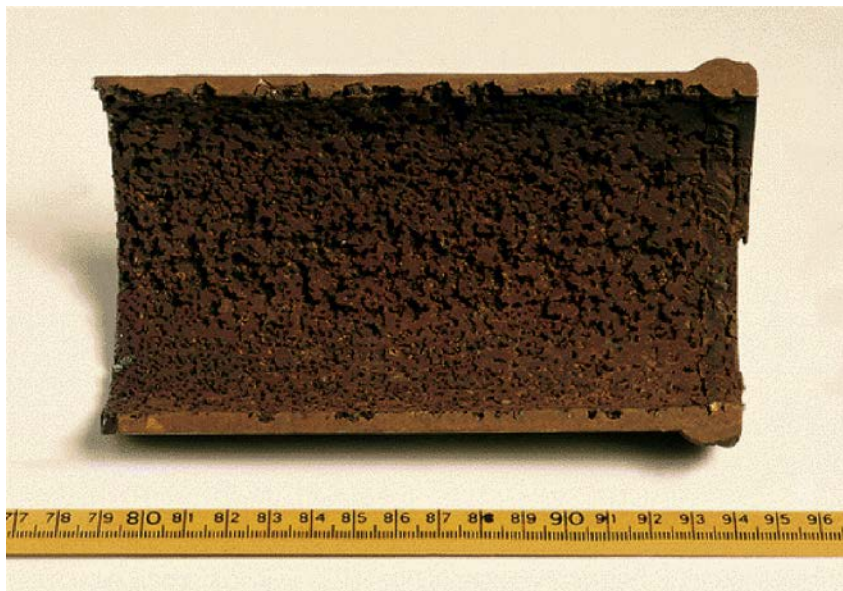
01.02.33.05

MATERIAL	Carbon steel.
SYSTEM	Condensate system.
PART	Condensate pipe.
PHENOMENON	Cavitation erosion.

APPEARANCE	Sharp-edged pits in a sponge-like pattern.
TIME IN SERVICE	Unknown.
ENVIRONMENT	Condensate.
CAUSE	When high-pressure condensate was supplied in a low-pressure condensate line, expansion of the high-pressure condensate caused steam bubbles to form, which imploded in the low-pressure condensate.
REMEDY	<ul style="list-style-type: none"> • High-pressure and low-pressure condensate should be returned separately to the boiler house; or • Expand the high-pressure condensate before feeding it to the low-pressure condensate, and the expansion steam can be routed into a low-pressure steam line.

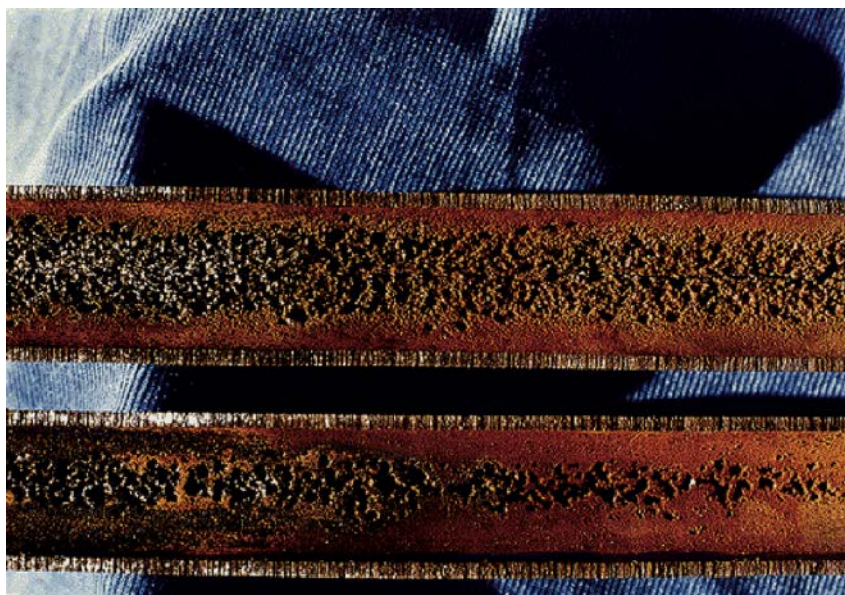
01.02.33.06

MATERIAL	Mild steel.
SYSTEM	Turbine exhaust steam-cooling system.
PART	Horizontal fin-fan condenser tube (OD: 2.5 cm).
PHENOMENON	Cavitation erosion.

APPEARANCE	A rough, jagged contour of deep, overlapping pits, free of corrosion products, in opposite areas (top and bottom of the internal surface). Note longitudinal crack.
TIME IN SERVICE	2.5 years.
ENVIRONMENT	Internal: steam and condensate (pressure: 276 kPa); pH 8.5–8.8 with excursions to 6.9.
CAUSE	The cavitation damage was caused by cyclic vibration of the tube in the vertical plane, which led to rapid pressure changes of the condensing flow in the tube. Microstructural examination revealed deformation twins (Neumann bands) in metal grains at wasted surfaces. Coupled with the opposite sides attack, this confirms the diagnosis of cavitation damage (see also Case History 01.06.33.05).
REMEDY	Prevent vibration of the tubes by reducing flow velocity.

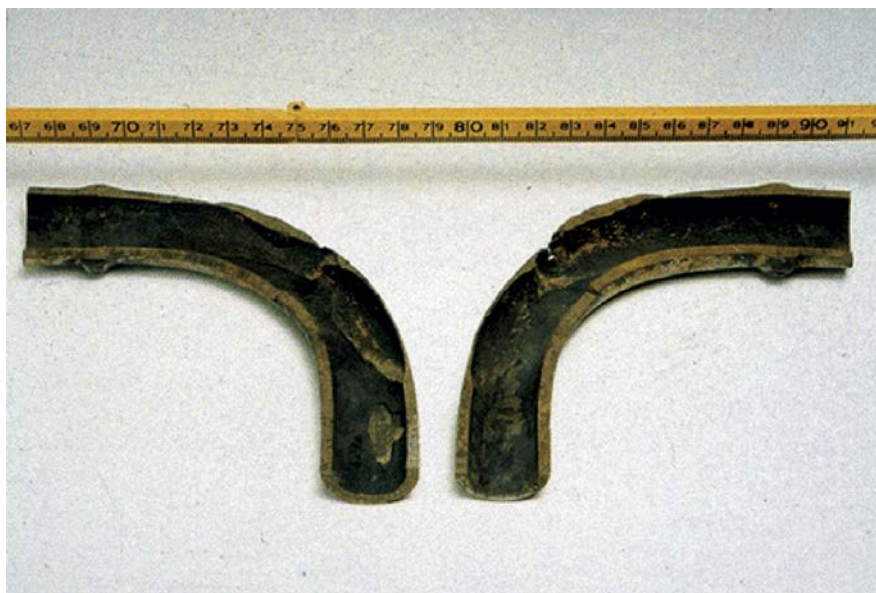
01.02.34.01

MATERIAL	Carbon steel.
SYSTEM	Steam condensate system.
PART	Condensate pipe.
PHENOMENON	Erosion corrosion.

APPEARANCE Severe attack, in bend.

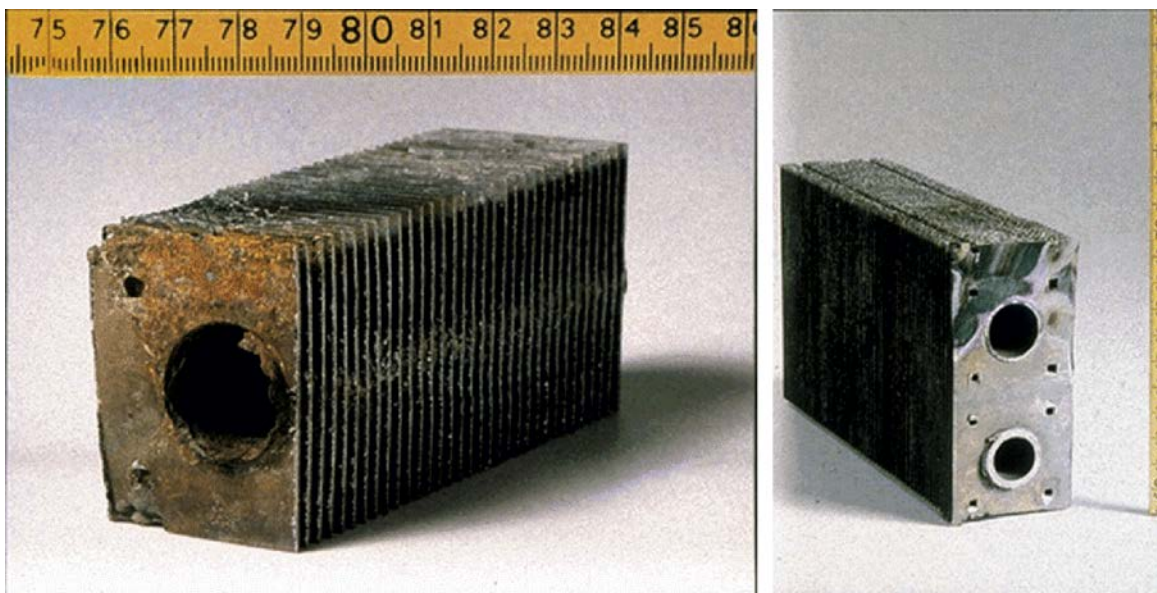
PART Air heater tubes.

PHENOMENON Erosion corrosion.

APPEARANCE Preferential attack to one of the pipes; uniform attack to the material over the entire surface of the first 20 cm.

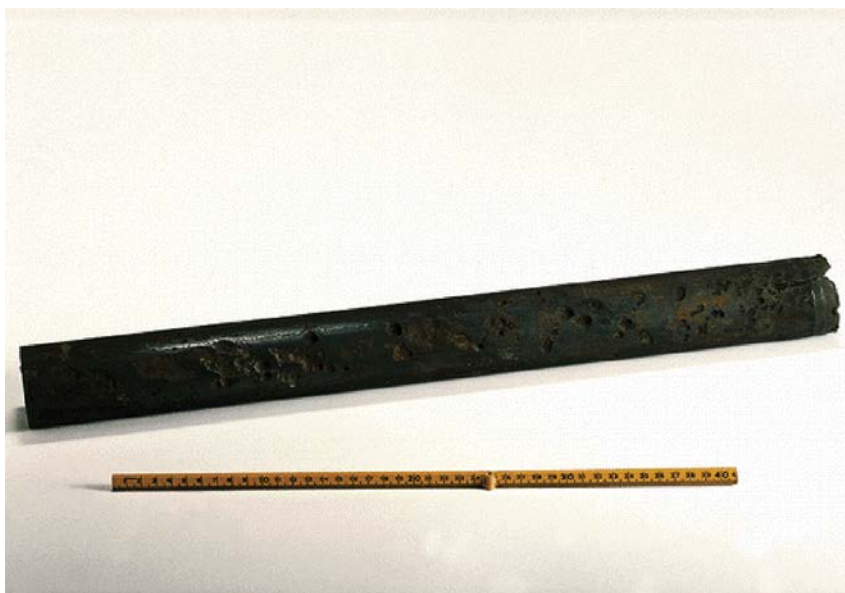
PART Boiler fire tube.

PHENOMENON Oxygen corrosion.

APPEARANCE Pitting attack.

TIME IN SERVICE 1 year.

CAUSE Frequent makeup during construction of the large-scale central heating system because of the construction of the new hospital in phases.

- Unnecessarily excessive makeup during new construction can be avoided by making use of section valves so that water loss is limited.
- In the present case, water consumption after startup was found to be zero, so it was decided not to apply water treatment.
- The corroded fire tubes were of course replaced.

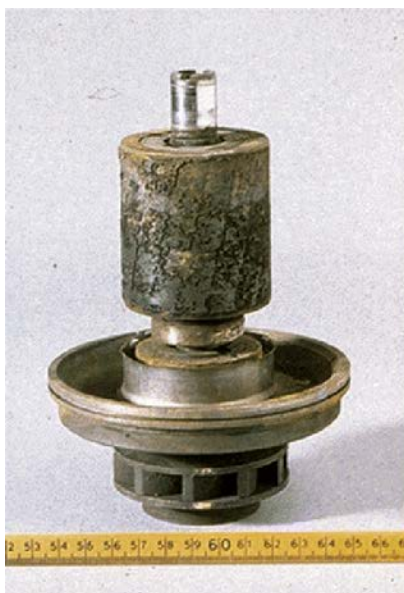
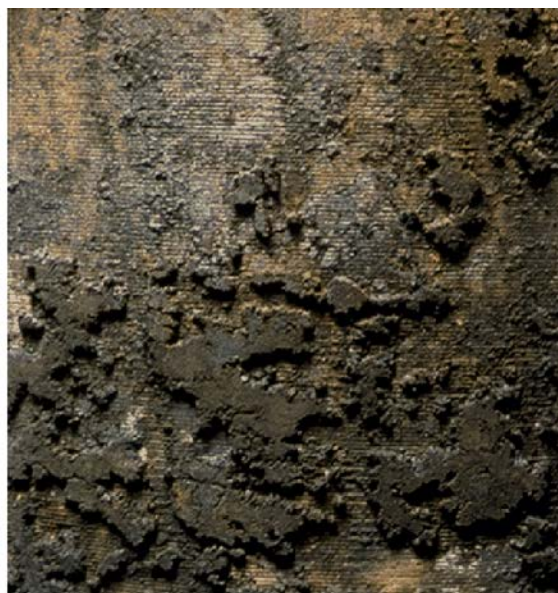
01.04.01.02

MATERIAL	Carbon steel.
SYSTEM	Central heating system.
PART	Circulating pump rotor.
PHENOMENON	Oxygen corrosion.

APPEARANCE	Deposition of black iron oxide (magnetite) on the rotor.
------------	--

TIME IN SERVICE	Unknown.
-----------------	----------

CAUSE	Entry of air (e.g., via seals) into the heating water as a result of which corrosion of the central heating system occurred. The resultant magnetite was deposited in the magnetic field of the rotor, causing it to seize (see also Case Histories 01.01.01.07 and 01.04.01.03).
-------	--

REMEDY	<ul style="list-style-type: none"> • Removal of magnetite from the system. • Optional dosing of a corrosion inhibitor. • Prevention of air entry by using metallic seals and not using air-permeable plastic pipes (see also Case History 01.04.01.03).
--------	--

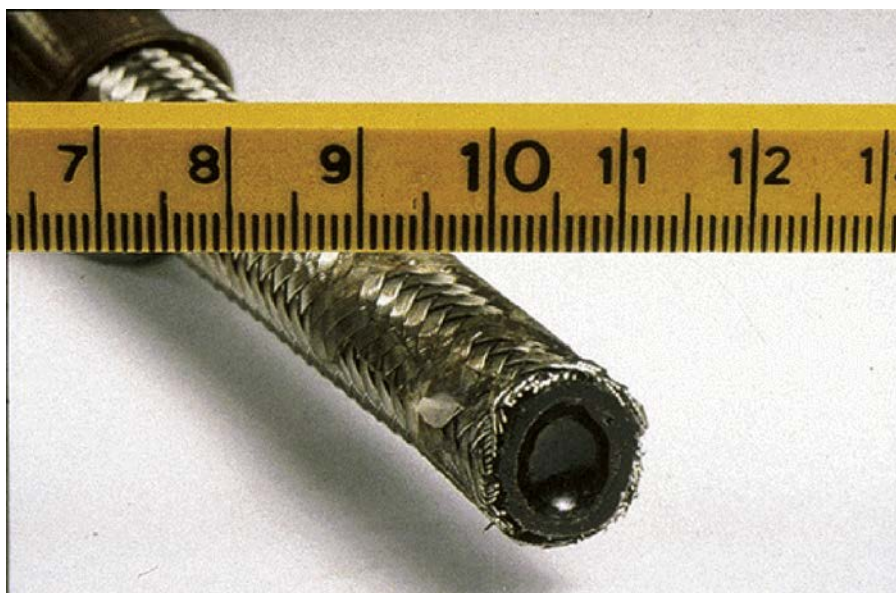
01.04.01.03

MATERIAL	Carbon steel and cast iron.
SYSTEM	Central heating system.
PART	Radiator connection hose of polytetrafluoroethylene (Teflon).
PHENOMENON	Oxygen corrosion.

APPEARANCE Deposition of black iron oxide (magnetite) leading to complete blockage.

TIME IN SERVICE Several years.

CAUSE Formation of magnetite owing to corrosion of the heating system by the penetration of oxygen via seals and the Teflon hoses themselves. The magnetite deposits in the Teflon hoses (see also Case Histories [01.01.01.07](#) and [01.04.01.02](#)).

- Chemical cleaning of the system.
- Replacement of the Teflon hoses by rigid or flexible metal connection pipes.
- Optionally dosing an oxygen scavenger.

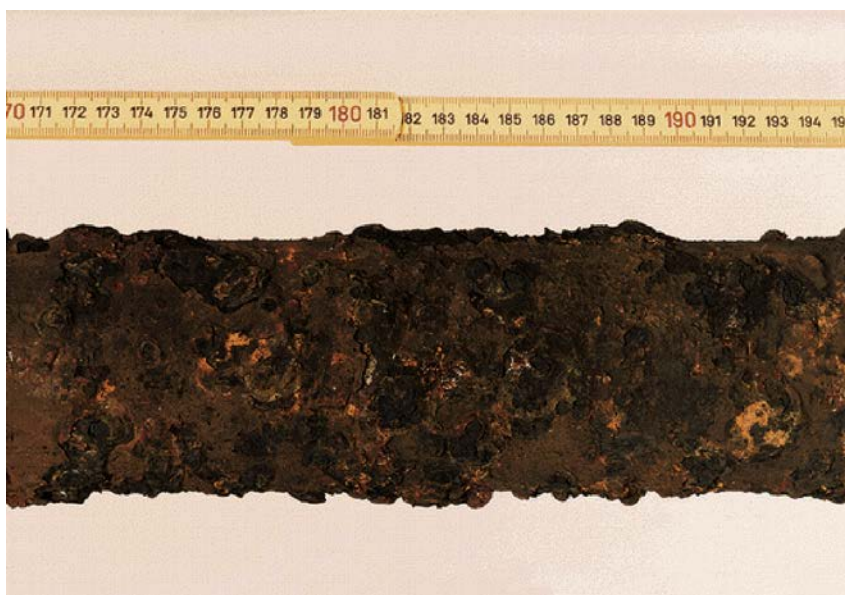
PART Boiler fire tube.

PHENOMENON Oxygen corrosion.

APPEARANCE Fire tube covered with thick layer of knob-like mounds of brown corrosion products (tubercles).

TIME IN SERVICE 16 years.

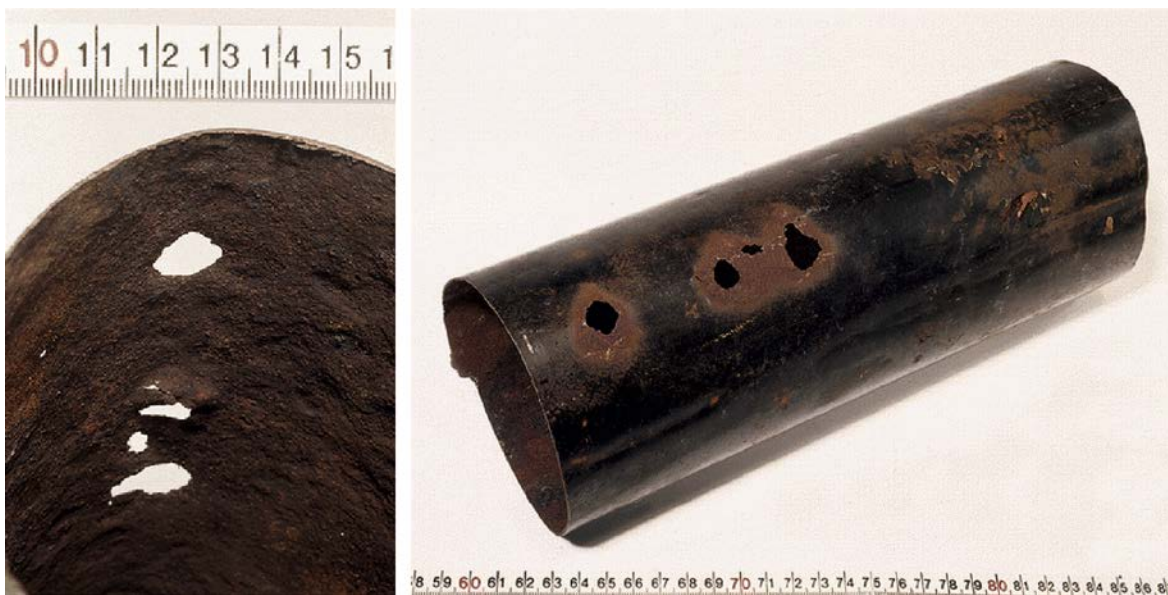
PART Flue-gas heated radiant tubes.

PHENOMENON Acid corrosion.

APPEARANCE Severe general corrosion on the inside (left photo).

TIME IN SERVICE Less than 2 years (normally more than 6–8 years).

CAUSE The air used to combust natural gas contains traces of a volatile solvent. This product, mainly trimethylchloride, lowered the condensate's pH significantly by the formation of hydrochloric acid and led to a major repair of the installation (see also Case Histories [02.01.04.01](#) and [07.04.04.01](#)).

REMEDY Avoid ingress of such harmful solvents or use a more corrosion-resistant material for the condensing parts.

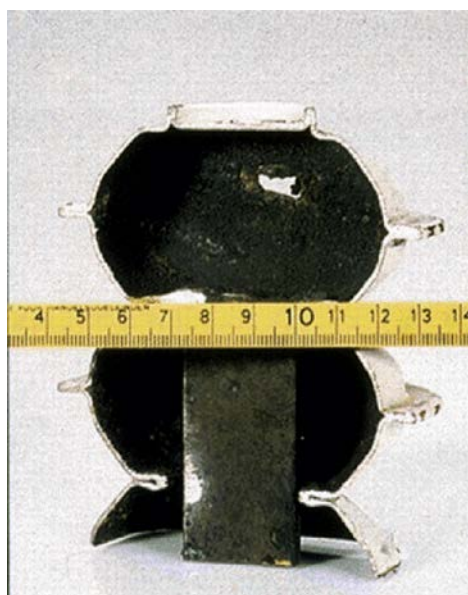
PART Lower part of radiator.

PHENOMENON Under-deposit corrosion.

APPEARANCE Local attack under deposit.

TIME IN SERVICE 3 years.

CAUSE Because of frequent leakage of the subterranean pipelines due to external corrosion, a large amount of makeup water had to be supplied to the system. The resultant hardness and rust sludge settled at the bottom of the radiators, leading to the formation of differential aeration cells. This caused attack to the material under the sludge (see also Case Histories 01.05.15.01 and 01.06.15.01). The water loss caused flooding of the residents' gardens.

- Short-term: chemical cleaning of the system by means of dispersants and switching to making up with softened water and improving the film-amine dosing (continuous instead of discontinuous).
- Long-term: prevention of leakages in the subterranean pipelines by the installation of jacket pipes.

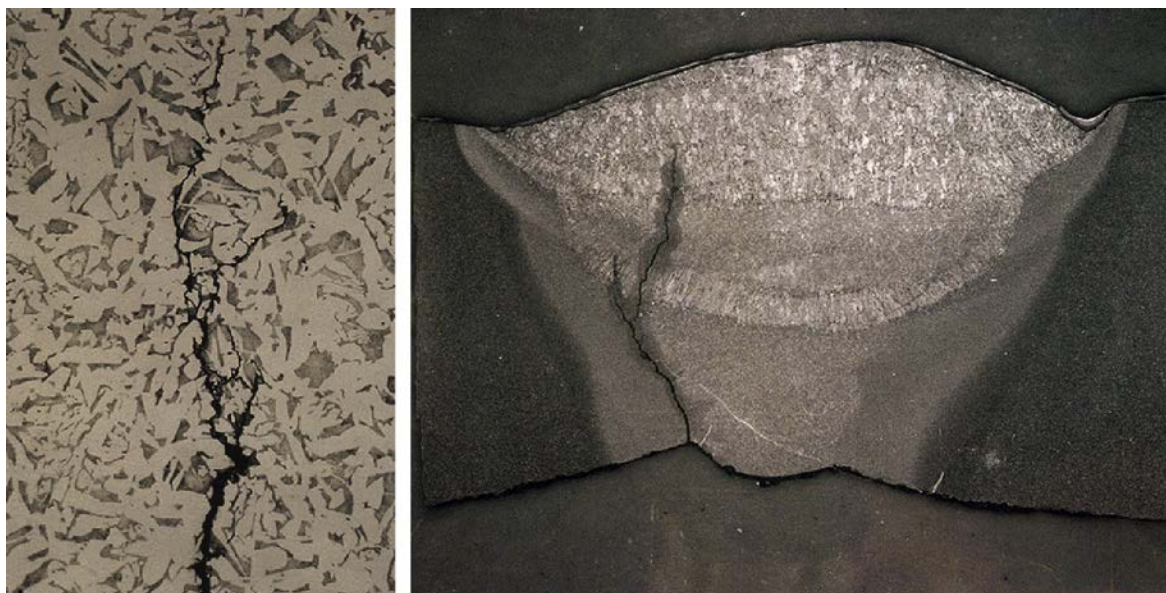
01.04.18.01

MATERIAL	Carbon steel.
SYSTEM	Closed hot and cold water system ($T = 8\text{--}85^{\circ}\text{C}$).
PART	Piping, mainly HAZ of welds.
PHENOMENON	Nitrate stress-corrosion cracking.

APPEARANCE	Intergranular cracks starting in a pit. Left photo: in base metal; right photo: between weld and HAZ.
TIME IN SERVICE	6 months.
ENVIRONMENT	$\text{NO}_3^- > 2000$ ppm; temperature: $86\text{--}89^{\circ}\text{C}$ (hot water system); pH 7 or lower.
CAUSE	Unexpected bacterial conversion of the inhibitor nitrite (NO_2^-) into the corrosive nitrate (NO_3^-) during a period out of service with water inside the pipes. Deposits were formed on the carbon steel surface, causing an increase in NO_3^- and pitting. In service at temperatures $>50^{\circ}\text{C}$, more NO_3^- and intergranular cracking initiating from the pit.
REMEDY	<ul style="list-style-type: none"> • Adding biocide to inhibitor; or • Change inhibition to a molybdate inhibitor.

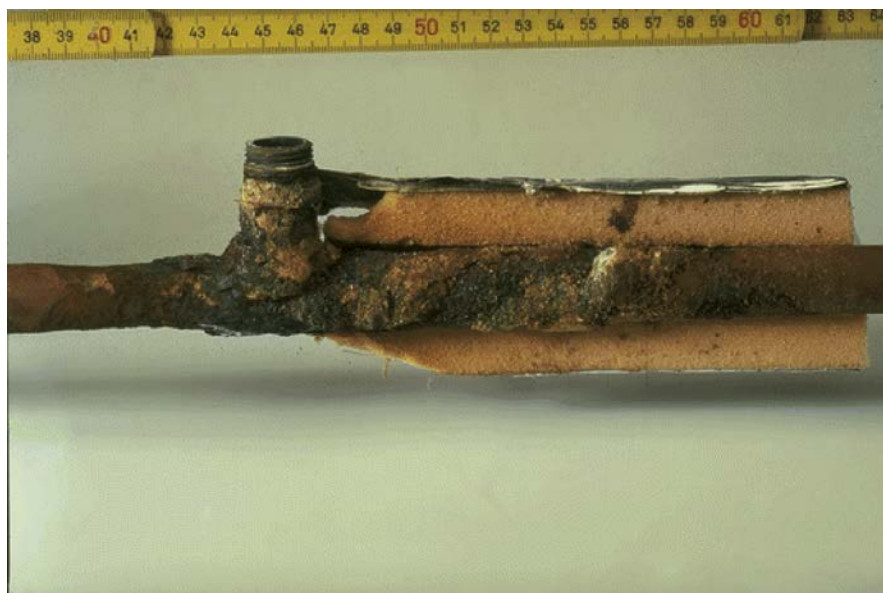
01.04.25.01

MATERIAL	Carbon steel.
SYSTEM	Central heating system.
PART	Insulated pipe section.
PHENOMENON	Corrosion under insulation.

APPEARANCE Externally, the pipe exhibits uniform corrosion to the point of leakage near the connection.

TIME IN SERVICE 3 years.

CAUSE Because of the short thread, the fitting of the connection was not suitable for the use of a sealing washer, so that hot water escaped (poor workmanship). As a result of evaporation, the salt content beneath the insulation became high (26% NaCl in the moisture of the deposit). The steel was attacked by the combination of salt-containing moisture and oxygen ingress (see also Case History 04.01.25.01).

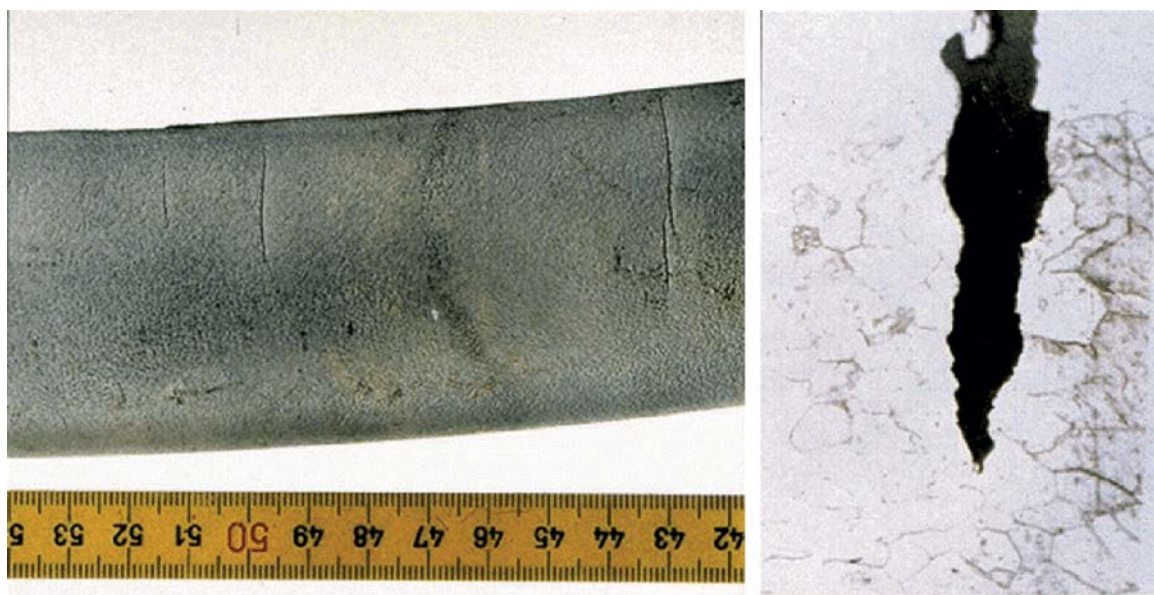
01.04.28.01

MATERIAL	Carbon steel.
SYSTEM	Autoclave heating system (with heating oil).
PART	External part of heating coil.
PHENOMENON	Thermomechanical corrosion fatigue.

APPEARANCE	Fine, parallel cracks (“magnaflexed” pipe). (The photograph has been placed upside down deliberately in order to reflect the real situation.)
TIME IN SERVICE	15 years.
ENVIRONMENT	At the outside: industrial atmosphere; at the inside: heating oil, 270–340°C.
CAUSE	High stresses caused by fluctuating temperatures, combined with atmospheric oxidation (corrosion products found in the cracks; see also Case Histories 01.02.28.01 , 01.11.28.03 , and 04.11.28.01).
REMEDY	<ul style="list-style-type: none"> • Improvement of the design. • Regular preventive magnetic fracture examination of the existing plant to prevent leakages.

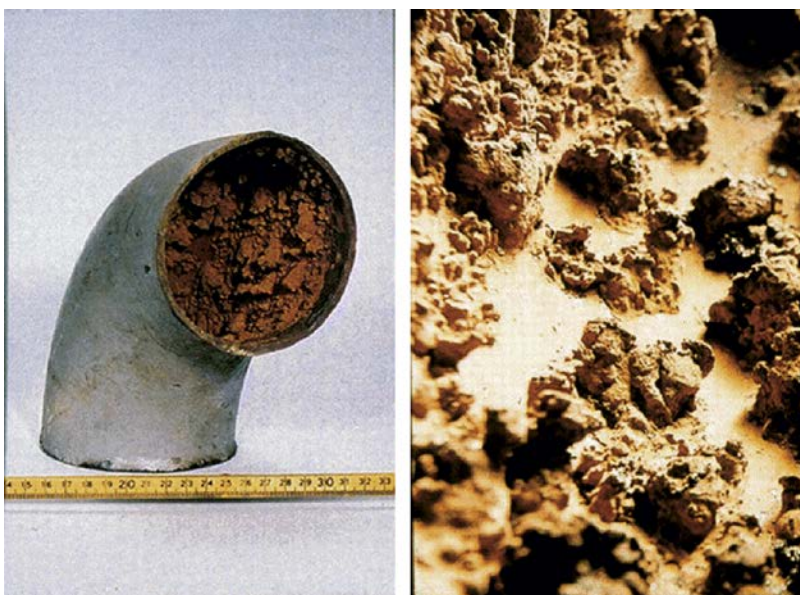
PART Pipe section.

PHENOMENON Oxygen corrosion with tuberculation.

APPEARANCE Pitting with corrosion tubercles.

TIME IN SERVICE 1½ years.

CAUSE Use of untreated steel for oxygen-containing water; also, because of the low bicarbonate hardness (temporary hardness) of the water, no protective lime-rust layer was formed. As rust accumulates, oxygen migration is reduced through the corrosion product layer. Regions below the rust layer become oxygen depleted. An oxygen concentration cell then develops. Corrosion naturally becomes concentrated into small regions beneath the rust, and tubercles are born (see also Case Histories [01.05.01.02](#), [01.06.01.01](#), and [01.06.01.02](#)).

REMEDY Construct water pipes from 316 stainless steel or plastic.

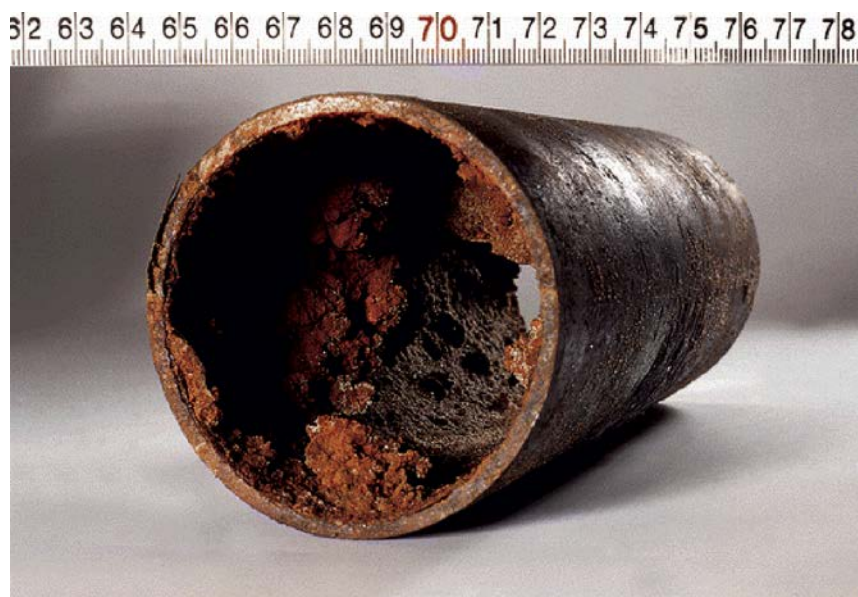
PART Pipe section.

PHENOMENON Oxygen corrosion and tuberculation.

APPEARANCE Severe tuberculation of corrosion products.

TIME IN SERVICE Unknown.

CAUSE Attack by oxygen followed by aeration cell formation and tuberculation. The anaerobic conditions underneath the tubercles led to sulfide corrosion caused by the development of sulfate-reducing bacteria.

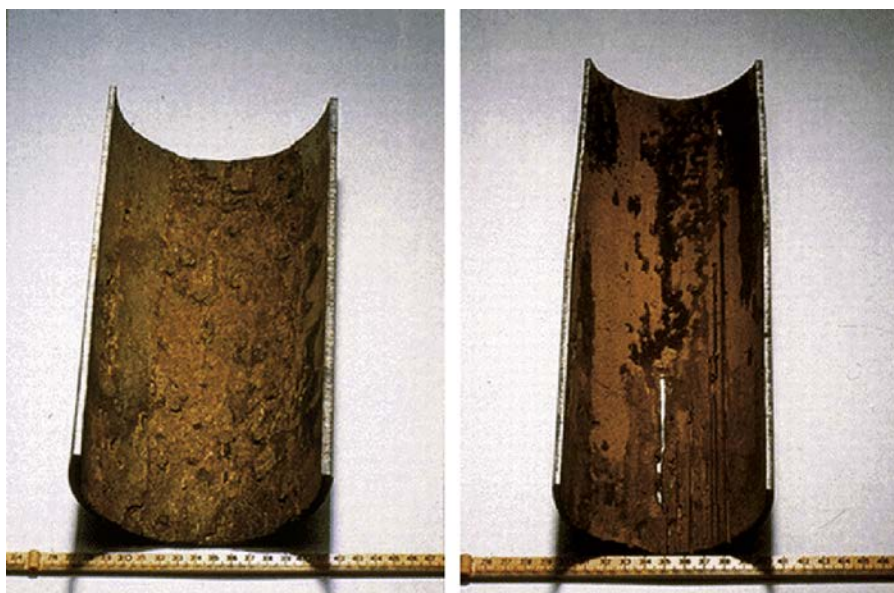
01.05.02.01

MATERIAL	Carbon steel.
SYSTEM	Cold tap water system.
PART	Pipe section.
PHENOMENON	Carbonic acid corrosion.

APPEARANCE	Severe attack over a large area, with localized corrosion and narrow, deep grooves in longitudinal direction.
TIME IN SERVICE	Approximately 5 years.
ENVIRONMENT	Corrosive, untreated, anaerobic well water; temperature approximately 15°C.
CAUSE	Carbon dioxide in the well water combined with high velocity (in the right-hand pipe).
REMEDY	Construct the water pipe system from plastic or coated steel (baked coating).

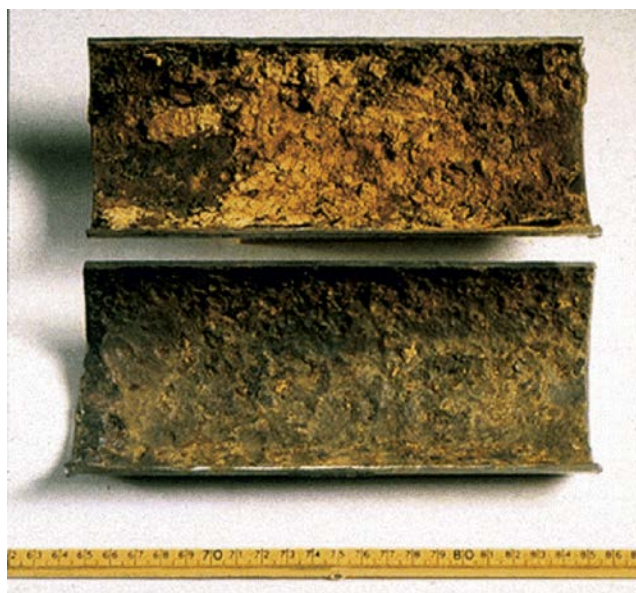
PART Pipe section.

PHENOMENON Under-deposit corrosion.

APPEARANCE Local attack leading to leak.

TIME IN SERVICE $2\frac{1}{2}$ years.

ENVIRONMENT Tap water heated to 85°C by a boiler. Boiler with copper heating tubes (steam passing through tubes) and steel jacket. In order to prevent corrosion of the steel jacket, the boiler was provided with cathodic protection by means of aluminum sacrificial anodes.

CAUSE Deposition of aluminum hydroxide (originating from the anodes) in the pipes, which led to corrosion as a result of formation of differential aeration cells (see also Case History [01.06.15.01](#)).

REMEDY Cleaning of the system and fitting of the boiler with platinum-coated titanium anodes. Use of aluminum sacrificial anodes can also cause dezincification of brass fittings (see Case History [06.05.16.03](#)) and also fouling of the boiler, blockage of the pipes and an excessively high aluminum content of the water, making it unsuitable for drinking purposes.

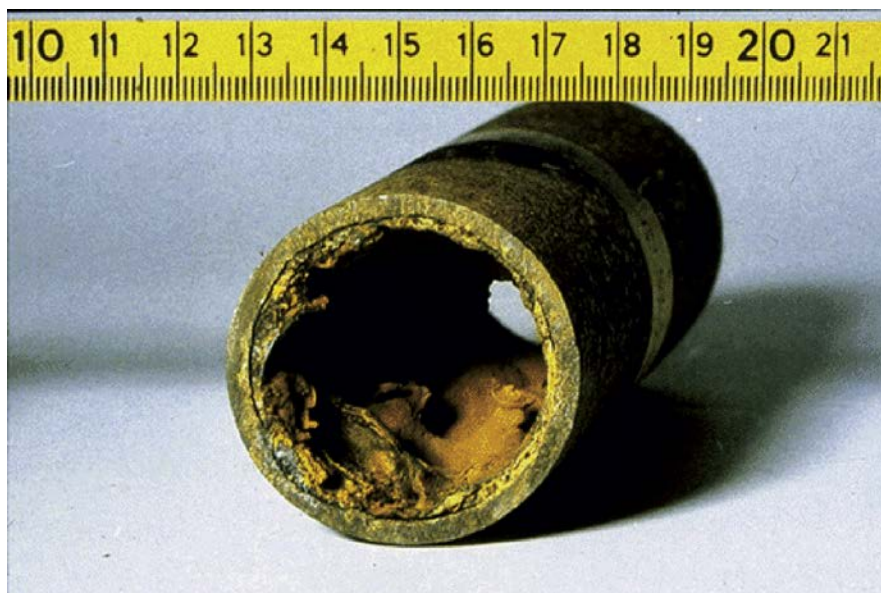
01.05.17.01

MATERIAL	Carbon steel.
SYSTEM	Cold tap water system.
PART	Pipe section.
PHENOMENON	Microbiologically induced corrosion.

APPEARANCE	Pitting underneath corrosion pocks.
TIME IN SERVICE	Unknown.
ENVIRONMENT	Standing tap water (dead section of pipe). Pocks consist of Fe_3O_4 with 0.4% SO_4^{2-} ; negative reaction to sulfide, presumably due to conversion to sulfate by extended exposure to air.
CAUSE	In an anaerobic environment, sulfide can be formed from sulfate by means of sulfate-reducing bacteria. Steel is attacked by sulfide.
REMEDY	Dead sections in water systems should be avoided. Use coated steel, galvanized steel, stainless steel or plastic pipes for cold tap water systems.

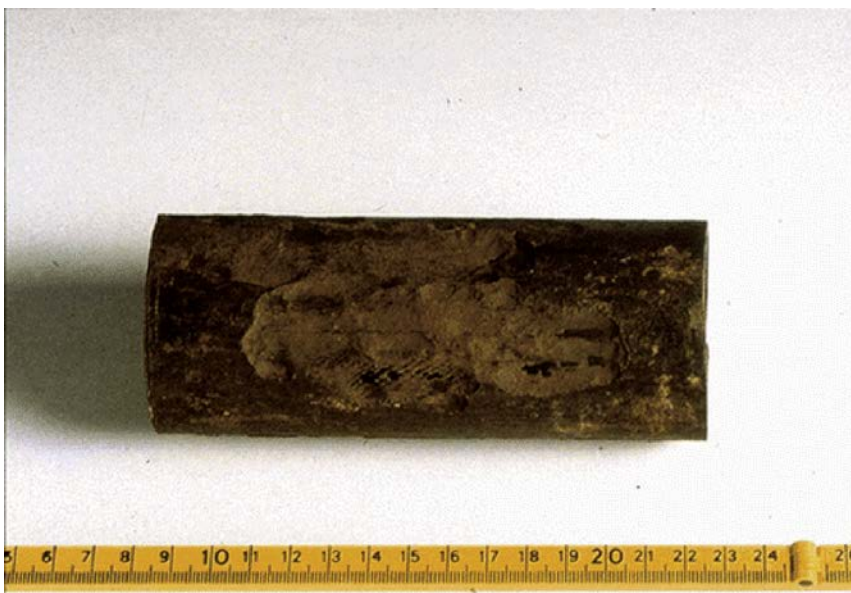
01.05.26.01

MATERIAL	Carbon steel.
SYSTEM	Hot tap water system.
PART	Underground pipe section.
PHENOMENON	Stray current corrosion.

APPEARANCE Severe attack at a single site.

TIME IN SERVICE Unknown.

CAUSE Stray currents originating from a neighboring oil storage tank provided with cathodic protection; the material is attacked where the current leaves the pipe back to the storage tank (see also Case Histories [03.14.26.01](#) and [03.14.26.02](#)).
