Corrosion Atlas

THIRD, EXPANDED AND REVISED EDITION

A Collection of Illustrated Case Histories

Evert D.D. During

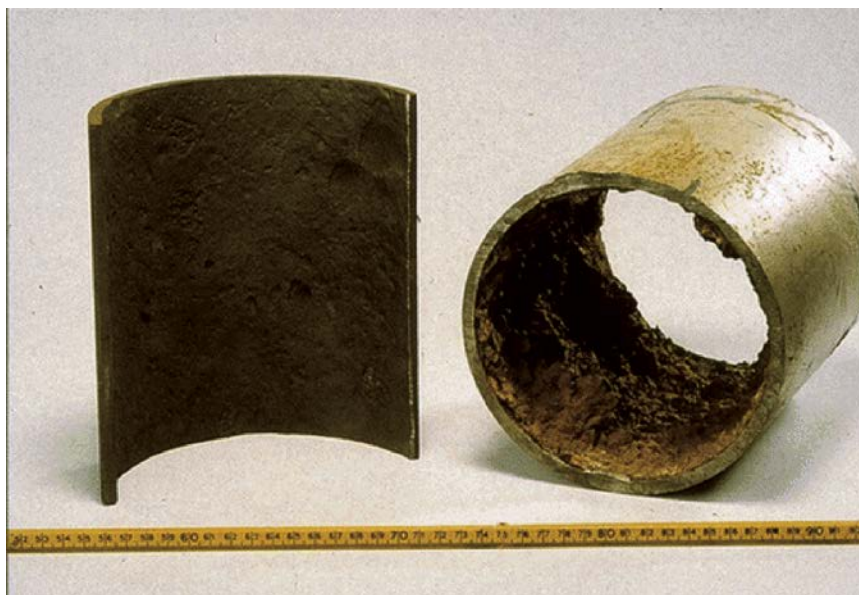
01.06.01.01

MATERIAL	Carbon steel.
SYSTEM	Cooling water system (open, circulating, with cooling tower).
PART	Pipe section.
PHENOMENON	Oxygen corrosion with tuberculation.

APPEARANCE	Pitting attack underneath large tubercles.
TIME IN SERVICE	2 years.
ENVIRONMENT	Cooling water existing of concentrated well water; pH: 7; temperature 30°C.

CAUSE The oxygen in the cooling water causes the formation of hydrous ferric oxide ($\text{Fe}(\text{OH})_3$) on the steel surface. As rust accumulates, oxygen migration through the corrosion product layer is reduced. Regions below the rust layer become oxygen depleted. An oxygen concentration cell then develops. Corrosion naturally becomes concentrated into small regions beneath the rust, and tubercles are born (see also Case Histories [01.05.01.01/02](#)).

- Dosing of corrosion inhibitors.
- Additionally, replacement of the well water by demineralized water for make-up purposes (demineralized water available for other purposes, with sufficient surplus capacity).

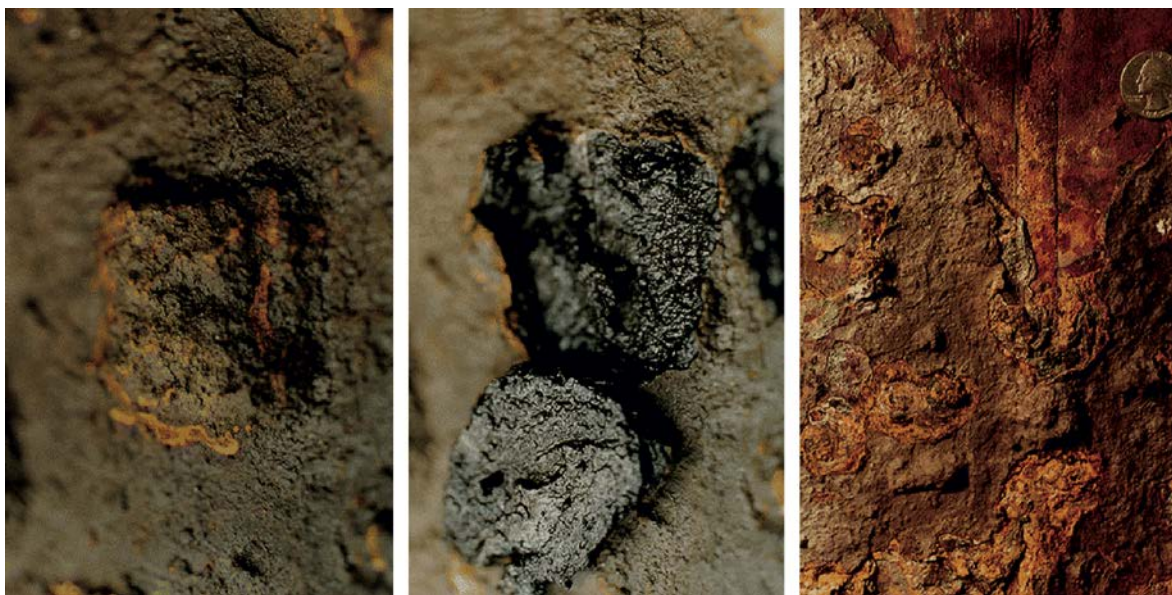
01.06.01.02

MATERIAL	Mild steel.
SYSTEM	Once-through cooling-water system.
PART	Horizontal water supply line for a steel mill (OD: 137 cm).
PHENOMENON	Oxygen corrosion and tuberculation.

APPEARANCE	Large tubercles (up to 15 cm diameter) with dark interior and preferential weld attack. The tubercle floor shows a shallow dish-shaped depression.
------------	--

TIME IN SERVICE	23 years.
-----------------	-----------

CAUSE	Development of oxygen concentration cells beneath a corrosion product layer formed in oxygenated water. The tubercle contents were fairly acidic due to hydrolysis of FeCl_2 into HCl , which accelerated the attack. Tuberculation is in fact a next step after general oxygen attack. The contamination with oil and grease had thickened the layer and enhanced the attack.
-------	--

REMEDY	<ul style="list-style-type: none"> • Effective cleaning of the mains. • Implement system operations changes to reduce grease and oil fouling. • Complete the water treatment with corrosion inhibitors and biocides; or • Replace the steel pipe by a coated or plastic pipe.
--------	---

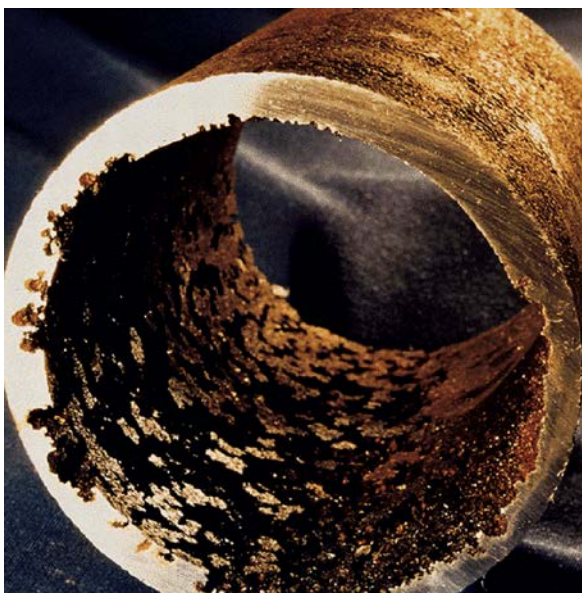
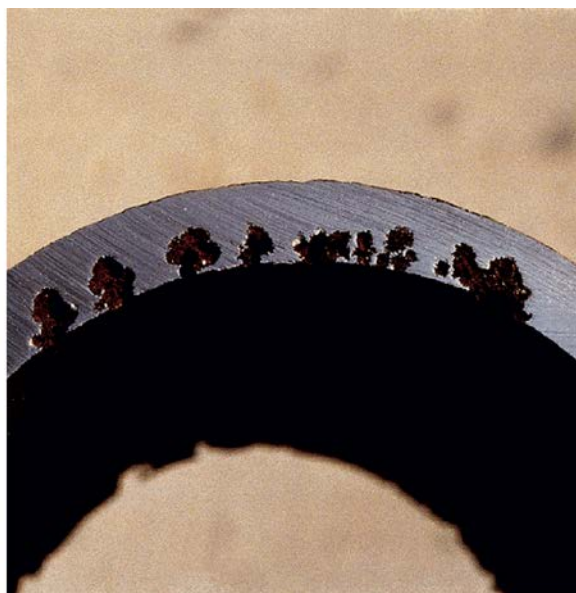
01.06.04.02

MATERIAL	Carbon steel.
SYSTEM	Cooling system in a fossil utility.
PART	Horizontal cooling pipe (OD: 7.6 cm).
PHENOMENON	Acid corrosion.

APPEARANCE Heavy pitting with pronounced undercutting. Almost no internal corrosion products in pits.

TIME IN SERVICE Less than 30 days.

CAUSE Carbon steel is not resistant to diluted sulfuric acid solutions. Attack is especially rapid when pH falls below 4. A 10-m³ tank of sulfuric acid was accidentally drained into a cooling tower basin during a holiday (poor workmanship!). After about 1 week the cooling water pH was still below about 2.

REMEDY Emergency blow-down procedures (and other procedural modifications) were begun after piping began to leak throughout the plant and the upset was discovered. Massive additions of caustic were begun until pH in tower basin reached 6. All acid feed was suspended, and lockout procedures were initiated to prevent accidental acid upsets in the future.

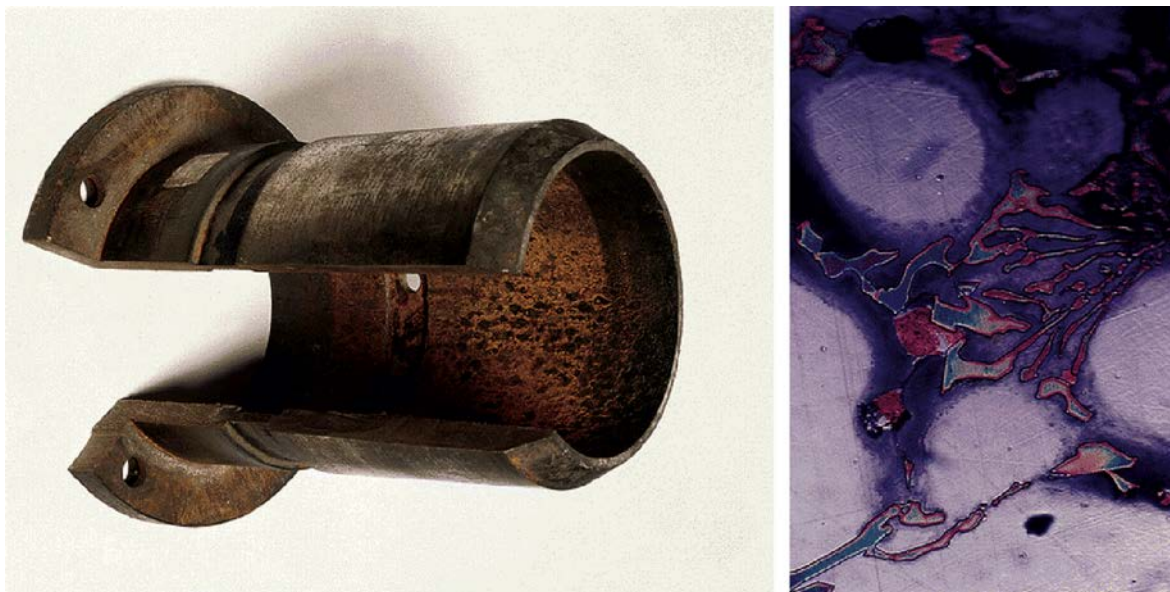
PART Bearing of a circulating pump.

PHENOMENON Galvanic corrosion.

APPEARANCE Uniform attack.

TIME IN SERVICE One year.

CAUSE The result of a material analysis of the bearing shows a copper content of 6.4% instead of the material specification of 0%. At the microstructure level, copper is present as heterogeneous precipitations (see microprint). Attack of the Ni-resist is due to the copper/iron combination in conductive oxygen-containing water.

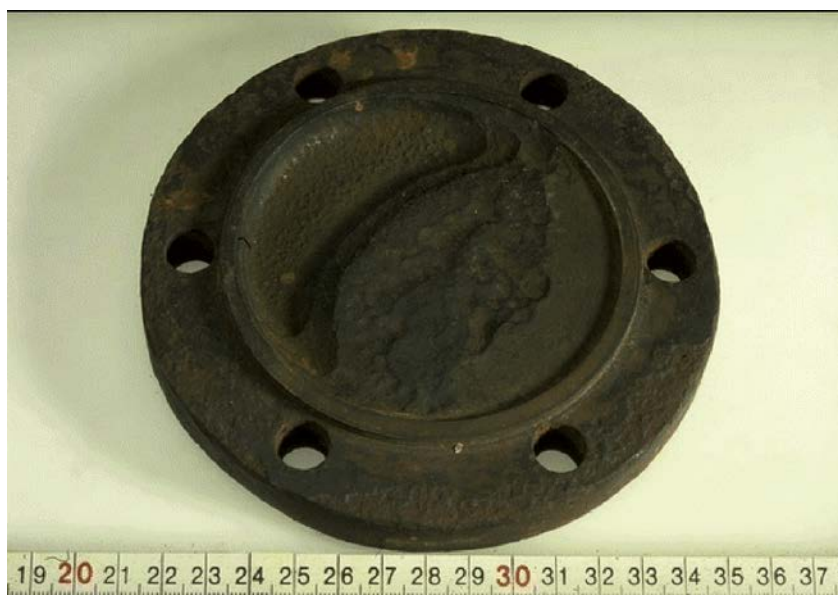
PART Blind flange.

PHENOMENON Under-deposit corrosion.

APPEARANCE Pitting and uniform attack.

TIME IN SERVICE 3 years.

CAUSE As a result of the formed deposition, differential aeration cells occurred which cause the cast iron to become anodic underneath the deposition and subject to attack (see Case History [01.05.15.01](#)).

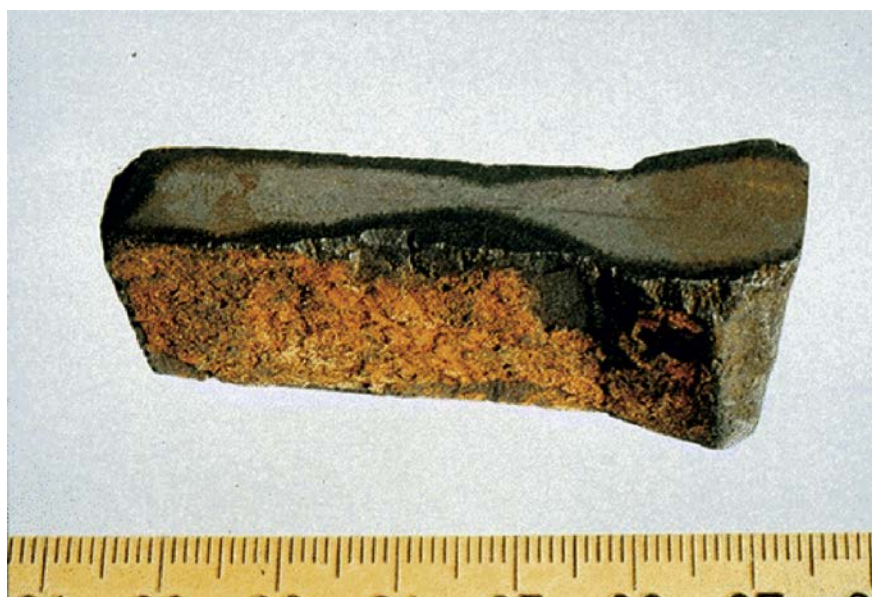
PART Cooling water pump check valve.

PHENOMENON Selective leaching (graphitic corrosion).

APPEARANCE Outer edge black due to graphitic corrosion.

TIME IN SERVICE 6 years.

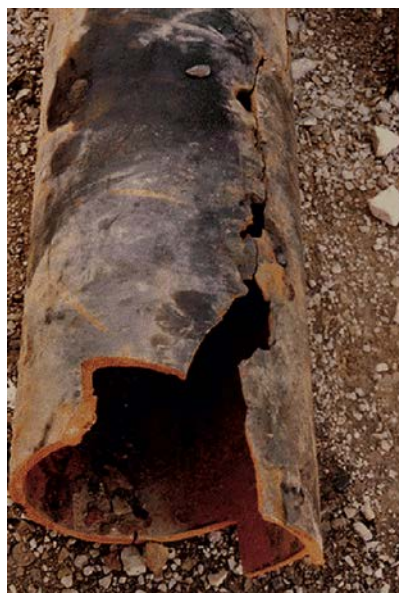
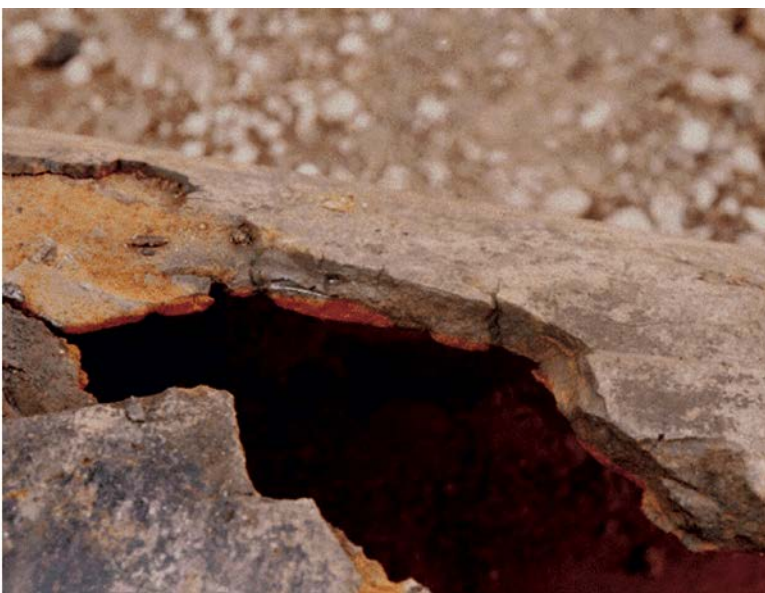
01.06.16.02

MATERIAL	Grey cast iron.
SYSTEM	Once-through cooling-water system.
PART	Horizontal subterranean supply line (OD: 25 cm).
PHENOMENON	Selective leaching (graphitic corrosion).

APPEARANCE	Brittle fracture in the pipe bottom; External: Graphitically corroded cast iron (black); Internal: a thin layer of reddish iron oxides.
------------	---

TIME IN SERVICE	25 years.
-----------------	-----------

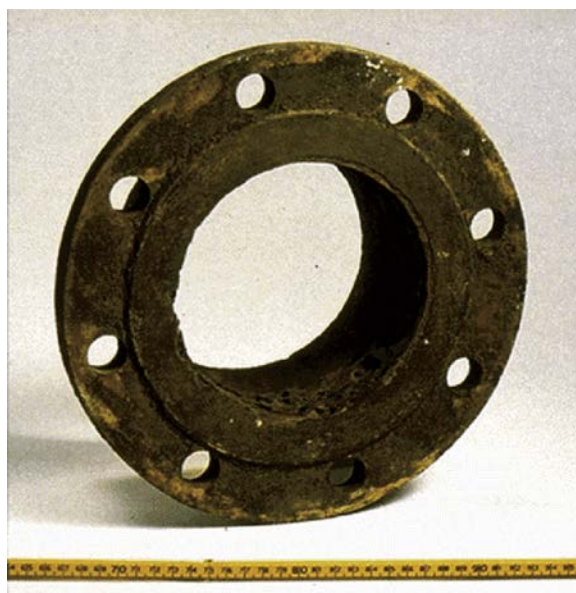
MATERIAL	Carbon steel.
SYSTEM	Once-through cooling system.
PART	Flange from conveyor line.

PHENOMENON Microbiologically induced corrosion.

APPEARANCE Locally severe attack.

TIME IN SERVICE 3 years.

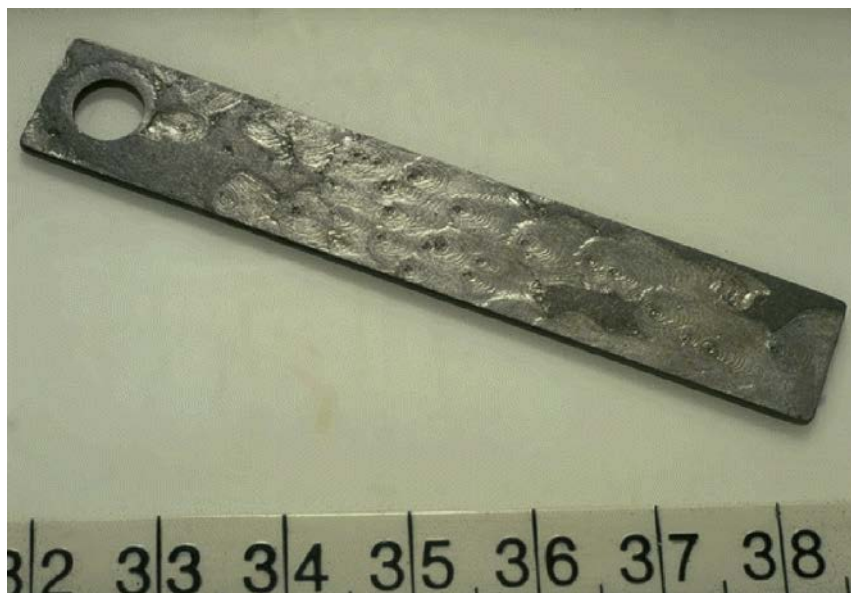
01.06.17.02

MATERIAL	Carbon steel.
SYSTEM	Open circulating cooling water system.
PART	Corrosion coupon.
PHENOMENON	Microbiologically induced corrosion.

APPEARANCE	Shallow pitting corrosion which has spread in the form of "flakes."
TIME IN SERVICE	Two months.
ENVIRONMENT	Cooling water: pH 8.5–9.0; conductivity 200 mS/m; chloride 200 ppm; sulfate 250 ppm; calcium hardness 400–480 ppm CaCO ₃ ; organic inhibitor.
CAUSE	Development of sulfate-reducing bacteria (SRB) under anaerobic conditions (under scale), as a result of which the steel is attacked by sulfide. SRB demonstrated with the API broth test: positive, formation of black iron sulfide.
REMEDY	Dosing of a dispersant to prevent scaling.

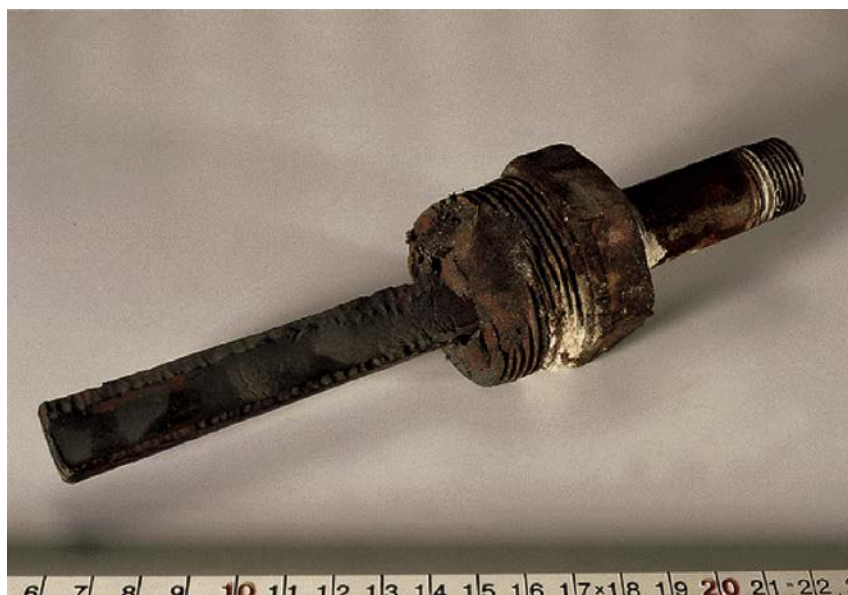
01.06.21.01

MATERIAL	Carbon steel.
SYSTEM	Pressurized closed cooling water circuit.
PART	EDTA dosing nozzle in flash tank.
PHENOMENON	Chelant corrosion.

APPEARANCE	Severe uniform attack.
TIME IN SERVICE	1 year.
ENVIRONMENT	Steam from flashed cooling water and chelant: EDTA (the heated cooling water was flashed from 1 to 0.6 MPa, temperature 160°C).
CAUSE	The dosing nozzle was situated above the water level in the steam phase. Consequently, chelant tended to concentrate at the nozzle. The nozzle was corroded by the high EDTA concentration and the simultaneous presence of oxygen (see also Case Histories 01.01.21.01/02/03).
REMEDY	Move the nozzle to a location below water level in the flashed oxygen-free cooling water.

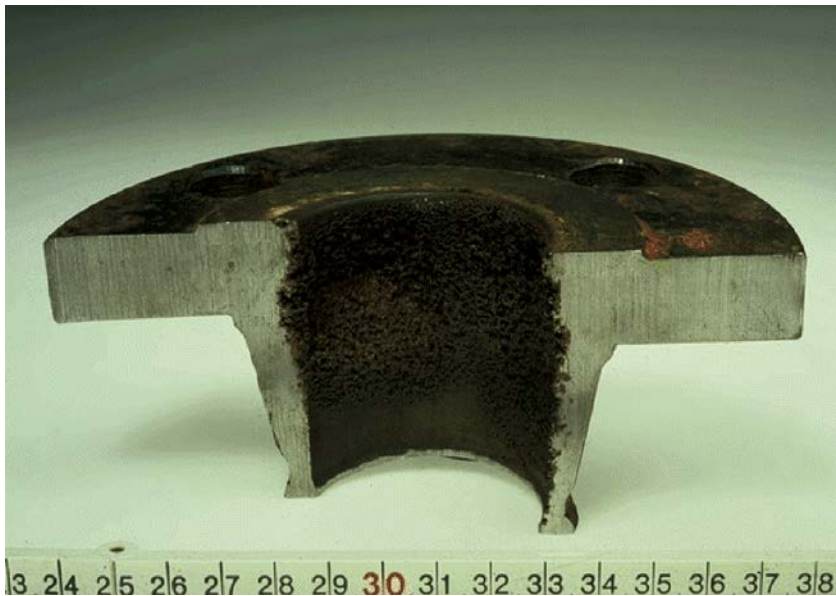
01.06.33.01

MATERIAL	Carbon steel.
SYSTEM	Through-flow cooling water system.
PART	Flange downstream of control valve.
PHENOMENON	Cavitation erosion.

APPEARANCE Local pitting corrosion of the material.

TIME IN SERVICE Two years.

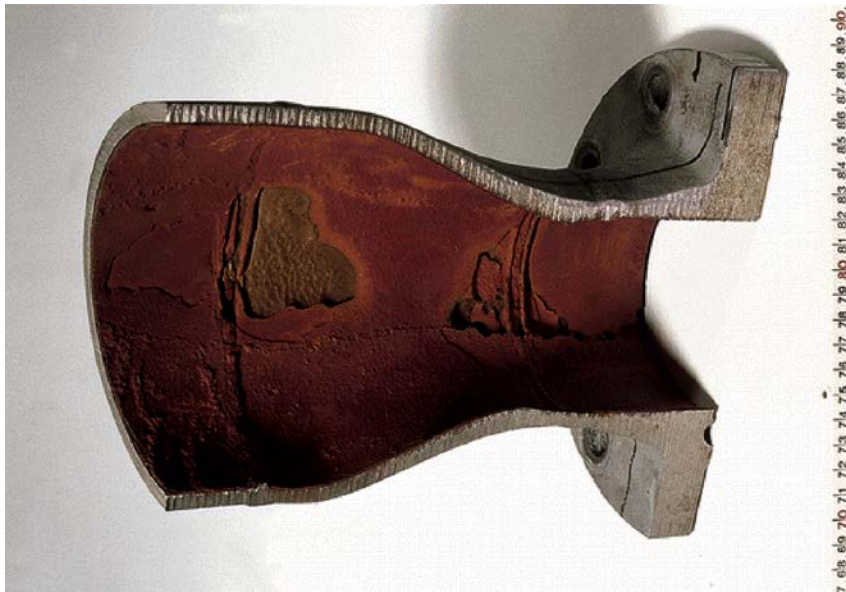
01.06.33.02

MATERIAL	Carbon steel.
SYSTEM	Cooling water system.
PART	4"–6" reducing pipe.
PHENOMENON	Cavitation corrosion.

APPEARANCE Material worn away locally.

TIME IN SERVICE 2.5 years.

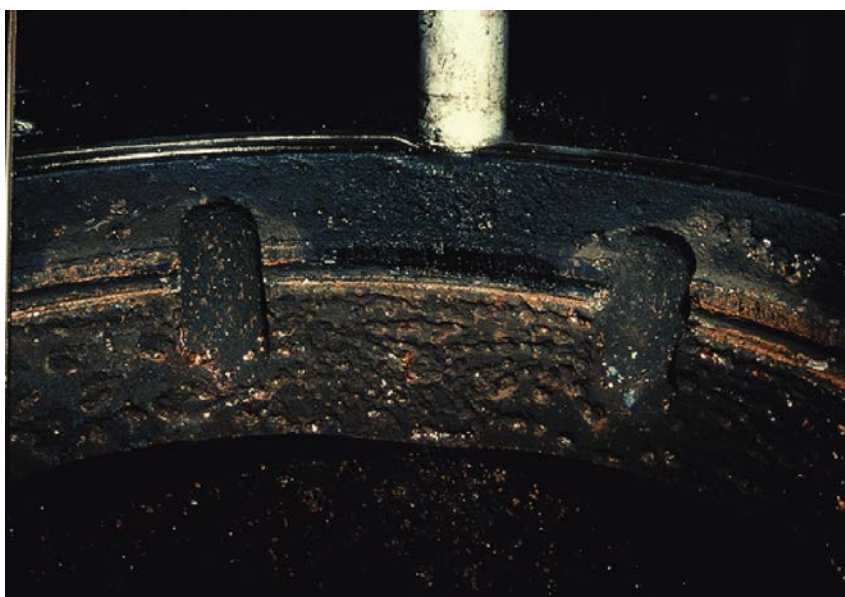
PART Cylinder block and cylinder sleeve.

PHENOMENON Cavitation/erosion corrosion.

APPEARANCE Severe local attack.

TIME IN SERVICE One year.

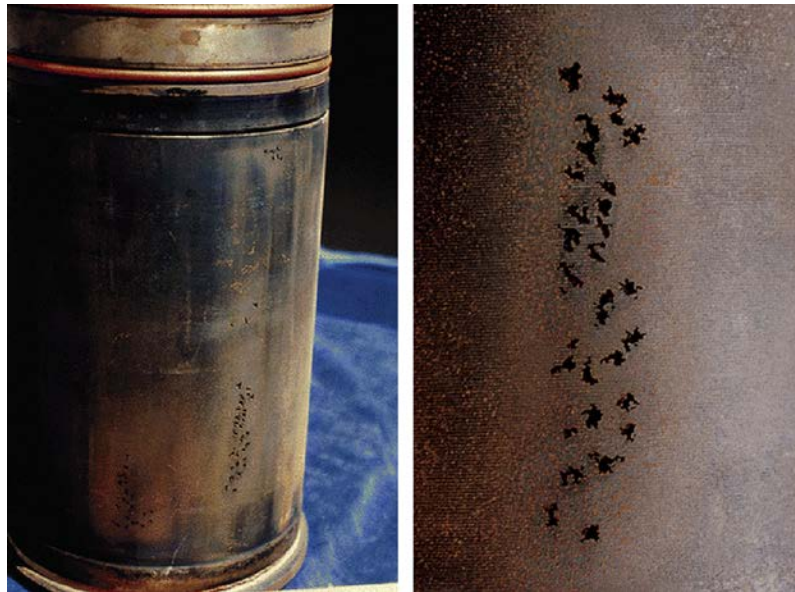
PART Vertical cylinder liner.

PHENOMENON Cavitation corrosion.

APPEARANCE Vertical alignment of jagged, cavernous pits.

TIME IN SERVICE Unknown.

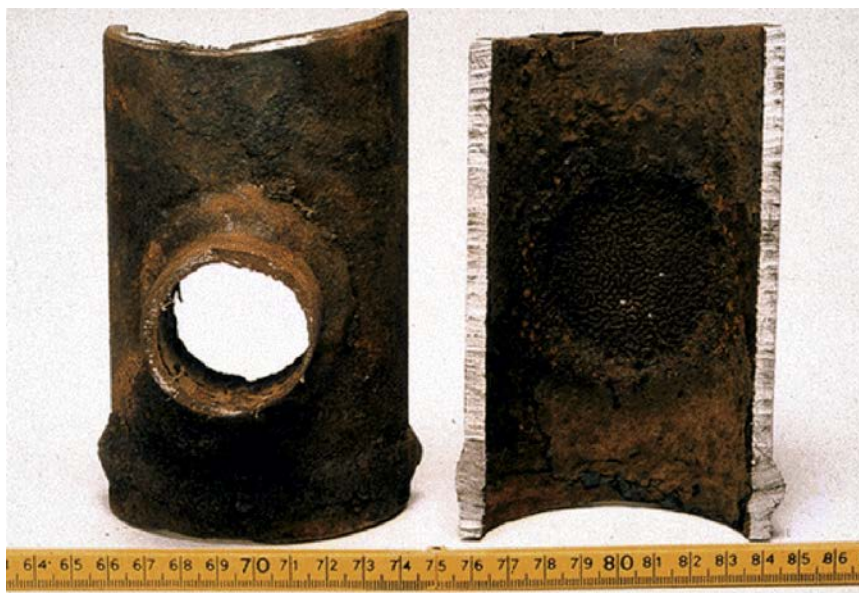
01.06.34.01

MATERIAL	Carbon steel.
SYSTEM	Cooling water system.
PART	Pipe section with branch.
PHENOMENON	Erosion corrosion.

APPEARANCE	Local excavation of the material
TIME IN SERVICE	2 to 2 $\frac{1}{2}$ years.
ENVIRONMENT	Cooling water which is periodically displaced by air, via the branch positioned perpendicular to the line, to make way for a cold calcium chloride brine.
CAUSE	Violent turbulence caused by injection of the air into the water-filled pipe.
REMEDY	<ul style="list-style-type: none"> • Introduction of air via an injection pipe bent in the direction of flow. • Alternative: a hardened steel shield placed opposite the air inlet.

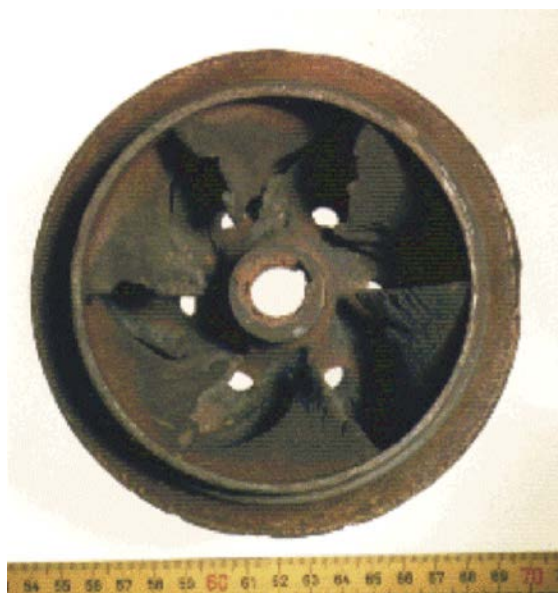
01.06.34.02

MATERIAL	Cast iron.
SYSTEM	Cooling water system.
PART	Cooling water pump impeller.
PHENOMENON	Erosion corrosion.

APPEARANCE	Material locally worn away entirely.
TIME IN SERVICE	Unknown.
ENVIRONMENT	Cooling water; temperature 15–20°C.
CAUSE	Intake opening just under water level, so that an eddy arose and the air–water mixture drawn in caused the erosion corrosion.
REMEDY	Inlet opening should point downwards and/or be positioned deeper.

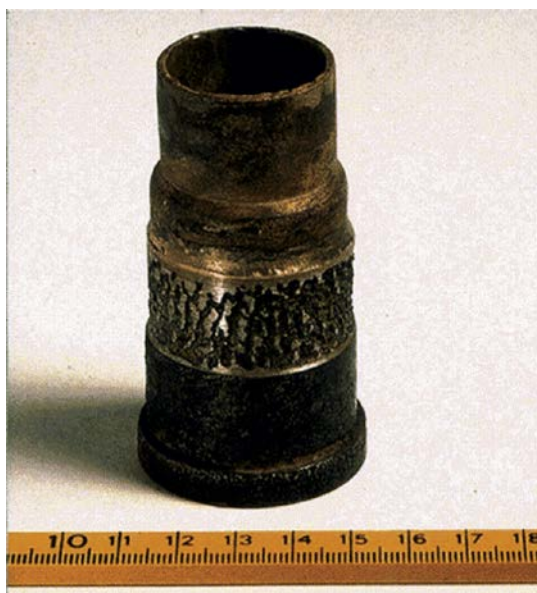
PART Compressor suction pipe.

PHENOMENON Galvanic corrosion.

APPEARANCE Grooved attack to the steel surface.

TIME IN SERVICE Unknown.

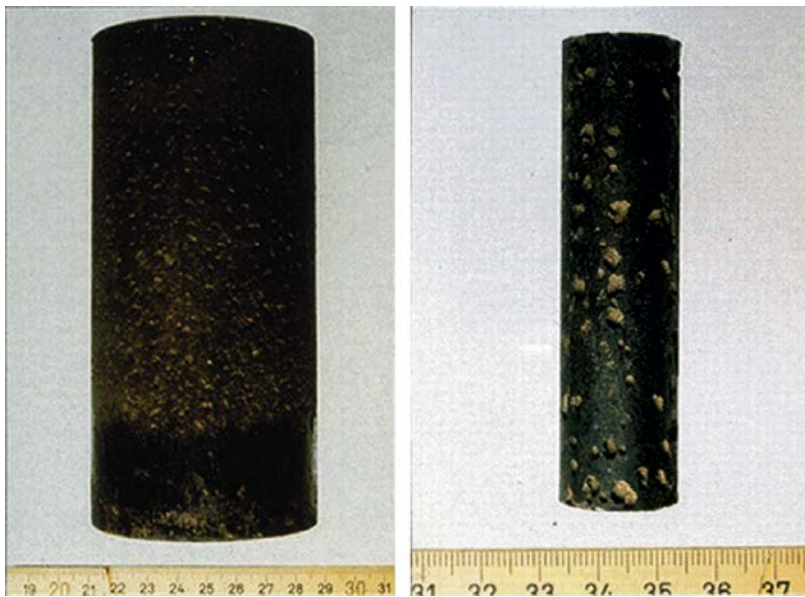
01.07.25.01

MATERIAL	Carbon steel.
SYSTEM	Cooling system (ammonia).
PART	Insulated steel pipe.
PHENOMENON	Corrosion under insulation.

APPEARANCE	External pitting.
TIME IN SERVICE	10 years.
ENVIRONMENT	Internal: Ammonia gas, -10°C ; external: pipe coated with a bitumen product and provided with polyurethane insulation.
CAUSE	The insulation was not vapor-tight, so that condensation water and ice were regularly formed when the cooling system was switched off and started up again. The bitumen product had hardened and was tending to flake off, so it provided inadequate protection. The steel was subjected to pitting corrosion owing to the presence of oxygen.
REMEDY	Before fitting the insulation, provide the pipes with a coating and then make the insulation vapor tight by means of a vapor barrier. The insulation shells' seams should be sealed by tape and/or compound.

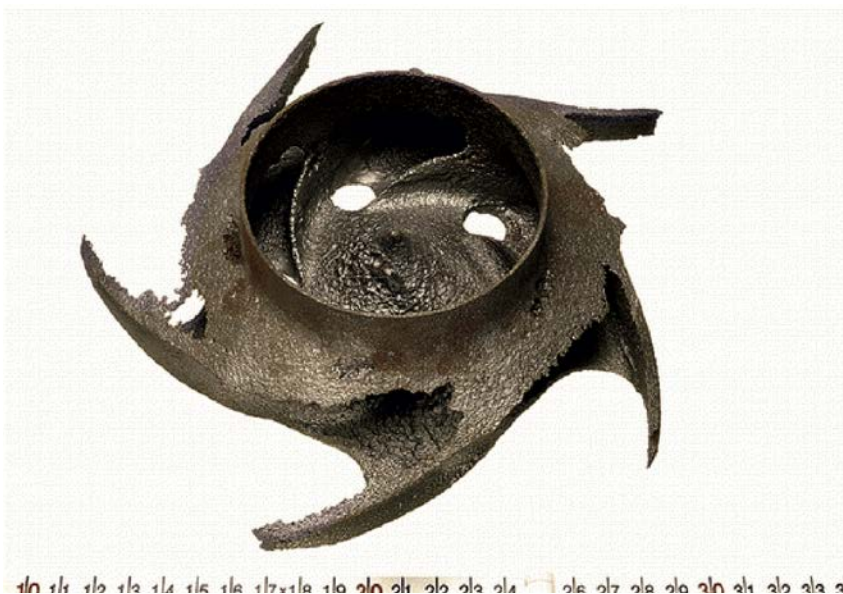
PART Pump impeller.

PHENOMENON Acid attack.

APPEARANCE A rough eroded surface. At the exits, material is partly worn away.

TIME IN SERVICE 3 years.

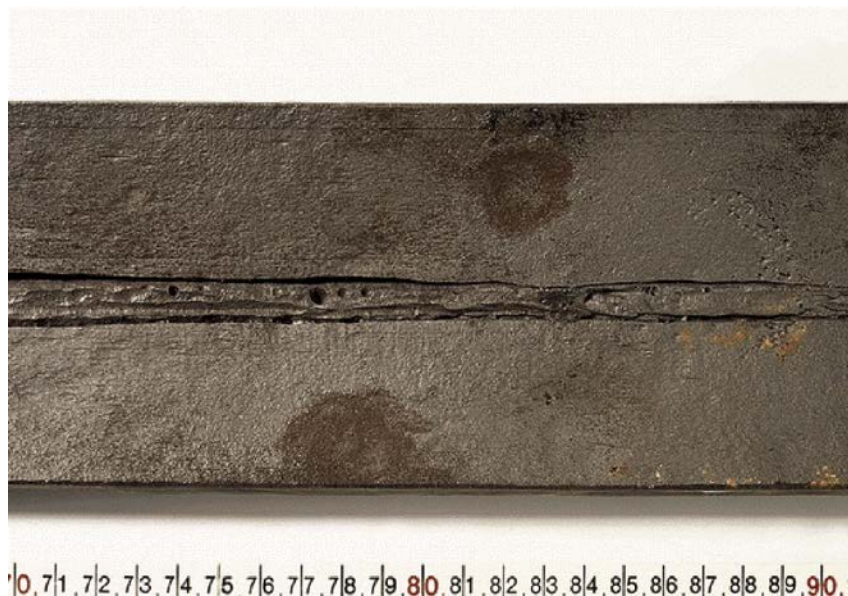
01.10.01.01

MATERIAL	Carbon steel.
SYSTEM	Fire extinguishing system.
PART	Underground pipe.
PHENOMENON	Oxygen corrosion.

APPEARANCE	Uniform corrosion of pipe wall and preferential attack of weld under deposits.
TIME IN SERVICE	20 years.
ENVIRONMENT	Aerated water with low flow (the system is also used for cleaning operations and illegal cooling).
CAUSE	The unprotected steel pipe is attacked by oxygen. Galvanic effects take place as a result of difference in the microstructure of weld and Heat Affected Zone (HAZ), leading to preferential attack of the weld.
REMEDY	Replaced by glass fiber-reinforced epoxy pipe.

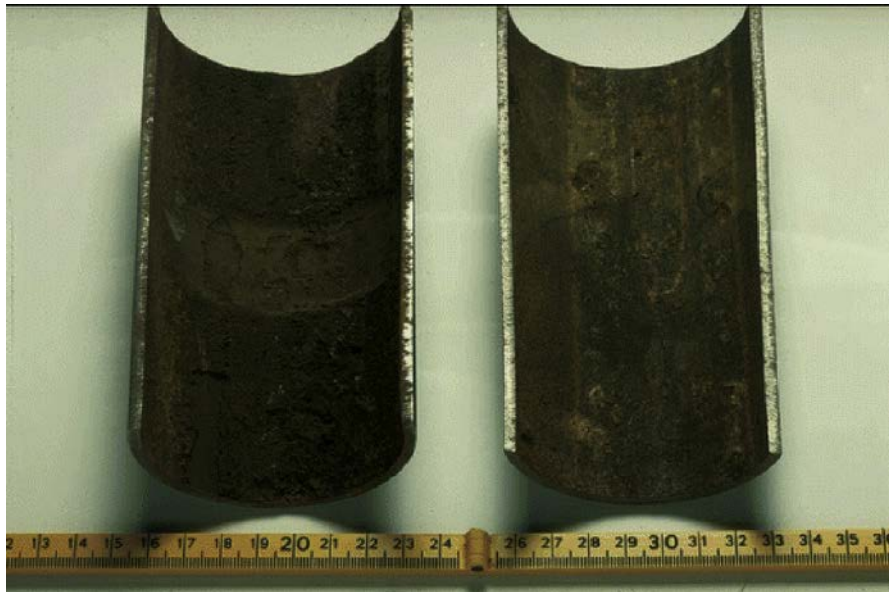
01.10.17.01

MATERIAL	Carbon steel.
SYSTEM	Sprinkler extinguishing system (wet).
PART	Pipe section.
PHENOMENON	Microbiologically induced corrosion.

APPEARANCE Local attack under the corrosion products, to the point of leakage.

TIME IN SERVICE 10 years.

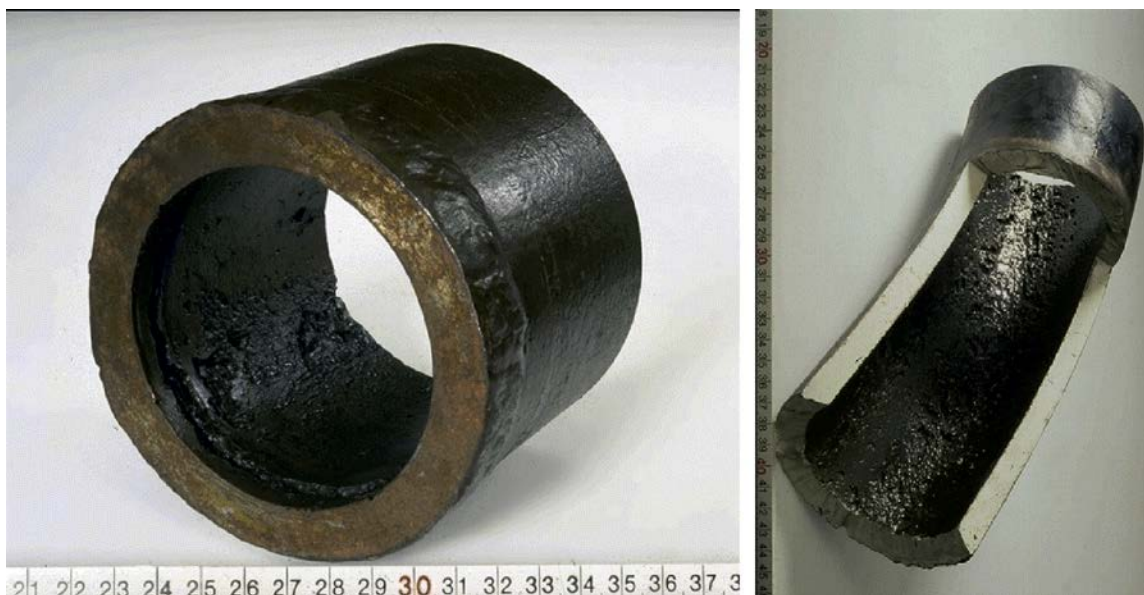
01.11.02.01

MATERIAL	Carbon steel (ASTM A 106).
SYSTEM	Transport line from gas well to treatment plant.
PART	Straight pipe section and bend (13 cm wall thickness) (both sections coated afterward for preserving in good condition).
PHENOMENON	Flow-enhanced carbon dioxide corrosion (sweet corrosion).

APPEARANCE	Left: pits and selective attack to the weld. Right: pitted, irregular attack at the outside of the bend.
------------	---

TIME IN SERVICE	15 months.
-----------------	------------

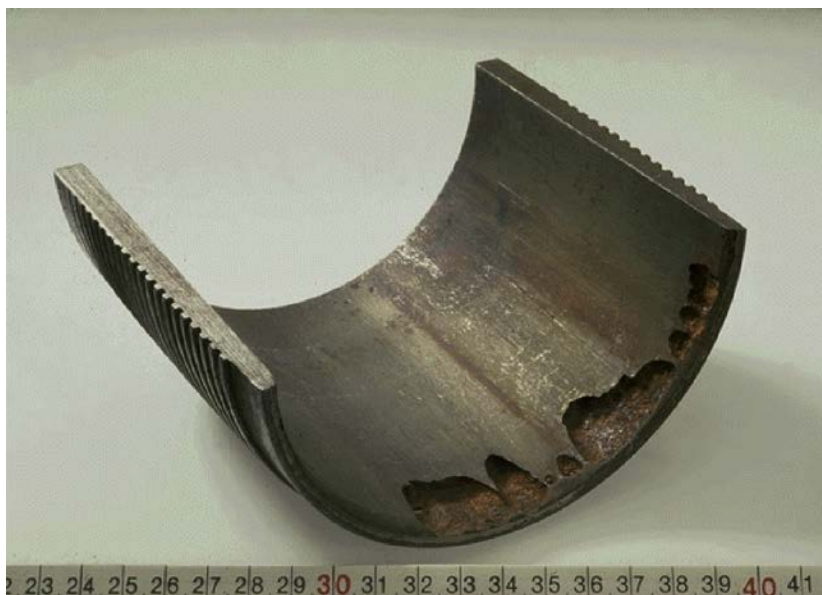
PART Connecting piece (wall thickness 8 mm) on well tubing.

PHENOMENON Turbulence-enhanced carbon dioxide corrosion (sweet corrosion).

APPEARANCE Pipe section severely attacked downstream side, at the screwed connection.

CAUSE The slight irregularity at the connection caused high turbulence, preventing formation of a protective iron carbonate scale.

REMEDY Controlled flow velocity and enhanced corrosion protection by means of downhole inhibitor injection.

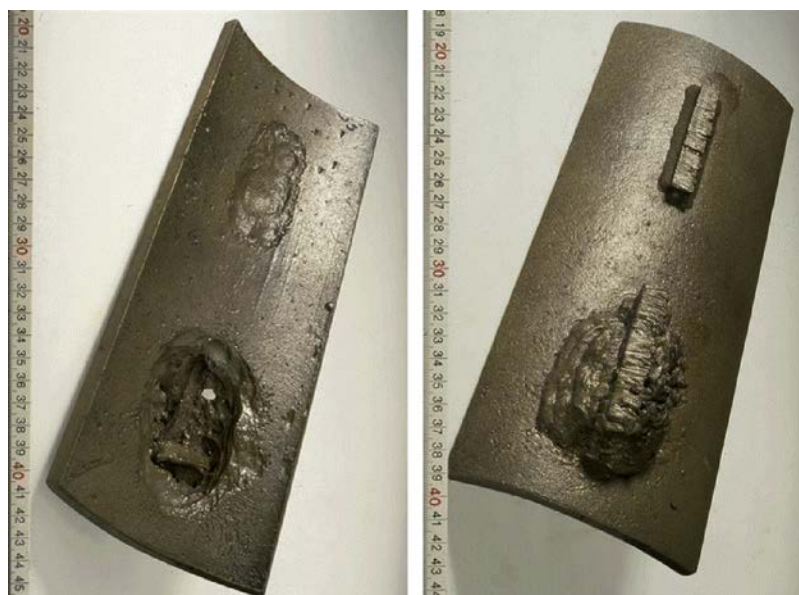
01.11.02.03

MATERIAL	Carbon steel.
SYSTEM	Gas production station piping.
PART	Pipe section (8 mm wall thickness).
PHENOMENON	Carbon dioxide corrosion (sweet corrosion).

APPEARANCE	Local attack to the point of penetration near welded pipe supports.
------------	---

CAUSE	The welding treatment affected the structure of the steel, resulting in galvanically enhanced localized corrosion at a location where water was able to collect. The supports may have cooled the pipe locally (forming a cold bridge), leading to additional condensation.
-------	---

REMEDY	<ul style="list-style-type: none"> • Improved treatment with corrosion inhibitors, and • Improved pipe support design where possible (use of dishes clamped to T-beam).
--------	---

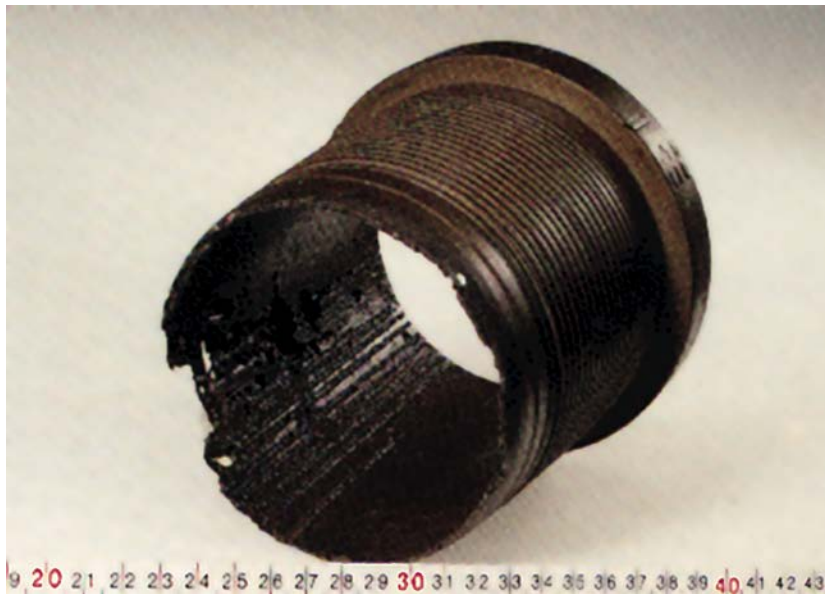
01.11.02.04

MATERIAL	Carbon steel.
SYSTEM	Natural gas well.
PART	Well tubing connection piece.
PHENOMENON	Carbon dioxide corrosion (sweet corrosion).

APPEARANCE	Severe pitting and grooves in the longitudinal direction.
TIME IN SERVICE	Several years.
ENVIRONMENT	Wet carbon dioxide-containing natural gas.
CAUSE	Both turbulence and wireline work inside the pipe have reduced the formation of protective iron carbonate scales, thereby enhancing CO ₂ corrosion.
REMEDY	Control flow velocities and inhibitor injection downhole.

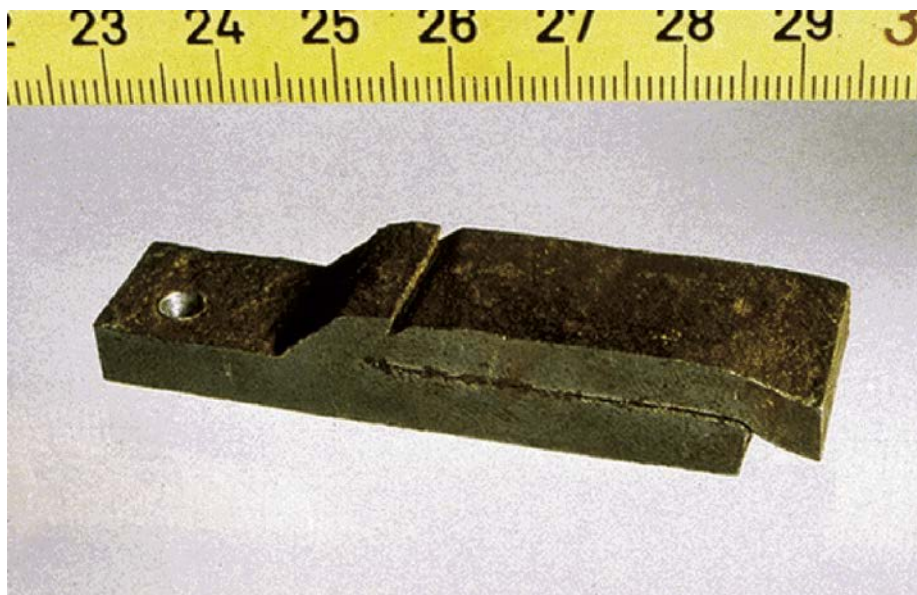
01.11.02.05

MATERIAL	Carbon steel.
SYSTEM	Crude oil storage tank.
PART	Bottom plate weld.
PHENOMENON	Attack by aggressive water.

APPEARANCE	Sharp groove adjacent to the weld, like knife-line attack of stabilized stainless steel (see Case History 04.11.19.04).
TIME IN SERVICE	5 years.
ENVIRONMENT	Crude oil and aqueous bottom layer.
CAUSE	The heat-affected zone dissolved electrolytically, because this zone was less noble in relation to the rest of the plate.
REMEDY	Attack by aggressive water can be prevented by application of a coating to the bottom. In this case, no measures have been taken because the lowest bottom plate was still intact, so there was no danger of leakage.

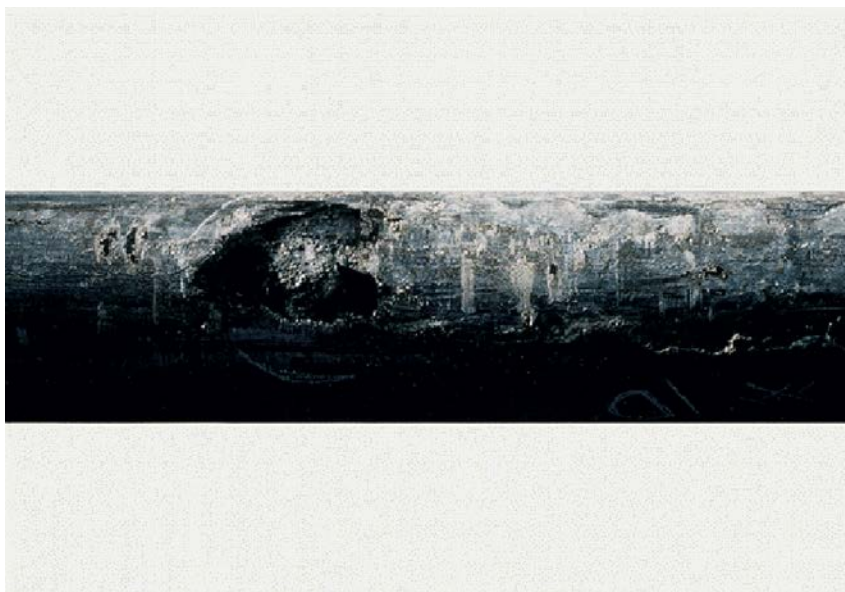
01.11.02.06

MATERIAL	Carbon steel (API grade J-55).
SYSTEM	Oil well.
PART	Casing (OD: 219 mm), located at a depth of 122 m.
PHENOMENON	Carbon dioxide corrosion (sweet corrosion).

APPEARANCE Localized external casing corrosion of the mesa type.

CAUSE Direct contact of the casing with a formation containing corrosive water. (Ref. Gordon, B.A., Grimes, W.D. and Treseder, R.S.: "Casing corrosion in the South Belridge Field", Materials Performance (1984) 23, No. 3, 9) (see also Case Histories [01.11.02.01/02/03/04](#)).

REMEDY Provide positive cement cover of the casing in locations where corrosive formation waters exist. Apply cathodic protection where feasible.

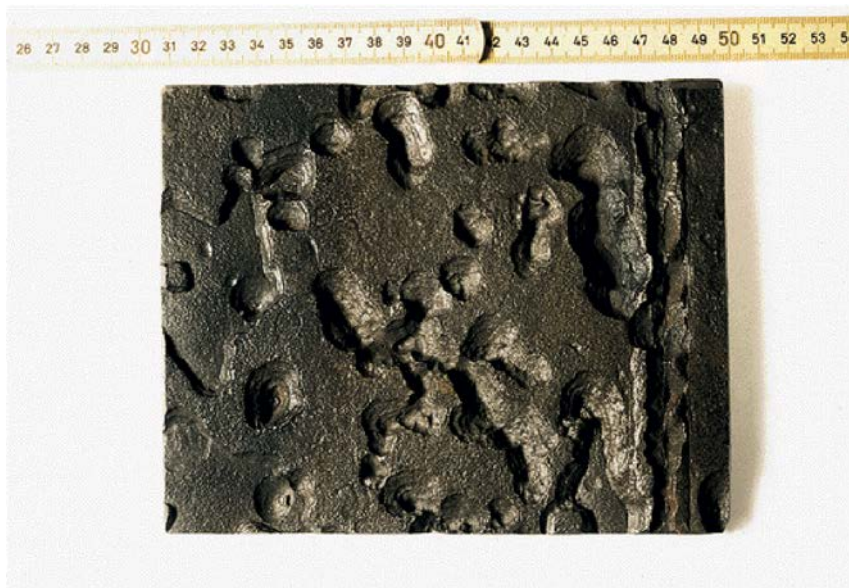
PART Bottom pipe wall.

PHENOMENON Carbonic acid corrosion.

APPEARANCE Severe terraced attack.

CAUSE The carbonic acid in the water attacks the steel.
Underdeposit corrosion under precipitated sediment occurs at the same time.

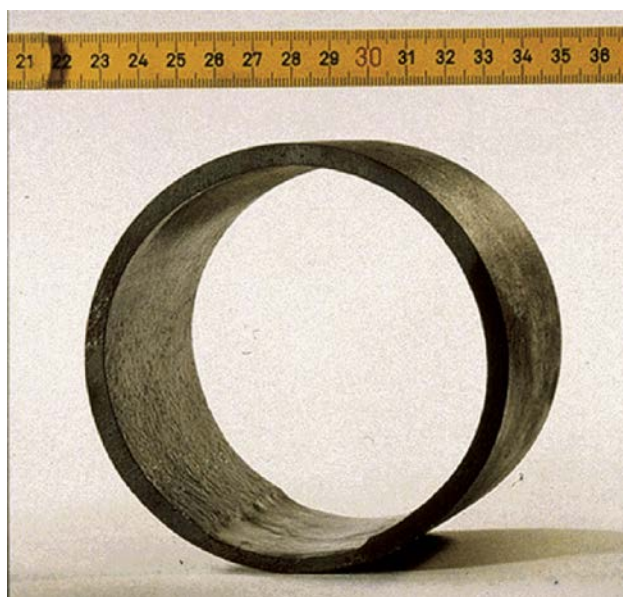
PART Pipe.

PHENOMENON Caustic corrosion.

APPEARANCE Local reduction in wall thickness by uniform attack.

CAUSE NaOH attack at the steam tracing, due to locally excessive wall temperature during product standstill steel is attacked by caustic according to: $\text{Fe} + 2\text{NaOH} \rightarrow \text{Na}_2\text{FeO}_2 + \text{H}_2 \uparrow$. (See also Case History [01.01.03.01](#).)

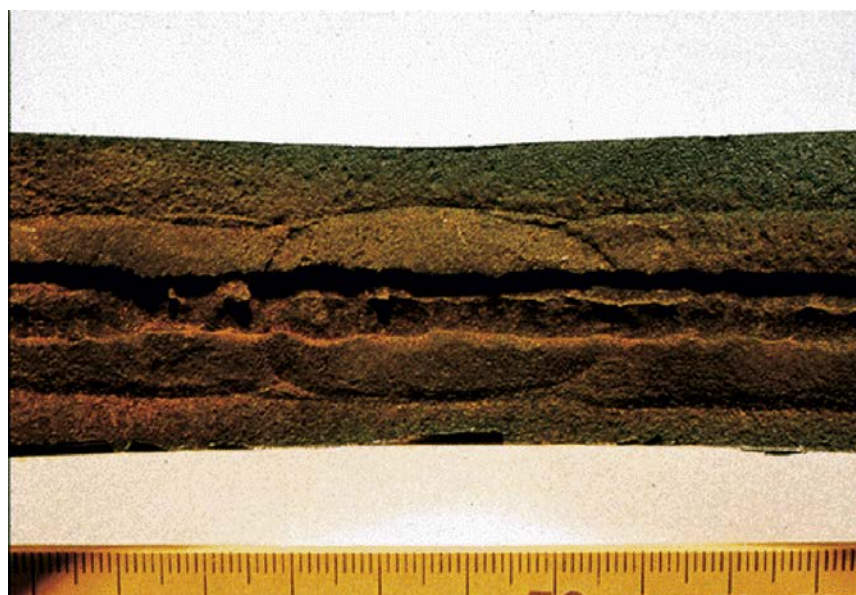
PART Pipe section.

PHENOMENON Acid corrosion.

APPEARANCE Selective leaching of the weld.

CAUSE The difference in structure between the weld and the pipe material leads to selective attack to the weld (the oval ring at the center betrays the presence of a local repair in the weld) (For selective attack to the weld, see also Case Histories [01.01.04.03](#) and [01.10.01.01](#) and refer also to section stainless steel.)

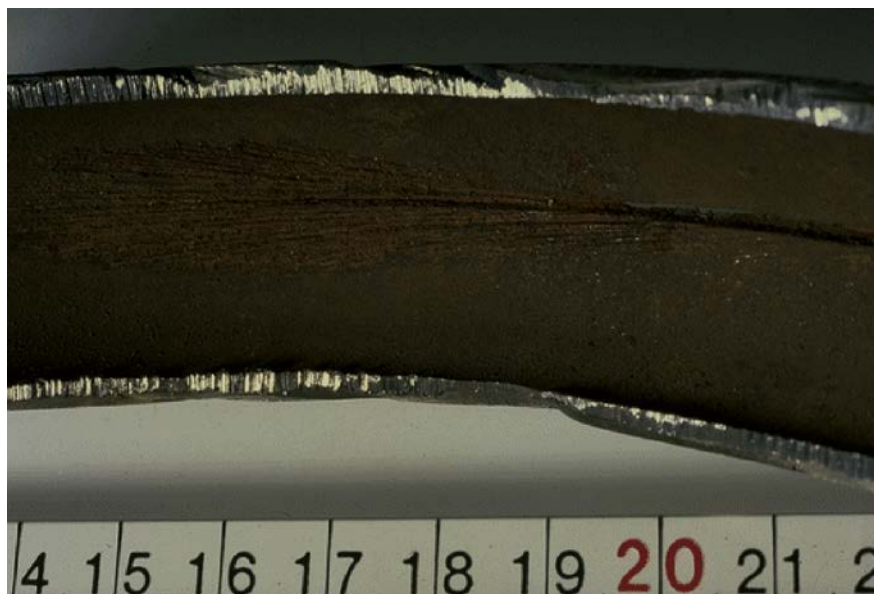
01.11.04.03

MATERIAL	Carbon steel (ASTM A 106, grade B).
SYSTEM	Sulfuric acid transport system.
PART	Pipe bend curving from the vertical to the horizontal, with electrical tracing at the outside of the bend.
PHENOMENON	Acid corrosion (hydrogen grooving).

APPEARANCE	A long sharp groove 1.5 mm wide, becoming increasingly deep until it penetrates the 5mm-thick pipe wall, then fanning out in several dozen small grooves.
------------	---

ENVIRONMENT	95–96% sulfuric acid, temperature 25°C, maximum wall temperature 40°C. Pressure 3.5 bar, flow rate 1 m/s. Regular stagnant conditions.
-------------	--

CAUSE	Carbon steel possesses good resistance to concentrated sulfuric acid at ambient temperature and low flow rate (<0.9 m/s), due to the precipitation of a ferrous sulfate layer which acts as a corrosion barrier ($\text{Fe} + \text{H}_2\text{SO}_4 \rightarrow \text{FeSO}_4 + \text{H}_2$). Under special conditions (when strong acid is not moving), the steady passage of the hydrogen bubbles on a preferred path can disturb the ferrous sulfate layer. The normal steady state of low corrosion will be disrupted and grooving will result with high local corrosion rates of 3–7 mm/yr. The local high wall temperature has accelerated the corrosion.
-------	---

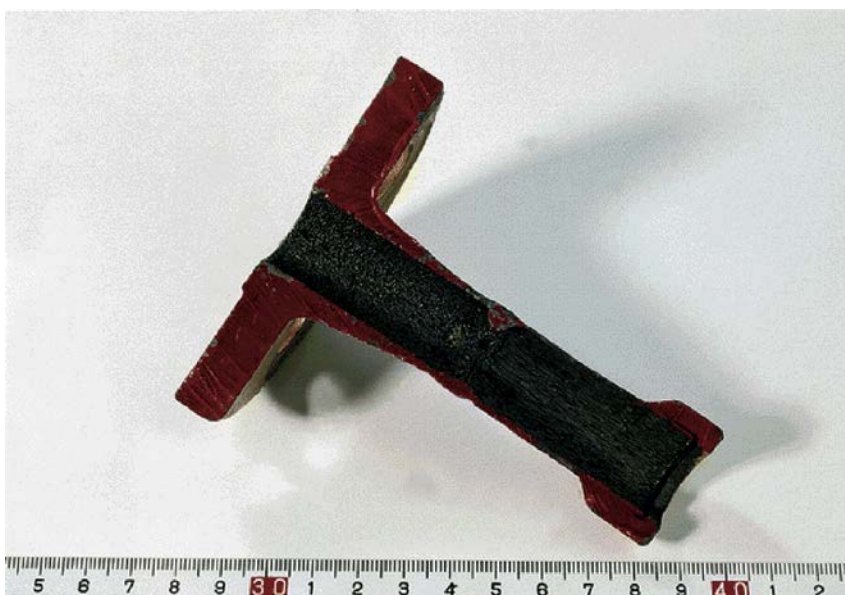
PART 3/4" pipe section with flange.

PHENOMENON Acid corrosion.

APPEARANCE Grooved attack in the rolling direction of the pipe and pitting attack to the flange pipe.

CAUSE The sulfuric acid line was blown through with steam because it was blocked. The resultant dilution and high temperature caused the rapid attack. Unlike concentrated sulfuric acid, dilute sulfuric acid is aggressive to carbon steel.

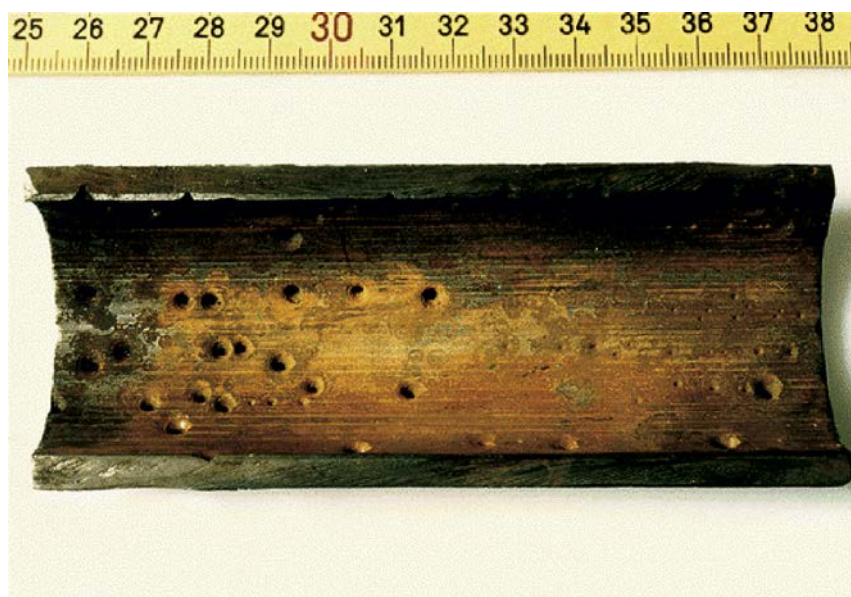
01.11.04.05

MATERIAL	Carbon steel.
SYSTEM	Chemical transport system.
PART	Vertical overfall line from pump to storage tank.
PHENOMENON	Acid corrosion.

APPEARANCE	Pitting, each pit consists of narrowing rings.
TIME IN SERVICE	4 months.
ENVIRONMENT	Sulfuric acid 96%; flow rate: 0.5 m/sec; temperature 15–20°C.
CAUSE	Probably local breakdown of the passive iron sulfate layer by contaminations in the sulfuric acid (moist, air) or local variations in concentration with continually alternately passivation and activation, resulting in the corrosion picture illustrated. Present mill scale can cause serious pitting too.
REMEDY	The overfall line was replaced.

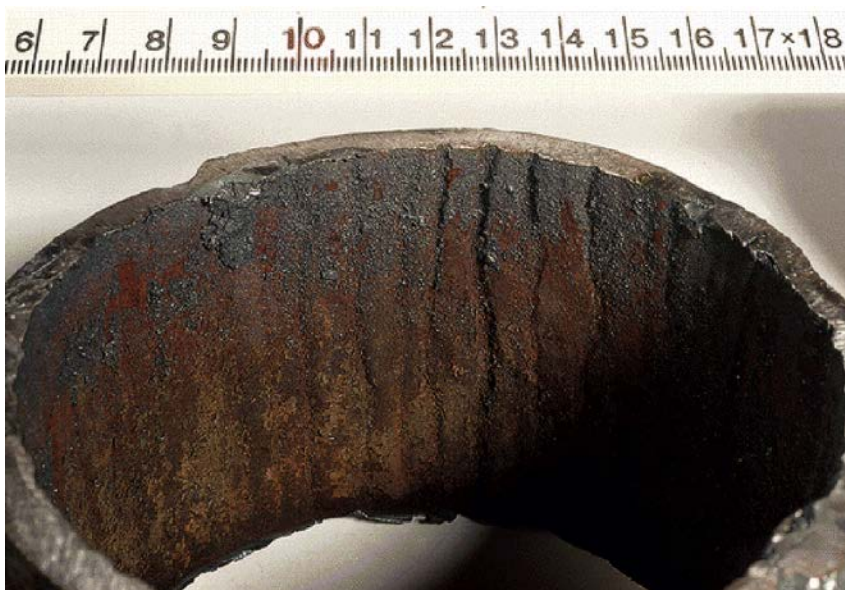
01.11.04.06

MATERIAL	Carbon steel.
SYSTEM	Crude distiller.
PART	Dead-end nozzle on mild vacuum column.
PHENOMENON	Acid corrosion (dew-point corrosion).

APPEARANCE	Local attack with grooves.
TIME IN SERVICE	4 years.
ENVIRONMENT	Hydrocarbons, water and hydrochloric acid.
CAUSE	Condensation of hydrochloric acid occurred in a cold nozzle due to wet insulation.
REMEDY	<ul style="list-style-type: none"> • Operate at higher temperatures. • Appropriate insulation.

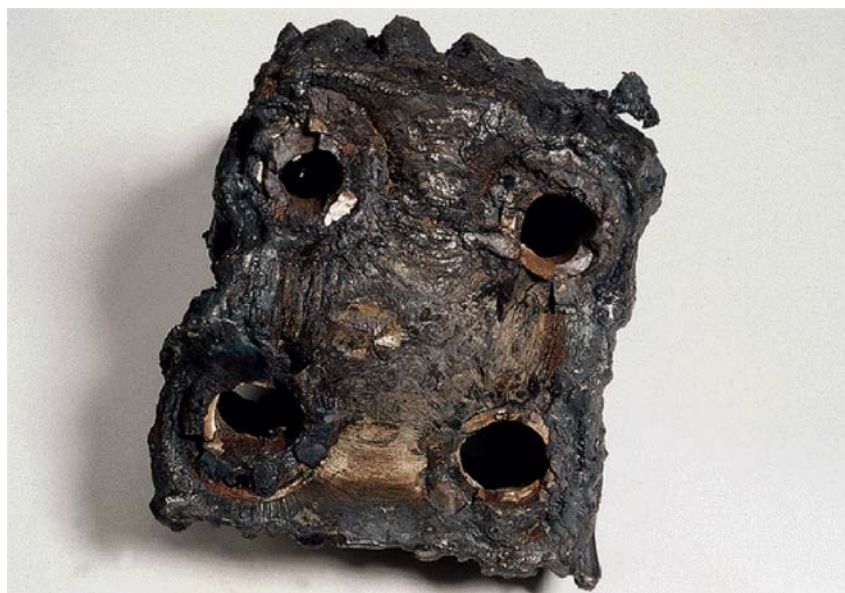
MATERIAL	Carbon steel.
SYSTEM	Sulfur recovery unit.
PART	Tube sheet of waste heat boiler.

PHENOMENON High-temperature corrosion (sulfidation).

APPEARANCE General corrosion.

CAUSE Refractory and tube inserts were damaged, causing ingress of hot gases between the tube sheet and refractory. This in turn caused high-temperature sulfidation (see also Case Histories [05.01.06.01](#) and [05.19.06.01](#)).
