Corrosion Atlas

THIRD, EXPANDED AND REVISED EDITION

A Collection of Illustrated Case Histories

Evert D.D. During

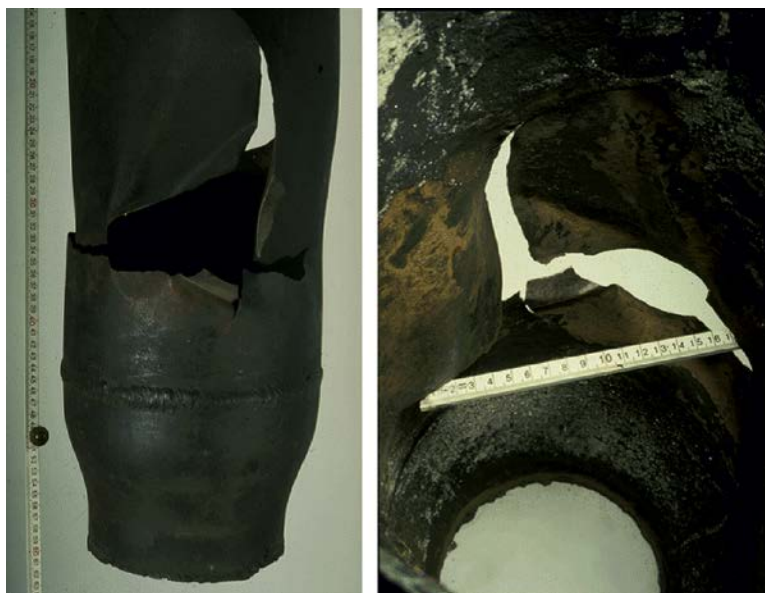
MATERIAL	Carbon steel.
SYSTEM	Distillation column.
PART	Bottom effluent line.

PHENOMENON High-temperature corrosion (sulfur corrosion).

APPEARANCE Pipe exhibits local reduction of wall thickness and has fractured (outside left, inside right).

CAUSE Rapid and local wall thickness reduction due among other things to turbulence and accelerated sulfur corrosion. By altering the operating conditions, namely applying a higher temperature, the sulfur corrosion was accelerated, thereby substantially reducing the operating time. The pipe fracture caused a fire which led to total destruction of the plant.

- Alterations in the process conditions should be submitted to the corrosion department in advance.
- Alternative: construct the pipe of 12 CrMo 19 5 (see also Case History [01.11.06.08](#)).

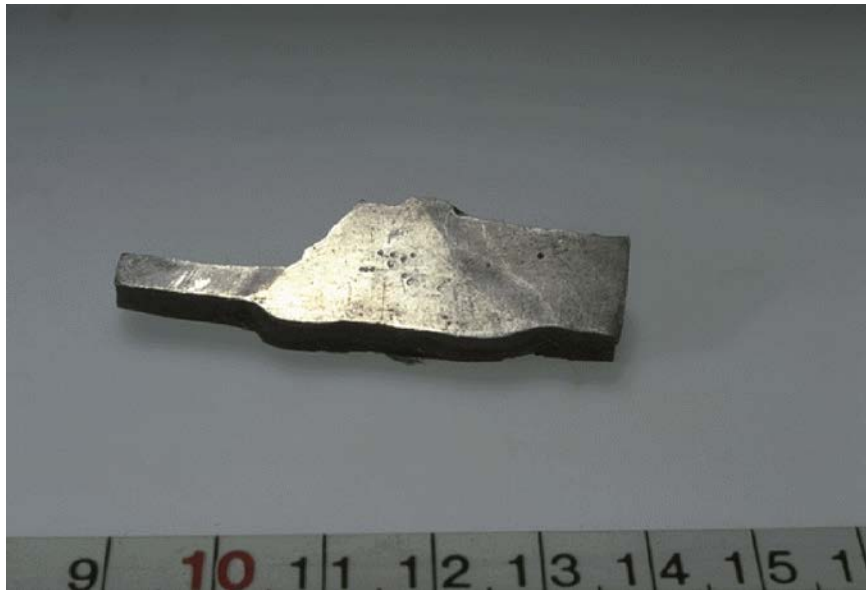
01.11.06.07

MATERIAL	Carbon steel.
SYSTEM	Slurry system.
PART	Attachment weld of two pipe sections from a transport pipeline.
PHENOMENON	High-temperature corrosion (sulfur corrosion).

APPEARANCE	Uniform attack to the left side of the weld.
TIME IN SERVICE	About 10 years.
ENVIRONMENT	Slurry consisting of hydrocarbons with sulfur and catalyst particles. Temperature 360°C. Pressure 10 bar.
CAUSE	Both API and ASTM pipes were used in the slurry system. Following the occurrence of corrosion, a metal analysis was performed which showed that the ASTM pipe had a higher silicium content than the API pipe, namely 0.23% against 0.1%, which made it more corrosion-resistant. The API pipe section is shown on the left.
REMEDY	ASTM pipe is now used.

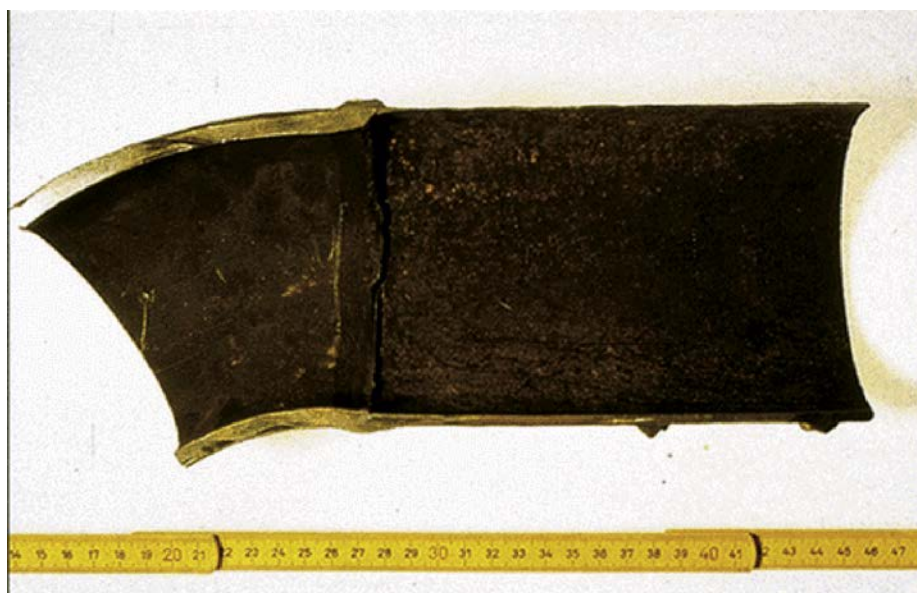
PART Process pipe.

PHENOMENON High-temperature corrosion (sulfur corrosion).

APPEARANCE Uniform attack to a pipe section.

CAUSE By error, a carbon steel pipe section was incorporated which is not resistant to sulfur corrosion.

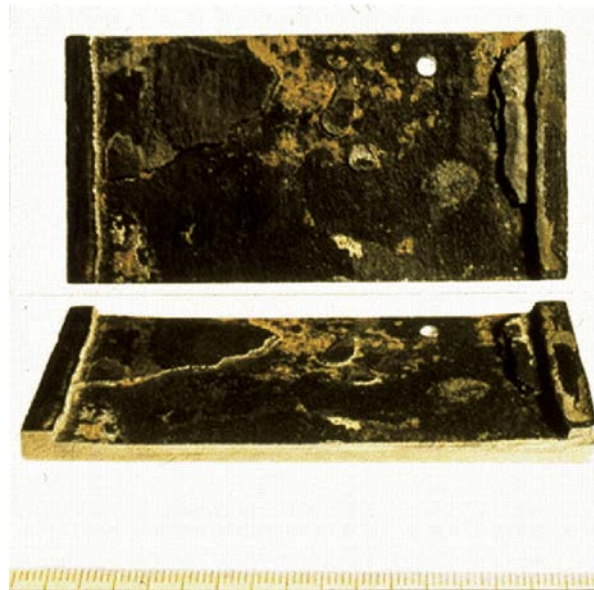
MATERIAL Base material: steel (10 CrMo 9 10; W.-Nr. 1.7380), welded-up at the sides with AISI 347 stainless steel.

PART Reactor test block.

PHENOMENON High-temperature corrosion (sulfur corrosion).

APPEARANCE Uniform attack of the base material.

ENVIRONMENT Hydrocarbons with H_2S and H_2 ; temperature 350–385°C; partial hydrogen pressure approximately 30 bar. Sulfur corrosion is also known as sulfidic corrosion.

CAUSE In the presence of hydrogen, the base material is attacked by sulfur at this high temperature.

REMEDY Use AISI 347 stainless steel cladding.

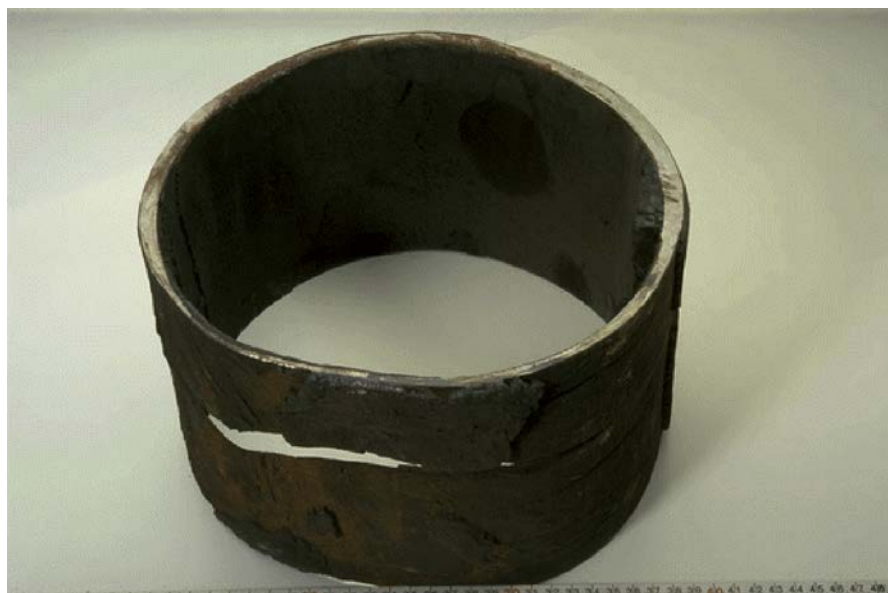
PART Roof furnace tube.

PHENOMENON High-temperature corrosion (oxidation).

APPEARANCE Internally, coke deposition with external scaling and wall thickness reduction.

CAUSE The wall temperature rose to excessive levels due to coke deposition at the top of the pipe (i.e., not the flame side). As a result, severe external scaling occurred due to combustion and the wall thickness decreased. The pipe fractured as a result of these factors.

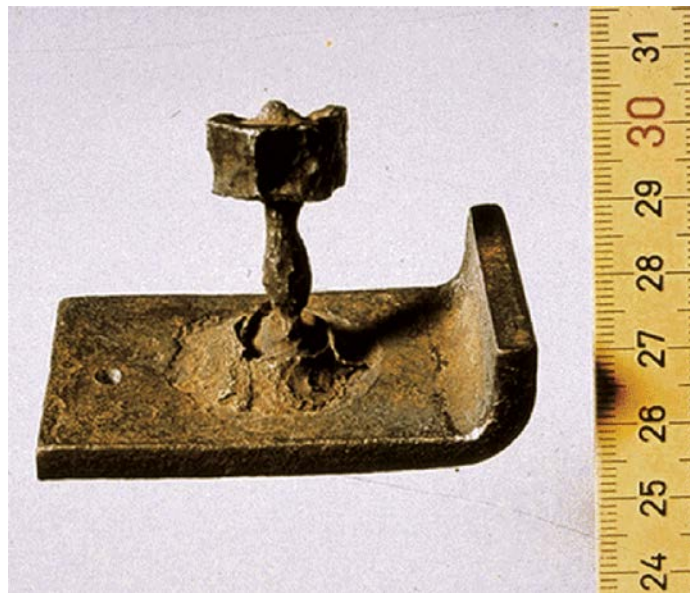
PART Tray clamp.

PHENOMENON Galvanic corrosion.

APPEARANCE Severe attack to bolt and nut over their entire surface.

CAUSE Two different steel grades in a conductive environment leads to galvanic corrosion to the less noble steel (couple action) (see also Case History [01.06.14.01](#)).

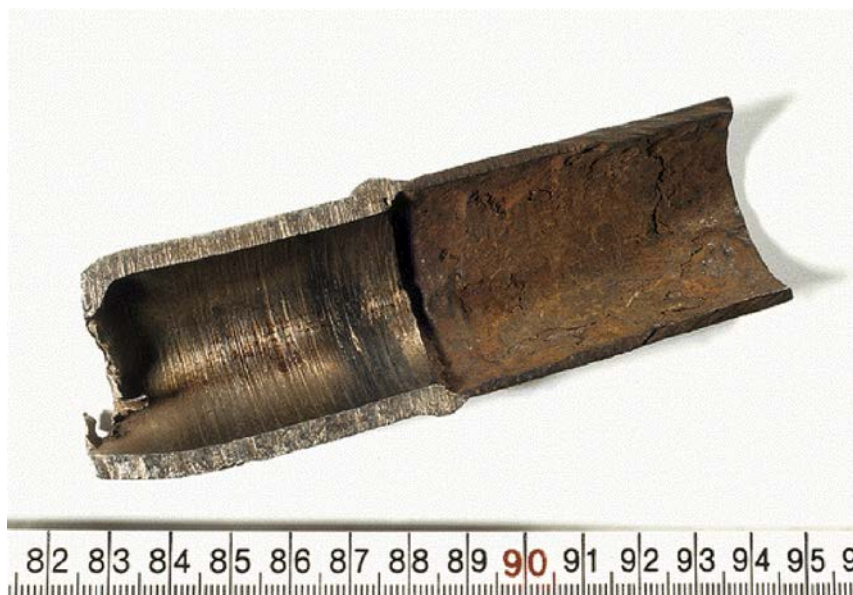
MATERIAL Carbon steel attached to stainless steel.

PART Pipe section.

PHENOMENON Galvanic corrosion and erosion corrosion.

APPEARANCE Uniform attack of the carbon steel pipe.

CAUSE Carbon steel is normally resistant to concentrated sulfuric acid, as a passivating iron sulfate skin is formed. In this case, the potential difference between the stainless steel and the carbon steel, as well as erosion caused by the meanwhile eroded welded joint, prevented build-up of this skin (see also Case History [01.11.34.03](#)).

REMEDY Construct the pipe completely of carbon steel or stainless steel. Lower the velocity of H_2SO_4 in carbon steel pipeline to <0.6 m/s.

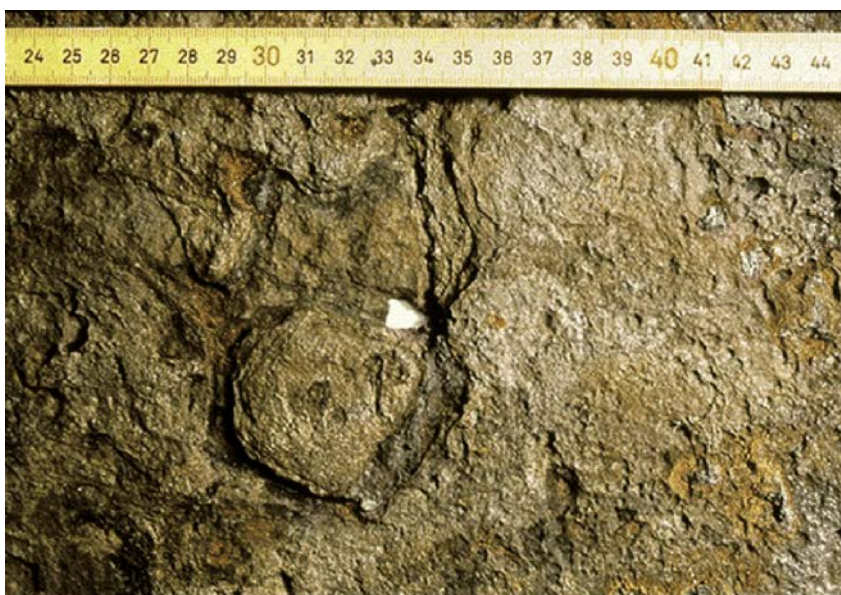
PART Bottom plate.

PHENOMENON Microbiologically induced corrosion.

APPEARANCE Severe local attack (external).

CAUSE The insulation in the tank pad below the tank was found to be contaminated with sulfate. In combination with the high groundwater level, this led to the growth of sulfate-reducing bacteria. The resultant sulfide attacked the steel.

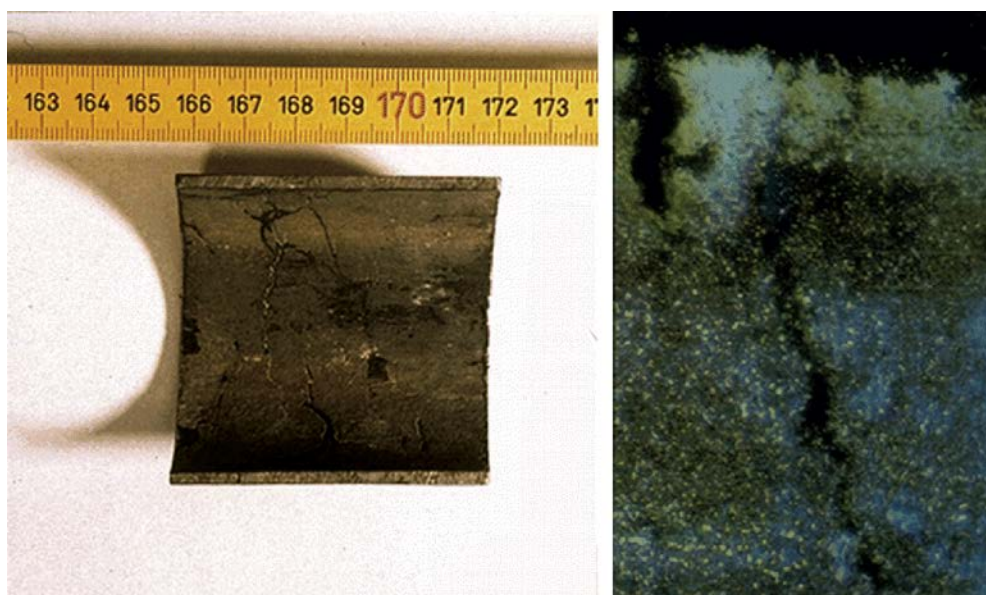
PART Pipe section.

PHENOMENON Intergranular stress corrosion (caustic stress-corrosion cracking).

APPEARANCE Cracking at suspension point.

CAUSE Combination of stresses at the suspension point coupled with the high alkalinity (see also Case Histories [01.01.18.02](#), [01.01.18.05](#), and [01.11.18.04](#)).

REMEDY Replace the pipe by a new pipe with multiple supports in order to reduce the stresses.

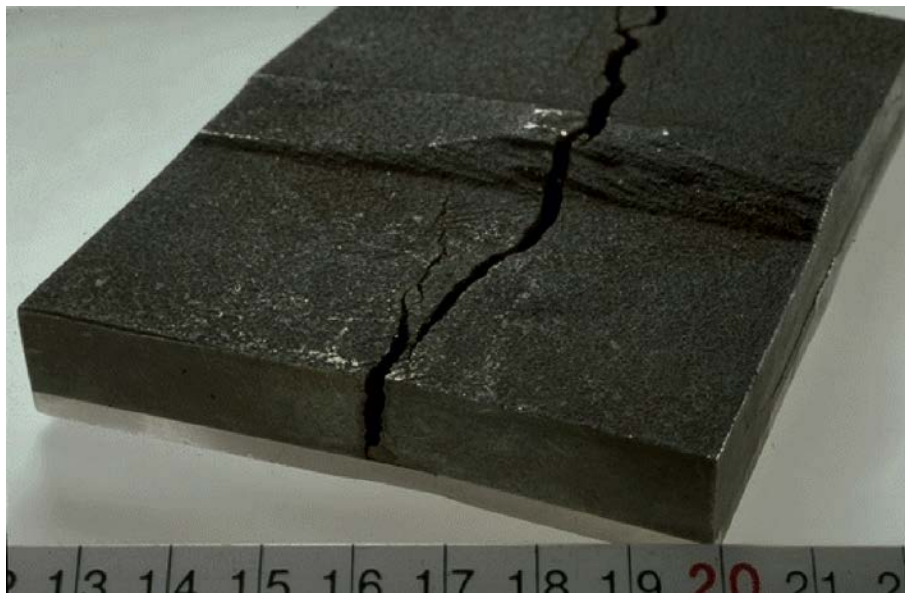
PART Carbon steel jacket with a stainless steel lining.

PHENOMENON Intergranular stress corrosion (nitrate stress-corrosion cracking).

APPEARANCE Cracking transverse to the weld.

CAUSE Intergranular stress corrosion caused by nitrate.

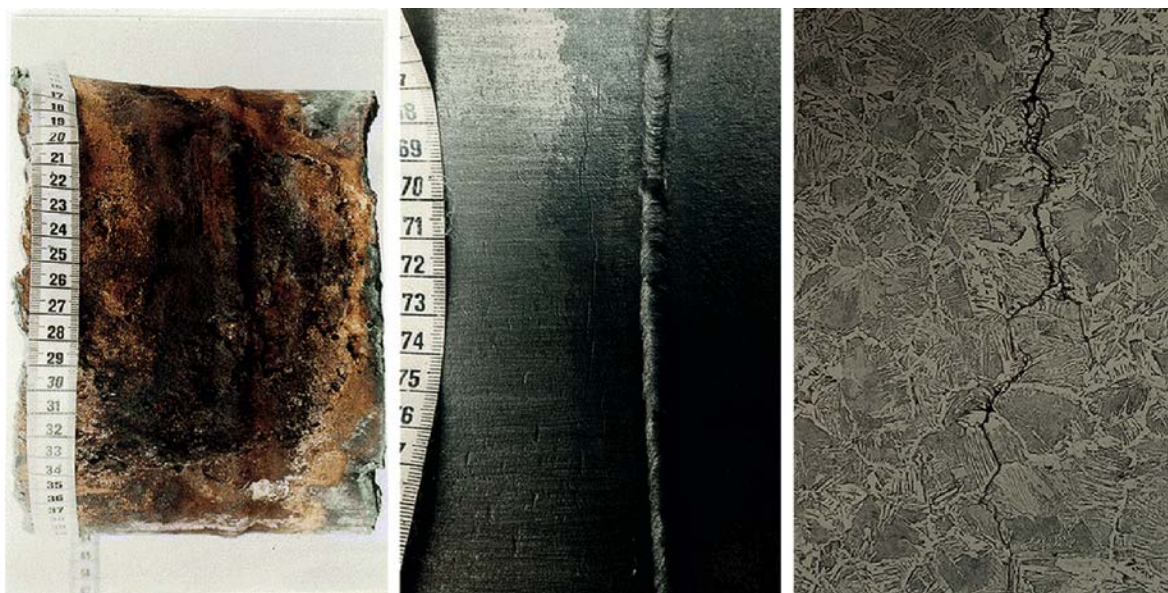
01.11.18.03

MATERIAL	Carbon steel.
SYSTEM	Sour water stripper.
PART	Insulated overhead line to sulfur recovery unit.
PHENOMENON	Carbonate/bicarbonate stress-corrosion cracking.

APPEARANCE	Intergranular cracking near the weld.
TIME IN SERVICE	14 years.
ENVIRONMENT	Wet sour gas containing CO ₂ , H ₂ O, H ₂ S, and NH ₃ .

The potential problem in the line is condensation of the wet sour gas resulting in general corrosion and/or stress corrosion cracking. The line has been protected against these phenomena by steam tracing. However, water ingress under the insulation reduced the metal temperature, resulting in condensation. At the outside surface, underlagging corrosion was present. In this instance, the corrosives have provoked stress-corrosion cracking, resulting in leakage (see also Case History 01.05.18.01).

Maintaining the metal temperature above dew point by prevention of water ingress by both repair of the insulation and sealing-off the protective sheathing in an effective way.

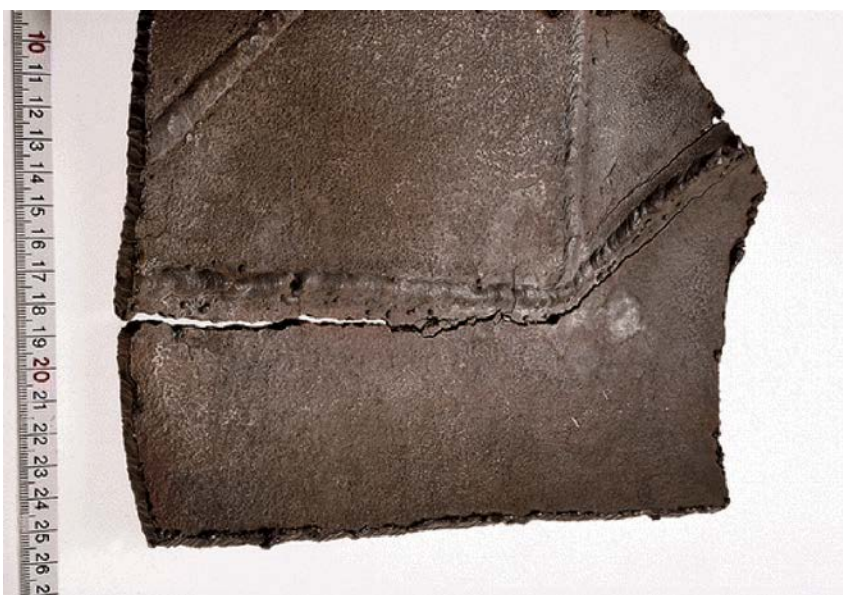
PART Off-gas line.

PHENOMENON Stress-corrosion cracking (caustic stress-corrosion cracking).

APPEARANCE Selective cracking in the heat-affected zones beside the weld.

CAUSE With the combination of stresses and caustic soda at the present temperature, carbon steel is subject to stress corrosion (see also Case Histories [01.01.18.02](#) and [01.11.18.01](#)).

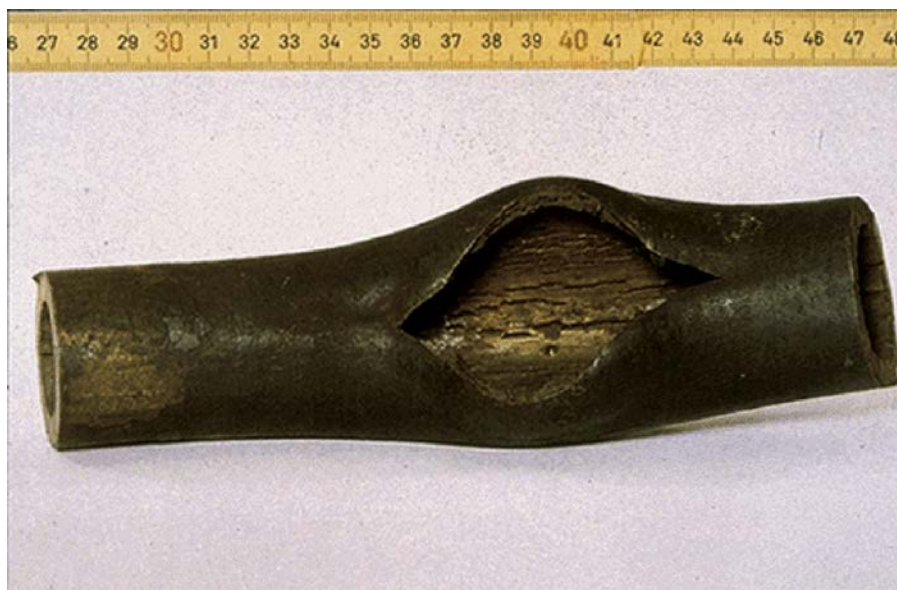
01.11.20.01

MATERIAL	Carbon steel.
SYSTEM	Cooling tower with heat exchanger.
PART	Cooler pipe from heat exchanger (with aluminum brass jacket pipe, see Case History 06.06.18.01).
PHENOMENON	Hydrogen damage (high-temperature hydrogen attack, decarburization).

APPEARANCE	Laminar Assuring.
TIME IN SERVICE	Several years.
ENVIRONMENT	Through the steel pipe: a high-pressure (150 bar) gas mixture of hydrogen, nitrogen, and ammonia at approximately 240°C.
CAUSE	Under these conditions, molecular hydrogen (H_2) dissociates at the steel surface to atomic hydrogen (H), which readily diffuses into the steel, where it reacts with the cementite (Fe_3C) of the steel to form methane gas ($Fe_3C + 2H_2 \rightarrow 3Fe + CH_4$). The steel cracks owing to pressure build-up (see also Case Histories 01.01.20.02/03/04/05/06 and 01.11.20.03).
REMEDY	Application of 0.5 Mo steel or one of the Cr-Mo steels, depending on the metal temperature and hydrogen partial pressure (according to the Nelson curves, see API 941).

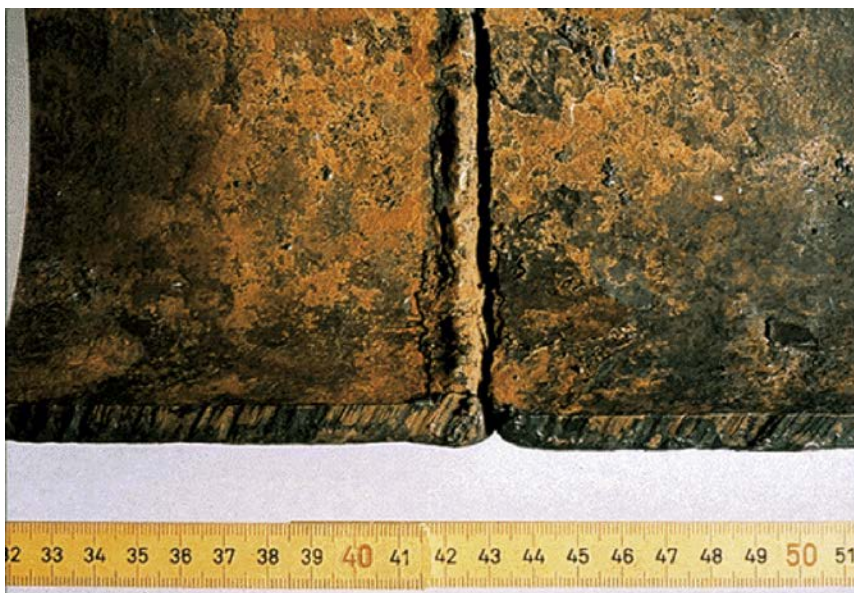
PART 6" pipe to the furnace.

PHENOMENON Hydrogen damage (high-temperature hydrogen attack).

APPEARANCE Crack beside the weld.

CAUSE Injudicious moving of the hydrogen injection point. This exposed the existing carbon steel pipe system to “hot hydrogen.” The heat-affected zone beside the weld was selectively attacked as a result.

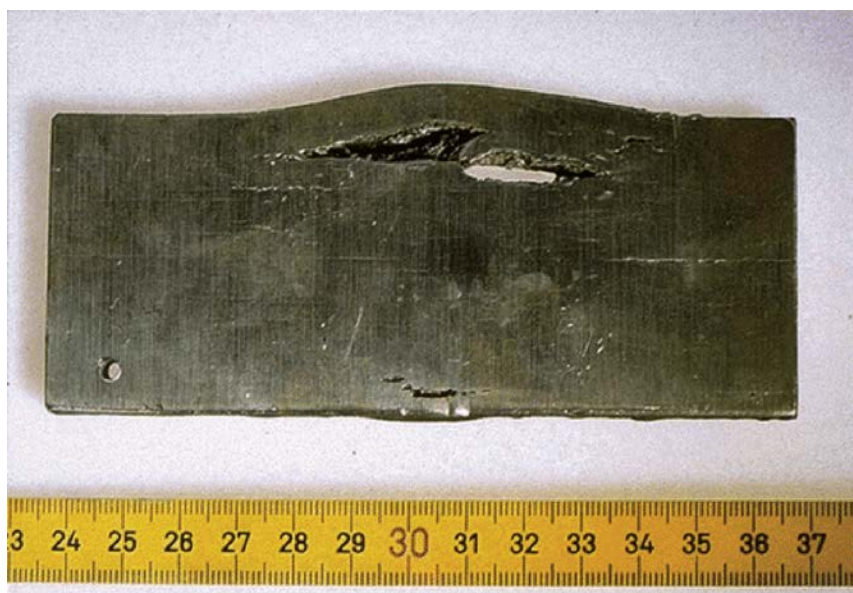
PART Ballast plate.

PHENOMENON Hydrogen damage (high-temperature hydrogen attack, decarburization).

APPEARANCE Blistering.

CAUSE Atomic hydrogen diffuses into the metal where it forms methane by reacting with the carbon of the metastable carbides. Pressure build-up causes the metal to crack (see also Case History [01.11.20.01](#)).

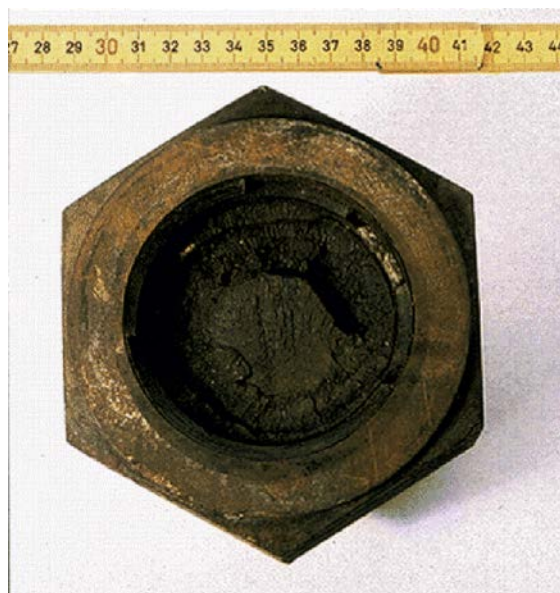
PART Nut with bolt.

PHENOMENON Hydrogen damage (hydrogen embrittlement).

APPEARANCE Bolt completely broken off.

CAUSE The large screw thread can easily retain rainwater, which is acidified by the industrial atmosphere. The atomic hydrogen formed during corrosion diffuses in the steel, thereby causing its strength to diminish.

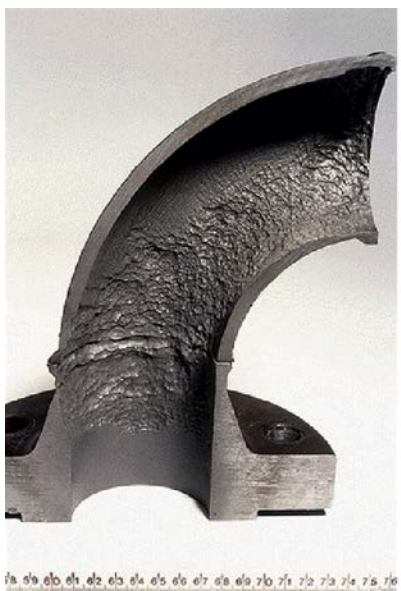
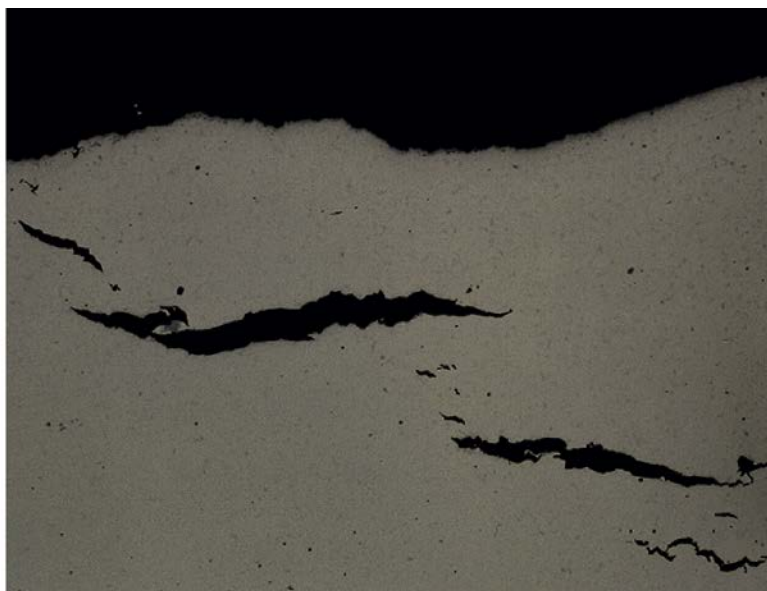
PART Flange and bend upstream of depressuring valve, from an interconnecting line between high-pressure and low-pressure separators.

PHENOMENON Hydrogen damage (hydrogen-induced cracking) and general corrosion.

APPEARANCE Thinning and internal cracking.

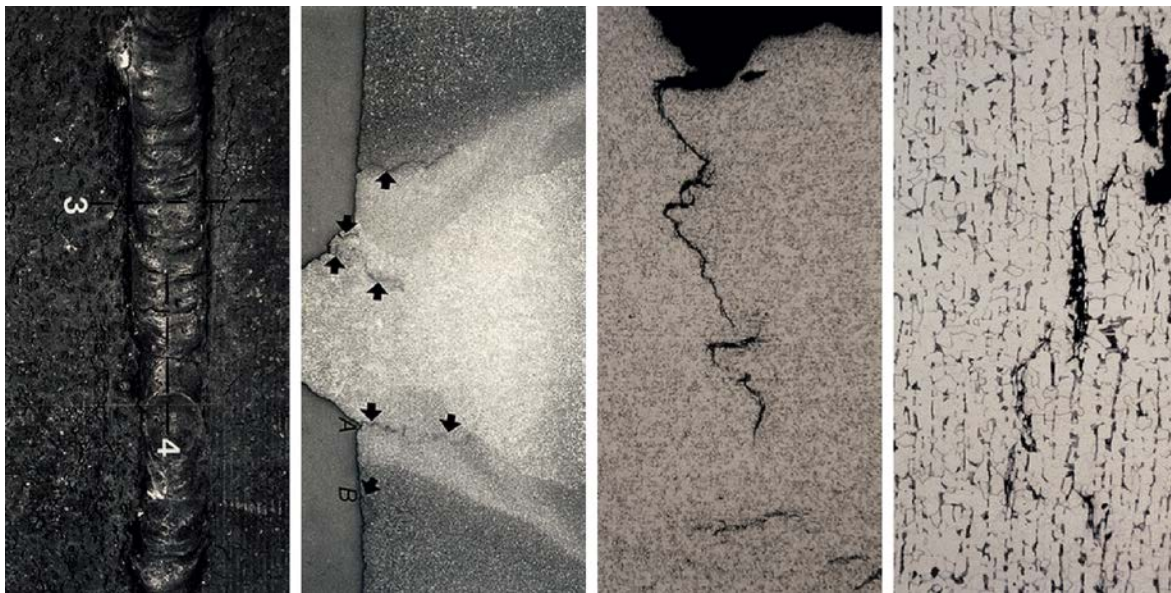
01.11.20.07

MATERIAL	Carbon steel (ASTM A 105 N).
SYSTEM	Amine unit.
PART	Outlet header of overhead condenser (air-fin bank).
PHENOMENON	Hydrogen damage [stress-oriented hydrogen-induced cracking (SOHIC)].

APPEARANCE	Stepwise transgranular cracking in the zone between the round weld and the base material (ferrite and perlite).
------------	---

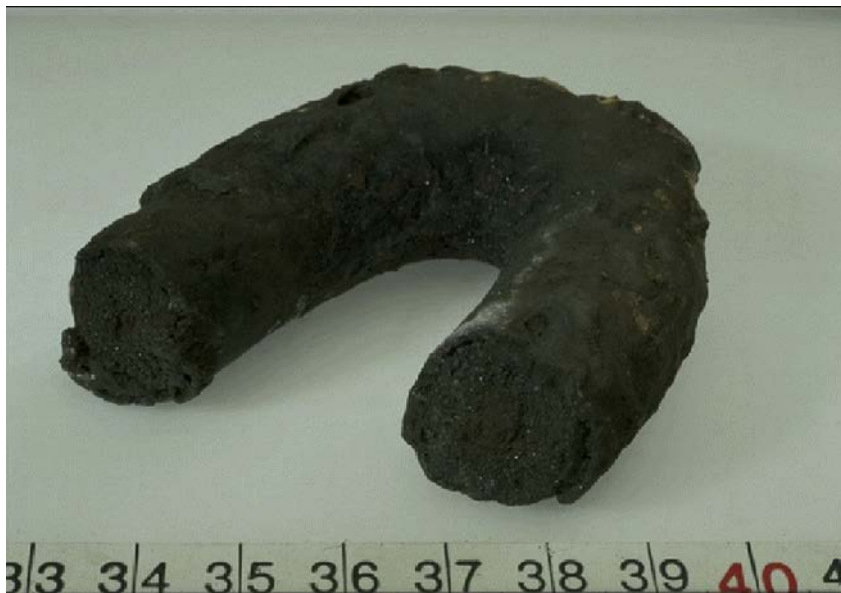
PART Link of an iron chain.

PHENOMENON “Gaseous metal embrittlement.”

APPEARANCE Flaking-off scale formation and brittle fracture.

REMEDY Manufacture the chain using brass, or replace it regularly.

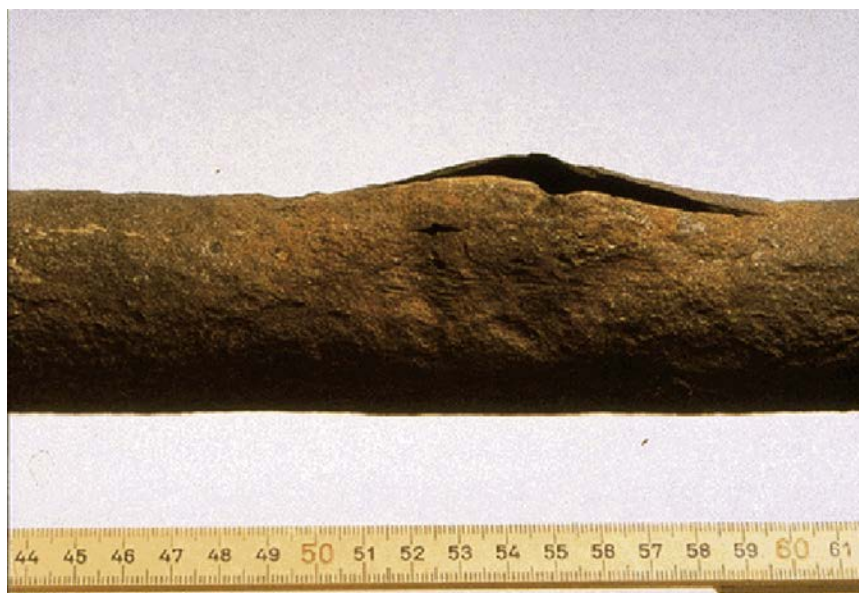
PART Pipe section.

PHENOMENON Corrosion under insulation.

APPEARANCE Irregular general attack.

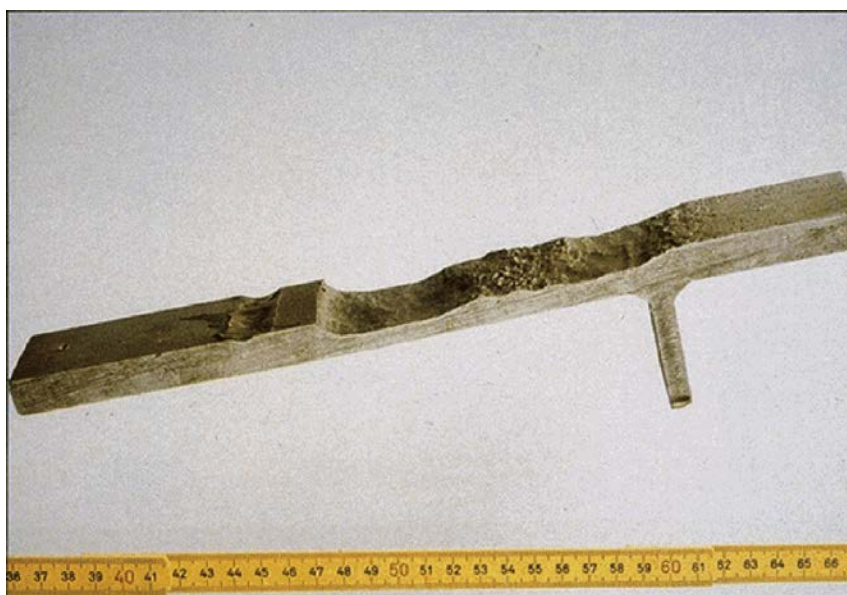
01.11.25.02

MATERIAL	Carbon steel.
SYSTEM	Oil distillation plant.
PART	Column wall.
PHENOMENON	Corrosion under insulation.

APPEARANCE Locally severe attack.

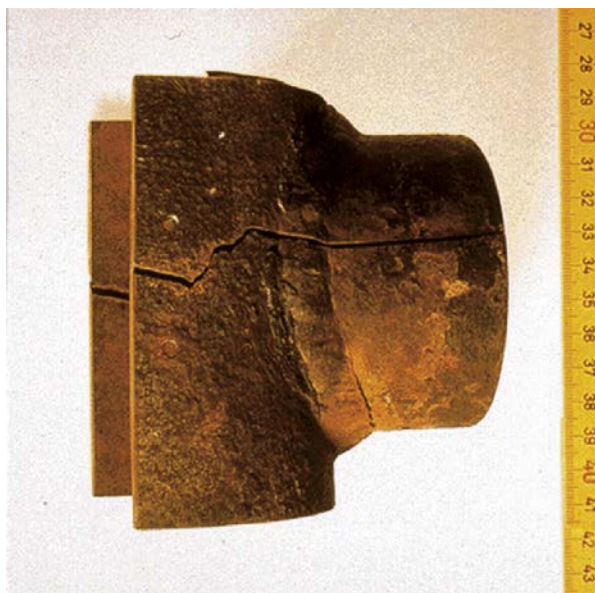
PART T-piece (3"/4").

PHENOMENON Fatigue.

APPEARANCE Distortionless crack in the horizontal plane.

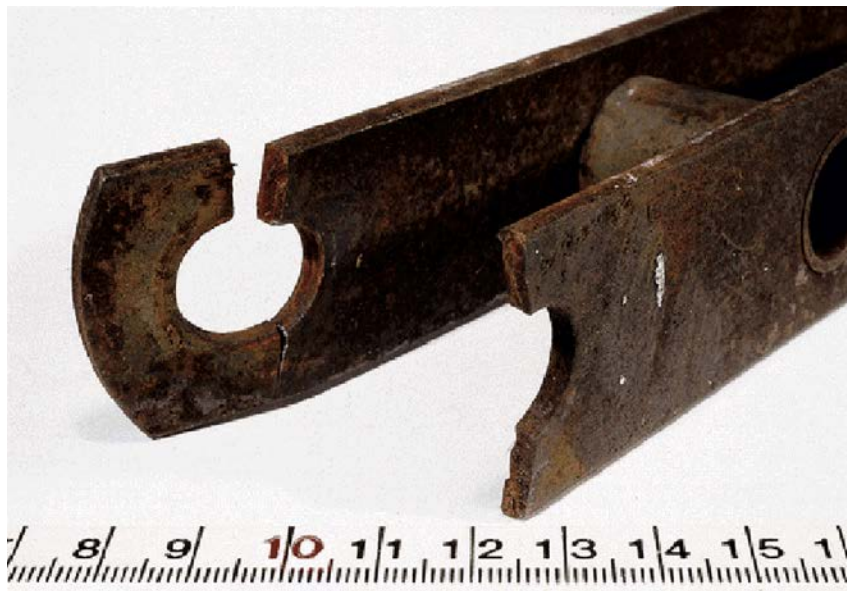
MATERIAL	Carbon steel.
SYSTEM	Conveyor belt in a cheese store.
PART	Chains.

PHENOMENON Low cycle fatigue or strain fatigue.

APPEARANCE Cracks and rupture.

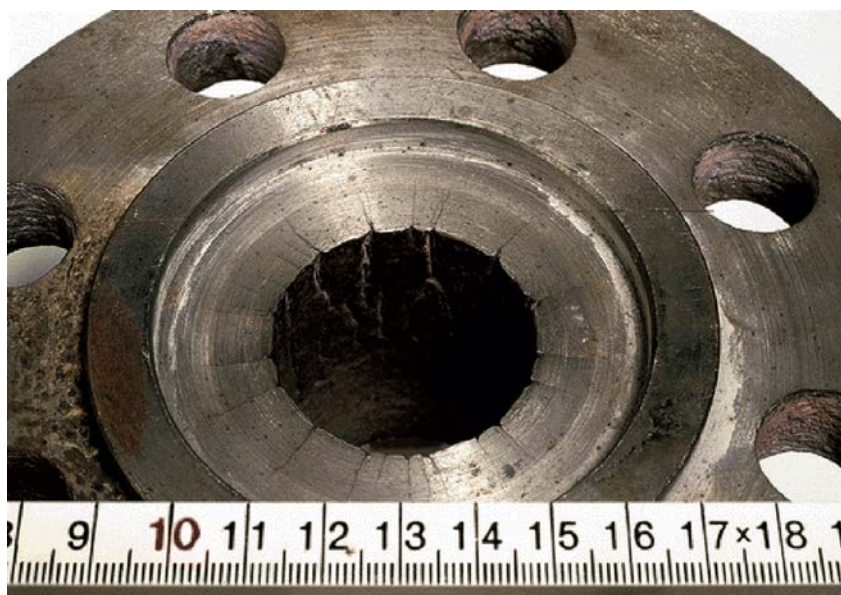
PART Flange in steam and cooling water delivery line.

PHENOMENON Thermomechanical corrosion fatigue.

APPEARANCE After removal of the corrosion products, the pipe section of the flange shows numerous perpendicular low-branched radial cracks, also running axially.

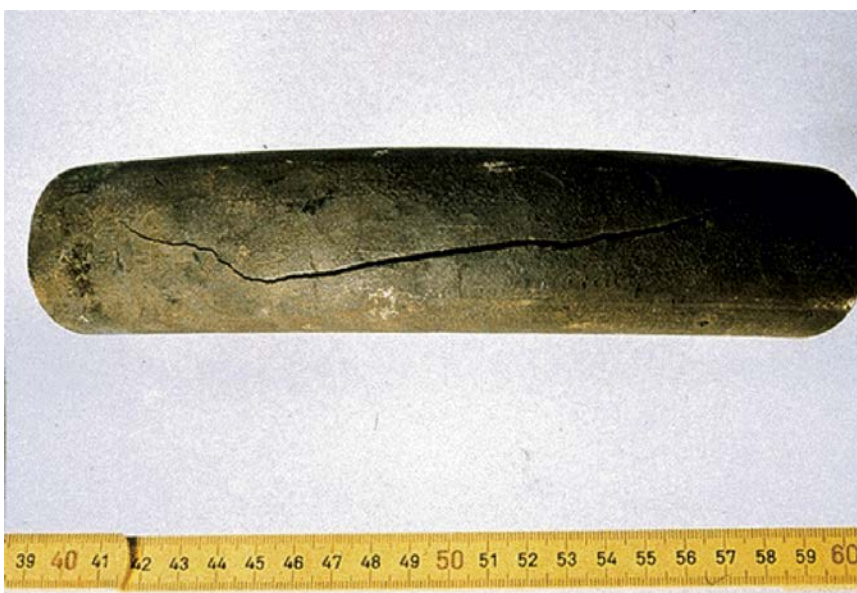
PART Process pipe.

PHENOMENON Ageing.

APPEARANCE Brittle fracture.

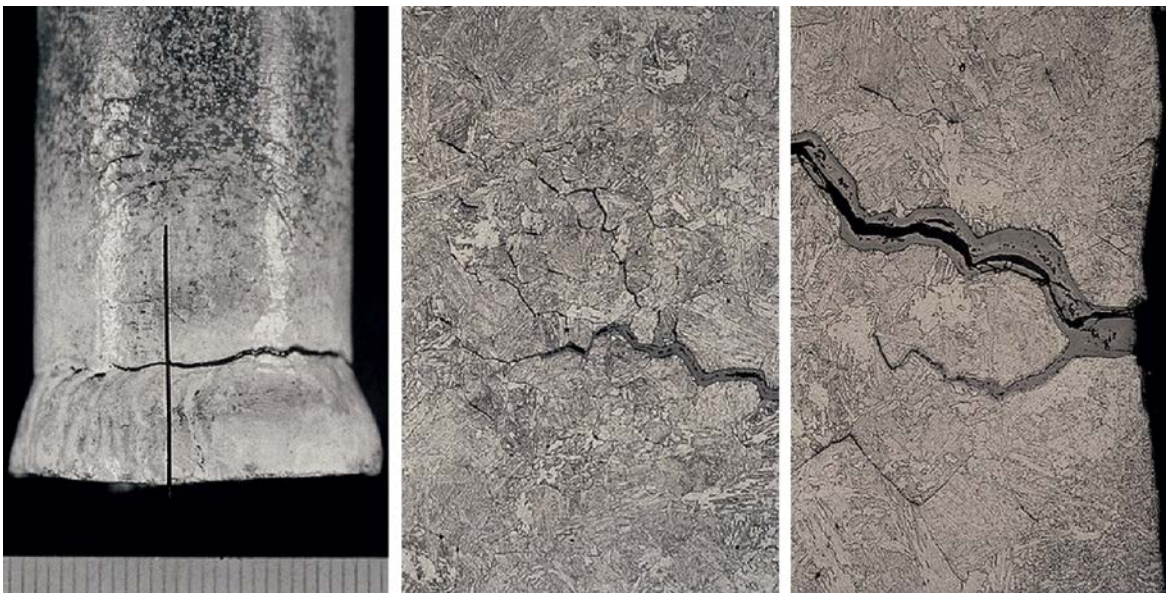
PART Inlet header pigtails (OD: 26.7 mm, wall thickness: 2.87 mm).

PHENOMENON Creep embrittlement.

APPEARANCE Left photo : pigtail with intergranular cracking in the HAZ revealed by magnetic particle inspection;
Right photos : micro of the crack mouth and the crack tip.

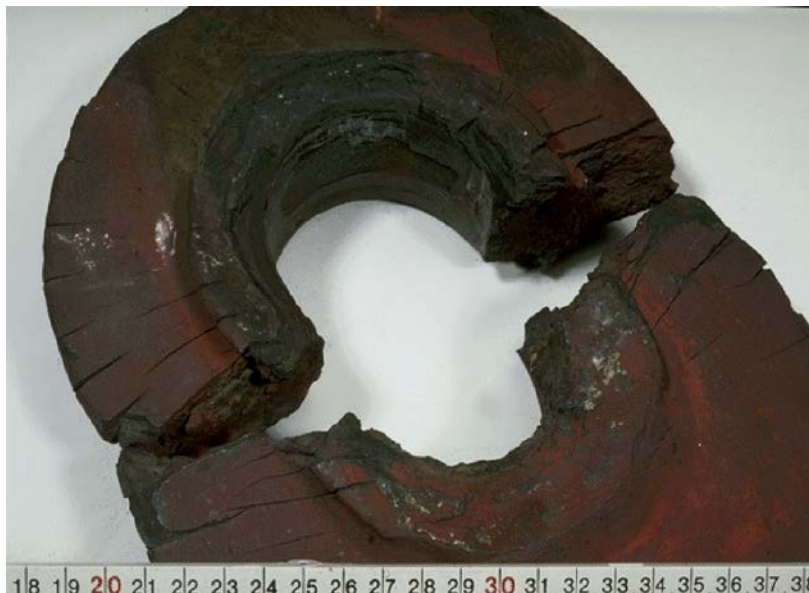
PART Lug of a bracket.

PHENOMENON Creep.

APPEARANCE Cracking with fracture.

CAUSE Owing to the absence of molybdenum, the creep strength is too low, which allowed fracture to occur.

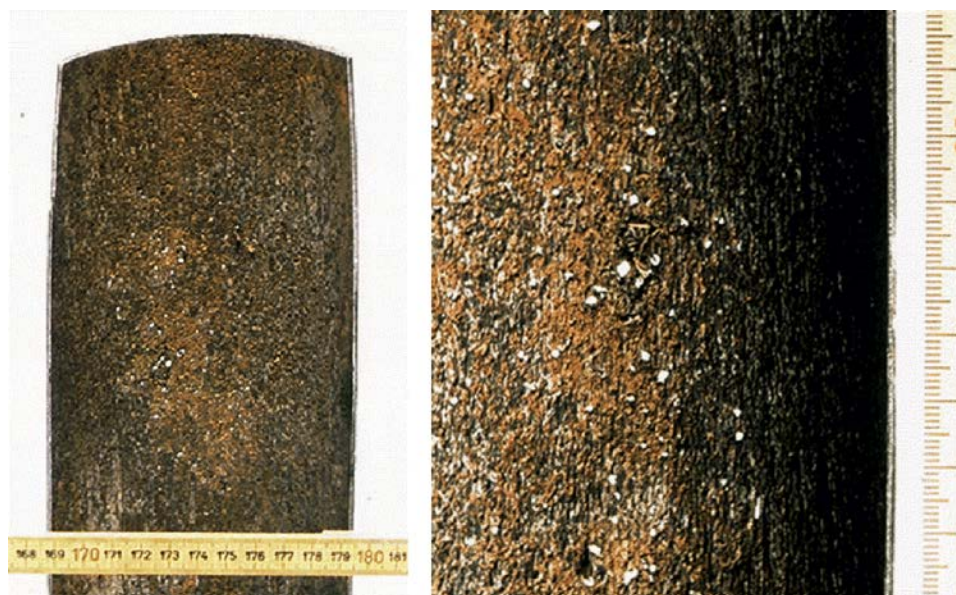
01.11.32.01

MATERIAL	Carbon steel (37).
SYSTEM	Brewery.
PART	Spent grain transport pipe.
PHENOMENON	Erosion.

APPEARANCE	Pipe worn over entire surface.
TIME IN SERVICE	4 years (after transporting 25,000 tons of spent grain).
ENVIRONMENT	Spent grain (dried bran); transportation air; temperature 75°C.
CAUSE	The spent grain particles transported at high velocity wore the line out.
REMEDY	Accept the attack. To extend the life span, replace the pipe by one with greater wall thickness.

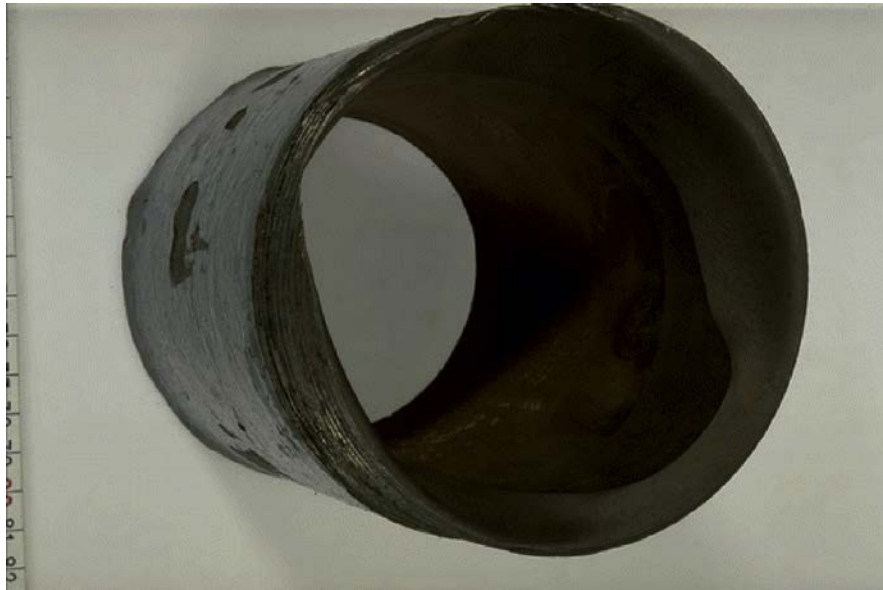
01.11.32.02

MATERIAL	Carbon steel.
SYSTEM	Gas transport system.
PART	Screwed nipple near choke (wall thickness 14 mm).
PHENOMENON	Erosion.

APPEARANCE	Material worn away smoothly.
TIME IN SERVICE	Several years.
ENVIRONMENT	Solids-containing natural gas.
CAUSE	High flow velocities downstream from choke connected to the nipple combined with the presence of solids originating from the formation caused this corrosion.
REMEDY	Reduce flow velocities.

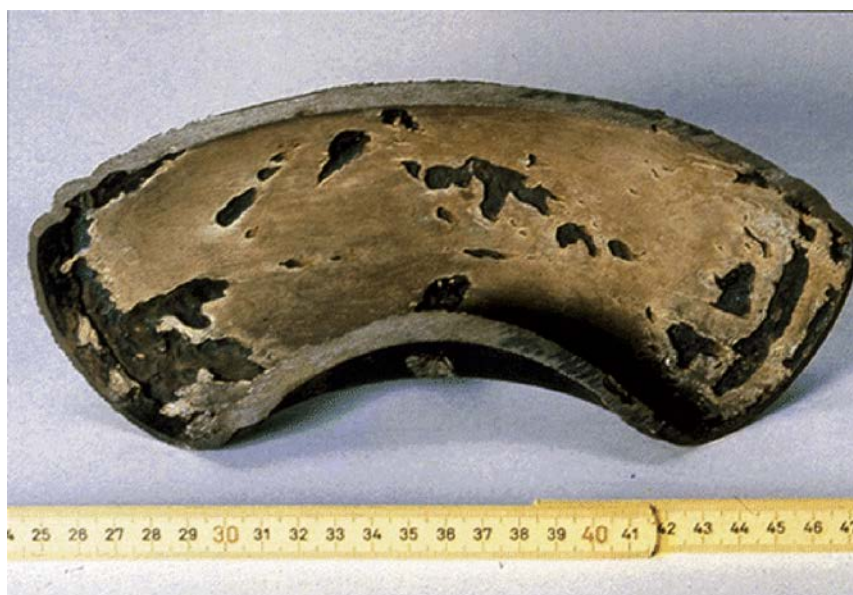
PART Pipe bend.

PHENOMENON Erosion corrosion.

APPEARANCE Local attack.

CAUSE Erosion corrosion due to excessive velocity (4–4.5 m/s).

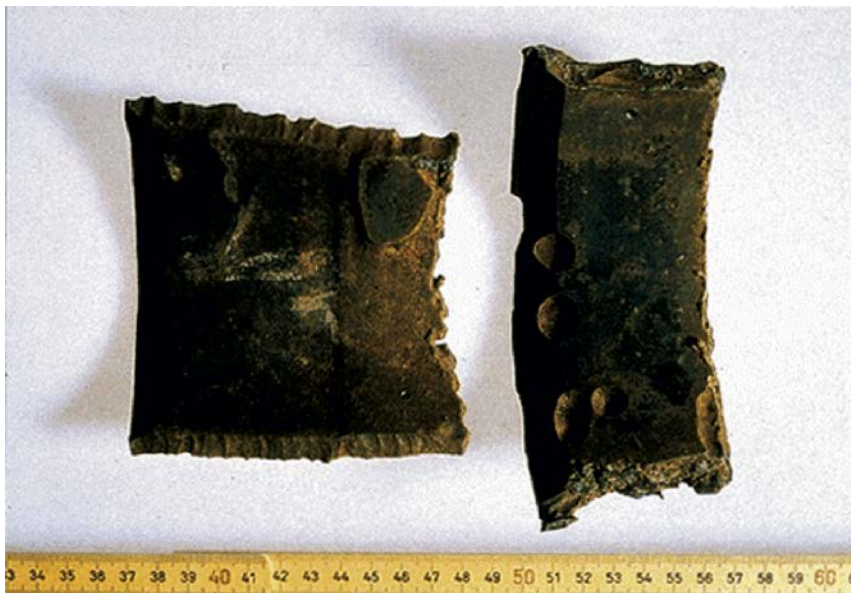
PART Furnace tube.

PHENOMENON Erosion corrosion.

APPEARANCE Both uniform and pining.

CAUSE Naphthenic acid can lead to extremely high rates of corrosion (see also Case History [01.11.34.05](#)).

- Neutralize acids and reduce velocity, or
- Select another steel grade, e.g., stainless steel (AISI 316), which is more resistant to naphthenic acid.

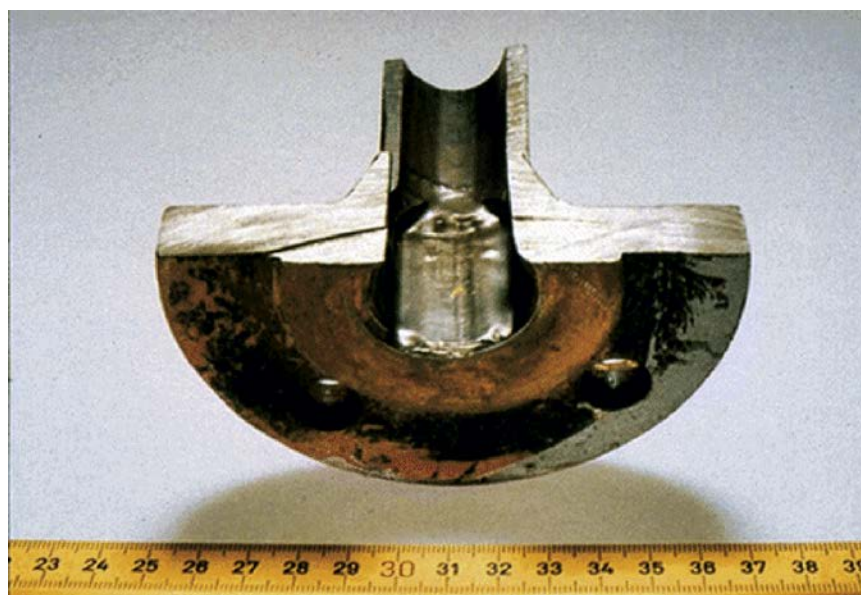
PART Flange in pipe.

PHENOMENON Erosion corrosion.

APPEARANCE Severe local attack.

CAUSE Locally severe turbulence resulting from an excentrically positioned seal, preventing the build-up of a passivating iron sulfate skin.

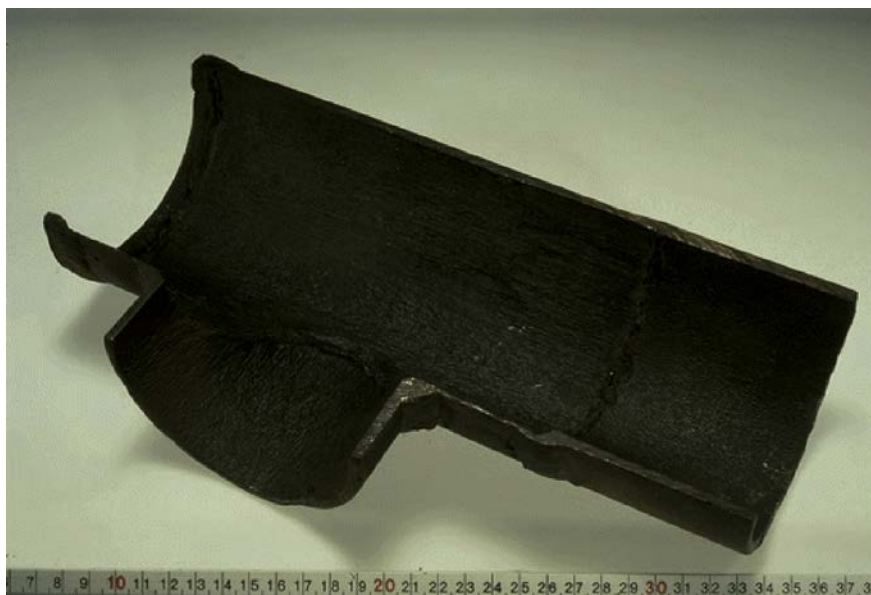
MATERIAL	Carbon steel.
SYSTEM	Crude oil distillation column.
PART	Tops rundown pipeline.

PHENOMENON	Erosion corrosion.
------------	--------------------

APPEARANCE	Surface exhibits grooved etching.
------------	-----------------------------------

CAUSE	Attack by HCl traces in combination with high velocity.
-------	---

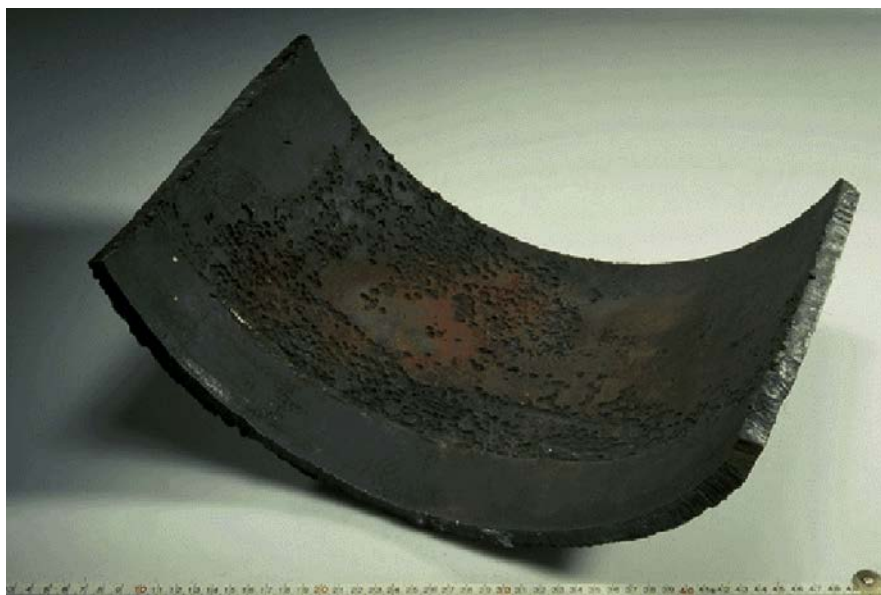
PART Vapor line.

PHENOMENON Erosion corrosion.

APPEARANCE Pitting corrosion picture on a section of the pipe.

CAUSE As in Case History 01.11.07.04, this was also a case of the mixed usage of ASTM and API piping, only the API material being subject to attack (see also Case History [01.11.34.02](#)).

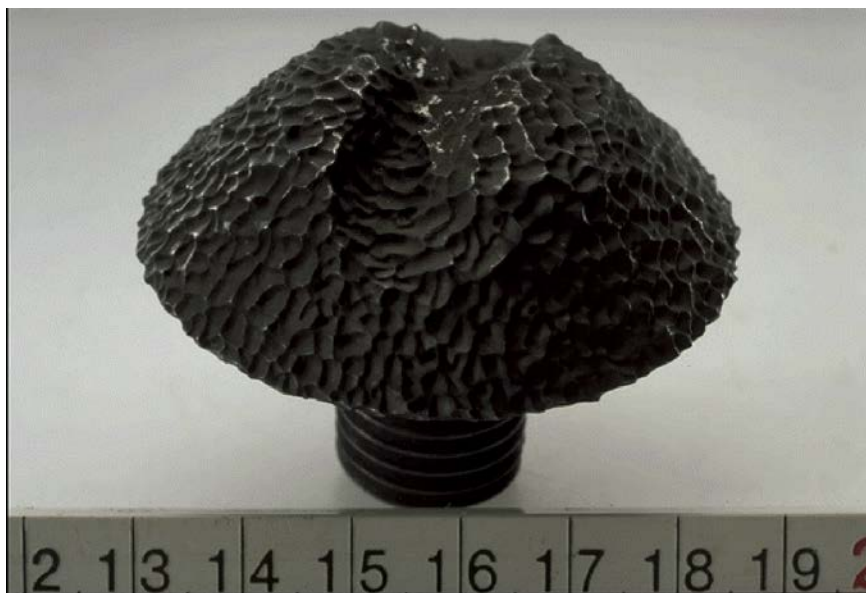
PART Pump bolt.

PHENOMENON Erosion corrosion.

APPEARANCE Material irregularly eroded all over the surface.

CAUSE Glycolic acid and carbon dioxide at a certain minimum velocity cause erosion corrosion of the carbon steel.

REMEDY Use bolts made from the more corrosion-resistant stainless steel AISI 316.

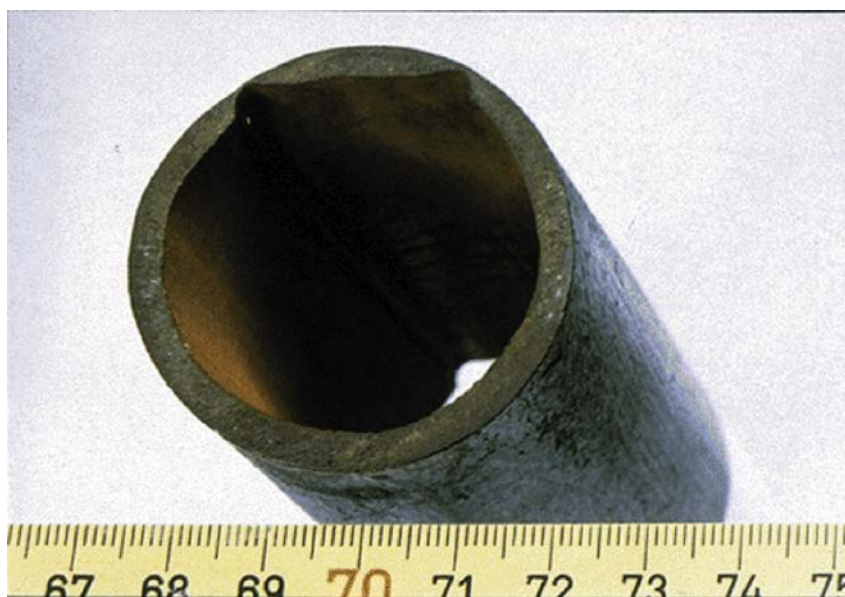
PART Main distribution pipe.

PHENOMENON Erosion corrosion.

APPEARANCE Locally, uniform attack to upper part of pipe.

CAUSE In view of the site of the attack, namely the upper part of the pipe, the corrosion is most likely attributable to turbulent flow because of the presence of a retained air bubble leading to erosion corrosion.

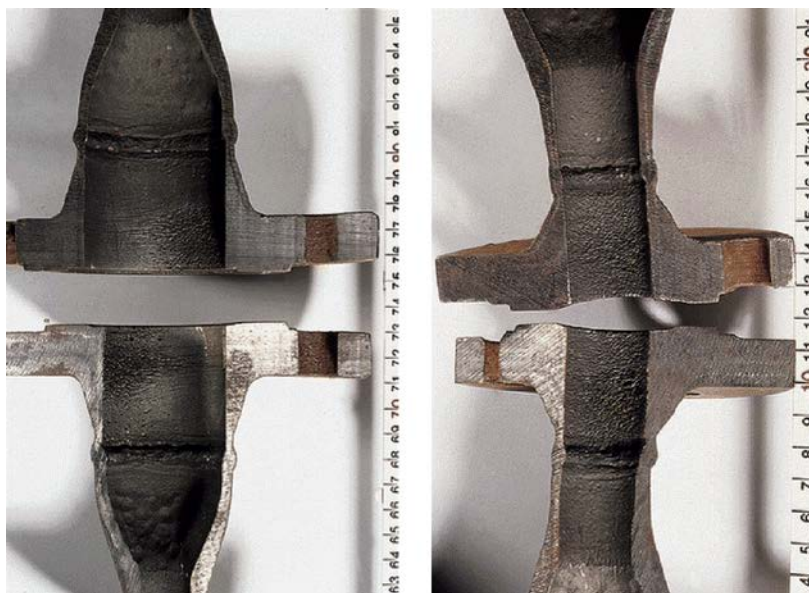
01.11.34.08

MATERIAL	Carbon steel.
SYSTEM	Oil refinery, crude oil distillation.
PART	Side stream of high-vacuum unit.
PHENOMENON	Erosion corrosion.

APPEARANCE	General attack upstream and especially downstream a weld.
TIME IN SERVICE	17 years.
ENVIRONMENT	Gasoil, temperature 300–330°C, varying conditions with regard to sulfur content and acidity (Total Acid Number).
CAUSE	High flow conditions causing turbulence near the weld, which in turn removed protective layers giving the corroding acid/sulfur species access to the bare metal (see also Case History 01.11.34.02).
REMEDY	Carbon steel has been replaced by low-alloyed steel.
