Corrosion Atlas

THIRD, EXPANDED AND REVISED EDITION

A Collection of Illustrated Case Histories

Evert D.D. During

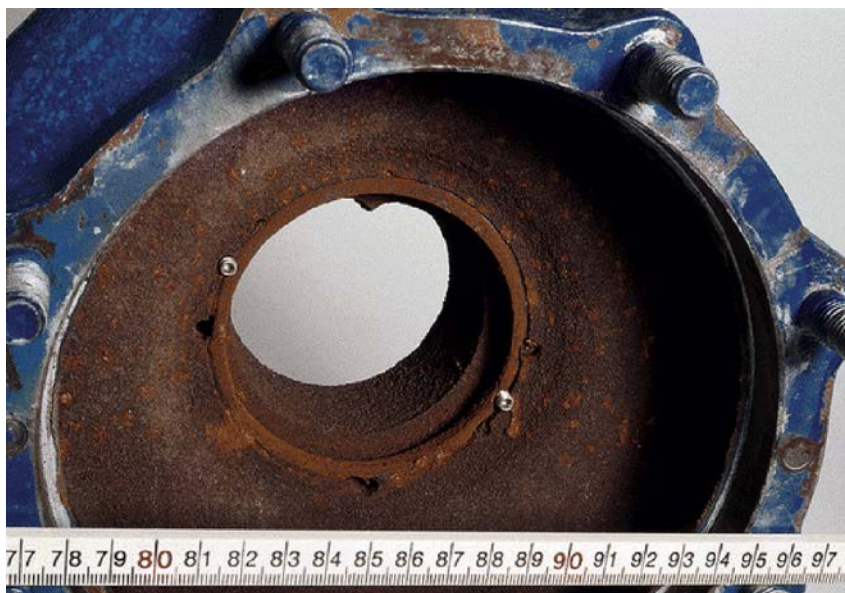
01.12.04.01

MATERIAL	Carbon steel.
SYSTEM	Air scrubber system.
PART	Prescrubber caustic pump.
PHENOMENON	Acid corrosion.

APPEARANCE	Overall shallow pitting.
TIME IN SERVICE	3 months.
ENVIRONMENT	10% NaOH with aniline and traces of mercaptobenzaldehyde (MCB). Temperature: 15–55°C, pressure: 1.0 MPa, streaming.
CAUSE	Breakthrough of HCl gas that was neutralized insufficiently by NaOH.
REMEDY	<ul style="list-style-type: none"> • Adjustments in process technique, and • Construction of the pump of Si cast iron (Si > 14.2% + Mo + Cr + Cu) or duplex stainless steel (SAF 2205).

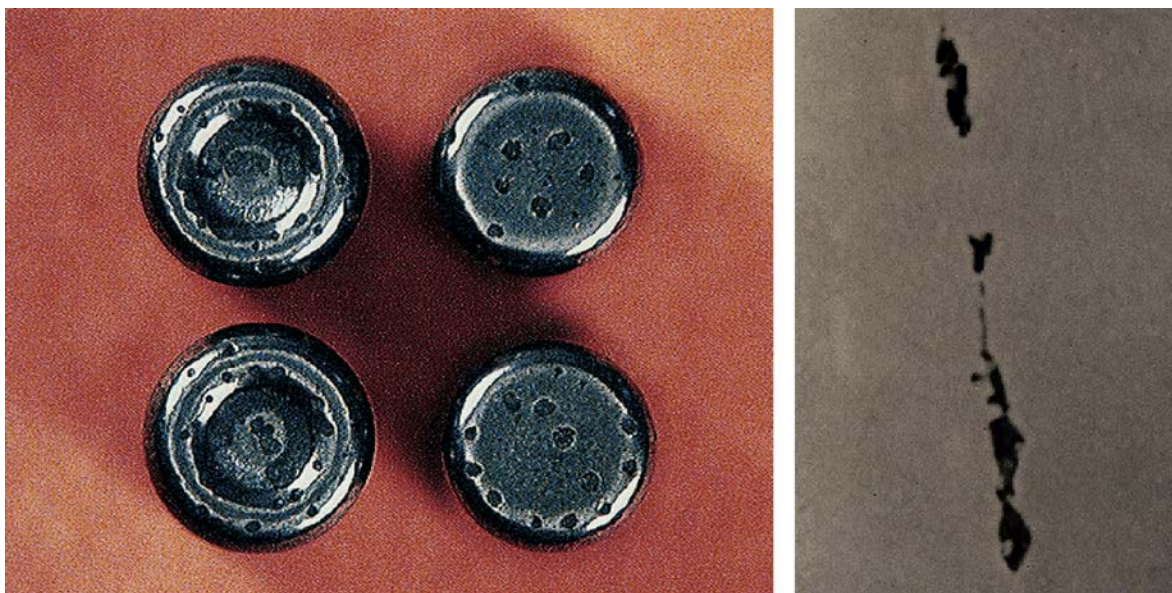
01.12.42.01

MATERIAL	Carbon steel 100 Cr 6 (W.-Nr. 1.3505).
SYSTEM	Rotary drum for production of ball bearings.
PART	Ball bearings for tapered roller bearings (dimensions: length 7.5 mm, OD 6 mm).
PHENOMENON	End grain attack.

APPEARANCE	Pitting at the extremities of the ball bearings, depth 0.15–0.20 mm, diameter 0.4–0.5 mm, circular shaped with cone shaped to the inside.
TIME IN SERVICE	Maximum 16 h during tumbling.
ENVIRONMENT	Well water with abrasive (Al_2O_3). At the end of the tumbling process, sodium silicate is added as corrosion inhibitor. pH: 12; temperature 50–60°C.
CAUSE	Sodium silicate is not only effective as a corrosion inhibitor but can also be an aggressive agent under defined circumstances (temperature, pH, concentration, see also Case History 02.04.27.01). Attack of the steel surface cut perpendicular to the rolling direction took place at the end of the non-metallic inclusions (stringers). MnS inclusions are shown by EDX analysis and X-ray (performed by HMC Technology, Leiden, Netherlands) (see also Case Histories 04.11.42.01 and 05.11.42.01).
REMEDY	<ul style="list-style-type: none"> • Reduce sodium silicate dosing to a pH of 10–10.5. • Alternative: select and test an organic-based corrosion inhibitor.

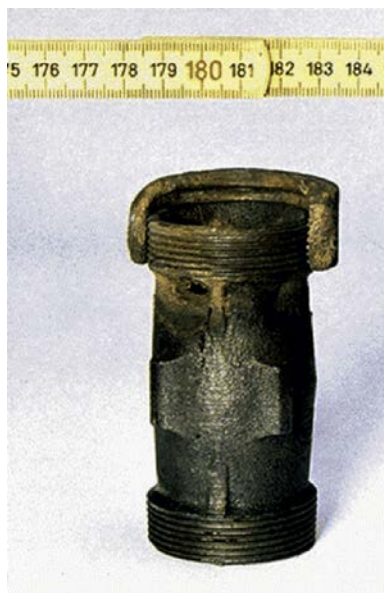
PART Underground coupling.

PHENOMENON Galvanic corrosion.

APPEARANCE Highly localized attack.

CAUSE Galvanic coupling with copper indoor piping.

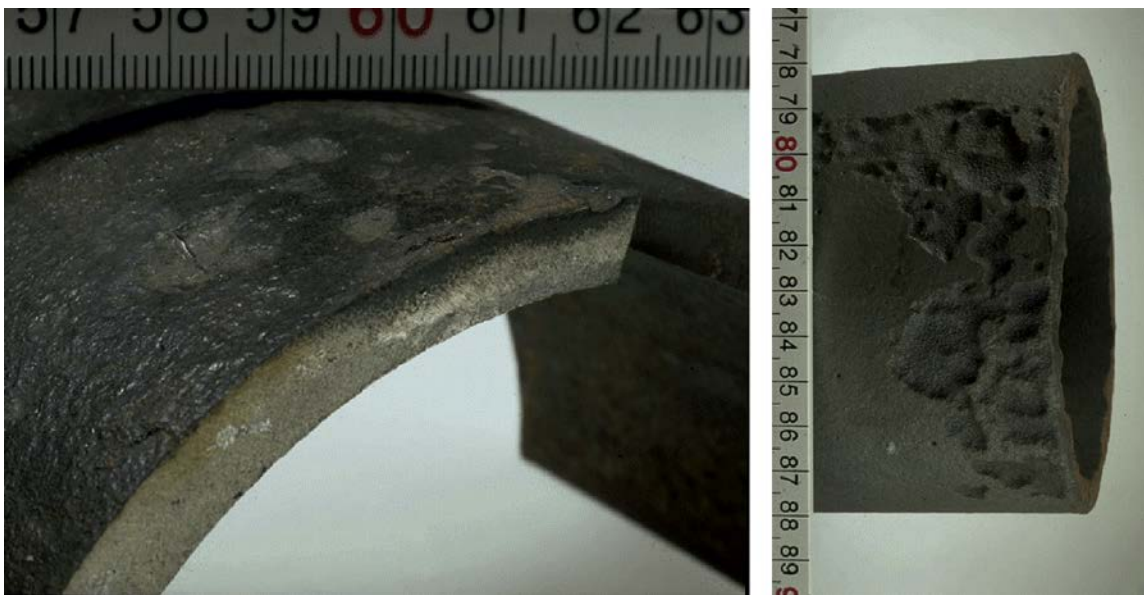
PART Underground pipe.

PHENOMENON Selective leaching (graphitic corrosion).

APPEARANCE Left-hand photograph: Graphitization visible on cut section.
Right-hand photograph: Depth of attack visible after blasting (different pipe section).

CAUSE Sulfate-reducing bacteria converted sulfate into sulfide, as a result of which the cast iron is attacked and graphitic corrosion takes place (see also Case History [01.06.16.01](#)).

REMEDY Replaced by polyethylene pipe.

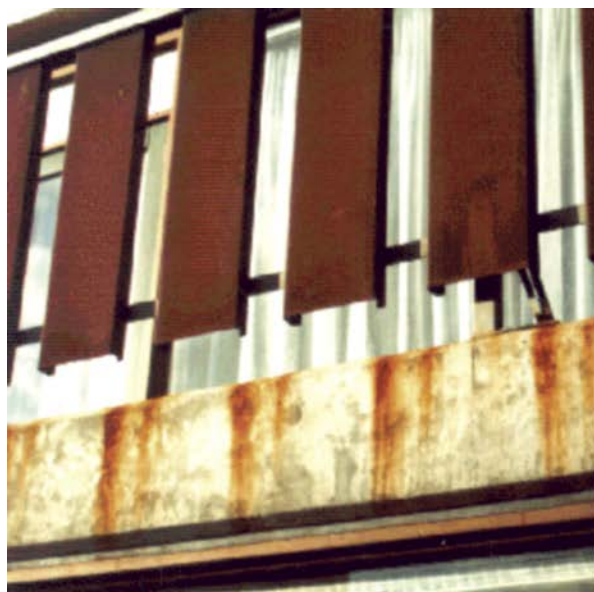
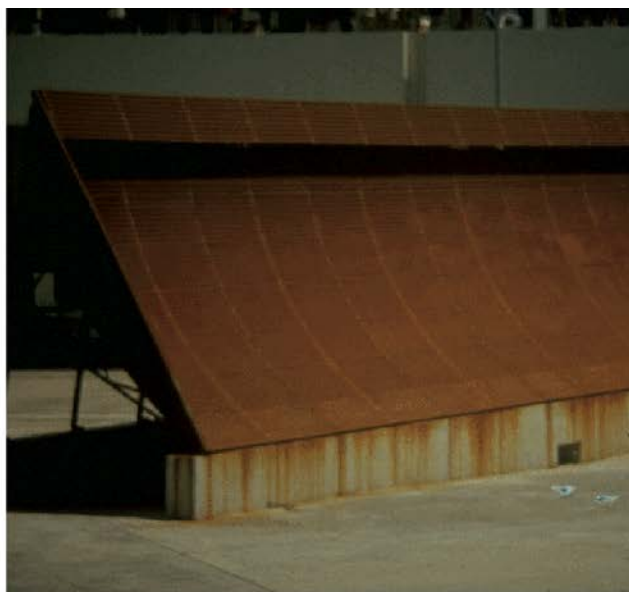
MATERIAL Cor-Ten steel (slow-rusting carbon steel with several tens of percents manganese, copper, silicon, and chromium).

PART Left: balcony railing of apartment; Right: jet screen at airport.

PHENOMENON Atmospheric corrosion.

APPEARANCE The Cor-Ten steel is uniformly corroded, and corrosion products have travelled to the concrete structure.

CAUSE Cor-Ten steel is covered with a compact, less moisture absorbing rust layer, due to the alloy metals, but does not possess long-term resistance to corrosion in marine and industrial atmospheres.

REMEDY Although Cor-Ten steel is often chosen deliberately because of aesthetic considerations, the staining of the concrete structure is not acceptable. Under these circumstances, the use of coated steel or hot-dip galvanized steel is preferable.

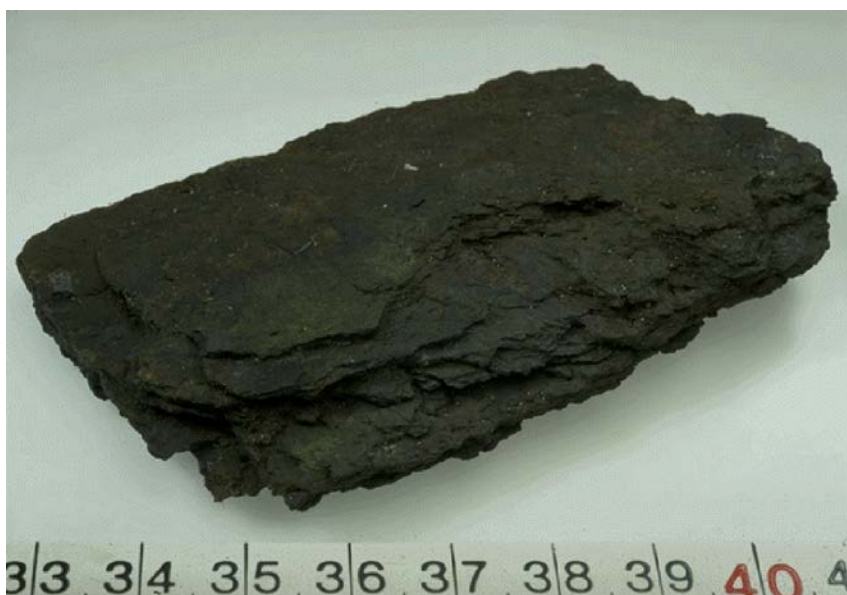
PART Part of girder.

PHENOMENON Atmospheric corrosion.

APPEARANCE Layered corrosion.

CAUSE The humid atmosphere attacks the insufficiently protected steel, forming stratified oxide layers. Stratification of corrosion products is common in intermittent wet-dry conditions. This form of corrosion is also called "packing corrosion" or "exfoliation" (see also Case History [07.11.19.01](#)).

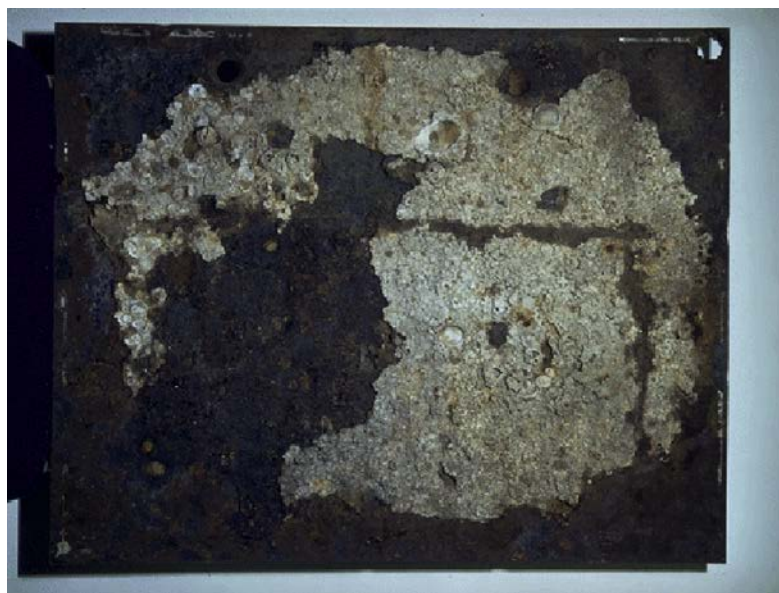
PART Ship's shell.

PHENOMENON Chloride attack and under-deposit corrosion.

APPEARANCE Pitting corrosion, also underneath mussels.

CAUSE The high chloride content of the seawater causes pitting of the steel; in addition, as a result of mussels growing on the ship's shell differential aeration cells will form, and the oxygen-lean areas – i.e., under the mussels – will become anodic and subject to attack.

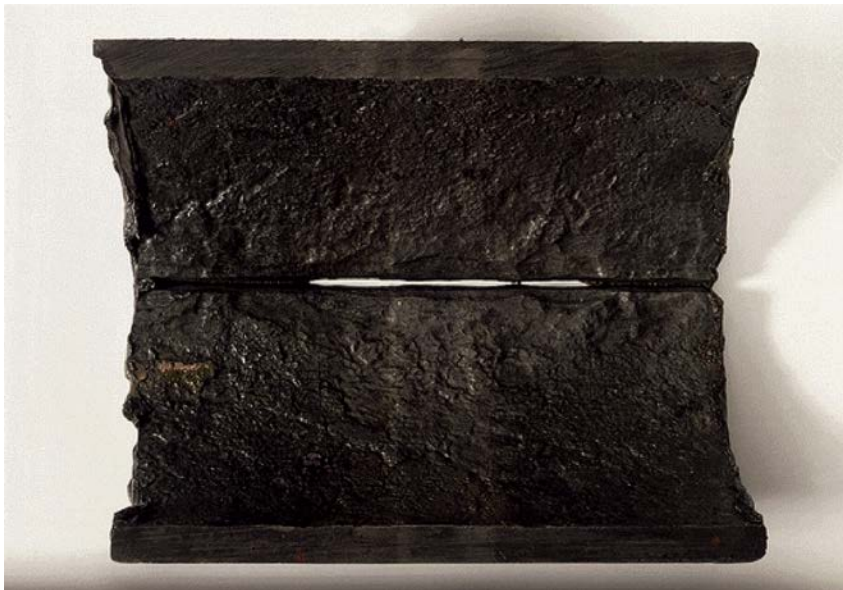
01.21.17.01

MATERIAL	Carbon steel.
SYSTEM	Ship.
PART	Bilge water pipe section through heated fuel tank (70°C).
PHENOMENON	Microbiologically induced corrosion (MIC).

APPEARANCE	Extensive pitting and wall thinning; tunneling in rolling direction with preferential attack of the weld.
TIME IN SERVICE	Approximately 3 years.
ENVIRONMENT	Ship's bilge: seawater (polluted harbor water).
CAUSE	Development of acetic acid-producing bacteria (<i>Clostridia aceticum</i>), promoted by high temperature of environment (see also the following Case History).
REMEDY	Cleaning, removal of deposits and sludge (will be difficult in practice). After ballasting, replace harbor water by fresh seawater.

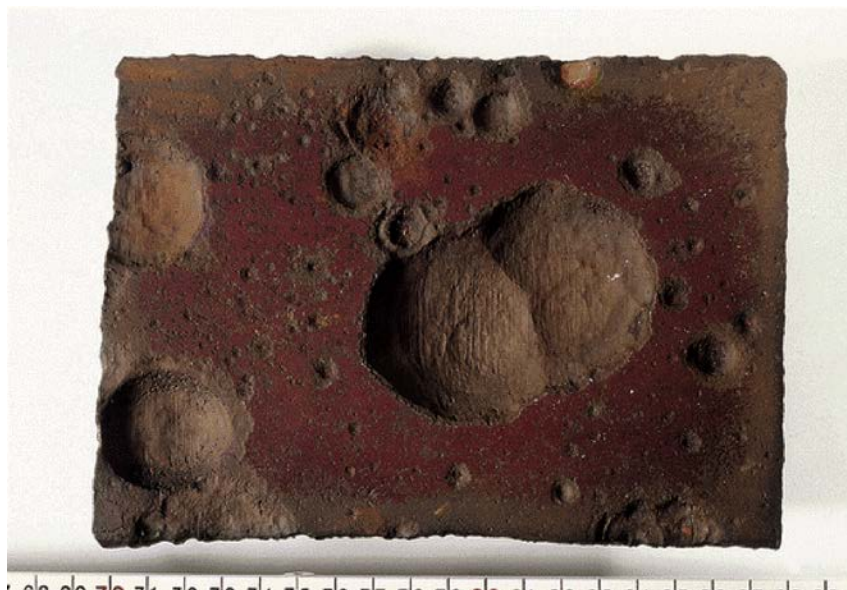
01.21.17.02

MATERIAL	Carbon steel.
SYSTEM	Ship.
PART	Bottom plate of bilge compartment.
PHENOMENON	Microbiologically induced corrosion (MIC).

APPEARANCE	Extensive pitting and wall thinning, tunneling in rolling direction of plate.
TIME IN SERVICE	Approximately 3 years.
ENVIRONMENT	Oil and waste water from engine room, drinking water maker etc., that collected in bilge compartment and remained there for extended periods.
CAUSE	Development of acetic acid-producing bacteria (<i>Clostridia aceticum</i>), leading to corrosion of bottom plate by acetic acid.
REMEDY	Regular cleaning of compartment.

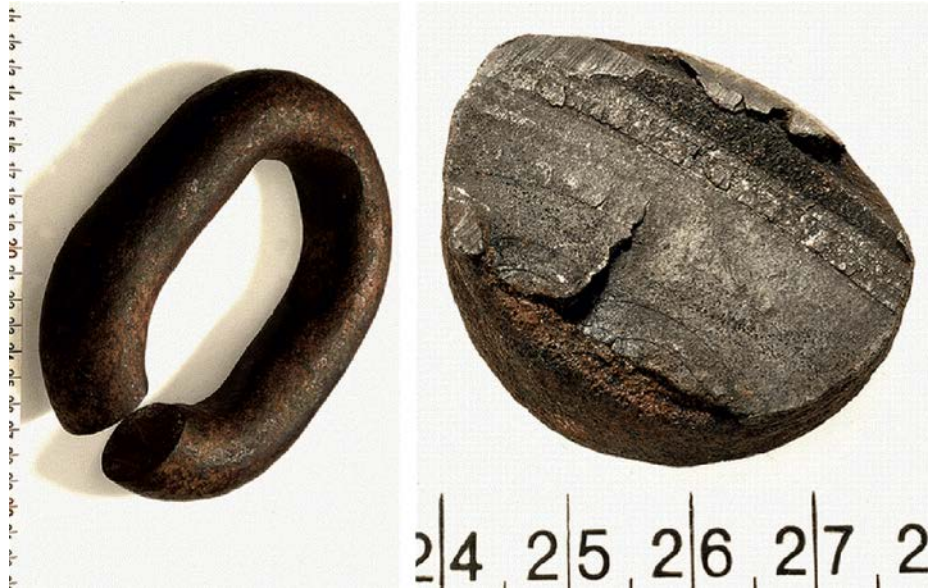
PART Chain link.

PHENOMENON Corrosion fatigue.

APPEARANCE Partly ductile fracture with distinct fatigue rings and corrosion pitting, partly brittle fracture with pits (see fracture surface on the right-hand photograph).

CAUSE Fatigue occurred during operation; the link concerned had been jammed, as a result of which torsional forces had occurred and the link had suffered external damage (see also Case History [01.01.28.01](#)).

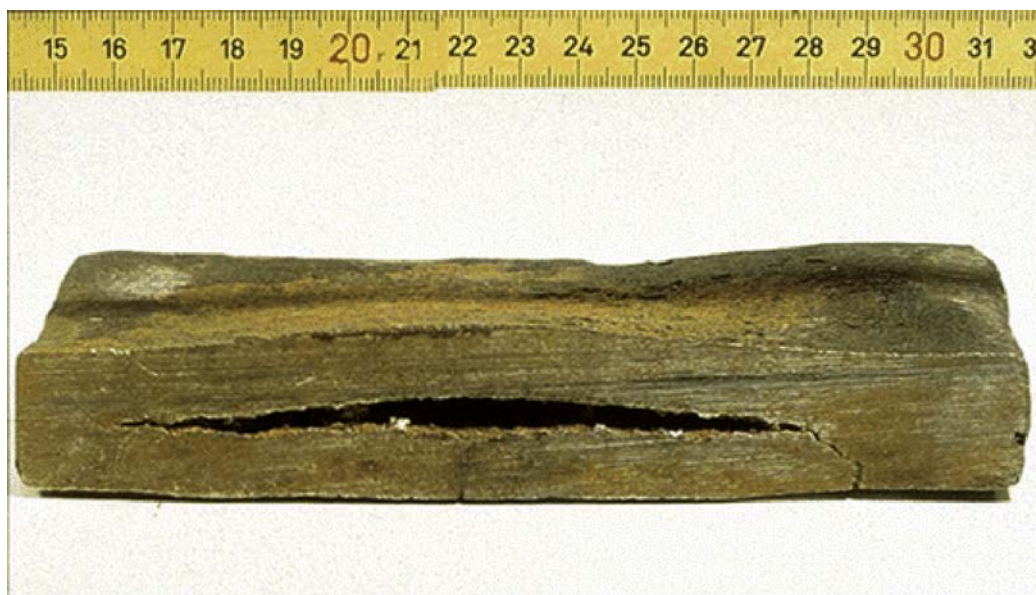
PART Wall.

PHENOMENON Hydrogen damage (hydrogen blistering, cold hydrogen attack).

APPEARANCE Formation of cavities in the steel.

CAUSE Diffusion into the steel of atomic hydrogen formed by slight corrosion. The diffusion stops at contaminations in the steel. Here, atomic hydrogen (H) is converted into molecular hydrogen (H₂). Pressure build-up then causes the steel to fracture (see also Case History [01.11.20.04](#)).

- Change-over to another (non-corrosive) scrubbing liquid, or
- Use of better quality purer steel, or
- Acceptance of the corrosion, monitoring its progress.

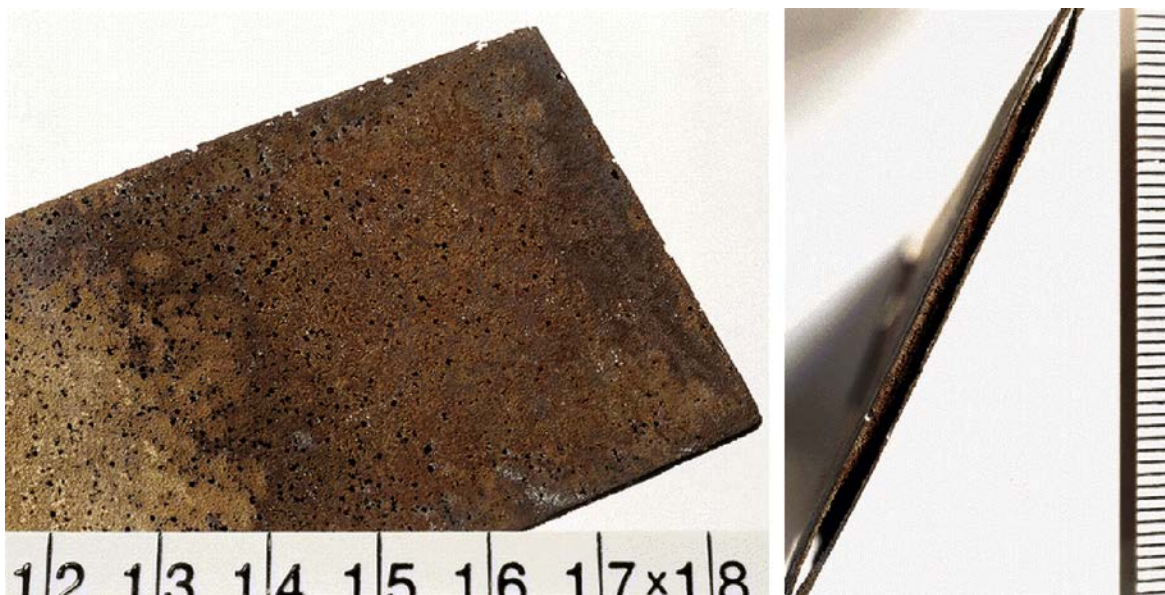
01.24.04.01

MATERIAL	Low-alloyed steel.
SYSTEM	Test rig.
PART	Carbon steel test plate (thickness 2.5 mm).
PHENOMENON	Acid corrosion.

APPEARANCE	Severe corrosion on surface and on cutting edges.
TIME IN SERVICE	About 20 days.
ENVIRONMENT	Sulfuric acid pickling bath; inhibited; concentration: 12% w/w, sulfuric acid in water; temperature: 70°C.
CAUSE	Carbon steel is not resistant in sulfuric acid at this concentration and temperature. As a result of the deformation and activation by cutting of the edges, they corroded more than the sheet surface (see also Case History 04.24.04.01).
REMEDY	Use a more resistant material. Passivation of edges after cutting.

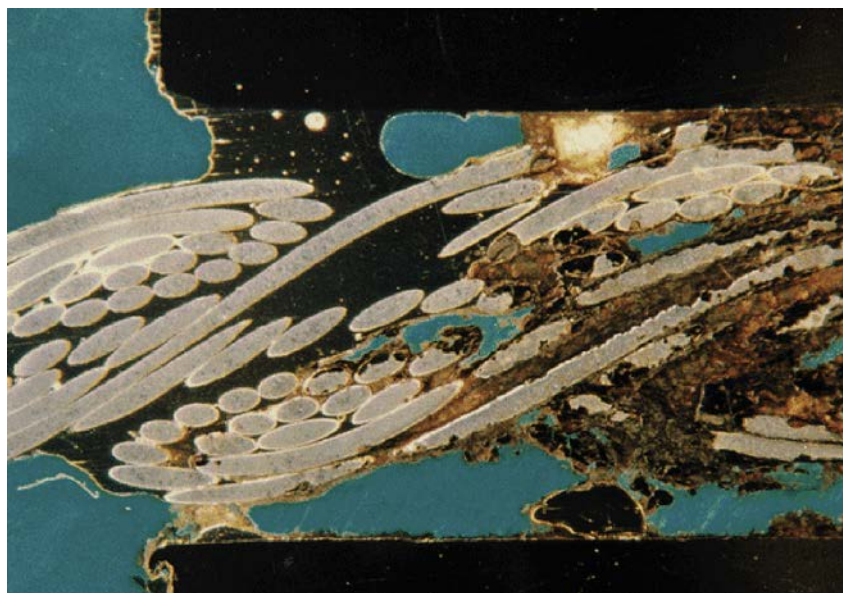
01.25.14.01

MATERIAL	Carbon steel.
SYSTEM	Cut wire of flare.
PART	End of wire with nipple.
PHENOMENON	Galvanic corrosion.

APPEARANCE	Corrosive attack and fracture of guy wire in nipple. The picture shows a longitudinal section of the nipple.
TIME IN SERVICE	Unknown.
ENVIRONMENT	Open air. Because of badly performed copper brazing of the carbon steel wire inside the stainless steel nipple, the part of the wire inside the nipple was exposed to stagnant moisture and water.
CAUSE	The different alloys used (carbon steel, stainless steel, and copper alloy) caused an electrochemical cell inside the nipple. As the carbon steel protected the more noble alloys, it went into solution.
REMEDY	Prevent the existing electrochemical cell inside the nipple by appropriate soldering so that water cannot enter the nipple.

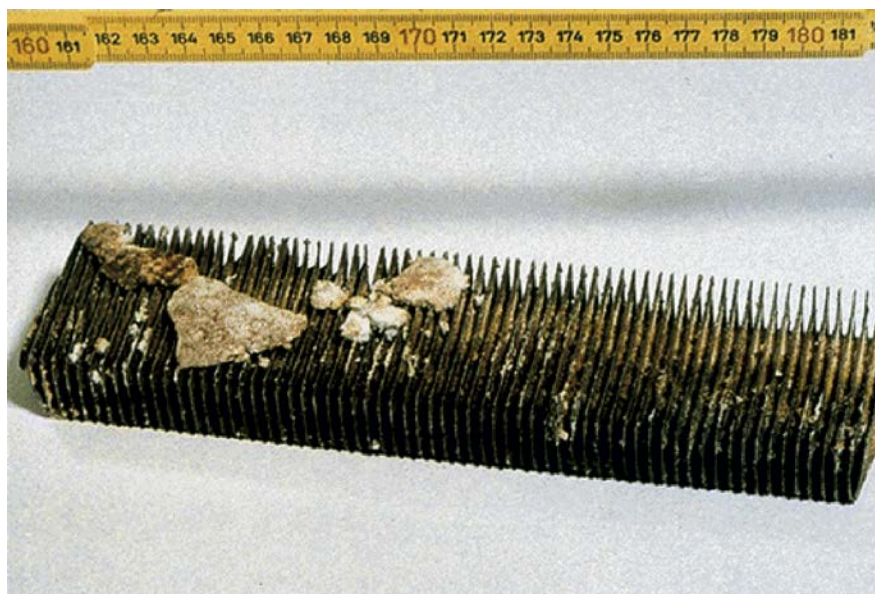
PART Flue gas heat exchanger.

PHENOMENON Acid corrosion (cold end corrosion).

APPEARANCE Uniform attack.

CAUSE Condensation on the heat exchanger as the plant started up regularly, coupled with the presence of 3 mg of HCl/m³ in the flue gases owing to contamination of the combustion air with trichloroethylene. Blockage of the heat exchanger with corrosion products, at the flue gas side, reduced the boiler capacity by 40% (see Case History 01.04.04.01).

REMEDY Because construction of the heat exchanger of corrosion-resistant material (high-alloyed stainless steel, Teflon, Monel or titanium) or purification of the combustion air would have been uneconomic, heat recovery was discontinued.

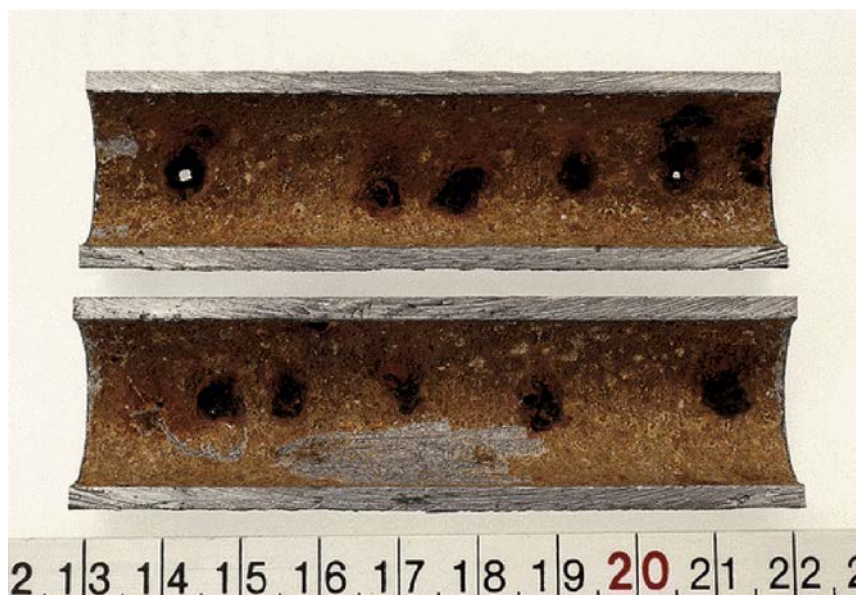
PART Line.

PHENOMENON Oxygen and galvanic corrosion.

APPEARANCE Pitting to leakage.

CAUSE Pitting due to the presence of oxygen in the condensate reinforced by reversal of potential of the zinc/iron cell above 60°C and chloride ions originating from the contamination with boiler water. The latter had also caused deposition of hardness salts from the boiler water.

- Improve steam/water separation.
- Construct lines of stainless steel (AISI 316).
- Use softened water for boiler make-up.
- Dose an oxygen scavenger.

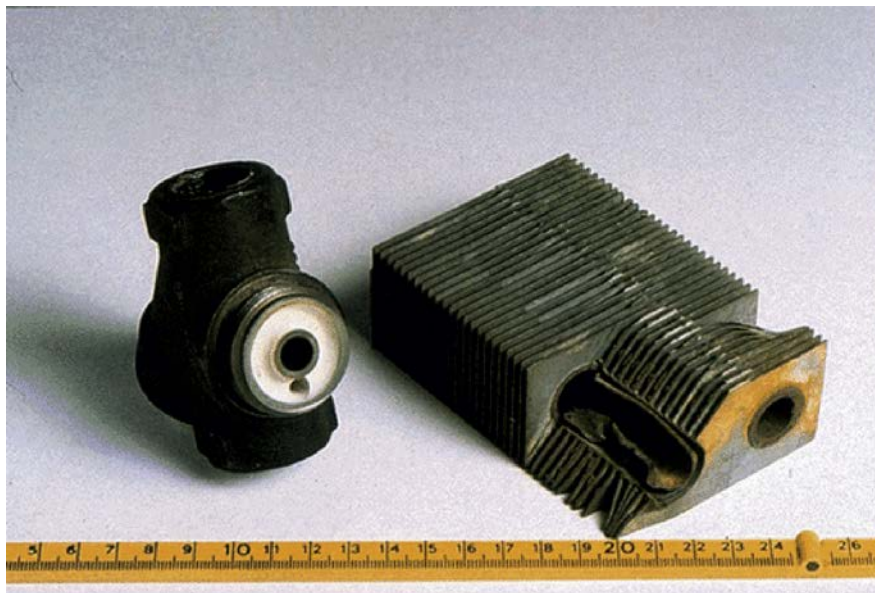
02.02.02.01

MATERIAL	Hot-dip galvanized steel.
SYSTEM	Steam condensate system.
PART	Element from air heater and steam trap.
PHENOMENON	Carbonic acid corrosion.

APPEARANCE	Uniform corrosion.
TIME IN SERVICE	7 months.
ENVIRONMENT	Corrosive condensate, 90–100 °C.
CAUSE	Corrosive condensate attacks zinc and steel. Zinc from the galvanized air heater was deposited in the steam trap as zinc oxide.
REMEDY	<ul style="list-style-type: none"> • In this case, it was possible to switch to water with a much lower bicarbonate content for make-up purposes. This reduces the aggressivity of the condensate. • Alternatives: Alkalinity reduction of the make-up water and/or dosing of film-forming amine or construct the air heaters of stainless steel.

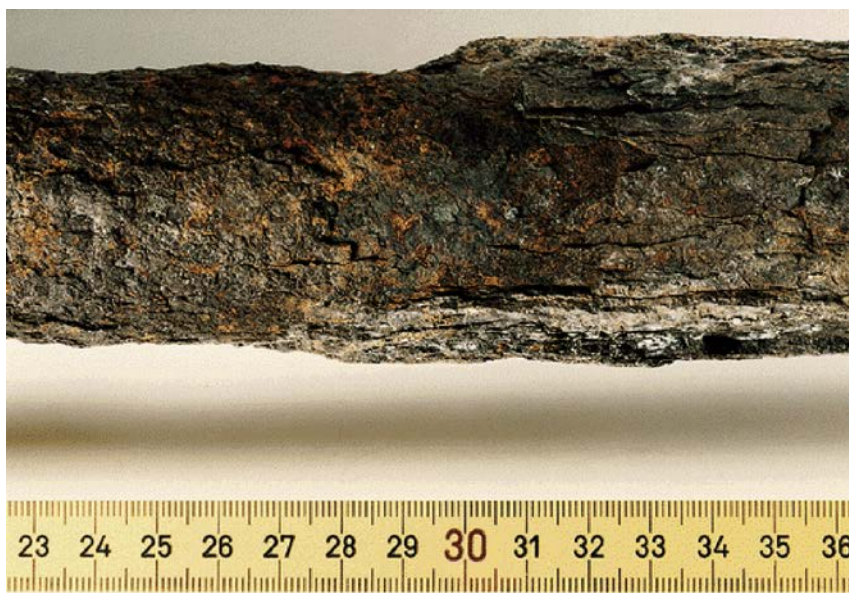
02.04.13.01

MATERIAL	Hot-dip galvanized steel.
SYSTEM	Central heating system, 90–70°C.
PART	Pipe transit through brickwork wall immediately above floor.
PHENOMENON	Crevice corrosion.

APPEARANCE	Pipe covered with layered corrosion products.
TIME IN SERVICE	40 years.
ENVIRONMENT	Humid atmosphere.
CAUSE	Oxygen-containing flushing water remaining in the gap between the pipe and wall first attacks the zinc coating and then the steel, resulting in the layered build-up of corrosion products.
REMEDY	The pipe should be provided with a moisture barrier, e.g., a plastic pipe (a 'pipe-in-pipe' system), with thermal insulation applied between the steel pipe and the plastic pipe.

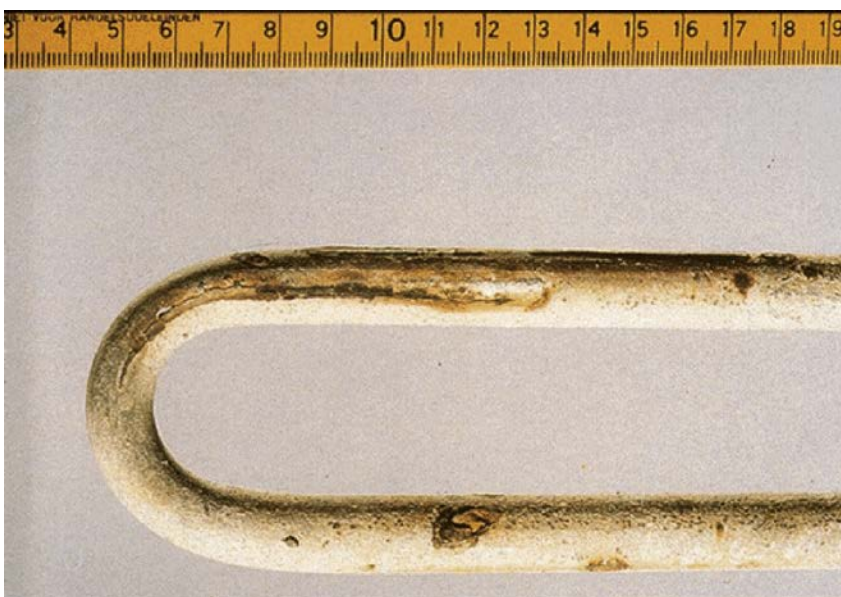
02.04.14.01

MATERIAL	Hot-dip galvanized steel.
SYSTEM	Hot water system, 160 °C.
PART	Heating tube from make-up water vessel.
PHENOMENON	Galvanic corrosion (reversal of potential).

APPEARANCE	Pitting attack.
TIME IN SERVICE	1 year.
ENVIRONMENT	Softened water, 60 °C, to which hydrazine was added before make-up to the system. Hot water at 160 °C passing through the tubes.
CAUSE	Reversal of potential in the zinc/iron couple as a result of the high temperature of the water in combination with the water composition (high contents of bicarbonate and nitrate). The galvanized steel will be attacked as the pores have becomes less noble (see also Case Histories 02.05.14.01/02).
REMEDY	Construct the tubes from stainless steel AISI 316 L, or inject water from the hot water system into the make-up tank directly.

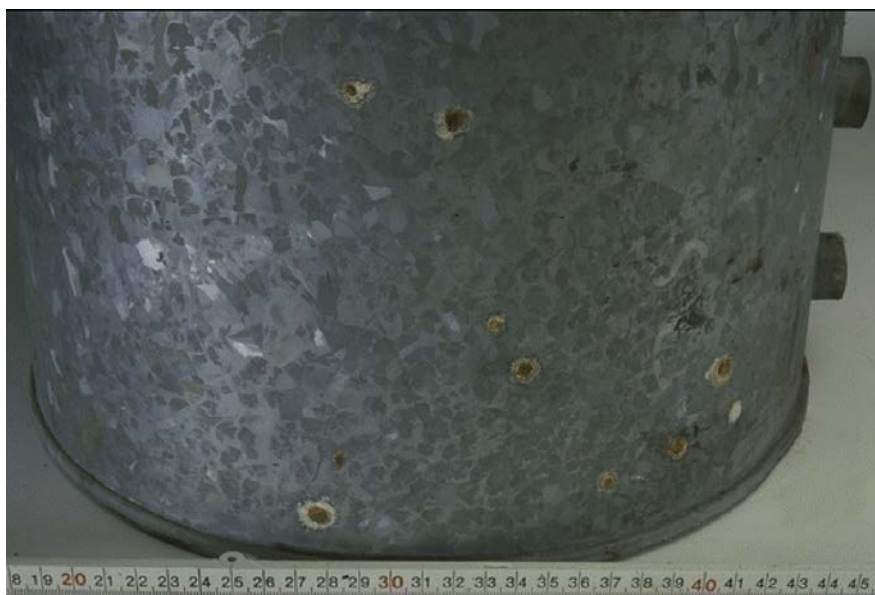
PART Expansion vessel.

PHENOMENON Atmospheric corrosion.

APPEARANCE Local rust patches.

CAUSE Insufficient cleaning (degrease and/or cleanse by pickling) of the steel prior to galvanizing, as a result of which there was locally no zinc present on the steel due to poor adhesion. As a result, local corrosion took place caused by condensation of water on the surface.

REMEDY Repair: Vessel to be blasted, degreased, pickled and then regalvanized.
Prevention: Clean the steel thoroughly before galvanizing.

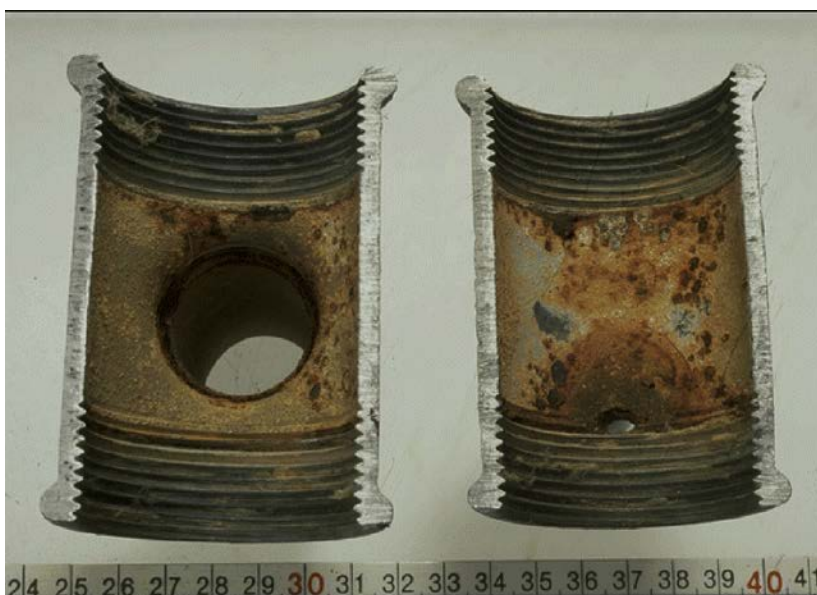
02.04.27.01

MATERIAL	Hot-dip galvanized steel.
SYSTEM	Central heating system.
PART	Circulation pipe, internally and externally galvanized.
PHENOMENON	Silicate corrosion.

APPEARANCE	Brown corrosion nodules on the galvanized surface, with pitting underneath leading to leak in threaded end.
TIME IN SERVICE	2–3 years.
ENVIRONMENT	Mains water with soluble silicates added to prevent corrosion. Temperature: Maximum 60°C.
CAUSE	An acid environment is formed underneath (amorphous, gel-like) silicate-containing deposition as a result of the exchange of cations such as calcium and iron, releasing an equivalent quantity of hydrogen ions. The metal surface is attacked due to the increase in acidity. This process occurs both on a bare steel surface and on a galvanized steel surface, and both at ambient temperature and elevated temperature. The corrosion is strongly accelerated by the addition of extra silicate (Ref. Helsen, J.A., Huybrechts, P., Braber, M.J.: “Corrosion initiation of steel in potable water by silicates”, International Congress on Metallic Corrosion, Vol. 2, Toronto, Canada, 1984).

REMEDY	Stop the dosing of silicate; circulation system chemically cleaned and if necessary replaced, in which case bare steel would be preferable.

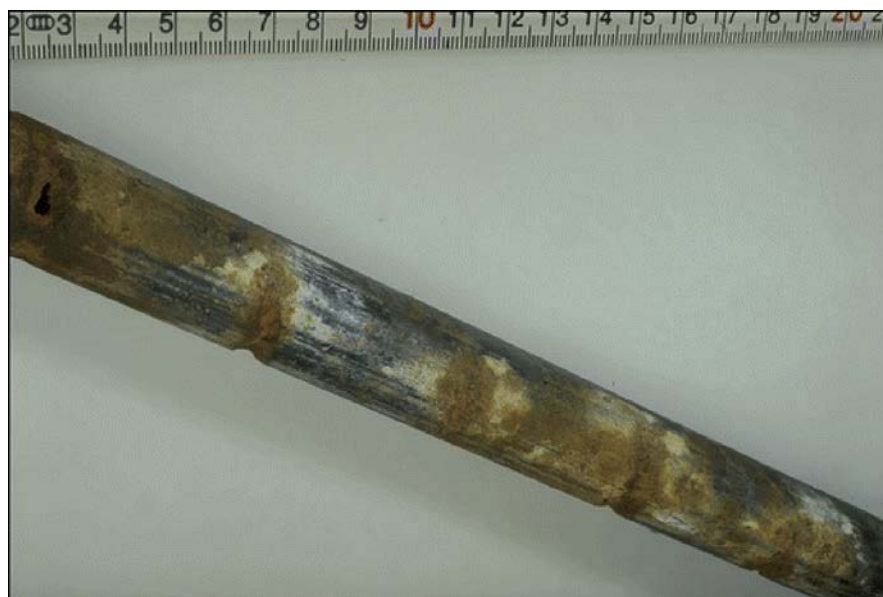
PART Pipe.

PHENOMENON Aggressive water.

APPEARANCE Grooved attack at regular interspacing (about 5.5 cm).

CAUSE Poor overlap of the wrapping tape. The aggressive groundwater was thereby able to attack the pipe surface.

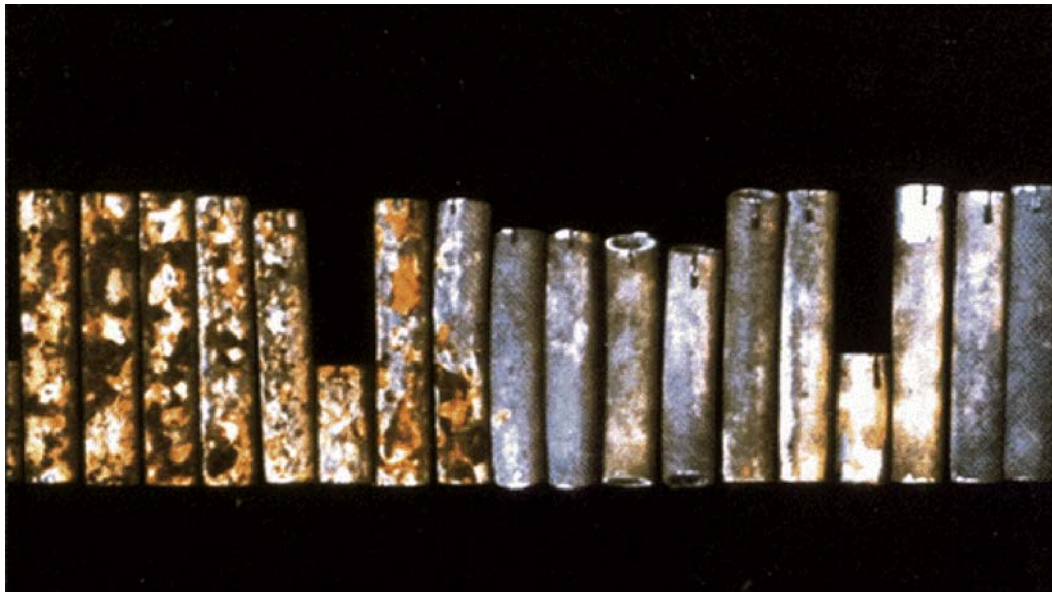
02.05.14.01

MATERIAL	Hot-dip galvanized steel.
SYSTEM	Hot tap water system.
PART	Heating tube (sawn into pieces) of the hot water storage boiler.
PHENOMENON	Galvanic corrosion (reversal of potential).

APPEARANCE	Local pitting attack to the hottest part of the tube.
TIME IN SERVICE	1 year.
ENVIRONMENT	Mains water around the tubes; hot water at 130 °C through the tubes.

CAUSE Reversal of potential in the zinc/iron couple, in this case above a wall temperature of 70 °C; the cold part exhibits no attack. Above that temperature, blisters first formed and then burst, after which the bare steel surface is attacked by the ennoblement of the zinc potential (see also Case History [02.04.14.01](#)).

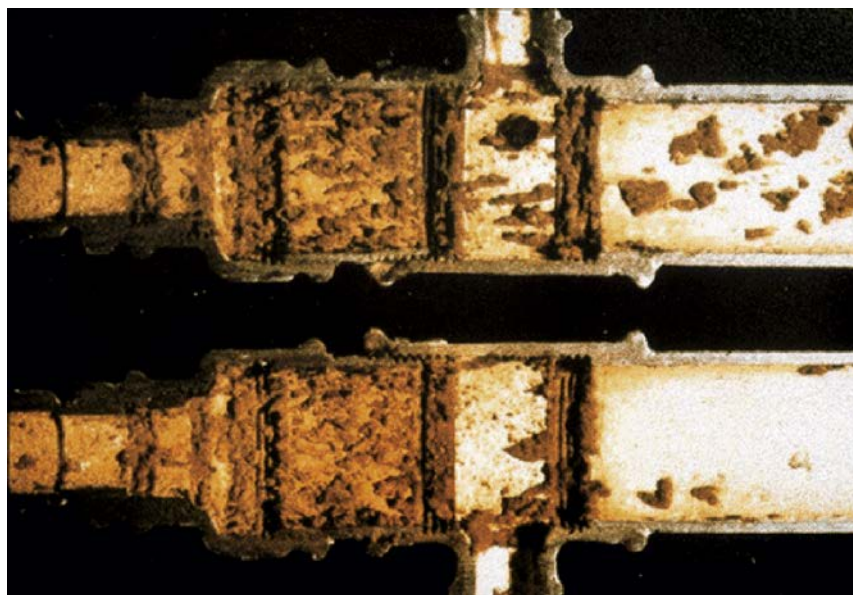
PART Pipe.

PHENOMENON Galvanic corrosion (reversal of potential).

APPEARANCE Pitting attack.

CAUSE Reversal of potential in the zinc/iron couple due to the high temperature of the tap water in combination with the high content of bicarbonate; this corrosion can be prevented by dosing phosphates, but an underdosage was applied (see also Case history [02.04.14.01](#)).

REMEDY Construction of the hot tap water system from corrosion-resistant material, e.g., copper, stainless steel or glass fiber-reinforced vinyl ester. In hot tap water systems, the dosing of chemicals is generally prohibited.
N.B.: For hygienic reasons, reducing the water temperature cannot be recommended (in view of the development of legionella bacteria which causes legionnaires' disease).

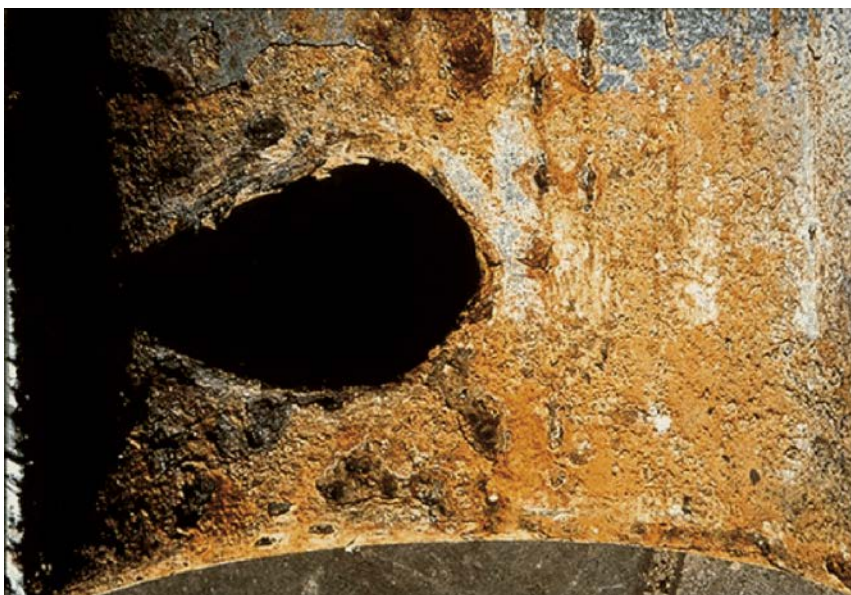
02.05.14.03

MATERIAL	Hot-dip galvanized steel.
SYSTEM	Hot tap water system.
PART	Wall of hot water storage tank.
PHENOMENON	Galvanic corrosion.

APPEARANCE	Severe local attack.
TIME IN SERVICE	3 months.
ENVIRONMENT	Hot mains water (45–75 °C).
CAUSE	Galvanic corrosion caused by the potential difference between the hot-dip galvanized steel wall and the copper rivets.
REMEDY	Construction of the hot water storage boiler entirely from copper or AISI 316 L stainless steel.

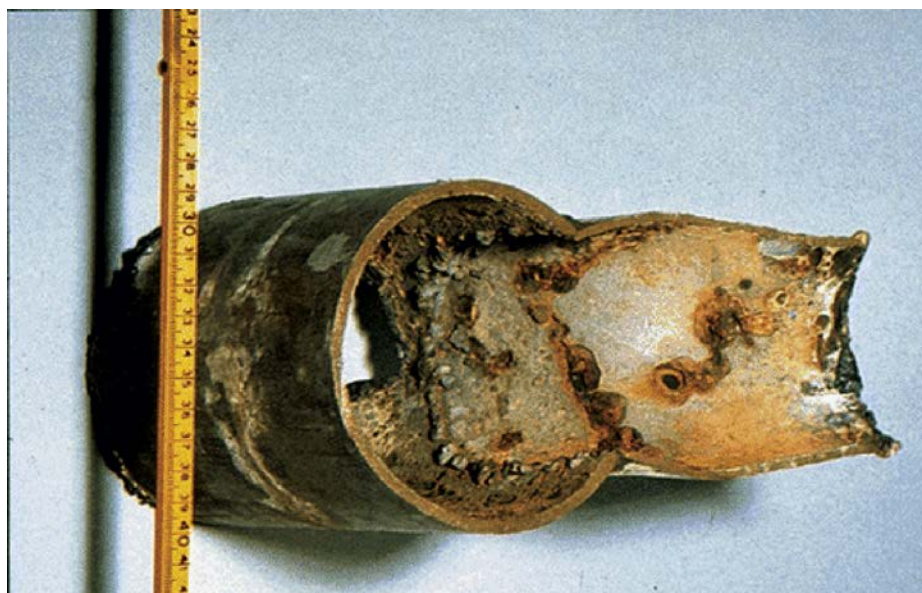
PART Pipe section.

PHENOMENON Galvanic corrosion (deposition corrosion).

APPEARANCE Pitting throughout pipe.

CAUSE Formation of cells by deposition of copper (originating from the copper boiler) on the galvanized steel and galvanic corrosion because of the couple action between the copper welds and the galvanized pipe (see also Case history [02.06.14.02](#)).

- Construct the boilers and the pipes from 316L stainless steel, and apply partial softening of the water to prevent deposits (differential aeration cells).
- Optionally, construct the pipes of heat-resistant plastic or coated steel.

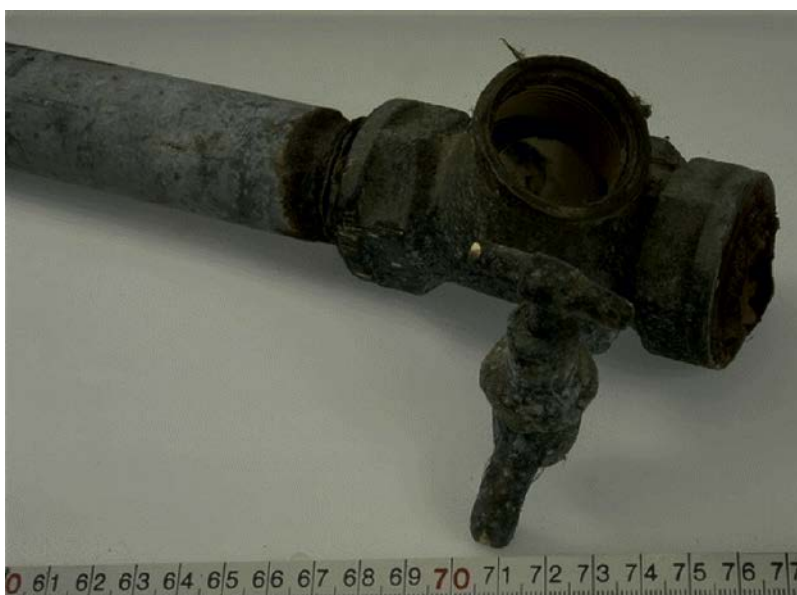
PART Pipe.

PHENOMENON Galvanic corrosion.

APPEARANCE Pipe section at connection to brass check valve; severely corroded on the left and fractured on the right.

TIME IN SERVICE 15 years.

CAUSE Cell formation resulting from the combination of galvanized steel/brass/galvanized steel. The brass is slightly affected by dezincification, presumably due to the formation of differential aeration cells underneath condensation droplets.

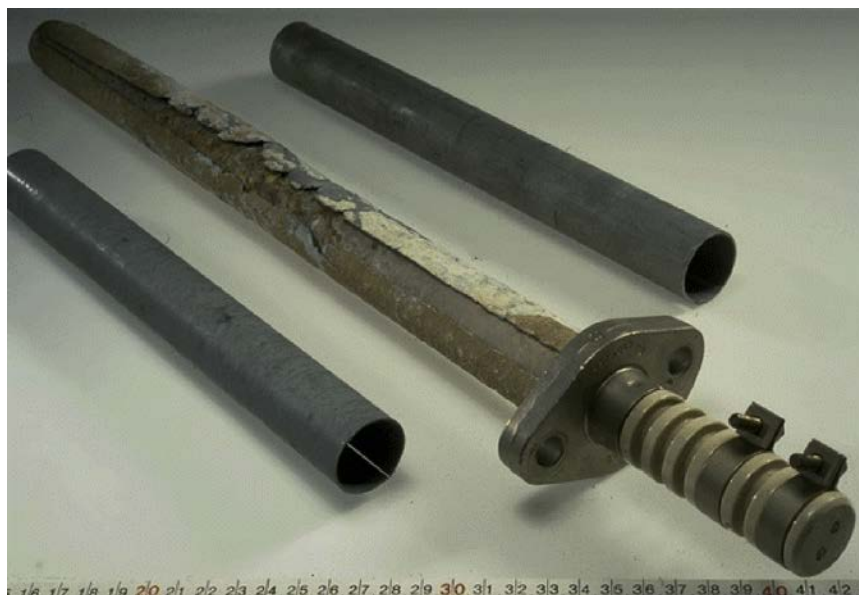
02.05.14.06

MATERIAL	Hot-dip galvanized steel.
SYSTEM	Hot tap water system.
PART	Galvanized steel casing of electric heating element.
PHENOMENON	Galvanic corrosion (reversal of potential).

APPEARANCE	Severe attack to the galvanized steel. In addition, calcium deposition on casing and element (above and underneath new casings).
TIME IN SERVICE	One year.
ENVIRONMENT	Hot tap water. Temperature $>60^{\circ}\text{C}$.
CAUSE	Reversal of potential of the iron–zinc couple at temperatures $>60^{\circ}\text{C}$ (see also Case history 02.05.14.01).
REMEDY	Removal of galvanized steel casing.

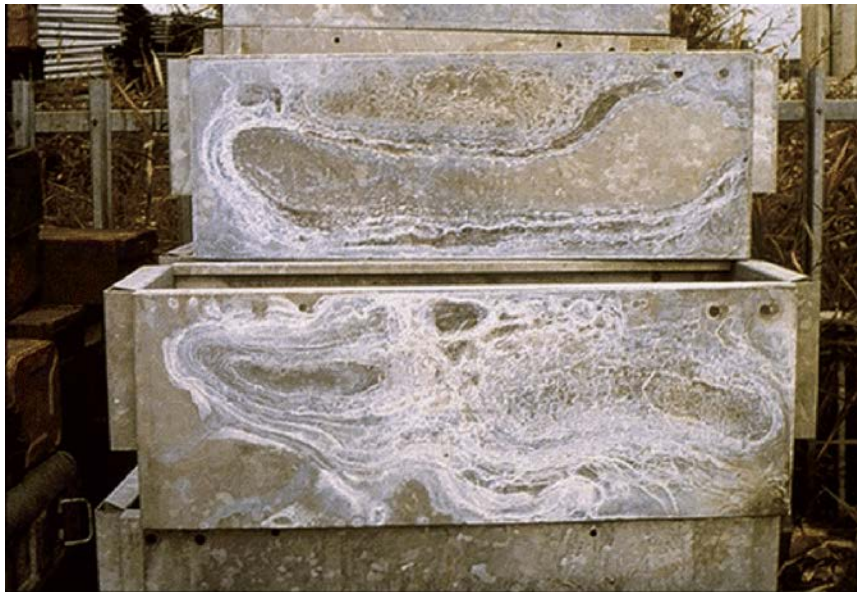
PART Drinking troughs.

PHENOMENON Atmospheric corrosion (white rust).

APPEARANCE Uniform corrosion with locally abundant zinc corrosion products.

TIME IN SERVICE 3 weeks outdoor storage.

CAUSE Vertical stacking too close together, as a result of which the air circulation was insufficient for the rainwater to evaporate. The zinc coating is attacked, with formation of zinc oxide hydrate, known as "white rust."

REMEDY Inspection revealed that there was no question of reduced coating thickness, so that regalvanizing was not necessary; all that was required was removal of the white rust areas by brushing. If the troughs are again stacked, a space of at least 1 cm should be maintained between the flat parts of the stack should be laid at a slope.

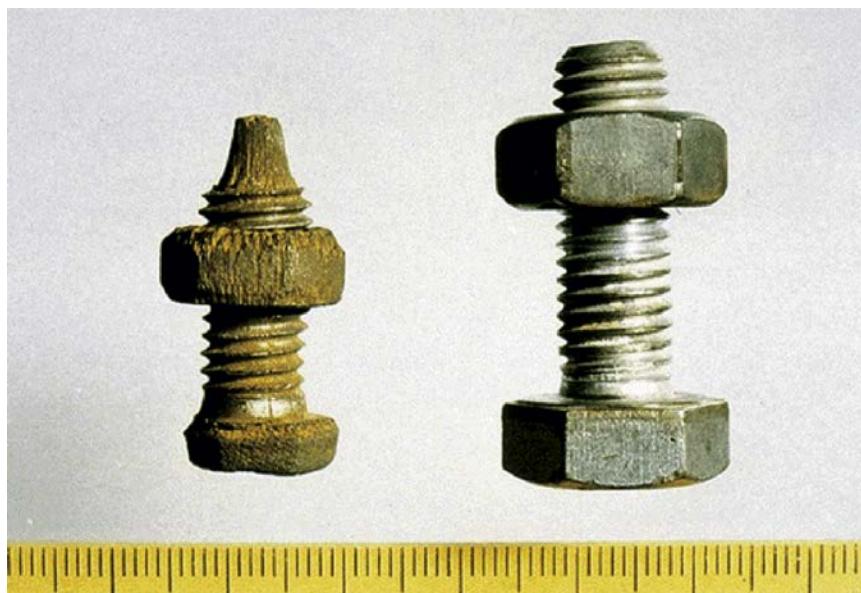
02.06.14.01

MATERIAL	Sherardized carbon steel.
SYSTEM	Cooling water system.
PART	Left-hand: cooling water pump filter bolt; right-hand: new bolt.
PHENOMENON	Galvanic corrosion.

APPEARANCE	Severe uniform attack over entire surface.
TIME IN SERVICE	A few months.
ENVIRONMENT	River water.
CAUSE	The bolts are subjected to galvanic attack as a result of couple action between the sherardized carbon steel bolts and the stainless steel filter gauze.
REMEDY	Use stainless steel bolts.

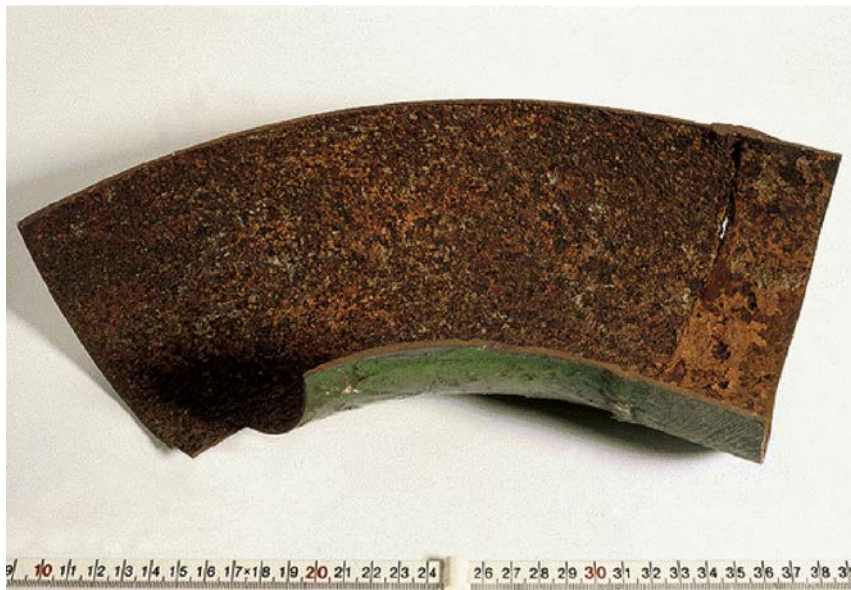
PART Piping.

PHENOMENON Galvanic corrosion (deposition of noble ions).

APPEARANCE Overall attack.

TIME IN SERVICE One year.

CAUSE (Galvanized) carbon steel is subjected to galvanic attack as a result of couple action between steel and copper after deposition of the copper ions on the steel surface (copper content of the deposit: 1%).

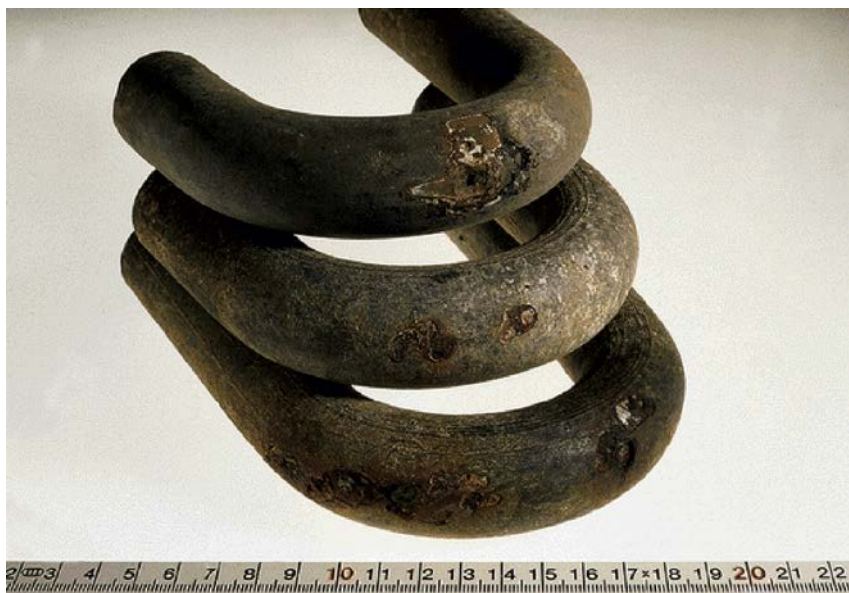
PART Tube bends.

PHENOMENON Galvanic corrosion (deposition corrosion).

APPEARANCE Pitting.

TIME IN SERVICE 1.5 years.

ENVIRONMENT Circulating chilled water; temperature 6–8°C. NH_4^+ : 200 ppm; copper 50 ppm (corroded from the copper air coolers in the system); zinc: 2 ppm.

CAUSE Porosity of the evaporator welds caused leakage of ammonia into the cooled water. The first result was corrosion and leakage of the copper air coolers. They were renewed. The second result was depletion of the copper in the cooled water, which originated from the corrosion of the air coolers onto the galvanized surface of the evaporator. This caused pitting by galvanic corrosion (deposition corrosion, see also Case history [02.05.14.01](#)).

REMEDY The material choice was fundamentally wrong. Combination of galvanized steel and copper in a circulating water system causes corrosion problems. Construction of the evaporator and coolers of the same material, galvanized steel, or better stainless steel would have been a better choice.

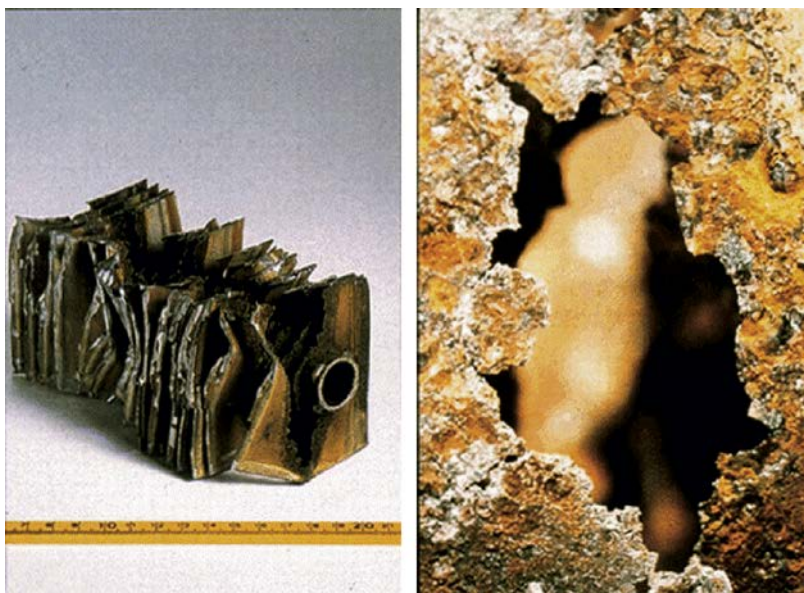
PART Evaporator.

PHENOMENON Attack by corrosive water.

APPEARANCE Uniform attack to zinc and steel.

TIME IN SERVICE 5 years.

ENVIRONMENT Ice (frozen condensed moisture from the cooled air); corrosive deferrized well water (sprayed above evaporator for periodical thawing of the ice) (Langelier index -2.6, Ryznar index 11.3).

CAUSE Because of the highly corrosive well water, no protective patina coating (of basic zinc salt) is formed. Corrosion of zinc is accelerated by the presence of many pores and fractures in the zinc coating. The corrosion products force the zinc coating away.

REMEDY Provide new evaporator with better galvanization and reduce the corrosiveness of the well water by removing the carbon dioxide.
