Corrosion Atlas

THIRD, EXPANDED AND REVISED EDITION

A Collection of Illustrated Case Histories

Evert D.D. During

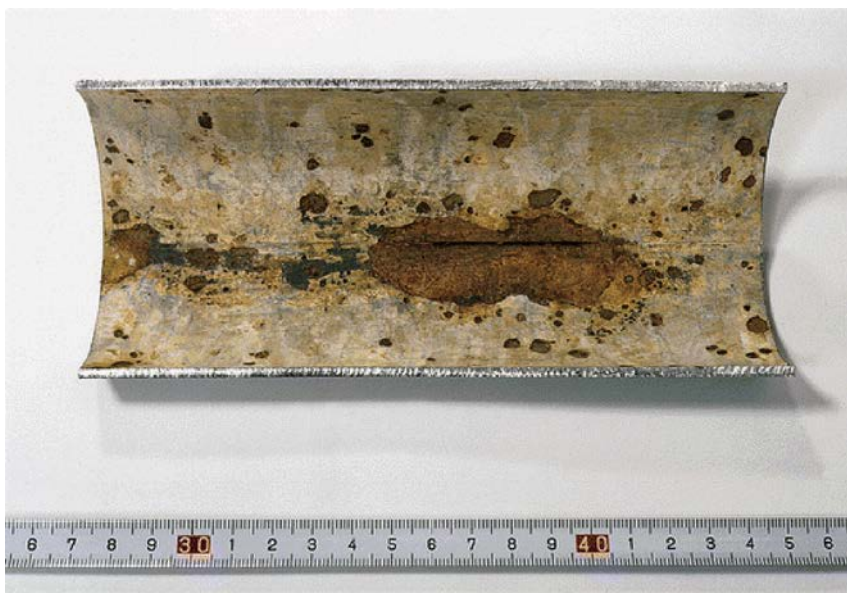
PART Dry sprinkler line.

PHENOMENON Under-deposit corrosion.

APPEARANCE After removal of the 4- to 5-mm-thick light- to grey-brown deposit, consisting of iron oxide and zinc oxide, it was found that the zinc layer had disappeared at many sites, with pitting attack and selective attack to the weld.

TIME IN SERVICE 2 years.

CAUSE The lengthy presence of a considerable quantity of mains water in the lower part of the pipe had prevented the formation of a protective layer of basic zinc carbonate (zinc patina). "White rust" was formed, and aeration cells originated. The resultant corrosion products were wetted with condensate from the compressed air, allowing the corrosion to continue (see also Case Histories [02.05.24.01](#) and [02.08.15.01](#)).

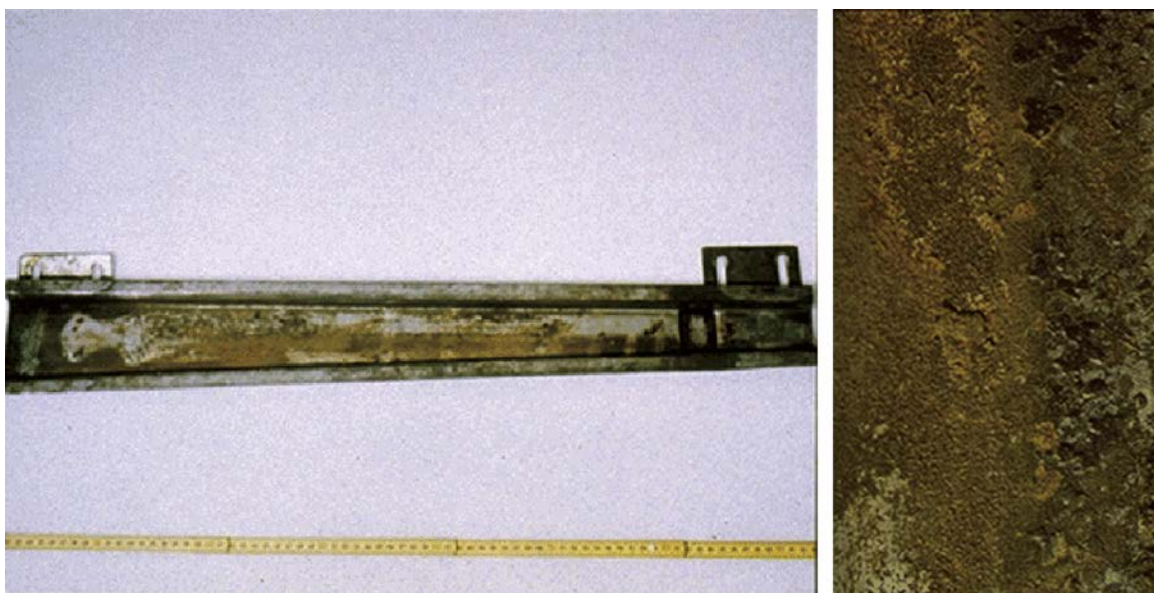
PART Conveyor plate.

PHENOMENON Alkalinity corrosion.

APPEARANCE Uniform attack, with rust formation.

TIME IN SERVICE 6 months.

CAUSE Galvanized steel is not resistant to water with a pH >8.5, since no patina layer is formed. Moreover, the galvanization method applied yielded a zinc coating of only 20–25 μm , without formation of iron–zinc alloy. This coating is therefore extremely sensitive to attack. Softened water in itself is also aggressive to zinc.

- Construct the system in stainless steel or hot-dip galvanized steel (zinc coating approximately 100 μm).
- In the latter case, use less aggressive cleaning chemicals and of nonsoftened cleaning water.
- Or derust and repaint the system periodically.

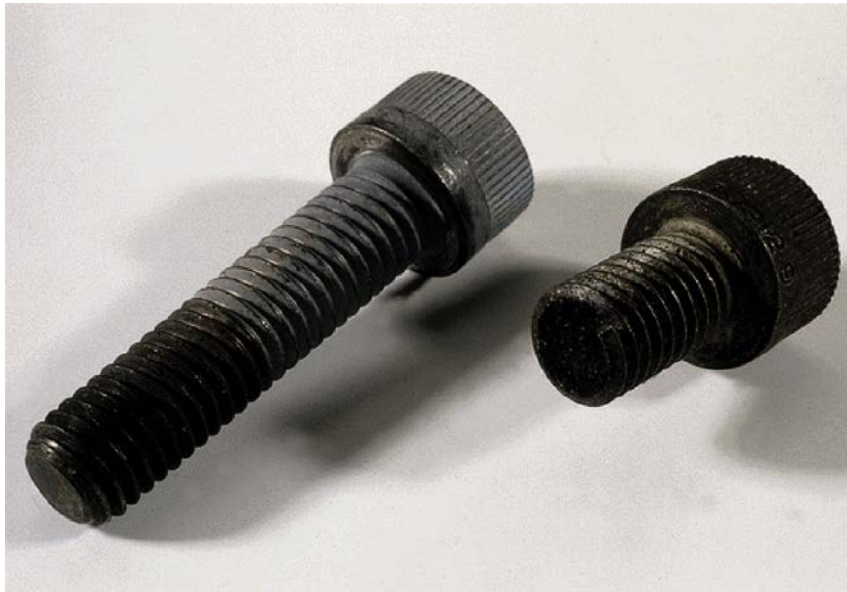
PART Bolt.

PHENOMENON Solid metal-induced embrittlement.

APPEARANCE Left: a new bolt.
Right: Used bolt with brittle fracture.

TIME IN SERVICE 3 months.

CAUSE Embrittlement of bolt material by zinc penetration. This occurs at a temperature above 240 °C but below the melting point of zinc (see also Case history 01.04.22.01).

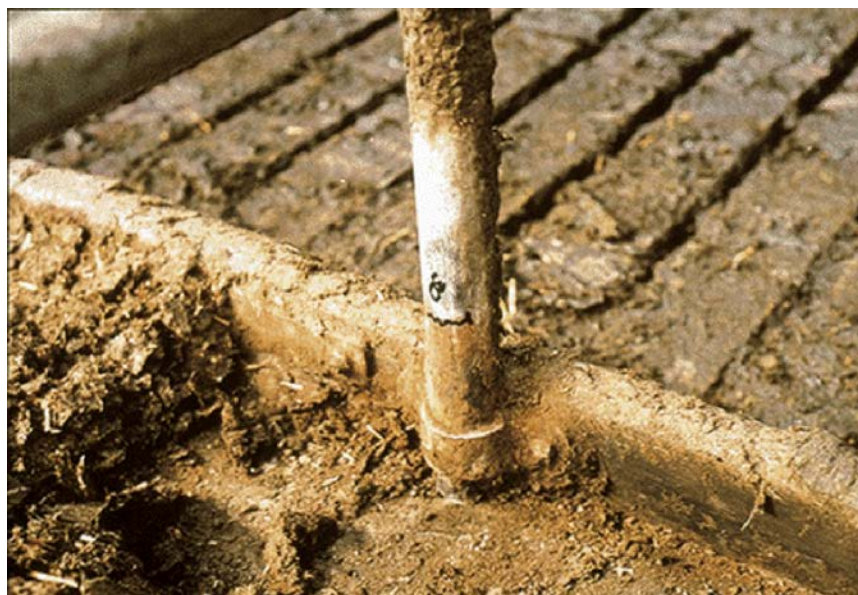
PART Rear support of partition wall between the cows.

PHENOMENON Ammonia corrosion.

APPEARANCE Irregular pitting.

TIME IN SERVICE $1\frac{1}{2}$ years.

CAUSE The defective construction (plastic sleeve was applied too low) and failure to remove the manure regularly allowed the zinc coating to be dissolved by ammonia and corrosive substances from the manure, after which the steel was attacked and rusted through.

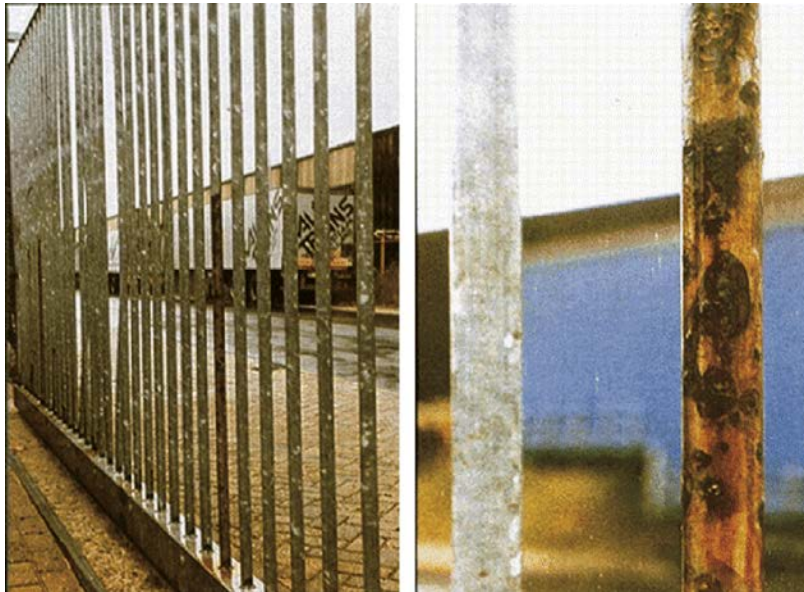
PART Tubular railings.

PHENOMENON Chloride attack.

APPEARANCE Pitting (typical of chloride corrosion).

TIME IN SERVICE $2\frac{1}{2}$ years.

CAUSE During the galvanizing process, flux (zinc ammonium chloride) and zinc oxide-substances which when wet are corrosive to steel remained on certain railings.

REMEDY Replace the corroded railings and re-galvanize the entire gate.

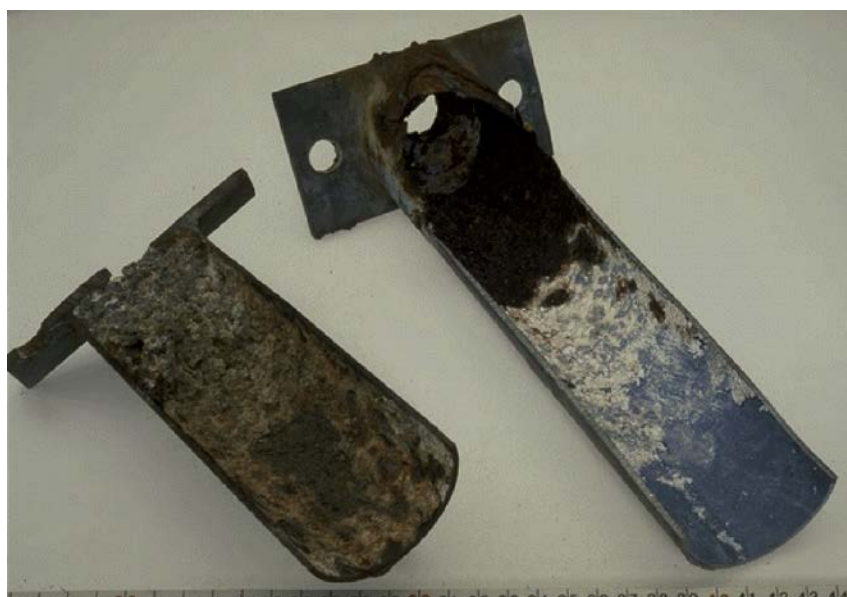
PART Upper tube of the roof truss.

PHENOMENON Chloride attack.

APPEARANCE Left: pipe section partially filled with deposit.
Right: pipe section corroded through, with pitting.

TIME IN SERVICE 14 years.

ENVIRONMENT Humid atmosphere.

CAUSE Because the outflow orifice provided for galvanizing purposes had been made at an incorrect site and was much too small, zinc and flux ash residues (zinc ammonium chloride) were unable to escape sufficiently. Particularly the flux ash residues, when wet, are corrosive in relation to steel (see also Case History [02.16.12.01](#)).

REMEDY Replace trusses by new trusses having a larger outflow orifice at the appropriate site.

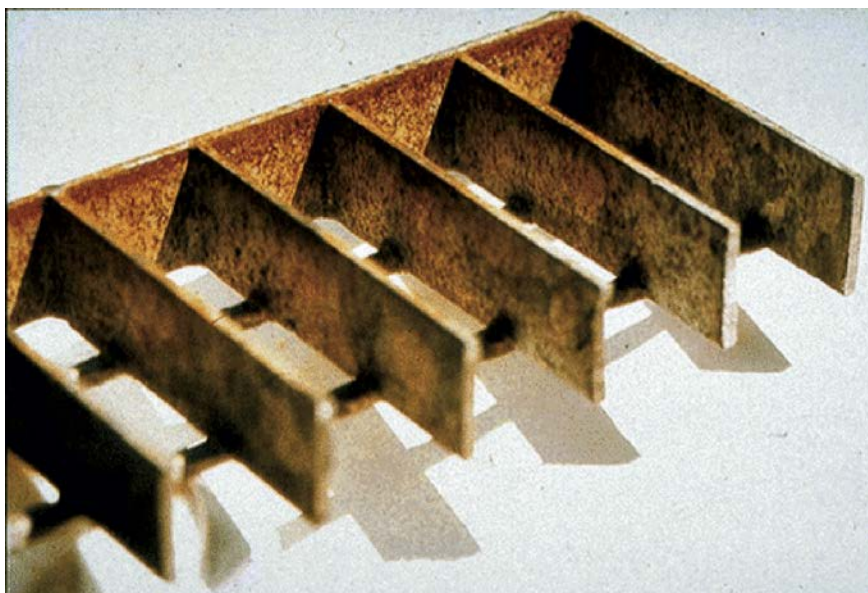
PART Part of a floor section.

PHENOMENON Atmospheric corrosion.

APPEARANCE Brown rust spots.

TIME IN SERVICE 3 months.

CAUSE Abrasive dust originating from grinding and welding operations to the pipelines remained on the hot-dip galvanized gratings. The iron particles began to corrode and caused the brown color of the zinc surface. Accordingly, this attack was caused by poor workmanship.

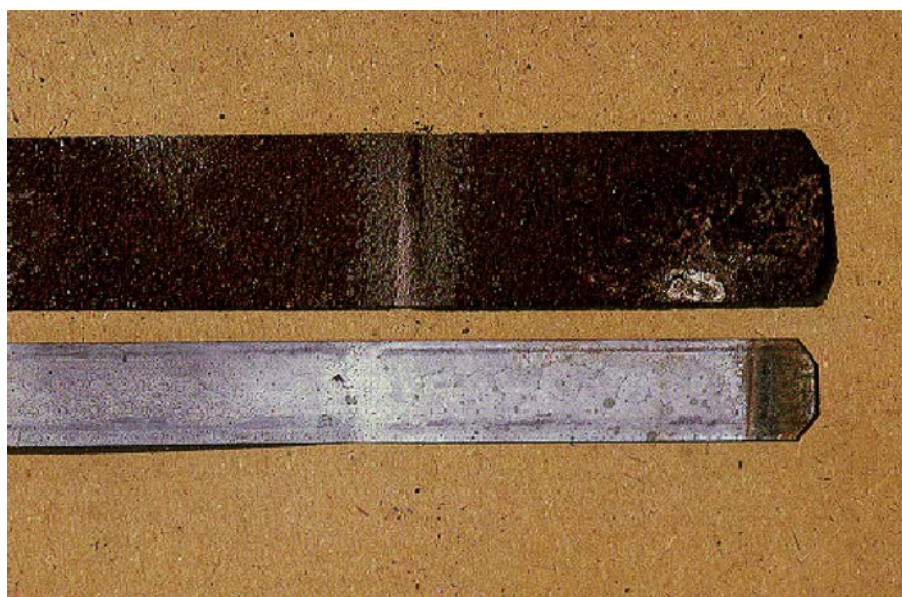
PART Attachment strips.

PHENOMENON Atmospheric corrosion.

APPEARANCE The upper strip is uniformly corroded, but the lower strip exhibits no corrosion apart from the extremities.

TIME IN SERVICE 4–5 years.

CAUSE The upper zinc-electroplated strip (zinc layer $10\mu\text{m}$) proved to be insufficiently corrosion-resistant in the marine atmosphere. By contrast, the hot-dip galvanized strip (zinc layer $40\text{--}50\mu\text{m}$) proved to be sufficiently corrosion resistant.

REMEDY The electroplated snips should be replaced by hot-dip galvanized strips.

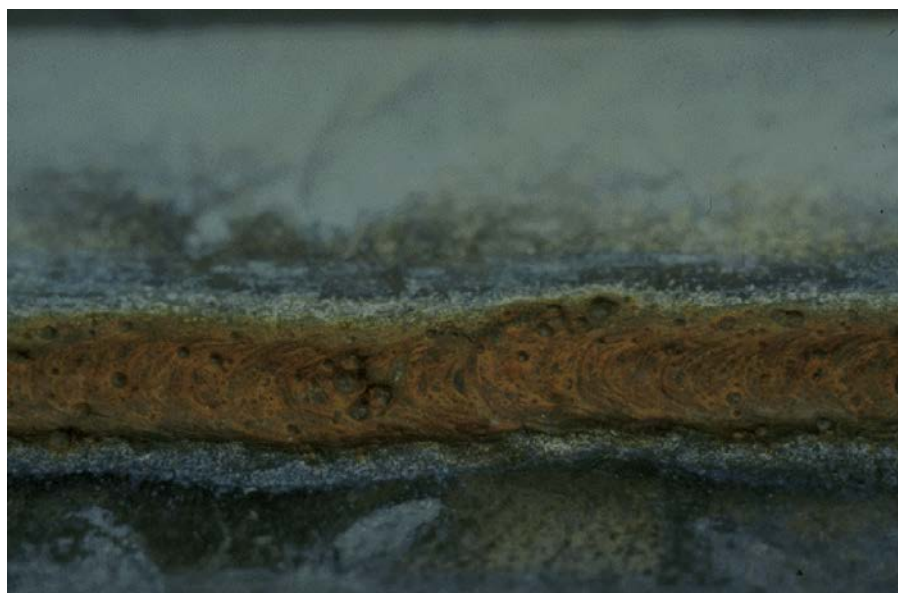
PART Weld.

PHENOMENON Atmospheric corrosion.

APPEARANCE Only the weld is uniformly corroded.

TIME IN SERVICE 4 years.

CAUSE Damage to the zinc layer during welding. The weld was not protected and therefore corroded. The abutting zinc layer prevented the rust formation from spreading.

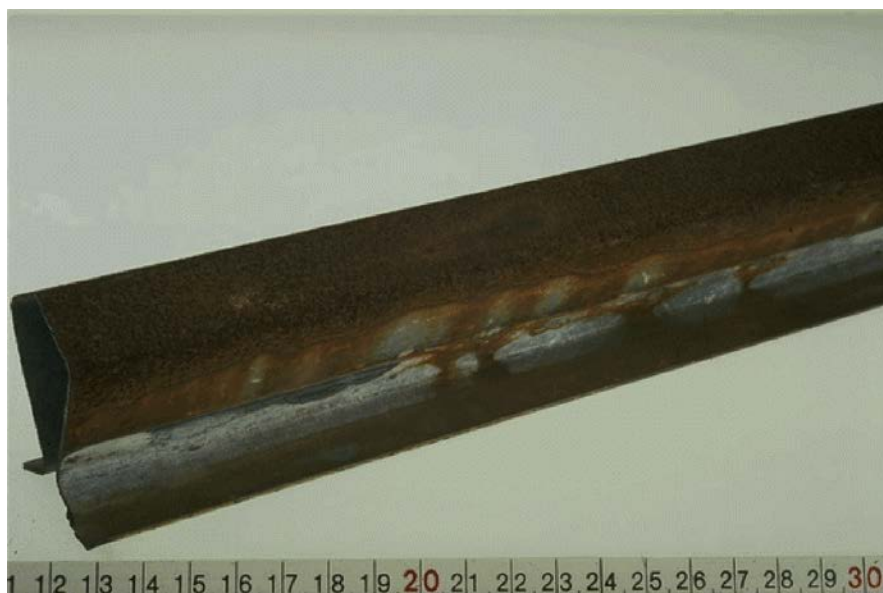
PART Beam.

PHENOMENON Atmospheric corrosion.

APPEARANCE Uniform attack with rust formation.

TIME IN SERVICE About 1 year.

CAUSE The combination of an excessively thin permeable zinc coating with SO_2 vapors originating from a boiler plant installed nearby. The manufacturer had provided a 2-year warranty on the galvanized steel.

REMEDY Continuous hot-dip zinc-coated steel is not suitable for outdoor use. In this case, the galvanized steel structure was replaced by an aluminum structure. Alternative: After pickling, the corroded structure could be hot-dip galvanized and provided with a coating (duplex system).

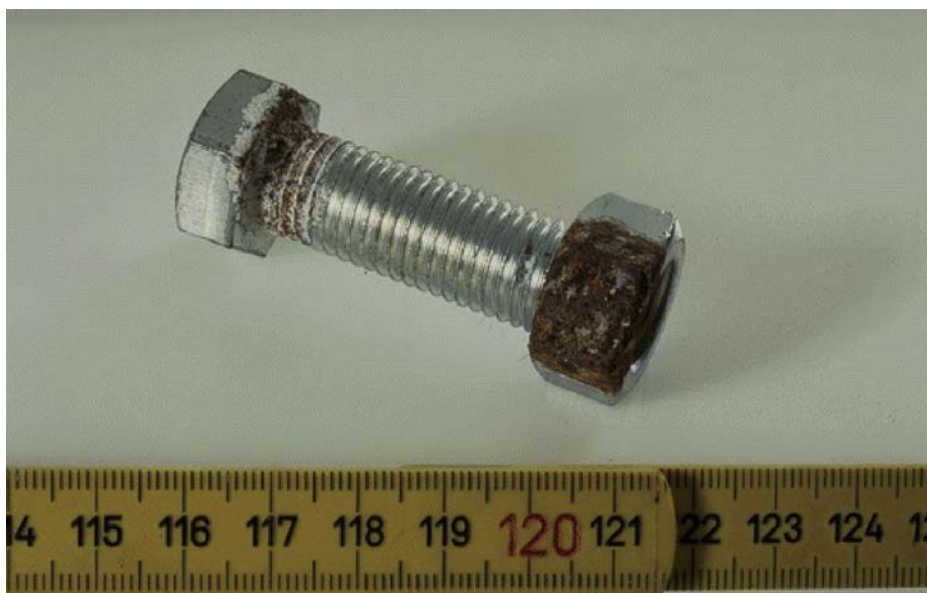
PART Bolt with nut.

PHENOMENON Atmospheric corrosion.

APPEARANCE Bolt head and nut rusted at one side.

TIME IN SERVICE 2 days.

CAUSE Sherardized steel is not resistant to this aggressive atmosphere, the still fresh, unoxidized zinc layer being rapidly attacked, after which corrosion of the steel occurs.

REMEDY After brushing off the corrosion products in mildly alkaline demineralized water, the bolts and nuts were painted with a coal tar epoxy paint.

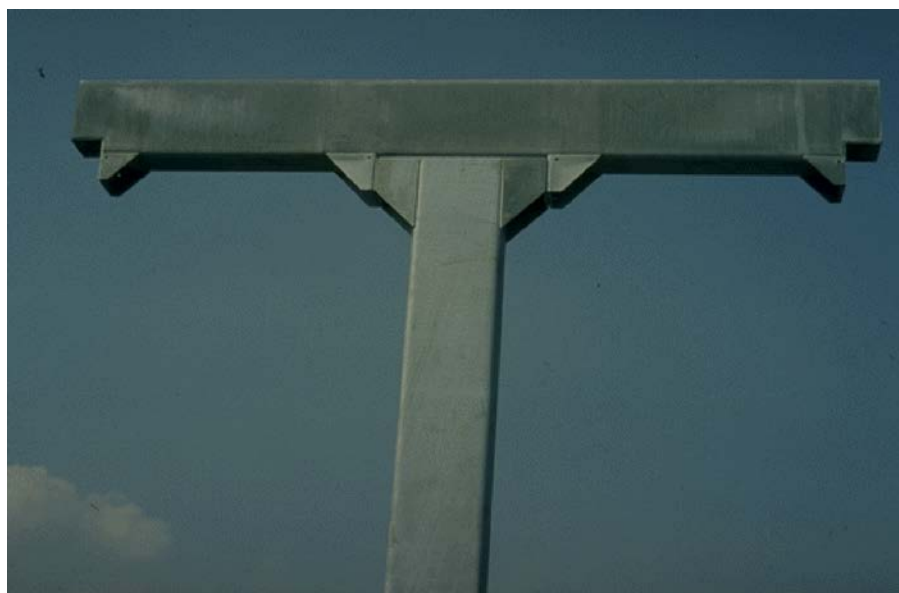
PART Structural beams.

PHENOMENON Sandelin phenomenon.

APPEARANCE Cross-beam exhibits an abnormal, grey-veined appearance.

CAUSE The cross-beam is manufactured from silicon-killed steel, which renders the steel more reactive in the presence of molten zinc, with the zeta layer growing profusely during galvanizing and while the coating is cooling down. The effect can be severe, usually at silicon levels above about 0.3%, with the alloy layer growing through to the surface of the coating. This is in contrast to the coating on the vertical beam which is made from unkilld steel where the normal relatively pure eta surface zinc layer is present. The same effect also occurs in semi-killed steel (Si content above 0.03%) but it is normally only significant at silicon levels above about 0.05%, with a substantial reduction in the rate of zeta alloy formation at about 0.11%.

REMEDY The resultant overall thicker coating provides a proportionately higher degree of corrosion protection but excessively thick coatings should be handled with care as they can be brittle and therefore liable to damage. If the galvanizer is provided in advance with an analysis of the steel offered for galvanizing, he can make appropriate adjustments to the process to avoid excessively thick and brittle coatings. This Sandelin phenomenon does not occur with aluminum-killed steel when reactive levels of silicon are not present.

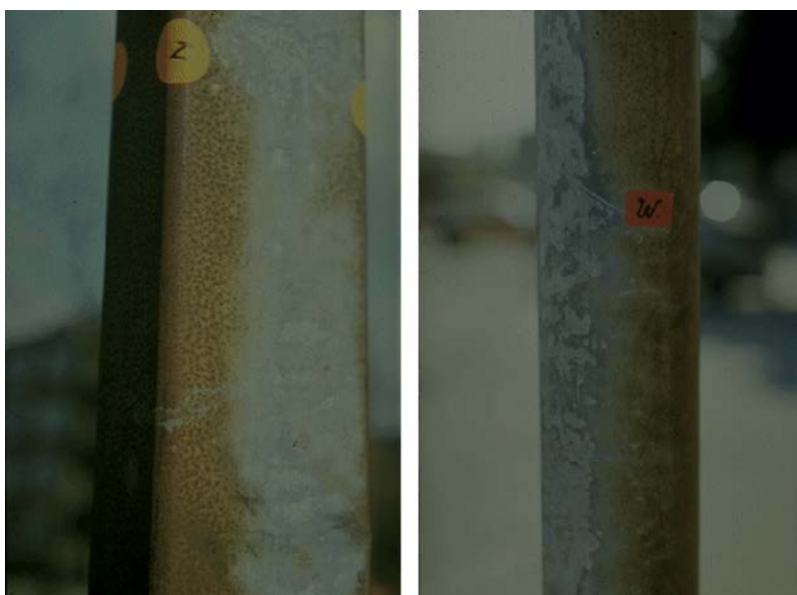
PART Left: Letter-box support profile; right: Traffic bollard.

PHENOMENON Atmospheric corrosion.

APPEARANCE Brown corrosion visible only on the south-west and west sides.

TIME IN SERVICE 20 and 17 years, respectively.

CAUSE Attack to the zinc coating and the steel surface by the contaminants carried on the wind. Strong one-sided attack by the prevailing local wind direction and wetting by acid rain (differential atmospheric corrosion).

REMEDY Replacement of these elements by new hot-dip galvanized components, possibly with one or two coats of paint (duplex system). Reconditioning is no longer possible because excessive rust formation has already taken place.

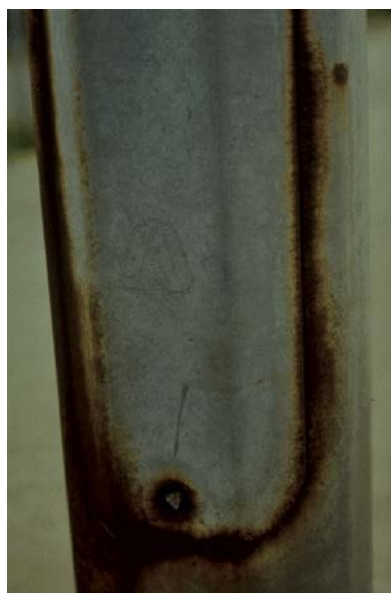
PART Lamp-post.

PHENOMENON Atmospheric corrosion.

APPEARANCE Brown corrosion products in and beside the crevice around the hatch in the post.

TIME IN SERVICE About 12 years.

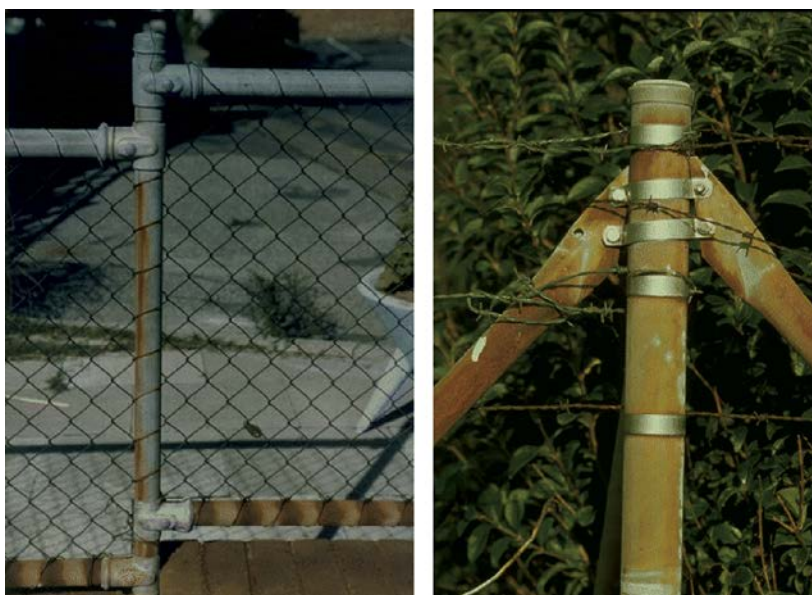
PART Left: Wire netting of fence
Right: Barbed wire fence.

PHENOMENON Atmospheric corrosion.

APPEARANCE Rust formation on the wire netting and the barbed wire, with corrosion patches on the tubes.

TIME IN SERVICE About 10 and 14 years, respectively.

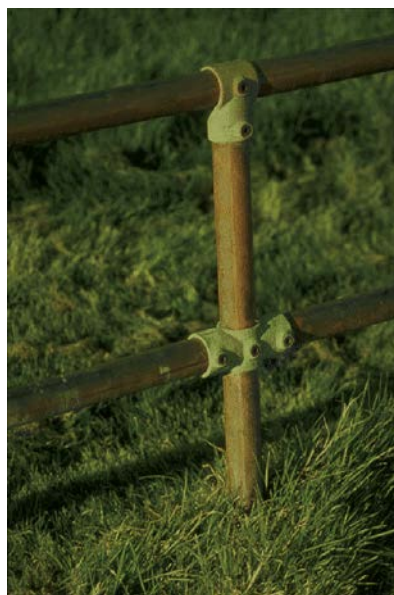
PART Fence posts.

PHENOMENON Atmospheric corrosion.

APPEARANCE The posts are uniformly corroded or exhibit areas of rust. The attachment fittings are not corroded.

TIME IN SERVICE 14 years.

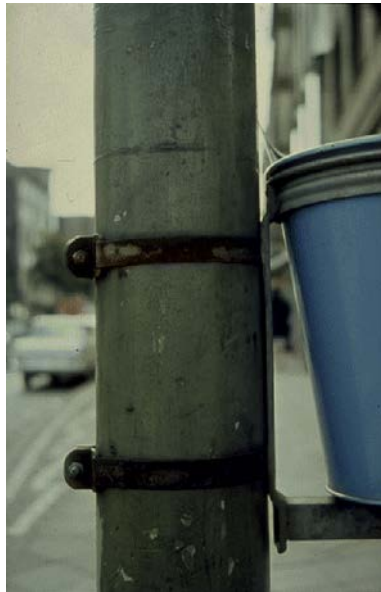
PART Fastening strips on a waste-bin.

PHENOMENON Atmospheric corrosion.

APPEARANCE The fastening strips are uniformly corroded. The lamp-post itself is not.

TIME IN SERVICE 14 years.

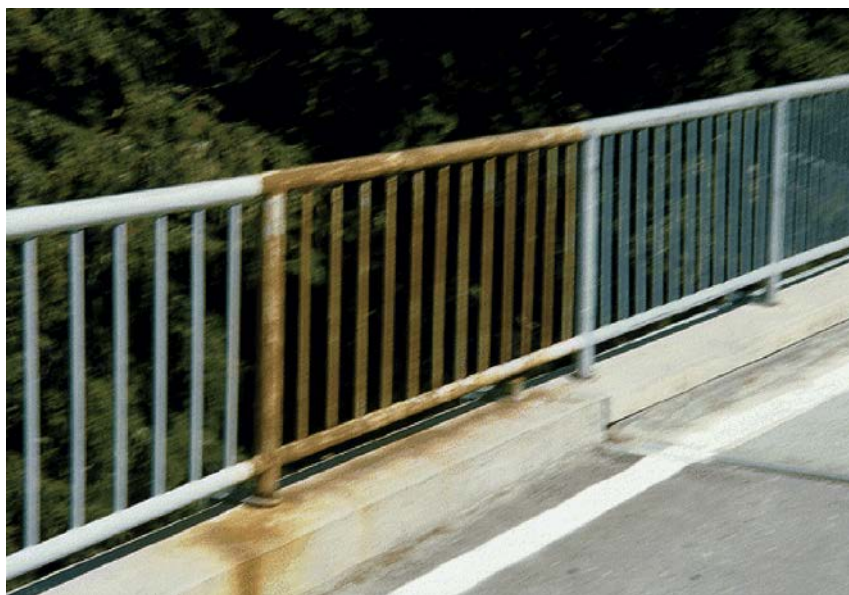
02.17.24.06

MATERIAL	Hot-dip galvanized steel.
SYSTEM	Separating structure.
PART	Barrier alongside a mountain road.
PHENOMENON	Atmospheric corrosion.

APPEARANCE Part of the barrier exhibits uniform corrosion.

TIME IN SERVICE Probably less than 5 years.

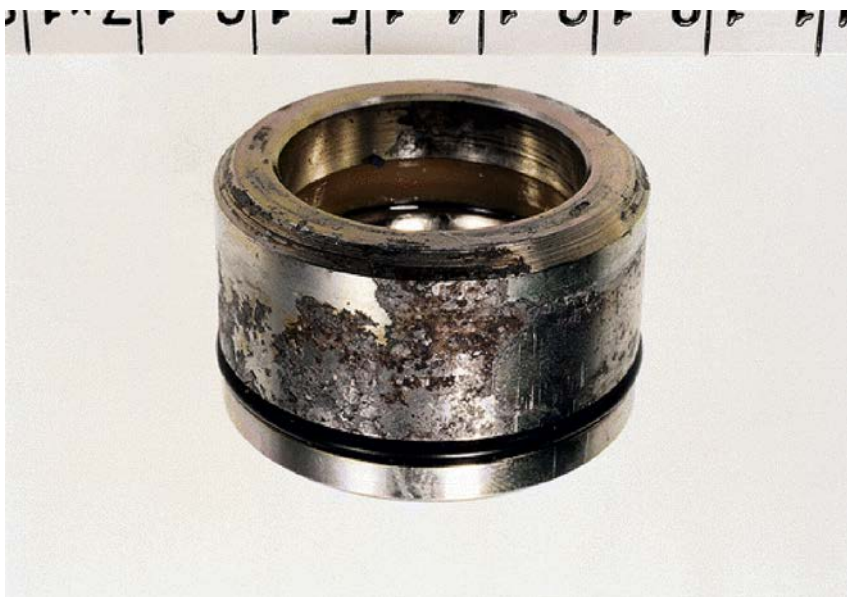
PART Hydraulic lift cylinder, mounted in steel tube by means of an adhesive.

PHENOMENON Crevice corrosion.

APPEARANCE Overall attack of the zinc coating.

TIME IN SERVICE 1 year.

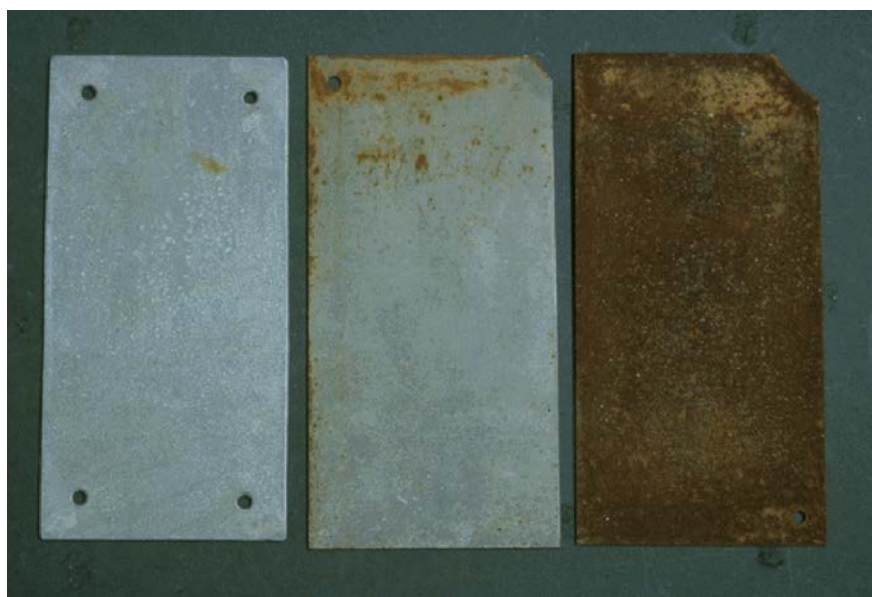
PART Three plates.

PHENOMENON Oxygen corrosion.

APPEARANCE The left-hand plate (hot-dip galvanized) exhibits no corrosion, the center plate (electroplated) is slightly corroded and the right-hand plate (continuous electroplated) is severely corroded.

TIME IN SERVICE 18 months (at sequences of 8 h *in* – 16 h *out* of mains water, etc.).

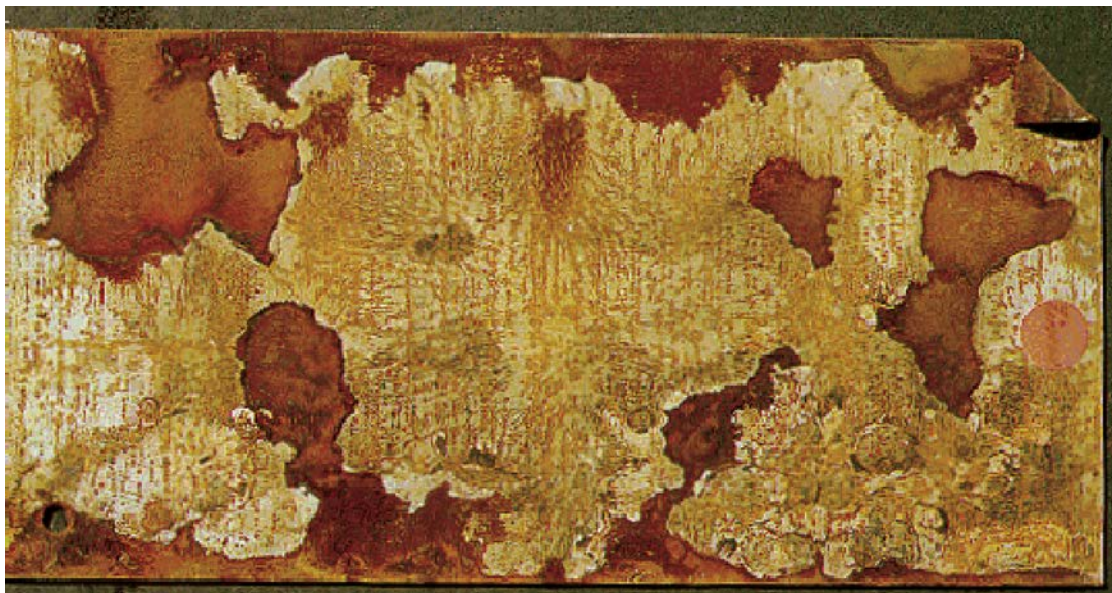
PART Panel.

PHENOMENON Chloride attack.

APPEARANCE Zinc layer locally disappeared and steel surface uniformly corroded

TIME IN SERVICE 8 months.

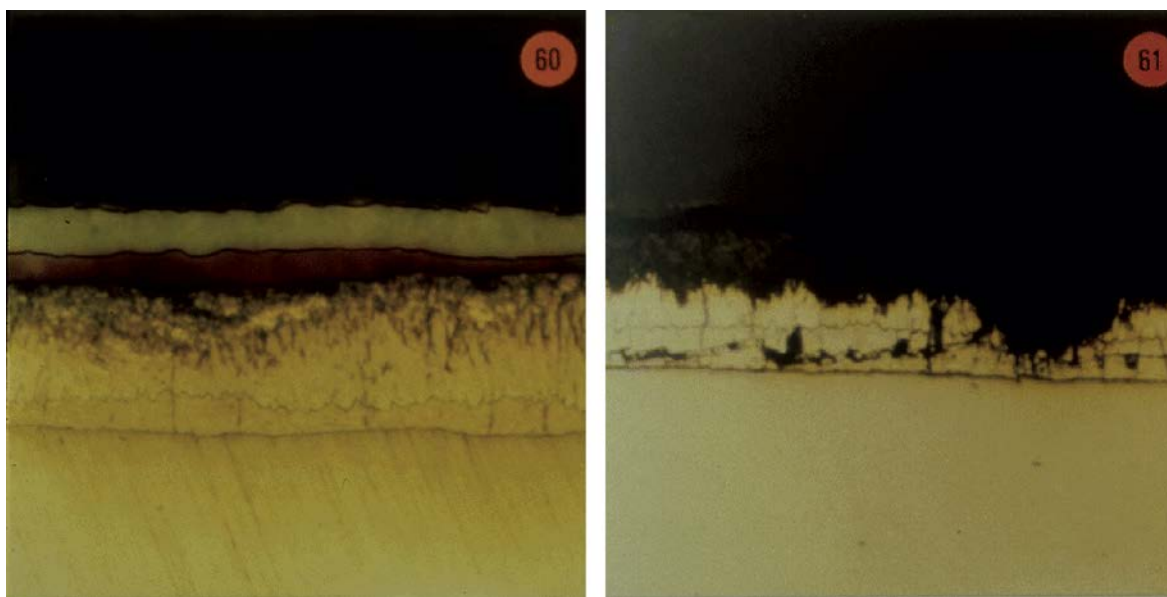
PART Test plates.t

PHENOMENON Atmospheric corrosion.

APPEARANCE Two microphotos: On the left a steel surface provided with a duplex system, on the right a hot-dip galvanized steel surface.

TIME IN SERVICE About 12 years.

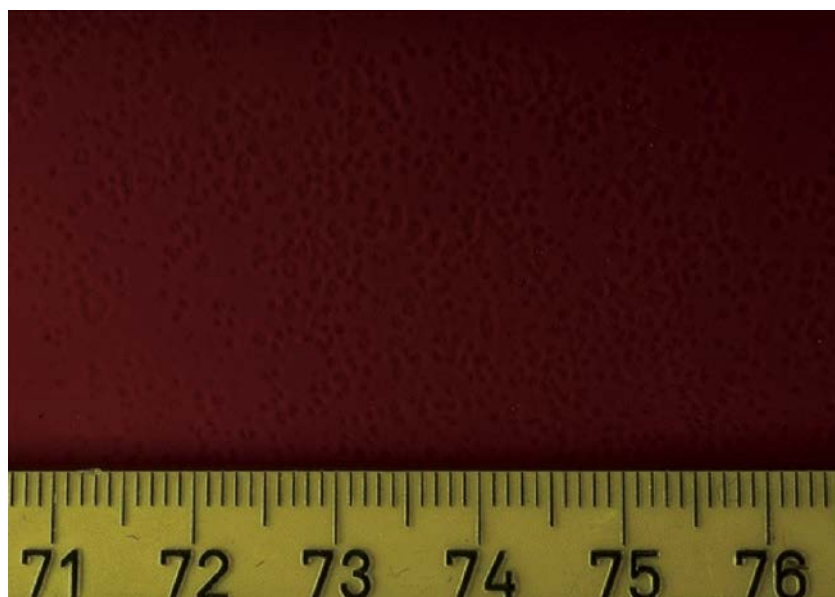
PART External surface.

PHENOMENON Coating failure.

APPEARANCE About 30% of the surface of the coating is covered with closely juxtaposed pits.

TIME IN SERVICE During production.

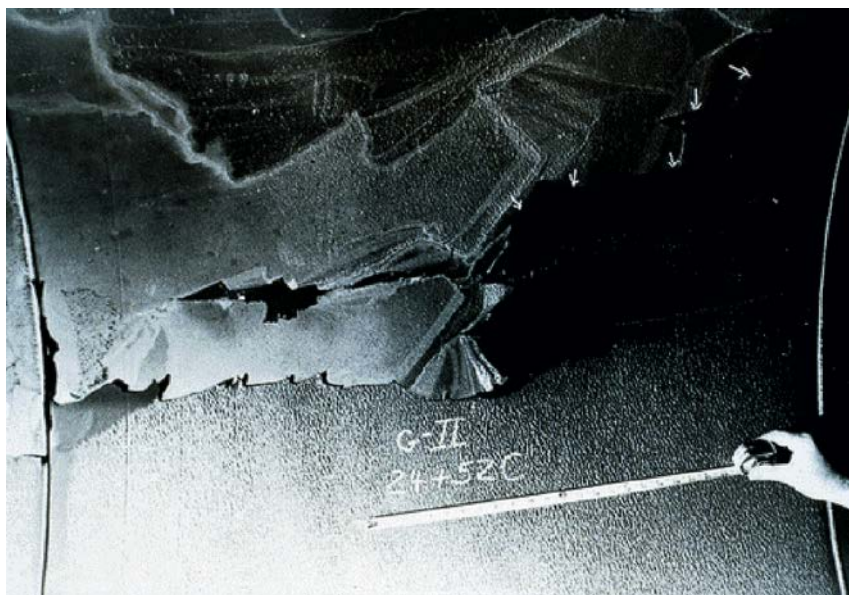
PART Internally coated water transmission line (coating thickness 450–500 μm).

PHENOMENON Coating failure (intercoat delamination).

APPEARANCE Severe delamination of the second coat from the first. Note the complete lack of bond between coats.

TIME IN SERVICE A few months.

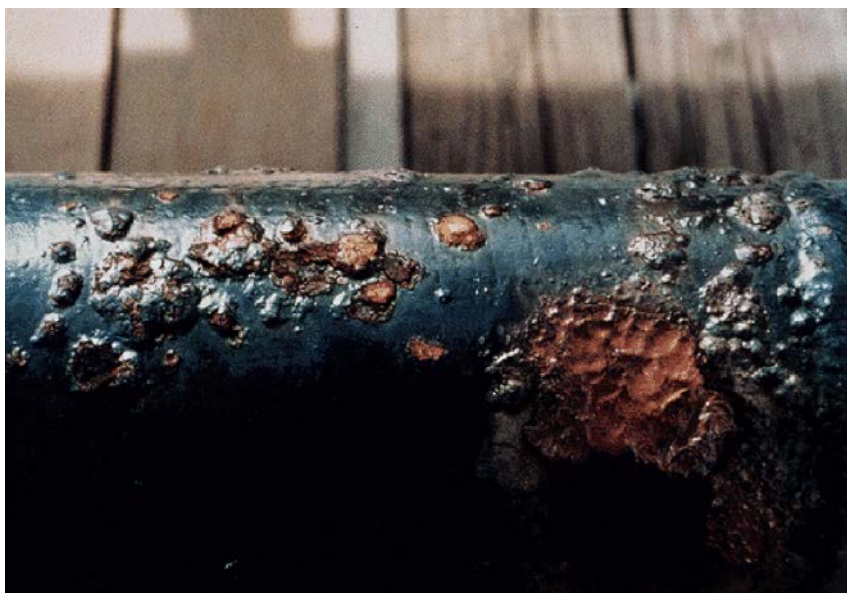
PART Externally coated pipe.

PHENOMENON Coating failure (underfilm corrosion).

APPEARANCE Broken tubercles, with rust increasing in volume under unbroken film lifting off surface (similar to undercutting).

TIME IN SERVICE Several months.

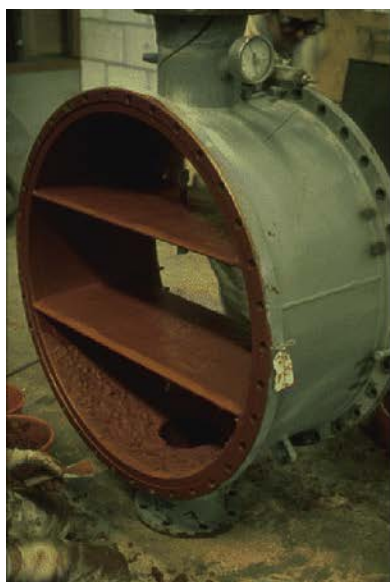
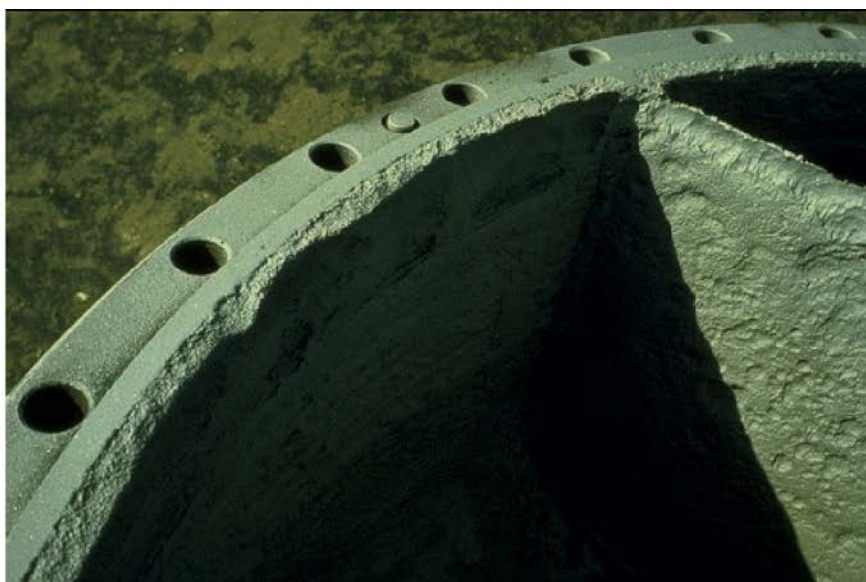
PART Channel head of heat exchanger.

PHENOMENON Galvanic corrosion.

APPEARANCE Severe attack in particular immediately beside the pipe plate, which was also attacked itself. On the left, the channel head with temporary coating; on the right, after blasting.

TIME IN SERVICE Within 3 months.

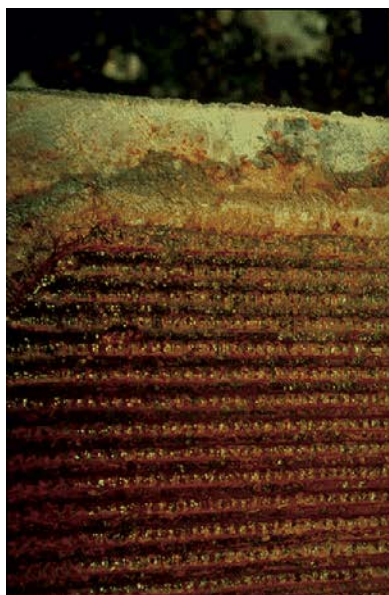
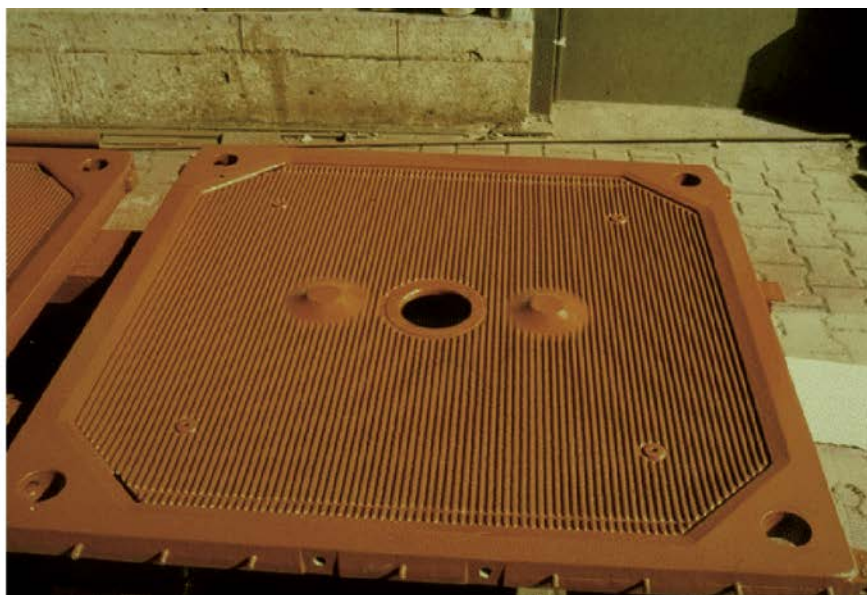
03.08.04.01

MATERIAL	Cast iron (with a coating unsuited for this purpose).
SYSTEM	Sewage treatment plant.
PART	Filter pressure plates (1200 × 1200 × 50 mm) of a sludge dewatering unit.
PHENOMENON	Acid corrosion and erosion.

APPEARANCE	Left: original coating disappeared, severe fouling and attack underground. Right: the same plate after application of synthetic coating.
------------	---

TIME IN SERVICE	5 years.
-----------------	----------

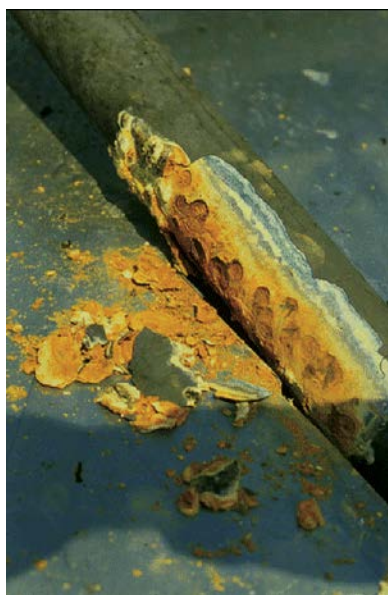
PART Skimmer in settling tank.

PHENOMENON Galvanic corrosion.

APPEARANCE Local flaking-off of the coating, with pitting attack of the steel.

TIME IN SERVICE $\frac{1}{2}$ year after fitting stainless-steel cap.

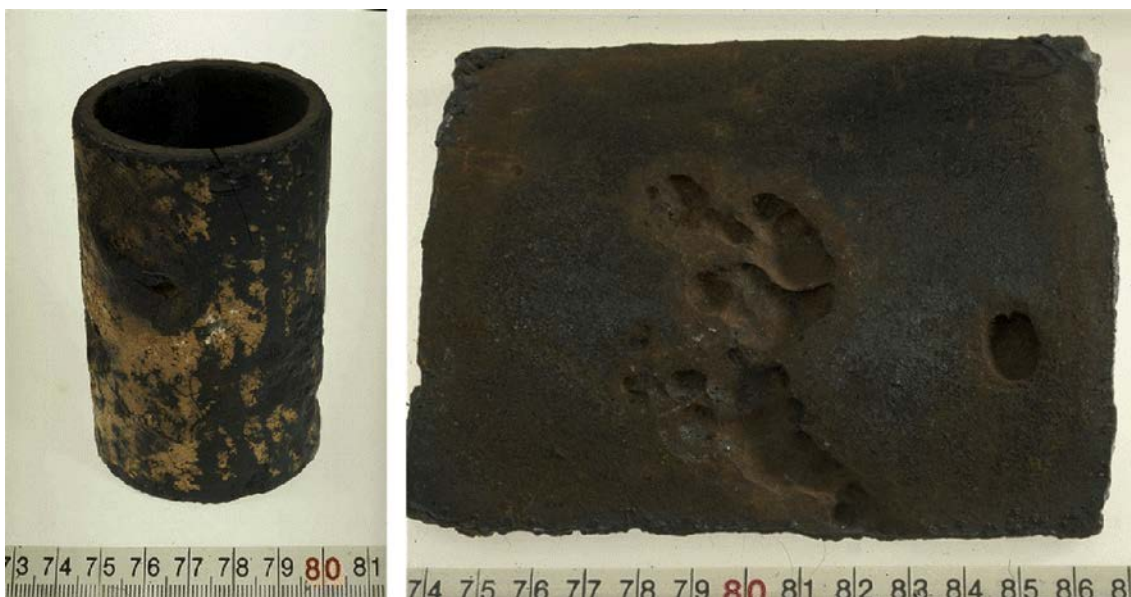
PART Underground transport pipeline.

PHENOMENON Microbiologically induced corrosion.

APPEARANCE Locally severe bowl-shaped attack.

TIME IN SERVICE About 1 year.

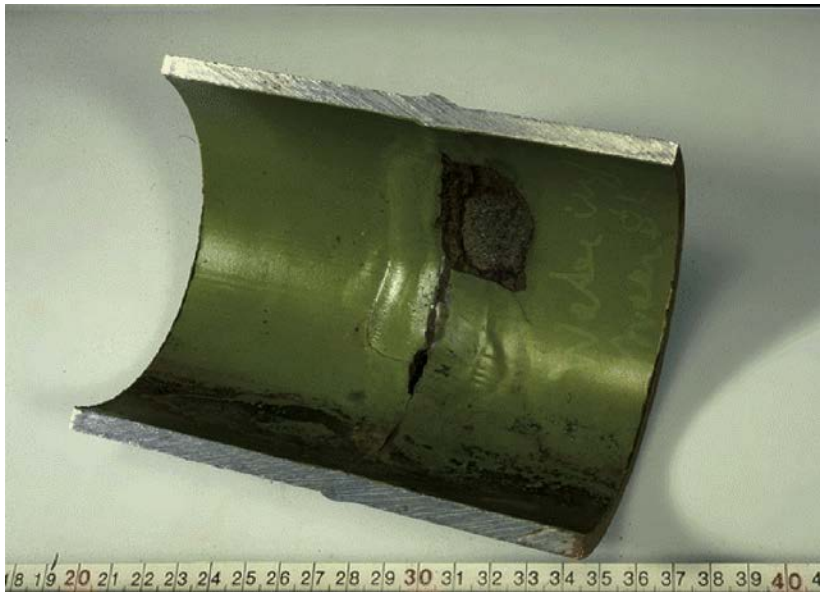
PART Straight pipe section with weld (wall thickness 7 mm).

PHENOMENON Oxygen corrosion.

APPEARANCE Attack near field weld at coating failure.

TIME IN SERVICE 5 years or more.

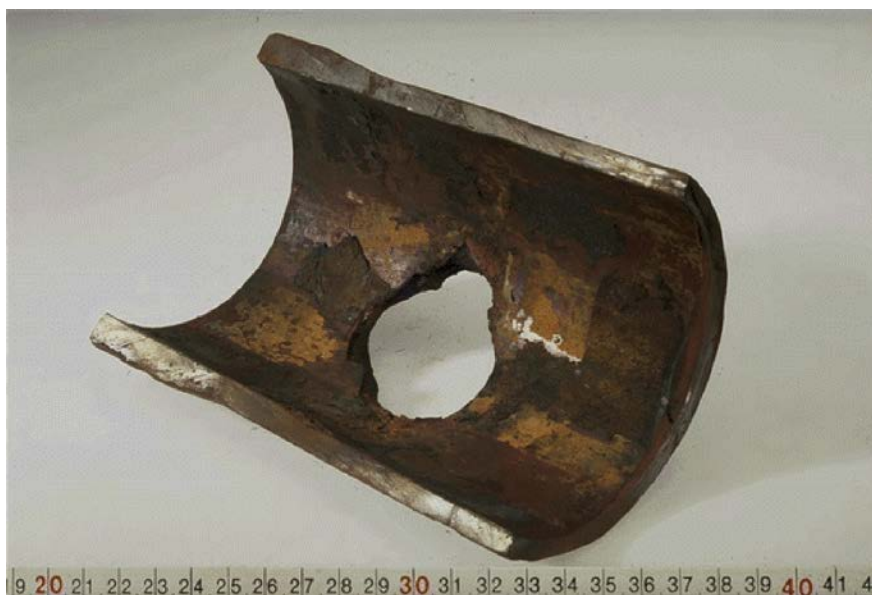
PART Pipe section (wall thickness 11 mm) near upset of the well tubing.

PHENOMENON Carbon dioxide corrosion (sweet corrosion).

APPEARANCE Large hole at the coating damage.

TIME IN SERVICE 2 years.

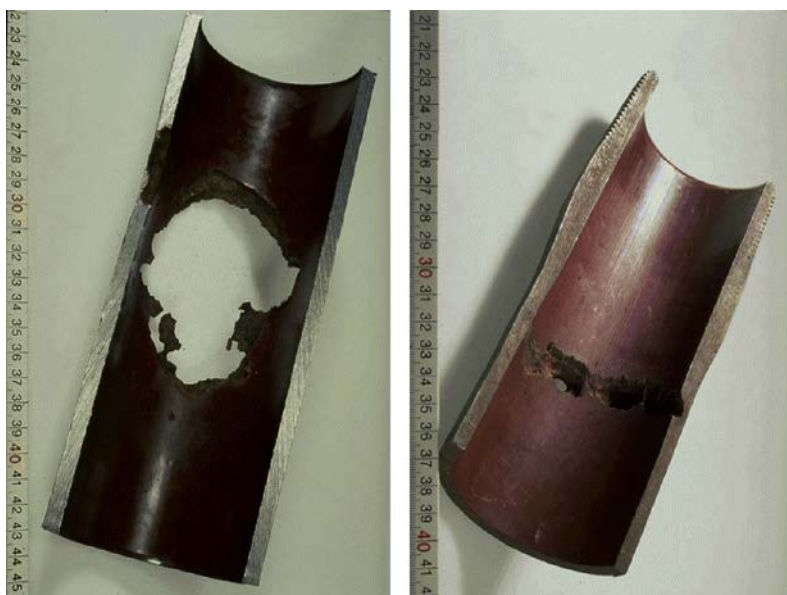
03.11.02.02

MATERIAL	Epoxy-coated carbon steel.
SYSTEM	Oil well.
PART	Section of the well tubing and upset screwed connection (wall thickness 11–6 mm and 6 mm).
PHENOMENON	Carbon dioxide corrosion (sweet corrosion).

APPEARANCE	Severe localized attack at sites where the coating is damaged. On the right, ringworm corrosion at the upset extremity.
------------	--

TIME IN SERVICE	2–4 years.
-----------------	------------

CAUSE	Severe CO ₂ corrosion at sites where the coating afforded no protection due to pinholes and/or damage present. Coating defects may be attributable to errors in pretreatment or coating application or to rough handling of the pipes.
-------	---

REMEDY	<ul style="list-style-type: none"> • Improved inspection of coating quality by the manufacturer (spark testing for pinholes); • Careful handling of coating pipes, local conditions permitting; • Application of corrosion inhibitor; • Application of duplex stainless steel under highly corrosive conditions.
--------	--

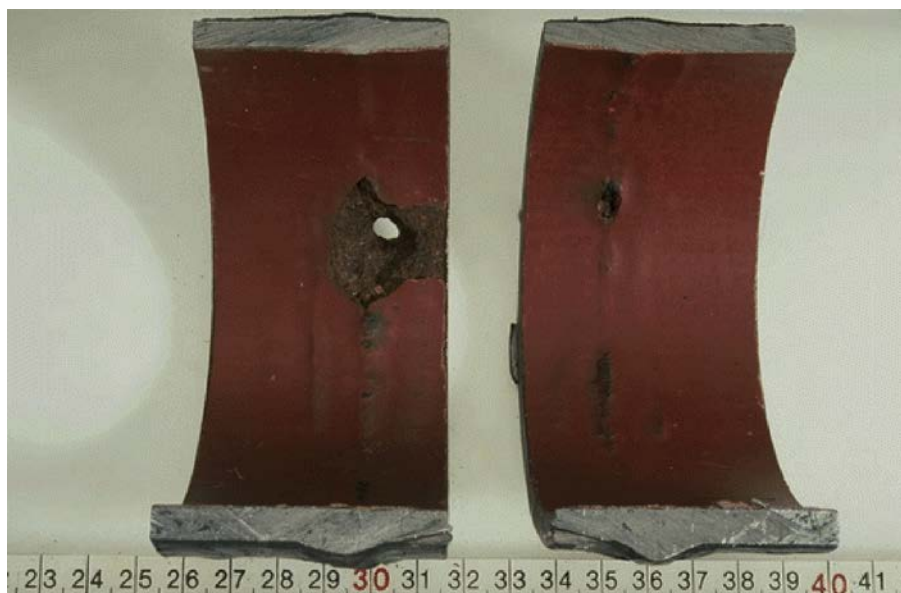
PART Pipe section (wall thickness 6 mm).

PHENOMENON Carbon dioxide/oxygen corrosion.

APPEARANCE Pitting attack near the weld.

CAUSE In situ applied internal coating leaves holidays near the weld penetration. Corrosion in these places may lead to very rapid penetration, sometimes as high as 10 mm/year.

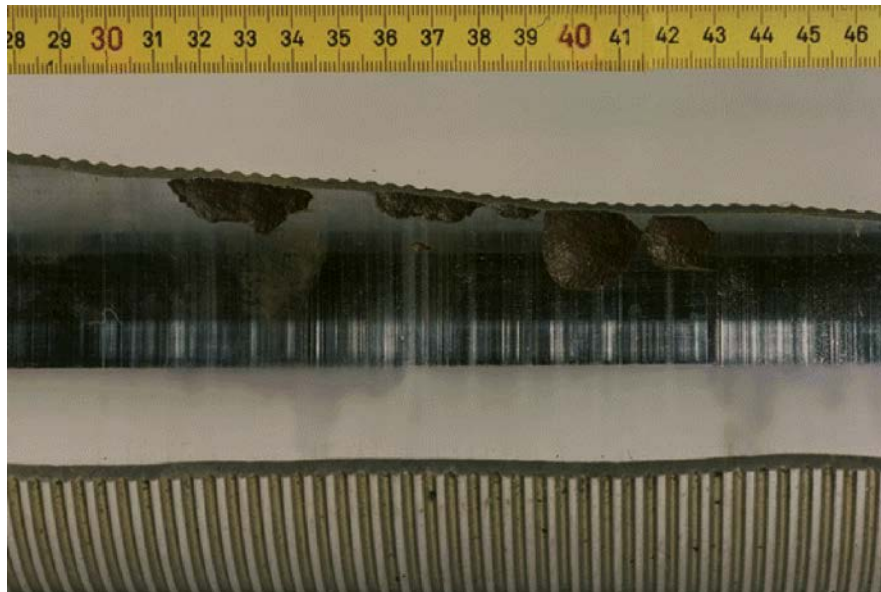
03.11.12.01

MATERIAL	Nickel plated steel (St52) (40 μm Ni + 70 μm Cr).
SYSTEM	Margarine manufacture.
PART	Perfector tube for cooling margarine with ammonia (externally).
PHENOMENON	Chloride attack.

APPEARANCE	Severe pitting on the underside of the tube.
TIME IN SERVICE	1/2 year.
ENVIRONMENT	Margarine emulsion, in mixed form during the production process, in unmixed fat and water phase during shut down.
CAUSE	During operating shut down (at night), the water phase containing 8% salt settled out and caused pitting of the coating and next of the carbon steel (galvanic corrosion may have played a contributory role via pores in the coating).
REMEDY	<ul style="list-style-type: none"> • Prevent demixing by maintaining cooling at night. • Alternative: make the perfector tubes of Stellite 6 (a highly abrasion-resistant and chloride-resistant cobalt-chromium alloy).

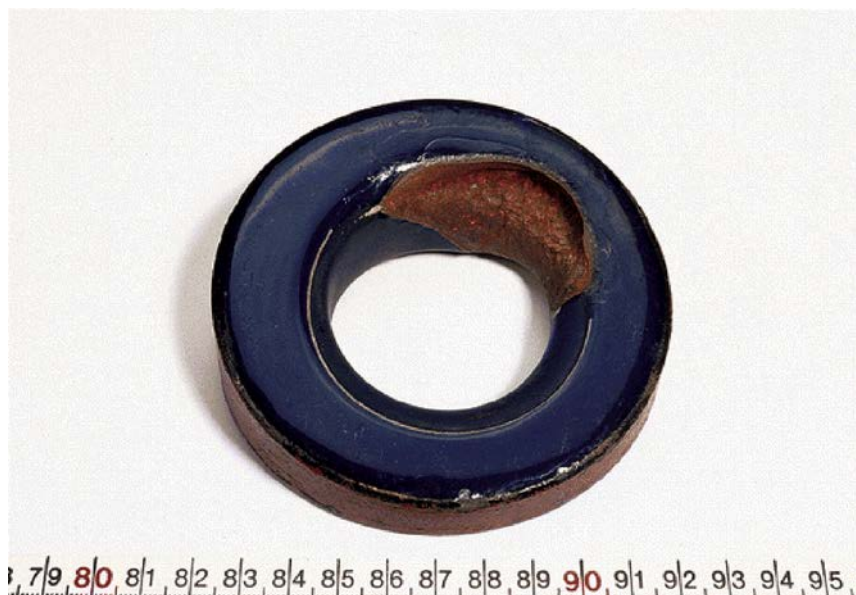
APPEARANCE Severe local attack of the enamel lining and the steel.

CAUSE Glass-lined steel, just like glass (see Case History 13.11.12.01), is not resistant to environments containing F^- at elevated temperatures. Even at room temperature, glassy materials are attacked in a diluted HF solution.

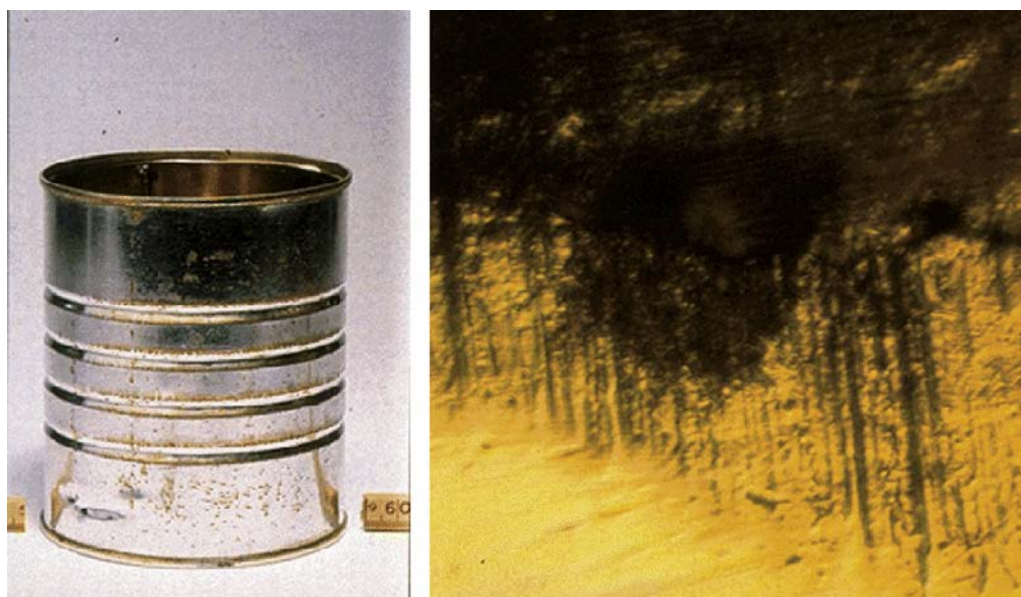
APPEARANCE Rust spots at one side of the can.

CAUSE The oxygen is dispelled from the water by the steam injection. Under anaerobic conditions, reversal of potential of the tin/iron cell takes place, after which, at the side facing the wall of the basket, the tin enters anodically into solution. The steel of the baskets and autoclave acts as cathode. After the detinning process, rusting occurs upon entry of oxygen with the cooling water (the tin coating is now cathodic relative to the steel in the pores).
