Corrosion Atlas

THIRD, EXPANDED AND REVISED EDITION

A Collection of Illustrated Case Histories

Evert D.D. During

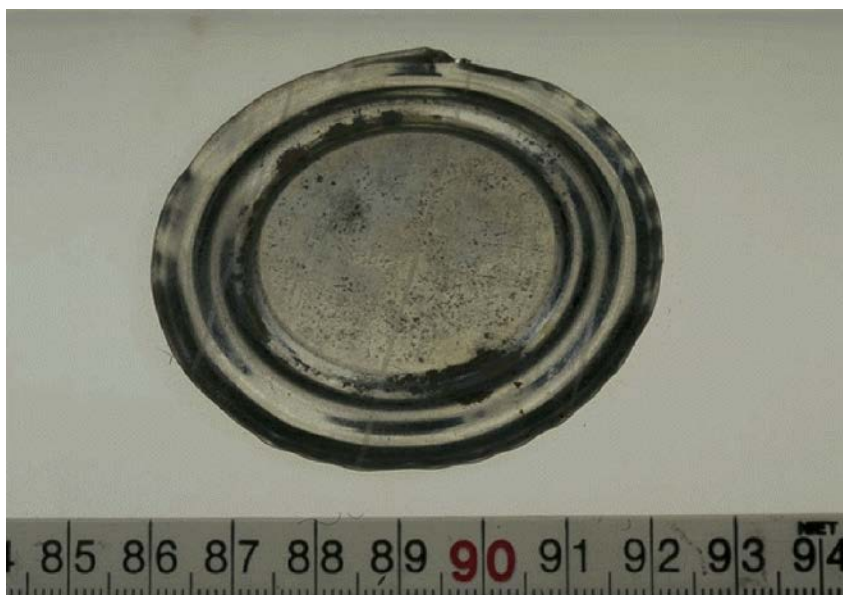
03.11.14.02

MATERIAL	Tin-plated steel.
SYSTEM	Dairy.
PART	The inside of the base of a can.
PHENOMENON	Galvanic corrosion.

APPEARANCE Black corrosion patches and spots.

CAUSE The porous tin coating is unable to prevent corrosion in contact with low-fat milk. In the case of other foods, the corrosion will only occur after an extended period or not at all because the products contain colloids which act as an inhibitor, or tin-complexing substances such as benzoic acid. In the latter case, the tin surface becomes less noble than the steel surface so that no corrosion occurs.

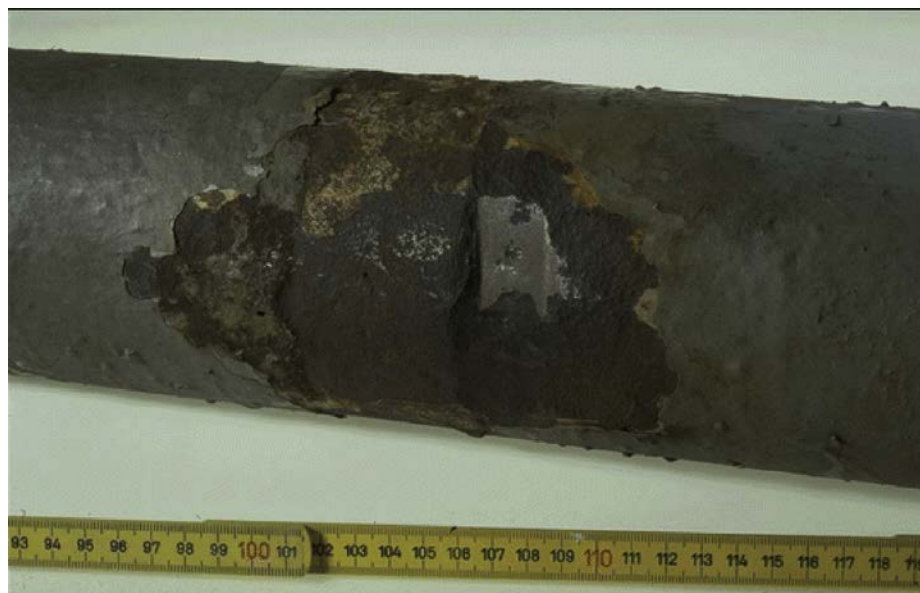
APPEARANCE The coating flaked off at the I-beam support, and the steel pipe was attacked.

CAUSE Moisture (in the form of acid chloride-containing rainwater and salt-containing droplets from the cooling towers installed in the direct vicinity) remains between the pipe and the I-beam.

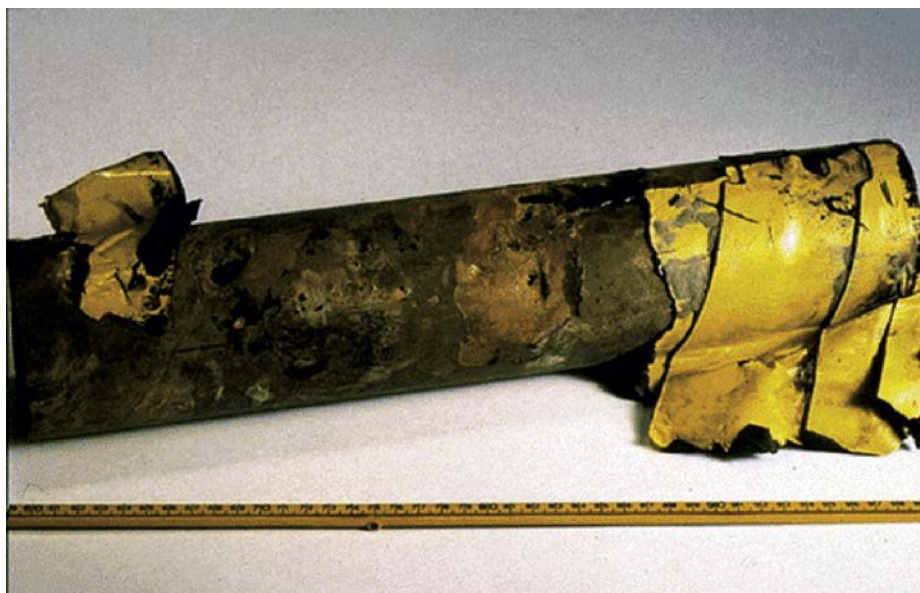
APPEARANCE Severe local attack.

CAUSE Owing to poor application (the result of poor workmanship), the bandage (X dur coat) had become detached at a number of points and water present underneath it probably became anaerobic, allowing sulfate-reducing bacteria to develop (sulfide detected in corrosion products). The resultant sulfide attacked the steel.
Note: Any unprotected pipe will be attacked by groundwater without sulfate-reducing bacteria as well.

REMEDY Affected sections should be replaced by properly wrapped pipe.

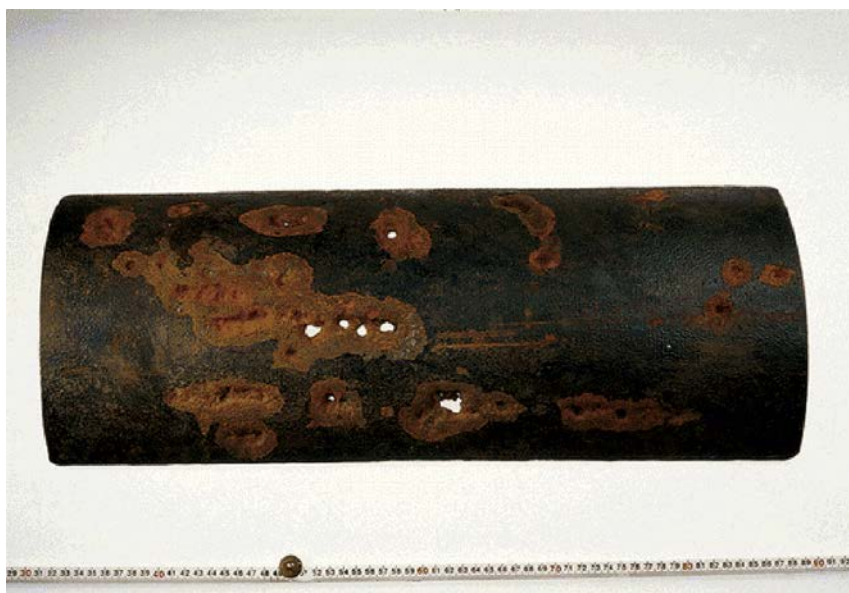
APPEARANCE Severe localized attack.

CAUSE When the soil was compacted after the pipe was laid, the bitumen coating was damaged by the slag, after which the exposed cast iron was attacked by sulfide formed from sulfate by sulfate-reducing bacteria (see also Case History [03.10.17.01](#)).

REMEDY Pipe was replaced by a bitumen-coated steel pipe laid in a homogeneous sand bed.

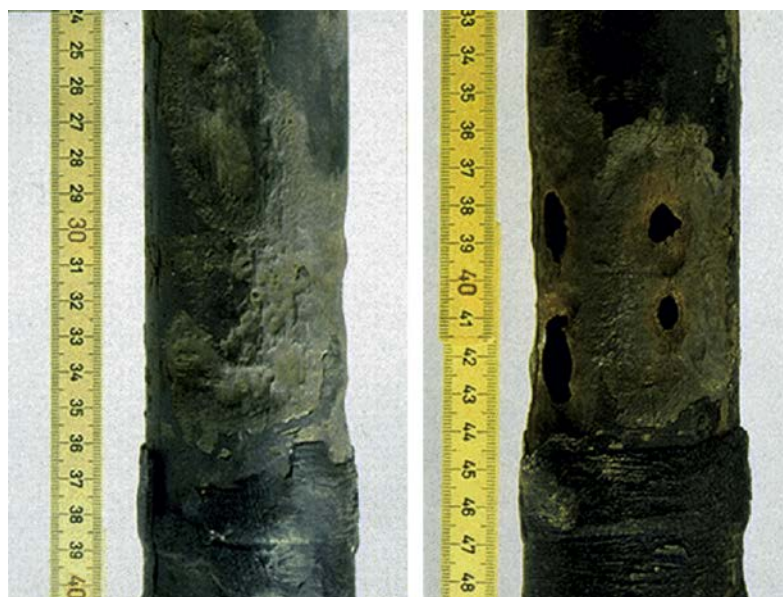
APPEARANCE Severe local attack in part near home connection.

CAUSE The gas pipe was used for earthing electrical appliances in the home; the earthing currents left the pipe underground and caused local attack (see also Case History 01.05.26.01).

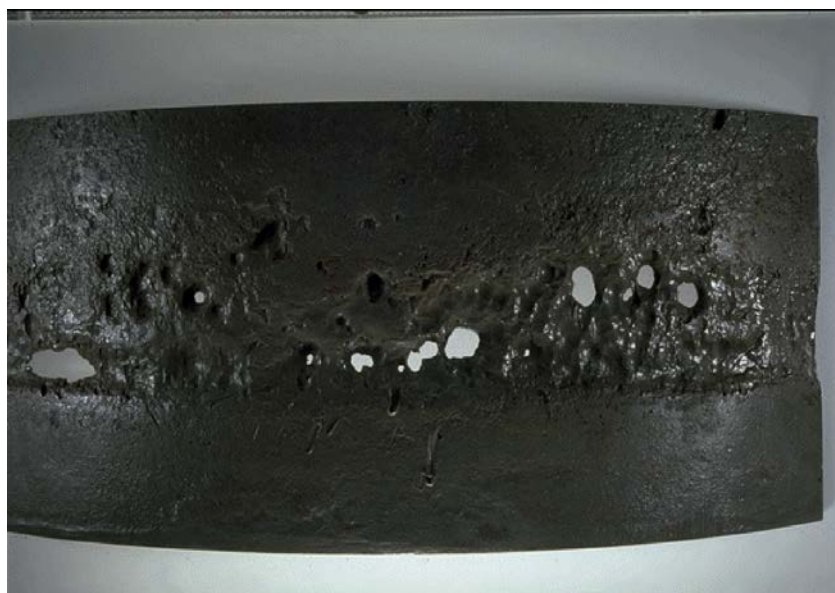
APPEARANCE Localized corrosion with many holes, before the socket connection.

CAUSE The bitumen-coated pipe ran parallel with a tram-line. Absorbed stray currents left the pipe just before the socket connection (hemp and lead).

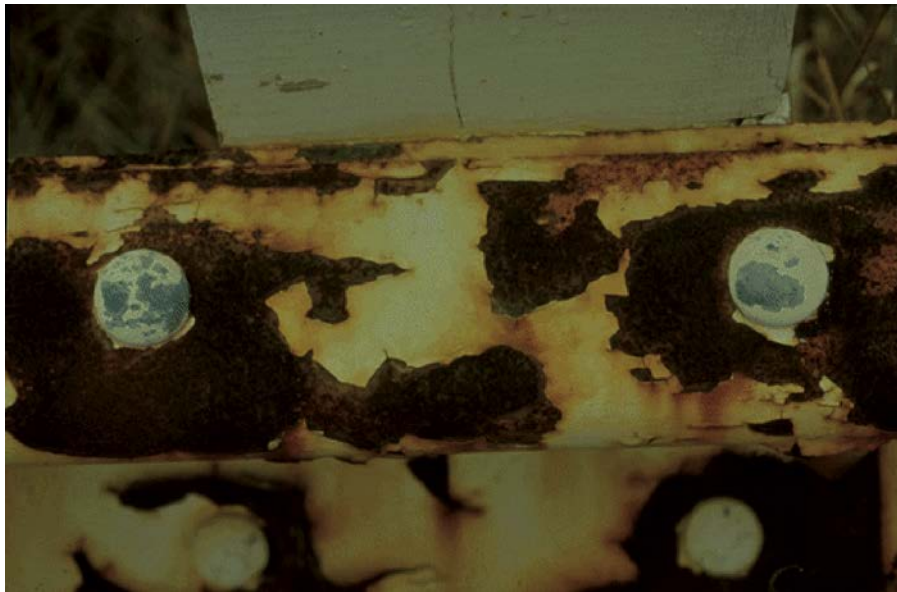
APPEARANCE The paint coating has flaked off due to under-rusting, the bare steel is uniformly corroded, but the galvanized steel bolts are corrosion-free.

CAUSE Painting bare steel provides insufficient local protection against corrosion. The galvanized steel girders, gutters, angle plates, bolts, nuts, etc., however, exhibited no rust after 10 years (see also Case History 02.17.24.06).

REMEDY The corrosion could have been prevented by subjecting all the steel bridge components plus attachment fittings to hot-dip galvanizing treatment.

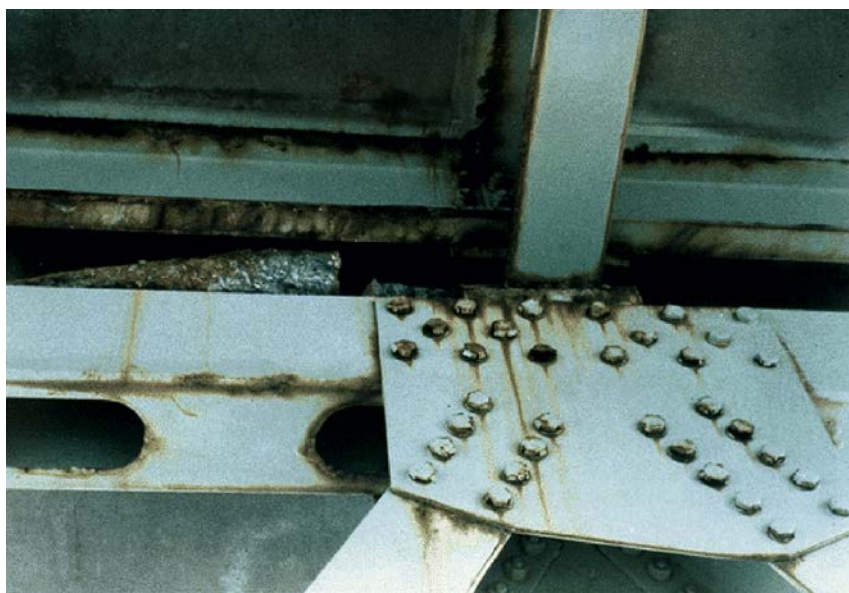
APPEARANCE General rusting on edges, bolt heads, flat, and recessed areas.

CAUSE Poor application because the coating used was not adequate for the exposure. The coating surface tension pulls coatings away from sharp corners and edges, causing rapid penetration of edges and thin areas.

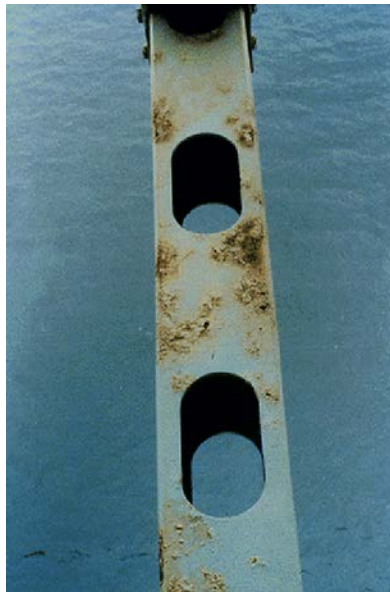
APPEARANCE General rust penetration through the coating. Failure on plane surfaces with severe undercutting of the coating.

CAUSE Inappropriate coating selection. This coating was new and had never been previously applied or tested. The first application of this coating failed within 2 years at both edges and plane surfaces. It was reapplied and failed similarly after 2 years. The photograph shows the second application (see also Case History [03.21.40.08](#)).

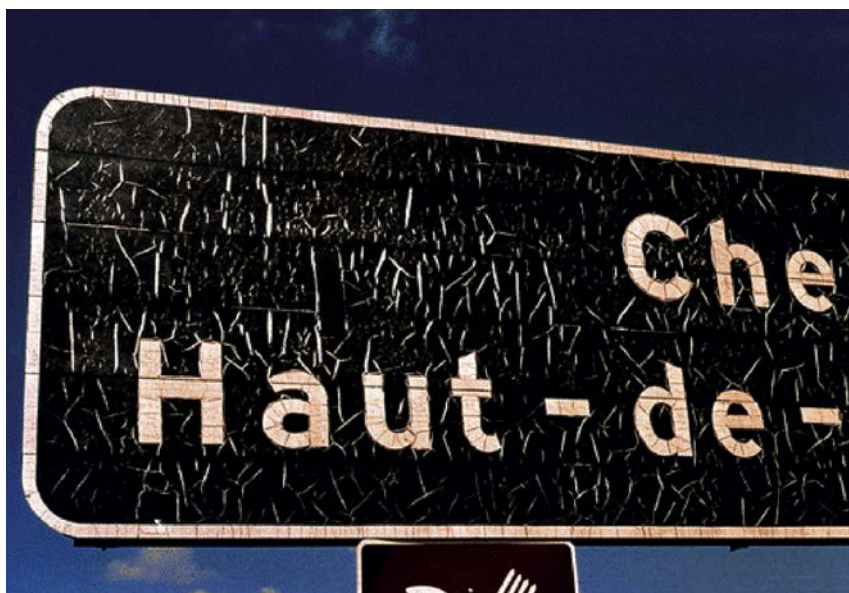
APPEARANCE General large checking overall: a crack system not penetrating to the substrate.

CAUSE Inappropriate coating selection. Checks are caused by weathering, oxidation, and polymerization. Excessive shrinkage of the alkyd top coat on curing over a softer less highly cured primer causes this type of coating failure over a period of time. Some pigments may stimulate the crazing process.

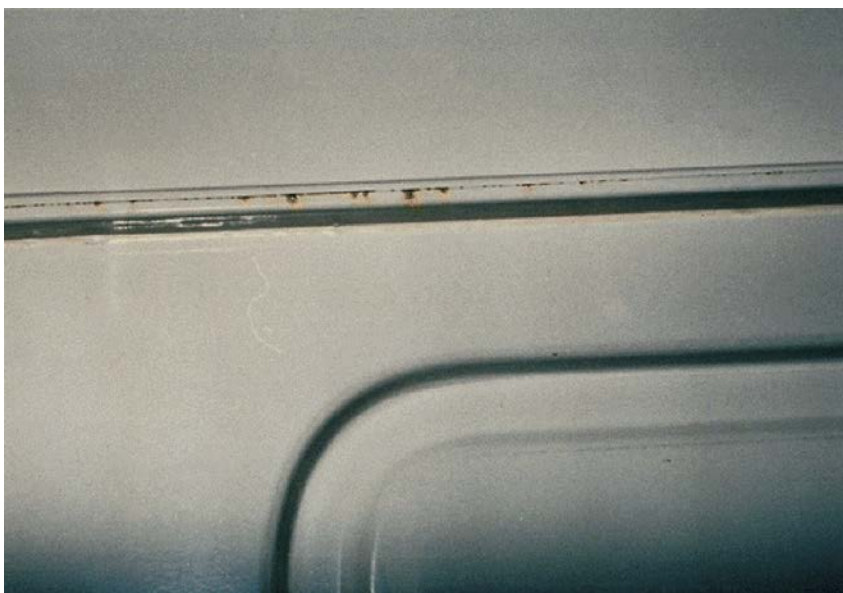
APPEARANCE Edge corrosion.

CAUSE Poor pretreatment before coating:
Sharp edges on rain gutter due to poor deep-drawing and grinding activities in body shop prevented effective covering.

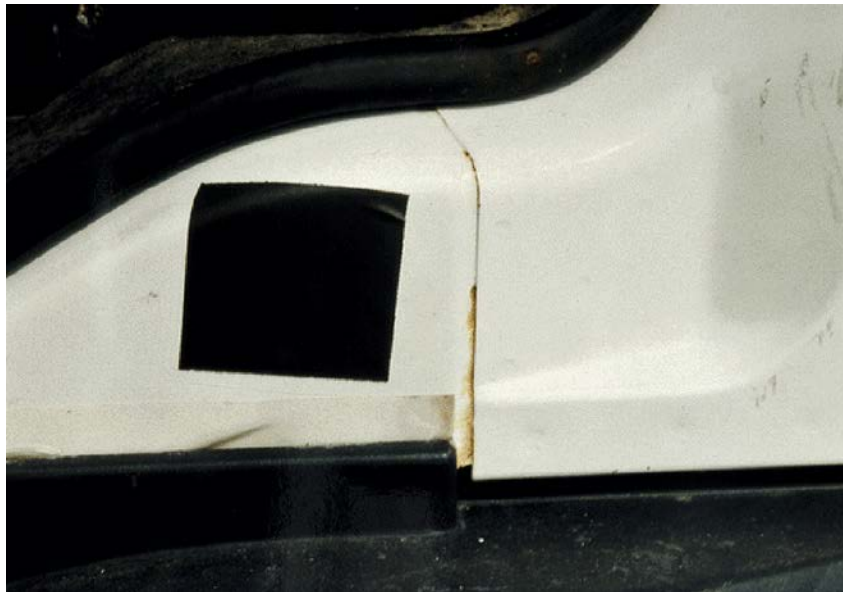
APPEARANCE Rust (water) bleeding from seams.

CAUSE Poor coating application: no extra corrosion protection between seams, poor seam sealing (see Case Histories [03.20.24.05/06/08/09](#)).

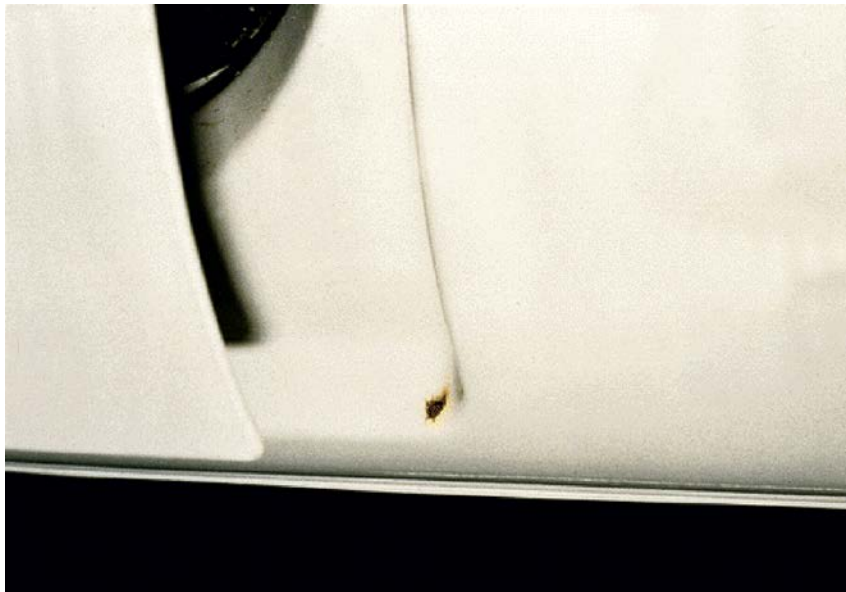
APPEARANCE Rust on damaged part(s).

CAUSE Poor fit and finish caused paint damage.

REMEDY Improve positioning of door in order to overcome paint damage on the body due to closing of the cab door.

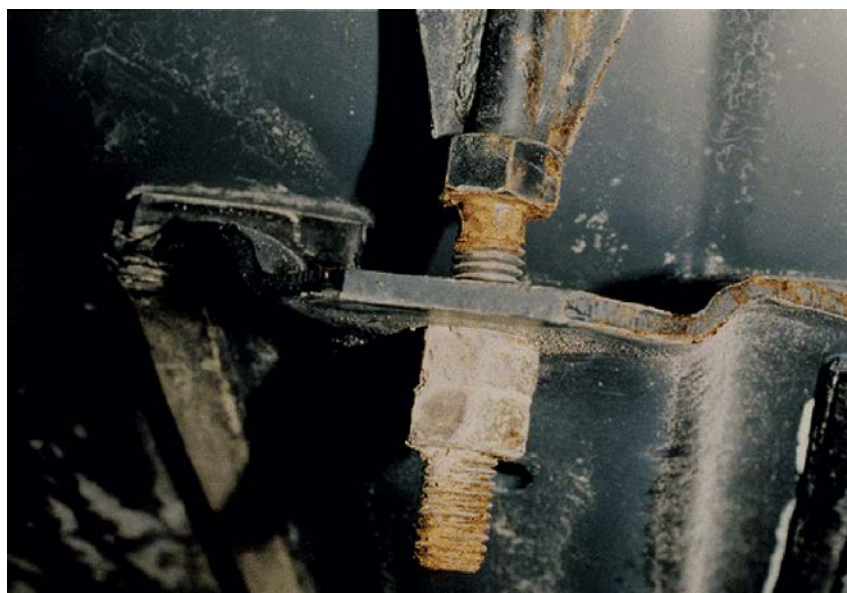
APPEARANCE Rust on welded part; edge corrosion; rust on screw.

CAUSE “Overall” corrosion, by a combination of dirt, road salts and humidity, caused by poor pretreatment and application:

- scale on weld, paint damage due to distortion of the support (weight of fuel tank);
- sharp edges (see also Case History [03.20.24.01](#));
- paint damage due to screwing of bolts.

- Descaling of the weld.
- Removing sharp edges before painting.
- Application of wax-based corrosion protection after final assembly.

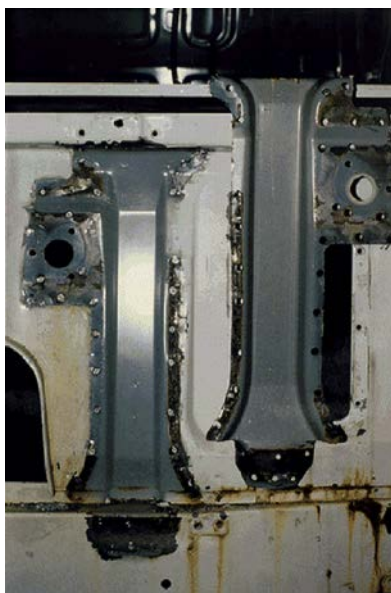
- Rusting of spot-welded seams.
- Rust bleeding.

- Insufficient protection of the spot-welded seams.
- Crevice corrosion by a combination of dirt, road salts, and humidity.

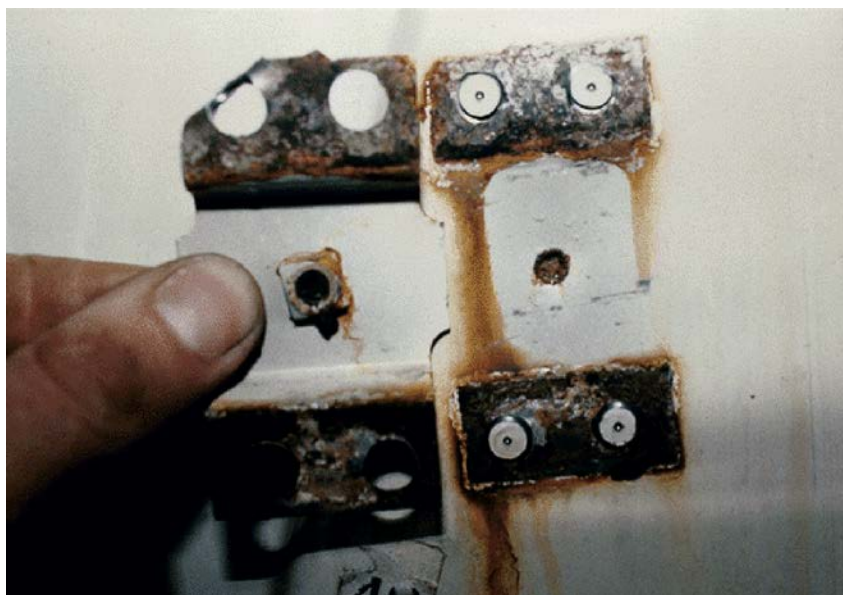
APPEARANCE Rust in seam, rust bleeding from seam.

CAUSE No corrosion protection on support caused crevice corrosion in seams (see Case History [03.20.24.09](#)).

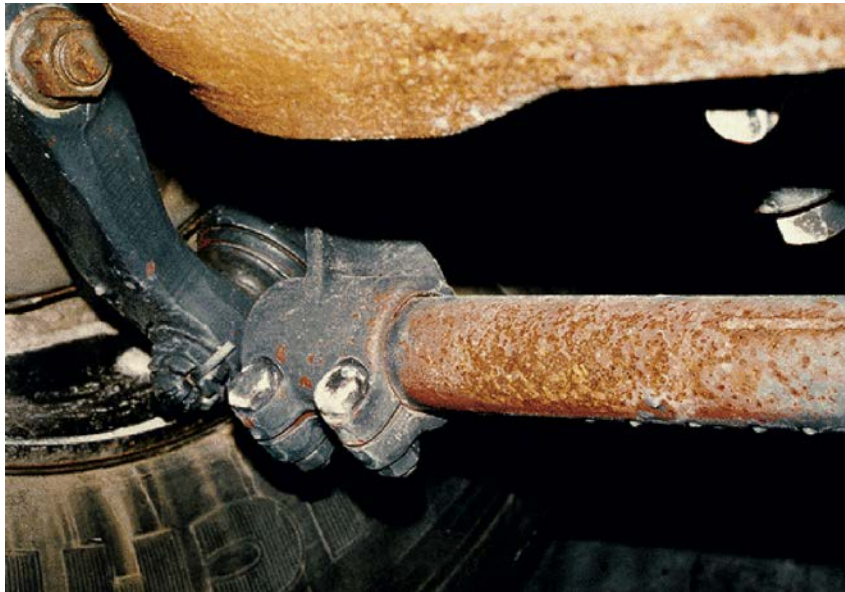
APPEARANCE Stone chipping with rust.

CAUSE Paint damage due to stone chipping in combination with dirt, road salts, and humidity, resulting in rusting.

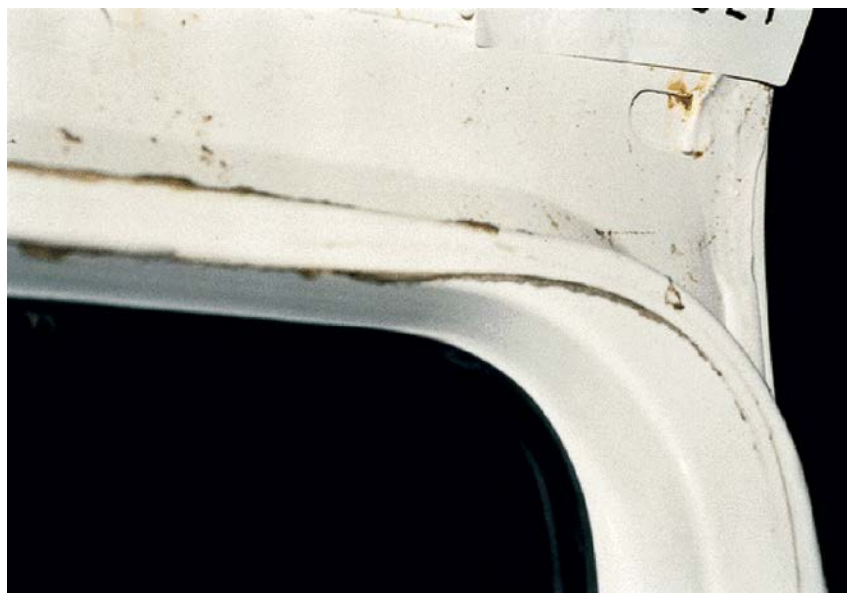
APPEARANCE Rust bleeding from clinched seam.

CAUSE Crevice corrosion in overlap seams, by a combination of dirt, road salts, and humidity. Poor painting of overlap, insufficient corrosion protection in overlap (see Case Histories [03.20.24.02/05/06](#)).

- Improve application of adhesive in overlap, and use a more corrosion-resistant clinch adhesive.
- Improve cavity waxing (after painting).

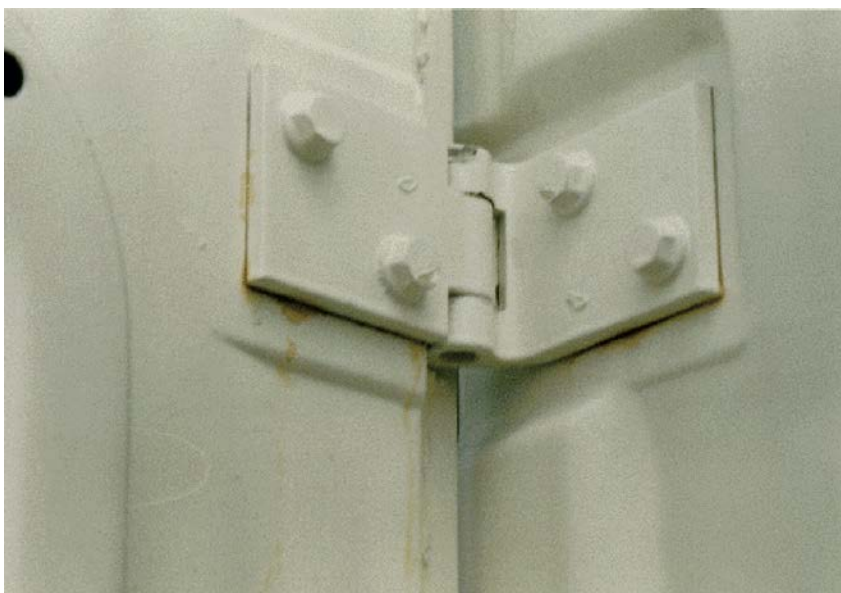
APPEARANCE Rust water coming from the overlap between hinge and cab, and hinge and door panel.

CAUSE Poor coating application: absence of paint in overlap between hinge and cab panel made this connection sensitive to crevice corrosion because of oxygen concentration cell formation (see also Case History [03.20.24.06](#)).

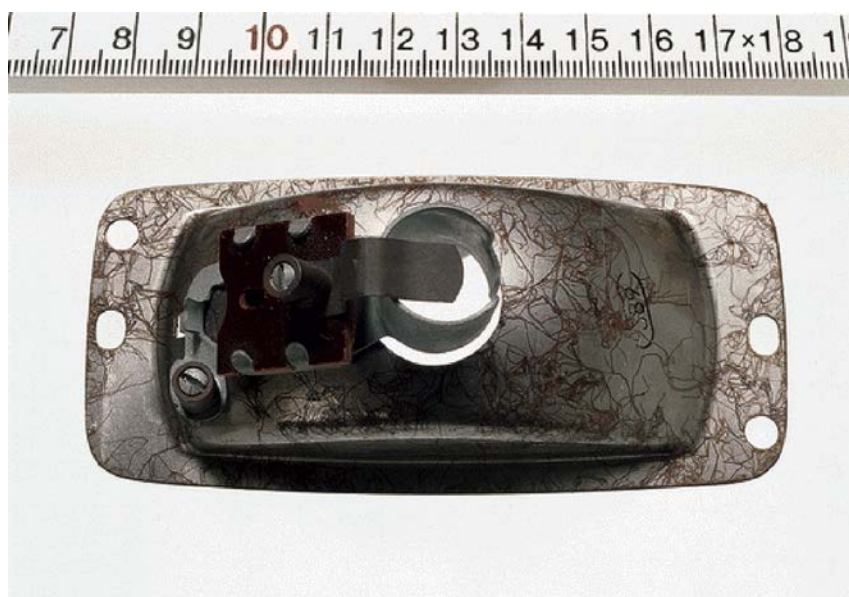
03.20.41.01

MATERIAL	Varnished steel.
SYSTEM	Automotive system.
PART	Light reflector, with clear enamel coating.
PHENOMENON	Filiform corrosion.

APPEARANCE	Corrosion of the steel under the coating in the form of hairlike filaments, starting from the edges.
TIME IN SERVICE	More than 10 years.
ENVIRONMENT	Storage in moist indoor atmosphere.
CAUSE	The discontinuity of the coating system at the edges and at defects elsewhere, allowing moisture to diffuse underneath coating, resulting in a filiform, fanning-out corrosion of the steel. Filiform corrosion is activated by chlorides. Oxygen concentration cells are formed between the moving end (head = anode) and the remainder of the track (tail = cathode). The pH at the head drops to 1.5–2.5 (see also Case Histories 03.24.41.01 and 12.20.41.01).
REMEDY	<ul style="list-style-type: none"> • Storage under less moist conditions (humidity below 65%). • Apply a different coating system (with at least two coats) after pretreatment of the steel surface. • Prevent the presence of chlorides and other salts by rinsing with demineralized water before coating.

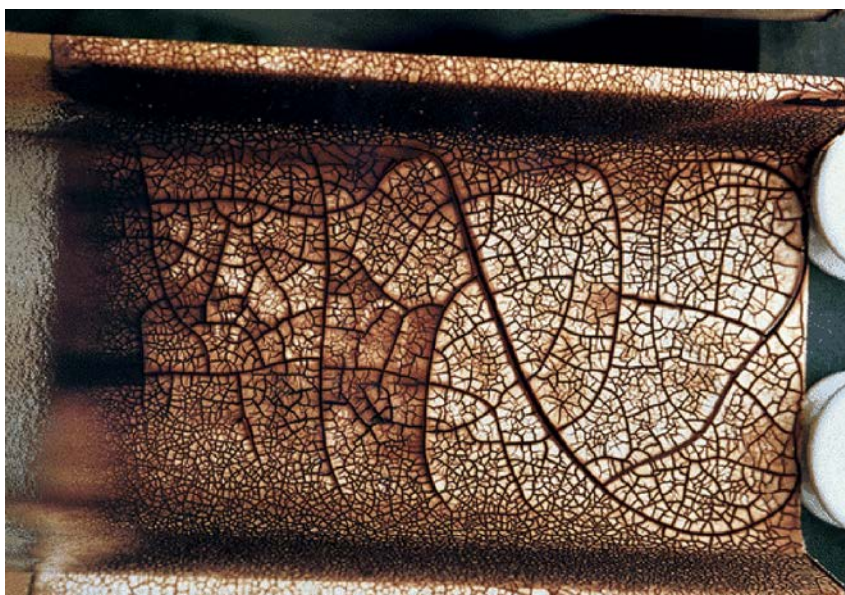
03.21.40.01

MATERIAL	Heavy epoxy coat over steel.
SYSTEM	Steel structure.
PART	Gutter on an offshore installation.
PHENOMENON	Coating failure (cracking).

APPEARANCE	General long curved cracks overall. All cracks penetrate to the substrate. Corrosion starting at steel interface.
TIME IN SERVICE	Several months.
ENVIRONMENT	Marine.
CAUSE	Inappropriate coating selection. Poor expansion and contraction characteristics of the coating. Continued oxidation and polymerization over a long period of time leads to excessive coating shrinkage, causing cracks down to the bare metal. Improper pigmentation may aid in the weather-related cracking process (as with checking, see Case History 03.17.40.01). Oxidizing coatings are often more susceptible to cracking than are the fully polymerized thermoplastic-type resins.
REMEDY	Select a weather-resistant coating which incorporates reinforcing pigments and permanent plasticizers in order to add some extensibility and flexibility to the coating.

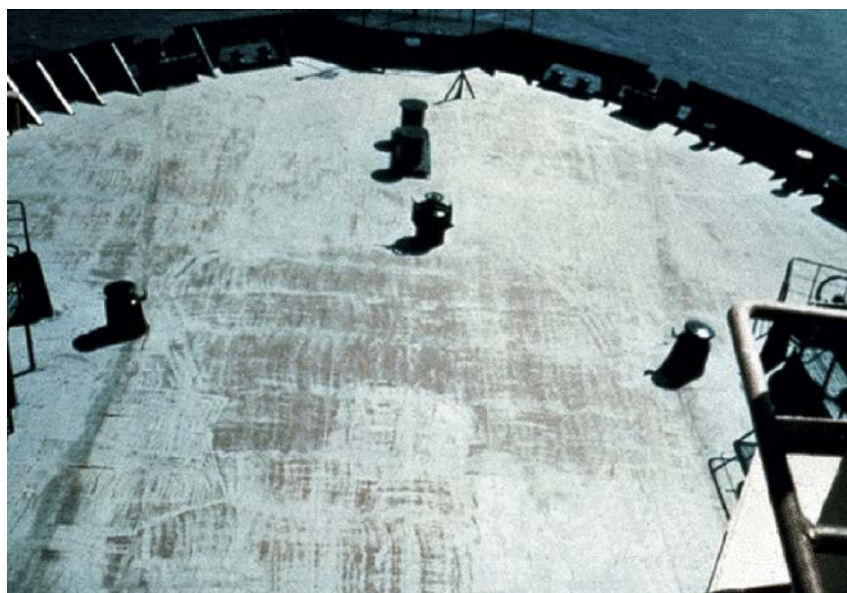
APPEARANCE General soft, dusty surface. Only the top coat is attacked. The intact red epoxy primer shines through the powdered grey top coat.

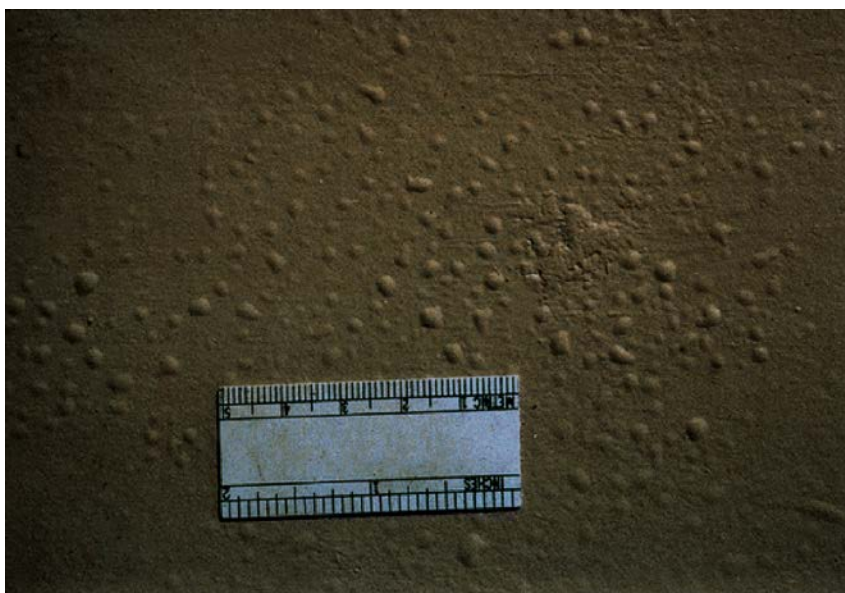
APPEARANCE Severe fine blistering of the coating. After removal of the coating, corrosion was found.

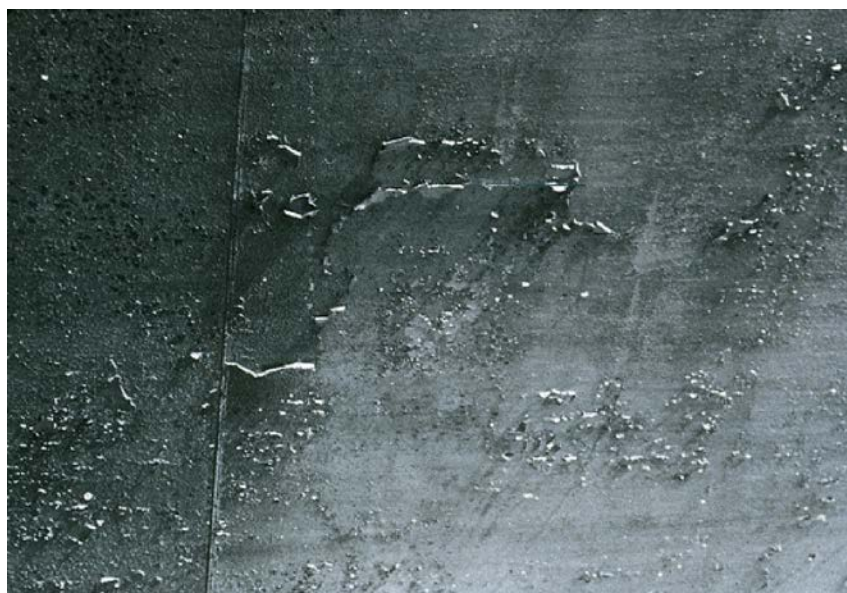
APPEARANCE Scaling and peeling of one coat from another.

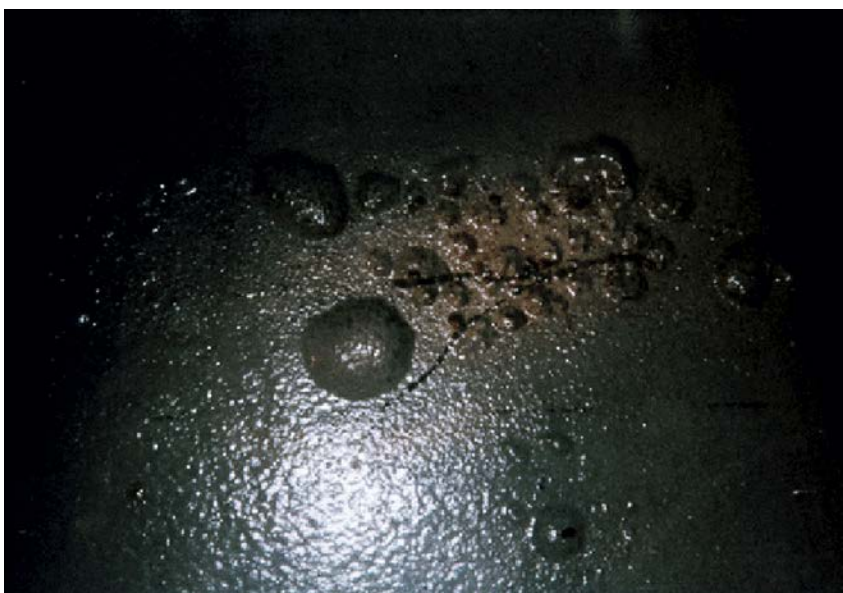
APPEARANCE Blisters and rust surrounding break in coating.

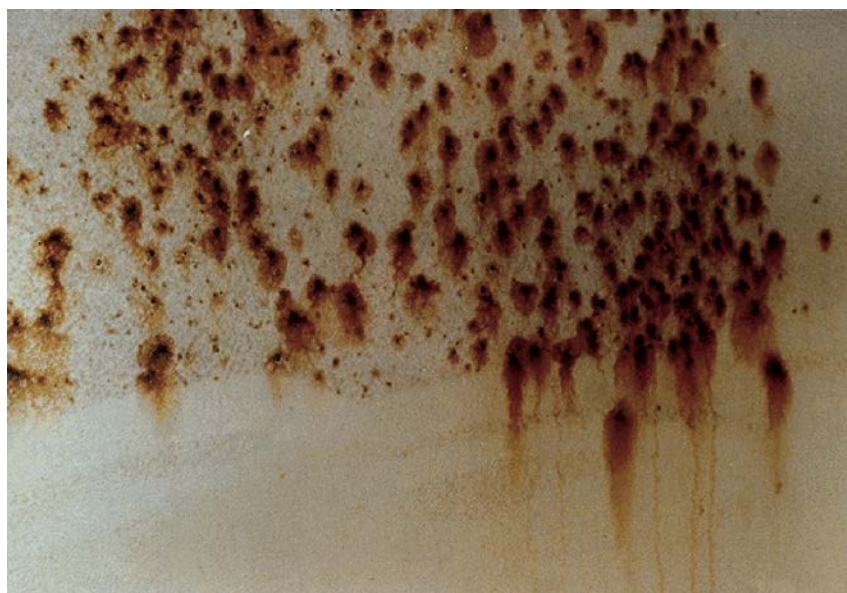
APPEARANCE Rusty pinpoint area above clean area.

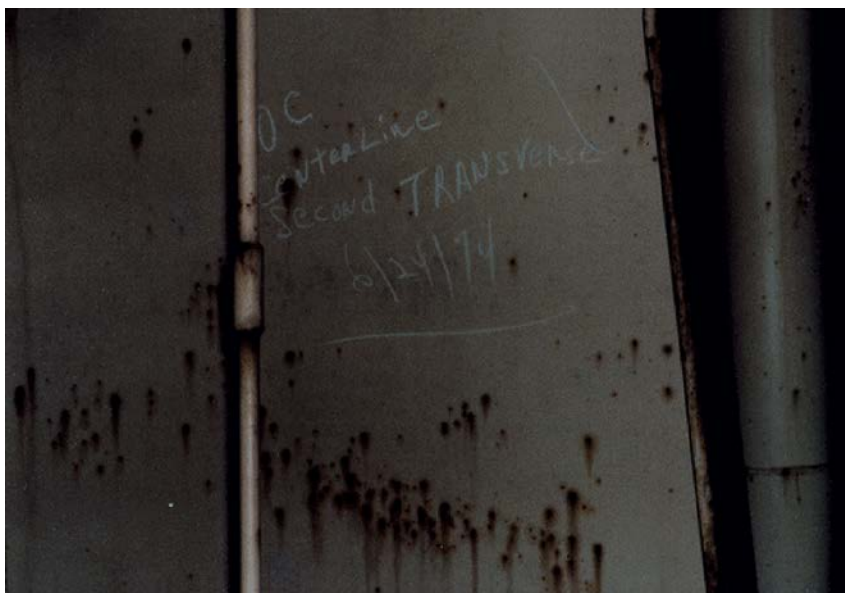
APPEARANCE Small rusty tubercles in the coating. Note that the area between pinholes is relatively free of corrosion. Only the pinholes which penetrate to the substrate show corrosion.

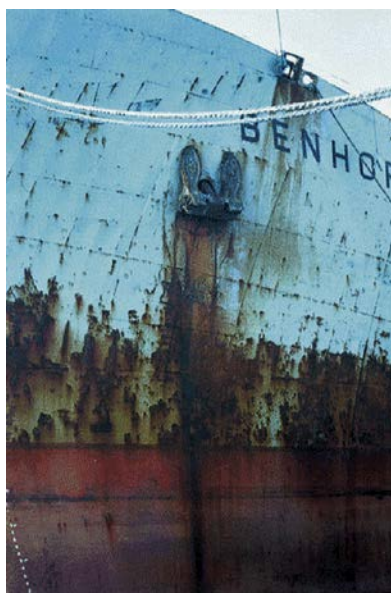
APPEARANCE General rusting and coating break-down.

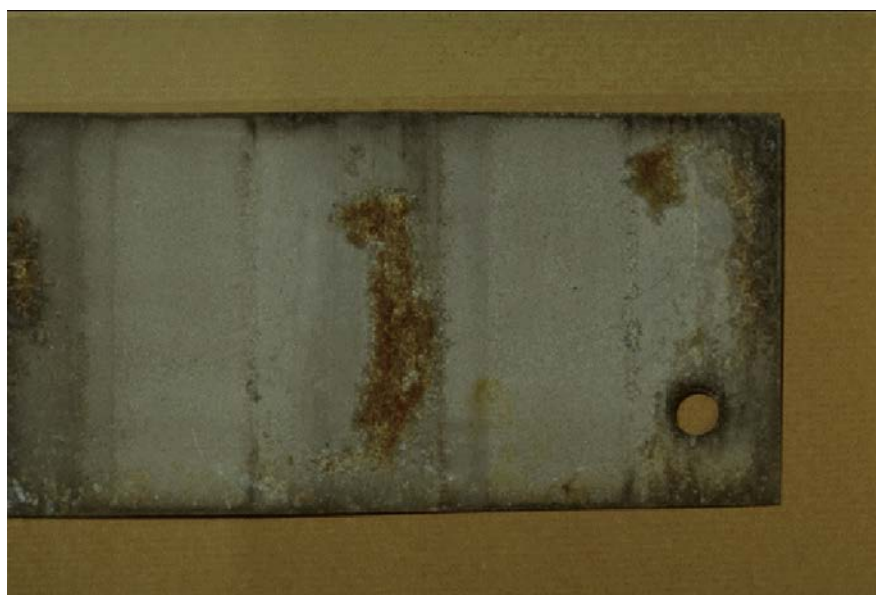
APPEARANCE Locally the surface exhibits slight corrosion.

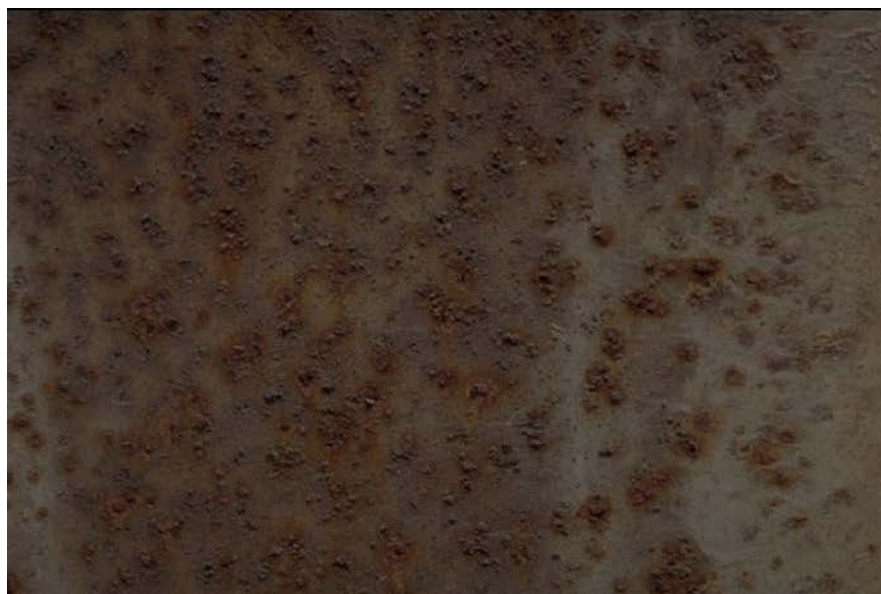
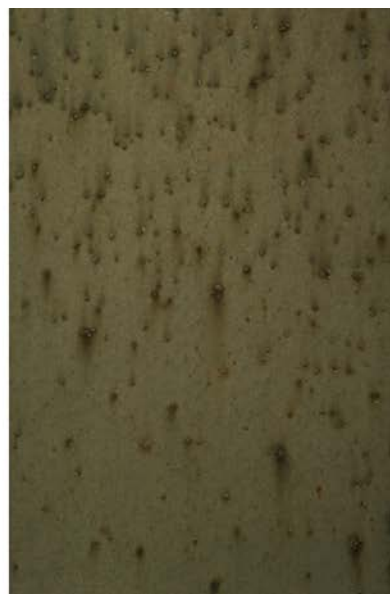
APPEARANCE Pitting corrosion over the entire surface.

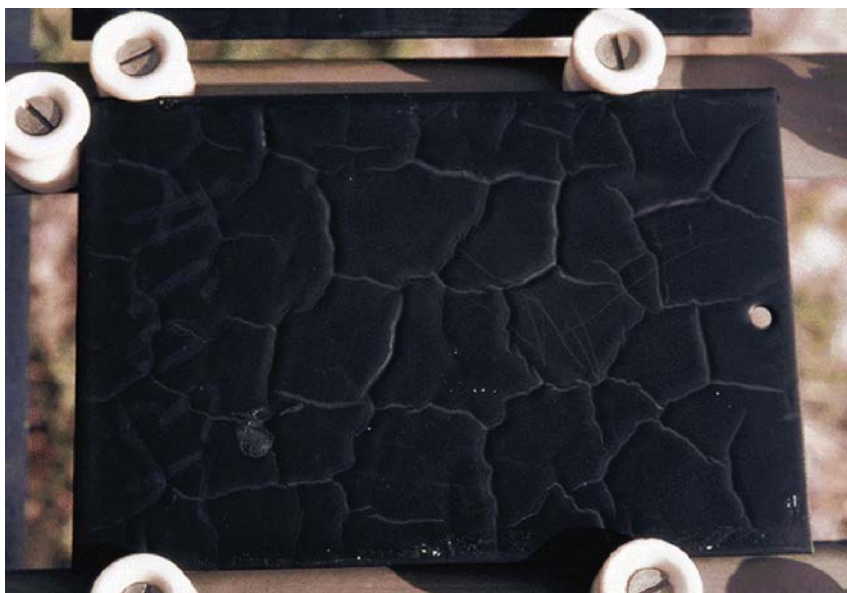
APPEARANCE General large (some cm Ø) checking in an alligator (or dried mud) pattern in the top coat (not to the substrate).

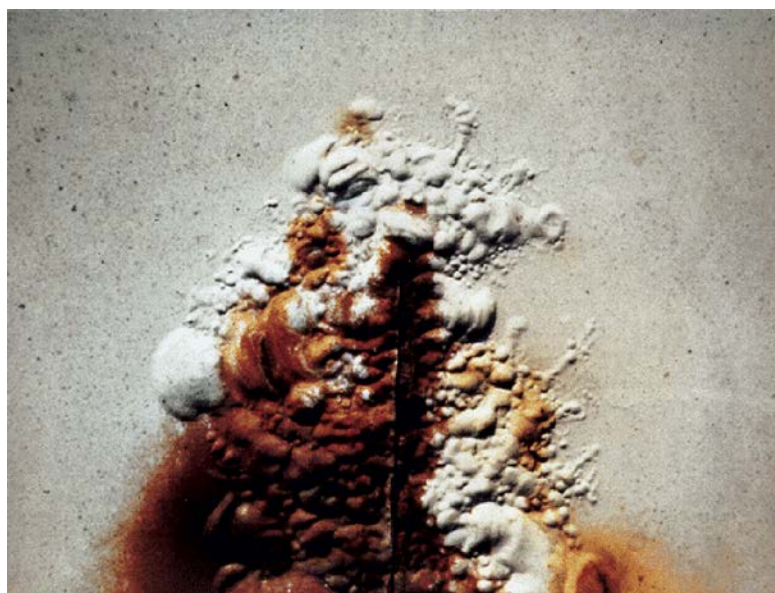
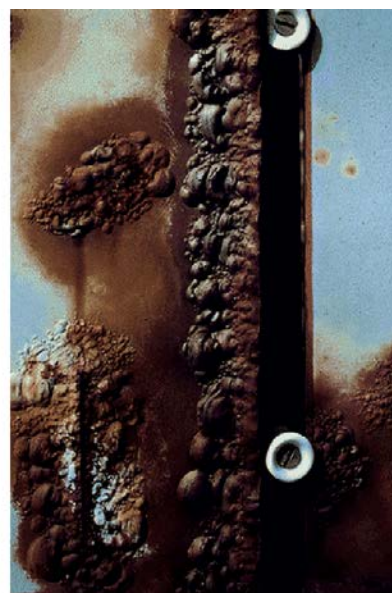
03.24.40.02

MATERIAL	Epoxy polyamide coating (three coats) over steel.
SYSTEM	Weathering test rig.
PART	Coated steel panels (coating thickness 250–300 μm).
PHENOMENON	Coating failure (undercutting).

APPEARANCE	Severe rusting at the scribe (left photo) and at the edge (right photo) with penetration of the rust under the film to blistering. The plain surface is corrosion free.
TIME IN SERVICE	3 years (corrosion started almost immediately at the scribe).
ENVIRONMENT	Marine –15 m above high tide along the coast.
CAUSE	Poor coating adhesion caused by application of the coating over a contaminated surface (mill scale, rust, oil, dirt, and dust). Oxygen will penetrate under the film from a break in the coating, causing the growth of iron oxide underneath the film. As the oxide builds up, it expands under the coating, causing the blistering effect. Chloride in the atmosphere will accelerate the corrosion process.
REMEDY	<ul style="list-style-type: none"> • Use a very highly adherent coating over a properly abrasion-blasted surface which is perfectly clean and free of contamination, or • Apply the epoxy over an inorganic zinc primer.

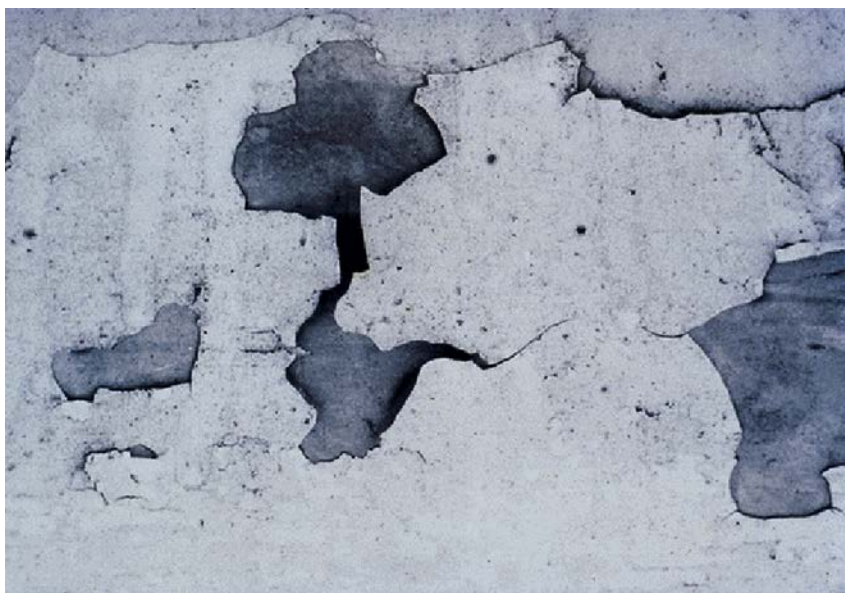
APPEARANCE Coating is pulling away from the substrate.

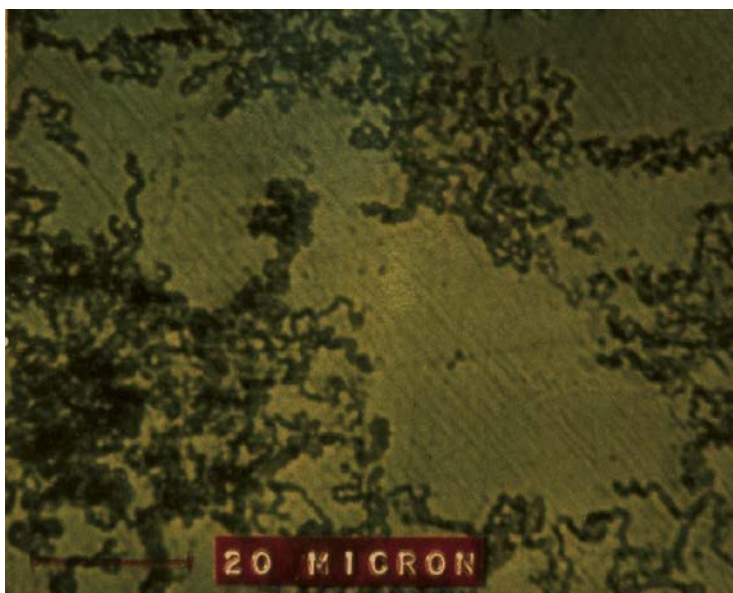
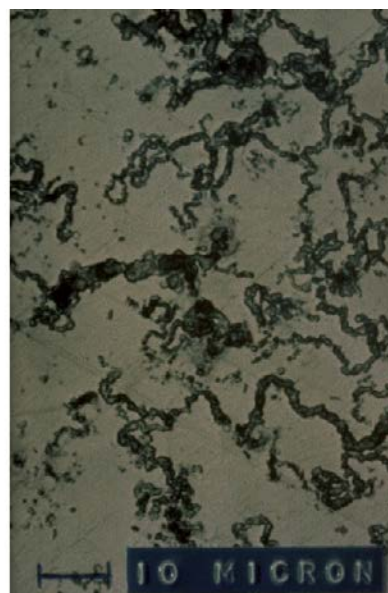
PART Plates for instrument cabinets.

PHENOMENON Filiform corrosion.

APPEARANCE Corrosion under the coating in the form of hairlike filaments.

CAUSE As a result of local differences in humidity on the smooth surface, differential aeration cells originated, and iron oxide hydrate begins to form from the edges, fanning out beneath the coating (filiform corrosion). The transparent coating allows locally intensified diffusion of moisture to occur, thereby creating initiation points for filiform corrosion (see also Case Histories [03.20.41.01](#) and [12.19.41.01](#)).

- Keep the humidity below 65% if possible.
- Apply a different coating system (with at least two coats).

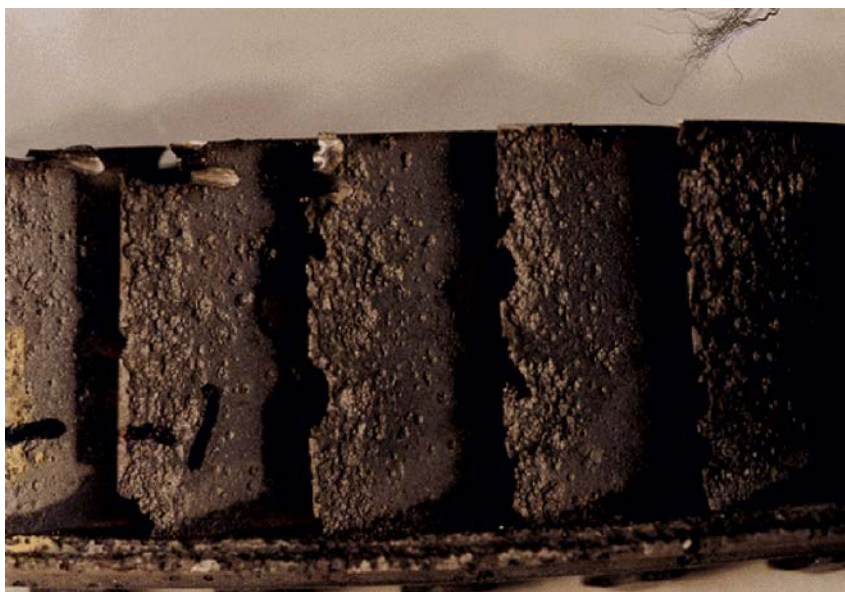
PART Blades from high-pressure condensing stage.

PHENOMENON Acid corrosion.

APPEARANCE Severe pitting especially at the edges; parts are corroded away. Deposits were removed to reveal attack.

CAUSE Because of vaporous carry-over, the steam contained salts from the boiler water. These salts (chlorides and sulfates) were deposited on the blades. Hydration caused severe corrosion due to hydrolysis (see also Case History [04.11.04.01](#)).

REMEDY Preventing carry-over by good boiler-water conditioning and the best possible steam/water separation equipment.

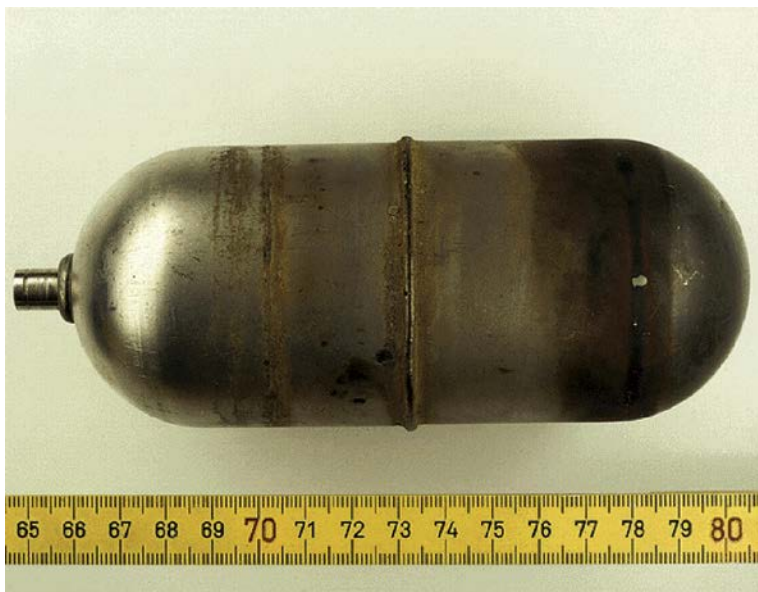
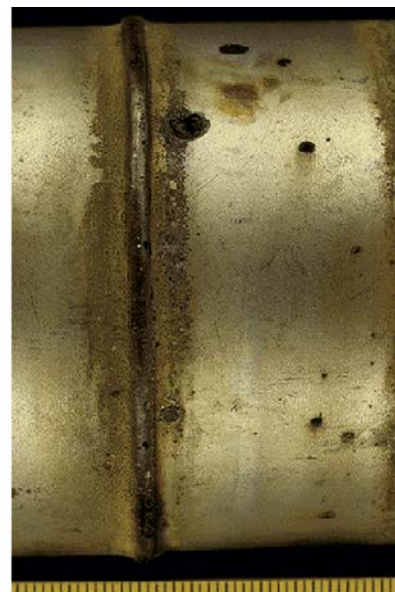
04.01.14.01

MATERIAL	Stainless steel (AISI 316).
SYSTEM	Boiler feedwater system.
PART	Float of feedwater deaerator tank.
PHENOMENON	Galvanic corrosion (deposition corrosion).

APPEARANCE	Pitting under blue-green deposits.
TIME IN SERVICE	2 years.
ENVIRONMENT	Boiler feedwater with low oxygen concentration.

CAUSE Copper originating from the copper condensate lines has deposited on the stainless steel surface of the float. Since this surface was activated because of low oxygen content, it was less noble than the copper particles. As a result of this, galvanic corrosion took place by cathodic contamination of the anode (see also Case History 02.05.14.04).

REMEDY Because copper deposition caused problems in the boiler too, a cation exchanger was placed to eliminate the copper from the condensate.

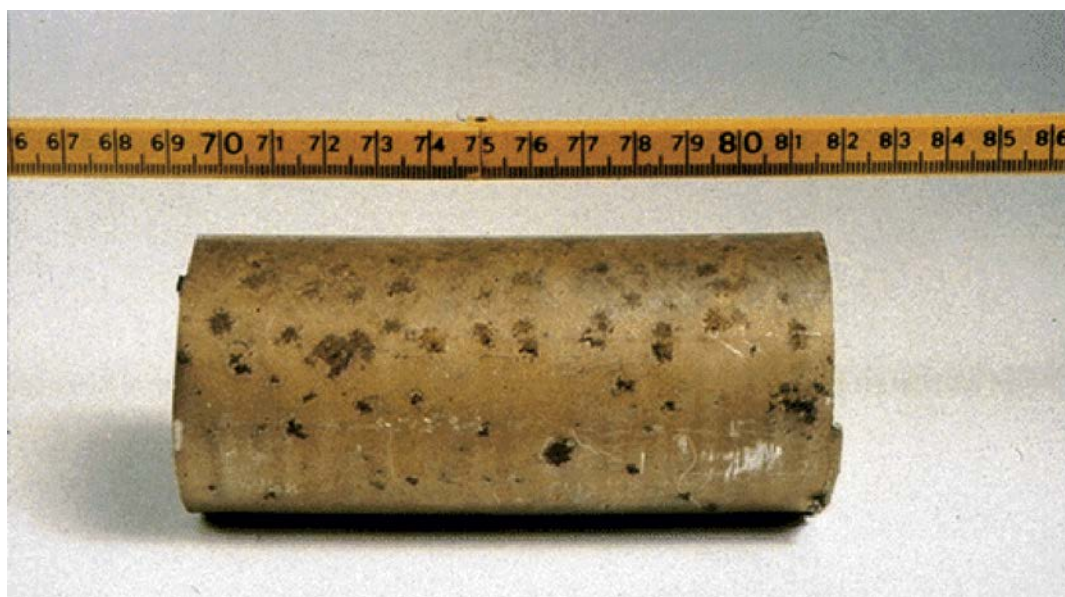
PART Steam coil.

PHENOMENON Under-deposit corrosion.

APPEARANCE Pitting attack concentrated at upper part of coil.

CAUSE Deposition of iron oxide from the condensate caused pitting by forming differential aeration cells (a form of crevice corrosion) (see also Case Histories [04.06.15.01/02/03](#)).

REMEDY Feeding of the iron-containing condensate directly into the deaerator; the presence of iron oxide in the condensate indicates corrosion in the condensate system, and measures should be taken to prevent this.

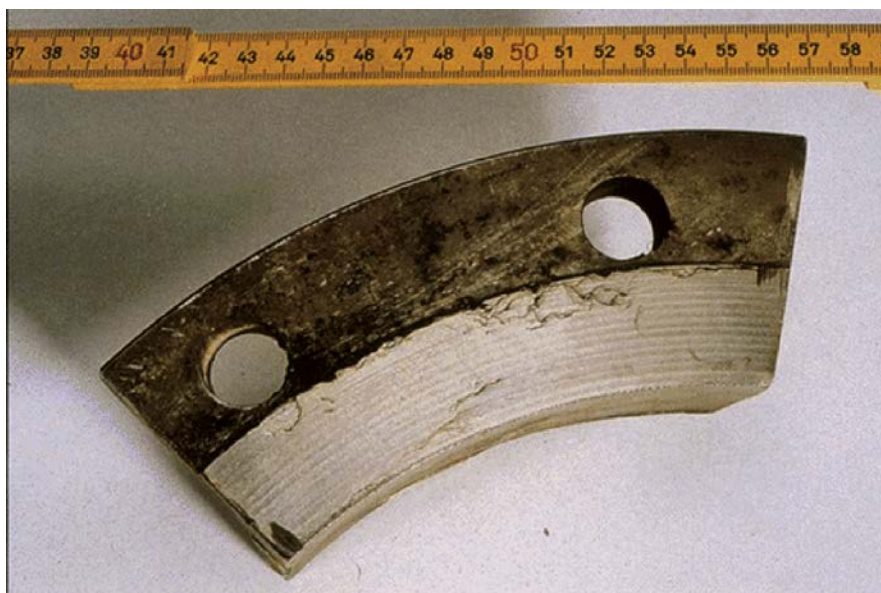
PART Flange.

PHENOMENON Stress-corrosion cracking (transgranular).

APPEARANCE Cracking on seal surface.

CAUSE Stress corrosion due to bonding the seal with chloride-containing adhesive (the seal was bonded in order to prevent crevice corrosion!) (see also Case Histories [04.02.18.01/02](#) and [04.11.18.01](#) and following).
