Corrosion Atlas

THIRD, EXPANDED AND REVISED EDITION

A Collection of Illustrated Case Histories

Evert D.D. During

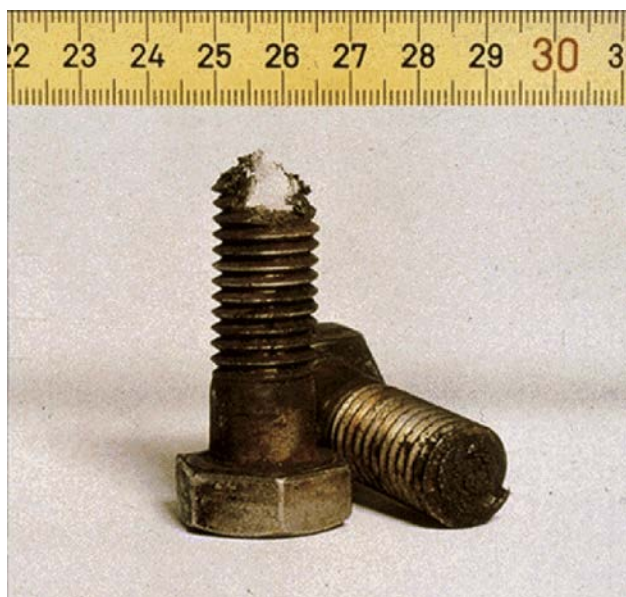
PART Valve bolts.

PHENOMENON Stress-corrosion cracking (transgranular).

APPEARANCE Fracture in screw thread at parts under highest loads.

CAUSE Near the coast, rainwater always contains chloride, which is capable of causing stress corrosion above 60°C.

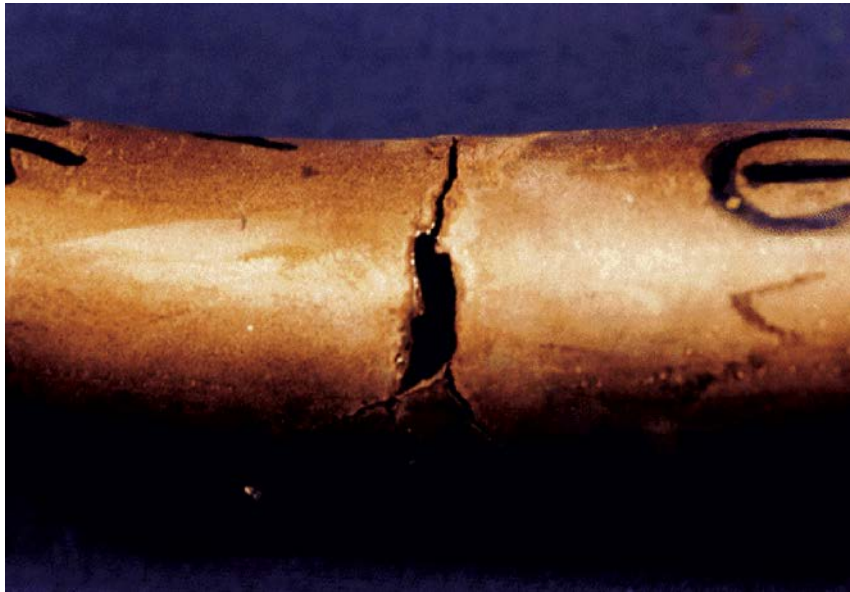
PART First-stage vertical superheater tube (OD 3.8 cm).

PHENOMENON Stress-corrosion cracking (intergranular, caustic stress-corrosion cracking see also Case History 04.25.18.01).

APPEARANCE Transverse highly branched crack in a bent tube. Note small “window” that has been blown out of the wall.

CAUSE The joint action of concentrated sodium hydroxide and tensile stresses:

- Improving the steam/water separation equipment and avoiding load swings.
- Replacement of the stainless steel tubes by carbon steel tubes (stainless steel superheater tubes in a boiler of this pressure are unusual).

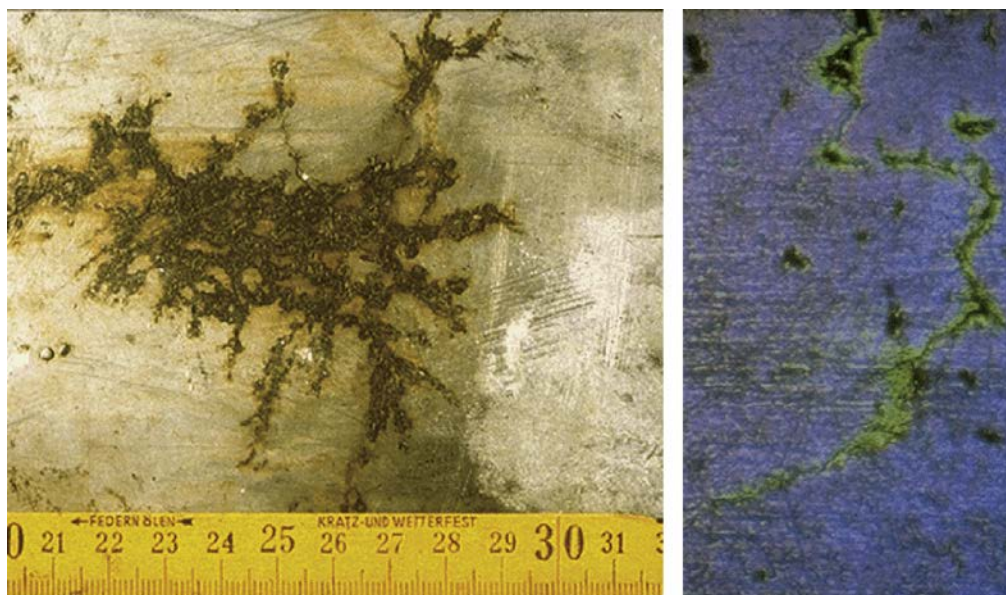
04.01.18.04

MATERIAL	Stainless steel (AISI 316).
SYSTEM	Boiler feedwater deaerator.
PART	Deaerator cascade jacket.
PHENOMENON	Stress-corrosion cracking (transgranular) under insulation.

APPEARANCE	Branched cracking.
TIME IN SERVICE	Unknown.
ENVIRONMENT	Internally: softened water, at 105°C.
CAUSE	Evaporation of boiler feedwater which had penetrated underneath the insulation through a leaking flange connection caused local high salt content, which led to transgranular stress corrosion (see also Case History 04.11.18.05).
REMEDY	Replacement of the affected plate. N.B.: in such a case, corrosion can be prevented by providing the stainless steel with an external coating.

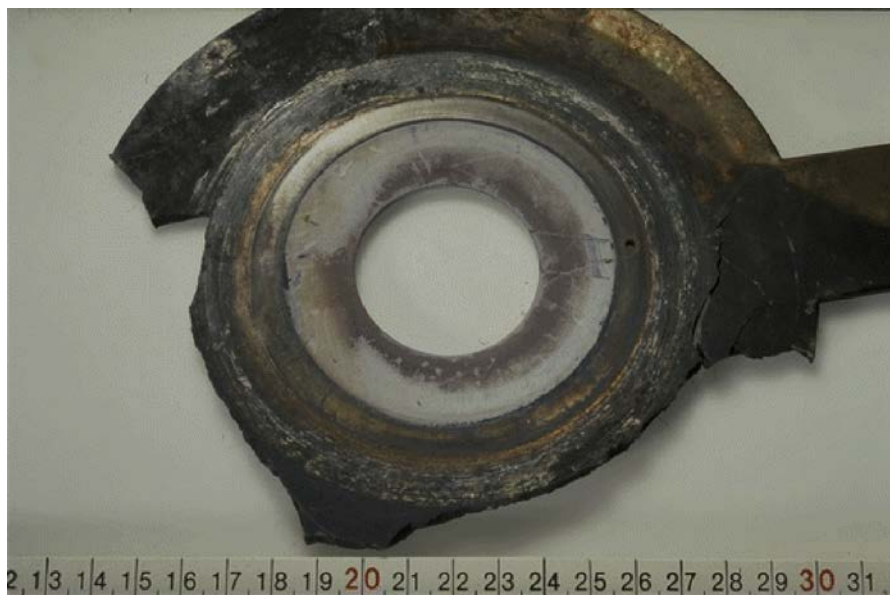
PART Orifice plate in steam line.

PHENOMENON Stress-corrosion cracking (transgranular) under insulation.

APPEARANCE Parts dislodged by extensive cracking.

CAUSE Ingress of chloride-containing rainwater, after which the salinity increased by evaporation, in conjunction with the mounting stresses present lead to stress-corrosion cracking (see also Case Histories [04.01.18.04](#) and [04.11.18.16](#)).

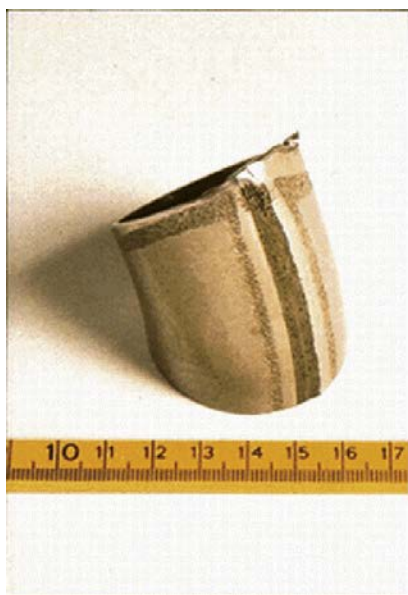
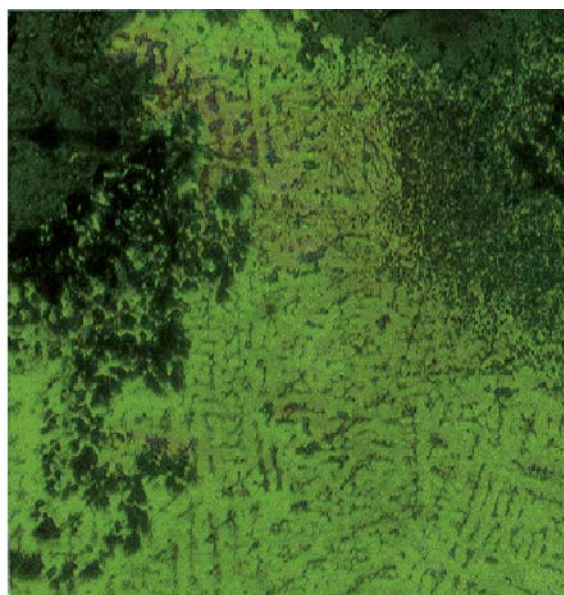
PART Welded bend in steam coil.

PHENOMENON Intergranular corrosion (weld decay).

APPEARANCE Attacked zones approximately 1 cm from the welds.

CAUSE Maintaining stainless steel in a temperature range from 600 to 850°C results in precipitation of chromium carbides ($M_{23}C_6$) at the grain boundaries. This carbide formation impoverishes locally the chrome content of the austenitic matrix and the corrosion resistance of the steel decreases as a result. This process takes place, e.g., at the heat affected zones during the welding treatment. Selective attack of these zones takes place at a distance of approximately 1 cm from the weld (see also Case Histories [04.08.19.01](#) and [04.11.19.02/04/07](#)).

- Application of seamless pipe and avoiding the use of welded bends; or
- Normalizing welds (Post Weld Heat Treatment, PWHT); or
- Use of stainless steel alloy with low carbon content ($\leq 0.03\%$) or stabilized with titanium or niobium.

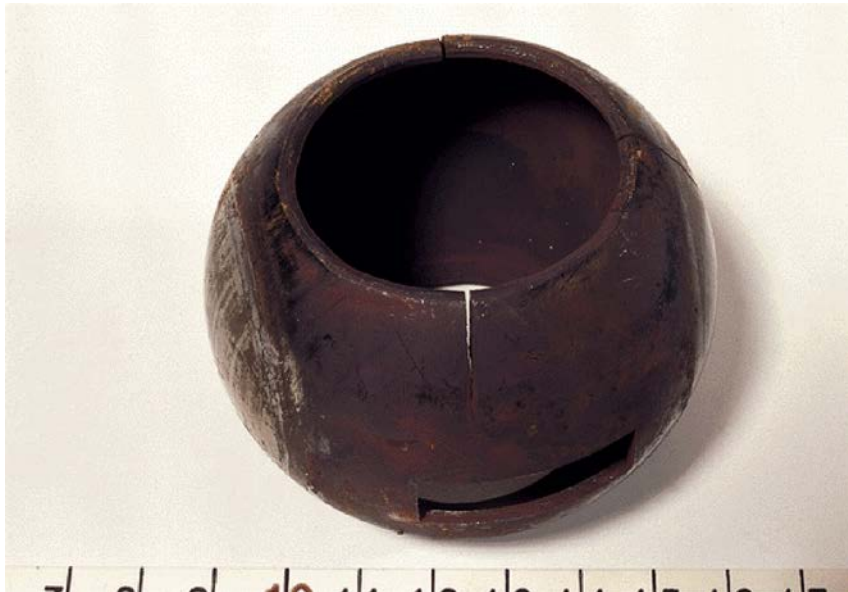
PART Ball from ball tap.

PHENOMENON Fatigue.

APPEARANCE At positions “12 o’clock, 3 o’clock and 6 o’clock,” three 15–20-mm-long straight cracks running perpendicularly downwards. The cracks gape about 0.5 mm.

CAUSE The present martensitic stainless steel is strong, hard, and scarcely tough. These properties in combination with the shape and site of the cracks point to the occurrence of fatigue cracking due to, e.g., water hammer or by the ball tap opening too fast, so that it receives a sudden impact from the steam pressure.

REMEDY Manufacture the ball tap from a tougher stainless steel, e.g., AISI 316, which is also resistant to chloride attack resulting from wet steam.

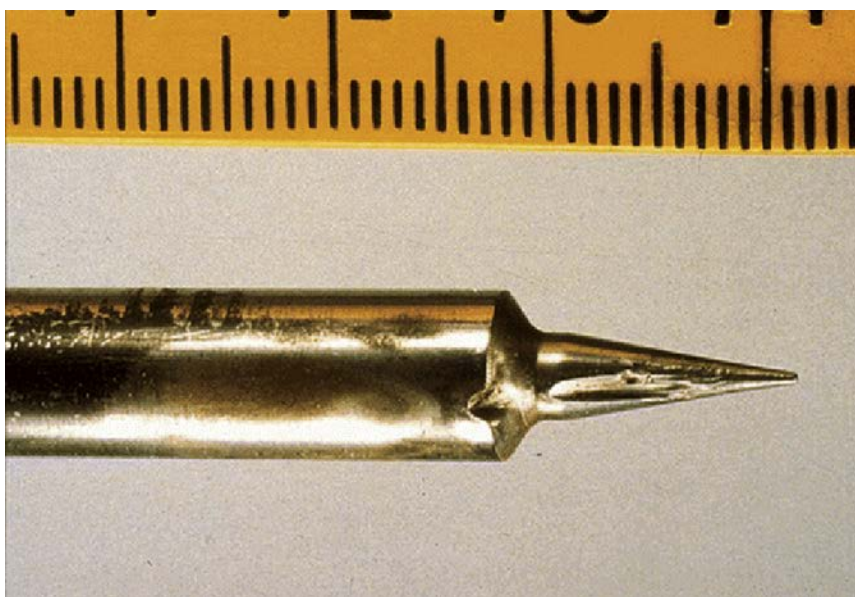
PART Spindle of high-pressure reducing valve for the sampling of boiler water.

PHENOMENON Erosion.

APPEARANCE The spindle point is severely worn and no longer makes a seal.

CAUSE According to the supplier's specifications, the spindle point was made of Satellite (a cobalt-chromium alloy), which is highly resistant to erosion. Analysis showed it to be made of highly deformed austenitic steel (see above), which is insufficiently erosion-resistant to the boiler water flowing past at high speed (see also Case Histories 04.11.32.01/02/03/04).

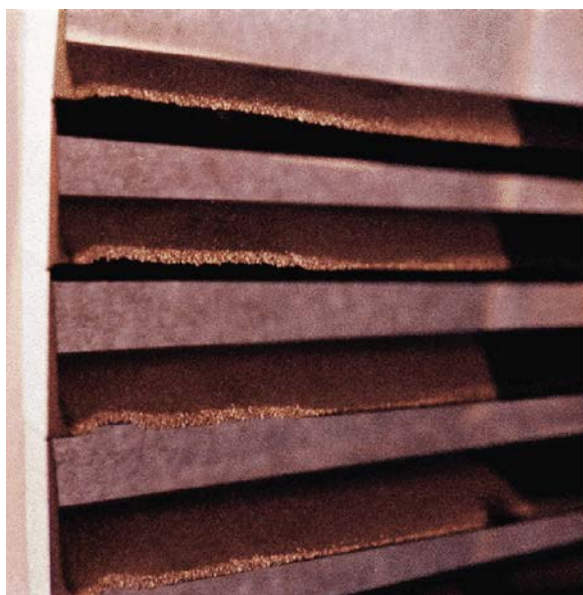
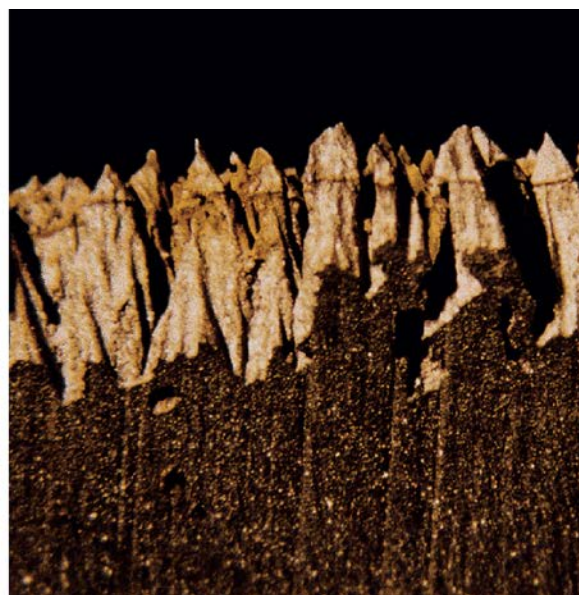
04.01.32.02

MATERIAL	Stainless steel (AISI 403).
SYSTEM	Steam turbine (45 MW, 3600 rpm).
PART	Final-stage turbine blades, condensing section. Horizontal turbine shaft
PHENOMENON	Erosion (water-droplet impingement).

APPEARANCE	Left: ragged leading edges of buckets. Right: fine, striated grooves on front face (magnification $\times 7.5$).
------------	--

CAUSE	Water-droplet impingement (see also Case Histories 01.01.32.02/04). A 0.45 MPa steam-extraction, non-return valve failed to seat properly during an electrical turbine trip. The 0.45 MPa header emptied through the turbine (vacuum condition). The turbine speed increased to 5000 rpm (design 3600 rpm) before manual shutdown.
-------	---

REMEDY	Ensure proper functioning of non-return valves by periodic testing and timely repair procedures.
--------	--

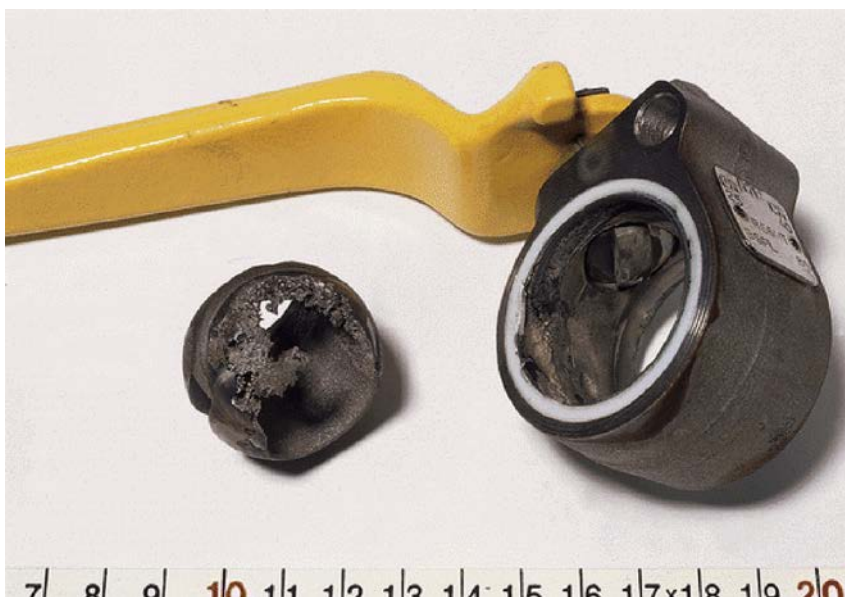
PART Ball valve in outlet pipe.

PHENOMENON Erosion corrosion.

APPEARANCE Severe erosion of ball and valve house.

CAUSE A near-closed ball valve causes high steam velocity, resulting in erosion corrosion.

- Place a throttle plate ahead of the ball valve, or
- Replace the ball valve by one constructed of Satellite.

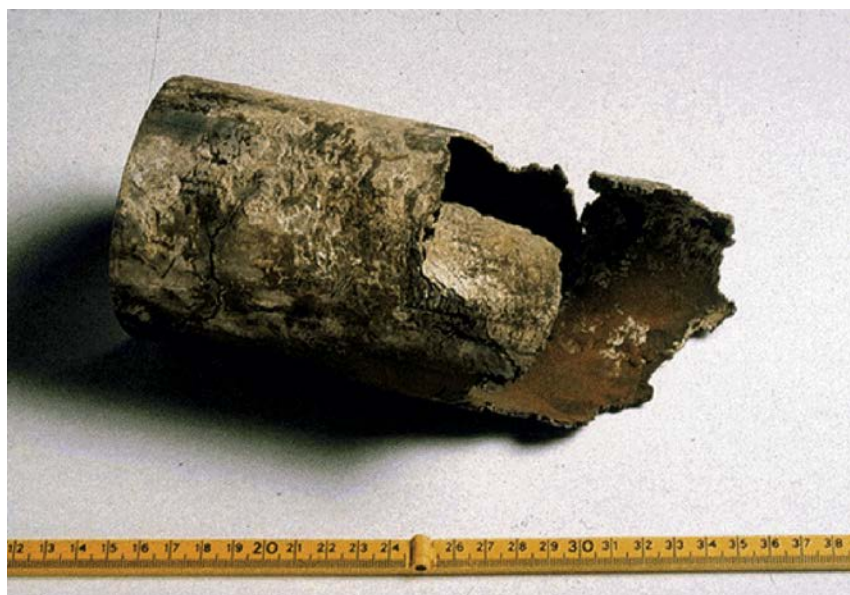
04.02.18.01

MATERIAL	Stainless steel (AISI 316).
SYSTEM	Steam condensate system.
PART	Uninsulated underground pipeline.
PHENOMENON	Stress-corrosion cracking (transgranular).

APPEARANCE	Cracking.
TIME IN SERVICE	2 years.
ENVIRONMENT	Chloride-containing groundwater.

CAUSE Chloride in the groundwater coupled with high temperature (90°C) of the condensate pipe and stresses present (see also Case Histories 04.11.18.01 and following).

- In view of the small quantity of condensate, it was decided not to replace the pipeline and to discharge the condensate into the sewer.
- Alternatively: a new condensate pipeline could be constructed as a double-walled pipe system with a carbon steel inner pipe and a plastic jacket, with insulation in between.

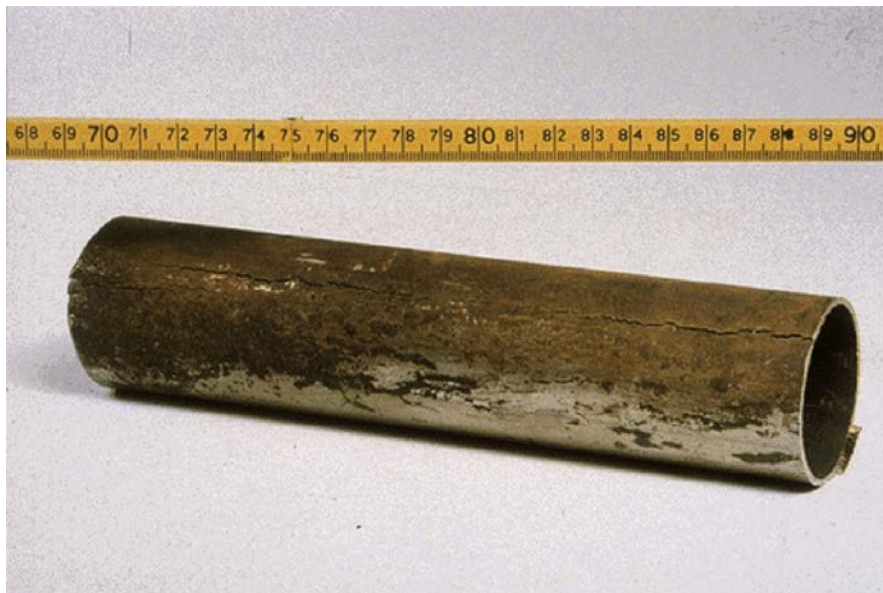
PART Uninsulated pipeline.

PHENOMENON Stress-corrosion cracking (transgranular).

APPEARANCE Longitudinal cracks, pipe fractured open.

CAUSE Regular external wetting with chloride-containing acid rainwater which evaporates on the hot pipe (see also Case Histories 04.11.18.01 and following).

REMEDY Wrap the stainless steel pipeline with aluminum foil and then insulate it; the aluminum gives cathodic protection to the stainless steel.

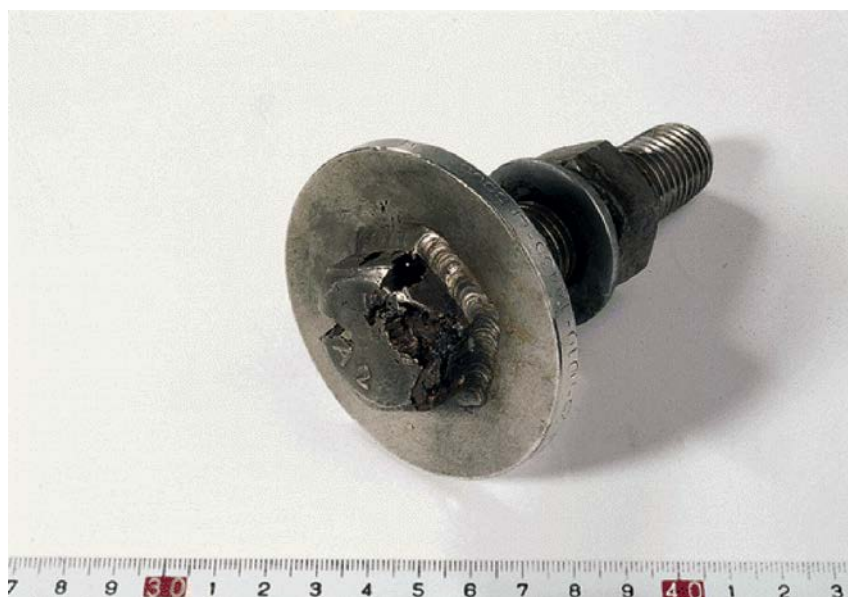
PART Bolt with plate.

PHENOMENON Chloride attack.

APPEARANCE Pitting attack on the bolt, none on the plate.

CAUSE Stainless steel AISI 304 is not resistant, whereas AISI 316L is resistant in the chloride-containing medium at 80°C. In view of the slight potential differential between the two types of stainless steel, there is no question of galvanic corrosion (see also Case History 04.11.12.03).

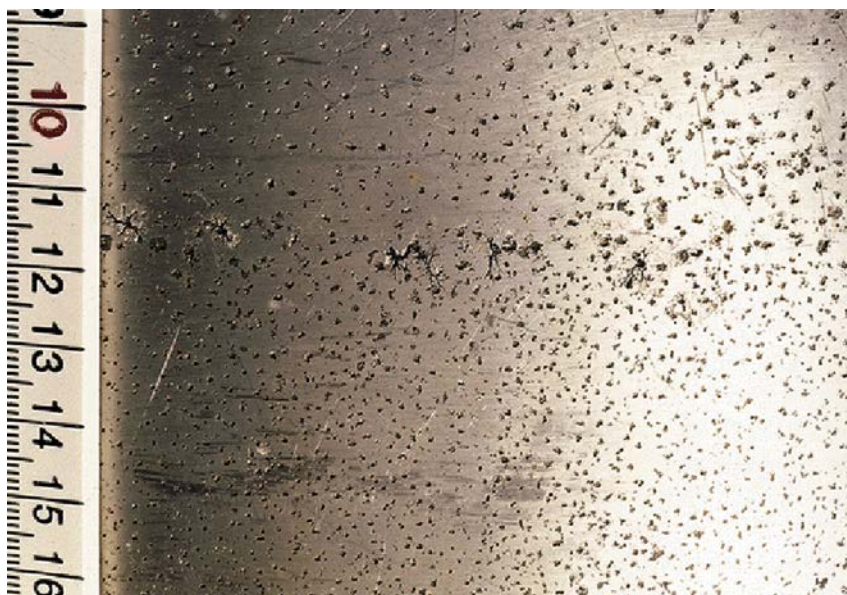
04.05.12.02

MATERIAL	Stainless steel (AISI 316L).
SYSTEM	Drinking water system in brewery.
PART	Pipe section (outside surface).
PHENOMENON	Chloride attack and stress-corrosion cracking.

APPEARANCE	Many pits and some cracks.
TIME IN SERVICE	3 weeks.
ENVIRONMENT	Inside: drinking water. Outside: Contaminated with hydrochloric acid.
CAUSE	Leakage of an HCl conveyor line, located overhead the affected pipe (see also Case History 04.11.12.08).
REMEDY	The HCl conveyor line was relocated.

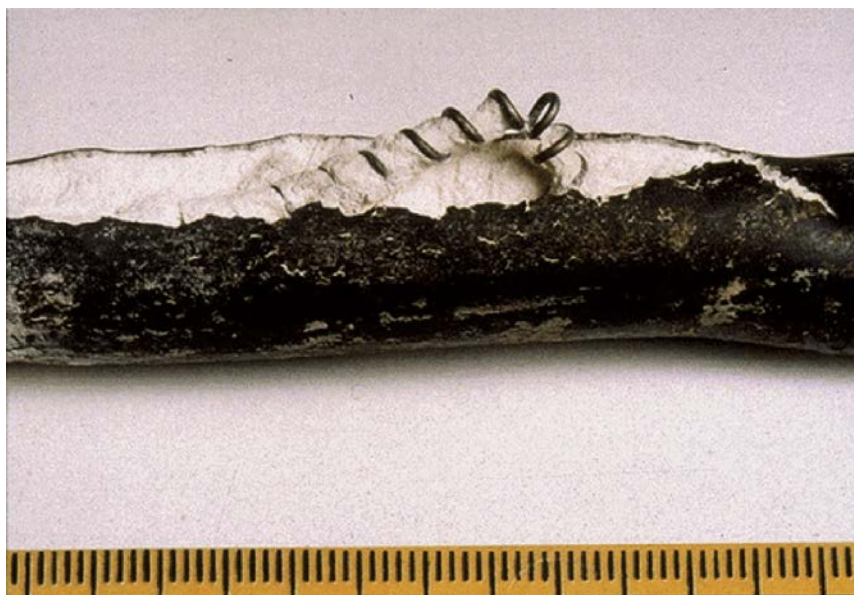
PART Electrically heated coil.

PHENOMENON Stress-corrosion cracking (transgranular).

APPEARANCE Cracking.

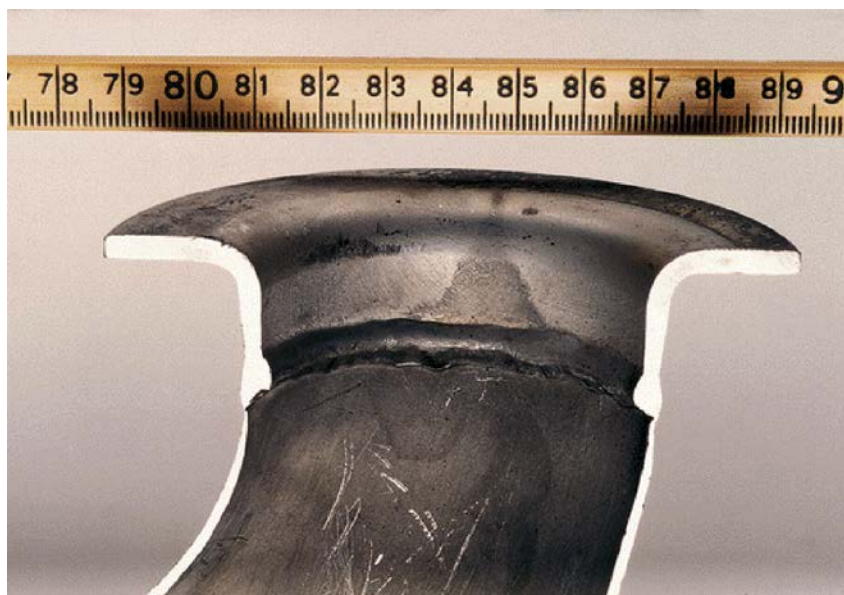
PART Pipe bend.

PHENOMENON Erosion corrosion.

APPEARANCE Severe attack of the weld at the side of the bend section, and gradual loss of wall thickness of the bend after the weld (in the direction of the weld).

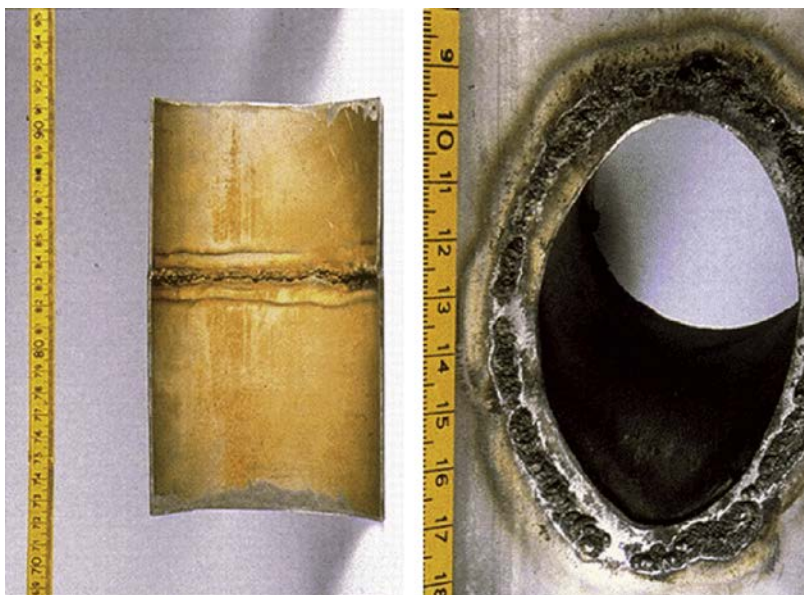
PART Pipe sections.

PHENOMENON Weld defect.

APPEARANCE Pitting attack in the welds.

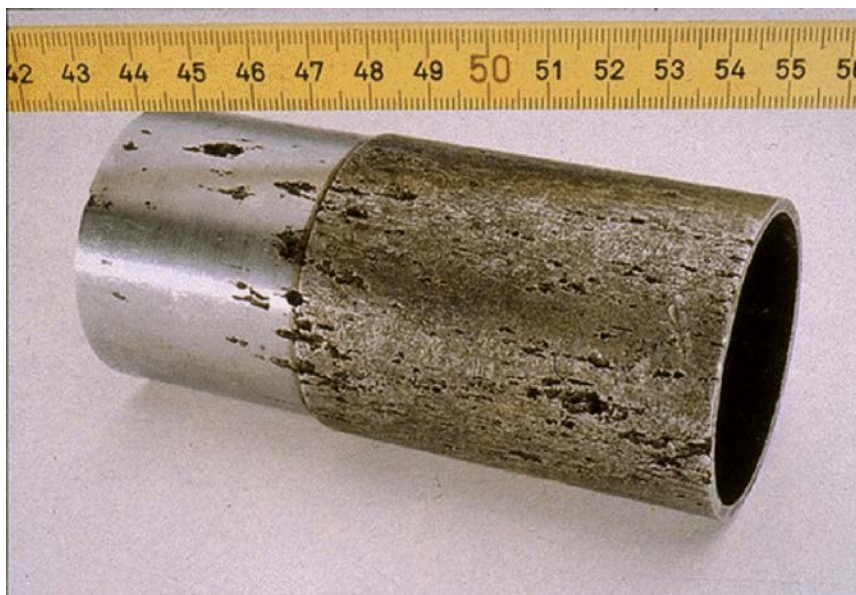
PART Pipe.

PHENOMENON Chloride attack.

APPEARANCE Pitting attack.

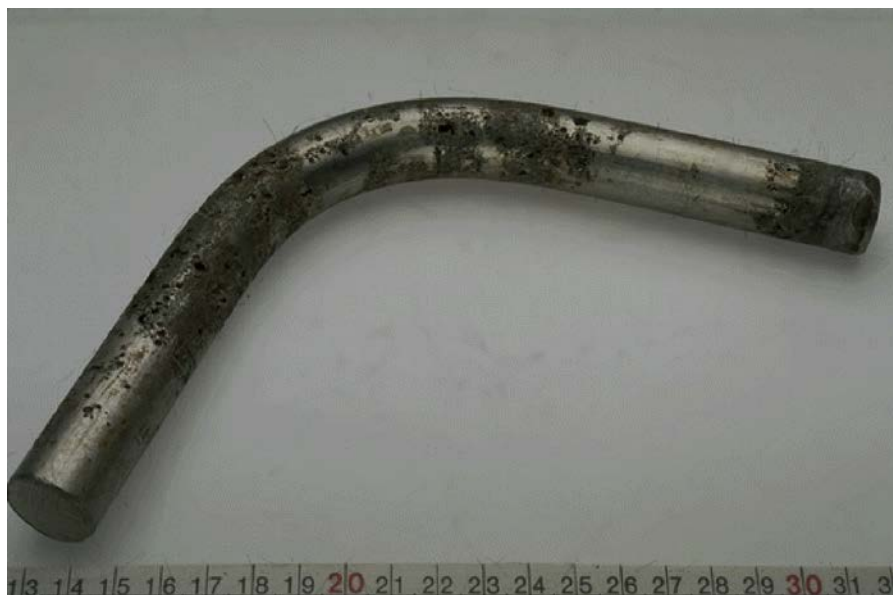
PART Step inside water header.

PHENOMENON Chloride attack.

APPEARANCE Pitting attack.

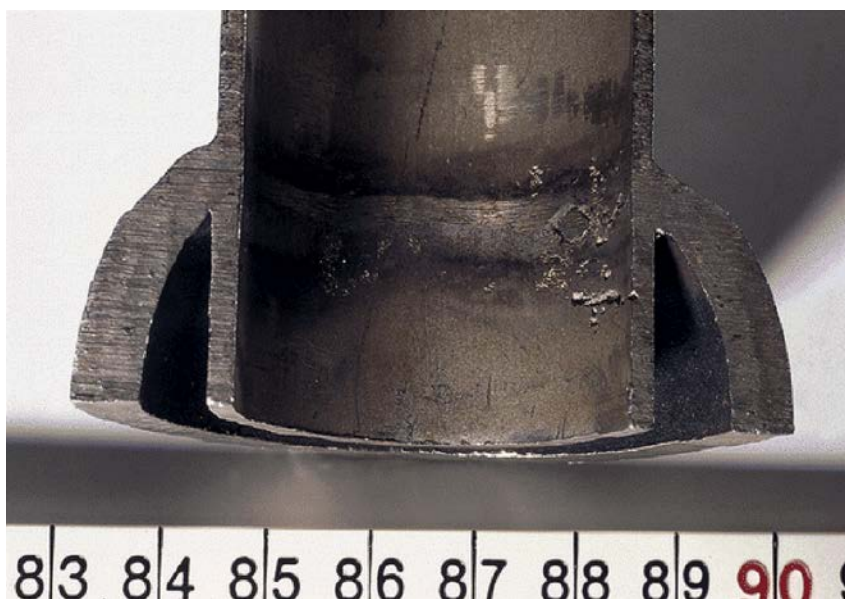
PART Cooling water coil.

PHENOMENON Chloride attack.

APPEARANCE Pitting attack of the weld and the HAZ.

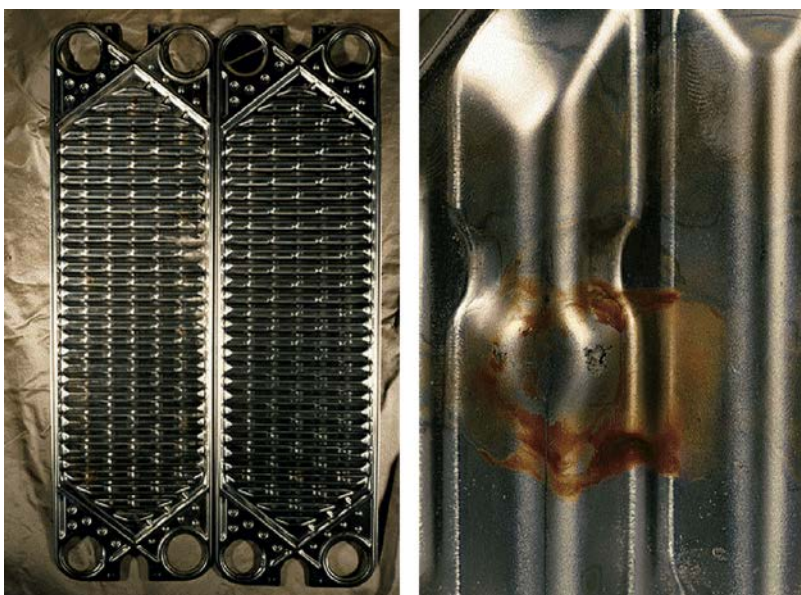
PART Heat exchanger plates.

PHENOMENON Crevice corrosion.

APPEARANCE Rust patches surround small pits on the stainless steel cooling water side.

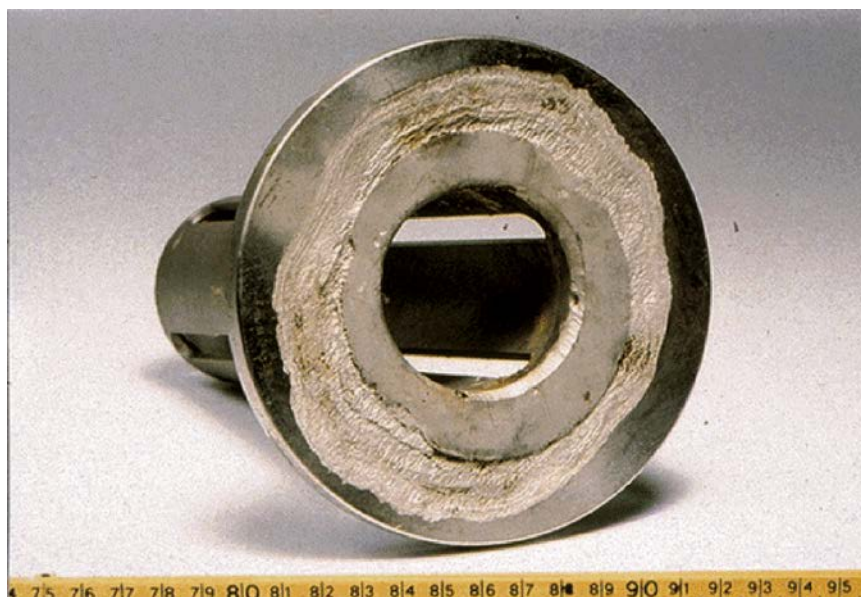
04.06.13.02

MATERIAL	Stainless steel (AISI 316).
SYSTEM	Power station cooling system.
PART	Sieve from steam condenser cooling water system.
PHENOMENON	Crevice corrosion.

APPEARANCE	Local attack underneath seal.
TIME IN SERVICE	2 years.
ENVIRONMENT	Flowing seawater, maximum temperature 40°C.

CAUSE Because of the presence of a crevice between the seal and the stainless steel, the construction is locally extra sensitive to attack by chloride (see also Case History 04.11.13.01).

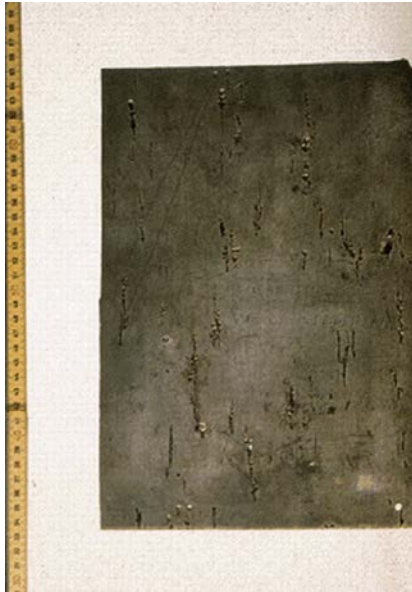
PART Cooler jacket.

PHENOMENON Under-deposit corrosion.

APPEARANCE Pitting developing into vertical grooves.

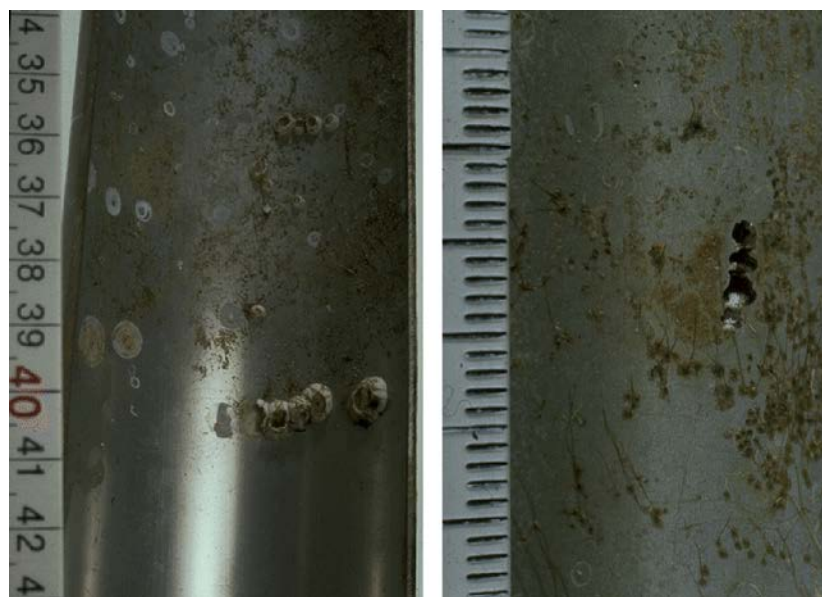
PART Riser pipes.

PHENOMENON Under-deposit corrosion.

APPEARANCE Inside pipe surface clean and uncorroded at the fluid bed. The upper section fouled by deposition of barnacles, including pitting attack (see right-hand photograph for more detail).

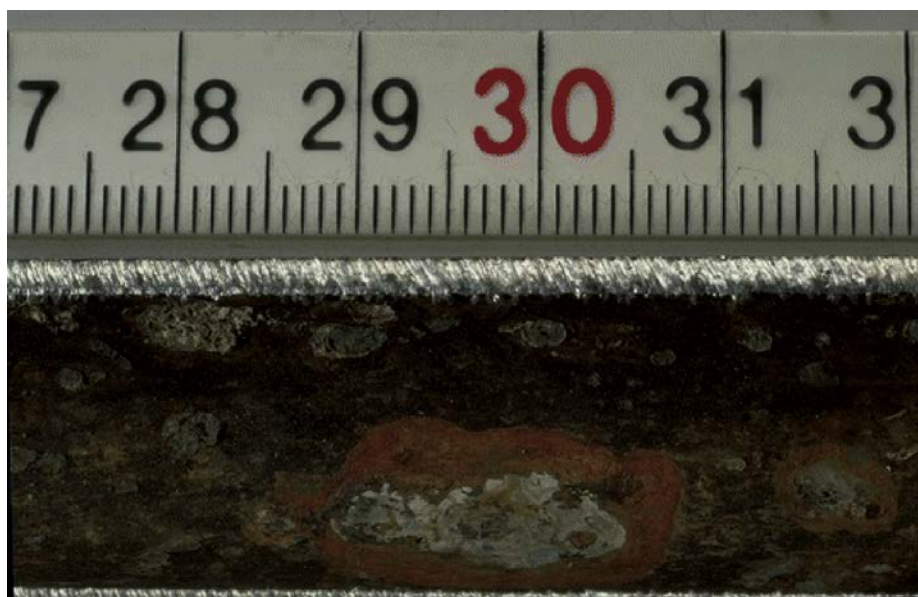
PART Cooler tube.

PHENOMENON Under-deposit corrosion.

APPEARANCE Local attack under deposits.

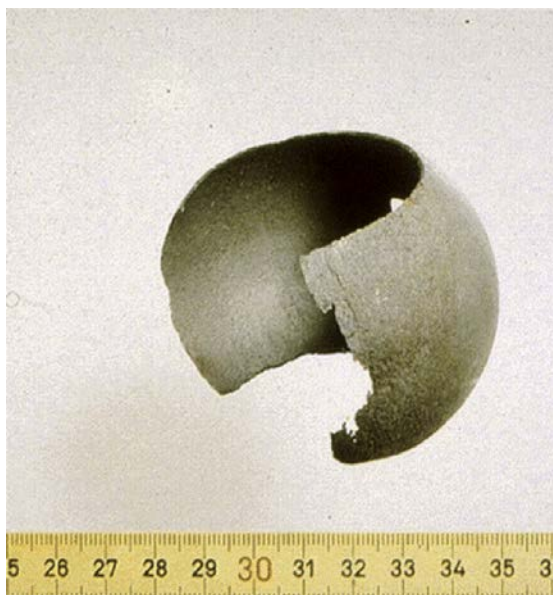
PART Ball valve ball.

PHENOMENON Acid corrosion.

APPEARANCE Entire surface of the ball attacked; locally, the material is totally eaten away.

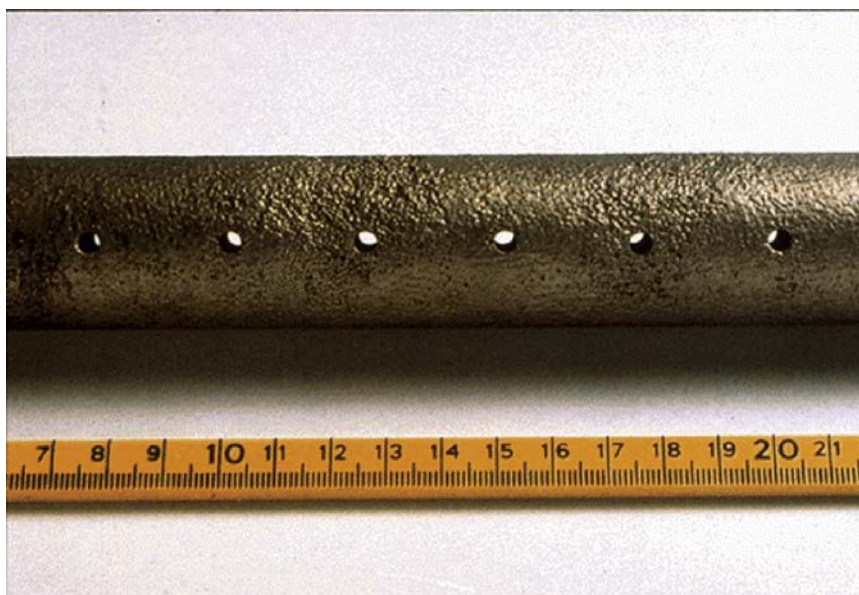
PART Drainage pipe.

PHENOMENON Chloride attack.

APPEARANCE Pitting attack over the entire surface.

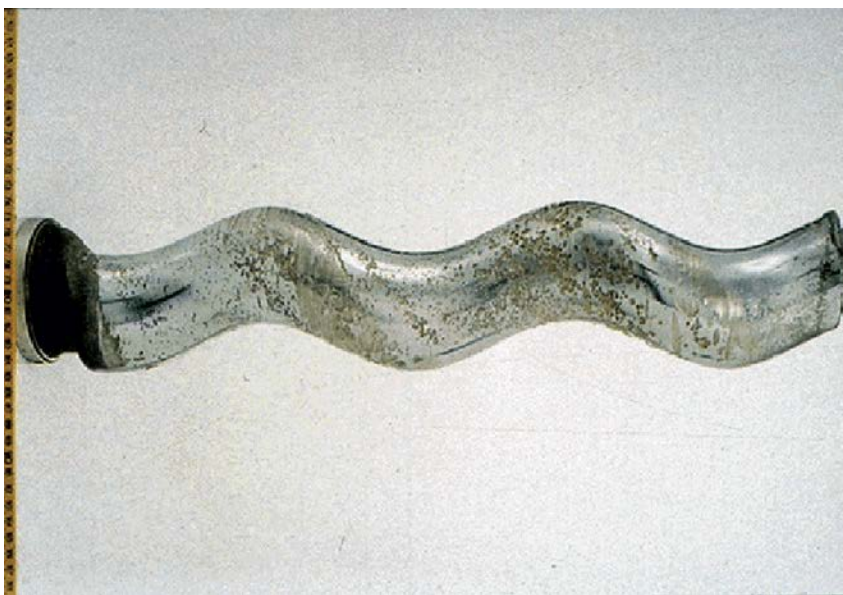
PART Worm from worm gear pump.

PHENOMENON Chloride attack and erosion.

APPEARANCE Pitting attack, with grooves.

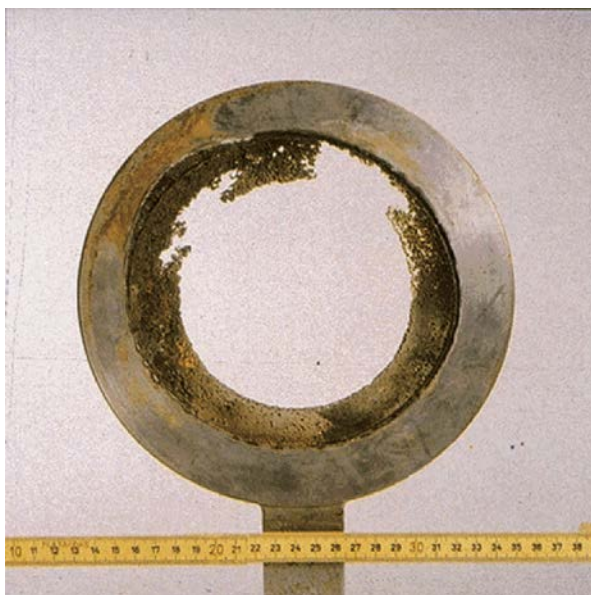
PART Mixing flange in wastewater pipeline.

PHENOMENON Chloride attack.

APPEARANCE Severe pitting attack.

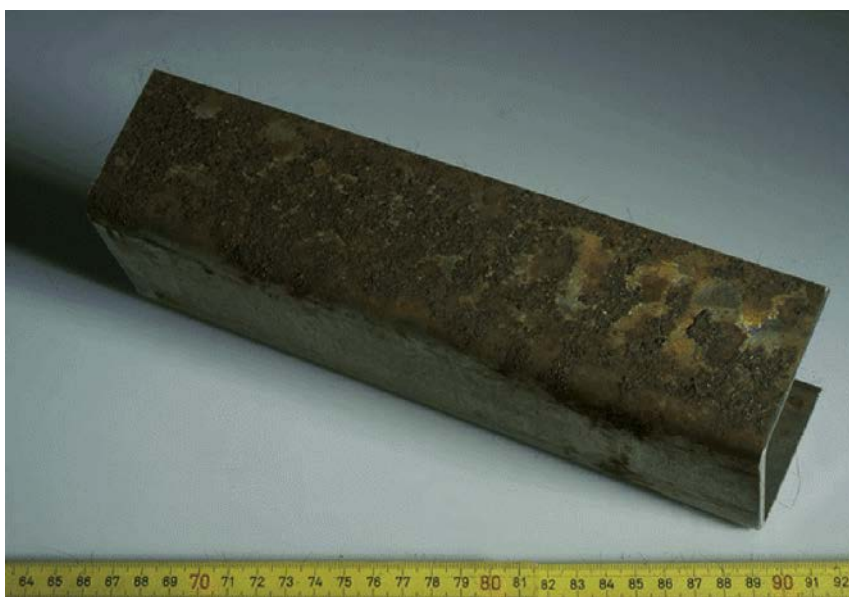
PART Section of the support construction of the canvas cover of the sand trap.

PHENOMENON Chloride attack.

APPEARANCE Reddish-brown, rusty exterior with slight pitting (<0.5 mm).

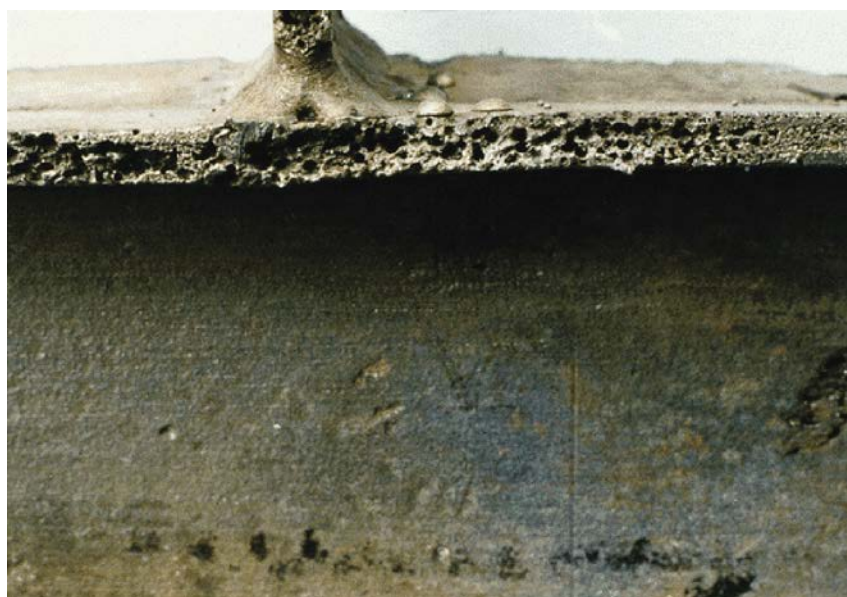
04.08.42.01

MATERIAL	Stainless steel (AISI 308).
SYSTEM	Water demineralization plant.
PART	Part of structure in cation exchanger.
PHENOMENON	End grain attack.

APPEARANCE	Pitting at the edge.
TIME IN SERVICE	3 months.
ENVIRONMENT	During generation: diluted sulfuric acid (6%); temperature: 40°C.

CAUSE Selective corrosion took place at the edges of the non-metallic inclusions in the metal. These were rolled out and elongated into long stringers during the rolling action. When the end grain is exposed to a strong corrodent, end grain attack starts at the end of the stringers and can aggressively proceed down into the steel (see also Case Histories 01.12.42.01 and 05.11.42.01).

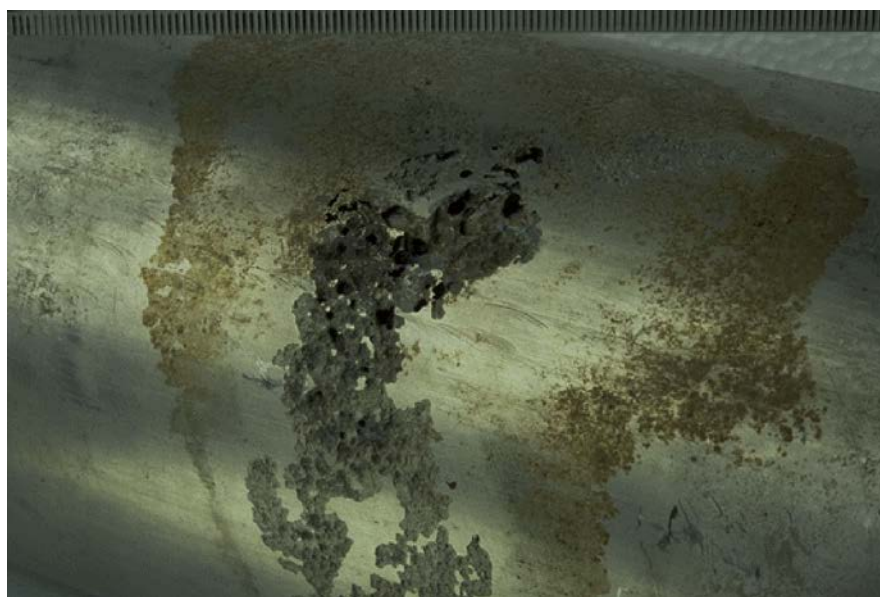
PART Underground pipe.

PHENOMENON Under-deposit corrosion.

APPEARANCE The pipe exhibited wide local zones of severe pitting corrosion, surrounded by iron oxide deposits (see also Case History [04.06.13.01](#)).

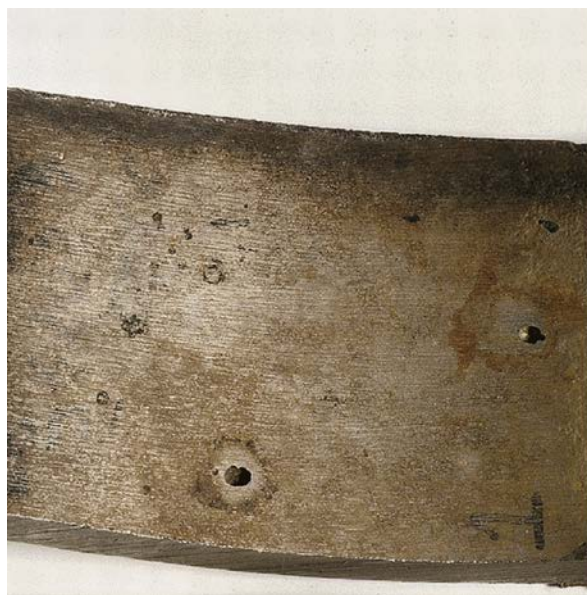
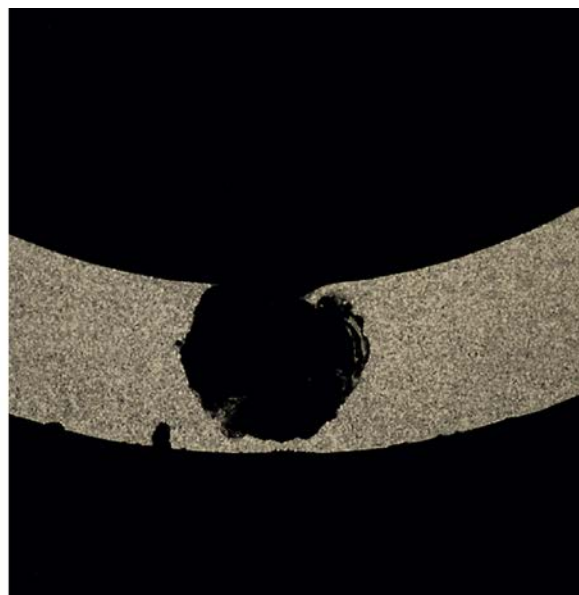
PART Strainer.

APPEARANCE Pits on surface, growing bigger below the surface.

CAUSE In the presence of water/condensation from the outside, vinyl chloride hydrolyses into hydrochloric acid.
Acid droplets corrode the passive film on the AISI 316L, causing pitting (see also Case History [04.01.04.01](#)).

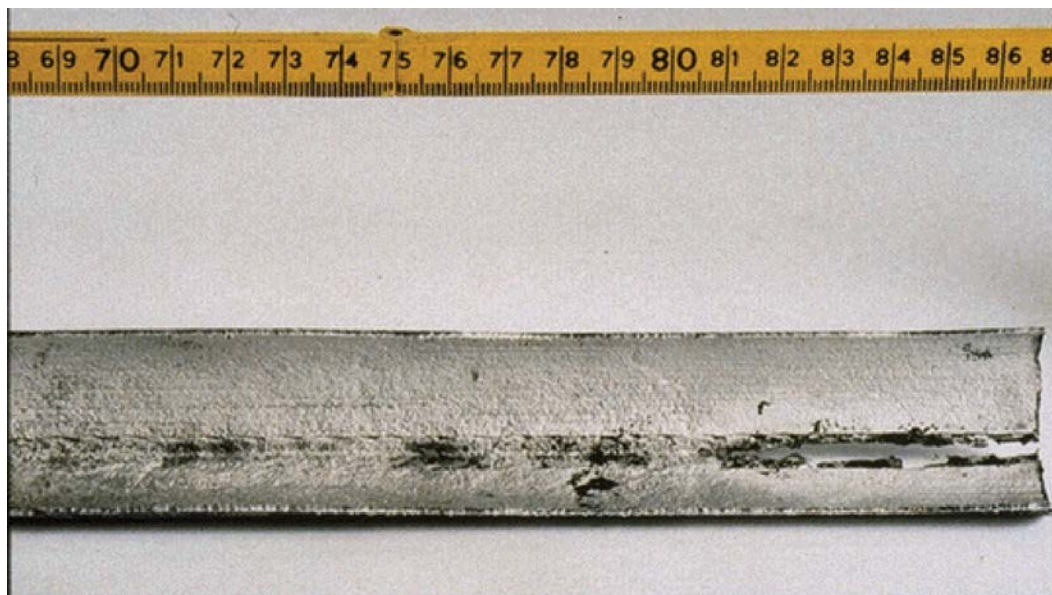
PART Autoclave charge pipe.

APPEARANCE Etched surface, uniform attack with preferent attack of the weld.

CAUSE Stainless steel 316L is not resistant to 75% phosphoric acid at 110°C (see also Case History 04.11.04.16).

REMEDY Construct the pipe from more resistant stainless steel (W.-Nr. 1.4563).

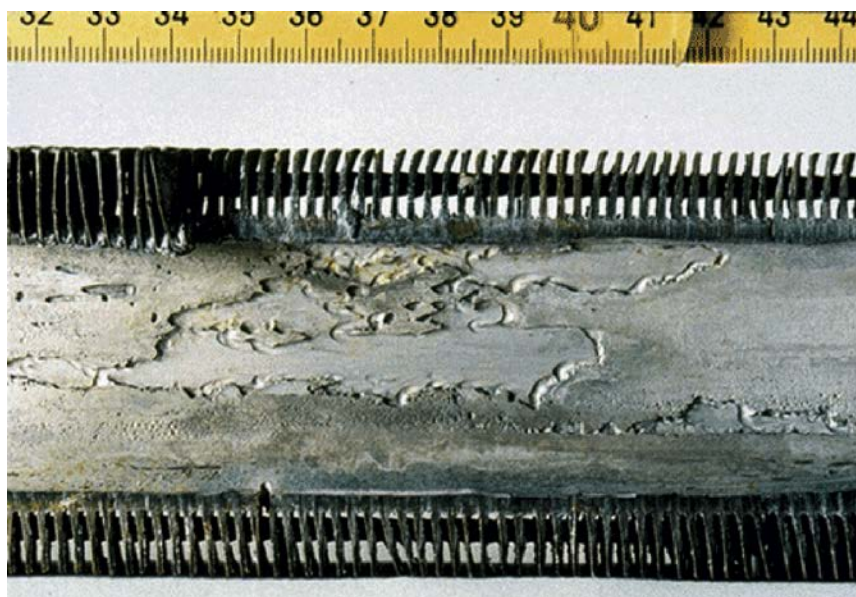
04.11.04.03

MATERIAL	Stainless steel (AISI 316 Ti).
SYSTEM	Sulfuric acid plant.
PART	Cooling element of air-cooled sulfuric acid heat exchanger.
PHENOMENON	Acid corrosion.

APPEARANCE	Local uniform attack.
TIME IN SERVICE	1 year.
ENVIRONMENT	96%–98.5% H ₂ SO ₄ ; temperature 80–85°C; velocity approximately 1 m/s.
CAUSE	316 Ti stainless steel is not resistant to 98.5% sulfuric acid at 80°C.

REMEDY	<ul style="list-style-type: none"> • Construction of the cooler from Cr and Mo alloyed nickel-based alloys, e.g., Hastelloy C (expensive!), or • Application of anodic protection to the present system.
--------	--

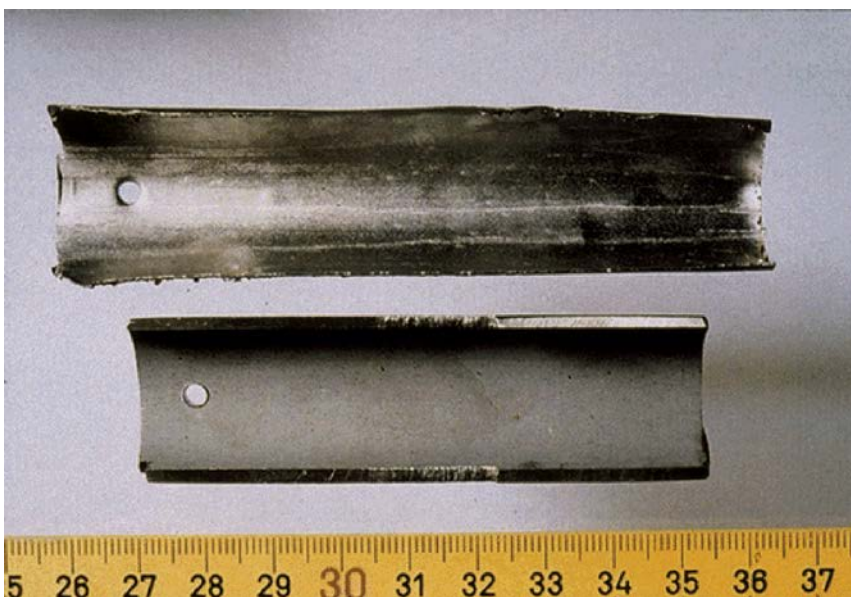
04.11.04.04

MATERIAL	Stainless steel (AISI 316 Ti).
SYSTEM	Heat exchanger.
PART	Attacked tube from bundle, with a new tube below it for comparison.
PHENOMENON	Acid corrosion.

APPEARANCE	Uniform attack to entire surface.
TIME IN SERVICE	14 days.
ENVIRONMENT	Around the pipe: steam, 140°C; through the pipe: synthetic detergent, sulfonic acid and occasional traces of sulfuric acid, pH < 1.
CAUSE	AISI 316 Ti is not resistant to sulfuric acid traces at the present temperature. Attack took place at the steam inlet, where the temperature is highest (for the resistance of stainless steel in diluted sulfuric acid, see also Case Histories 04.11.04.06/09 and 04.12.04.05).
REMEDY	<ul style="list-style-type: none"> • Reduction of the temperature if possible, and • Improvement of the sulfuric acid neutralization, or • Use of a more corrosion-resistant material, e.g., Hastelloy B-2.

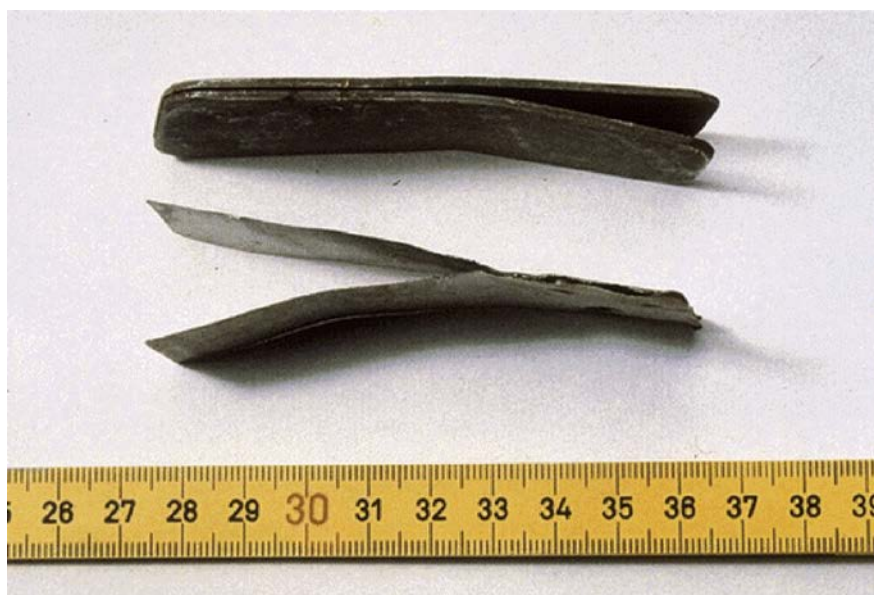
04.11.04.05

MATERIAL	Stainless steel (AISI 316).
SYSTEM	Distillation tower.
PART	Belleville washers (top specimen unused, bottom specimen corroded).
PHENOMENON	Acid corrosion.

APPEARANCE	Uniform attack, leaving the material wafer-thin.
TIME IN SERVICE	A few years.
ENVIRONMENT	Acetic acid with some formic acid and propionic acid; temperature approximately 120°C.
CAUSE	At this temperature, the stainless steel is attacked by the formic acid and propionic acid.
REMEDY	The cheapest solution is periodic replacement of the tray washers during shutdown.

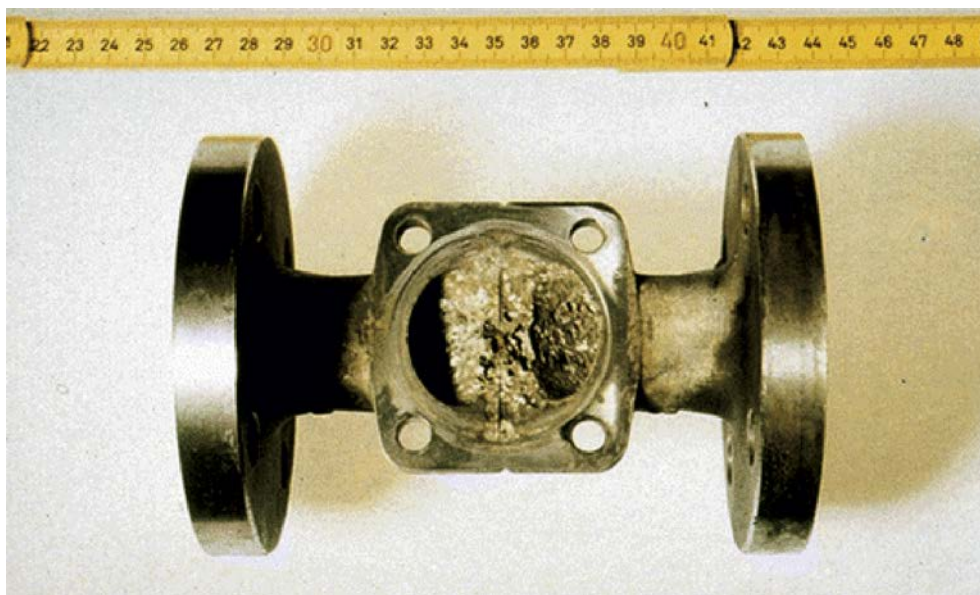
PART Valve.

APPEARANCE Severe attack to interior.

CAUSE The stainless steel valve was used as an ad hoc solution to replace a glazed specimen which had corroded through owing to a hole in the glazing.
