Corrosion Atlas

THIRD, EXPANDED AND REVISED EDITION

A Collection of Illustrated Case Histories

Evert D.D. During

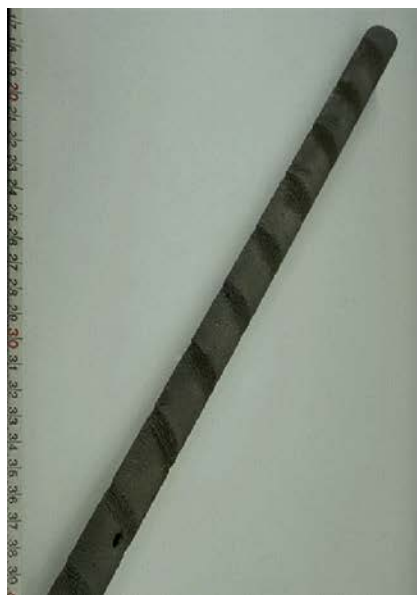
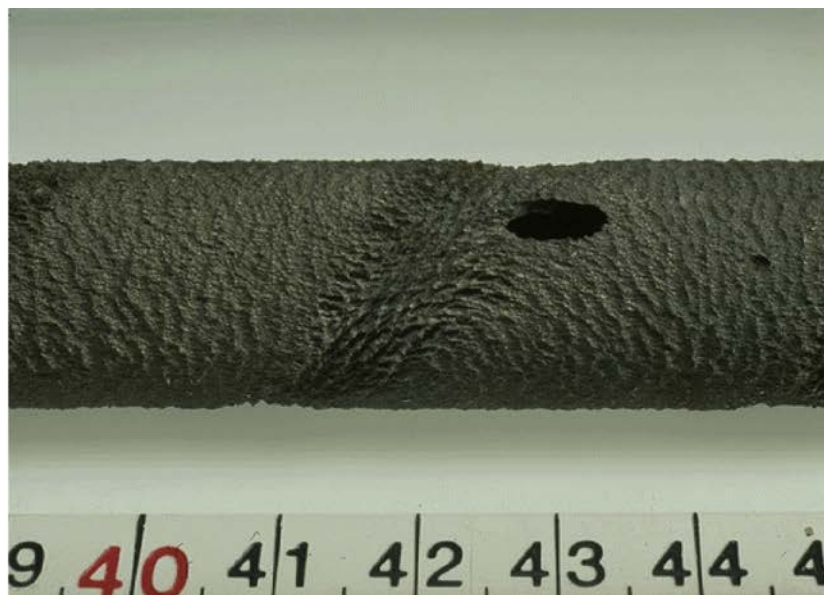
PART Heating pipe.

APPEARANCE General roughening and local penetration at the dark-colored, spiral-shaped, more severe area of attack.

CAUSE This material is not resistant to the present medium. Due to the lead wrapping of a thermocouple, a crevice was present at that site whilst moreover the heat transmission was lower and the wall temperature was therefore higher, so that intensified corrosion took place there (for the resistance of stainless steel in nitric acid, see also Case Histories 04.11.04.08, 04.12.04.04, 04.11.19.05, and 04.11.34.02).

- Do not wrap the thermocouple spiral around the tube.
- Periodic replacement of the bundle because of the general attack (roughening), which cannot be prevented.

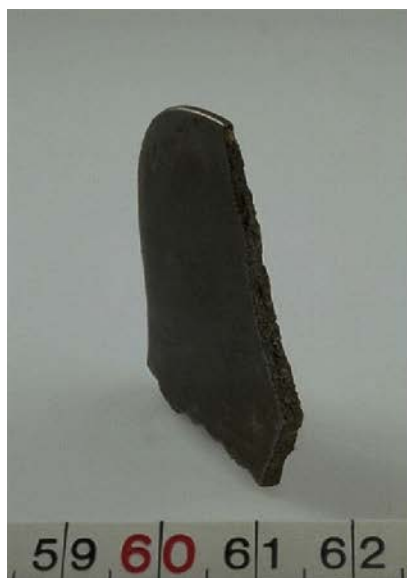
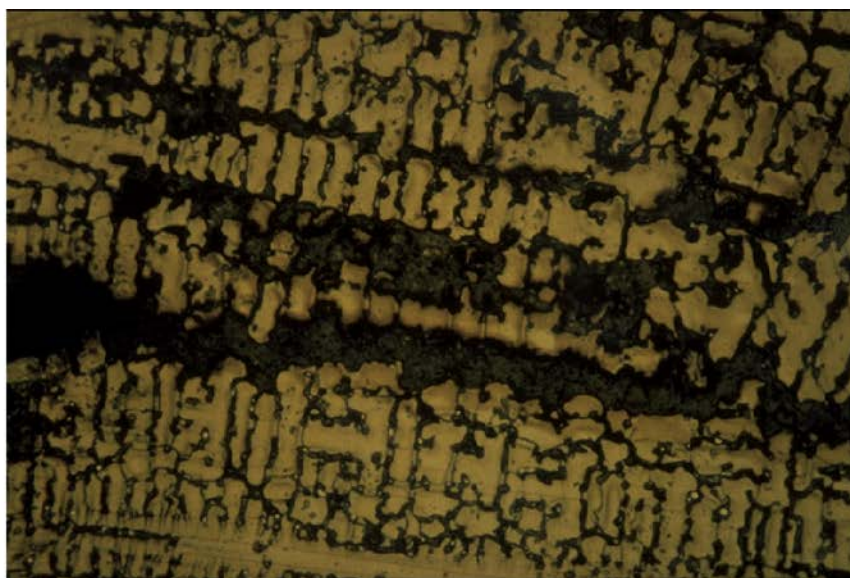
04.11.04.08

MATERIAL	Stainless steel (AISI 304).
SYSTEM	Mixing vessel of a nitrating plant.
PART	Piece of the cast propeller blade of the immersion stirrer.
PHENOMENON	Acid corrosion.

APPEARANCE	Outwardly, the material does not appear corroded. However, it can be deformed by hand as if it were a piece of rubber.
TIME IN SERVICE	Several weeks.
ENVIRONMENT	Nitrating acid, consisting of 80% nitric acid 98% and 20% fuming sulfuric acid. Temperature 25°C.
CAUSE	The interdendritic material, which was the last to solidify and therefore contains quite a variety of constituents, was found (see microphoto) to have been almost totally eroded. Because dendrites interlock, the integrity of the propeller was retained, but because each of the remaining dendrites acts as an independent hinge, the material can be moved to and fro as if it were rubber. Conclusion: selective attack of the connective interdendritic material.
REMEDY	Stainless steel AISI 304 is per se resistant to the present acid mixture. For casting purposes, however, the purest possible material should be used in order to prevent the formation of a less corrosion-resistant interdendritic phase. Alternative: construct the propeller blade of enameled cast iron.

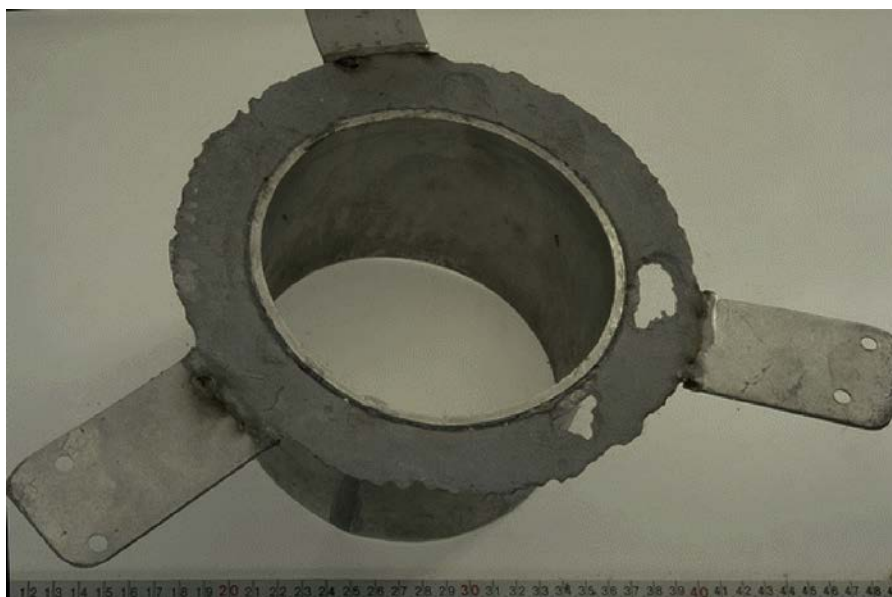
PART Stirrer support.

APPEARANCE Projecting edge uniformly attacked and totally eroded; the pipe section and welded-on strips are not attacked.

CAUSE Incorrect choice of material: like the pipe section and strips, the rim should also have been made of stainless steel AISI 316. The components concerned had been manufactured by the plant itself.

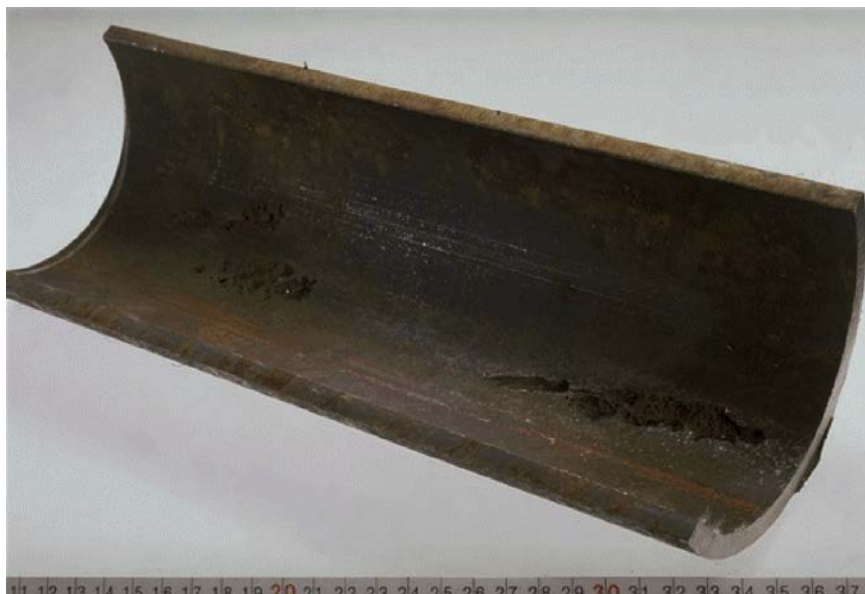
PART Section from well tubing.

APPEARANCE Localized attack in the longitudinal direction.

CAUSE Failure of the acid corrosion inhibitor due to excessive exposure duration at elevated reservoir temperature (70–80°C). This caused local breakdown of the inhibitor film (see also Case Histories 04.12.12.02 and 01.01.04.04).

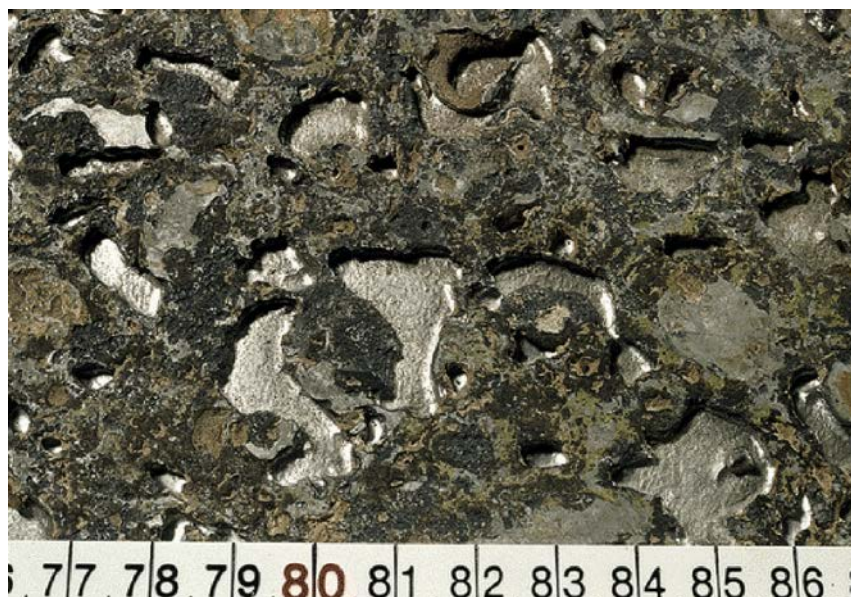
PART Reactor vessel wall.

APPEARANCE Local overall corrosion.

CAUSE The presence of amidosulfonic acid in the acidic nitrate phosphate solution in combination with traces of chloride and fluoride.

REMEDY The corrosion was halted by using an alternative material of construction: AISI 316L.

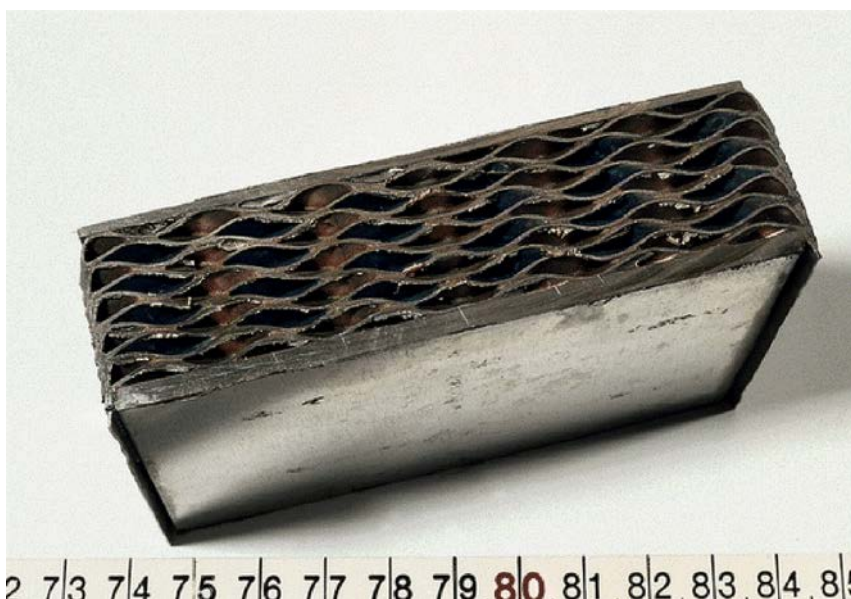
PART Sample cooler.

APPEARANCE Uniform attack of the copper solder. At some places the copper has totally disappeared, at other places the copper is blue-colored.

CAUSE The cooler leakage was caused by the condensing organic acids attacking the copper solder joints between the plates. This also caused the blue color. As a result of the attack, the stainless steel plates were no longer connected and deformation of the cooler took place, resulting in leakage.

REMEDY Replace the copper-brazed plate cooler by a cooler with aluminum-finned stainless steel tubes.

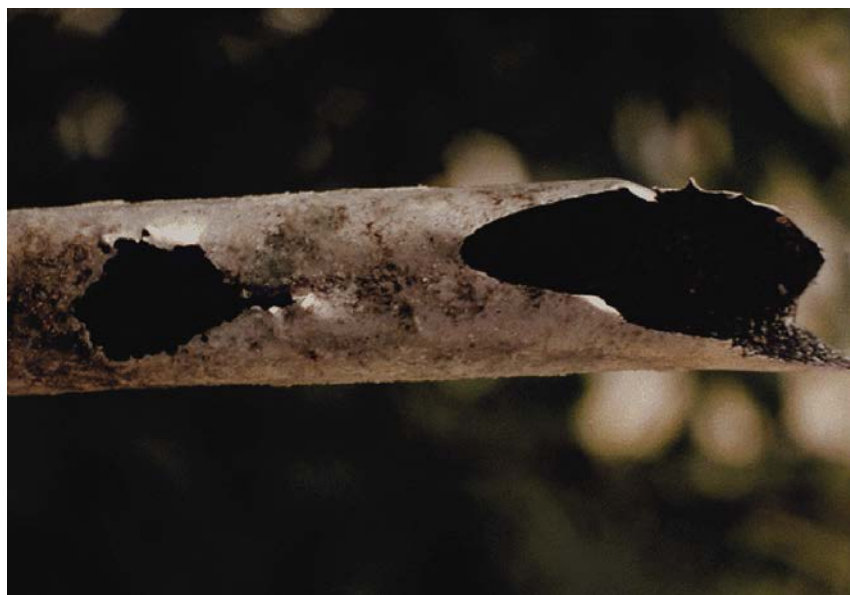
04.11.04.13

MATERIAL	Stainless steel (AISI 304).
SYSTEM	Sulfuric acid storage tank.
PART	Horizontal outlet piping (OD 1.3 cm, wall thickness: 0.76 mm).
PHENOMENON	Acid corrosion.

APPEARANCE	Internal severe general corrosion with dark tenacious corrosion products. Near the failure, the remaining metal was paper-thin.
TIME IN SERVICE	One year.
ENVIRONMENT	Sulfuric acid containing excessive water (20%–30%).
CAUSE	Water entered the storage tank due to condensation of moisture-laden air that was sucked into the tank. Air-drying systems were not in good working order. Stainless steel 316 is attacked by sulfuric acid with so much water (for the corrosion resistance of stainless steel in concentrated sulfuric acid, see Case Histories 04.11.04.03 and 04.11.19.01/03 and 04.11.34.03).
REMEDY	Keep the air-drying systems in a good working order, or if the acid contains 10% water or more, add acid to reduce water concentration to below 5%.

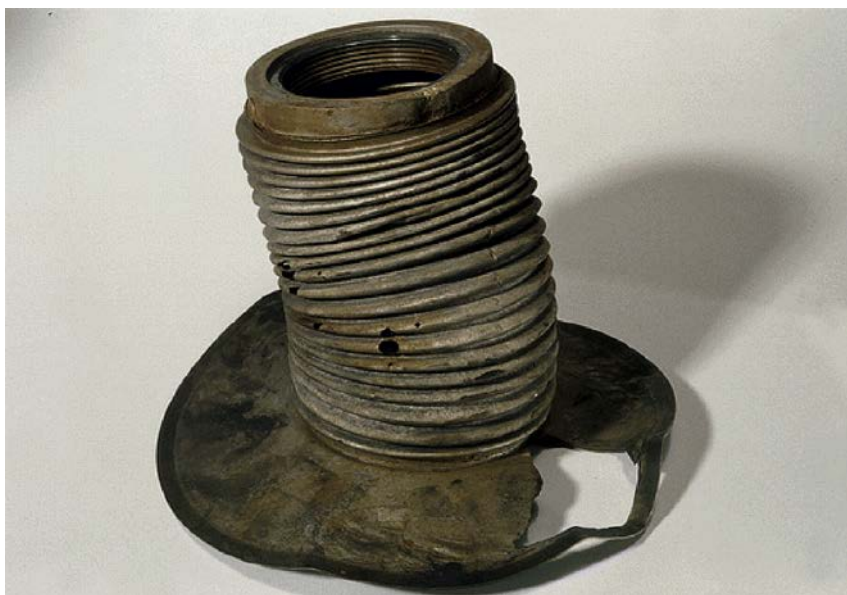
04.11.04.14

MATERIAL	Stainless steel (AISI 316).
SYSTEM	Chemical plant.
PART	Safety bellows of HCl gas pipeline.
PHENOMENON	Acid corrosion.

APPEARANCE	Uniform attack from the inside, holes in the bellows.
TIME IN SERVICE	0.5 years.
ENVIRONMENT	Dry HCl gas, ambient temperature.
CAUSE	Material exchange. The bellows were made from AISI 316 instead of Hastelloy C. Hydrochloric acid was formed as a result of the entrance of moisture and attacked the bellows.
REMEDY	Retrofitting a Hastelloy C bellows.

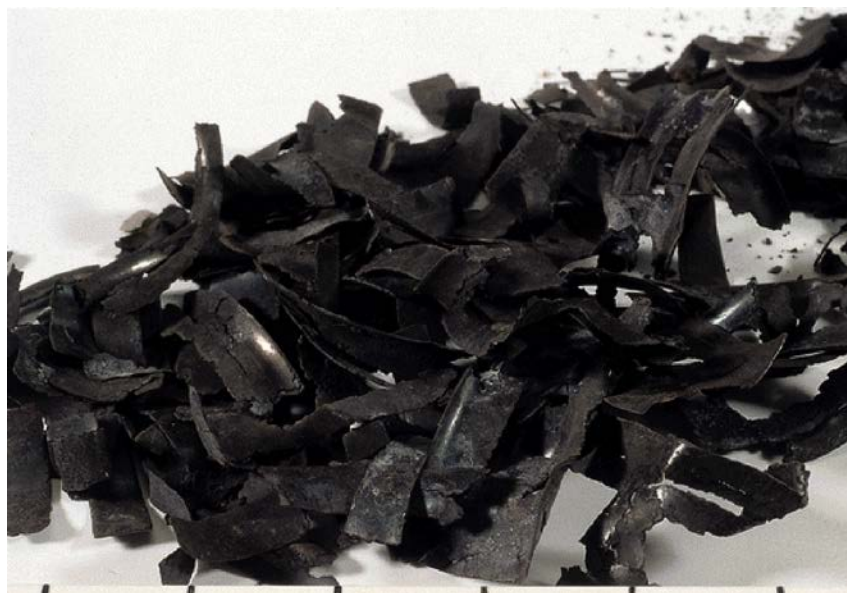
PART Column packing rings.

APPEARANCE Wall thinning by uniform attack.

CAUSE Oxidized glycol at high temperature gives an acidic environment by forming glycolic acid.

REMEDY Select stainless steel AISI 316.

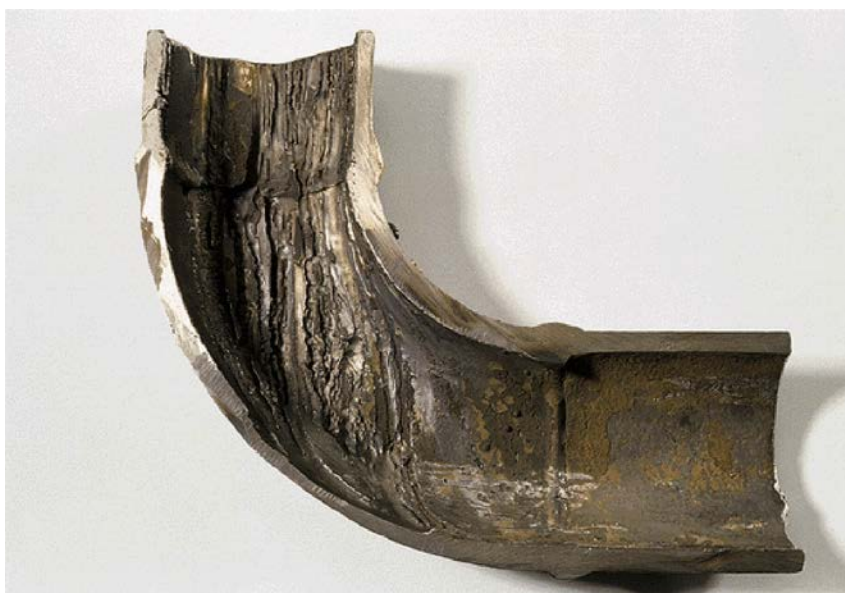
PART Tank drain line.

APPEARANCE Vertical grooves.

CAUSE Inappropriate initial material choice (see also Case History 04.11.04.02).

REMEDY Replaced by Hastelloy C276.

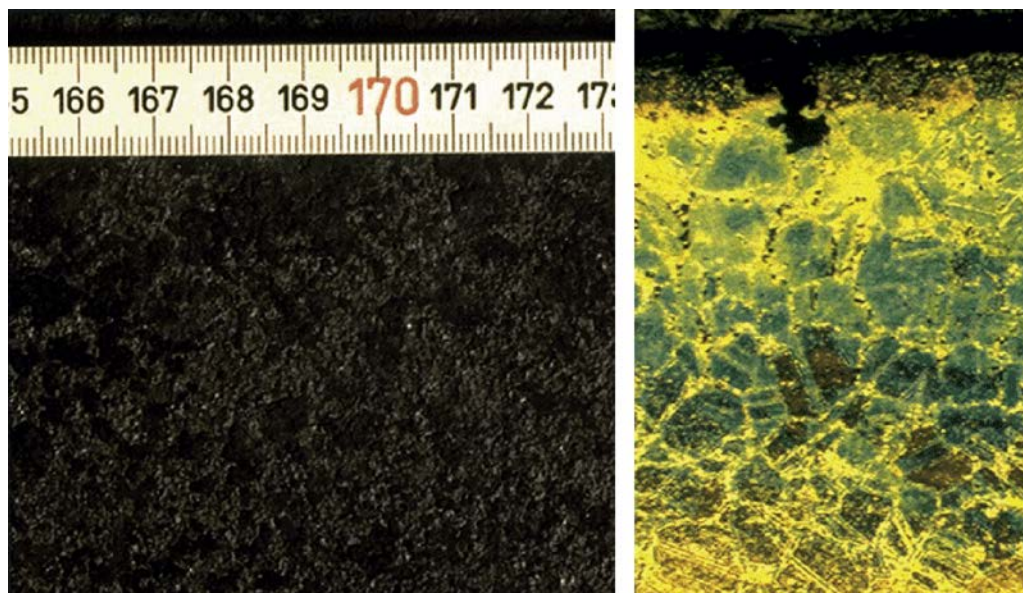
PART Wall of annealing furnace.

APPEARANCE Uniform attack.

CAUSE From the oil and hydrocarbons, carbon is formed which produces chromium and iron carbides in the stainless steel (carburization) (see also Case History 05.11.06.01). As a result, the material loses its ductility and the furnace collapses as a result of embrittlement. Formation of nitrides (nitriding) may also have played a role.

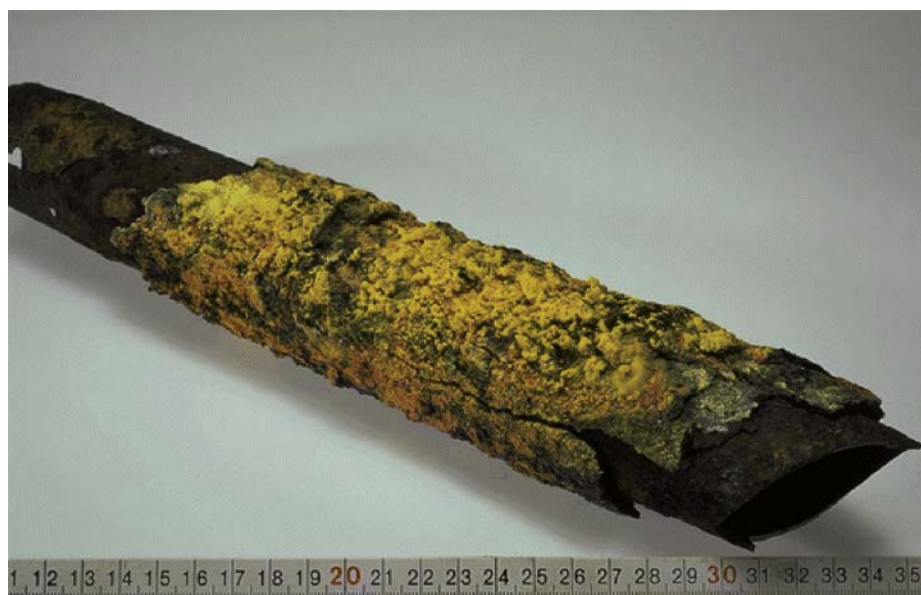
PART Pipe.

APPEARANCE Excessive wall thickness reduction and formation of a thick, yellowish scale with penetration of the pipe wall.

CAUSE Loss of corrosion protection by the chromium because, in the presence of chlorine in the combustion gases, chromium oxidizes to form yellowish alkali chromates. The chlorine accelerates the oxidation.

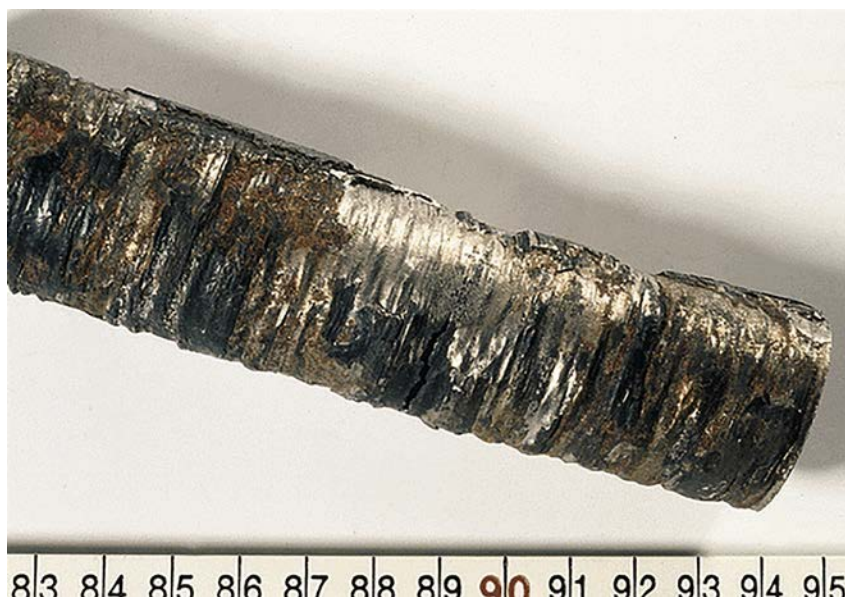
PART Heating coil.

APPEARANCE Severe overall and annular corrosion; 2–3 mm of the wall thickness had disappeared.

CAUSE Decomposition of ammonia produces atomic nitrogen that diffuses into the steel, followed by the formation of nitrides resulting in scaling of the nitride layer. In the case of a high nitriding potential, stainless steel has a limited lifetime (see also Case Histories 01.11.06.03 and 05.03.06.01).

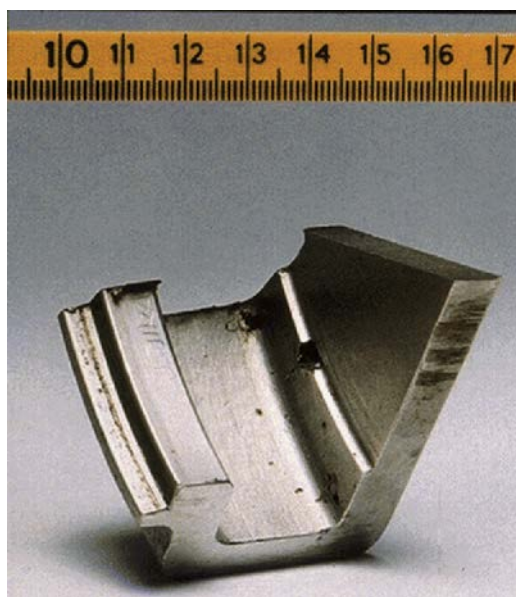
PART Part of cast pump casing.

APPEARANCE Severe pitting attack.

CAUSE Pitting corrosion is caused by the high chloride content together with the low pH and high temperature of the product. The pump casing was slightly magnetic, indicating ferrite precipitation in the casting process, and this increased its sensitivity to chloride.

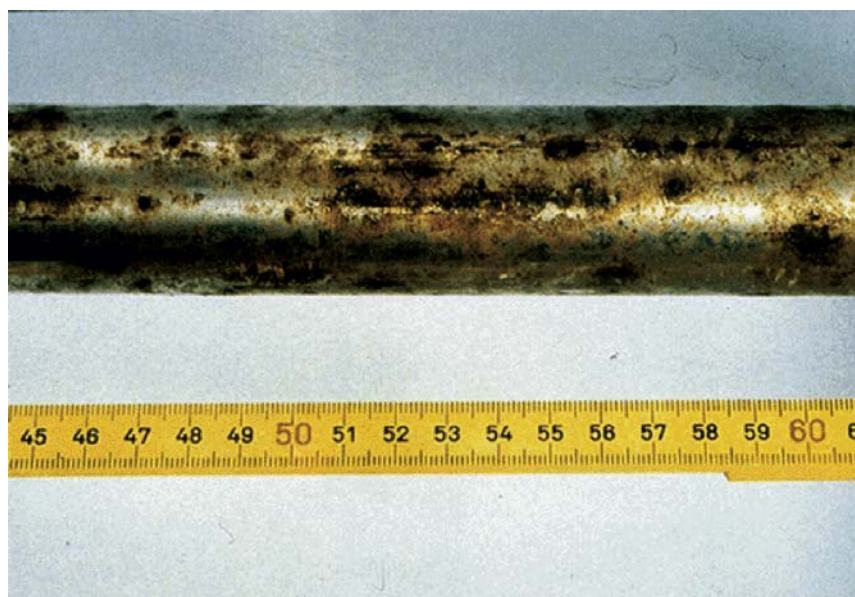
PART Whey transport pipeline.

APPEARANCE Pitting attack.

CAUSE Chloride pitting as a result of evaporation of the chloride-containing water on the pipe, reinforced by the oxidizing action of the sodium hypochlorite (see also Case History 04.08.12.04).

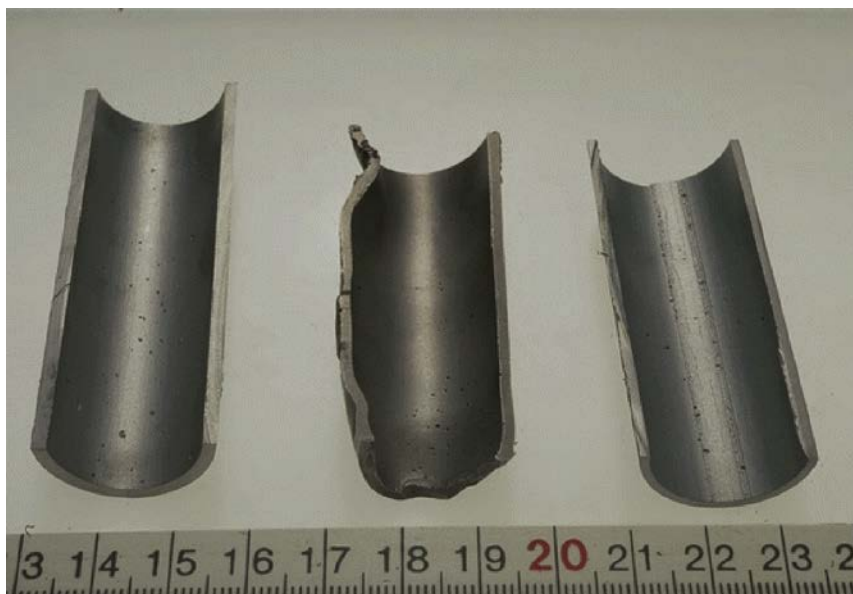
PART Heat exchanger pipes.

APPEARANCE Pitting corrosion, left: SAF 2205, center; Sanicro 28, right: E-Brite 26/1.

CAUSE None of the alloys used are sufficiently resistant to chloride attack.

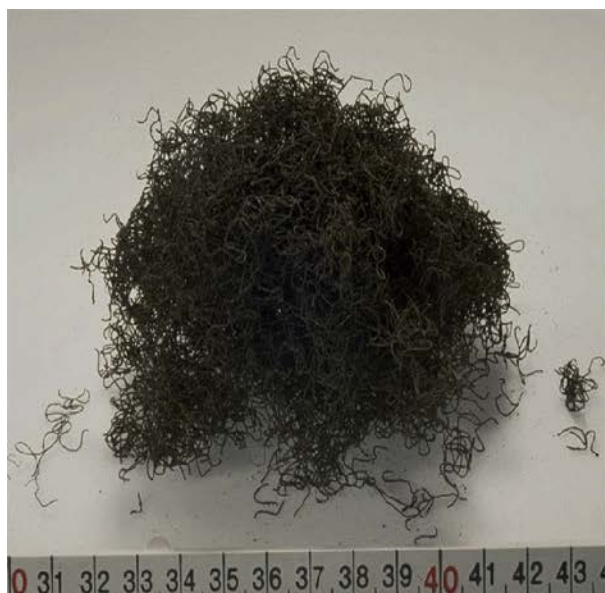
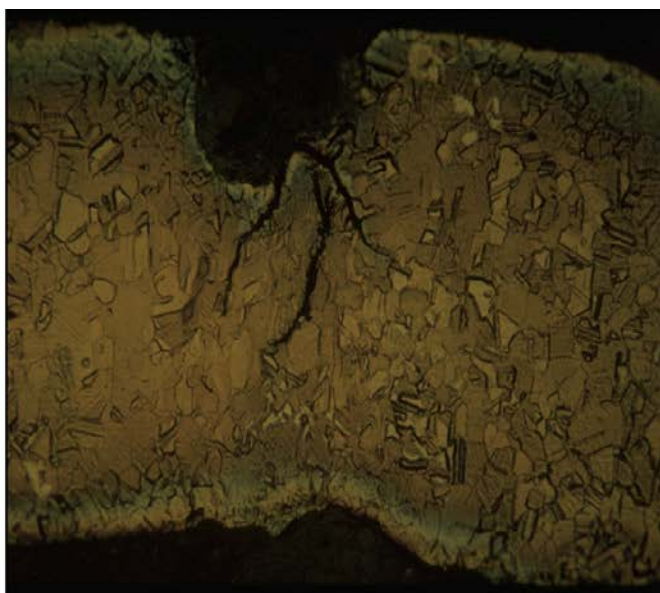
PART Demister material.

APPEARANCE Under the microscope: pitting with a few transgranular cracks. The material itself was totally embrittled.

CAUSE The corrosion of the stainless steel wires was caused by the presence of chloride in the medium, which led to pitting. Although the chloride content was low, enrichment of the content takes place at the surface in crevices and underneath hydrocarbon deposits. The transgranular cracking may have been caused by the presence of sulfides.

REMEDY Application of a more resistant material, e.g., AISI 316, or even better stainless steel W.-Nr. 1.4439 (17 Cr 13 Ni 5 Mo).

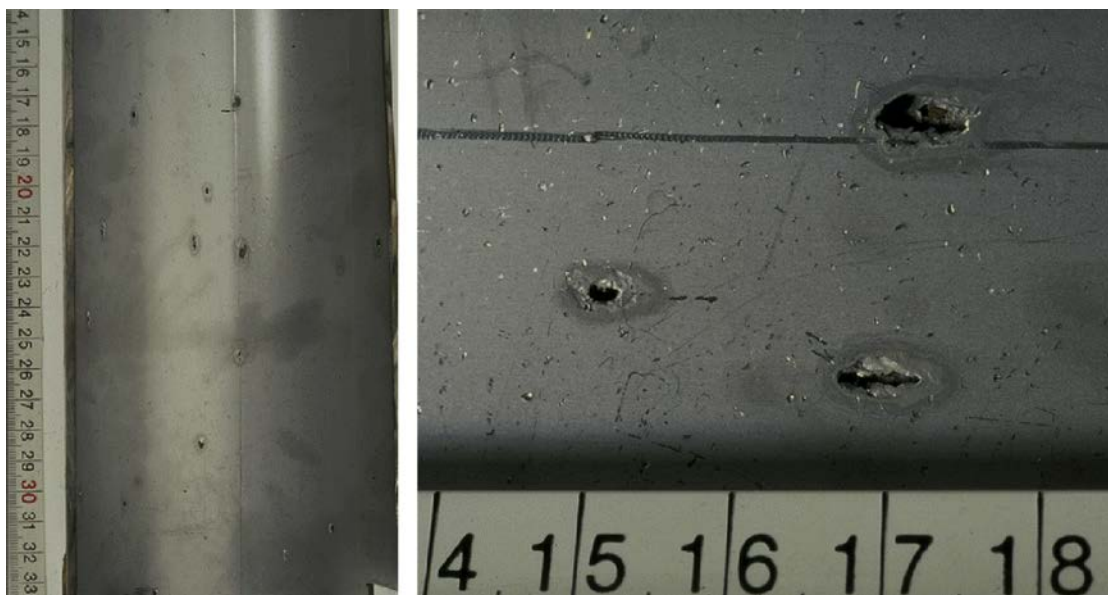
PART Feed line.

APPEARANCE Pitting attack at scratches and other sites.

CAUSE At the high temperature in this acid environment, the bromide contaminant causes pitting of stainless steel 316L, corresponding to pitting by chloride and other halides.

REMEDY • Use a more resistant alloy, e.g., stainless steel AISI 904L (25 Cr, 20 Ni, 5 Mo).
 • Modify the process equipment design in order to limit catalyst carry over.

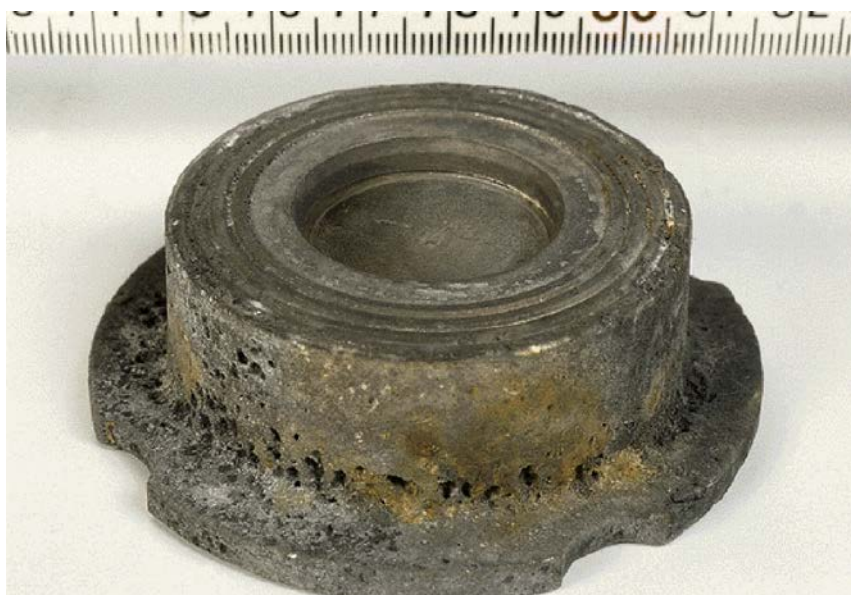
PART Nonreturn valve from reactor dosing pipe.

APPEARANCE Severe pitting.

CAUSE Stainless steel AISI 316 is not resistant to hydrochloric acid at any concentration or temperature (see also Case History 04.05.12.02).

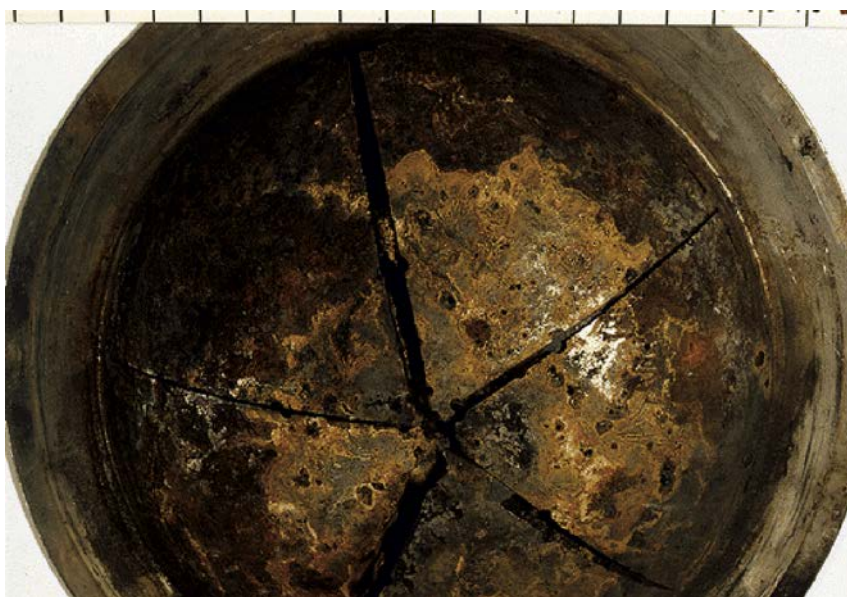
PART Bursting heat exchanger disk.

APPEARANCE Pitting under deposits.

CAUSE The corrosion at the outside of the plate was caused by contamination with dirt, iron oxide from the carbon steel standpipe above the bursting plate, and chloride-containing rainwater. This results in premature collapse of the disk.

REMEDY Provide the bursting disk with a stainless steel standpipe, sealed with a plastic foil at the top.

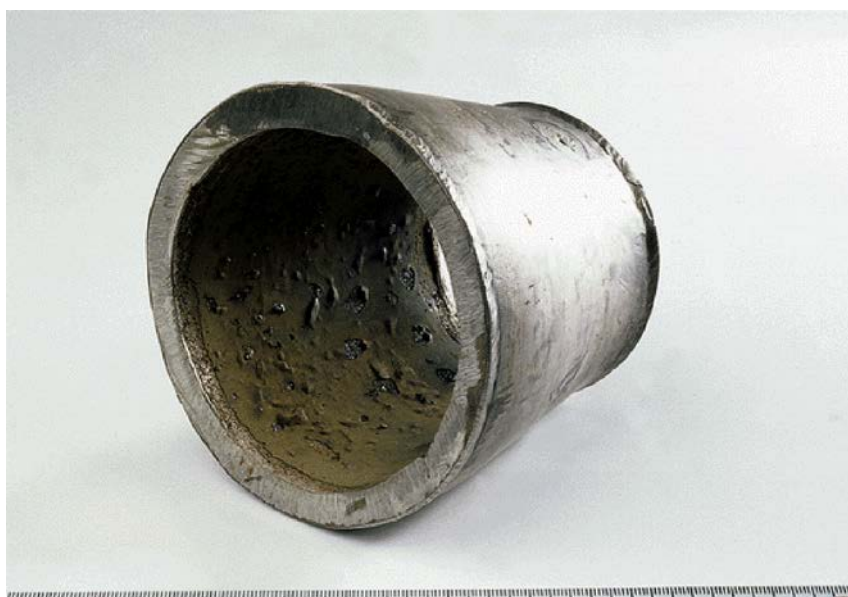
PART Reducer in feed line.

APPEARANCE Pitting attack.

CAUSE Stainless steel AISI 316 is not resistant to high chloride concentrations at the present temperature and pH (see also Case History [04.11.12.01](#)).

REMEDY Replace with a Glass Fiber Reinforced Polypropylene (GFR/PP)-lined steel line.

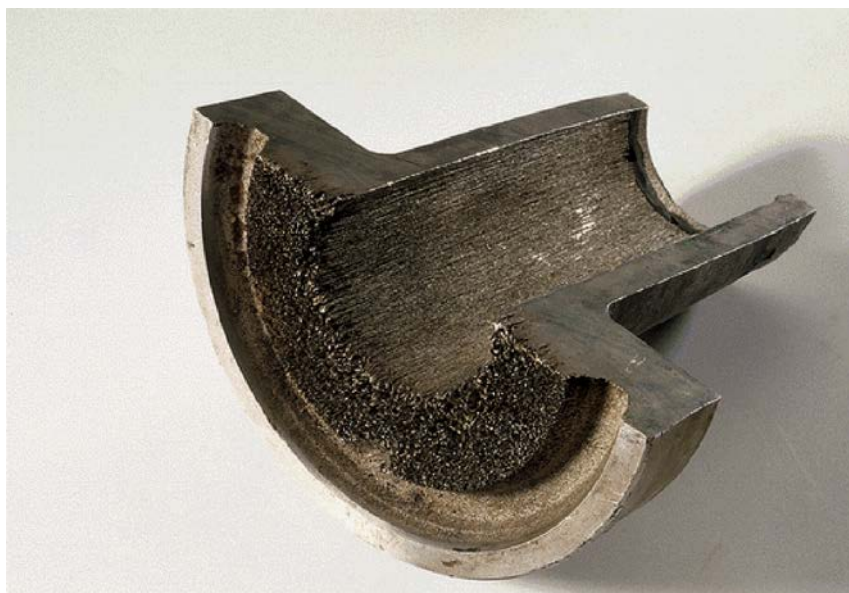
PART Flange.

APPEARANCE Severe uniform attack with clearly visible steel structure.

CAUSE The crevice-corrosion resistance of AISI 316 is insufficient (see also Case History 04.06.13.02).

REMEDY Replaced by duplex stainless steel W.-Nr. 1.4462 (SAF 2205).

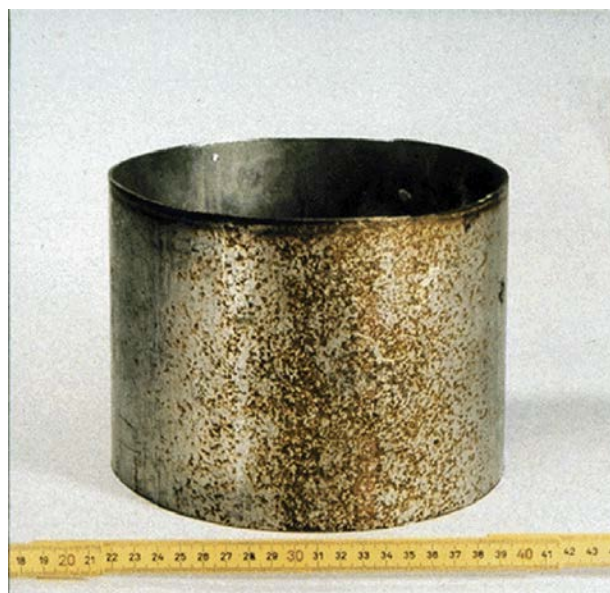
PART Pulp transport pipeline.

APPEARANCE Pitting attack with rust particles.

CAUSE When a carbon steel pipeline situated above the stainless steel pipeline was being cut off, cuttings landed on the stainless steel pipe. The carbon steel particles caused pitting by cell formation.

REMEDY Stainless steel pipelines should be covered when performing such operations.

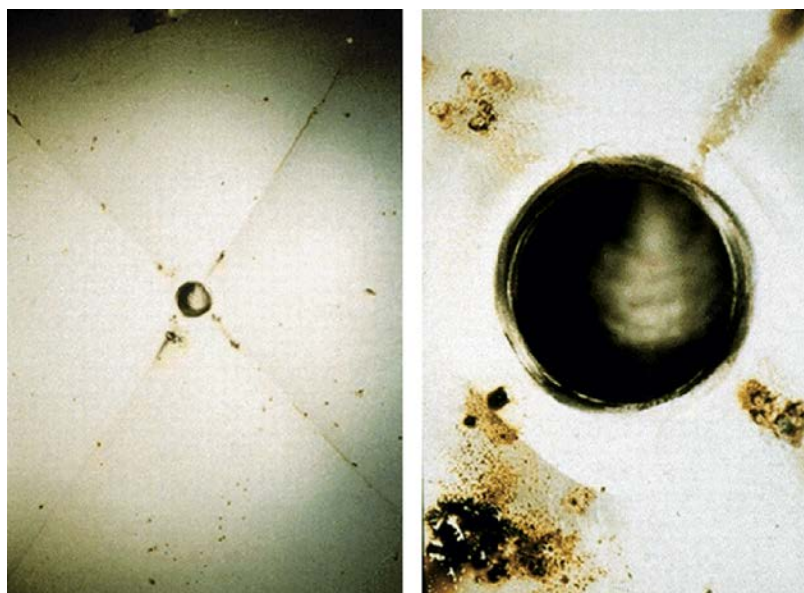
PART Base (with drain).

APPEARANCE Pitting attack.

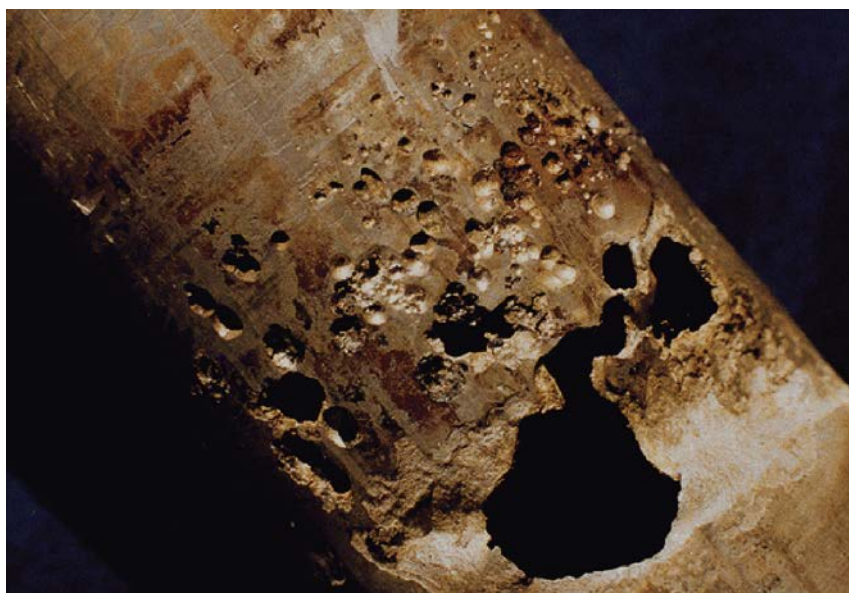
04.11.17.02

MATERIAL	Stainless steel (AISI 304).
SYSTEM	Chemical process industry (synthetic fiber manufacturing).
PART	Heat-exchanger tube end (OD 5.1 cm).
PHENOMENON	Microbiologically influenced corrosion.

APPEARANCE	Many small hemispherical pits on the tube end.
TIME IN SERVICE	Several years. The exchanger was removed from service several years before being reemployed. It was during the idle period that the pitting occurred.
ENVIRONMENT	Atmosphere.
CAUSE	The heat exchanger was removed from service and stored vertically outside and exposed to the elements for several years. Deposits accumulated at the lower tube ends where sulfate reducers flourished (see also former case).
REMEDY	Effective cleaning before storing and/or (dry) layup procedures.

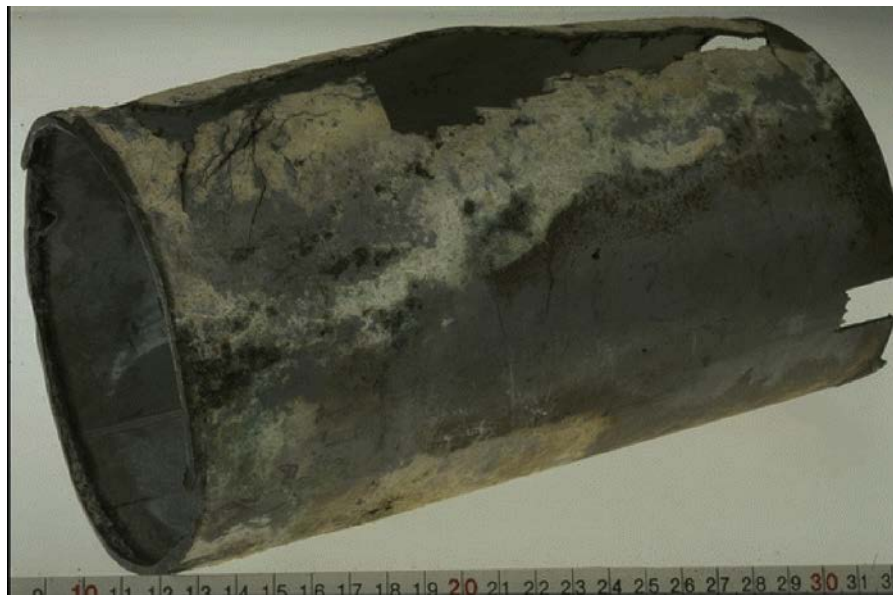
PART Pipeline section.

APPEARANCE Pipe burst open, branch fracturing under salt deposition with green patches.

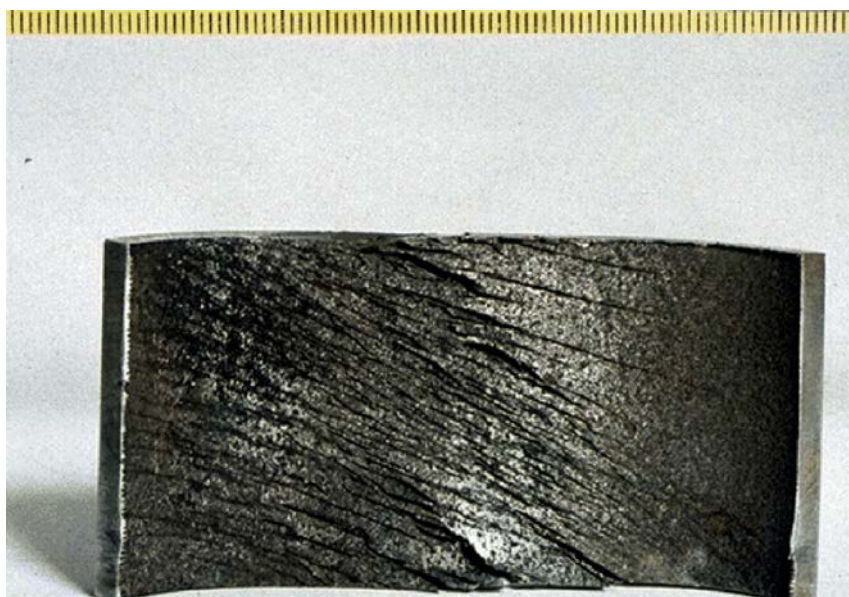
PART Pipe.

APPEARANCE Cracking at the steam tracing.

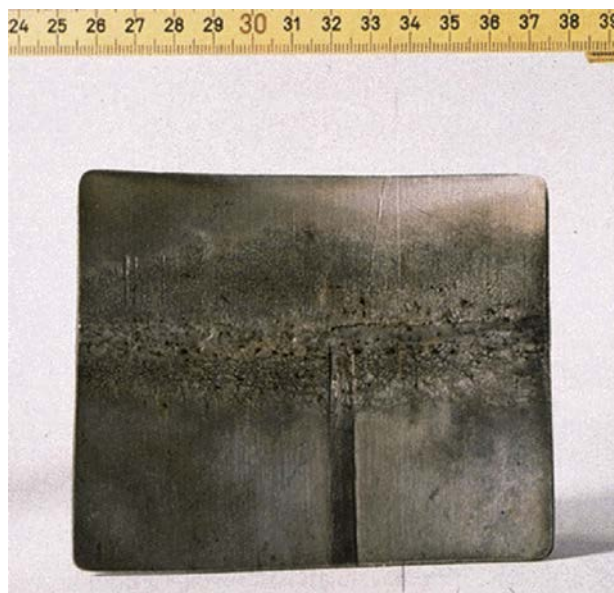
PART Inside wall section.

APPEARANCE Cracks in and adjacent to the welds.

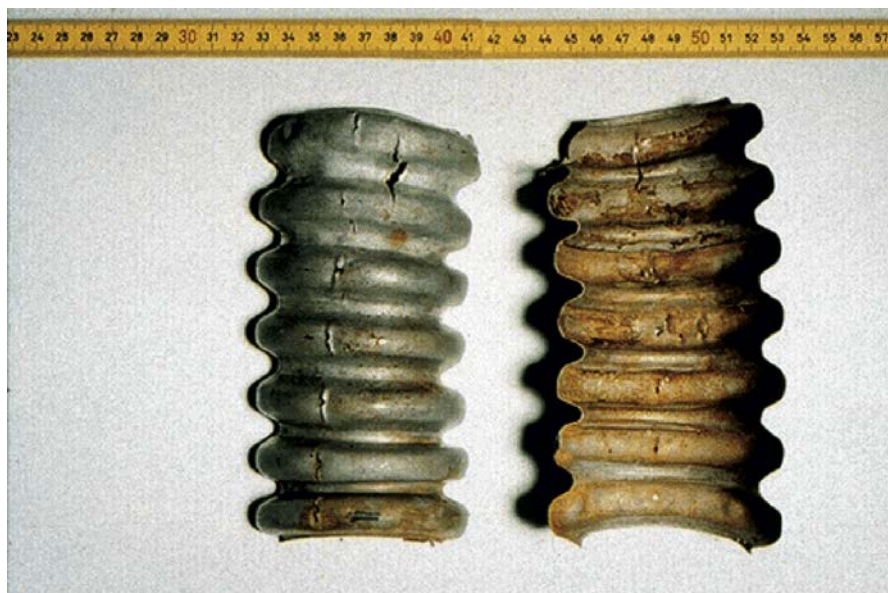
04.11.18.04

MATERIAL	Stainless steel (AISI 316).
SYSTEM	Hydrochloric acid transport pipe.
PART	Metal strengthener around plastic bellows.
PHENOMENON	Stress-corrosion cracking (transgranular).

APPEARANCE	Pitting attack with cracks.
TIME IN SERVICE	About 1 year.
ENVIRONMENT	Leaked hydrochloric acid with water vapor (atmosphere).

CAUSE	Error in choice of material: instead of a Monel strengthener, a stainless steel strengthener was used. From the product side, hydrochloric acid gas diffused through the plastic (PTFE). Together with atmospheric moisture, this gas formed concentrated hydrochloric acid, which attacked the stainless steel.
-------	--

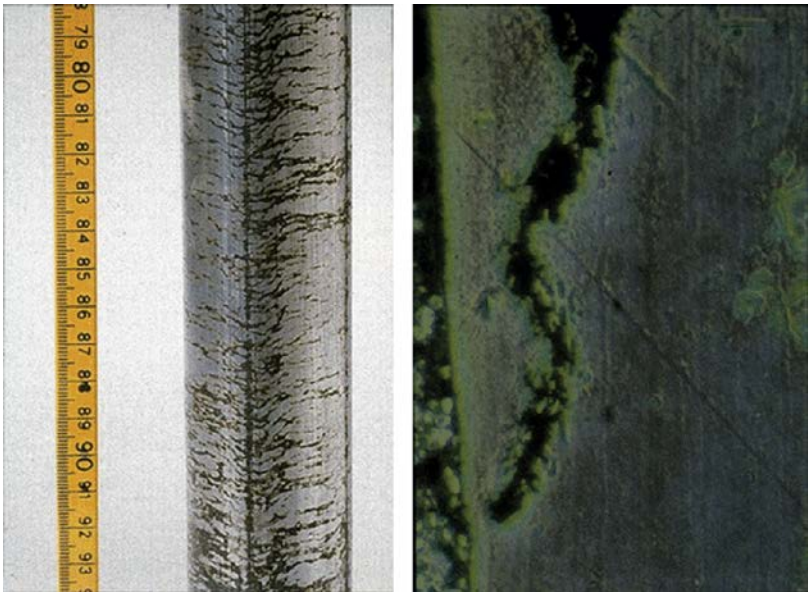
04.11.18.05

MATERIAL	Stainless steel (AISI 304).
SYSTEM	Textile steamer.
PART	Guide bar in textile conveyor system.
PHENOMENON	Stress-corrosion cracking (transgranular).

APPEARANCE	Transverse cracking.
TIME IN SERVICE	About 3 years.
ENVIRONMENT	Steam at 100°C, saturated by injection with softened water (at a later stage, with condensate).
CAUSE	<p>Stress corrosion took place as a result of the simultaneous presence of:</p> <ul style="list-style-type: none"> • tensile stresses in the bar, • high chloride content in the dyes in the textile, • high temperature.
REMEDY	Use of chloride-free dyes and injection with chloride-free condensate if the present 304 stainless steel construction is retained. Otherwise, construction of duplex steel (ferritic-austenitic stainless steel) if a chloride-free environment cannot be guaranteed.

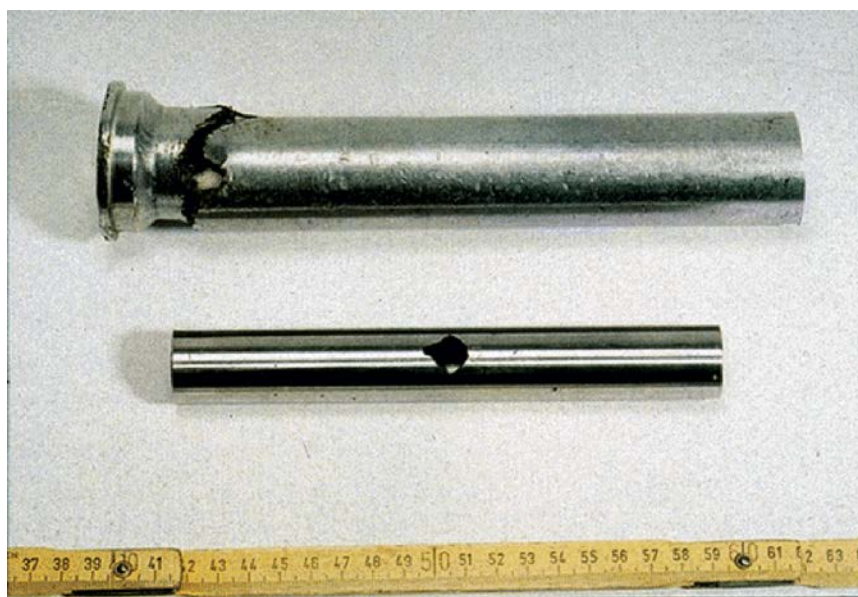
PHENOMENON Stress-corrosion cracking (transgranular).

APPEARANCE Cracking with some pitting.

CAUSE Stress corrosion and pitting caused by the combination of the high salt concentration, the low pH, and the high temperature of the product (see also Case History [04.11.18.11](#)).

REMEDY Construction of the ketchup pipes from duplex stainless steel (e.g., W.-Nr. 1.4462) that is more resistant to stress-corrosion cracking.

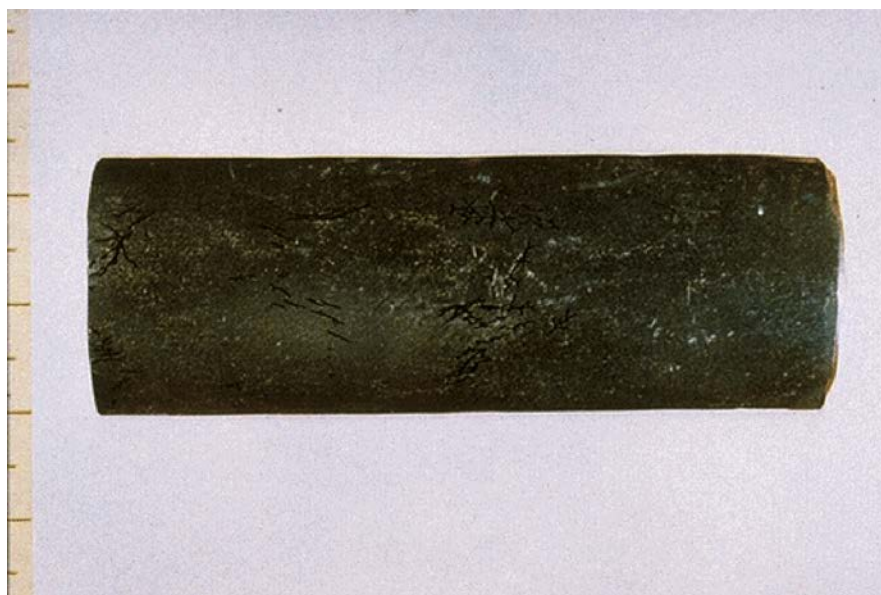
PHENOMENON Stress-corrosion cracking (transgranular).

APPEARANCE Cracking.

CAUSE The stainless steel pipe was marked with a chloride-containing marker (the number 357 or 857 is visible) (see also Case History 04.22.18.01).

REMEDY Use of chloride-free markers when marking stainless steel.

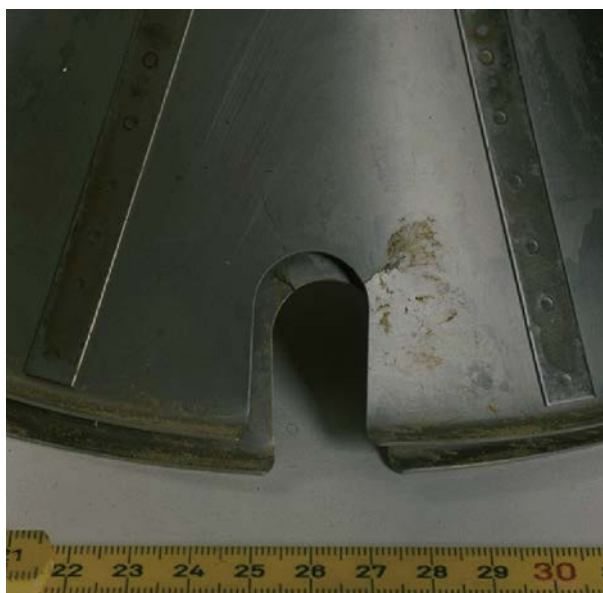
PHENOMENON Stress-corrosion cracking (transgranular).

APPEARANCE Cracks in the radius of the discharge channels.

CAUSE The build-up of local stresses during rotation of the trays caused stress corrosion in the present medium.

- Modify the structure by replacing the channels with round holes.
- Alternative: use less stress-sensitive stainless steel, e.g., duplex steel (W.-Nr. 1.4462)

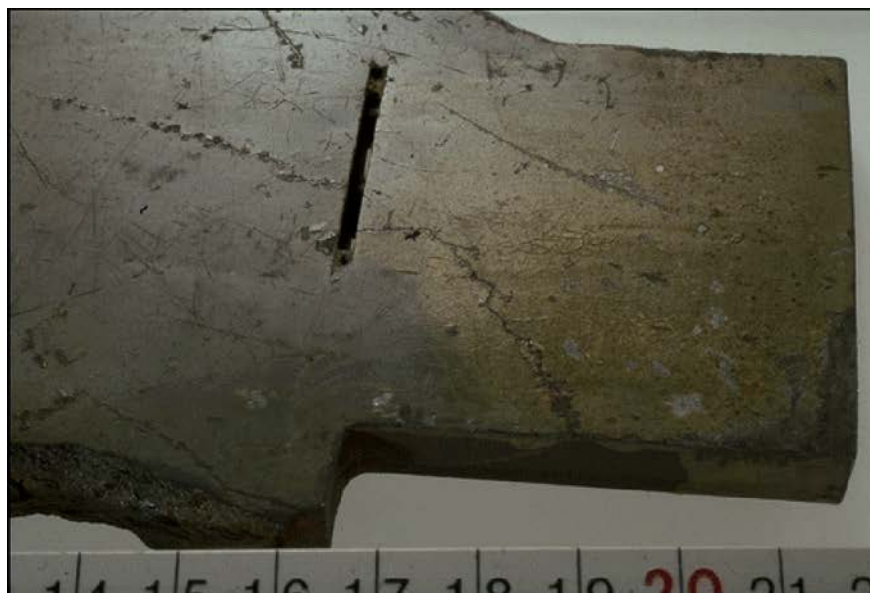
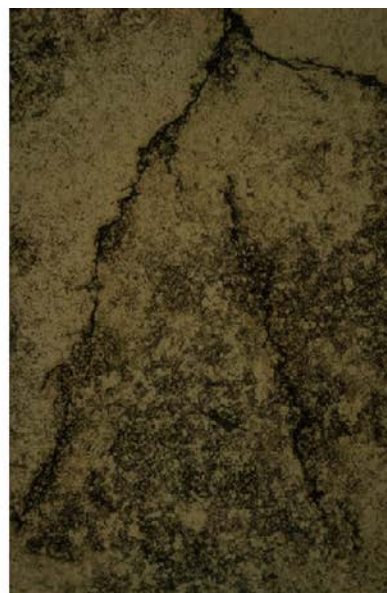
PHENOMENON Intergranular stress corrosion (nitrate stress-corrosion cracking).

APPEARANCE Cracking.

CAUSE In order to reduce the explosion risk due to a gas leakage, this reactor was sprinkled with (nitrate-containing) cooling water which penetrated into the insulation and caused salt deposition. The high nitrate content caused intergranular stress-corrosion cracks in the stainless steel cladding and in the carbon steel as well (see also Case History 01.11.18.02).

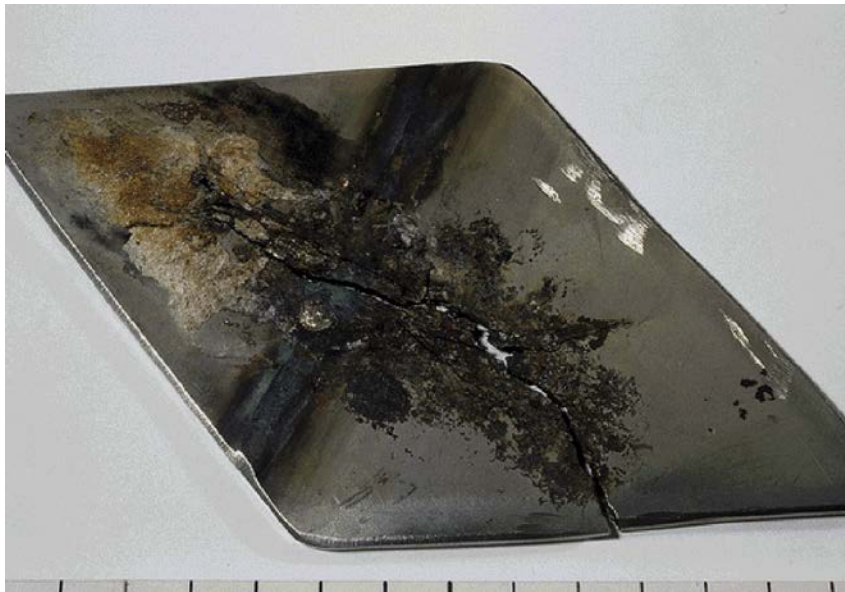
PHENOMENON Stress-corrosion cracking (transgranular).

APPEARANCE A perforating crack.

CAUSE The high chloride content in combination with the temperature caused stress corrosion cracking (see also Case History [04.11.18.06](#)).

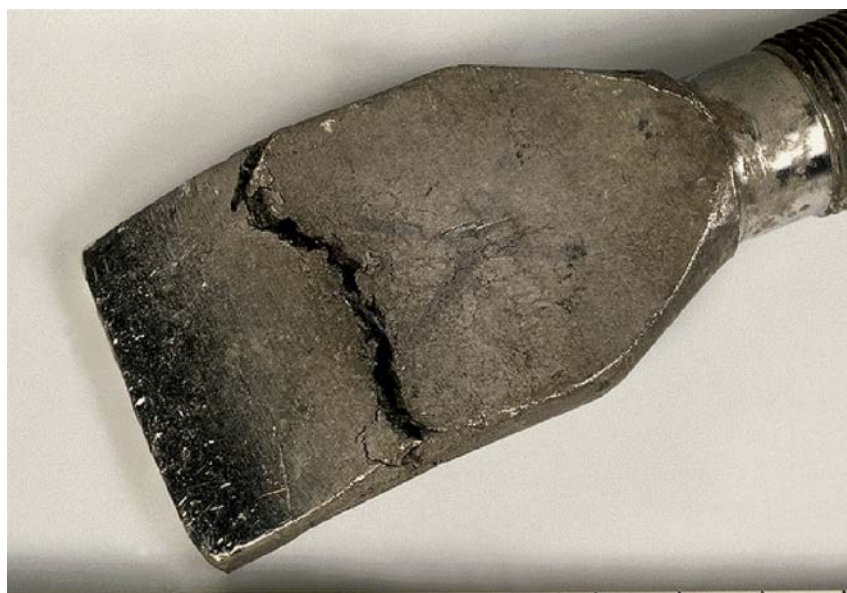
PHENOMENON Stress-corrosion cracking (transgranular).

APPEARANCE Transverse cracking over the paddle.

CAUSE Stress-corrosion cracking was able to occur due to the presence of moisture formed by condensation. The other conditions for stress corrosion cracking in stainless steel had been met, namely: presence of chloride, temperature $> 60^{\circ}\text{C}$, and the presence of stresses in the material.

REMEDY Prevent condensation by supplementary heating and use of predried air. If this is ineffective, construct paddles of stainless steel W.-Nr. 1.4539.
