Corrosion Atlas

THIRD, EXPANDED AND REVISED EDITION

A Collection of Illustrated Case Histories

Evert D.D. During

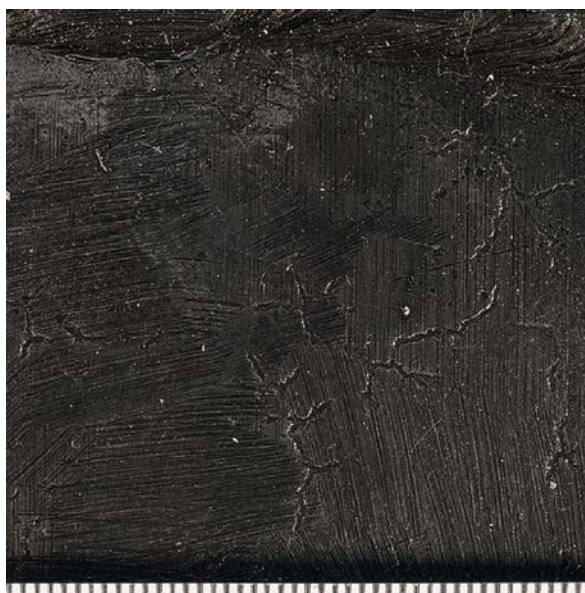
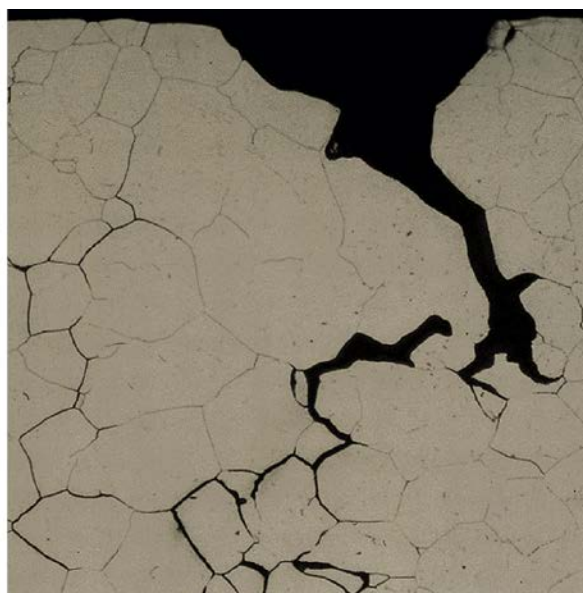
04.11.18.13

MATERIAL	Stainless steel (AISI 316).
SYSTEM	Hydrodesulfurization unit.
PART	Rolled bond cladding of reactor.
PHENOMENON	Polythionic acid stress-corrosion cracking.

APPEARANCE	Intergranular cracking.
TIME IN SERVICE	The corrosion took place during shutdown.
ENVIRONMENT	During operation sulfides are formed in the reducing H_2/H_2S environment. Upon shutdown, these sulfides are transformed into polythionic acids with ingress of both oxygen and water.
CAUSE	Production of polythionic acid in combination with sensitization of the rolled bond clad layer (see also Case History 04.11.18.15).
REMEDY	Neutralization by washing with a soda ash solution in accordance with NACE-RP-01-70.

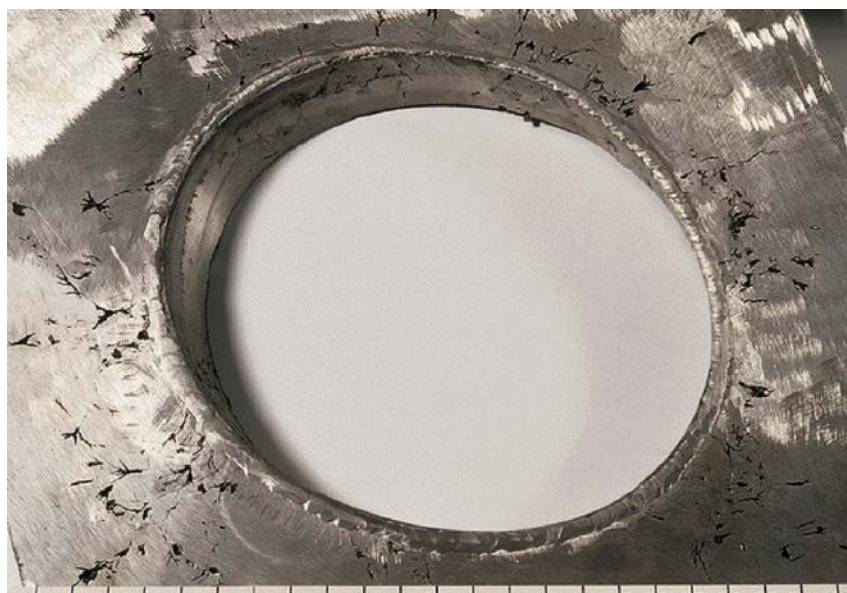
PHENOMENON Stress-corrosion cracking (transgranular).

APPEARANCE Small cracks in the tank wall.

- This medium is too aggressive for SS 304L.
- Stresses in the SS caused by welding and processing.

- The problem was solved by raising the pH to approximately 7 and lowering the chloride content to almost 0.
- Alternative: use duplex stainless steel.

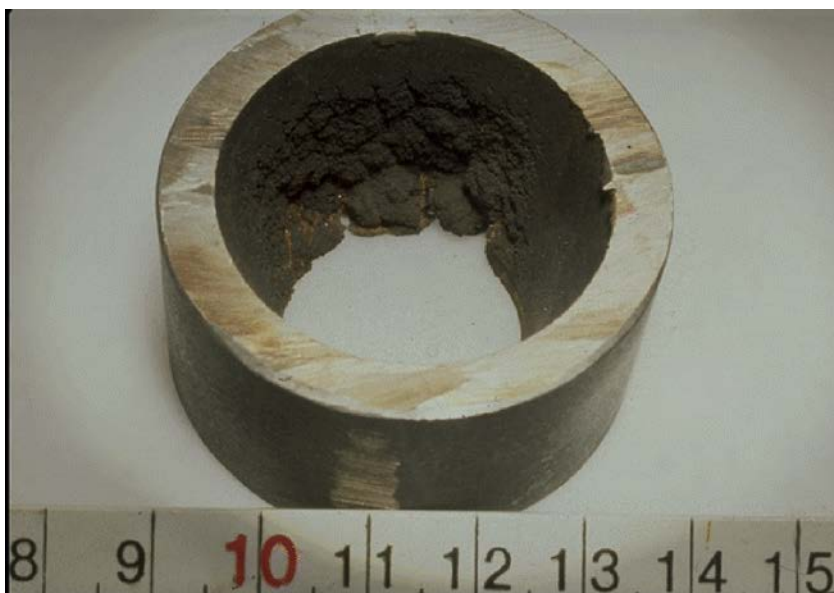
04.11.18.15

MATERIAL	Stainless steel (AISI 304 H).
SYSTEM	Cracking furnace.
PART	Nozzle on inlet header of a radiant coil outside furnace.
PHENOMENON	Polythionic acid stress-corrosion cracking.

APPEARANCE	Irregular intergranular cracking, causing a rough surface.
TIME IN SERVICE	80,000 h.
ENVIRONMENT	Polythionic acid formed by sulfides, water, and oxygen during idle periods.
CAUSE	Condensation of water in the inlet header, in which the polythionic acid dissolves. For this polythionic acid stress corrosion, the stainless steel must be sensitized due to chromium carbide precipitation at the grain boundaries (see Case Histories 04.01.19.01 and 04.11.18.13) and tensile stresses must be present. The rough surface is caused by loss of the metal grains.
REMEDY	Use of stainless steel AISI 321 H, which is not susceptible to sensitization.

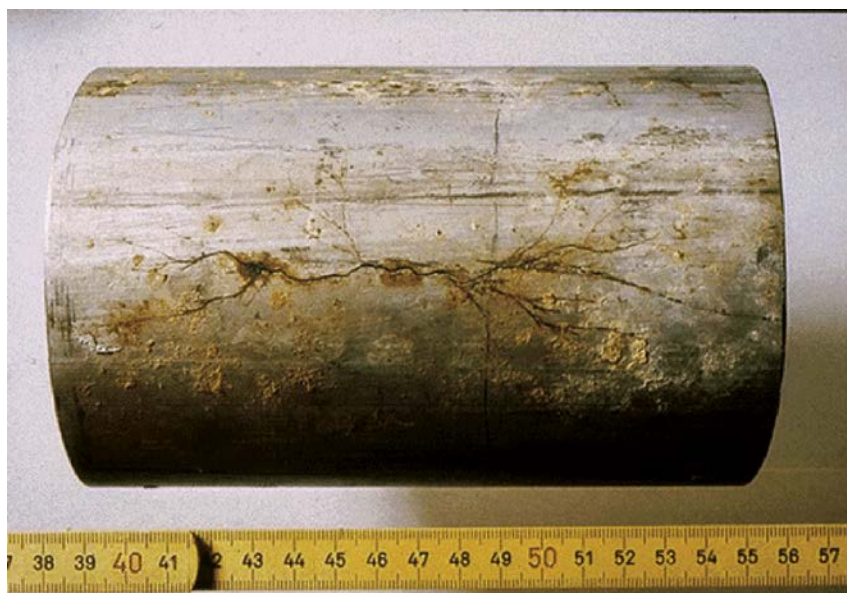
PHENOMENON Stress-corrosion cracking (transgranular) under insulation.

APPEARANCE Finely branched cracking pattern.

CAUSE The insulated pipeline is regularly wetted by the penetrated wash water. The water reaches the pipe via imperfections in the insulation, leading to evaporation. The combination of stresses, chloride, and temperature then gives rise to stress corrosion (see also 04.01.18.04).

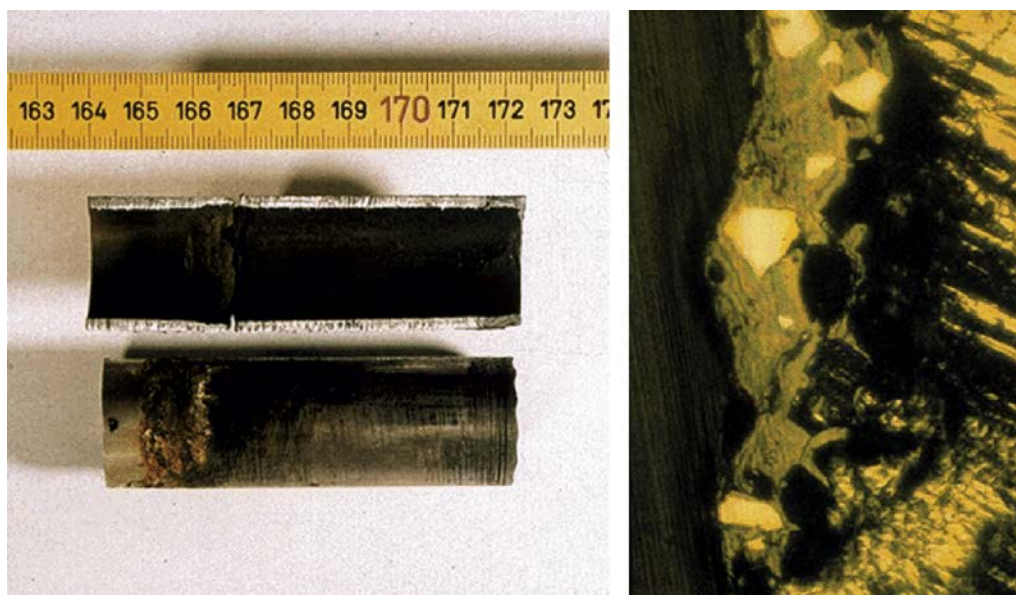
PHENOMENON Intergranular corrosion internally, crevice corrosion externally.

APPEARANCE Grooved attack internally, pitting attack externally.

CAUSE This material is susceptible to intergranular corrosion under the present circumstances, and to crevice corrosion of the tubes in the tube plate [the latter was manufactured of 3RE60 (W.-Nr. 1.4417) and displayed stress corrosion]; moreover the weld contained inclusions, as can be seen on the microphoto. In addition, pipes made of 304, 410, W.-Nr. 1.4465, and 316 L stainless steel had a short service life.

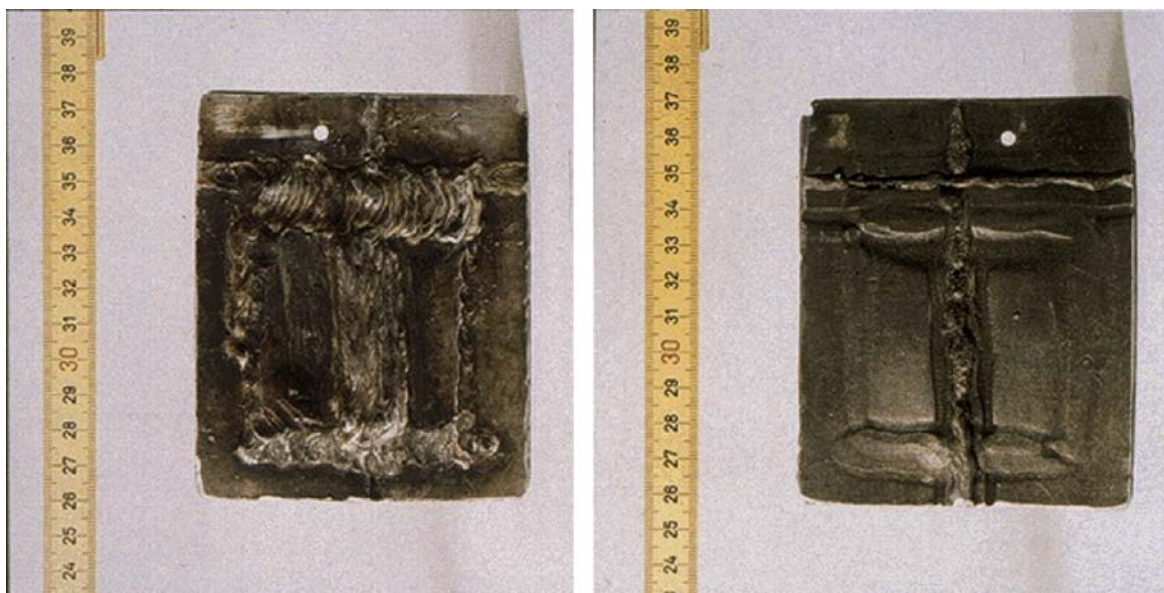
04.11.19.02

MATERIAL	Stainless steel (AISI 304).
SYSTEM	Nitric acid plant
PART	Vessel wall section (on both sides).
PHENOMENON	Intergranular corrosion (weld decay).

APPEARANCE	Local attack at a short distance from the weld.
TIME IN SERVICE	Unknown.
ENVIRONMENT	54% nitric acid; temperature approximately 80°C.

CAUSE Inappropriate material selection: in the present grade of stainless steel, chromium carbide precipitation occurs in the heat-affected zone (600–850°C) beside the weld, as a result of which the material becomes sensitive to corrosion owing to chromium depletion at the grain boundaries (see also Case History 04.01.19.01).

REMEDY Application of stainless steel with a lower carbon content (AISI 304L: C, 0.03%) or of stainless steel stabilized with Nb (AISI 347) or Ti (AISI 321).

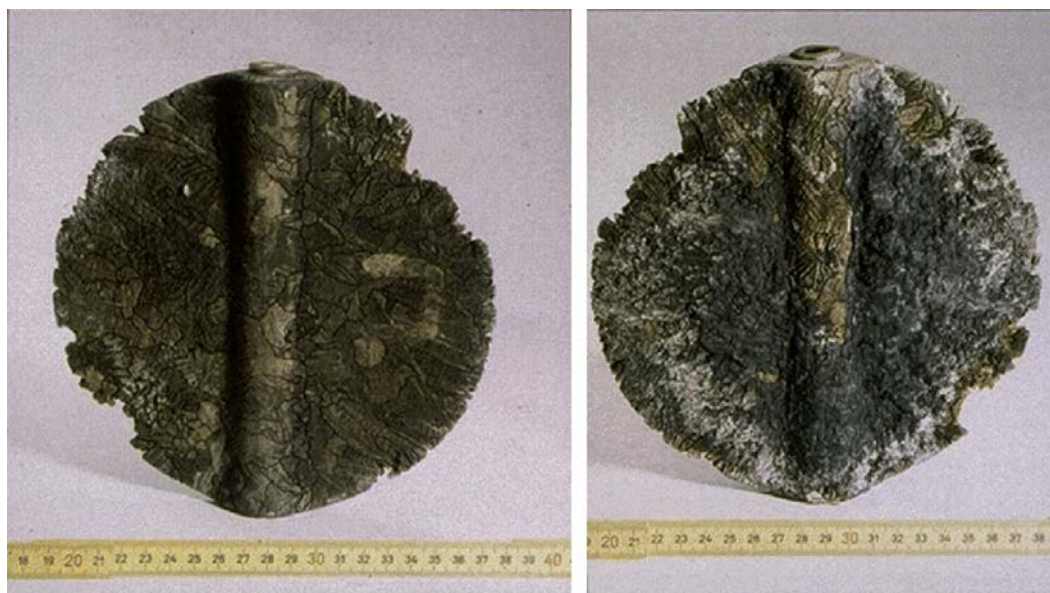
04.11.19.03

MATERIAL	Stainless steel (Uranus B6; W.-Nr. 1.4539).
SYSTEM	Contaminated sulfuric acid transport pipeline.
PART	Plate in a butterfly valve.
PHENOMENON	Intergranular corrosion.

APPEARANCE	Severe uniform attack with a network of cracks on both sides of the plate.
TIME IN SERVICE	15 months.
ENVIRONMENT	A solution of 7% H ₂ SO ₄ , 4% ZnSO ₄ , 1% MgSO ₄ , and 0.5% MnSO ₄ , temperature 30°C; pressure 2.8 bar; velocity 1.6 m/s.
CAUSE	The used alloy is not resistant to this solution (see also Case History 05.11.19.01).
REMEDY	Construction of the valve from Incoloy 825 (W.-Nr. 2.4858).

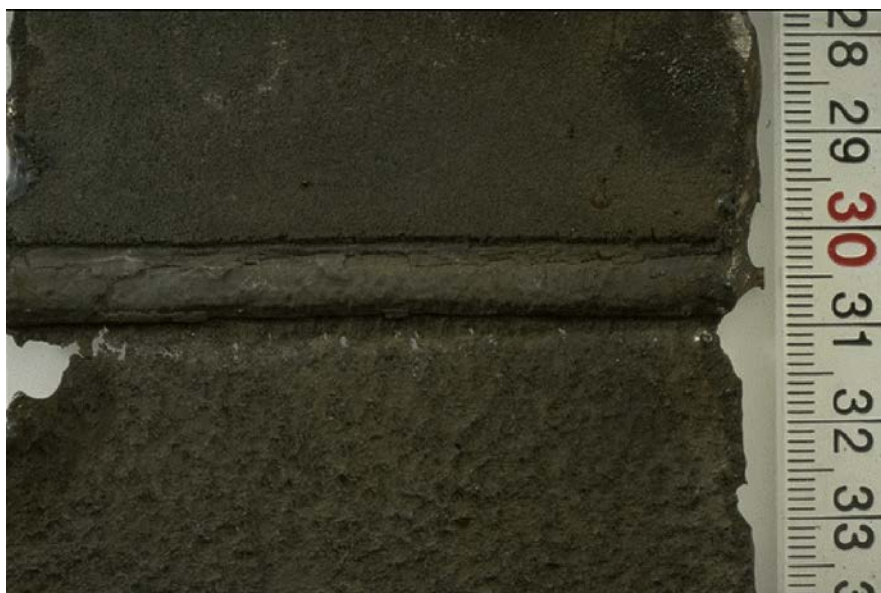
04.11.19.04

MATERIAL	Stainless steel (AISI 321 above the weld and AISI 316 underneath the weld).
SYSTEM	Mixing reactor in a metal plant.
PART	Wall with weld.
PHENOMENON	Two forms of intergranular corrosion near the weld: knife-line attack and weld decay.

APPEARANCE	Selective attack: Above, right along the weld: knife-line attack; below, at some distance from the weld: weld decay; below, also uniform attack.
------------	--

CAUSE	Weld decay: see Case Histories 0401.19.01 and 04.11.19.02. When stainless steel stabilized with niobium or titanium is welded, in the zone immediately around the weld, all the carbides enter into solution (temperature >1225°C) and remain so during rapid cooling. When the weld is heated in the critical temperature area (e.g., in stress-relief annealing or multilayered welding), precipitation of chromium carbide occurs. Consequently, this zone becomes sensitive to intergranular corrosion (see also Case History 04.18.12.01).
-------	---

REMEDY	Prevent knife-line attack to stabilized stainless steel by: <ul style="list-style-type: none"> • Post-weld heat treatment to 1065°C, so that the chromium carbide dissolves and titanium carbide forms. Thereafter, the cooling rate is no longer an important factor. • Alternative: select different material. Prevention of weld decay: see Case Histories 04.01.19.01 and 04.11.19.02.
--------	--

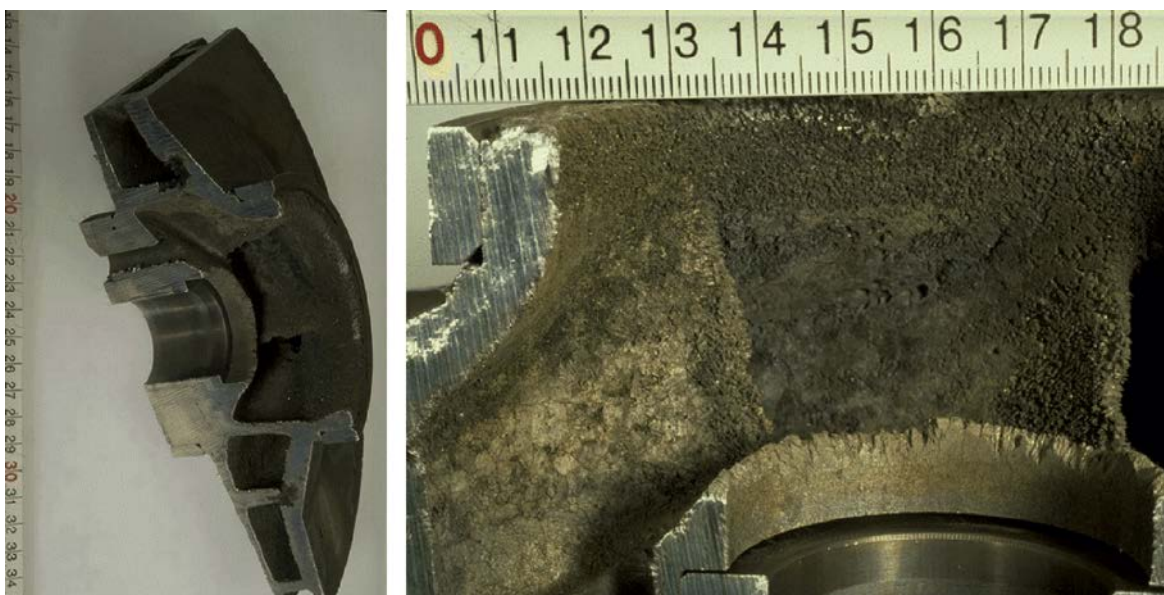
PHENOMENON Intergranular corrosion.

APPEARANCE Partly a granular surface with loose grains, and partly a network of cracks.

CAUSE The present type of stainless steel contains molybdenum and is relatively high in carbon content. The presence of both elements accelerates intergranular corrosion of stainless steel in concentrated nitric acid (see also Case History 04.11.19.10).

REMEDY In this specific environment, use stainless steel of type ACI CF-3 (AINSI 304L cast), which is low in carbon and molybdenum content.

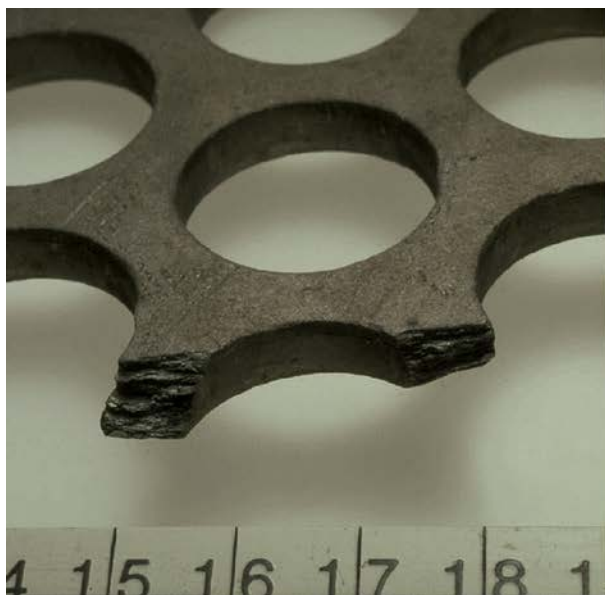
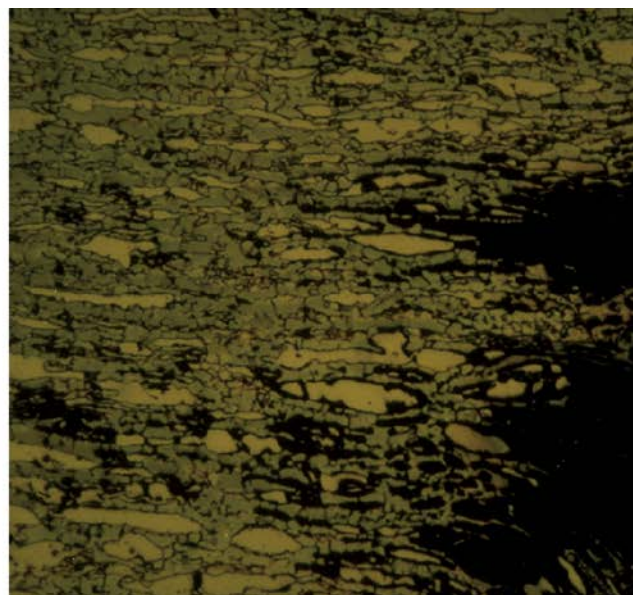
04.11.19.06

MATERIAL	Duplex stainless steel (X2 CrNiMoN 25 6).
SYSTEM	Partial condenser for ammonium carbamate (see also Case History 09.11.20.01).
PART	Hold-down plate.
PHENOMENON	Intergranular corrosion and selective austenitic attack.

APPEARANCE	Nothing is visible to visual inspection, but microscopic examination discloses both selective attack to the austenitic phase and intergranular corrosion along the ferrite–austenite grain boundaries.
------------	--

CAUSE	Poor quality duplex steel: a high content of austenite (60%–70%), a microstructure consisting of an austenite matrix with ferrite islands instead of a ferrite matrix with austenite. Under these conditions, repassivation of the austenite does not occur. As a result, a brittle fracture occurs (see also Case History 04.11.19.11).
-------	--

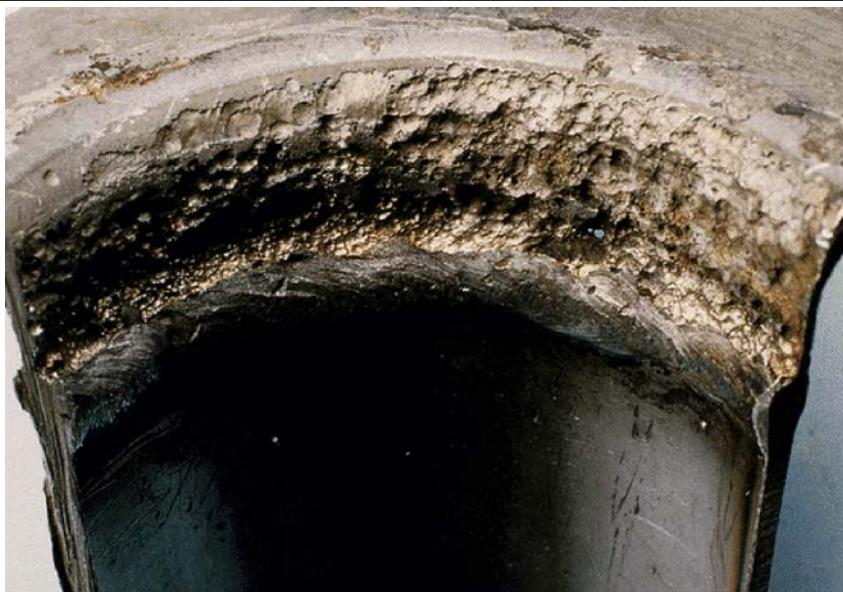
04.11.19.07

MATERIAL	Stainless steel (pipe: AISI 308, flange: AISI 304).
SYSTEM	Conveyor pipe system in pharmaceutical plant.
PART	Pipe with flange (joint welded by GTAW, Gas Tungsten Arc Welding process).
PHENOMENON	Intergranular corrosion (weld decay) with pitting.

APPEARANCE	Corrosion damage of fusion zone (HAZ, Heat affected Zone).
TIME IN SERVICE	2–3 years.
ENVIRONMENT	Solution with salt and acid; no further information available.

CAUSE In the HAZ (600–850°C), chromium carbide precipitation occurs beside the weld, as a result of which the material becomes sensitive to corrosion owing to chromium depletion at the grain boundaries (see also Case History [04.08.19.01](#)). With reference to the environment, chloride pitting has also taken place.

- For the present grade of stainless steel, application of PWHT (postweld heat treatment) to 1020–1150°C to dissolve the carbides, followed by rapid quenching.
- Application of stainless steel with a low carbon content or stainless steel stabilized with Nb or Ti. With reference to the environment, stainless steel-containing molybdenum is recommended (AISI 316 Cb or 316 Ti).

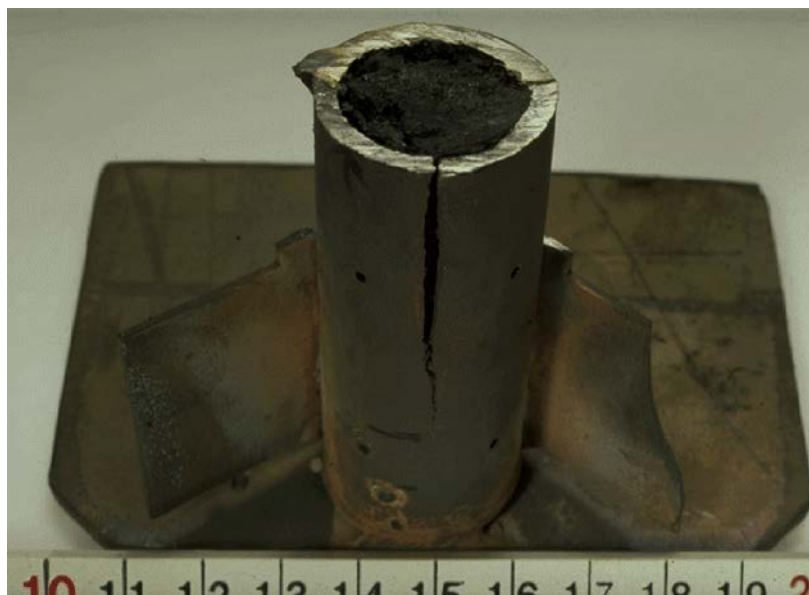
CASE HISTORY
04.11.19.08

MATERIAL	Stainless steel (AISI 310).
SYSTEM	Cracking furnace.
PART	Burner front of a low NO _x burner.
PHENOMENON	Intergranular corrosion (sigma phase embrittlement).

APPEARANCE Longitudinal crack with plugging due to internal coking.

CAUSE Coke formation caused plugging of the gas injection points, causing temperature rises into the sigma-phase formation range (500–900°C). The consequently embrittled metal cracked intergranularly due to stresses (see also Case Histories [04.11.19.09](#) and [04.12.19.01](#)).

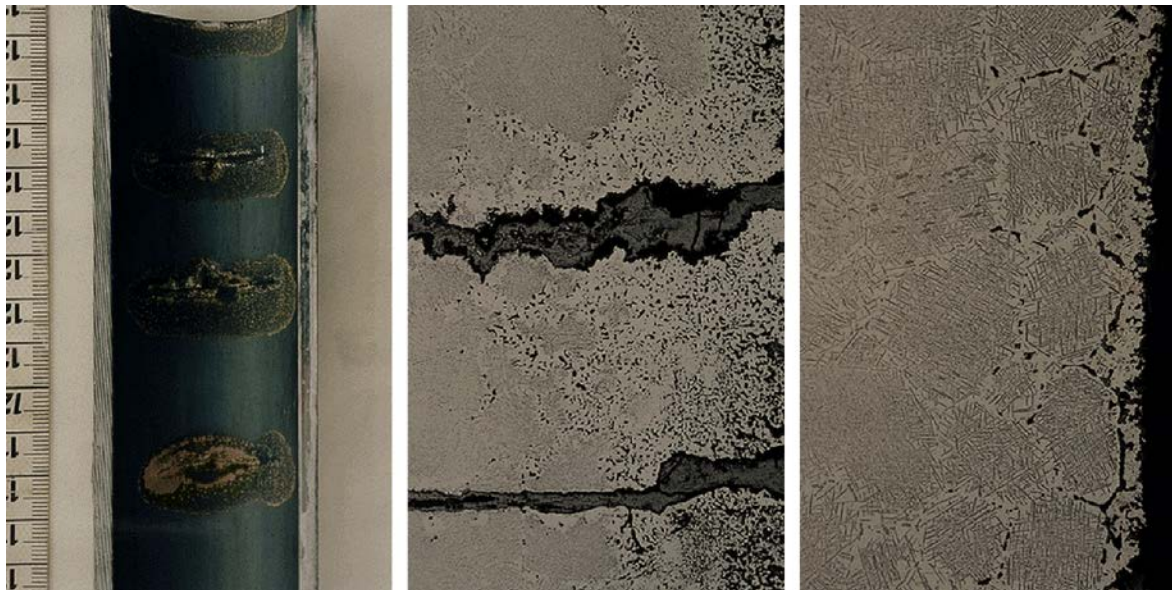
PHENOMENON Intergranular corrosion (sigma-phase embrittlement).

APPEARANCE Brittle fracture.

CAUSE The temperature exceeded the design temperature by about 100°C for the entire operating period or at any rate for much of it. At this temperature, materials of the AISI 310 type are sensitive to embrittlement by the formation of sigma phase. In this condition, thermal stresses will provoke the formation of cracks (see also Case History [04.12.19.01](#)).

REMEDY Replacement of W.-Nr. 1.4841 by Rolled Alloy 330/333, which is not sensitive to the formation of sigma phase in the temperature range concerned.

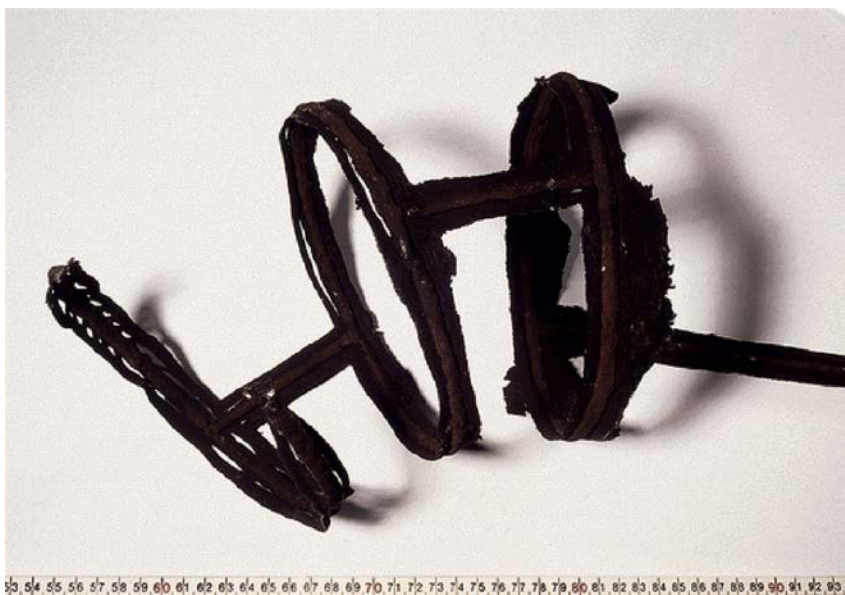
PHENOMENON Intergranular corrosion.

APPEARANCE Except for the welds, the material is completely corroded away.

CAUSE Intergranular corrosion of 316L in carbamate solutions.
Weld metal is more corrosion-resistant due to higher percentage of alloying components (see also Case History [04.11.19.06](#)).

REMEDY Alternative material of construction like duplex stainless steel W.-Nr. 1.4462 (UNS No. S31803).

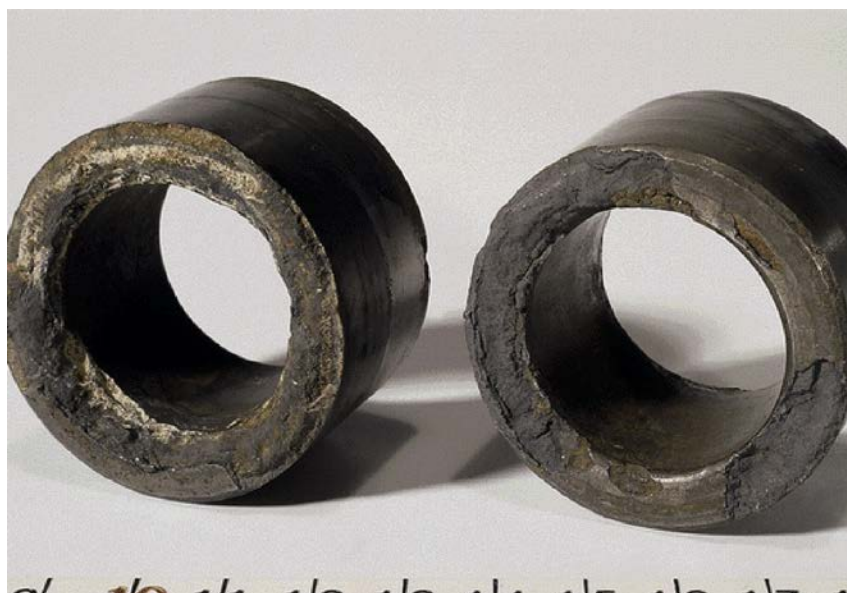
04.11.20.01

MATERIAL	Stainless steel (martensitic).
SYSTEM	Mine water pump.
PART	Suction and discharge valve guides.
PHENOMENON	Hydrogen damage (hydrogen embrittlement).

APPEARANCE	Crumbling.
TIME IN SERVICE	Unknown.
ENVIRONMENT	Acid and corrosive mine water.
CAUSE	Corrosion caused hydrogen development which embrittled the martensitic stainless steel (other parts of the pump were made of duplex stainless steel) (see also Case History 01.11.20.05).
REMEDY	Use a more ductile material with sufficient wear resistance (e.g., austenitic stainless steel).

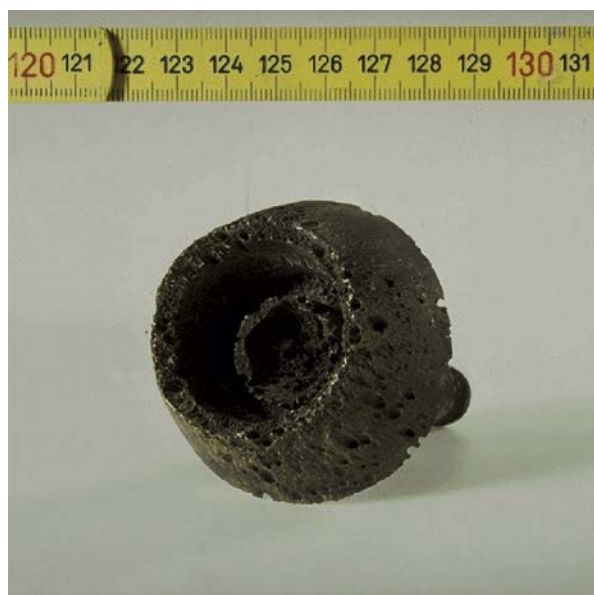
04.11.26.01

MATERIAL	Stainless steel (AISI 316).
SYSTEM	Electrolysis unit in zinc plant.
PART	Impeller cap in electrolyte pump.
PHENOMENON	Stray-current corrosion.

APPEARANCE Severe pitting attack over the entire surface.

CAUSE In the present process, the liquids carry an electric voltage. To prevent leakage currents, the entire unit has to be installed free of earth. In this case, the pump concerned was insufficiently isolated from the foundation. Outgoing stray currents caused severe corrosion, concentrated on this cap in particular.

REMEDY Ensure proper isolation (plastic) between the pump and the foundation.

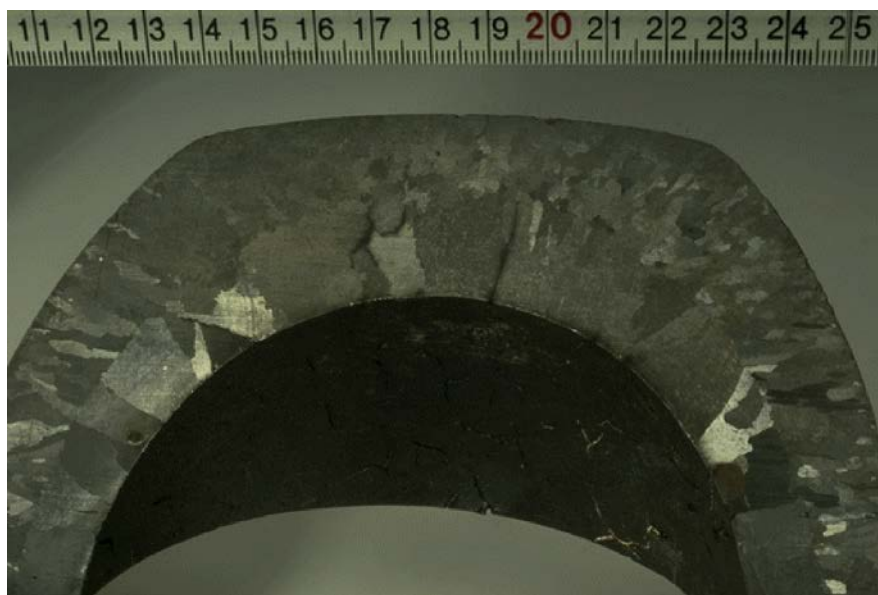
PHENOMENON Thermomechanical fatigue (intergranular).

APPEARANCE Cracks.

CAUSE Thermomechanical fatigue due to fluctuating temperature.

REMEDY Improvement of the casting quality and modification of the process conditions in order to prevent extreme temperature fluctuations.

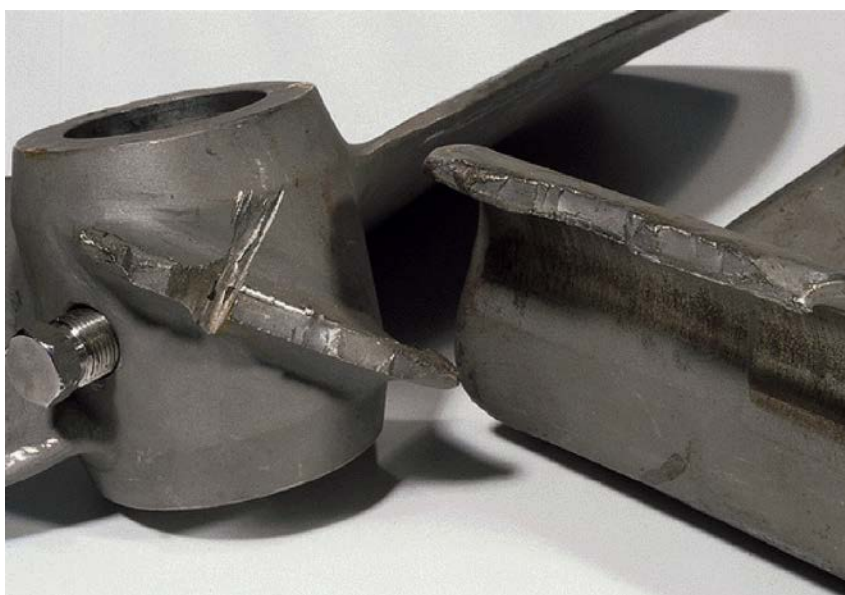
PHENOMENON Corrosion fatigue.

APPEARANCE One blade is ripped off. The remaining part contains several small cracks.

CAUSE Cracks were initiated by chloride-induced stress-corrosion cracking (SCC) in the most highly stressed area. These cracks grew by (corrosion) fatigue, which finally resulted in rupture of one of the blades (broken blade severely damaged the pump) (see also Case Histories [01.01.28.01](#), [01.21.28.01](#) and [04.11.28.03](#)).

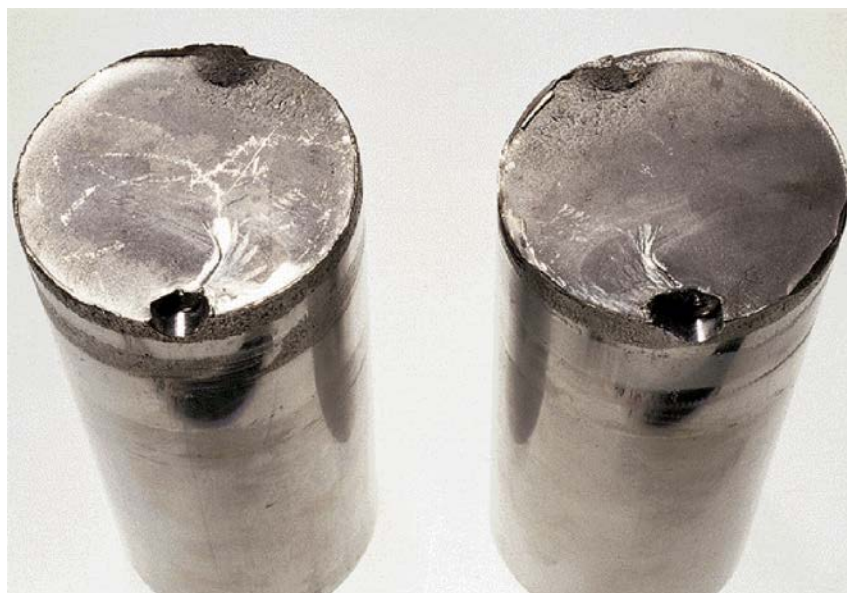
PHENOMENON Fatigue or corrosion fatigue.

APPEARANCE Crack growth lines which started at a drilled hole and small ductile fracture.

CAUSE The slightly damaged (bent) shaft had to be straightened (no additional stress-relieving) (see also Case Histories [01.01.28.01](#), [01.21.28.01](#), and [04.11.28.02](#)).

REMEDY Avoid sharp stress raisers (such as drilled holes), especially at highly stressed areas.
 Note: The allowable fatigue strain in a corrosive environment is much lower than the known values which are usually obtained in a noncorrosive environment.

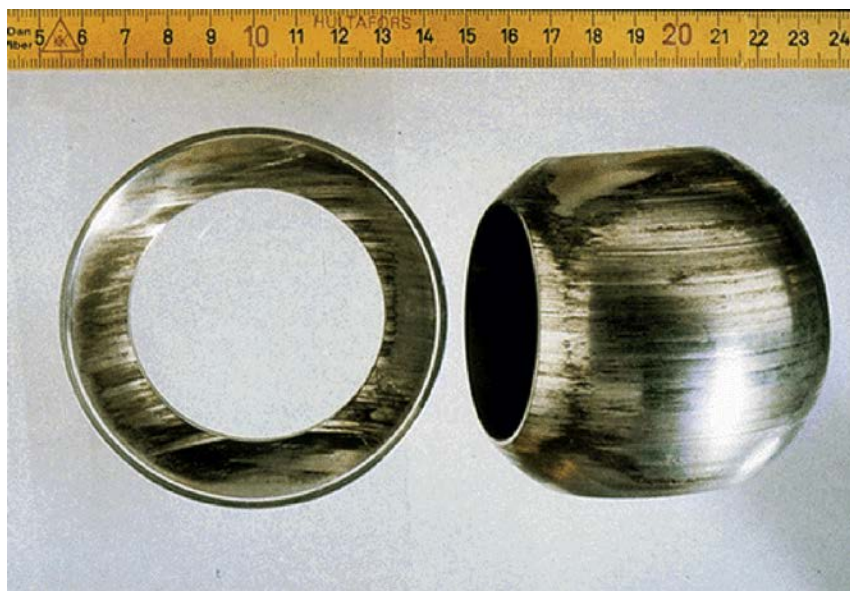
PHENOMENON Erosion.

APPEARANCE Ball and seat show grooves.

CAUSE The ceramic carrier is too hard in relation to the ball and seat, so that catalyst particles became embedded in the relatively soft material (see also the following Case Histories).

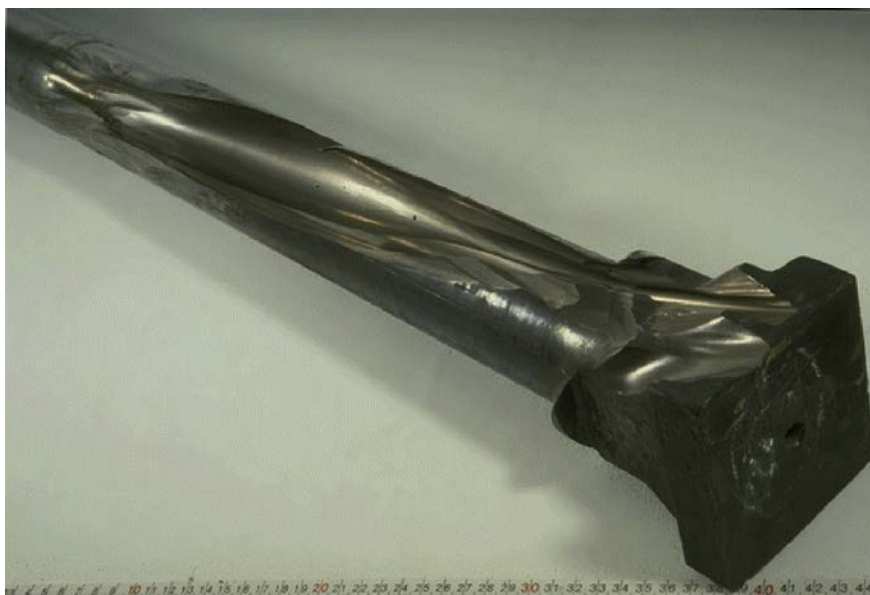
PHENOMENON Erosion.

APPEARANCE Material partly worn away, rod has become razor-sharp locally.

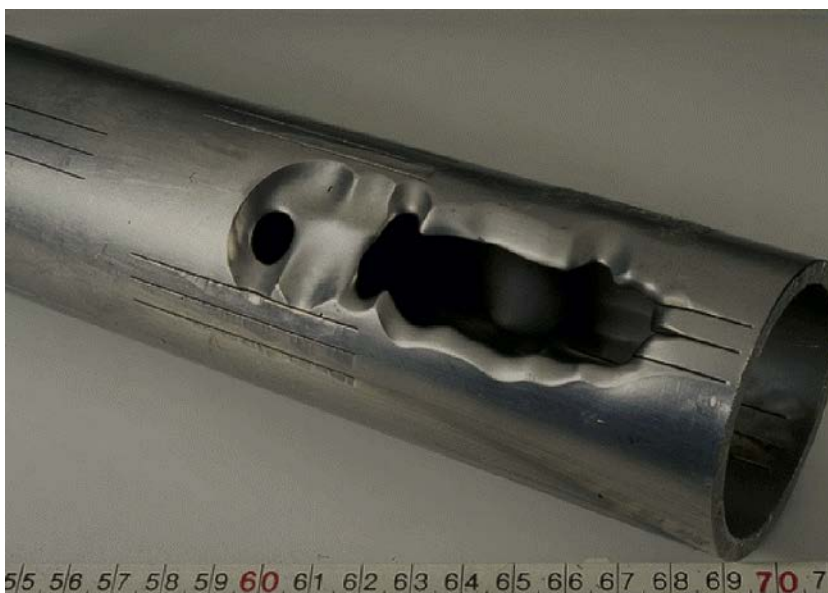
PHENOMENON Erosion.

APPEARANCE Material completely worn away near the slots.

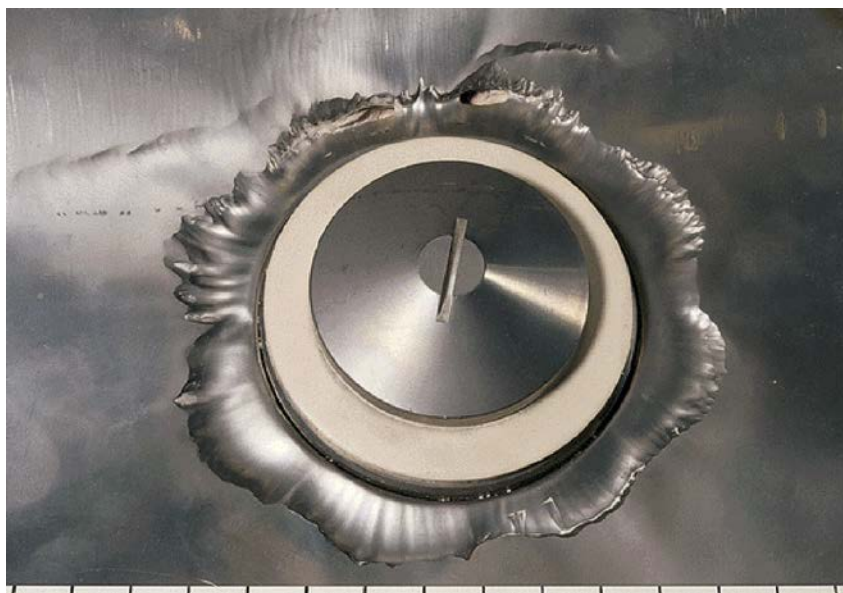
PHENOMENON Erosion.

APPEARANCE Uniform eroded surface all around the valve.

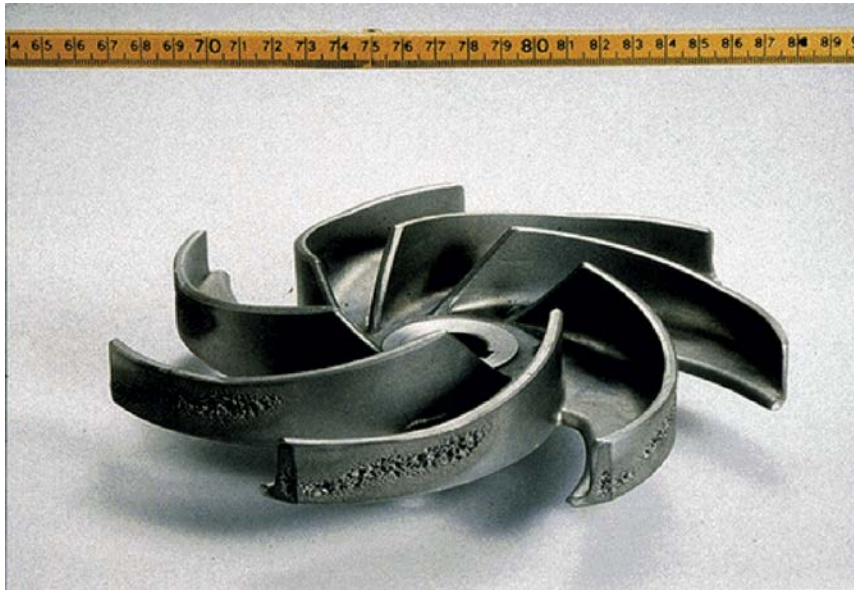
PHENOMENON Cavitation erosion.

APPEARANCE Material worn away locally.

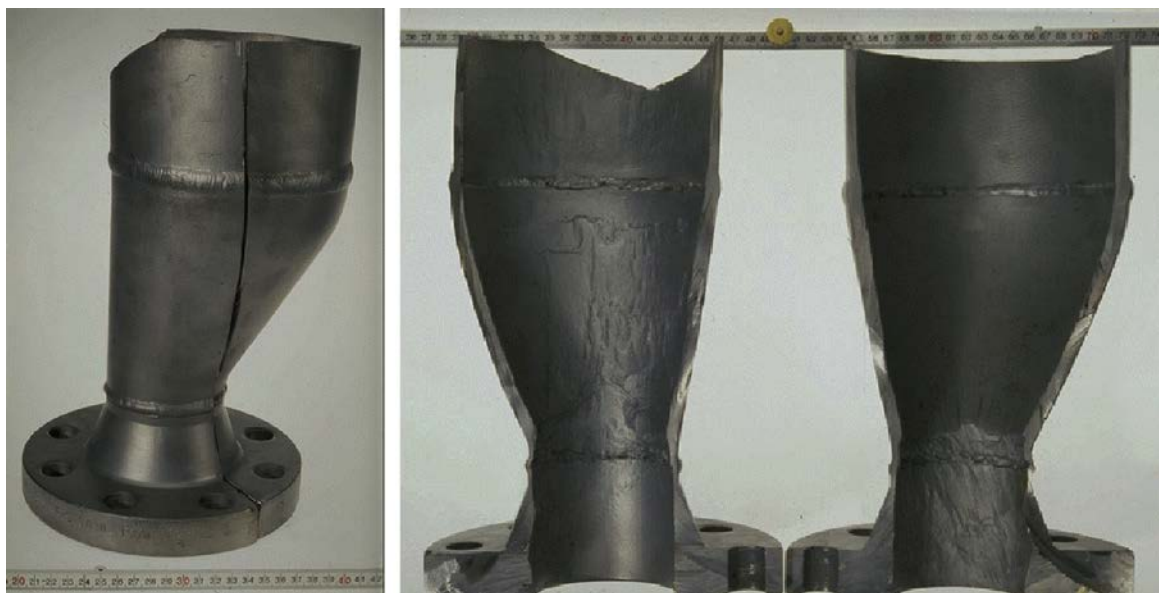
PHENOMENON Erosion corrosion.

APPEARANCE Attack with pronounced flow pattern and severe attack to the weld.

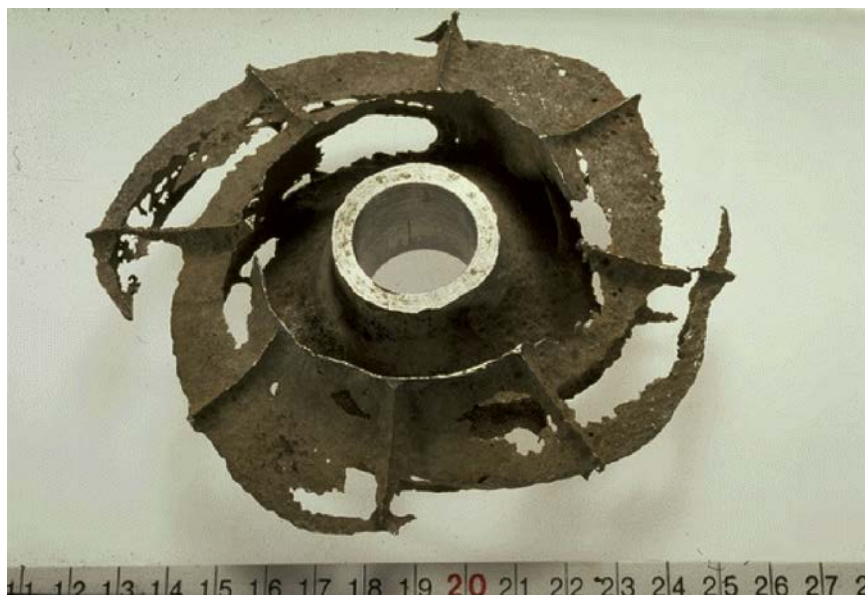
PHENOMENON Erosion corrosion.

APPEARANCE Impeller material partly eroded.

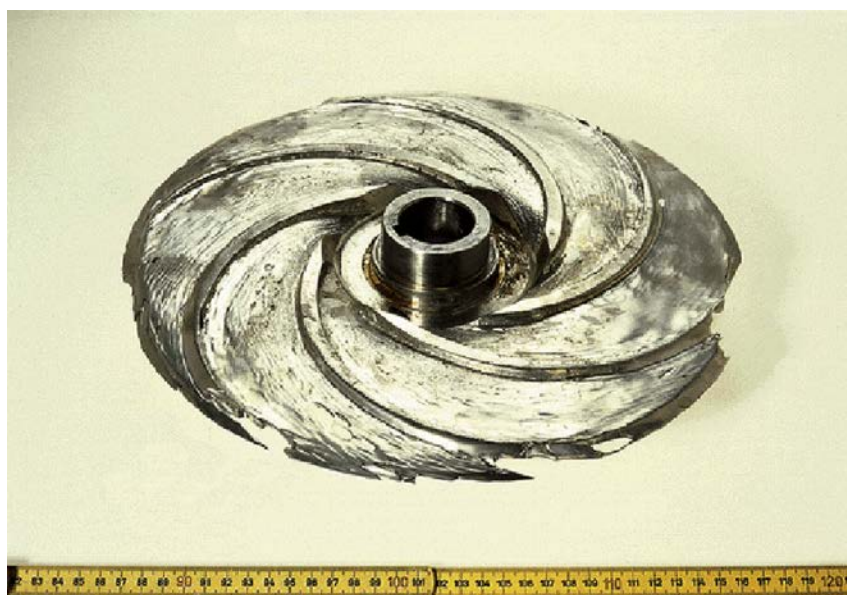
PHENOMENON Erosion corrosion.

APPEARANCE Impeller uniformly worn down from original 10 mm thickness to <1 mm.

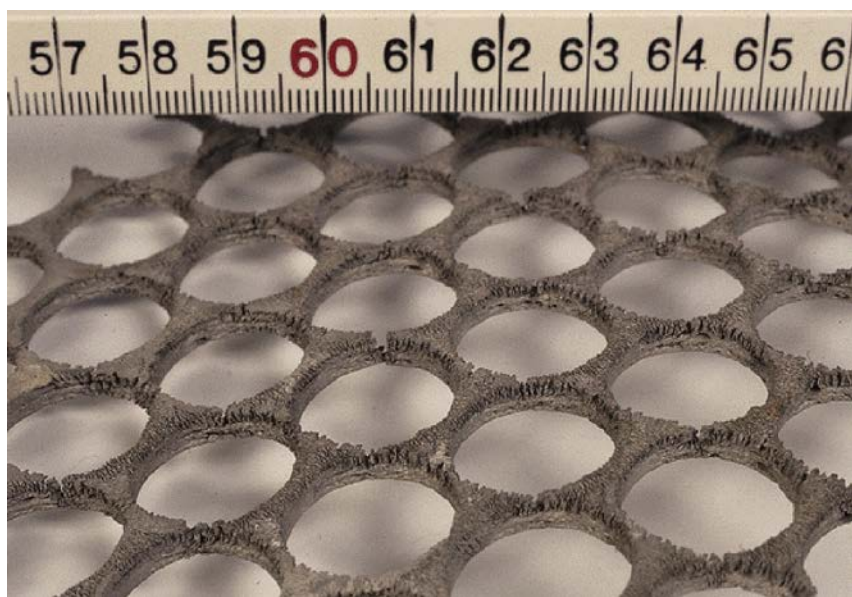
PHENOMENON Erosion corrosion.

APPEARANCE Severe general attack with many little cracks.

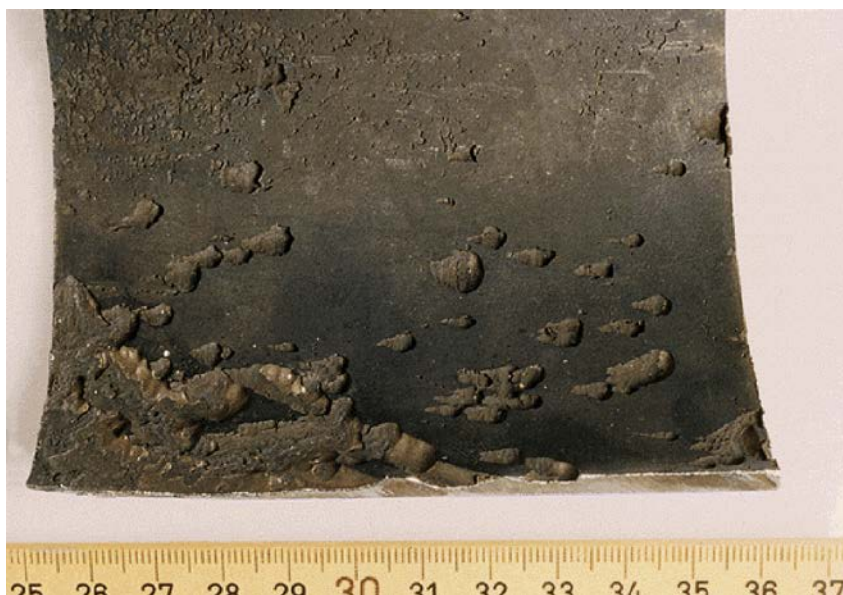
PHENOMENON Erosion corrosion.

APPEARANCE Material locally worn away.

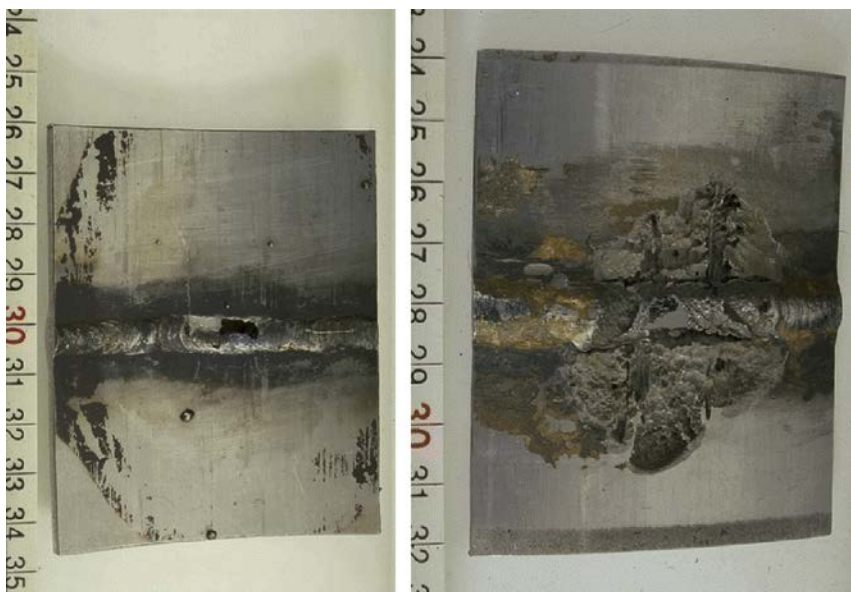
PHENOMENON Weld defect.

APPEARANCE Selective attack inside the weld zone (left) leading to leakage and external attack to the pipe (right).

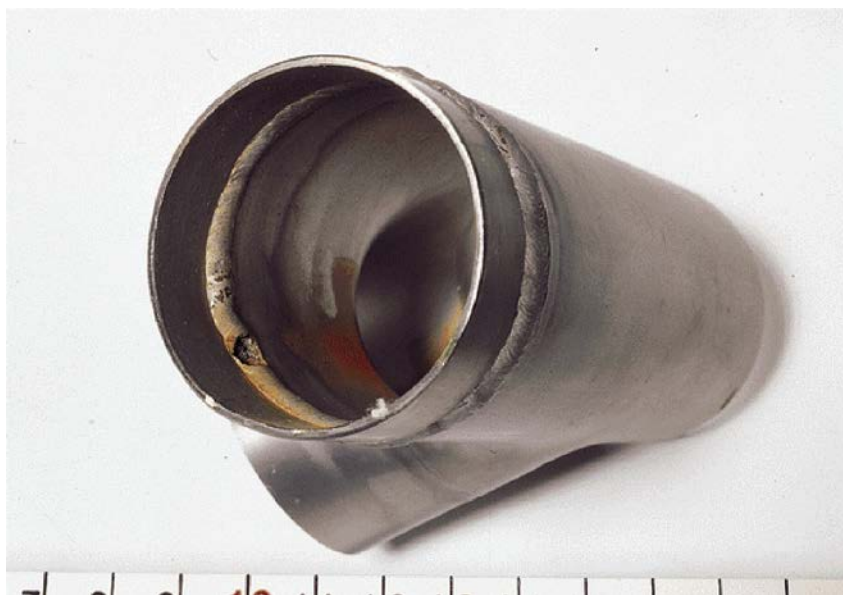
PHENOMENON Weld defect.

APPEARANCE Cavity in weld (carried out with GTAW welding process).

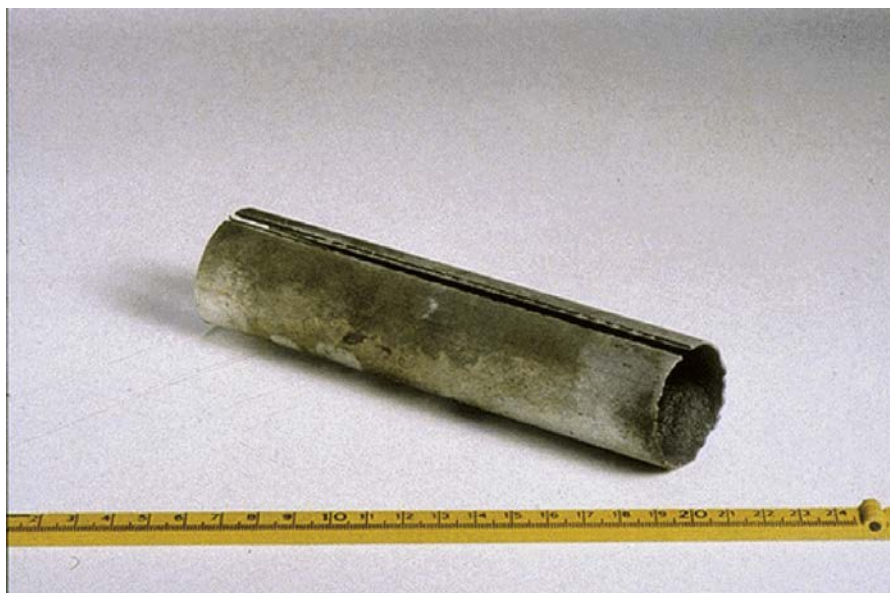
PART Pipe section.

PHENOMENON Acid corrosion.

APPEARANCE Etched surface, uniform attack, weld seam gone completely.

TIME IN SERVICE 2 weeks.

CAUSE 304 stainless steel is not resistant to 6% sulfamic acid. The preferential attack of the weld seam is probably due to use of the wrong weld metal (less noble than the pipe metal).

REMEDY Cleaning circuit constructed of AISI 317 stainless steel, properly welded (weld metal equal to or more noble than the pipe metal).

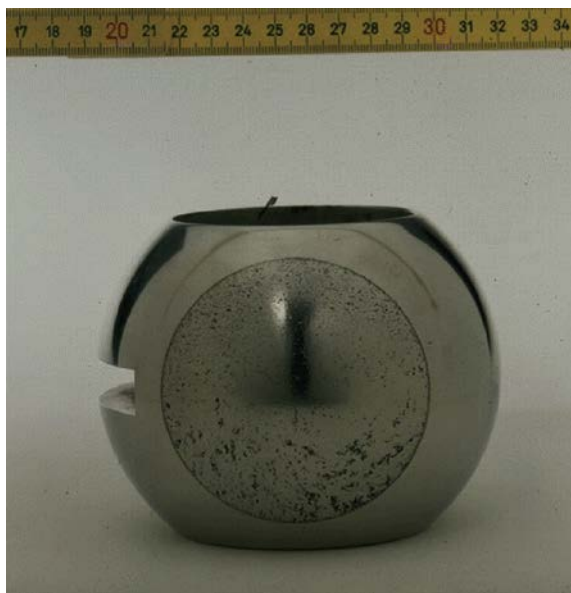
PART Ball valve.

PHENOMENON Acid corrosion.

APPEARANCE Pitting attack.

TIME IN SERVICE Several days.

CAUSE Standing acid remained after chemical cleaning; after degradation of the inhibitor, the stainless steel was attacked (for attack of stainless steel by hydrochloric acid, see also Case Histories [04.11.04.01/11/14](#)).

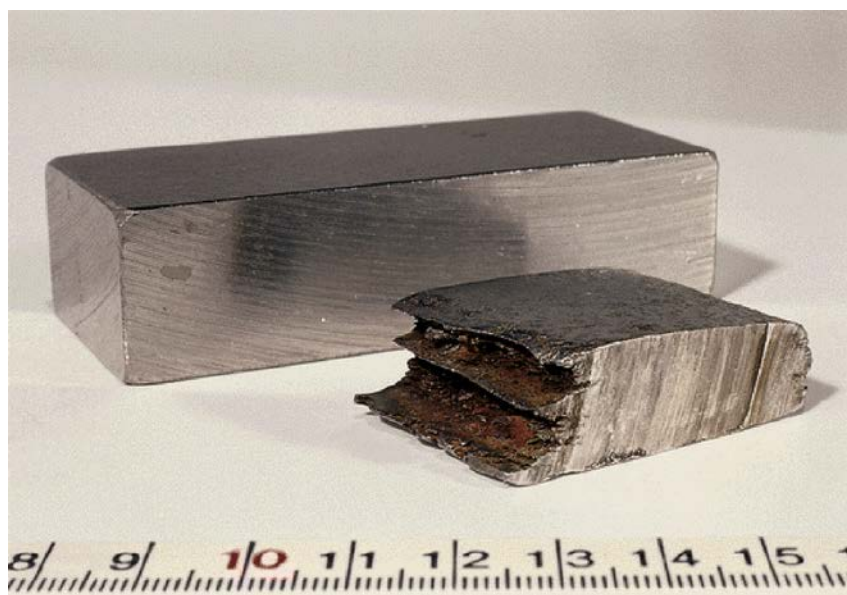
04.12.04.03

MATERIAL	Stainless steel (AISI 316 or 316Ti).
SYSTEM	Pickling installation in steel mill.
PART	Fixtures of spray system at the end of installation.
PHENOMENON	Acid corrosion.

APPEARANCE	General attack (in the background a new sample).
TIME IN SERVICE	Less than 1 year.
ENVIRONMENT	Condensing hydrochloric acid, at approximately 50°C.

CAUSE Stainless steel is not resistant to hydrochloric acid. The previously applied carbon steel fixtures, provided with a protective coating, require some maintenance after a period of approximately 5 years, mainly due to mechanical wear of the coating (for the attack of stainless steel by hydrochloric acid, see also the Case Histories [04.11.04.01/14](#) and [04.12.04.02](#)).

REMEDY Provide the coated carbon steel fixtures with replaceable wear plates of a suitable nonmetallic material.
