Corrosion Atlas

THIRD, EXPANDED AND REVISED EDITION

A Collection of Illustrated Case Histories

Evert D.D. During

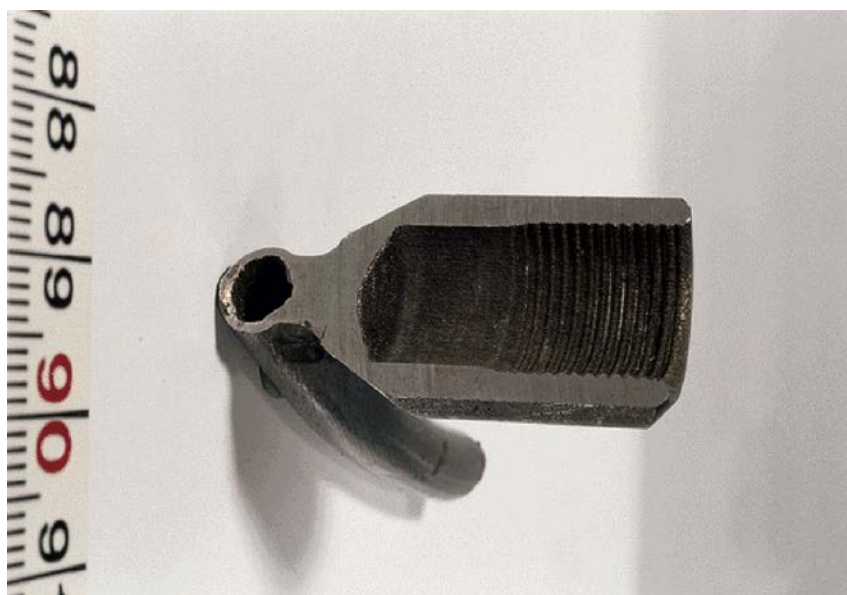
PART Ring line with sockets for spray nozzles.

PHENOMENON Acid corrosion.

APPEARANCE General corrosion. Loss of screw thread.

TIME IN SERVICE Several hours.

CAUSE Selection of a more easily machinable type of stainless steel for the sockets. As these types of stainless steels (usually with a higher sulfur content) have a much lower corrosion resistance, the threads dissolve during chemical cleaning (pickling).

REMEDY Material selection should not be solely based on the (sometimes rather mild) working conditions only. (Free-machining types of stainless steels cannot be pickled together with the standard types of stainless steels.)

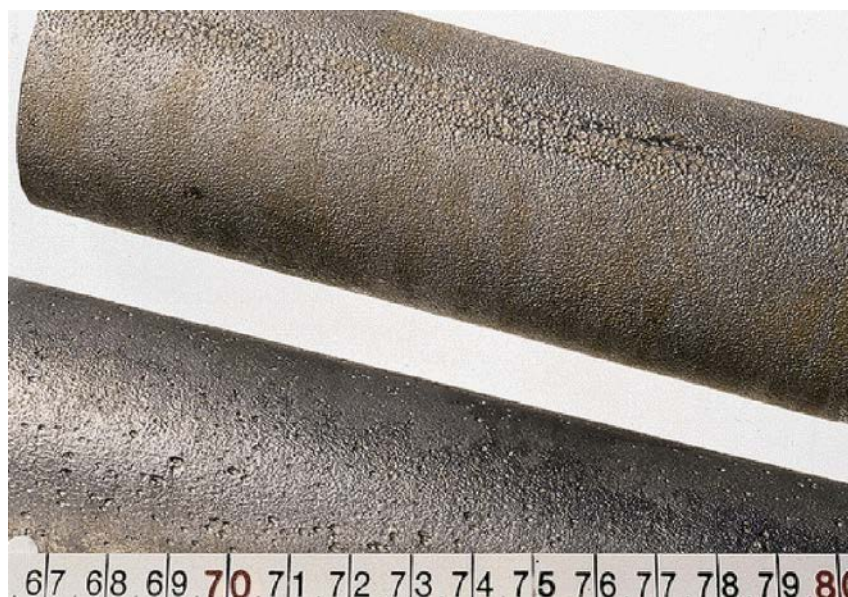
PART Heating pipe of pickling bath.

PHENOMENON Acid corrosion.

APPEARANCE Strong reduction of wall thickness by uniform corrosion, with many superficial pits (wall reduction from 4.4 to 2.5 mm).

TIME IN SERVICE About 1 year.

CAUSE Stainless steel is slowly attacked by sulfuric acid at this concentration and temperature, despite the added inhibitor (see for the resistance of stainless steel in diluted sulfuric acid also the Case Histories [04.11.04.04/06/09](#)).

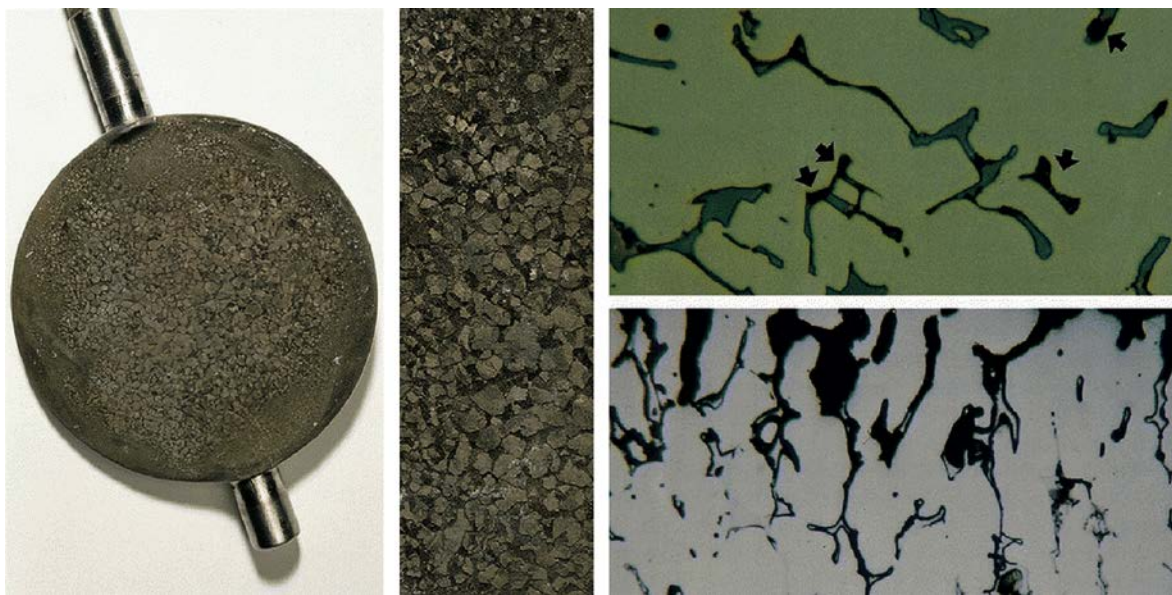
PART Butterfly valve in circulation line.

PHENOMENON Sigma-phase embrittlement.

APPEARANCE Overall attack, leaving the primary grain structure visible. Micro upper right: cast structure of austenite with delta-ferrite with conversion into sigma phase (see arrows). Micro lower right corrosion penetrates via the austenite–ferrite (sigma phase) into the material.

TIME IN SERVICE 3 years.

CAUSE Normally, AISI 316 Nb should be resistant to the above-mentioned chemical solutions. However, this was not the case due to the presence of sigma phase. This sigma phase forms during residence in a temperature range around 850°C, e.g., by excessively slow cooling during casting or inadequate heat treatment. The formation of this sigma phase, which consists of approximately equal parts of Cr and Fe, reduces the chromium content of the surrounding material and thereby makes it vulnerable to selective attack via these chromium-depleted zones. Microscopic examination shows that the attack has indeed travelled via these zones (see also Case Histories [04.11.19.08/09](#)).

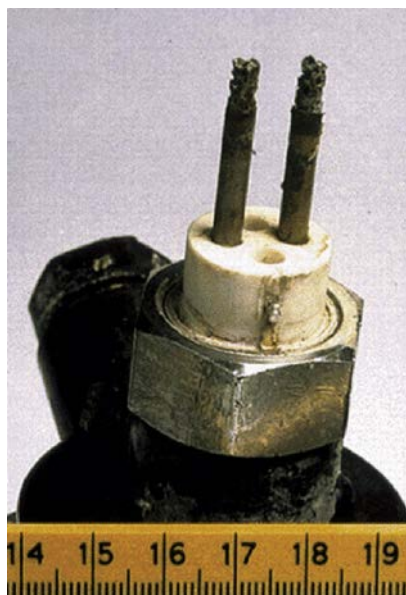
04.12.26.01

MATERIAL	Stainless steel (AISI 304).
SYSTEM	Cleaning circuit.
PART	Conductivity electrodes placed in the circuit.
PHENOMENON	Stray-current corrosion.

APPEARANCE	Electrodes completely dissolved.
TIME IN SERVICE	1 year.
ENVIRONMENT	An alternation of different cleaning liquids, namely: <ul style="list-style-type: none"> • mains water, • mains water with caustic soda and EDTA, • mains water with 20–30 ppm Cl₂.
CAUSE	Occurrence of a DC potential difference between the electrodes and the pipe wall as a result of difference in resistance of the earthing cables of electrodes and pipe wall. The exit current causes some kind of stray-current corrosion (see also Case History 04.05.26.01).
REMEDY	A DC potential difference between electrodes and pipe wall can be eliminated by improving the earthing.

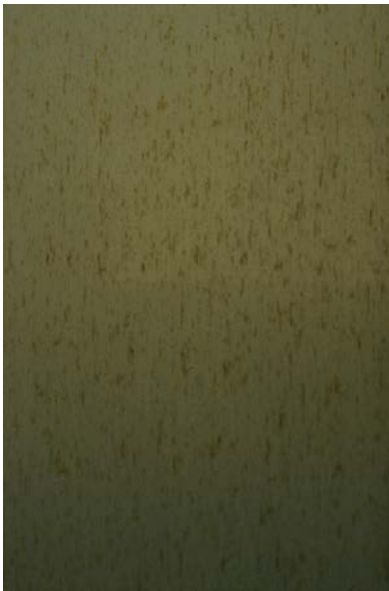
04.16.12.01

MATERIAL	Stainless steel (AISI 304).
SYSTEM	Housing for experimental animals.
PART	Wall panel.
PHENOMENON	Chloride attack.

APPEARANCE	Brown patches, no pitting apparent to visual inspection.
TIME IN SERVICE	1 week.
ENVIRONMENT	Atmosphere with 50% relative humidity, 25°C.
CAUSE	After completion, the walls were cleaned with a product which the supplier stated was based on phosphoric acid. The product was said to contain no chloride. However, analysis showed that the cleaning product contained hydrochloric acid instead of phosphoric acid. A chloride content of 1630ppm and a pH of 0.9 was found in the diluted product. It was therefore unsuitable for cleaning stainless steel. Residues remaining after insufficient rinsing caused the corrosion.
REMEDY	<ul style="list-style-type: none"> • Clean the walls with a neutral, chloride-free product and then rinse them with plenty of desalted water. • When cleaning stainless steel, have the proposed product analyzed and do not rely fully on the supplier's specification.

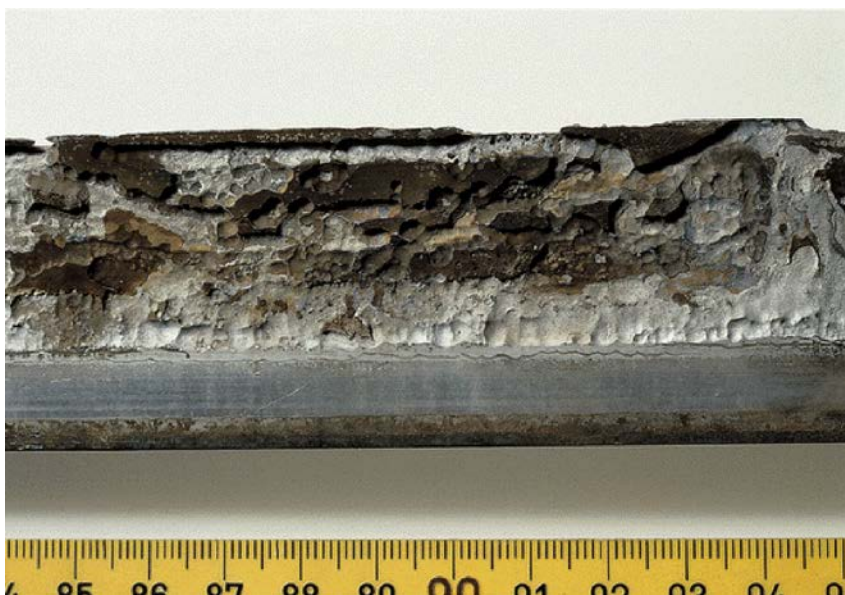
PART Strip from stack cyclone.

PHENOMENON Chloride attack.

APPEARANCE Irregular uniform attack with pitting.

TIME IN SERVICE 3–8 years (depending on position in cyclone).

CAUSE The chloride in the entrained scrubbing water caused attack to the stainless steel, whilst erosion–corrosion also occurred in combination with the speed of the droplets.

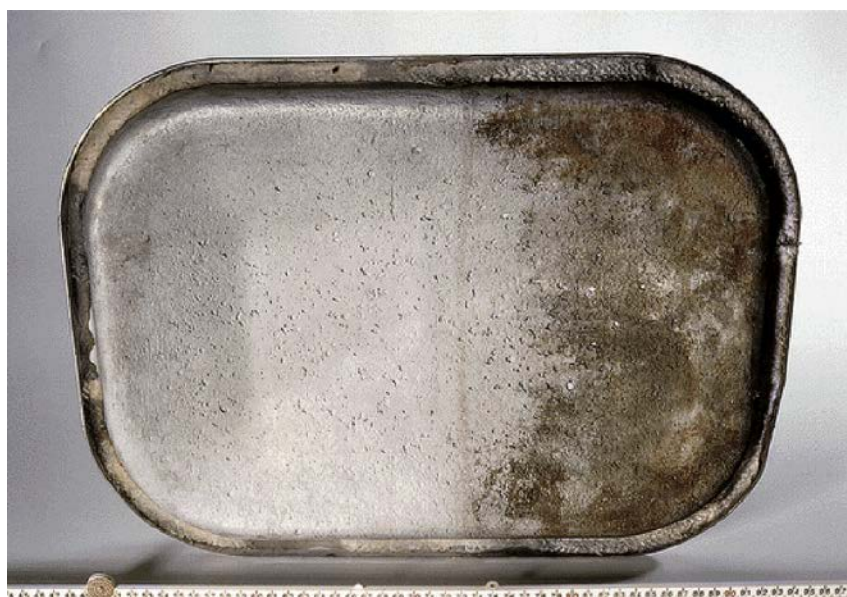
PART Inspection hatch.

PHENOMENON Chloride attack.

APPEARANCE Pitting (hatch partly cleaned).

TIME IN SERVICE Unknown.

CAUSE Combustion of chloride-containing waste (e.g., PVC) results in the formation of hydrogen chloride gas which attacks the stainless steel when condensing on the uninsulated inspection hatch (see also Case History [04.11.18.03](#)).

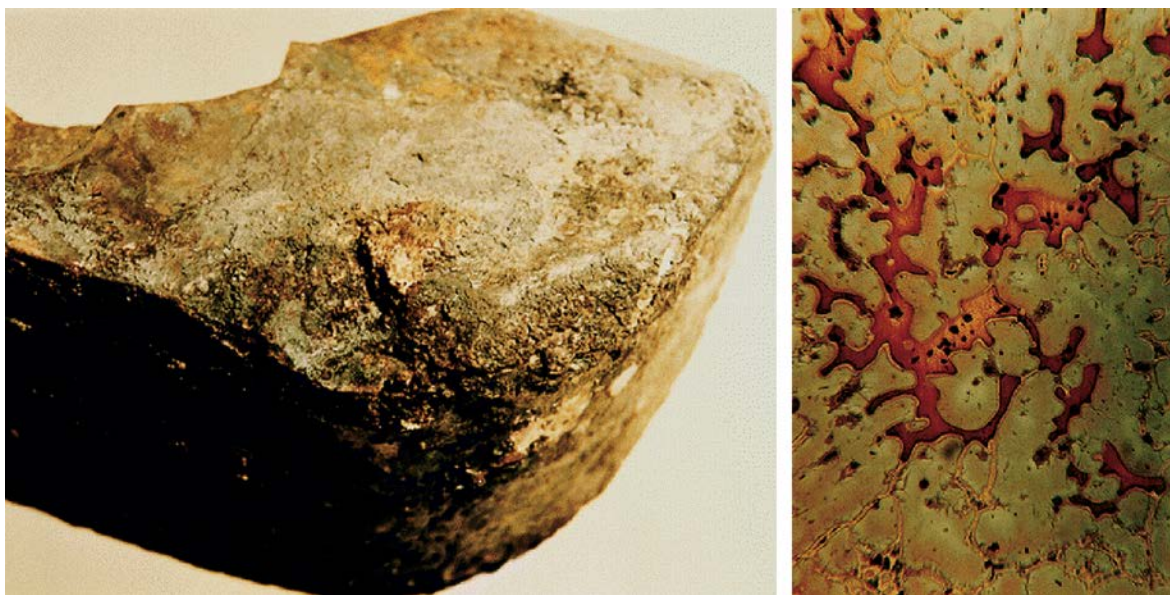
PART Grid.

PHENOMENON Liquid metal embrittlement.

APPEARANCE Copper-colored surface attack.

TIME IN SERVICE Unknown.

CAUSE Presence of liquid copper caused penetration of copper into the material. The brittle phase formed could easily be removed (see also Case Histories [01.01.22.01/02](#))

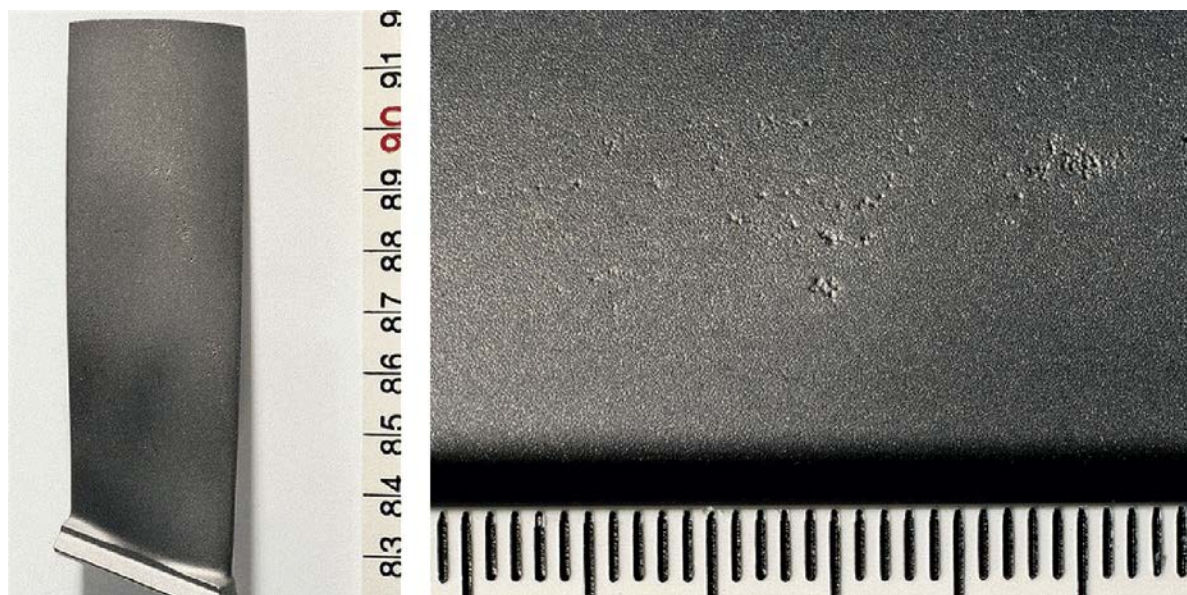
PART Compressor blade.

PHENOMENON Chloride attack.

APPEARANCE Isolated pits; depth in excess of rejection criterion.

TIME IN SERVICE Rejected during scheduled inspection after 3000 service hours.

CAUSE During service, sea salt is deposited. During shut-down periods, the deposits are wetted and acidified. The chlorides originating from the sea salt promote pitting corrosion. Blades with pits deeper than 250 μm are rejected in view of the danger of fatigue crack initiation.

- Frequent washing to remove sea salt,
- Use more corrosion-resistant materials such as titanium alloys or nickel-based superalloys, or
- Use a sacrificial coating.

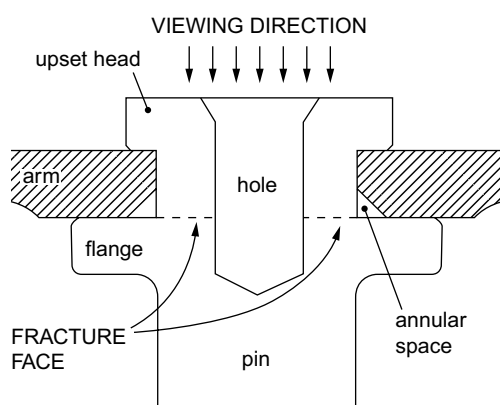
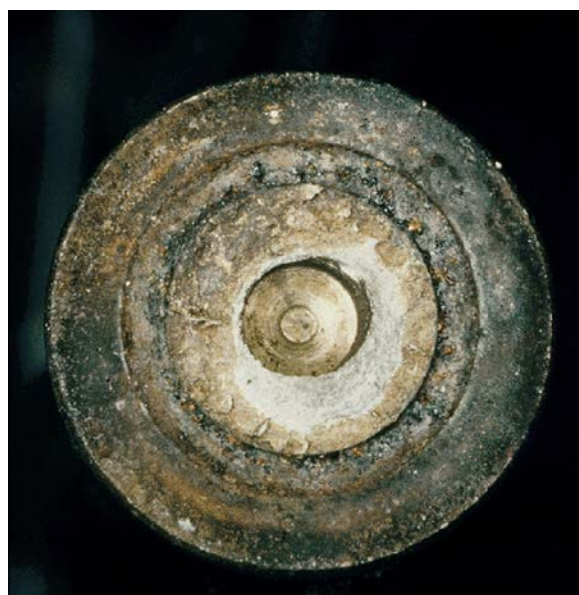
PART Lever pin in compressor variable vane system.

PHENOMENON SCC (transgranular).

APPEARANCE SCC (brownish) surrounding overload fracture (whitish) introduced by tensile testing of pin after service.

TIME IN SERVICE 500 service hours, followed by destructive testing.

CAUSE The three conditions for SCC were fulfilled:

- upsetting the head-introduced residual tensile stresses;
- salt deposits created a corrosive environment;
- Nitronic 60 has poor resistance against SCC.

After a flight accident, several hundred pins were tensile-tested; about 25% were found to suffer from SCC.

REMEDY The pin material was replaced by a material immune to SCC.

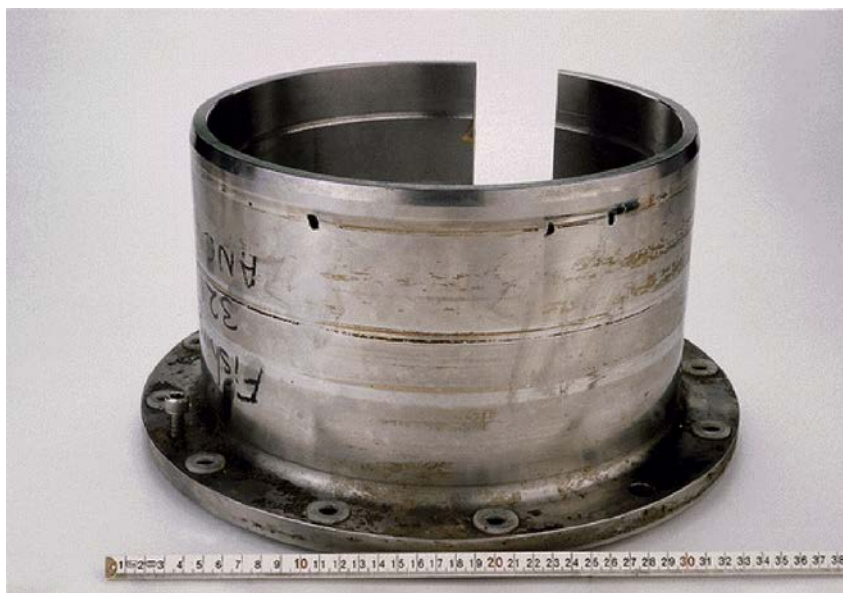
04.21.13.01

MATERIAL	Stainless steel (W.-Nr. 1.4464).
SYSTEM	Ship.
PART	Sleeve of a ship's propeller shaft seal.
PHENOMENON	Crevice corrosion.

APPEARANCE	Severe pitting in a fixed path around the sleeve between the lip seals.
TIME IN SERVICE	9 months to 4–5 years.
ENVIRONMENT	Mixture of seawater and lubricating oil, temperature 60–65°C. The lubricating oil acidifies as time passes.
CAUSE	In view of the site where the sleeve corrosion occurs, i.e., only in the seawater-filled crevices directly adjacent to the contact face with the lip seals, and the absence of pitting on the free faces of the sleeves, the cause may be assumed to be crevice corrosion. The occurrence of this corrosion was promoted by the temperature increase of the bearing surfaces of the lip seals and by the reduction in pH caused by acidification of the lubricating oil.
REMEDY	<ul style="list-style-type: none"> • Manufacture the sleeves with a cladding of a wear-resistant castable alloy with a pitting resistance equivalent index of at least 40 (e.g., W.-Nr. 1.4469, Alloy 654 or Zeron 100), or • Modify the construction such that the seawater is sufficiently replenished between the contact surfaces of the lip seals.

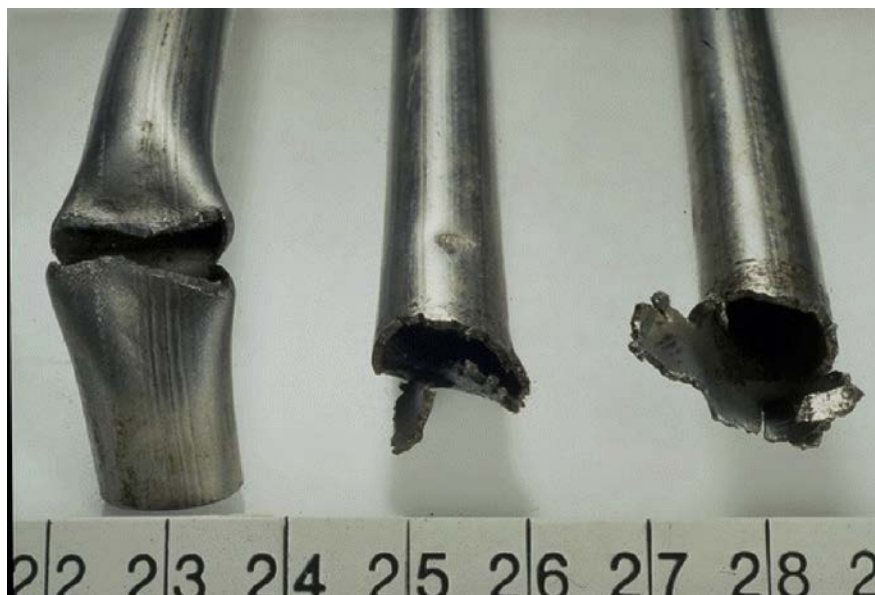
PART Pipes (12/10 mm dia.).

PHENOMENON SCC (transgranular).

APPEARANCE The pipes are locally cracked and broken off. In an area up to 2–10 mm from the cracks, the material exhibits pitting and cracking attack.

TIME IN SERVICE Several months.

CAUSE As a result of external markings being made on the pipes with a chloride-containing marker and tape, in combination with present tensile stresses and the elevated temperature, stress corrosion and pitting corrosion took place (see also Case History [04.11.18.07](#)).

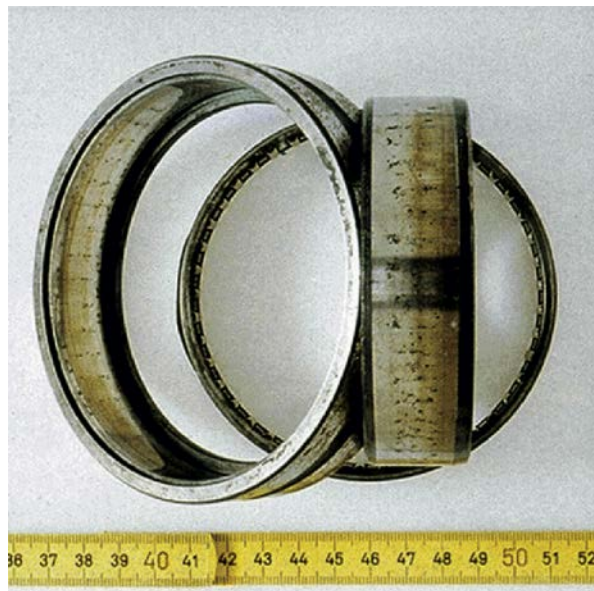
PART Roller bearing.

PHENOMENON False brinelling.

APPEARANCE Small pieces broken from the wearing surface.

TIME IN SERVICE Unknown.

CAUSE During shutdown, the system is subject to slight vibration caused by rotating equipment in the vicinity. This allows a slight movement to take place between the rollers and the wearing surfaces, causing damage to the latter.

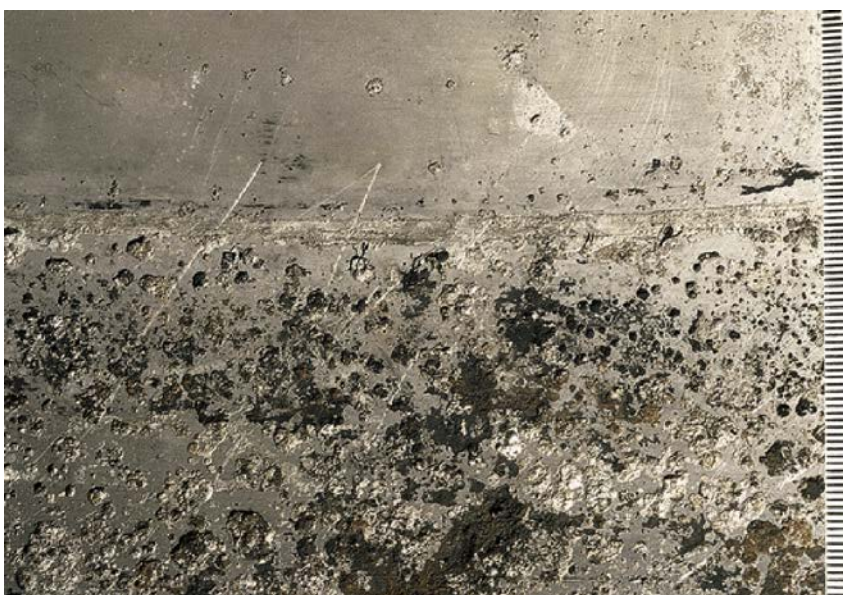
04.23.12.01

MATERIAL	Stainless steel (AISI 304L).
SYSTEM	Carbon-dioxide gas installation in brewery.
PART	Compressor suction pipe section.
PHENOMENON	Chloride attack.

APPEARANCE	Highly pitted.
TIME IN SERVICE	2 weeks.
ENVIRONMENT	CO ₂ gas with 72,000 ppm chlorides.
CAUSE	The sodium hypochlorite dosing in the CO ₂ scrubber, situated before the CO ₂ compressor, was set too high (see also Case History 04.11.12.02).
REMEDY	<ul style="list-style-type: none"> • The dosing was reduced, and • The suction pipe was constructed of polypropylene.

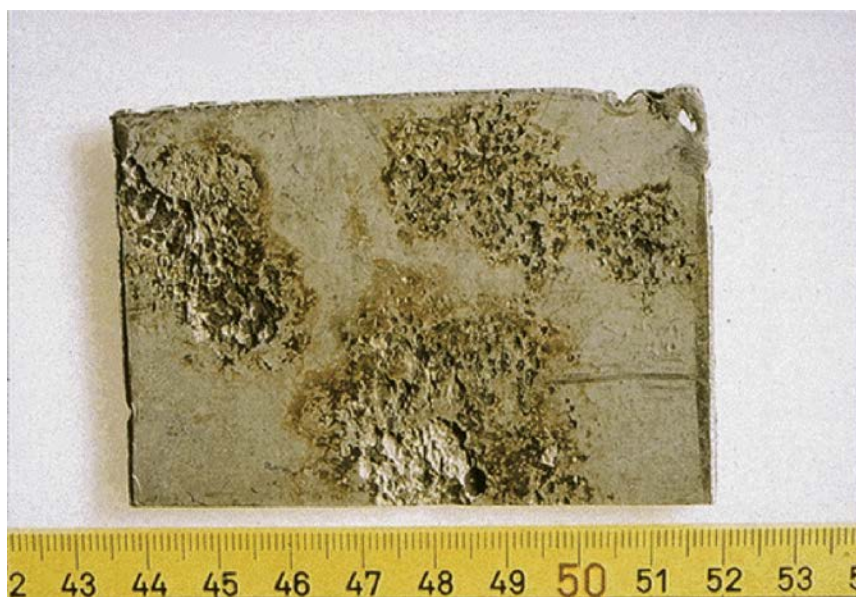
PART Wall section.

PHENOMENON Galvanic corrosion.

APPEARANCE Local pitting attack.

TIME IN SERVICE Unknown.

CAUSE During regeneration of the activated charcoal filter with steam, condensation causes a liquid film on the cold wall, as a result of which a galvanic cell is formed between the charcoal and the stainless steel (see also Case History [05.23.14.01](#)).

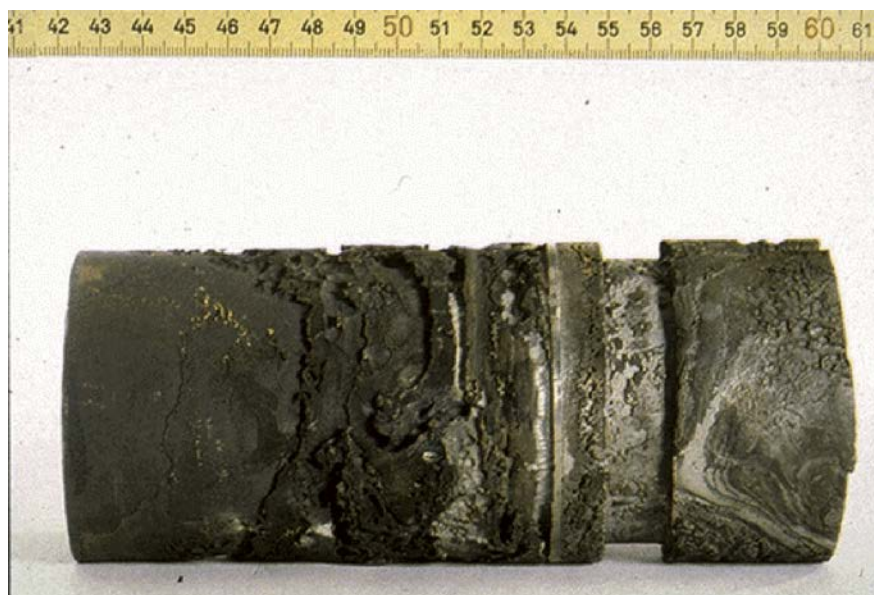
PART Pump shaft.

PHENOMENON Erosion corrosion.

APPEARANCE Severe local attack.

TIME IN SERVICE At most 5 years.

CAUSE Contact with a corrosive solution at high velocity and turbulence (see also Case Histories [04.08.12.02](#) and [04.11.34.01](#)).

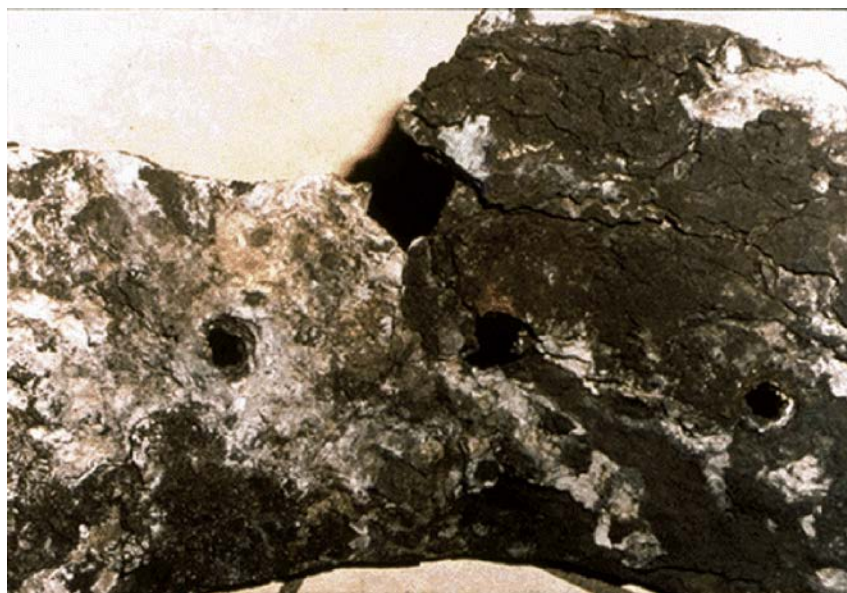
PART Burner deflector.

PHENOMENON High-temperature corrosion (sulfidation).

APPEARANCE Severe corrosion and cracking.

TIME IN SERVICE Approximately 5000 h.

ENVIRONMENT Flue gases from oil-fired burner; temperature 600–850°C.

CAUSE Sulfidation of the material due to firing sulfur-containing fuel oil (see also Case Histories [01.11.06.04](#) and [05.19.06.01](#)).

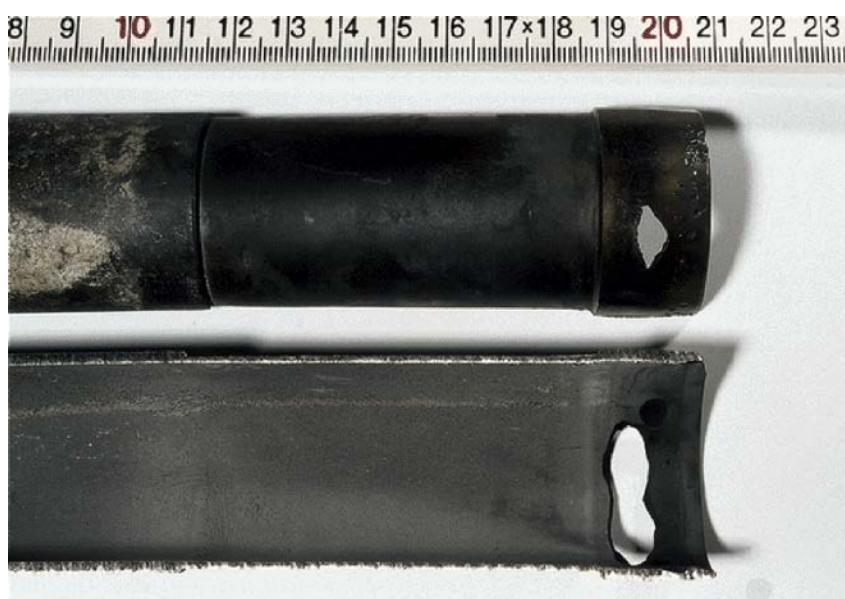
05.01.06.02

MATERIAL	Incoloy 800H.
SYSTEM	Ammonia plant.
PART	Ferrule of entry/exit tubes (tube) plate of waste heat boiler downstream from secondary reformer.
PHENOMENON	High-temperature corrosion (metal dusting).

APPEARANCE	Pitting attack with powdery surface to the point of leakage.
TIME IN SERVICE	2 years.
ENVIRONMENT	Through the tubes: gas mixture CO, CO ₂ , H ₂ , and O ₂ cooled from 850 °C to 540 °C. Around the tubes: cooling water.
CAUSE	Cr reacting with carbon components from the gaseous phase leads to the formation of excessive chromium carbide. This results in disintegration of the metal, which usually manifests itself as pitting (see also Case Histories 01.11.06.01/02 and 05.11.06.03).
REMEDY	Replacement with Inconel 601 tubes. Still no problems after 2.5 years.

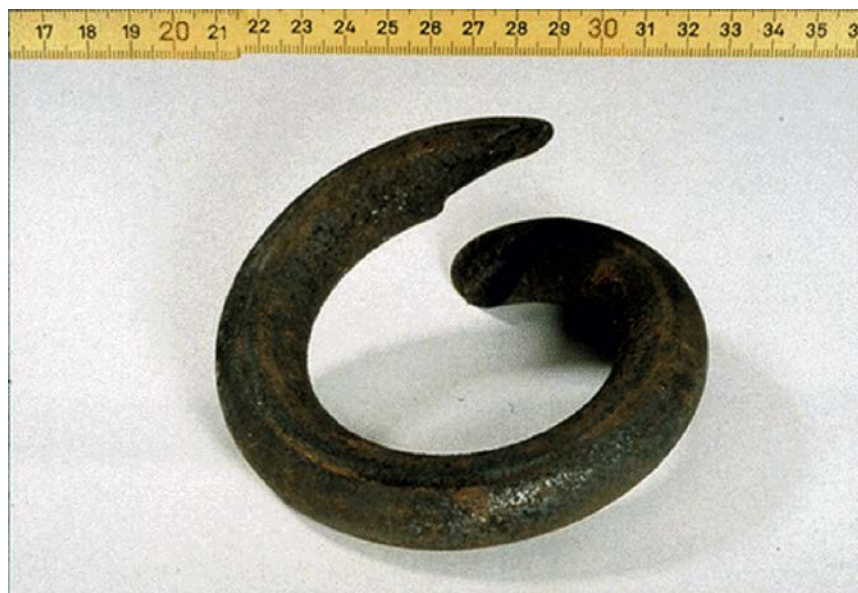
PART Part of spring ring of steam control valve.

PHENOMENON Intergranular stress corrosion cracking (caustic stress-corrosion cracking).

APPEARANCE Spring ring cracked at several points (brittle fracture).

TIME IN SERVICE 3 months.

CAUSE The steam had become contaminated with alkaline boiler water owing to a leak in the attenuator. Corrosion was caused by caustic deposition in combination with the stress in the spring ring (see also Case Histories 04.01.18.03 and 04.25.18.01).

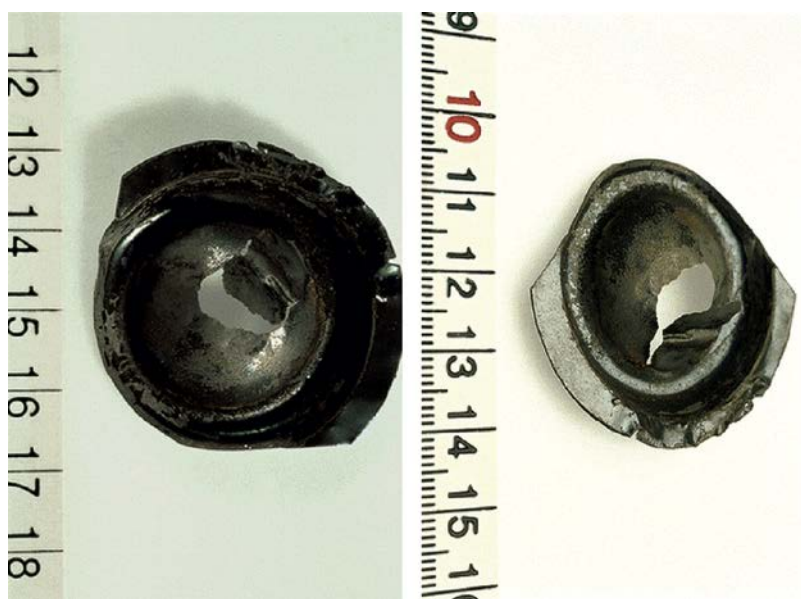
05.02.18.01

MATERIAL	Nickel ($\geq 99.5\%$).
SYSTEM	Steam/condensate system.
PART	Bursting disk (a dome-shaped membrane with a diameter of 47 mm and a thickness of 0.1 mm).
PHENOMENON	Stress corrosion cracking.

APPEARANCE A piece of the material has torn loose. The color inside is metallic but dull, the outside is green-grey.

TIME IN SERVICE A few months.

CAUSE
 The oxidizing acids like sulfuric acid and nitric acid formed from the contaminants with moisture and lead to corrosion of nickel in the presence of air at higher temperatures (see also Case History [05.11.18.02](#)). This corrosion process is promoted by the stresses in the bursting disk, which are present because the disk was cold-formed. In addition, conventional dome-shaped bursting disks are unsuitable for situations with cyclic or fluctuating pressures because of limitations like fragmentation, material fatigue, vacuum, and creep.

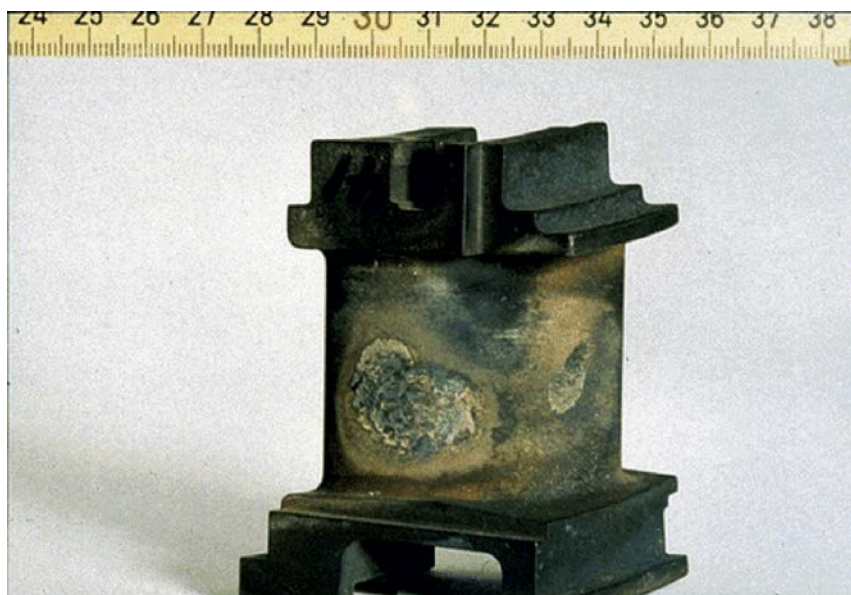
PART Stator blade.

PHENOMENON High-temperature corrosion (Nitriding).

APPEARANCE Attack where the highest wall temperature occurs.

TIME IN SERVICE 8000 hours.

CAUSE A locally too low cooling efficiency of the turbine blade caused the wall temperature to exceed the allowable temperature for the material (830°C) and diffusion of nitrogen followed by formation of nitrides to occur (see also Case History 04.11.06.03).

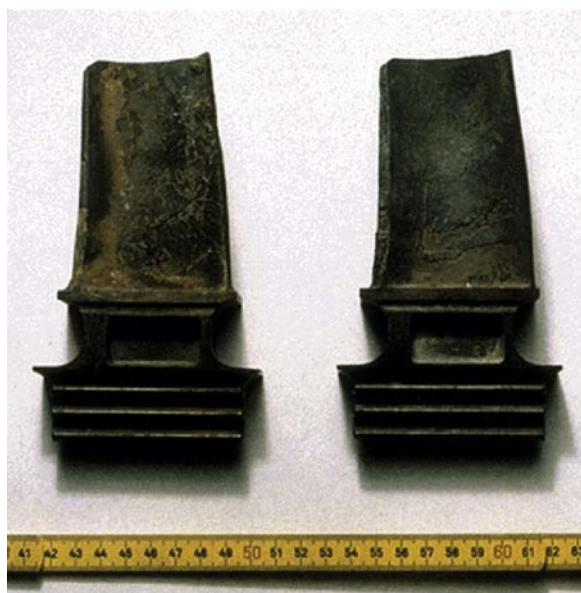
PART Vanes.

PHENOMENON High-temperature corrosion (sulfidation).

APPEARANCE Uniform attack.

TIME IN SERVICE A few years.

CAUSE Malfunctioning of the air filters allowed sodium sulfate powder to be entrained with the combustion air. The sodium sulfate was emitted by the plant. A liquid sodium sulfate layer is formed on the surface of the vane. The sulfur is released from the layer and diffuses into the material, where it forms chromium sulfides. This phenomenon is also known as high-temperature hot corrosion.

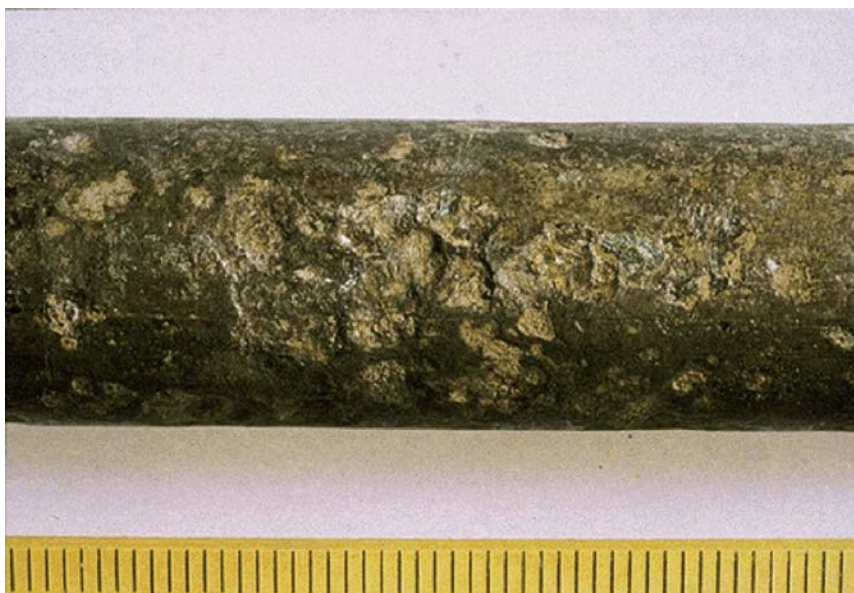
05.06.15.01

MATERIAL	Monel.
SYSTEM	Steam condenser.
PART	Pipe.
PHENOMENON	Underdeposit corrosion.

APPEARANCE Severe local attack on external surface, with green copper corrosion products.

TIME IN SERVICE Unknown.

CAUSE Formation of differential aeration cells owing to sludge deposition (see also Case History 04.06.15.03 and next case).

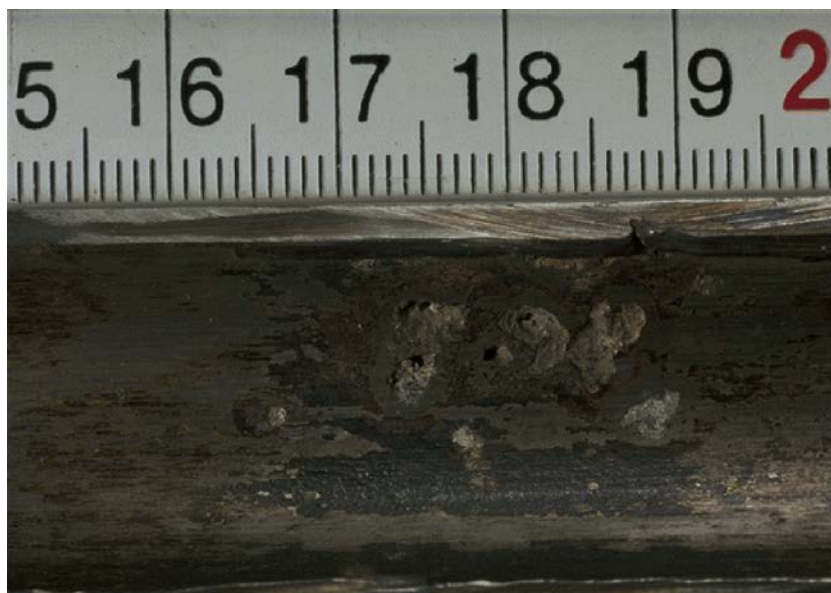
MATERIAL	Incoloy 825.
SYSTEM	Through-flow cooling water system.
PART	Heat exchanger tube.

PHENOMENON	Under-deposit corrosion.
------------	--------------------------

APPEARANCE	Local attack under deposits.
------------	------------------------------

TIME IN SERVICE	8 years.
-----------------	----------

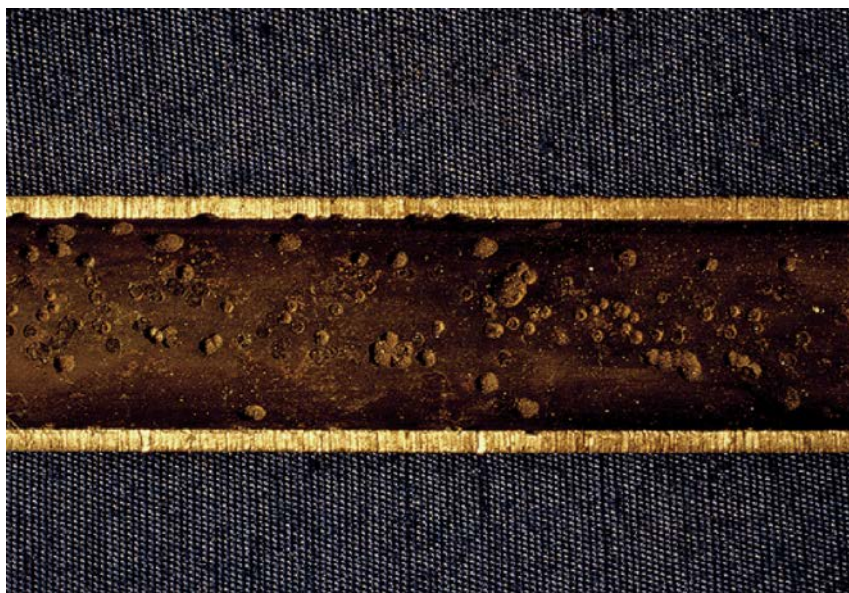
05.06.17.02

MATERIAL	Carpenter 20.
SYSTEM	Oil refinery overhead condenser.
PART	Horizontal condenser tube (OD 1.6 cm).
PHENOMENON	Microbiologically influenced corrosion.

APPEARANCE	Pitting.
TIME IN SERVICE	Less than 1 year.
ENVIRONMENT	Shell side: condensing hydrocarbon and H ₂ SO ₄ vapors. Tube side: cooling water, temperature ≈ 49 °C; water pH ≈ 8.2
CAUSE	Sulfate-reducing bacteria. Considerable sliming of the internal surfaces of the tube was noted during routine inspection. Furthermore, nondestructive testing confirmed deep pitting in more than 60% of tubes examined which was caused by sulfide attacking the nickel in the alloy. (See also former case.)
REMEDY	After cleaning the condenser, the cooling water was treated with high total free chlorine (>0.5 ppm).

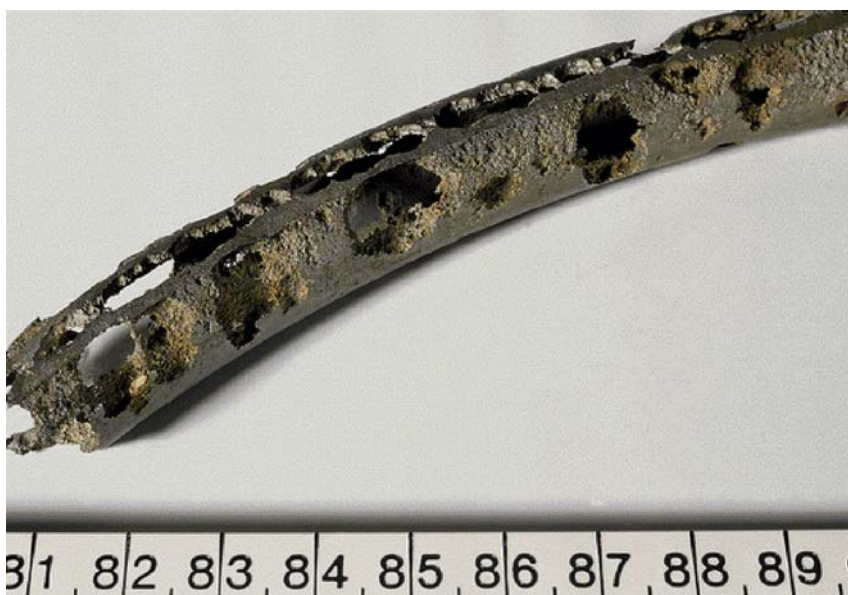
05.08.12.01

MATERIAL	Hastelloy B ₂ .
SYSTEM	Waste treatment plant.
PART	Tube.
PHENOMENON	Chloride attack.

APPEARANCE	Severe craterlike attack.
TIME IN SERVICE	2 weeks.
ENVIRONMENT	Sodium hypochlorite solution; ambient temperature.

CAUSE This nickel-based alloy is not resistant to a strongly oxidizing environment like sodium hypochlorite.

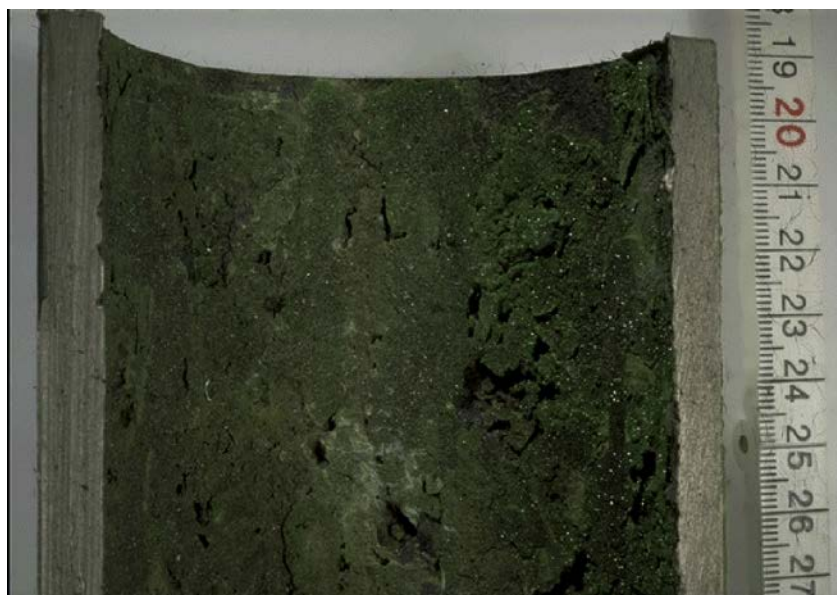
PART Reactor internal tube.

PHENOMENON Carbon dioxide corrosion (sweet corrosion).

APPEARANCE General corrosion and deep pits in the material.

TIME IN SERVICE 8 years.

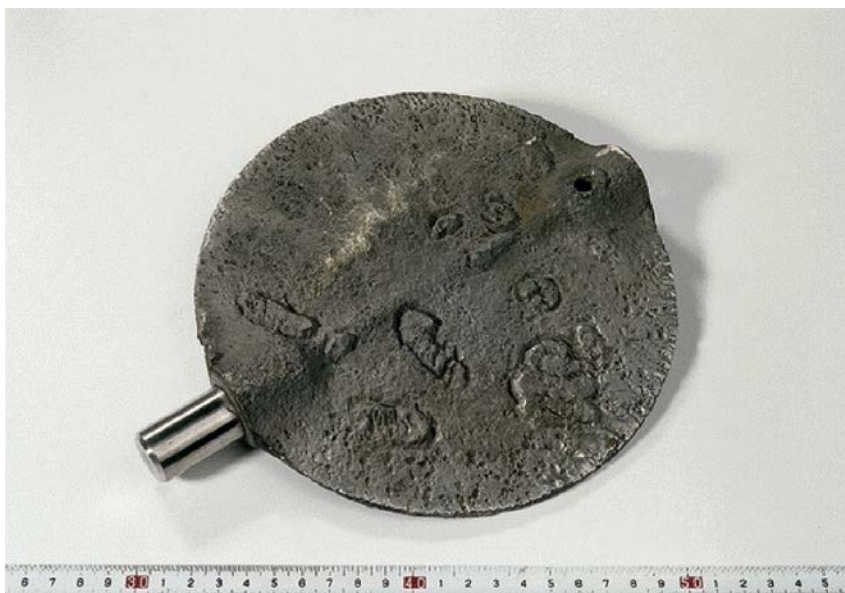
05.11.04.01

MATERIAL	Hastelloy C-22.
SYSTEM	Reactor in a fertilizer plant.
PART	Plate of butterfly valve mounted on the reactor.
PHENOMENON	Acid corrosion.

APPEARANCE	Pitting, overall attack, and mechanical damage.
TIME IN SERVICE	11 months.
ENVIRONMENT	Calcium sulfate-saturated phosphoric acid slurry with 42% P ₂ O ₅ , 33% solid particles (CaSO ₄ 0,5 H ₂), 2% sulfuric acid, 2500 ppm Cl ⁻ , 1000 ppm F ⁻ , temperature 100 °C.
CAUSE	Hastelloy alloy C-22 is resistant to pure phosphoric acid at 100 °C, but contamination with sulfuric acid, chloride, and fluoride substantially decreases this resistance. Mechanical damage is caused by periodical cleaning of the plate by mechanical force, to remove the calcium sulfate scale. This cleaning is necessary to guarantee a good sealing performance.
REMEDY	Application of a coating did not solve this problem, so the corrosion is accepted and the plate is regularly replaced.

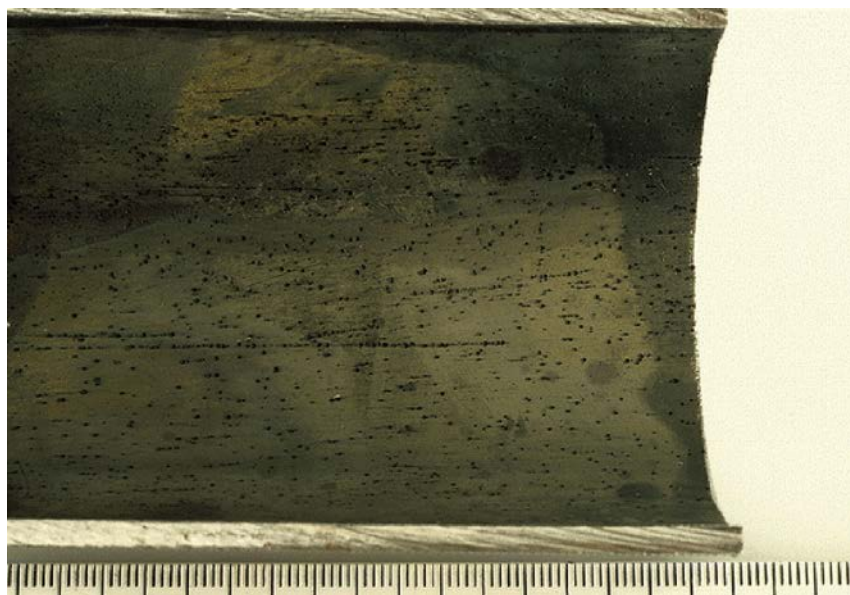
05.11.04.02

MATERIAL	Alloy 20 (UNS-Nr. N08020; W.-Nr. 1.4660).
SYSTEM	Neutralization unit.
PART	Seamless line (OD 60.3 mm, wall thickness 2.8 mm).
PHENOMENON	Acid corrosion.

APPEARANCE	The internal surface became shallow pitted by numerous small pits, diameter 0.5–0.7 mm, maximum depth 0.8 mm. Some pits lie in a row.
TIME IN SERVICE	A few weeks.
ENVIRONMENT	Alternately: 99% sulfuric acid and 20% sodium hydroxide, so the pH varies between 0 and 13. Normally the temperature is equal to the outside temperature, but during reaction the temperature can reach at least about 65 °C. The medium may have been standing still in the line.
CAUSE	Alloy 20 is resistant to sodium hydroxide solutions. The isocorrosion diagram of Alloy 20 in sulfuric acid shows that generally this alloy is suitable up to 80 °C at concentrations up to 50%. For higher concentrations, good corrosion resistance is expected up to 40 °C. So, the conditions in the line of the neutralization unit are rather critical for extended use of Alloy 20. The line is damaged, first by erosion corrosion and second by the pitting influence of contaminating halides, i.e., chloride.

REMEDY	Another nickel alloy should be selected, with: <ul style="list-style-type: none"> a. a higher nickel content to withstand general corrosion and erosion corrosion; b. a higher molybdenum content for enough passivity against pitting. The recommended alloy is Alloy B ₂ (UNS-nr. N 10665; W.-Nr. 2.4617)

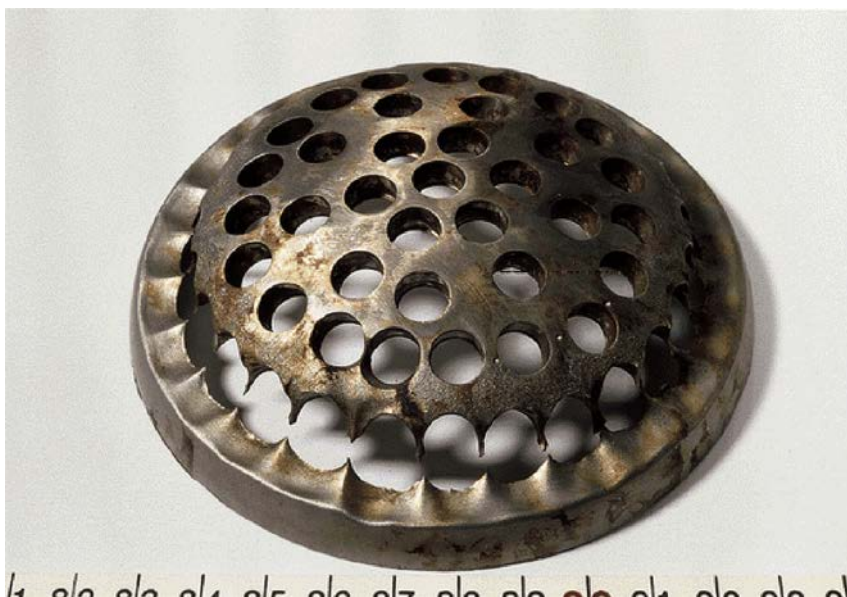
05.11.04.03

MATERIAL	Hastelloy C.
SYSTEM	Mixing trough.
PART	Nozzle of dip pipe.
PHENOMENON	Acid corrosion.

APPEARANCE	Uniform attack, material partly disappeared.
TIME IN SERVICE	6 months.
ENVIRONMENT	<p>Inside: 10% NaOH for neutralizing, ambient temperature.</p> <p>Outside: Initially 15% HCl, later on in the process a reaction mixture with inter alia aniline hydrochloride.</p> <p>Temperature: 30–90 °C.</p>
CAUSE	Hastelloy C is not resistant to HCl at 90 °C.
REMEDY	Improved process temperature control (maximum 50 °C).

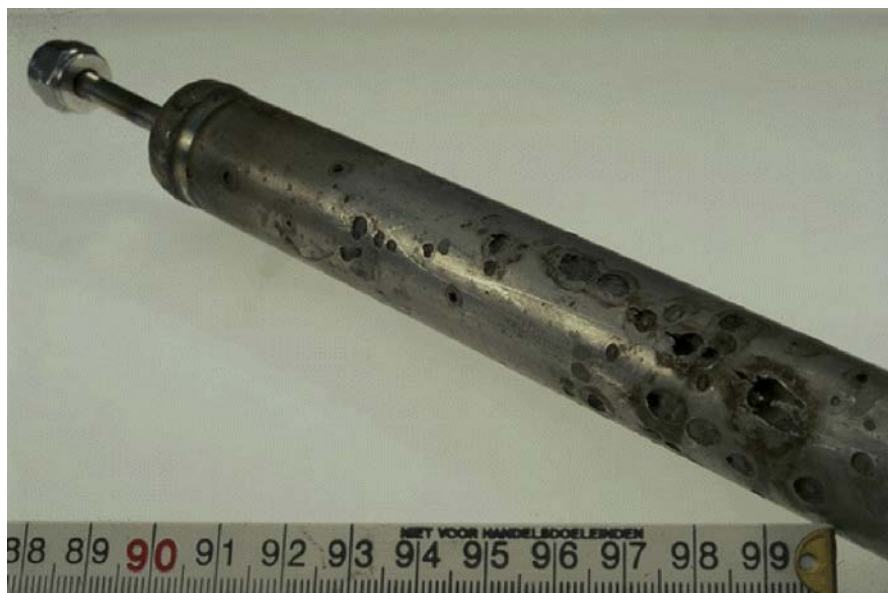
05.11.05.01

MATERIAL	Hastelloy B.
SYSTEM	Plastic plant.
PART	Guide roller for plastic film.
PHENOMENON	Sulfide corrosion.

APPEARANCE	Severe pitting attack.
TIME IN SERVICE	1–2 months.
ENVIRONMENT	A bath containing H_2S , sulfonates and flower of sulfur. In order to remove the flower of sulfur, the rollers were briefly immersed in a Na_2S bath to dissolve the flower of sulfur. Then the rollers were rinsed with water and air-dried (see also Case History 05.06.17.01).
CAUSE	Sulfide residues remaining after rinsing attack the nickel in the alloy during the drying period. Nickel is sensitive to attack by sulfide, and intergranular corrosion occurs.
REMEDY	If the rollers were polished after rinsing, as was done elsewhere, no corrosion occurred.

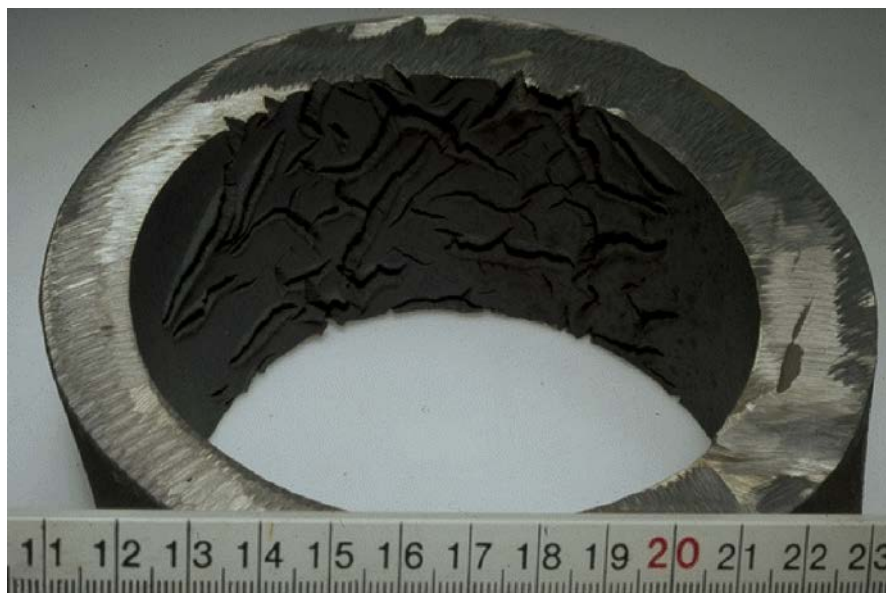
PART Radiant coil.

PHENOMENON High-temperature corrosion (carburization).

APPEARANCE Bulging with cracking.

TIME IN SERVICE 40,000 hours.

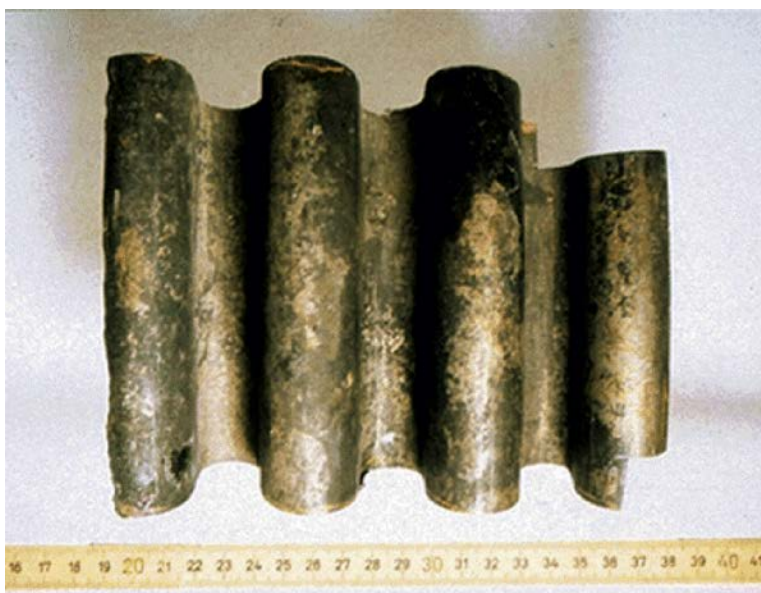
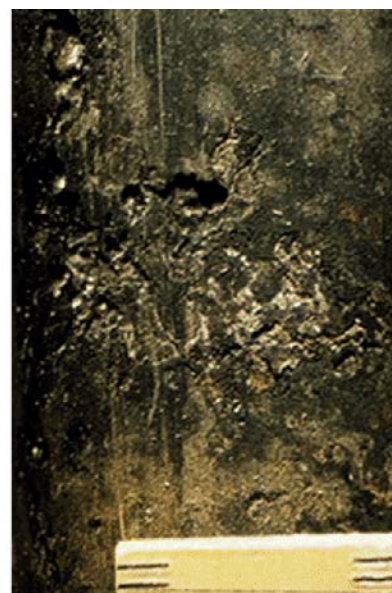
05.11.15.01

MATERIAL	Incoloy 825.
SYSTEM	Heat exchanger.
PART	Expansion bellows.
PHENOMENON	Underdeposit corrosion.

APPEARANCE	Local pits, varying in depth from 0.5 to 1.0 mm.
TIME IN SERVICE	4 years.
ENVIRONMENT	External: oil, contaminated with water and dirt; pressure 6 bar; temperature 160–200 °C.
CAUSE	Owing to insufficient through-flow in the dead end of the heat exchanger, dirt remained behind in the corrugations. This allows differential aeration cells to form, to which inter alia this alloy is sensitive (a form of crevice corrosion, see also Case Histories 05.06.15.01/02).
REMEDY	<ul style="list-style-type: none"> • Improvement of the through-flow. • Construction of the bellows from an alloy which is less sensitive to crevice corrosion, e.g., 254 SMO (ASTM S31254).

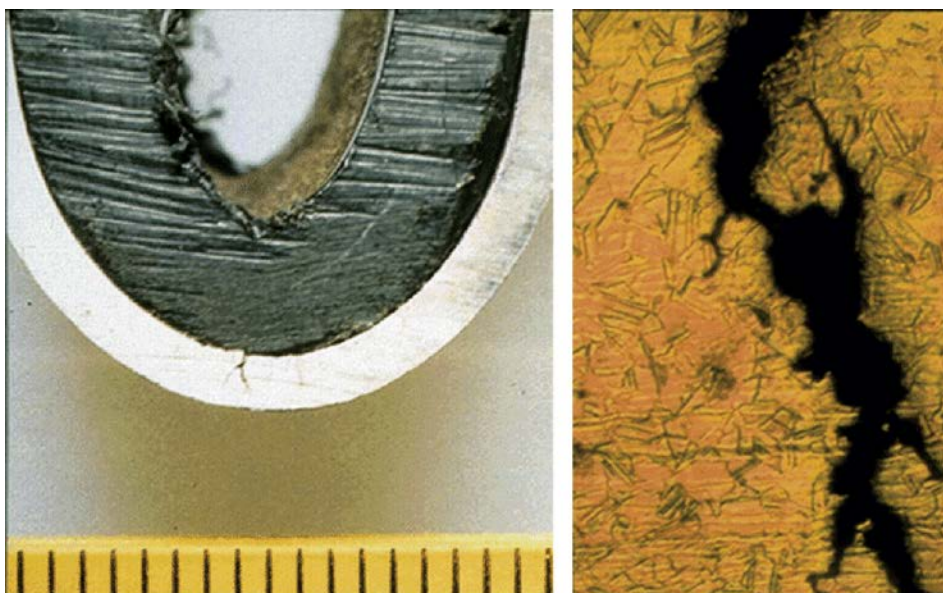
PART Bellows.

PHENOMENON Stress-corrosion cracking (intergranular).

APPEARANCE Cracks at an outer convolution.

CAUSE Over the years, the HCl diffused through the PTFE coating. Hastelloy C is not resistant to the present environment.
