Corrosion Atlas

THIRD, EXPANDED AND REVISED EDITION

A Collection of Illustrated Case Histories

Evert D.D. During

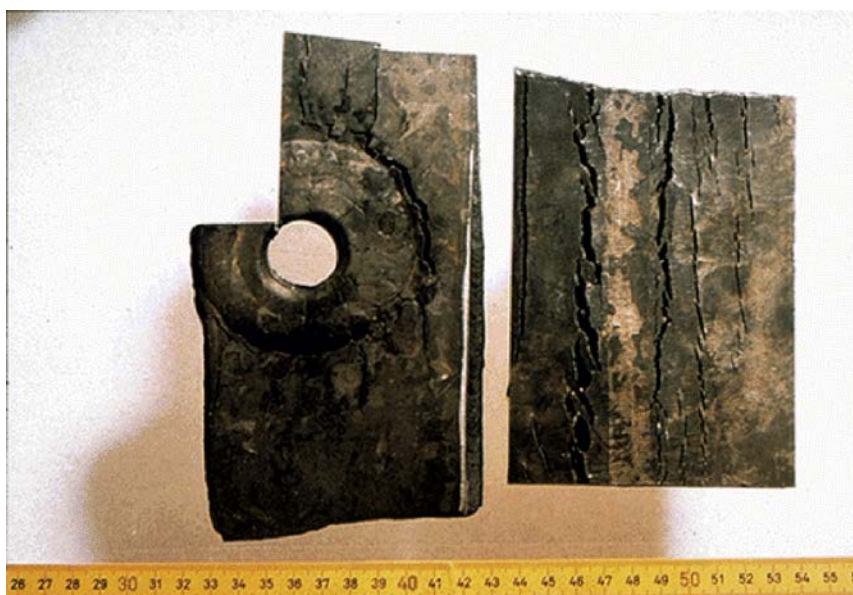
05.11.18.02

MATERIAL	Inconel 625.
SYSTEM	Oxidation reactor.
PART	Branch pipes of heat exchanger feed rundown.
PHENOMENON	Stress-corrosion cracking (intergranular).

APPEARANCE	Cracks.
TIME IN SERVICE	About 3 months.
ENVIRONMENT	Aerated disposal water; temperature approximately 350 °C; pressure approximately 200 bar.
CAUSE	High nickel alloys are sensitive to this attack in aerated water under high pressure and temperature. This results in oxygen stress-corrosion cracking (see also Case History 05.02.18.01).
REMEDY	Use carbon steel with stainless steel plating.

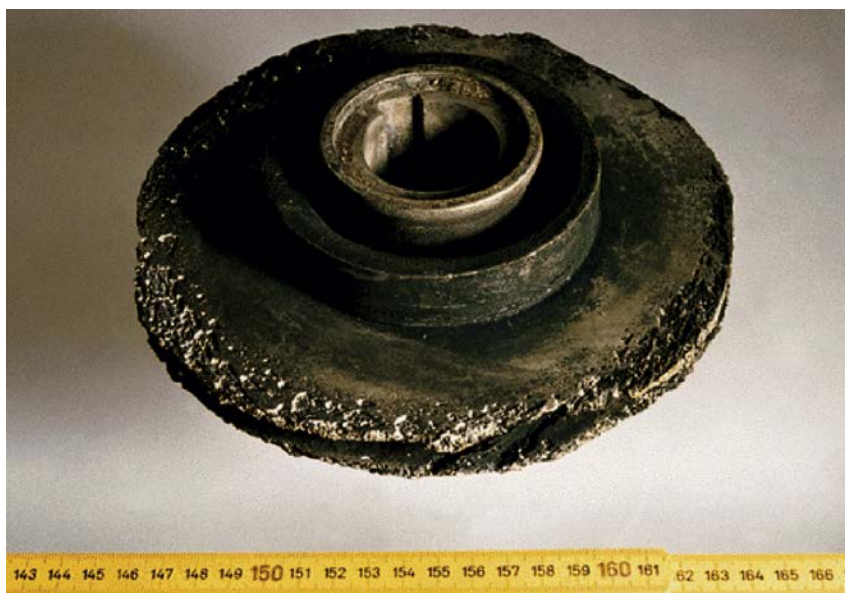
PART Pump impeller.

PHENOMENON Intergranular corrosion.

APPEARANCE Severe local attack and the material worn away.

CAUSE Carbide formation occurred at the grain boundaries owing to the high temperature of the sulfuric acid environment. Moreover, the material had not received proper heat treatment (see also Case History 04.11.19.03).

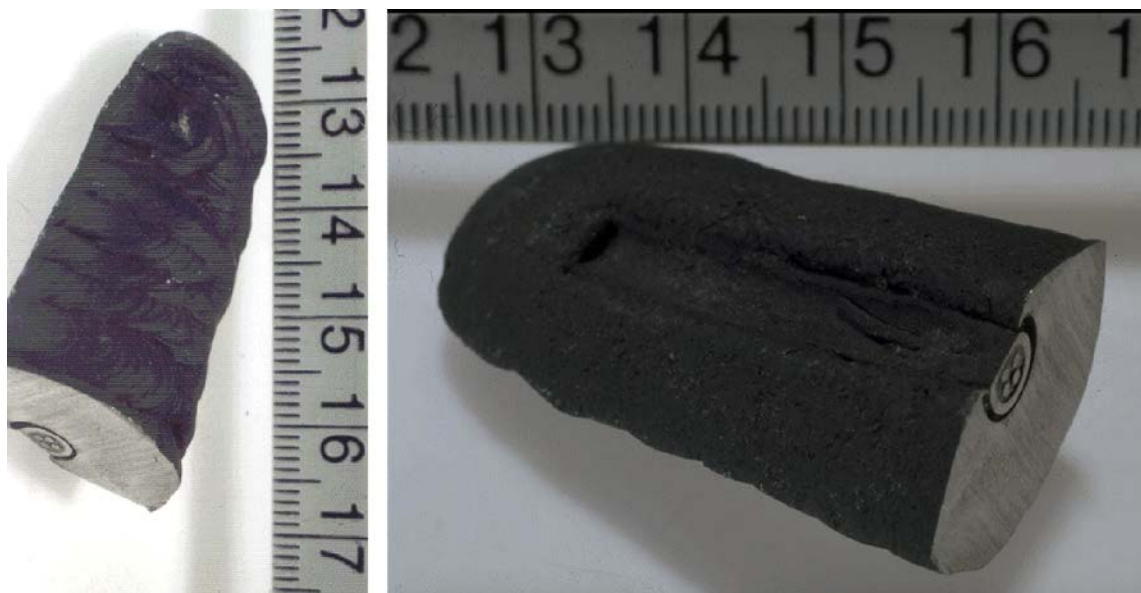
PART Thermocouple from outlet of radiant coil.

PHENOMENON Erosion.

APPEARANCE Material wear, original shape cylindrical. Left: the unaffected side; right: the eroded side perpendicular to the direction of flow.

CAUSE During decoking, the high velocity of the steam carrying coke particles causes erosion of the thermocouple; first the welded-on Stellite 6 and then the Incoloy 800H wears away.

REMEDY Use a cast Stellite 6 thermocouple, because this material is more wear resistant.

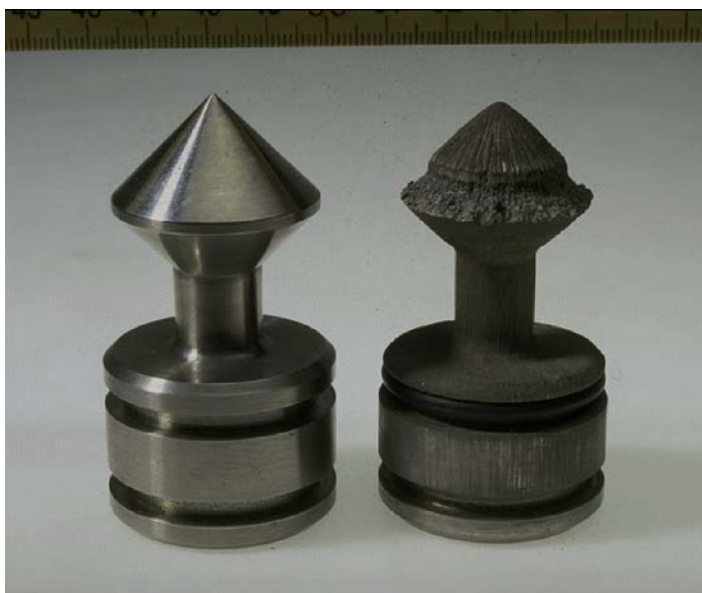
05.11.34.01

MATERIAL	Monel.
SYSTEM	Margarine manufacture.
PART	Back-pressure control valve of the mixing chamber of the pump of a margarine cooler.
PHENOMENON	Erosion corrosion.

APPEARANCE	Severe grooved attack of the used specimen (an unused specimen is shown for comparison).
TIME IN SERVICE	5 years.
ENVIRONMENT	Margarine emulsion (80% fat, 20% water). Temperature 45 °C. Aqueous phase: pH; 8% sodium chloride.
CAUSE	Attack by the salt-containing product combined with high local velocity caused erosion corrosion.
REMEDY	<ul style="list-style-type: none"> • Regular replacement, or alternatively • Make the back-pressure control valve from Stellite (see Case History 03.11.12.01).

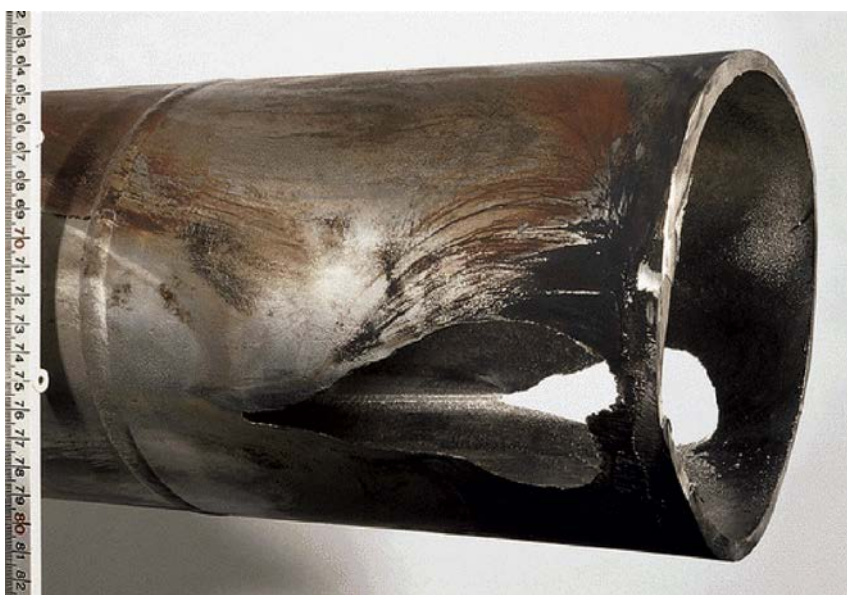
05.11.34.02

MATERIAL	Hastelloy C276.
SYSTEM	Mixer trough in chemical plant.
PART	Mixer tube.
PHENOMENON	Erosion corrosion.

APPEARANCE	Wall thinning by uniform attack, material partly eroded away.
TIME IN SERVICE	6 months.
ENVIRONMENT	Initially 15% HCl, later on in the process a reaction mixture with inter alia aniline hydrochloride. Temperature 90°C.
CAUSE	Hastelloy C276 has a rather good corrosion resistance in all HCl concentrations up to 50°C (corrosion rate <0.5 mm/year). Erosion corrosion was caused by high local velocities combined with attack by HCl at this high temperature.
REMEDY	<ul style="list-style-type: none"> • Design change, or • use lower velocities.

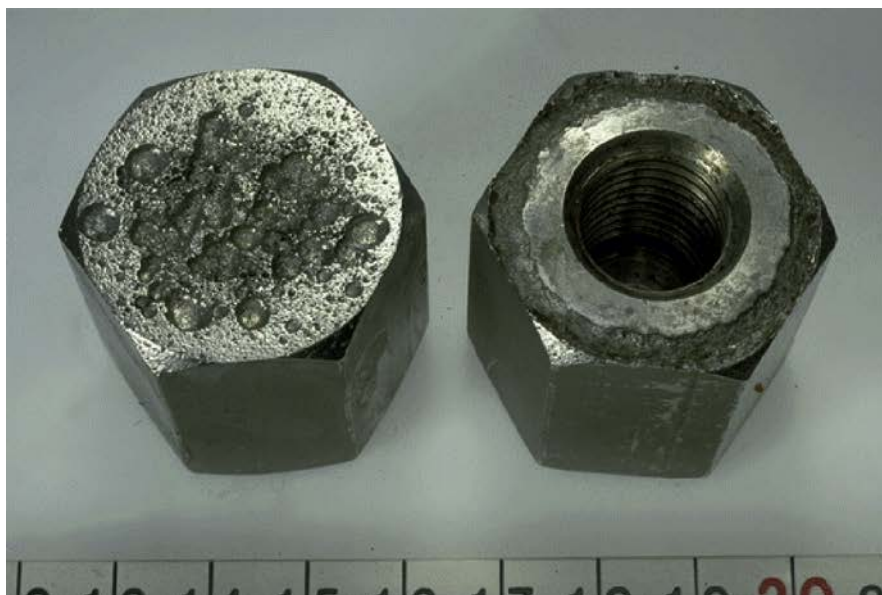
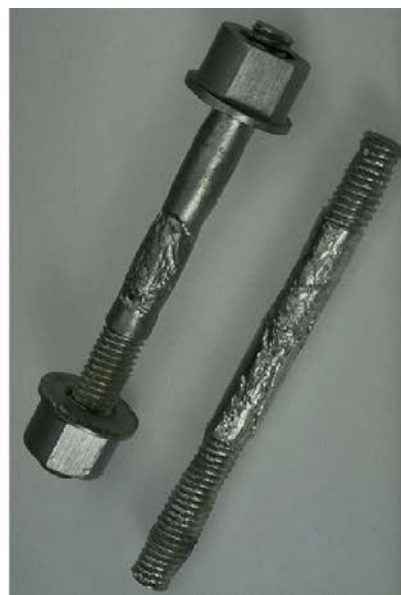
05.11.42.01

MATERIAL	Hastelloy C4.
SYSTEM	Mixing reactor at a metal plant.
PART	Bolts and nuts of agitator.
PHENOMENON	End grain attack and crevice corrosion.

APPEARANCE	Nuts: grooved attack in the crevice of the seat; pitting corrosion on the upper surface. Bolts: surface attack in the crevice of the shaft.
TIME IN SERVICE	1 year.
ENVIRONMENT	A mixture of nitric acid and other oxidizing mineral acids. Temperature 110–115 °C. Elevated oxygen pressure.
CAUSE	Topside of nuts: selective corrosion of the nonmetallic inclusions in the metal, rolled out and elongated into long “stringers” during the rolling action. When the end grain is exposed to a strong corrodent, end grain attack starts at the end of the stringers and can aggressively proceed down into the steel (see also Case Histories 01.12.42.01 and 04.08.42.01). The sides, on the other hand, do not corrode. Bolts and underside of nuts: formation of differential aeration cells due to the presence of crevices.
REMEDY	<ul style="list-style-type: none"> • Providing end grain protection by “buttering” the end grain with weld metal. Weld metal is not susceptible to this form of attack; or • Manufacture bolts and nuts from polyvinylidene fluoride (PVDF).

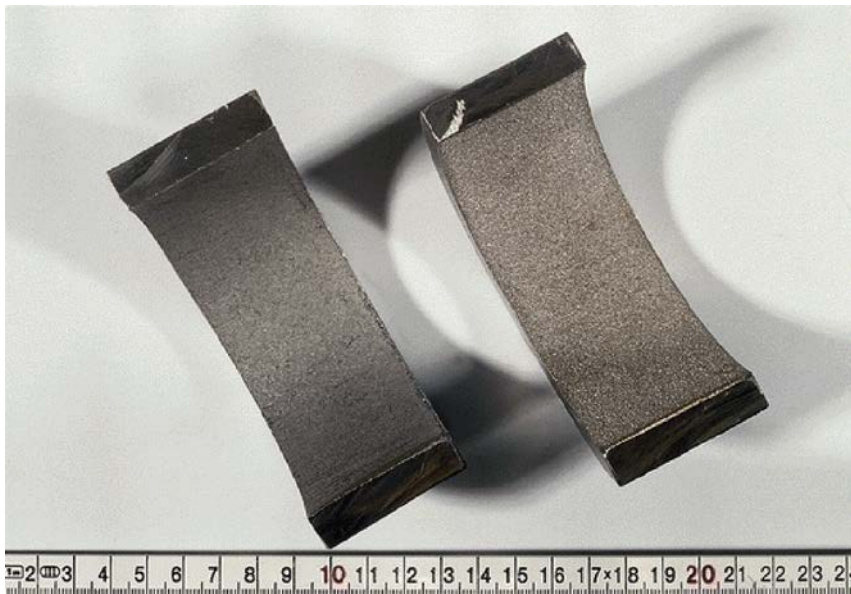
05.12.19.01

MATERIAL	Incoloy 800 H.
SYSTEM	Piping system.
PART	Bends (Ø 107 mm, 10 mm thick).
PHENOMENON	Intergranular corrosion.

APPEARANCE	A very rough internal surface.
TIME IN SERVICE	Approximately 20 hours.
ENVIRONMENT	Pickling bath (15% HNO ₃ + 2% HF at approximately 20 °C).

CAUSE Removal of the thick scale, formed during annealing after hot bended of the pipe, made it necessary to prolong the pickling treatment. However, as the bends had become sensitized during annealing, they became severely corroded.

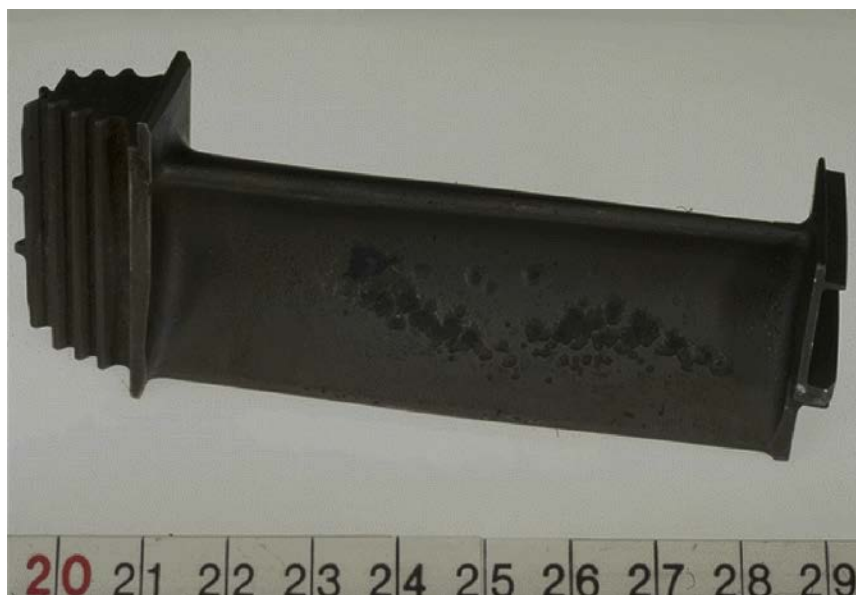
PART Vane.

PHENOMENON Sulfidation.

APPEARANCE Pitting attack.

CAUSE The fuel was found to be contaminated with vanadium and sulfur. Vanadium reduces the melting point of sodium sulfate. The resultant sodium sulfate melt attacks the cobalt alloy (see also Case History 05.01.06.01). The corrosion products were entrained by the combustion gases.

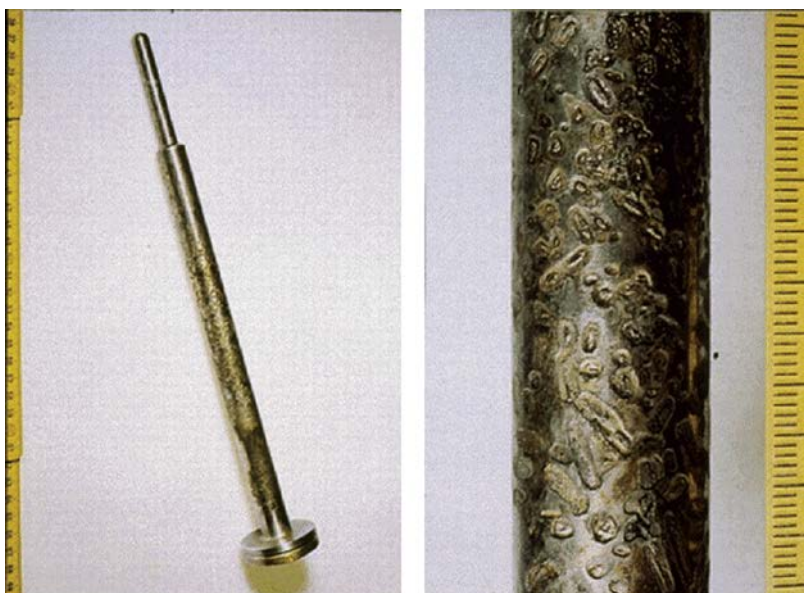
05.23.14.01

MATERIAL	Hastelloy B ₂ .
SYSTEM	Activated charcoal filter.
PART	Thermometer bulb.
PHENOMENON	Galvanic corrosion.

APPEARANCE	Pitting attack in the form of carbon grains.
TIME IN SERVICE	Unknown.
ENVIRONMENT	Activated charcoal; residual gas from vinyl chloride; condensing steam.
CAUSE	During regeneration of the activated charcoal filter with steam at 130–140°C, condensation leaves water vapor in the grains, forming acid decomposition products with the vinyl chloride, which causes galvanic attack to the metal at the grains (by couple action). (See also Case History 04.23.14.01.)
REMEDY	Application of a protective sprayed layer of Al ₂ O ₃ .

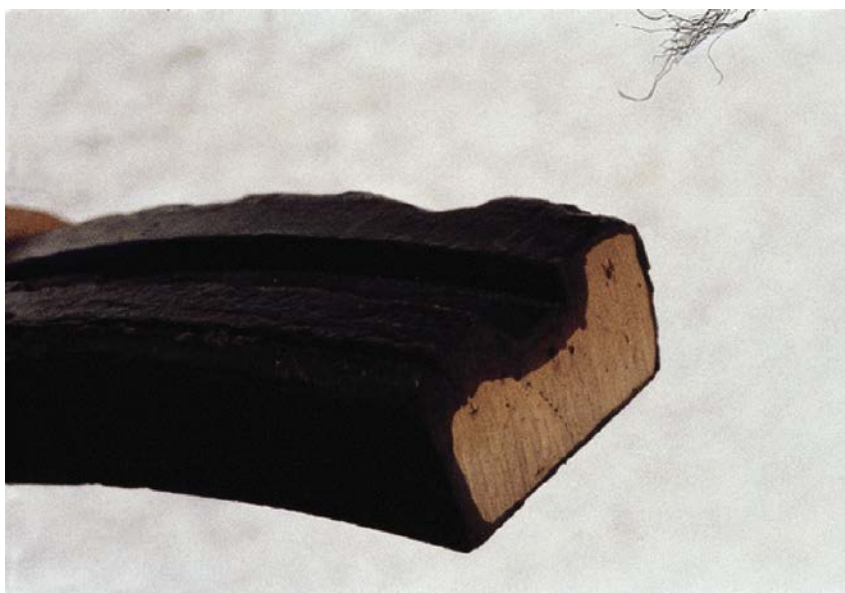
PART Feedwater pump component (13.8 by 1.3 cm).

PHENOMENON Selective leaching (layer-type dezincification, see also Case 06.20.16.01).

APPEARANCE A copper layer wrapping around the brass inner of the component.

ENVIRONMENT Contaminated boiler feedwater due to leaking condensers; temperature: 144 °C.

CAUSE Probably high chloride concentration during prolonged outage (see also Case History [06.06.16.01](#)).

REMEDY Condenser leakage repaired (condenser replaced).

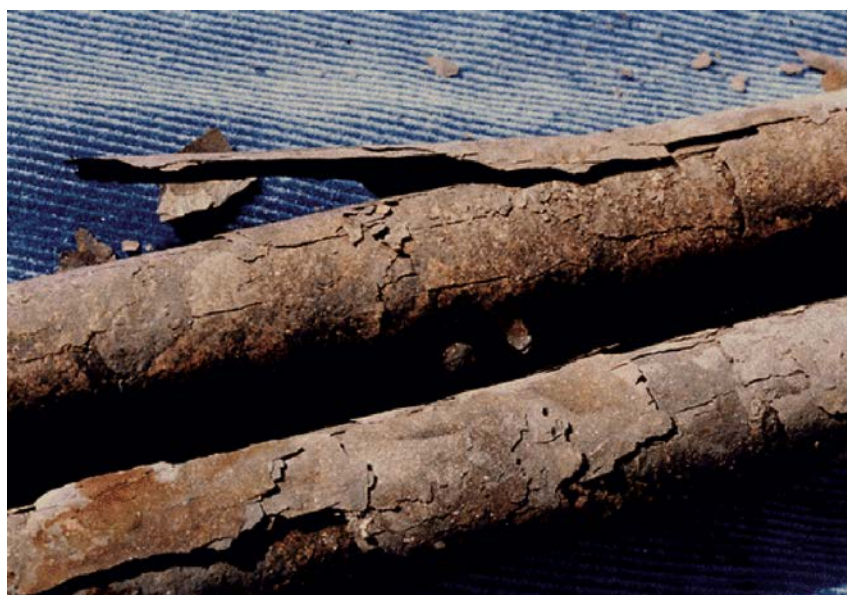
Selective leaching (denickelification).

Exfoliation at the outside where sheets are peeling off, with 15% reduction of the wall thickness.

Feedwater heater tubes were thinned by cyclic oxidation followed by reduction of oxides in service. During the previous 2 years, the boiler had experienced frequent outages during which air leaked into the heater shell and caused surface oxidation. Conversion of oxide to elemental copper occurred during normal operation.

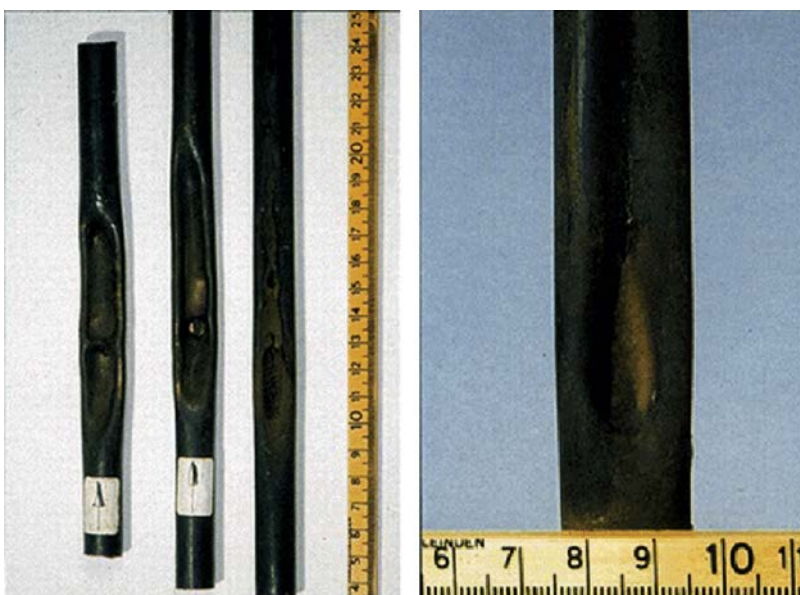
06.01.32.01

MATERIAL	Copper.
SYSTEM	Heat exchanger of hot water system.
PART	Heating tubes.
PHENOMENON	Erosion (impingement attack).

APPEARANCE	Deep dents, always at the same sites (on the steam side).
TIME IN SERVICE	7 months.
ENVIRONMENT	Steam (around the pipes).
CAUSE	Presence of water in the steam caused impingement attack by water droplets on the surface of the copper tubes facing the steam inlet nozzle (even after replacement of the tubes, this damage reappears at the same sites) (see also Case History 06.02.32.02).
REMEDY	Installation of a drain with steam trap immediately upstream of the steam feed regulator of the heat exchanger.

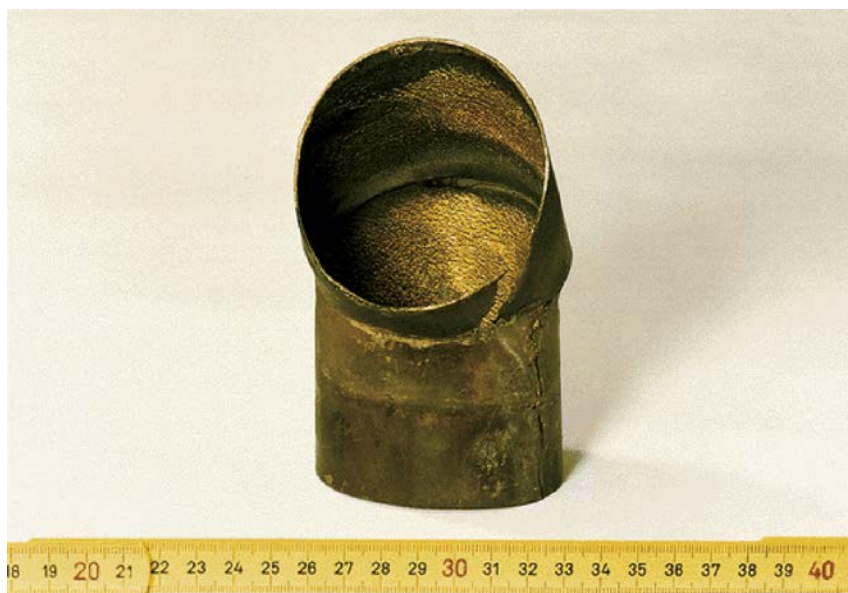
06.01.32.02

MATERIAL	Copper.
SYSTEM	Sterilizer.
PART	Steam vent pipe.
PHENOMENON	Erosion.

APPEARANCE	Roughened surface of bare copper.
TIME IN SERVICE	Unknown.
ENVIRONMENT	Steam with water droplets. Steam pressure 2.5 bar.

CAUSE Erosion due to excessive velocity combined with droplets in the steam.

- Bend section was dimensioned larger and water droplets were drained away by a steam trap.
- Alternative: construct of a less erosion-sensitive material, e.g., stainless steel.

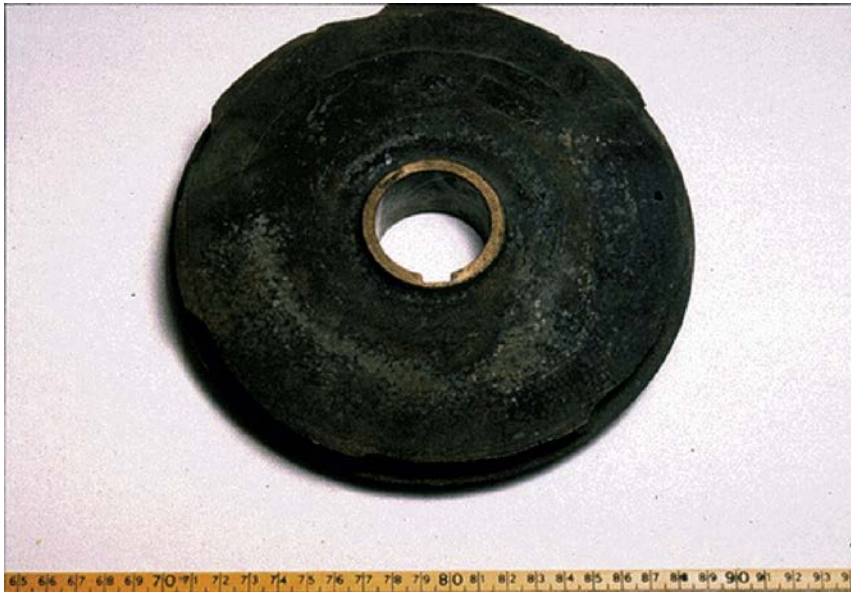
06.01.34.01

MATERIAL	Bronze.
SYSTEM	Boiler-feed system.
PART	Impeller of feedwater pump.
PHENOMENON	Erosion corrosion.

APPEARANCE The material wore away until it was paper-thin and then crumbled away.

CAUSE Feedwater was contaminated with ammonia which, in the presence of (traces of) oxygen, attacks copper and copper alloys. Together with the high velocity of the feedwater in the pump, this caused erosion corrosion (see also Case History 06.11.34.01).

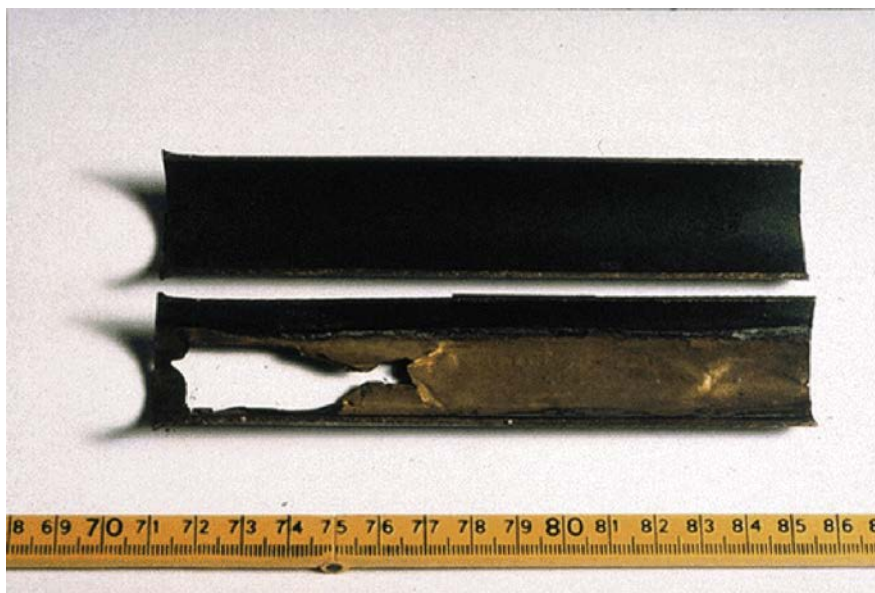
06.02.02.01

MATERIAL	Copper.
SYSTEM	Steam condensate system of air conditioning installation with steam humidification.
PART	Condensate pipe.
PHENOMENON	Carbonic acid corrosion.

APPEARANCE	Uniform corrosion.
TIME IN SERVICE	10 years.
ENVIRONMENT	Corrosive oxygen-containing condensate; temperature 90–100°C (low-pressure steam is produced by steam generators fed with softened, non-deaerated water; heating medium: hot water at 150°C).
CAUSE	Copper is not resistant to corrosive oxygen-containing condensate (see also Case History 06.02.02.02).
REMEDY	Deaeration of the feedwater. Alternatives: dosing of sodium sulfite as oxygen scavenger, or alkalinity reduction of the make-up water. In the present case, however, in view of the small quantity of condensate it was decided to discharge the condensate to the nearest sewer instead of recycling it to the boiler house via a new, long copper line.

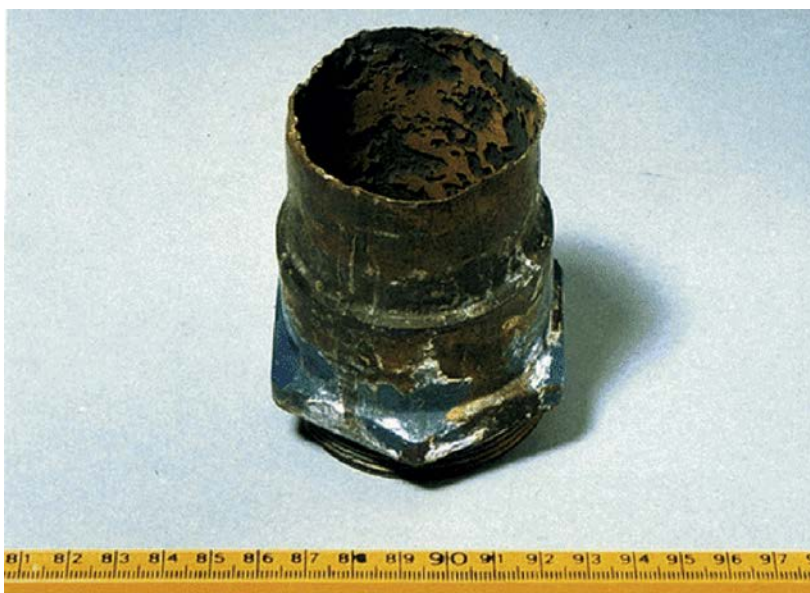
06.02.02.02

MATERIAL	Copper.
SYSTEM	Steam condensate system.
PART	Condensate pipe extremity.
PHENOMENON	Carbonic acid corrosion.

APPEARANCE	Severe irregular attack.
TIME IN SERVICE	About $1\frac{1}{2}$ years.
ENVIRONMENT	Corrosive oxygen-containing condensate, about 90°C; boiler fed with deaerated feedwater (mixture of softened make-up water and condensate).
CAUSE	Copper is well resistant to carbonic acid or oxygen alone in the condensate, but not to the combination of these two gases.
REMEDY	In view of the limited length of the condensate line, it was decided to construct it of stainless steel (AISI 304) (under different conditions, alkalinity reduction of the make-up water may be preferable).

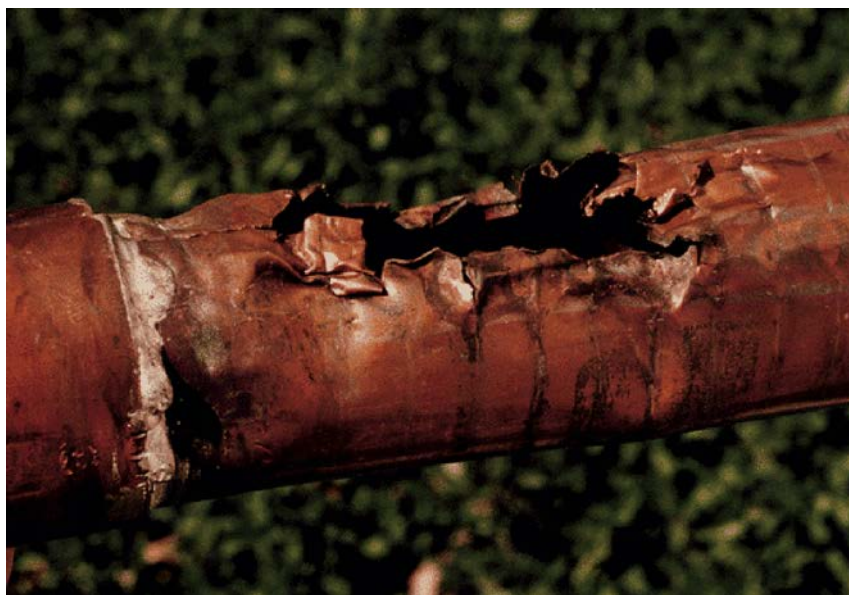
PART Horizontal condensate line.

PHENOMENON Ammonia corrosion.

APPEARANCE Severe internal general thinning along the bottom of the pipe.

CAUSE The ammonia in the condensate caused general attack of the copper condensate lines. Ammonia was carried over from boiler-water treatment chemicals.

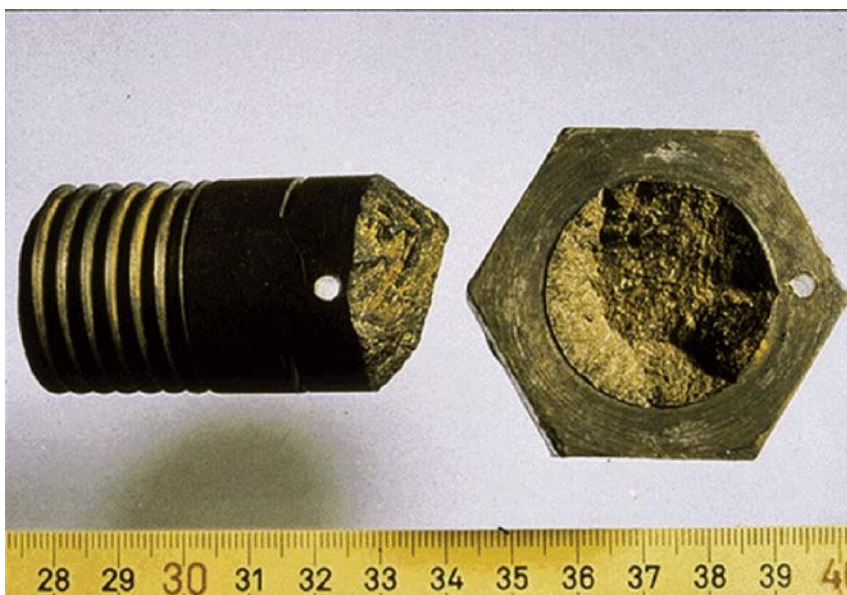
PART Bolt.

PHENOMENON Stress-corrosion cracking (transgranular).

APPEARANCE Brittle fracture plane.

CAUSE In combination with present material stresses, ammonia leads to stress-corrosion cracking in brass (season cracking) (see also Case Histories [06.06.18.01](#), [06.15.18.01](#), and [06.25.18.01](#)).

REMEDY Construct the bolts from a material that is not susceptible to ammonia attack, e.g., stainless steel.

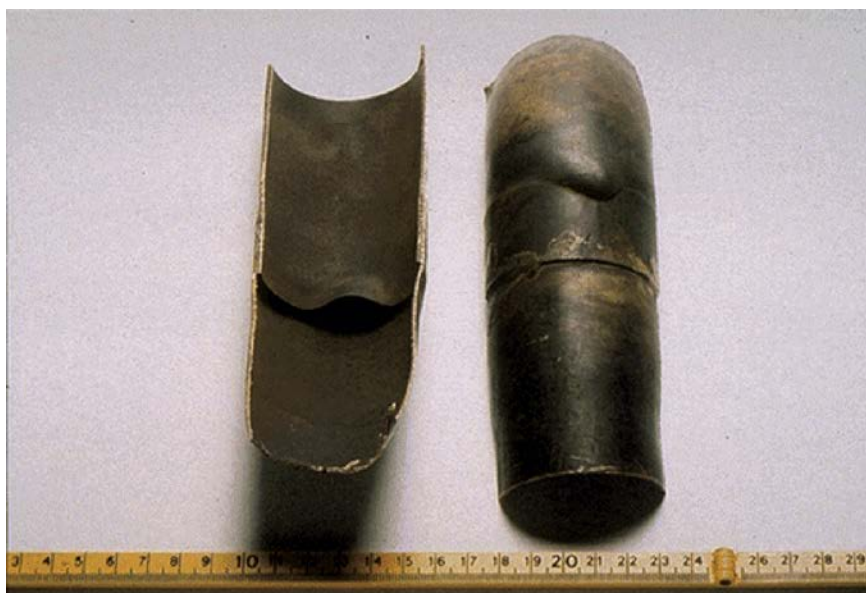
PART Condensate pipe.

PHENOMENON Erosion (deformation by water hammer).

APPEARANCE Bulging material, worn to the point of leaking.

CAUSE Installation error: equal-diameter pipes were connected by reducing the diameter of one pipe by means of hammering. External deformation due to water hammer until leakage occurred. This is obviously a case of poor workmanship (see also Case Histories [06.01.32.01](#) and [06.02.32.01](#)).

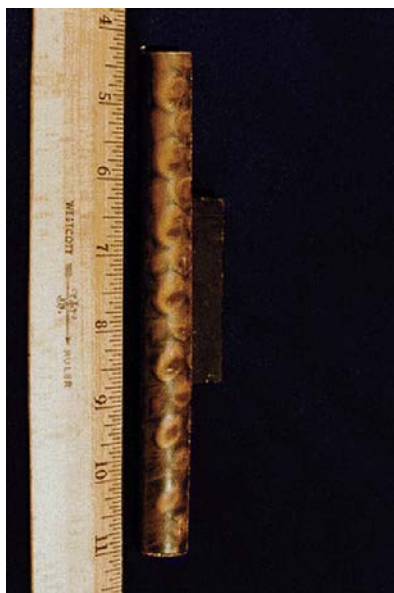
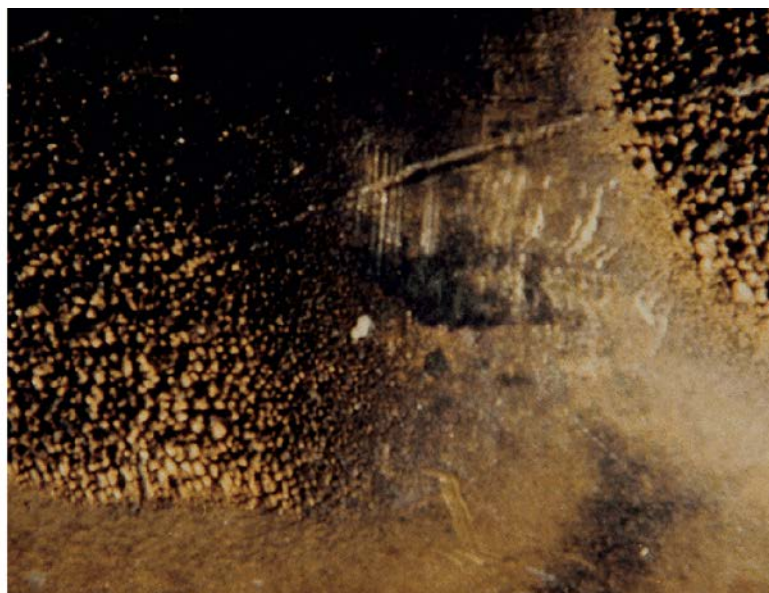
06.02.32.02

MATERIAL	Admiralty brass.
SYSTEM	Turbine steam condensate system (pressure 5.9 MPa).
PART	Horizontal condenser tube (OD 1.9 cm).
PHENOMENON	Erosion (impingement attack).

APPEARANCE	A pattern of erosion spots on the external surface facing the turbine exhaust inlet. The close-up (magnification $\times 7.5$) shows a small forest of erosion cones.
------------	--

CAUSE	Erosion was caused by the impingement of high-velocity steam probably mixed with droplets of condensate. The tube had been removed from a position directly in line with the turbine exhaust inlet. The circular, equally spaced erosion sites apparently reproduced corresponding equally spaced circular openings in the exhaust inlet (see also Case History 06.01.32.01).
-------	--

REMEDY	<ul style="list-style-type: none"> • Separate moisture from the steam before it enters the condenser (mechanically or by means of pressure reduction, which causes superheating). • Install a deflector shield to protect the area experiencing corrosion. • Specify metals that are more resistant to erosion, such as cupronickel, Monel, or stainless steel.
--------	--

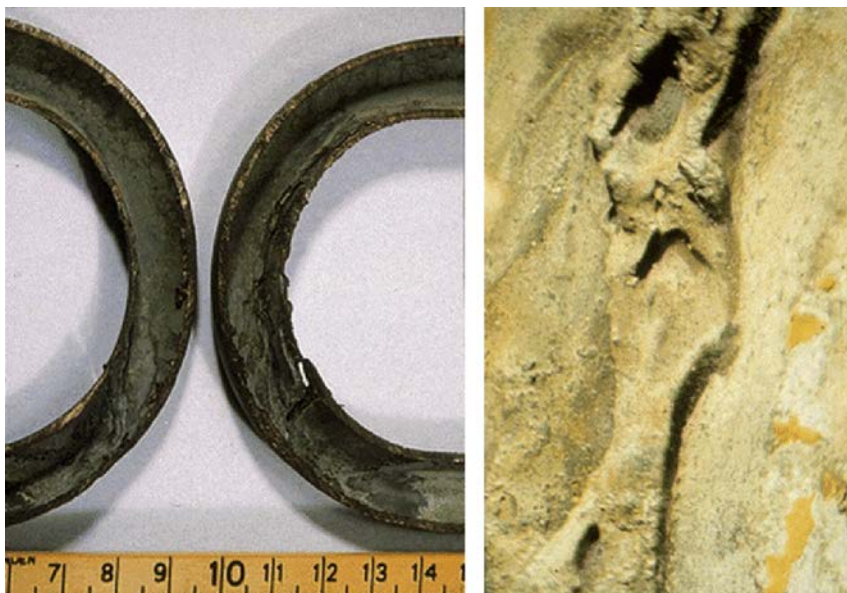
06.02.34.01

MATERIAL	Copper.
SYSTEM	Steam condensate system (0.15 MPa).
PART	Bends in heating tubes of hot water storage boiler.
PHENOMENON	Erosion corrosion.

APPEARANCE	Grooved attack.
TIME IN SERVICE	$1\frac{1}{2}$ to 2 years.
ENVIRONMENT	Steam-condensate mixture, corrosive due to the presence of carbon dioxide (130 ppm).

CAUSE The combination of corrosive condensate and strong turbulence in the bends (local high velocity) (see also next case).

- The cheapest solution was found to be constructing the heating tubes of AISI 316 stainless steel, which is resistant to carbon dioxide.
- Alternatives: copper tubes with straight pipes, reversal of media, alkalinity reduction of make-up water (dosing of chemicals into the steam was impossible in view of the steam used).

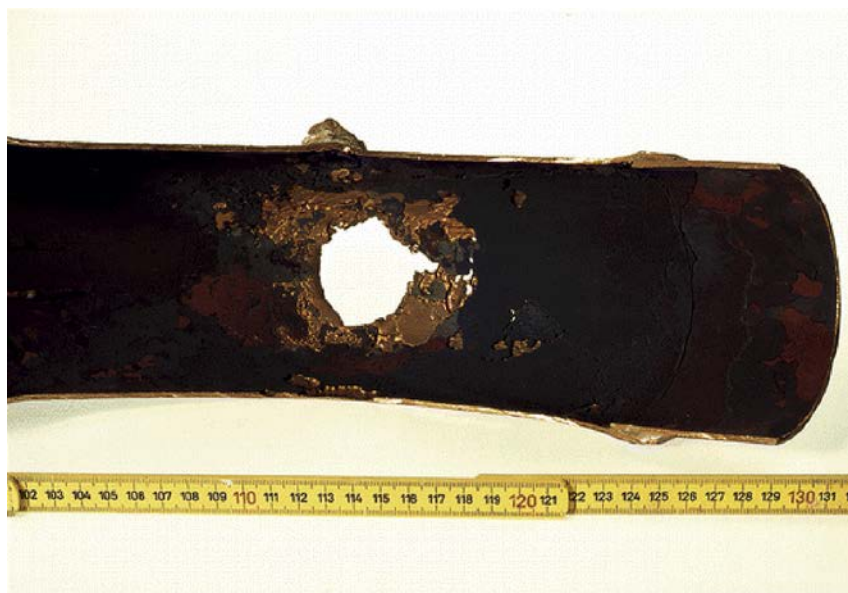
PART Bend section.

PHENOMENON Erosion corrosion.

APPEARANCE Pipe wall totally eroded away locally.

CAUSE Erosion corrosion was caused by the combination of high velocity and aggressiveness (see also former case).

- Reduce condensate aggressiveness by means of appropriate boiler feedwater treatment (dealkalization and deaeration).
- New copper bend sections should be dimensioned larger, or
- Replace copper pipes with stainless steel pipes.

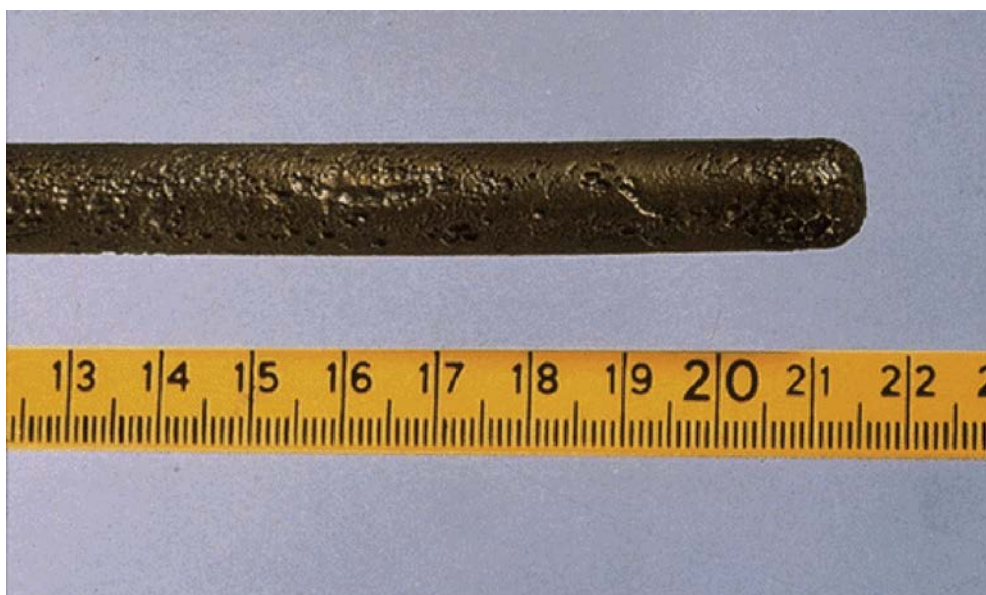
06.04.10.01

MATERIAL	Copper.
SYSTEM	Central heating water system.
PART	Thermometer bulb.
PHENOMENON	Ammonia corrosion.

APPEARANCE	Pitting attack.
TIME IN SERVICE	Unknown.
ENVIRONMENT	Hot softened water, 70–90 °C, to which hydrazine was added as an oxygen scavenger.

CAUSE The presence of ammonia in the water, originating from the partial decomposition of hydrazine, in addition to traces of oxygen. Oxygen accelerates the attack of copper and copper alloys by ammonia (see also Case Histories [06.02.10.01/02](#)).

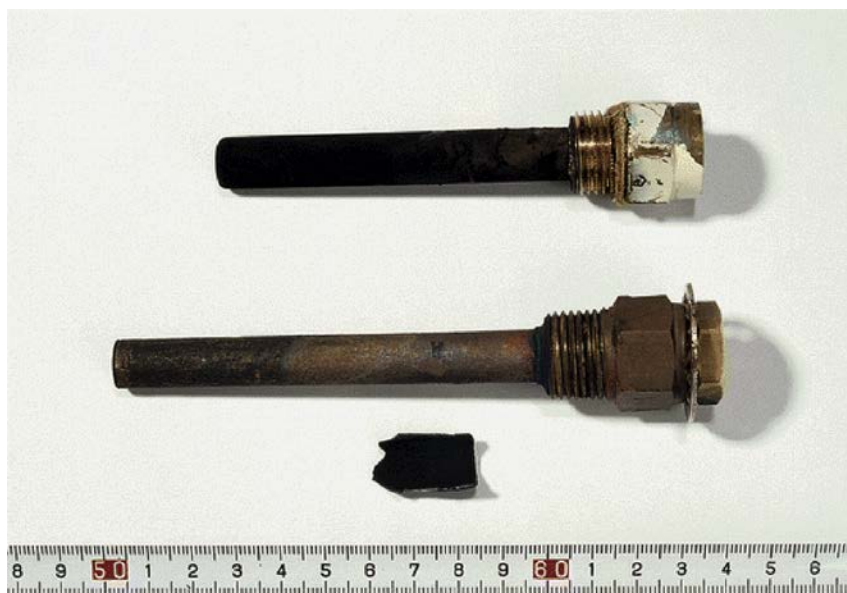
MATERIAL	Brass (>20% Zn).
SYSTEM	Central heating system.
PART	Temperature sensor tube.

PHENOMENON Selective leaching (layer type dezinkification).

APPEARANCE Above: tube covered with bluish-black coating (1–1.5 mm thick). Center: tube with bluish-black coating tapped off. Below: the bluish-black coating that surrounded the tube like a shell.

CAUSE Deposition of the more noble magnetite on the brass pipe caused dezincification, with the formation of a nonadhesive layer of copper oxide and iron oxide on the surface. The magnetite originates from the steel line work.

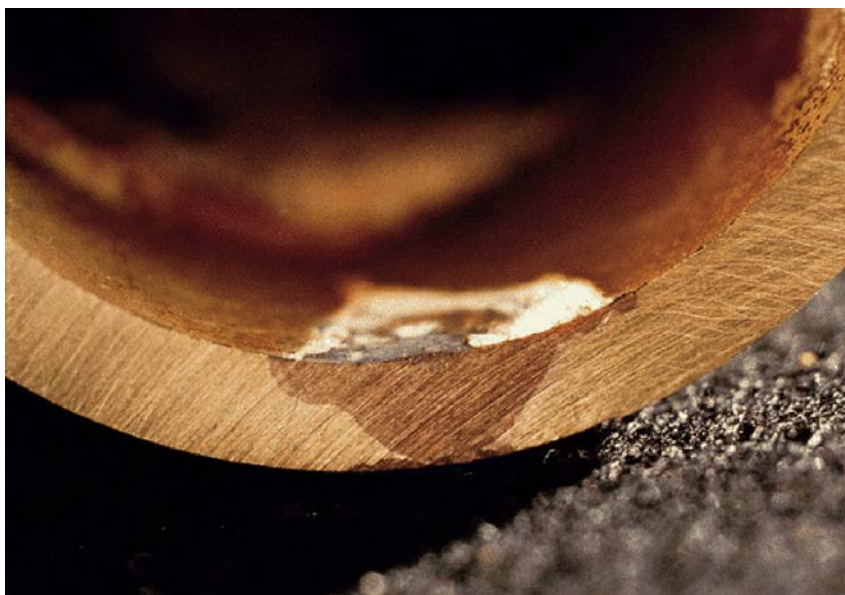
PART Horizontal pipe.

PHENOMENON Selective leaching (dezincification).

APPEARANCE Plug-type dezincification beneath a deposit.

CAUSE Brass is sensitive to dezincification under deposits. Deposits were dislodged in a vertical adjoining pipe and came to rest on the bottom surface of the pipe. Also, two phase brasses, not inhibited, are more susceptible to dealloying (see also Case History [06.05.16.03](#)).

- Prevent deposit formation by improved water treatment or by maintaining higher flow rate, or
- Replace with inhibited brass and/or copper.

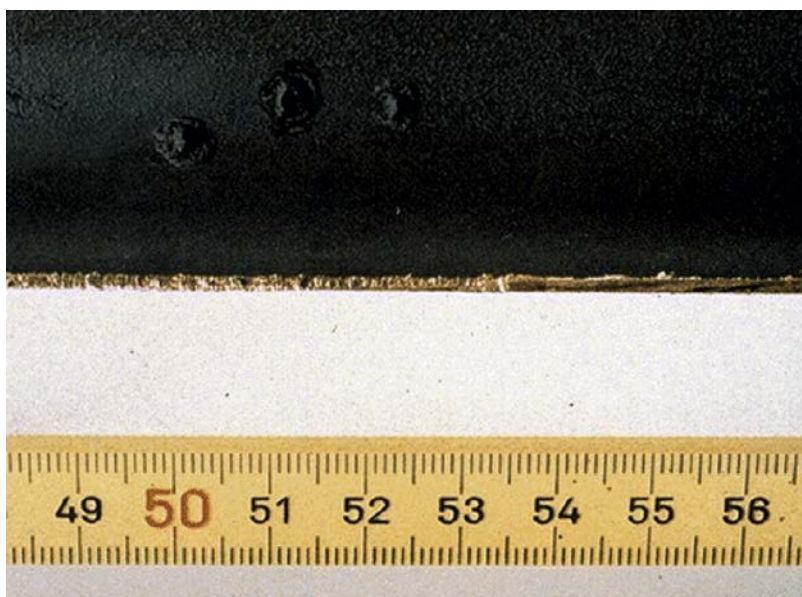
PART Pipe section.

PHENOMENON Pitting by copper-aggressive water.

APPEARANCE Pitting attack underneath corrosion nodules.

CAUSE The present water type leads to type II pitting corrosion of copper in hot water >60°C. In relation to the quantities of sulfate and chloride and the pH, the water has too low a content of bicarbonate (see also next case).

- Chemical cleaning of the system for removing the corrosion products.
- Increasing the water hardness by the admixture of different water or by filtration over activated dolomite.

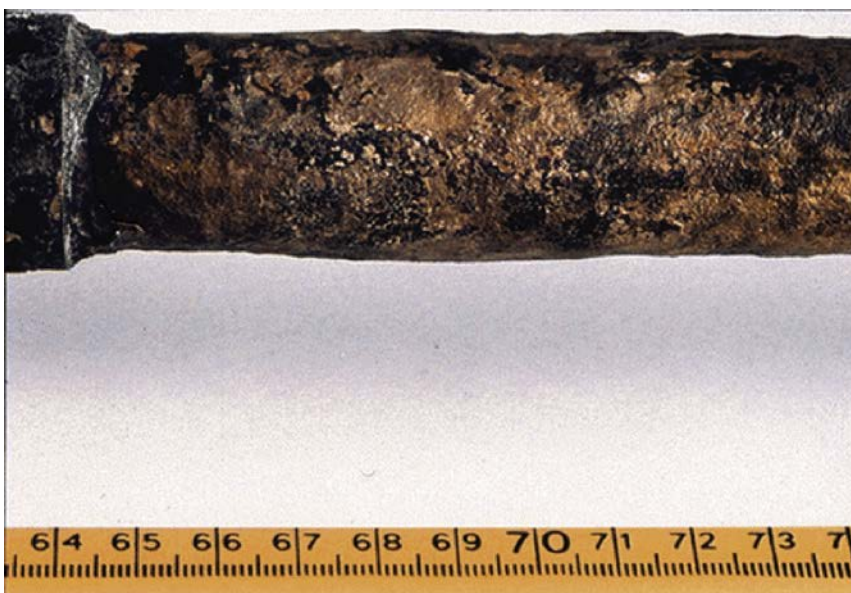
06.05.05.01

MATERIAL	Copper.
SYSTEM	Drinking water system.
PART	Underground pipeline.
PHENOMENON	Sulfide corrosion.

APPEARANCE	Irregular general attack, with black corrosion products.
TIME IN SERVICE	5 years.
ENVIRONMENT	H ₂ S-containing groundwater.
CAUSE	Copper is attacked by sulfide, with the formation of black copper sulfide (CuS).
REMEDY	Use of impermeable plastic pipe.

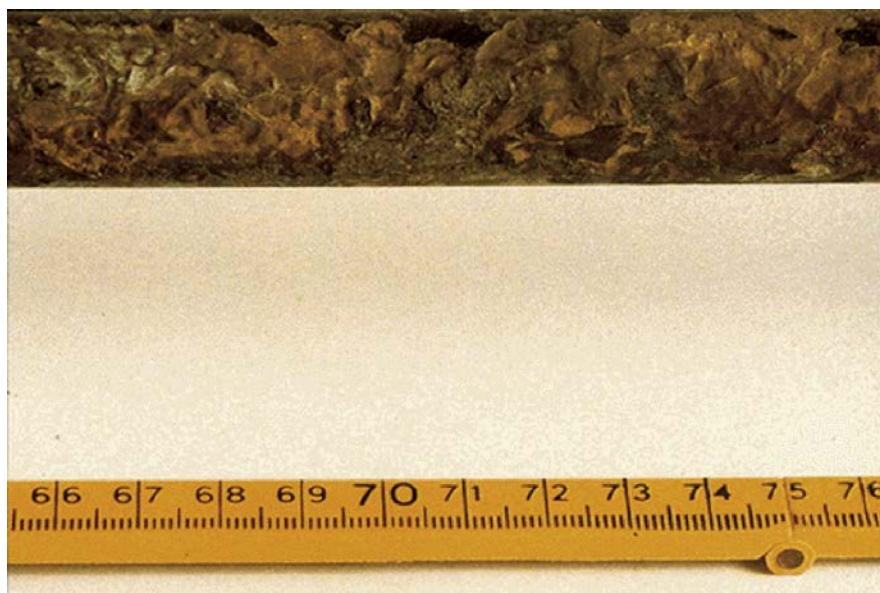
06.05.10.01

MATERIAL	Copper.
SYSTEM	Drinking water system.
PART	Pipe.
PHENOMENON	Ammonia corrosion.

APPEARANCE	Blotchy blue-green appearance due to irregular attack.
TIME IN SERVICE	Unknown.
ENVIRONMENT	Atmosphere in cow-shed.
CAUSE	Ammonia originating from cow manure attacks copper (see also Case History 06.13.10.01).
REMEDY	Use of impermeable plastic pipe.

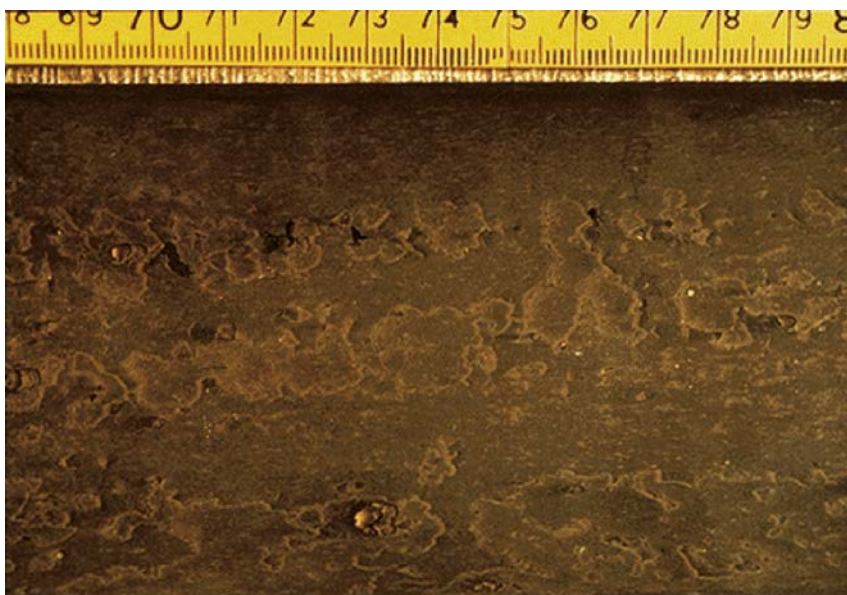
06.05.14.01

MATERIAL	Copper.
SYSTEM	Hot tap water system.
PART	Circulation pipe.
PHENOMENON	Galvanic corrosion.

APPEARANCE	Pitting attack.
TIME IN SERVICE	6 years.
ENVIRONMENT	Circulating oxygen-containing hot tap water; temperature 80°C; pH 7.5; chloride (Cl ⁻) 38 ppm; bicarbonate (HCO ₃ ⁻) 4.2 mEq/l (210 ppm CaCO ₃).
CAUSE	Damage to the oxide skin by air bubbles (erosion) followed by galvanic corrosion due to local Cu/Cu ₂ O cell formation.
REMEDY	<ul style="list-style-type: none"> • Fit an air vent on the hot water storage tank, or • Construct the circulation pipe of AISI 316 L stainless steel.

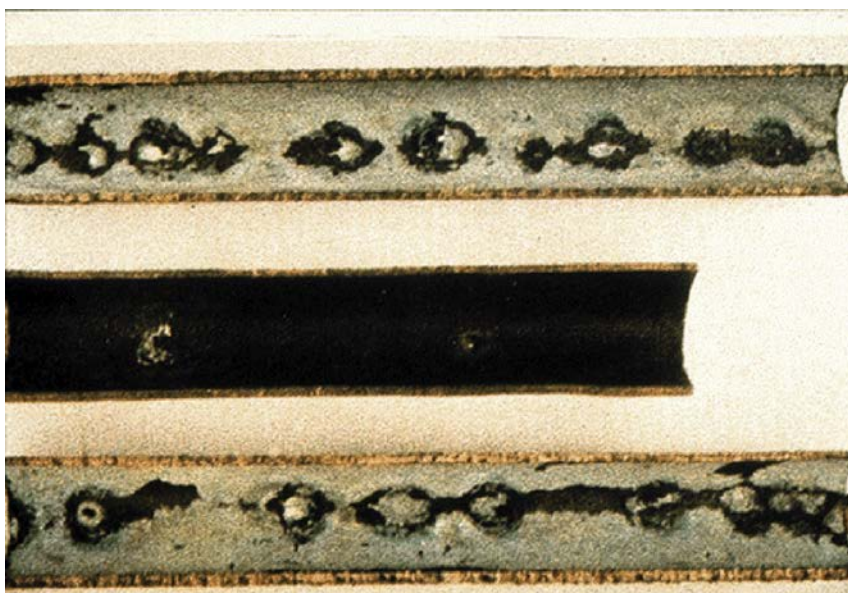
PART Pipe section.

PHENOMENON Underdeposit corrosion.

APPEARANCE Pitting attack.

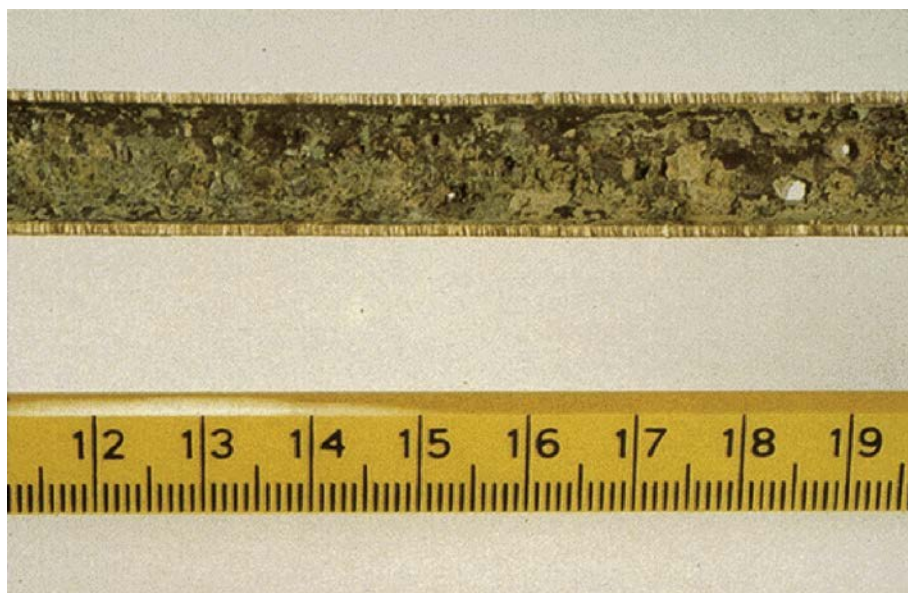
PART Indoor pipe.

PHENOMENON Underdeposit corrosion.

APPEARANCE Pitting attack.

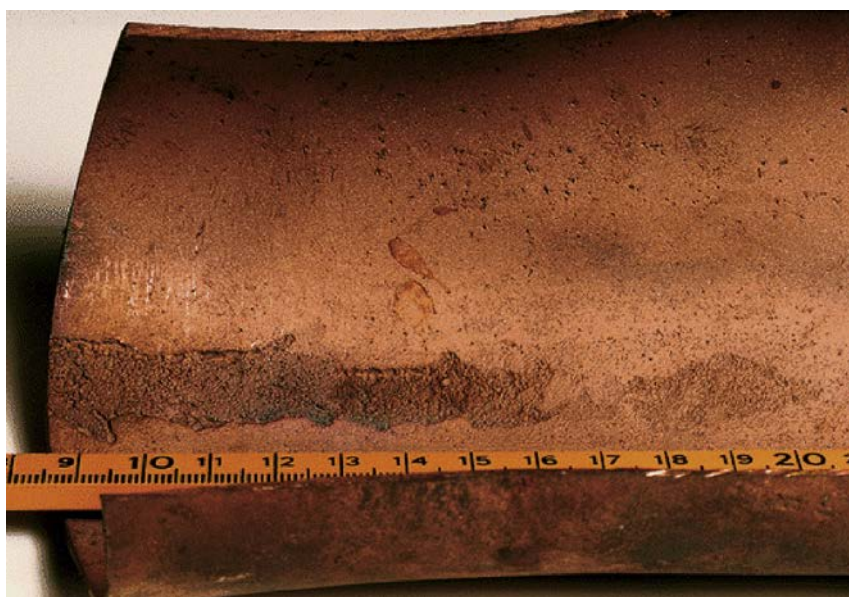
PART Pipe.

PHENOMENON Underdeposit corrosion.

APPEARANCE Local uniform attack at underside of the horizontal pipe (after blasting).

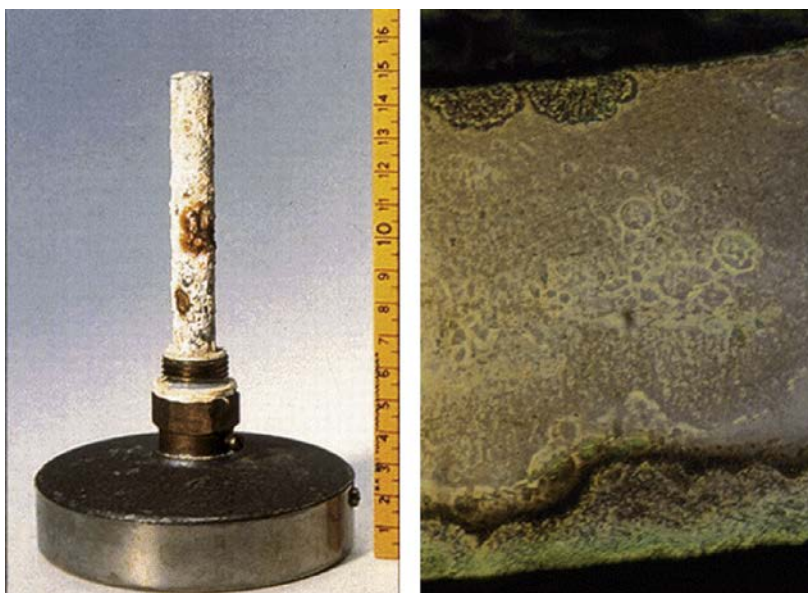
06.05.16.01

MATERIAL	Brass.
SYSTEM	Copper-lined hot water storage boiler with copper tubes.
PART	Thermometer bulb.
PHENOMENON	Selective leaching (plug-type dezincification).

APPEARANCE	Pitting underneath white deposition.
TIME IN SERVICE	Unknown.
ENVIRONMENT	Hot tap water, 60°C, with hardness sediment.
CAUSE	Dezincification of the brass occurs underneath the formed deposit and is additionally promoted by the potential difference between copper and brass (see also the next three cases).
REMEDY	Use of copper bulb.

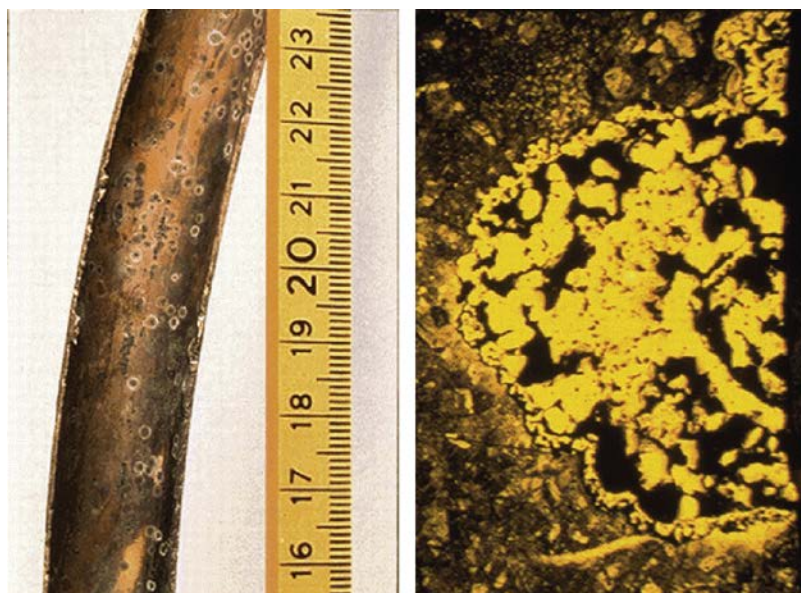
Selective leaching (plug-type dezincification).

Pitting attack.
