Corrosion Atlas

THIRD, EXPANDED AND REVISED EDITION

A Collection of Illustrated Case Histories

Evert D.D. During

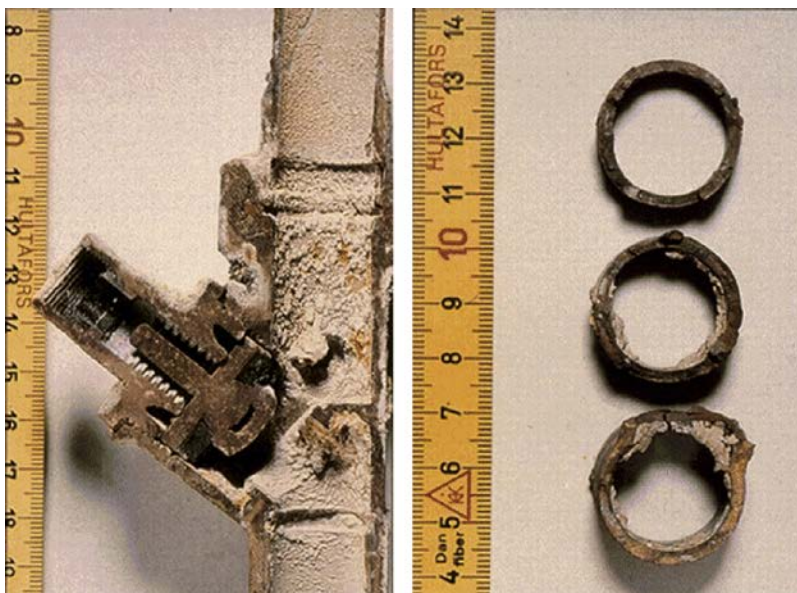
06.05.16.03

MATERIAL	Brass.
SYSTEM	Hot tap water system.
PART	Valve and pipe sections.
PHENOMENON	Selective leaching (plug-type dezincification).

APPEARANCE	Severe contamination with a white deposit, underneath which the brass was locally red-colored and brittle.
TIME IN SERVICE	Unknown.
ENVIRONMENT	Hot water, 70 °C; pH 7.6; bicarbonate (HCO_3^-) 1.8 mEq/l (90 ppm CaCO_3); aluminum (Al^{3+}) 2.0 ppm; deposit 90% $\text{Al}(\text{OH})_3$.
CAUSE	As a result of deposition of aluminum hydroxide (originating from the cathodic protection present in the boilers owing to aluminum anodes with impressed DC current), severe dezincification of the brass occurred (see also Case History 06.04.16.02).
REMEDY	Cleaning of the system and performing the cathodic protection with inert anodes (e.g., platinum-coated titanium anodes), not only to prevent dezincification of the brass fittings but also to prevent blockage of the pipe system and, from the health point of view, intolerable contamination of the water with aluminum.

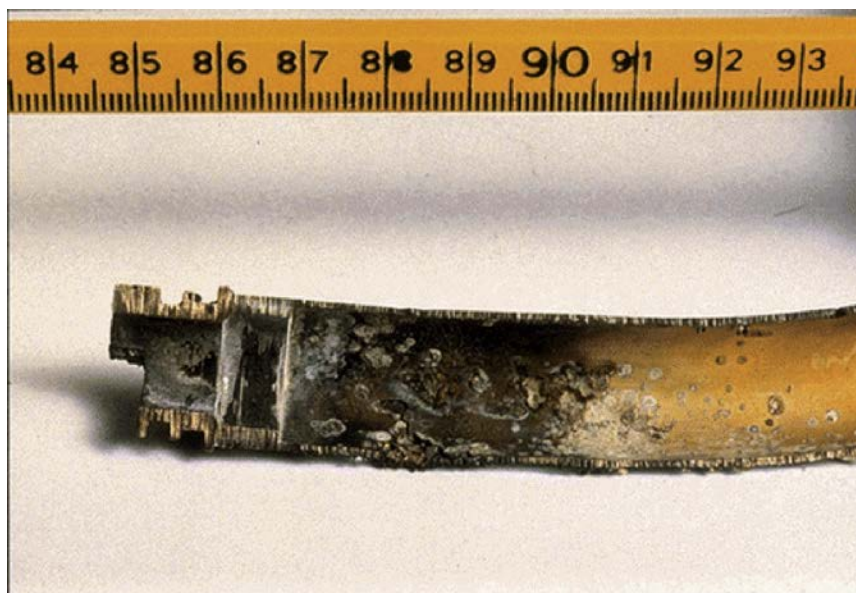
Selective leaching (plug-type dezincification).

Local pitting attack.

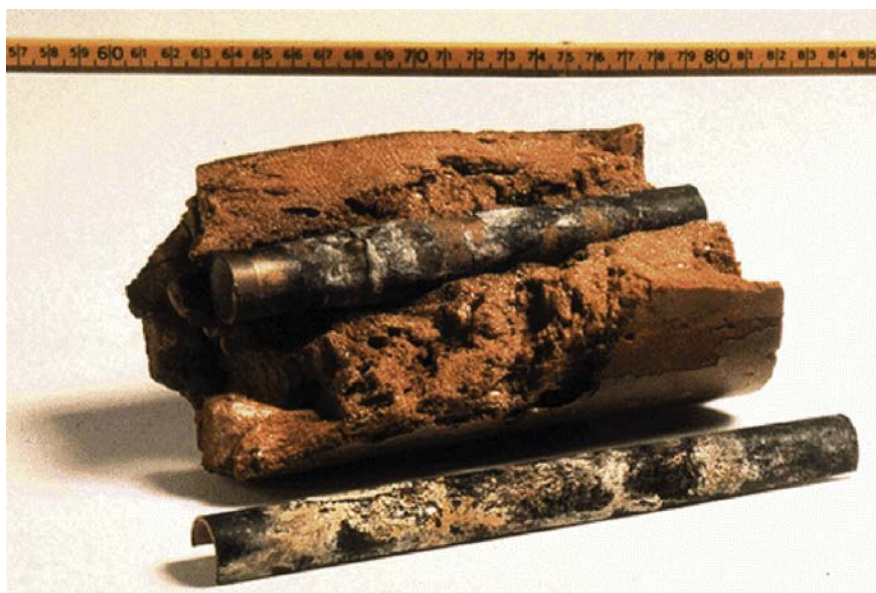
06.05.25.01

MATERIAL	Copper.
SYSTEM	Hot tap water system.
PART	Underground pipe section.
PHENOMENON	Corrosion under insulation.

APPEARANCE	Severe local attack to the point of leakage.
TIME IN SERVICE	12 years.
ENVIRONMENT	Wet polyurethane (PUR) foam insulation (pipe lay above the groundwater level).

CAUSE The insulation became wet as a result of leakage, through a fractured soldered connection; at the prevailing temperature of 80 °C, the fire-retardant substance trichloroethyl phosphate present in the insulation thereby decomposed into phosphoric acid and hydrochloric acid, which attacked the copper pipe.

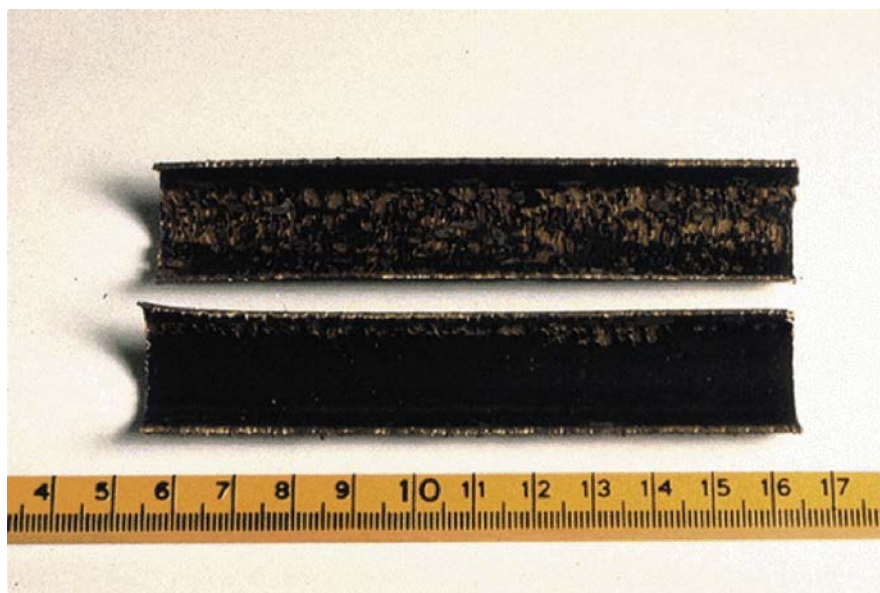
06.05.32.01

MATERIAL	Copper.
SYSTEM	Hot tap water system.
PART	Pipe section downstream from air vent.
PHENOMENON	Erosion.

APPEARANCE	Material locally worn away over approximately $1\frac{1}{2}$ m.
------------	---

CAUSE	Partial blockage of the boiler due to hardness deposition caused under pressure in the system; this caused aeration by the air vent; the air bubbles sucked in causing local erosion (see also Case History 06.05.34.02).
-------	---

REMEDY	<ul style="list-style-type: none"> • Replacement of the attacked pipe section. • Cleaning the boiler and avoiding future hardness deposition by partial softening of the water. • Maintain constantly sufficient pressure in the whole system.
--------	---

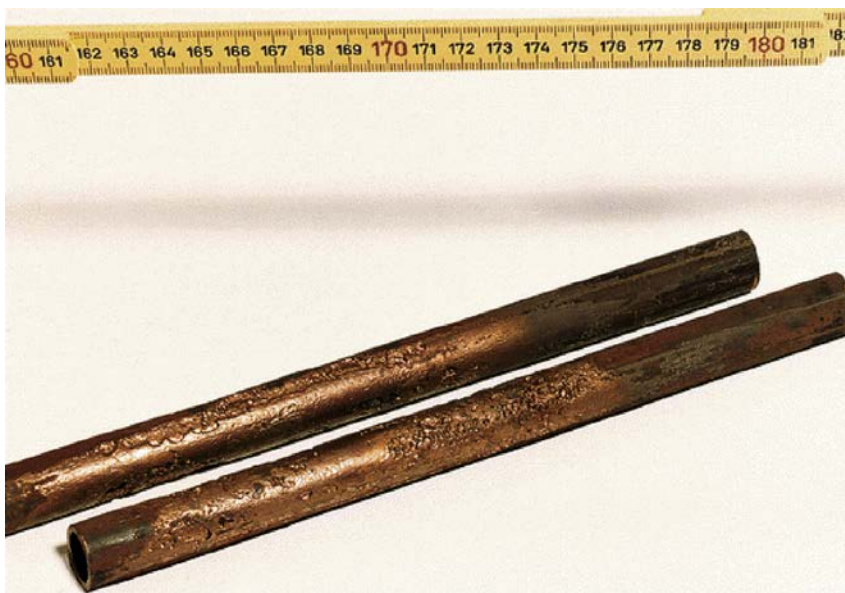
06.05.32.02

MATERIAL	Copper.
SYSTEM	Hot tap water system.
PART	Heat exchanger tube sections.
PHENOMENON	Erosion (impingement attack).

APPEARANCE	Eroded surface.
TIME IN SERVICE	15 years.
ENVIRONMENT	Steam through the tubes; softened tap water (oxygen-rich) around the tubes; temperature 32–55 °C; flow velocity 2 m/s.
CAUSE	The water inlet was set at 90° relative to the tubes, thereby causing impingement.
REMEDY	<ul style="list-style-type: none"> • Enlarge inflow orifice from 4" to 6" to reduce inflow velocity. • Alternative: fit an antisplash plate underneath the inflow orifice.

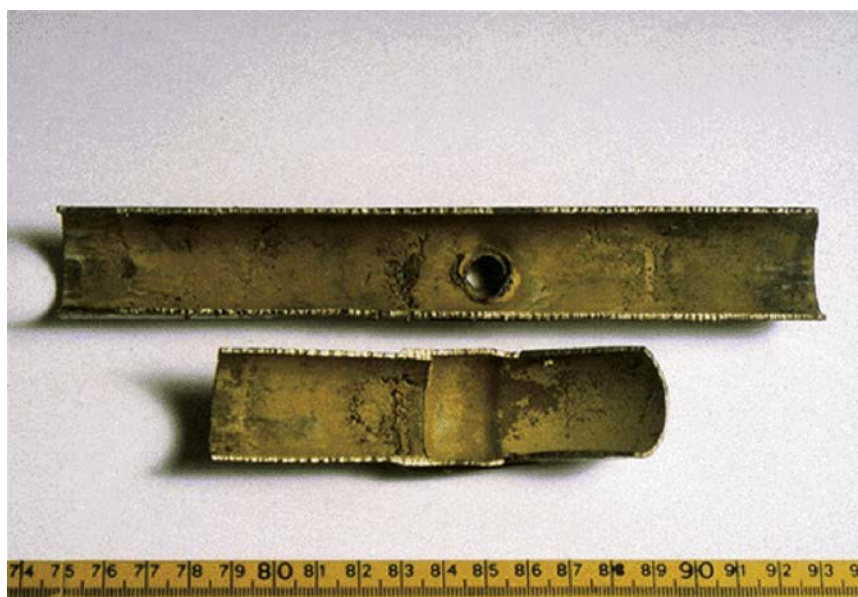
06.05.33.01

MATERIAL	Copper.
SYSTEM	Hot tap water system.
PART	Pipe section.
PHENOMENON	Cavitation erosion.

APPEARANCE Local attack downstream of irregularities.

CAUSE Eddies owing to irregularities in pipes at connections.

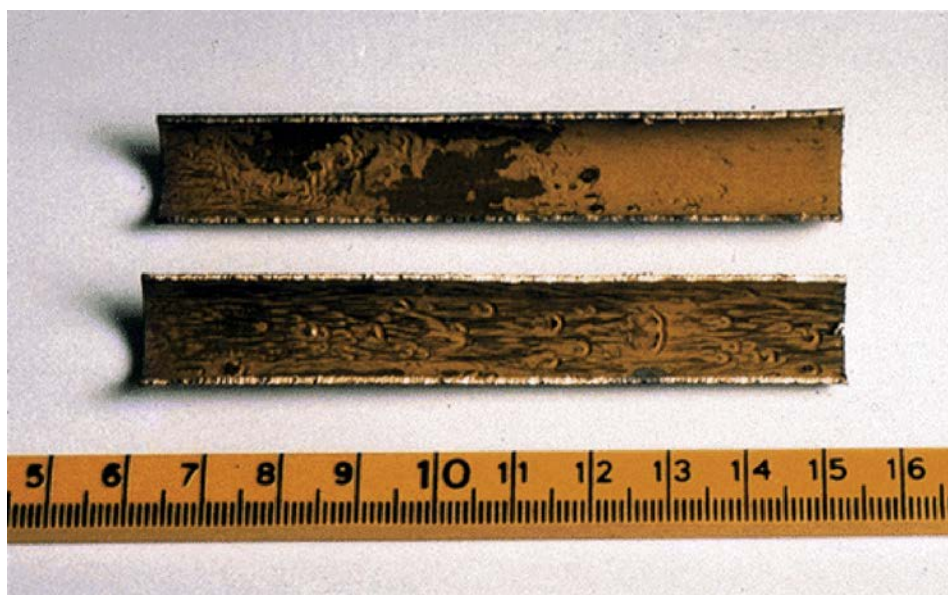
06.05.34.01

MATERIAL	Copper.
SYSTEM	Hot tap water system.
PART	Pipe section.
PHENOMENON	Erosion corrosion.

APPEARANCE Attack in a distinct flow pattern (horseshoe attack).

CAUSE Erosion corrosion resulting from excessively high water velocity (see also Case Histories 06.06.34.01/03).

- Replace the pipes by larger-diameter copper pipe, thereby reducing the velocity to ≤ 0.8 m/s, or alternatively
- Construct them of stainless steel.

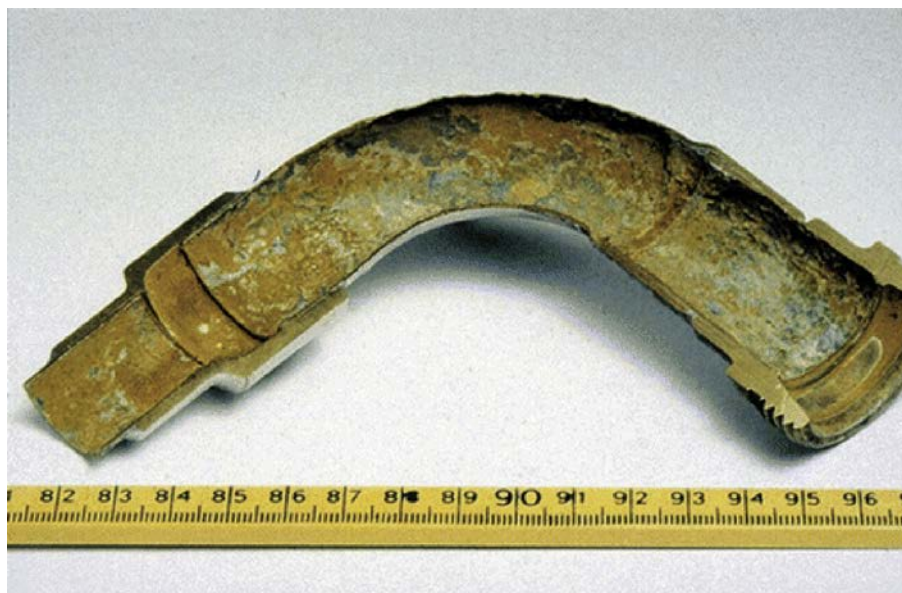
PART Bend section.

PHENOMENON Erosion corrosion.

APPEARANCE Severe internal eroded, particularly at the outside of the bend.

CAUSE The presence of many air bubbles in the water ("white" water), originating from the pressurized aeration at the iron-removing filters (see also Case History 06.05.32.01).

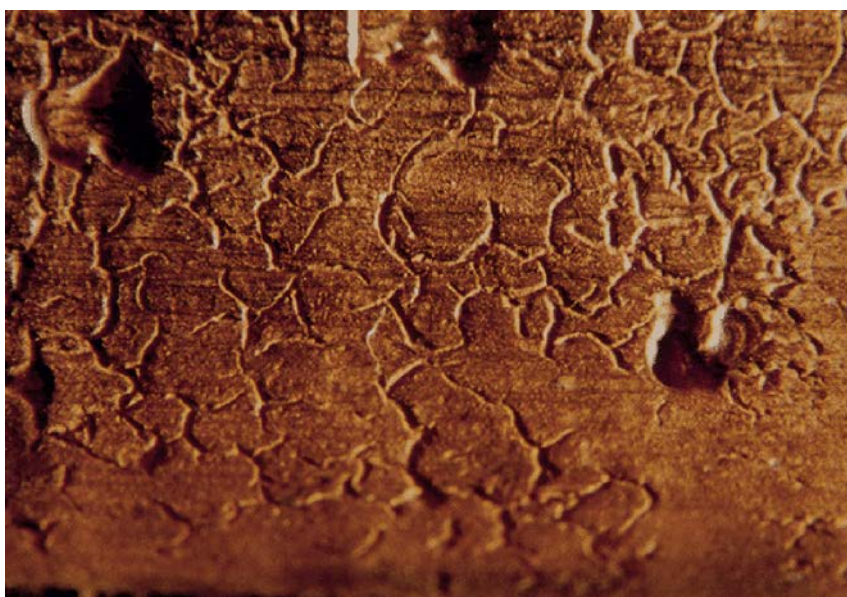
PART Condenser tube from main condenser.

PHENOMENON Acid corrosion.

APPEARANCE Network of shallow ditches.

CAUSE Condensation of acidic fluids during acid cleaning. The acid was used to remove calcium carbonate deposits. The resultant foaming prevented complete filling of the topmost tube and allowed dropwise condensation of acids on horizontal surfaces; topmost tubes were not cleaned at all. This indicates lack of experience by the cleaning firm (see also next case and the Case Histories 01.01.04.01/04).

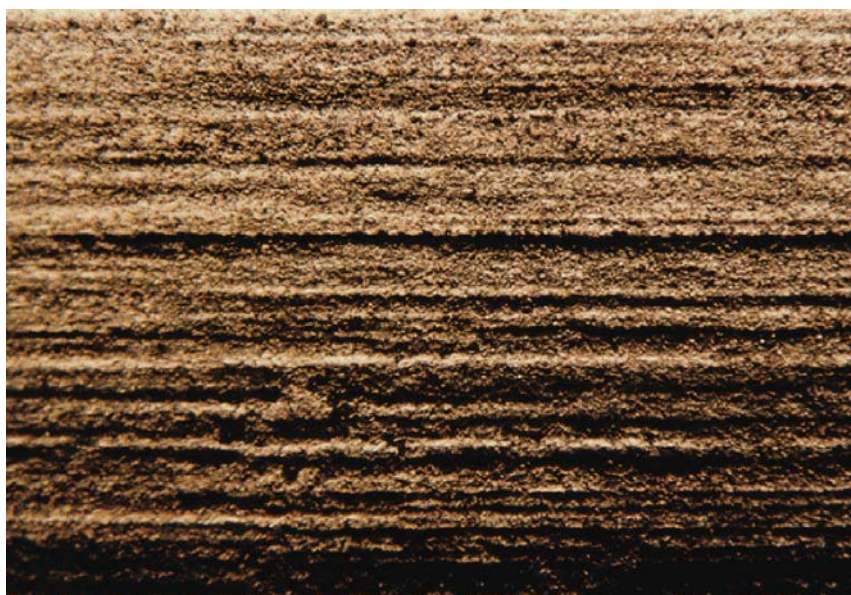
PART Condenser tube.

PHENOMENON Acid corrosion.

APPEARANCE Striations on the internal surface (magnification $\times 15$).

CAUSE Excessive exposure time and high residual stresses. Frequently, deposits are nonuniform. This necessitates excessive cleaning time in order to remove all deposits. Hence, lightly deposited surfaces are exposed to acid for longer periods than are heavily deposited surfaces.

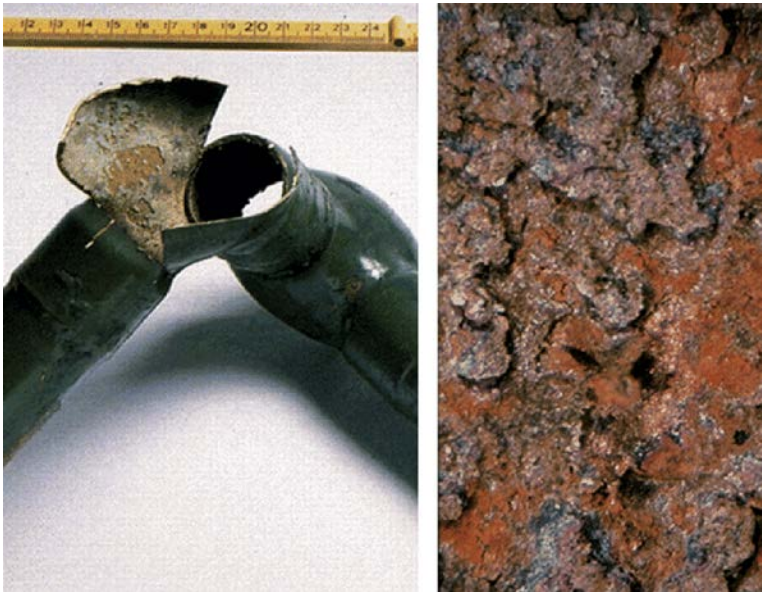
06.06.11.01

MATERIAL	Copper.
SYSTEM	Once-through compressor cooling system.
PART	Pipe section.
PHENOMENON	Corrosion caused by solder.

APPEARANCE	Local attack at the solder joints.
TIME IN SERVICE	1 year.
ENVIRONMENT	Oxygen-containing well water.
CAUSE	In view of the bowl-shaped appearance of the corrosion and the site of the attack (near the solder joints), the presumable cause is corrosion resulting from the use of an incorrect or excessive solder, i.e., a case of poor workmanship (see also Case History 06.15.11.01).
REMEDY	<ul style="list-style-type: none"> • Replacement of the copper cooling water pipes by plastic pipes was found to be the cheapest solution in this case. • Copper pipes have to be soldered by means of noncorrosive solder.

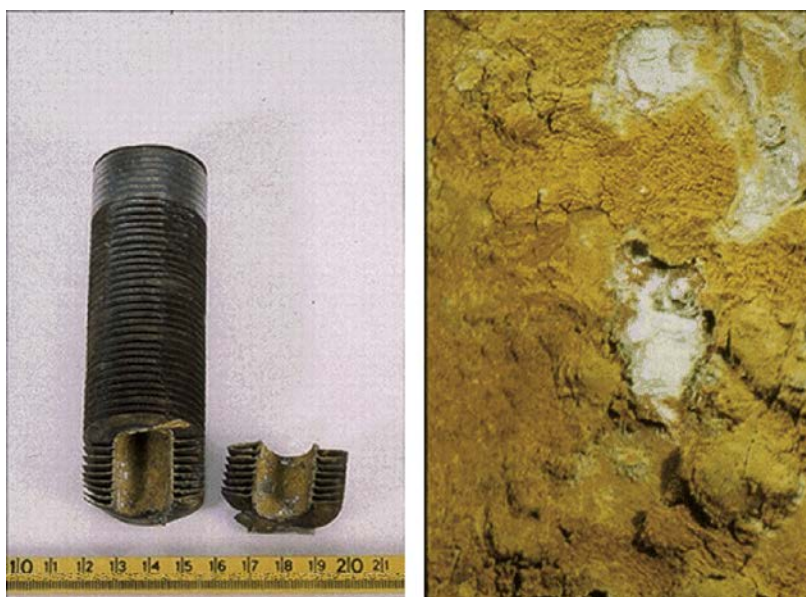
06.06.15.01

MATERIAL	Copper.
SYSTEM	Once-through cooling water system.
PART	Oil cooler tube.
PHENOMENON	Underdeposit corrosion.

APPEARANCE	Pitting attack.
TIME IN SERVICE	Unknown.
ENVIRONMENT	Softened oxygen-containing water (not corrosive to copper).

CAUSE Deposition of iron oxide originating from corrosion of untreated steel transport pipelines (underneath the iron oxide deposit, the copper surface will become anodic) (see also Case History [06.05.15.01](#)).

REMEDY Use of polymer transport pipelines, also to prevent corrosion of the pipelines themselves.

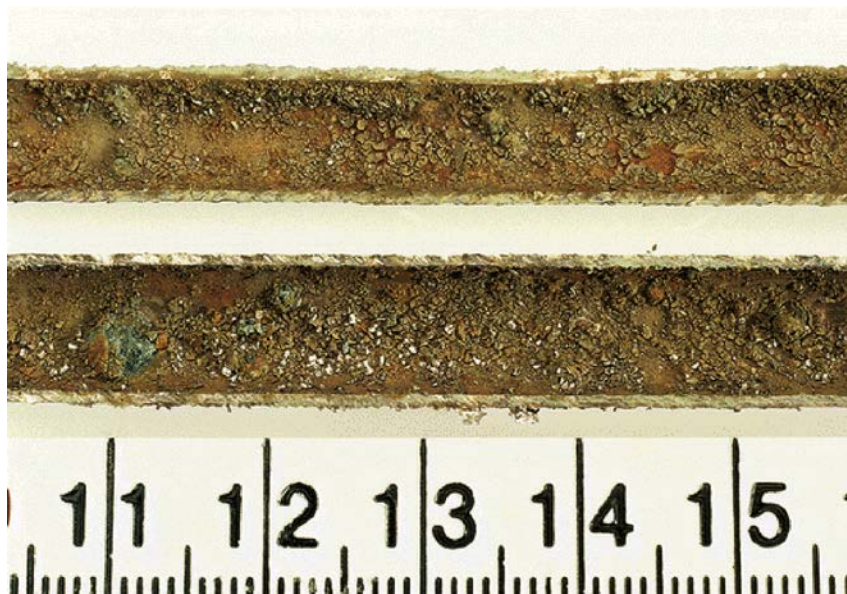
PART Oil cooler pipes.

PHENOMENON Underdeposit corrosion.

APPEARANCE Pitting corrosion to the point of leakage underneath a brownish-green sludge layer (the glittering particles are copper, resulting from sawing-through of the pipe).

CAUSE Due to too low a flow velocity, sand particles entrained with the river water deposited in the pipes, causing aeration cells to form; leading to pitting attack.

REMEDY In view of the presence of sand particles, increasing the flow velocity would probably lead to erosion corrosion. Possible options are:

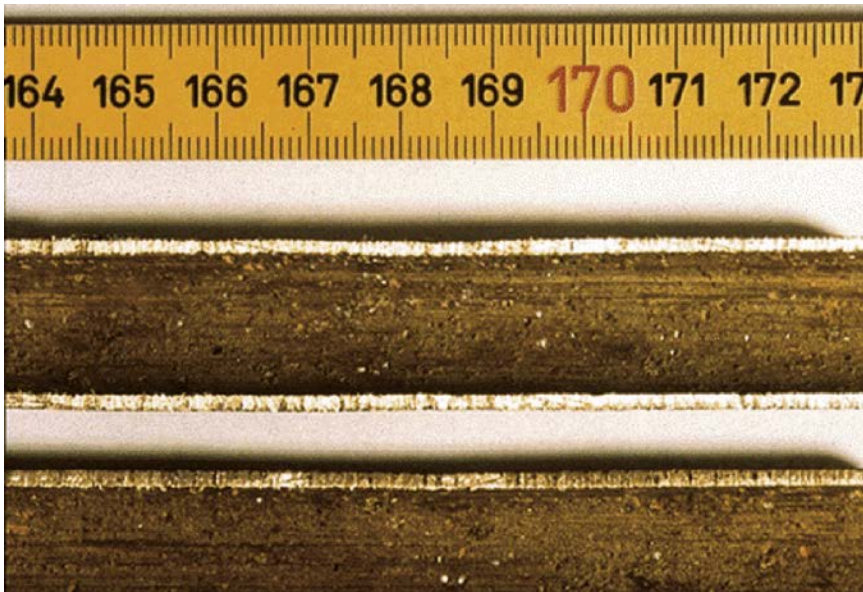
06.06.16.01

MATERIAL	Brass.
SYSTEM	150-kV plant transformer cooler.
PART	Cooling pipe.
PHENOMENON	Selective leaching (plug-type dezincification).

APPEARANCE	Pitting attack, with red copper spots.
TIME IN SERVICE	Half a year.
ENVIRONMENT	Brackish water, stagnant.
CAUSE	The formation of deposits in the stagnant water caused dezincification to take place, accelerated by the high salt content of the cooling water.
REMEDY	<ul style="list-style-type: none"> • When the cooler is shut down, it should first be purged with mains water and then put away dry; • Or allow the brackish cooling water to circulate normally (in the aerated state).

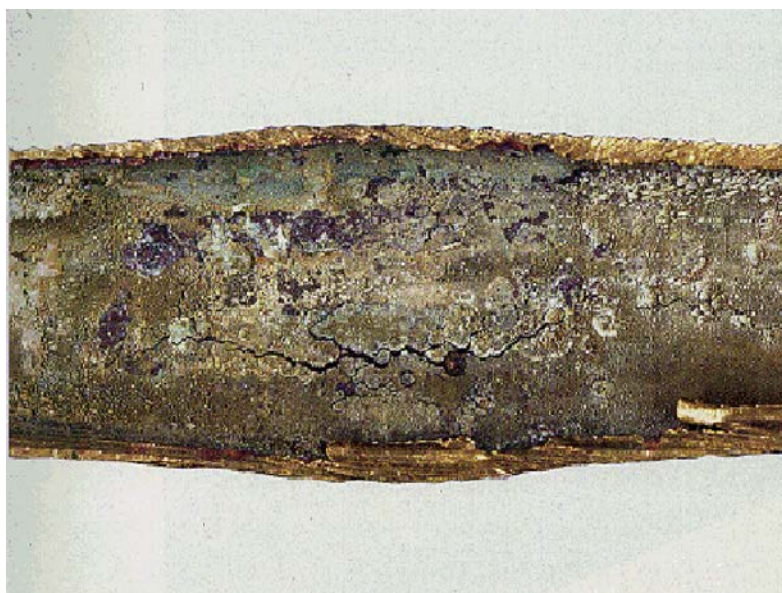
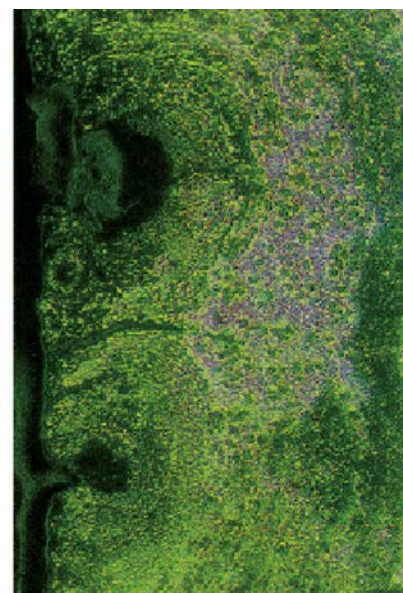
06.06.16.02

MATERIAL	Brass.
SYSTEM	Circulating cooling water system.
PART	Pipe.
PHENOMENON	Selective leaching (plug-type dezincification).

APPEARANCE	Pitting attack with red spots.
TIME IN SERVICE	Unknown.
ENVIRONMENT	Cooling water dosed with sodium hypochlorite to control bacterial growth.
CAUSE	Excessively high pH (>9) caused by uncontrolled dosing of sodium hypochlorite.
REMEDY	<ul style="list-style-type: none"> • Improved monitoring of sodium hypochlorite dosing, or • Use of an organic bactericide.

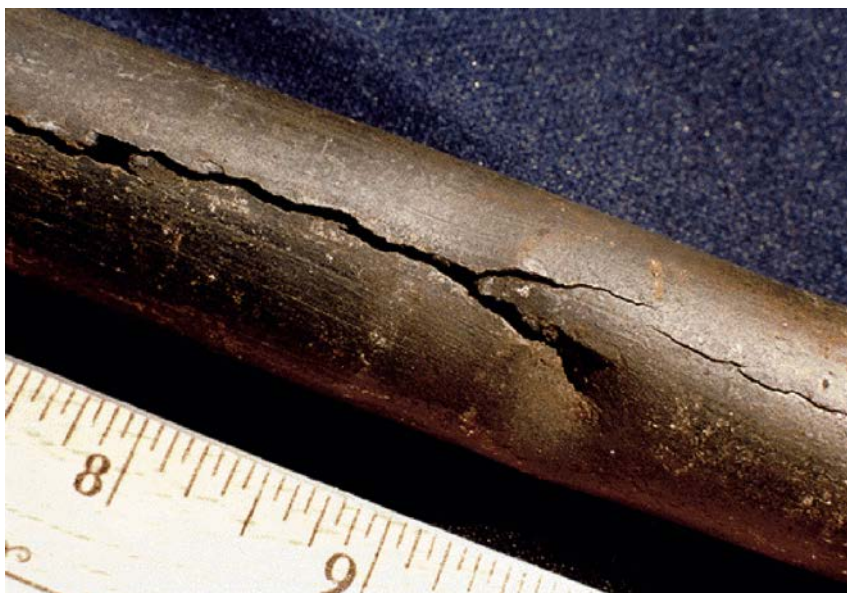
06.06.17.01

MATERIAL	Admiralty brass.
SYSTEM	Once-through cooling-water system.
PART	Horizontal condenser tube (OD 2.5 cm).
PHENOMENON	Microbiologically influenced corrosion (ammonia attack).

APPEARANCE	Longitudinal branched cracks, thick-walled.
TIME IN SERVICE	7 years.
ENVIRONMENT	Cooling water. Temperature: inlet $\approx 21^{\circ}\text{C}$, outlet $\approx 26^{\circ}\text{C}$; pH=7.4–8.3.
CAUSE	Decomposition of dead organisms at the bottom of the tube generated ammonia locally, high enough to produce stress-corrosion cracking of the brass condenser tubes. The tubes contained considerable residual hoop stress (see also Case Histories 06.06.18.01, 06.15.18.01, and 06.25.18.01).
REMEDY	Avoid low flow and dose biocides.

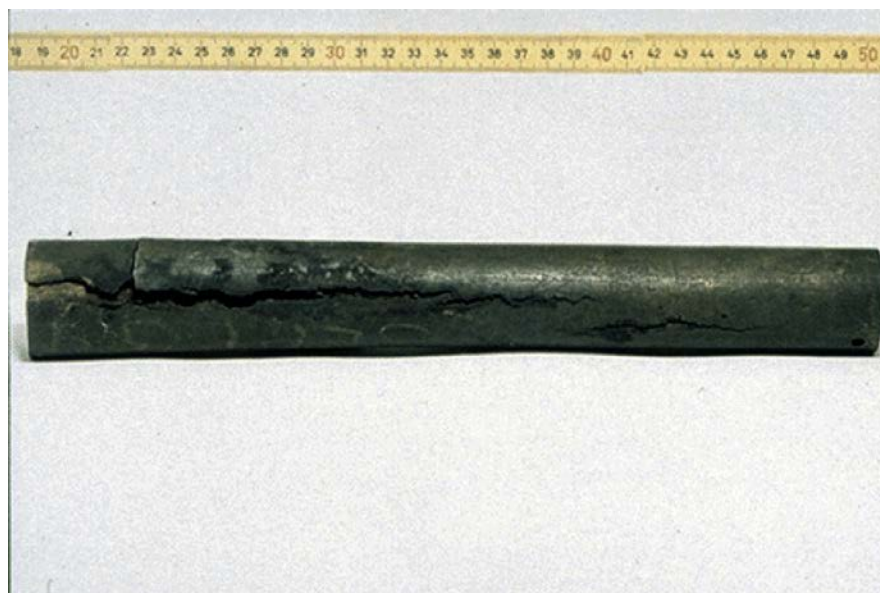
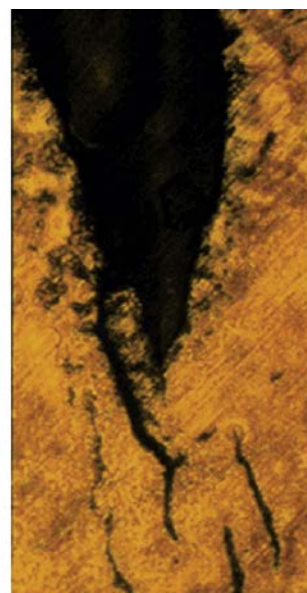
06.06.18.01

MATERIAL	Aluminum brass (76-22-2 + As).
SYSTEM	Circulating cooling water system with cooling tower.
PART	Outer jacket around unalloyed steel cooling pipe in cooling tower (see also Case History 01.11.20.01).
PHENOMENON	Stress-corrosion cracking (transgranular).

APPEARANCE	Cracks.
TIME IN SERVICE	A couple of months.
ENVIRONMENT	Around the pipe: chloride-containing cooling water temporarily contaminated with ammonia owing to leakage.
CAUSE	In combination with stresses in the brass, ammonia attack causes stress-corrosion cracking (also called: season cracking) (see also Case Histories 06.15.18.01 and 06.25.18.01).
REMEDY	<ul style="list-style-type: none"> • Leakage of ammonia should be prevented, or • Use an ammonia-resistant material.

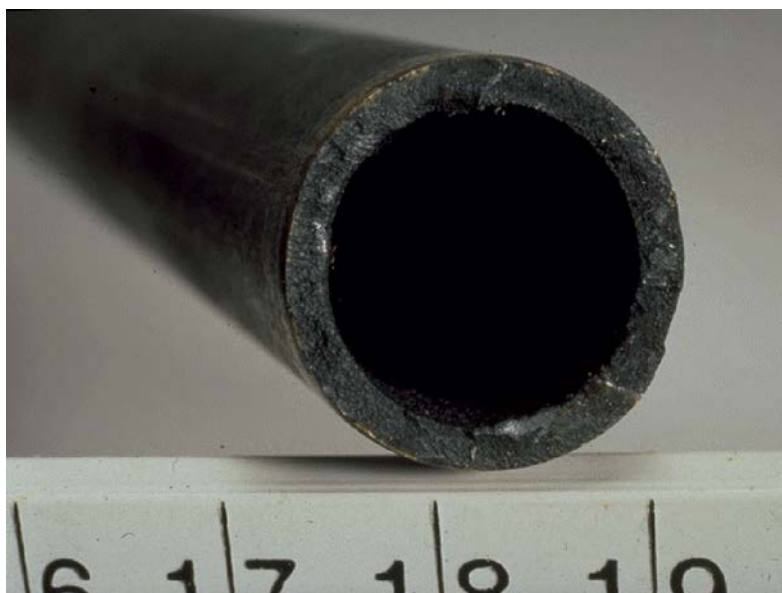
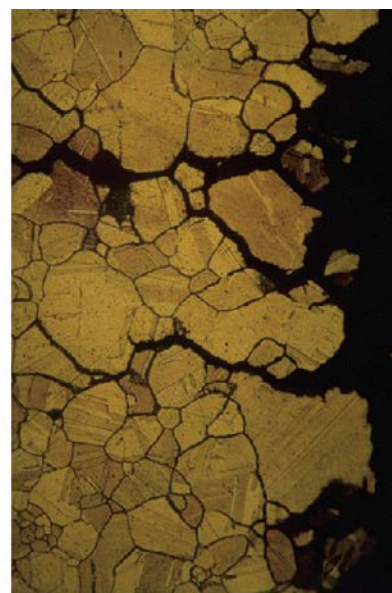
06.06.18.02

MATERIAL	Aluminum brass (ASTM B 111; CDA 687; UNS C 68700). Composition: Cu 76–79%, Al 1.8–2.5%, Zn remainder, As traces).
SYSTEM	Once-through cooling system.
PART	Fuel oil cooler pipes.
PHENOMENON	Stress-corrosion cracking (intergranular).

APPEARANCE	Cracking, with pipe fractured on the left and intergranular attack on the right.
TIME IN SERVICE	About 20 years.
ENVIRONMENT	Internally, brackish cooling water conductivity 463 mS/m; pH 7.8; total hardness 13 mEq/l (650 ppm CaCO ₃); chloride 1460 ppm; sulfate 235 ppm; ammonium 0.1 ppm. Externally, fuel oil: water <0.05%; sulfur 5.3%; acid number 0.50; total N 1000 ppm.
CAUSE	The aluminum brass showed a phosphorus content of 0.064% at an arsenic content of 0.018%. This rendered it sensitive to intergranular attack in the brackish cooling water, leading to stress corrosion. Transgranular stress corrosion due to ammonium could not be demonstrated and was also less probable in the present environment.
REMEDY	Construct the pipes of the heat exchanger of cupronickel 30 (CuNi 30 Fe, W.-Nr. 2.0882, UNS C 71500) with the average composition of Cu 69.5, Ni 30.0, and Fe 0.5. This material possesses good resistance to both stress corrosion and intergranular attack.

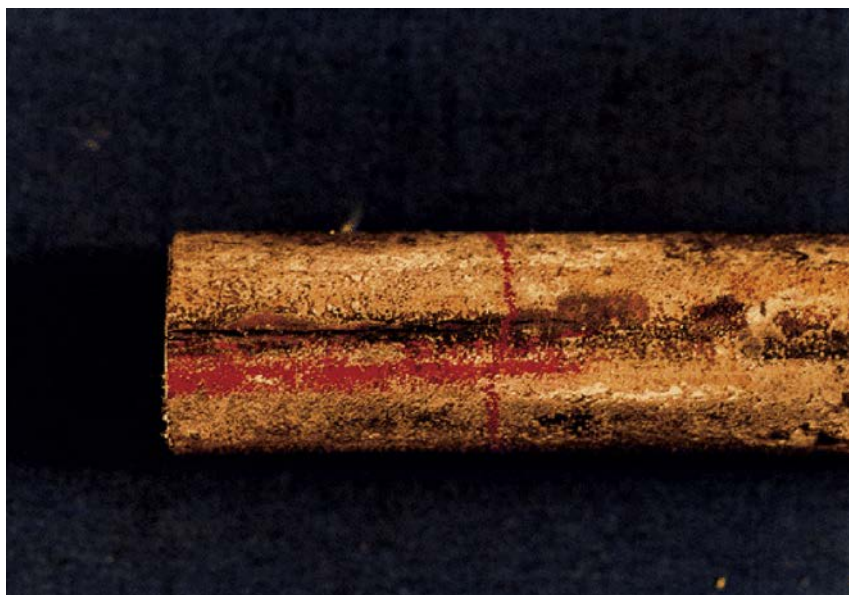
Corrosion fatigue.

Longitudinal crack, originating on the external surface.

Microstructural examinations revealed intergranular, low-branched cracks. The longitudinal orientation of the cracks revealed that the cyclic stresses were induced by fluctuations in internal pressures. (Intergranular corrosion-fatigue cracks in copper may be difficult to differentiate from stress-corrosion cracking.)

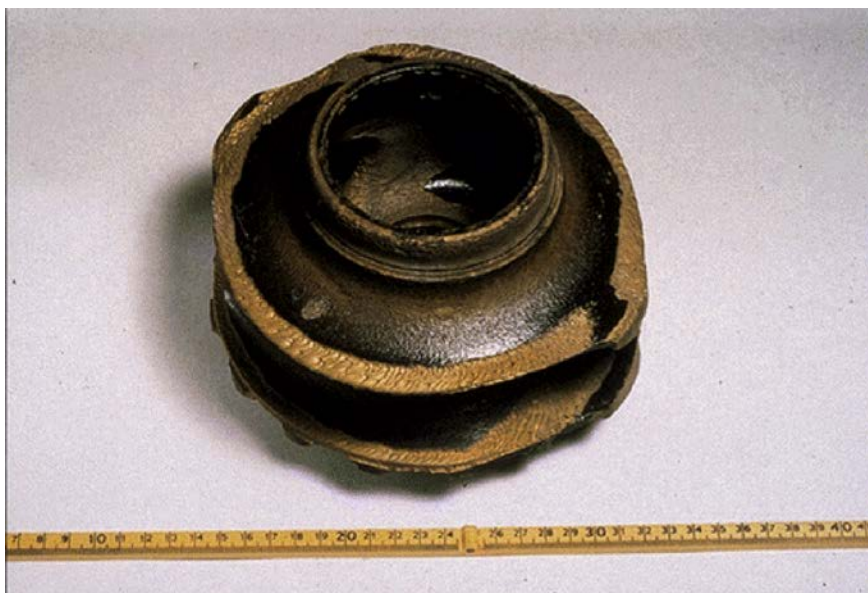
PART Pump impeller.

PHENOMENON Erosion.

APPEARANCE Bronze locally worn away.

CAUSE Discontinuation of the protective effect of the ferrosulfate dosing, allowing erosion by the ceramic-coated rubber balls to take place. The ferrosulfate dosing was used to protect the aluminum brass condenser from erosion corrosion. The dosing was stopped after replacement of the condenser by a titanium one. The cleaning installation was kept in operation for cleaning the bundle of contamination.

REMEDY Provide impeller with a wear-resistant coating.

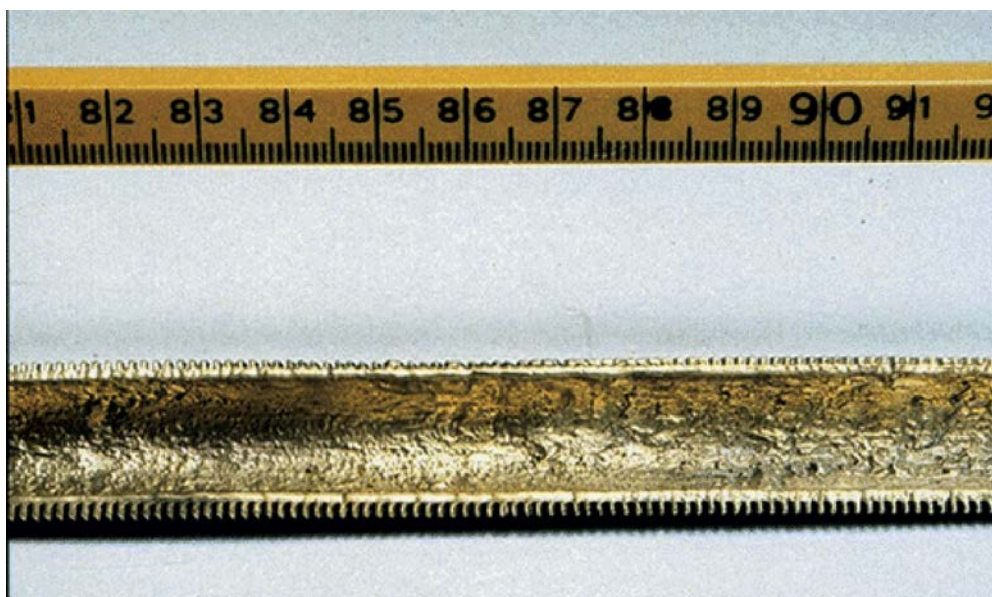
PART Condenser tubes.

PHENOMENON Erosion corrosion.

APPEARANCE Irregular attack over the entire surface, showing a distinct flow pattern.

CAUSE The present velocity is too high for this grade of brass (maximum allowable 1.5 m/s) (see also Case Histories 06.05.34.01 and [06.06.34.03](#)).

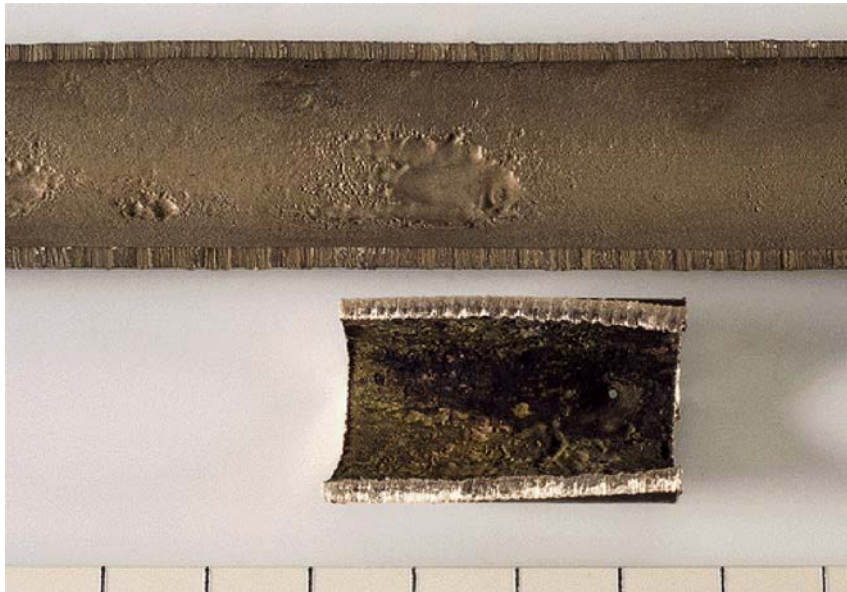
06.06.34.02

MATERIAL	Cupronickel 90/10.
SYSTEM	Once-through cooling-water system.
PART	Exchanger tubes.
PHENOMENON	Erosion corrosion.

APPEARANCE	Some dents. The leakages are located at 350 and 5550 mm from the inlet tube plate. Except for around these holes, the inside surface of the tubes is completely smooth.
------------	---

CAUSE	Maritime obstacles, e.g., a mussel shell clamped in the tube, cause local high seawater velocity. Plastic brush holders installed as a trial in the seawater inlet of the tubes to prevent mussel shells clamping in the tubes, which are too weak. The plastic brush-holders could not dislodge the mussel shells (see also Case History 06.06.34.04).
-------	--

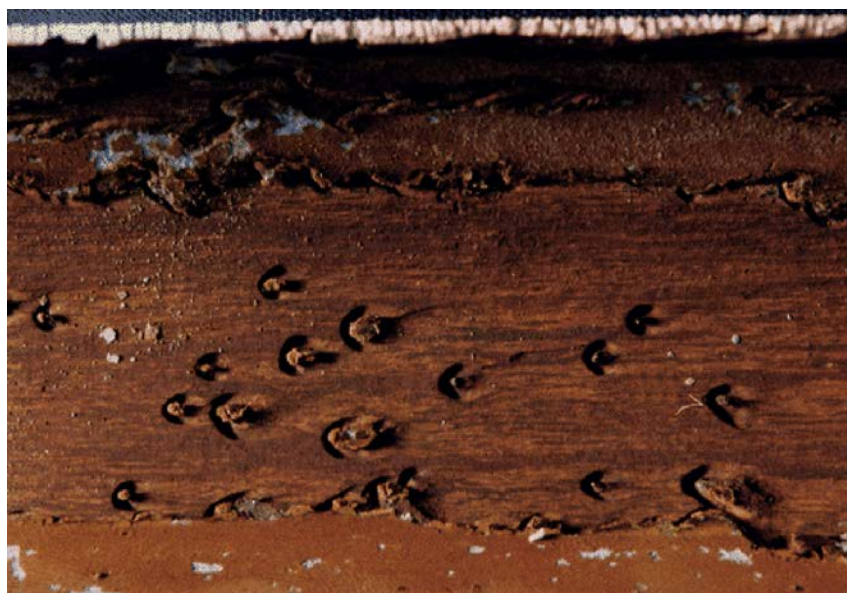
MATERIAL	Admiralty brass.
SYSTEM	Cooling-water system of overhead condenser in a refinery.
PART	Heat-exchanger tube.

PHENOMENON	Erosion corrosion.
------------	--------------------

APPEARANCE	Horseshoe-shaped depressions on the internal surface.
------------	---

CAUSE	Erosion may occur when a rapid or turbulent fluid impinges upon the surface of a susceptible metal. Flow rate through this exchanger was increased in the months prior to failure (see also Case Histories 06.05.34.01 and 06.06.34.01).
-------	---

REMEDY	<ul style="list-style-type: none"> • Diminish coolant flow rate. • Specify a replacement metal having greater resistance to erosion, such as 70/30 cupronickel. • Reduce corrosivity of coolant by increasing the dosage of the inhibitor.
--------	---

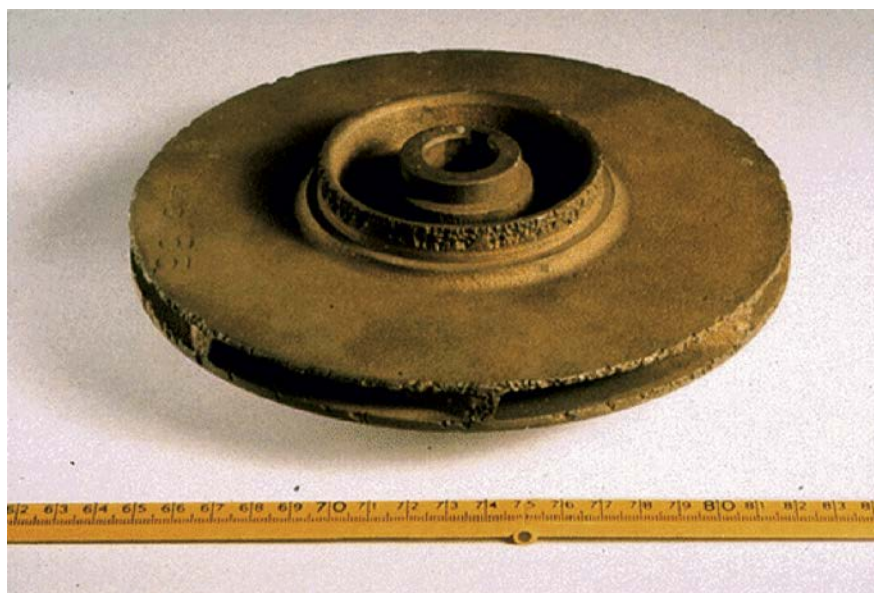
PART Pump impeller.

PHENOMENON Ammonia corrosion.

APPEARANCE Severe local attack.

CAUSE Bronze is not resistant to ammonia; the evaporator leak was caused by corrosion by the brine due to poor maintenance of the inhibitor level (potassium bichromate) because of regular brine loss in the plant (see also Case History 06.01.34.01).

REMEDY Bronze impeller replaced by a cast iron one; subsequently the brine, which caused numerous problems elsewhere as well, was replaced by a glycol-water mixture as cooling liquid.

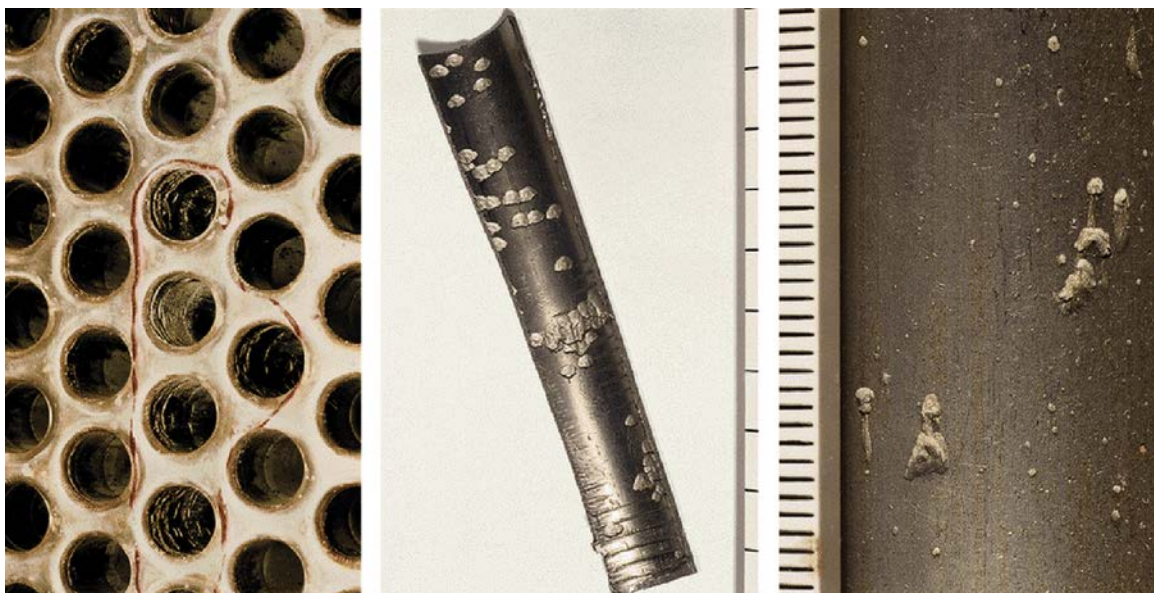
06.07.34.01

MATERIAL	Cunifer 70/30 (Cu Ni 30 Mn 1 Fe).
SYSTEM	Reboiler in the food and beverage industry.
PART	Tube of shell-and-tube heat exchanger ($\text{\O} 32 \times 1.65 \text{ mm}$).
PHENOMENON	Erosion corrosion.

APPEARANCE	Left photograph: tubes located in tube plate; middle photograph: the inner surface of a tube; right photograph: detail of the corrosion, attack horseshoe-shaped.
------------	---

CAUSE	After replacement of the previous boiler, which had been used for more than 15 years, the temperature was slightly raised to enhance process efficiency. As the boiling now started in the reboiler, previously in the evaporator, the velocity increased dramatically.
-------	---

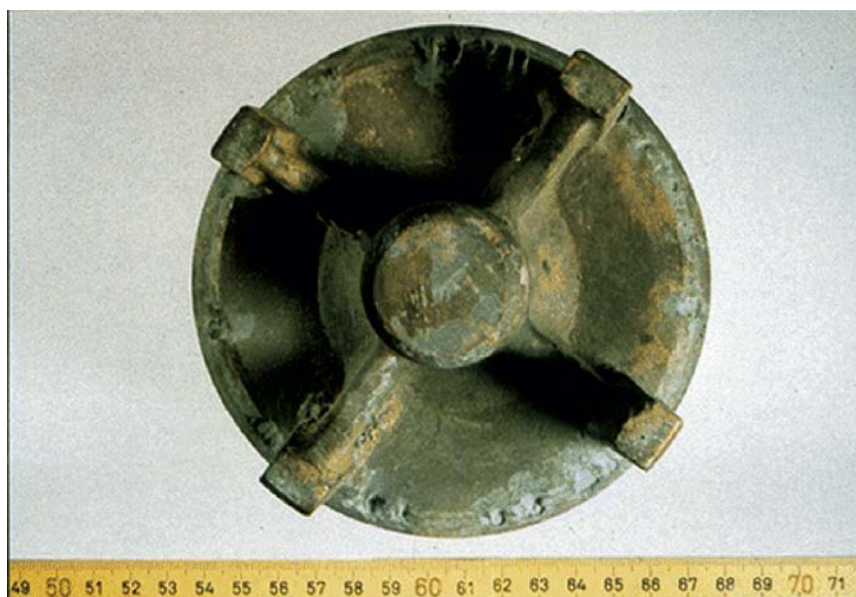
PART Delivery valve.

PHENOMENON Erosion corrosion.

APPEARANCE Material locally worn away at sealing edge.

CAUSE The delivery valve, sealing at the system pressure of 8 atm, failed to seal sufficiently because of the bronze-to-bronze contact. This, combined with the corrosive quality of the water, led to local erosion corrosion on leakage.

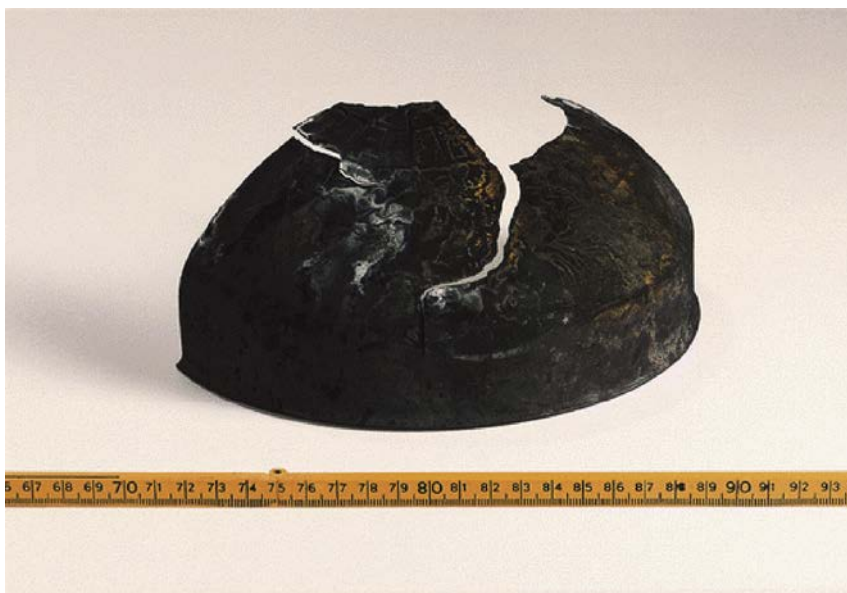
PART Float ball.

PHENOMENON Caustic attack.

APPEARANCE Uniform severe wall thickness reduction. Covered with a black copper oxide layer (CuO).

CAUSE Normally copper is not attacked by concentrated sodium hydroxide. Presumably, this case involved hypochlorite-contaminated sodium hydroxide solution, as produced by the diaphragm process.

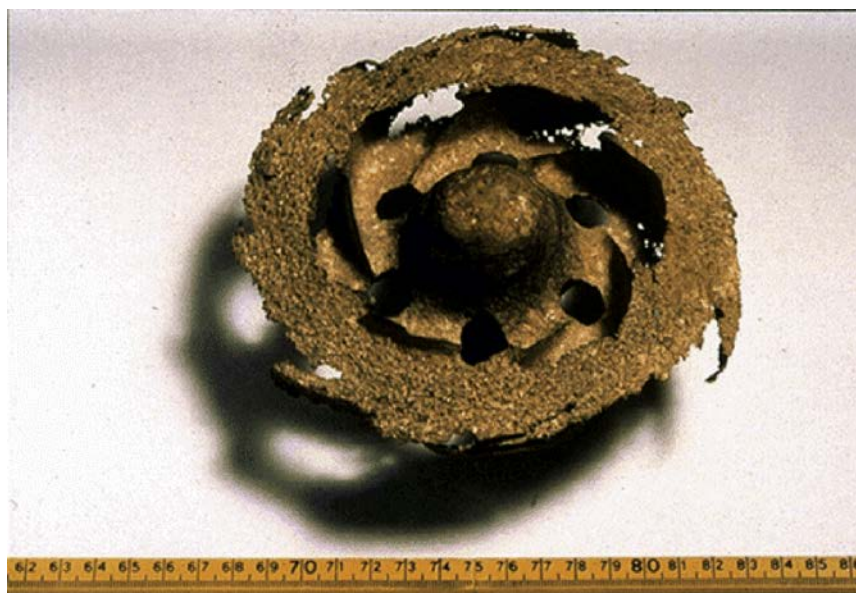
06.11.04.01

MATERIAL	Bronze.
SYSTEM	Pump forming part of a cleaning system.
PART	Pump impeller.
PHENOMENON	Acid corrosion.

APPEARANCE Severe uniform attack, material largely disappeared.

CAUSE Bronze is not resistant to sulfamic acid; previously another chemical was used for cleaning purposes and when the use of sulfamic acid had begun, its effect on the bronze impeller was overlooked.

REMEDY Use of an impeller constructed from AISI 316 L stainless steel.

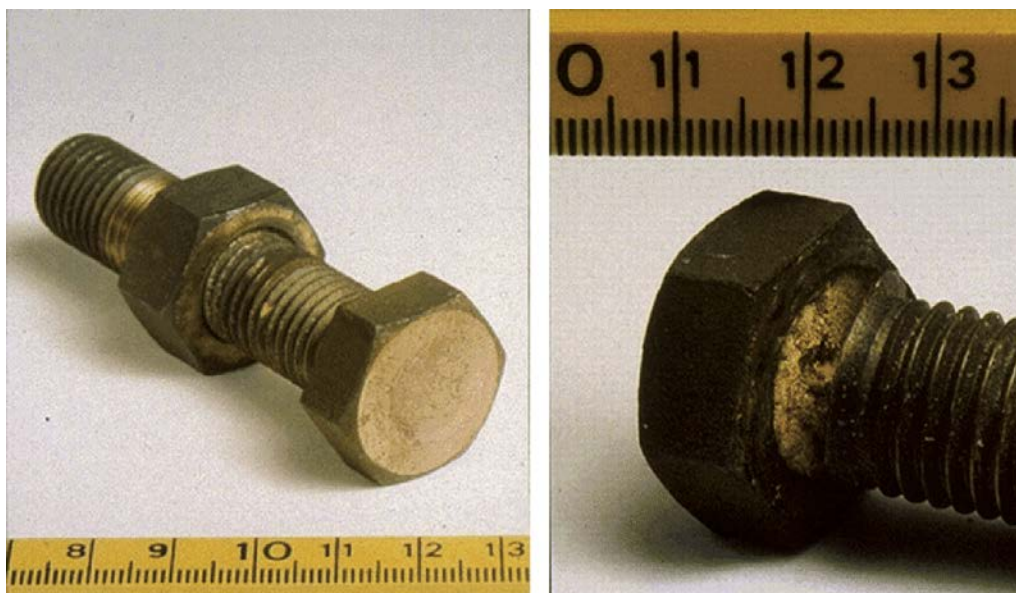
06.11.16.01

MATERIAL	Brass.
SYSTEM	Stainless steel outdoor product tank.
PART	Bolt of a stainless steel flange connection.
PHENOMENON	Selective leaching (plug-type dezincification).

APPEARANCE Red discoloration on bolt head, with fracture underneath the head.

CAUSE Dezincification of the brass caused by potential difference between brass and stainless steel, the remaining copper being responsible for the red discoloration.

REMEDY Use bolts also made from stainless steel.

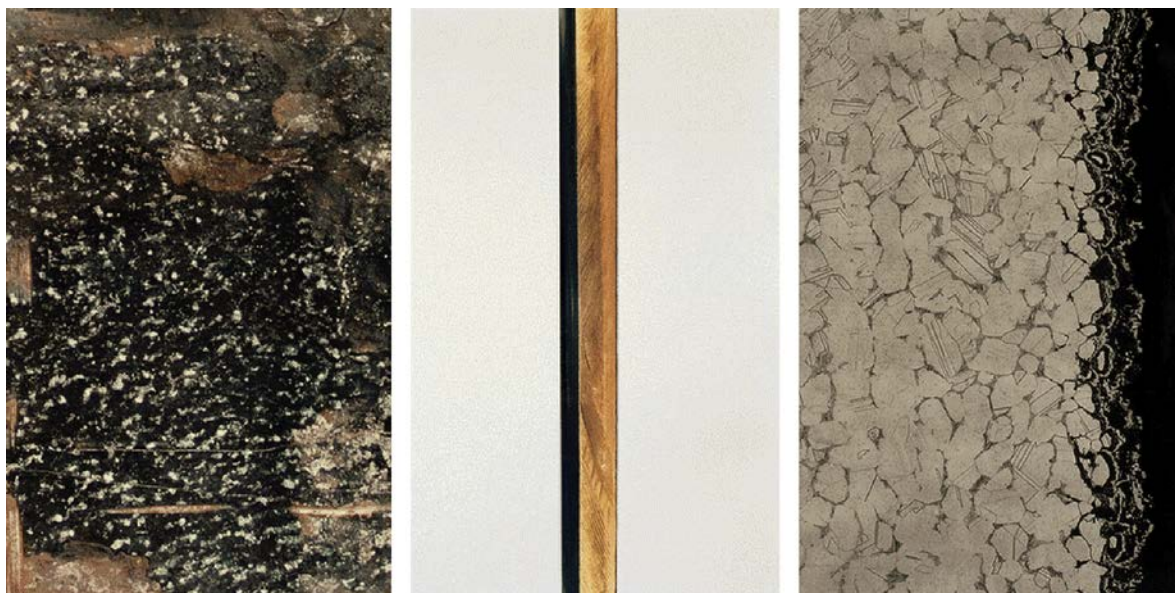
PART Internal reactor.

PHENOMENON Selective leaching (dealuminification).

APPEARANCE Red color of yellow plate at product side. General and intergranular attack α -granules with transformed eutectic β -areas (dark).

CAUSE Aluminum leaches out of the matrix in the presence of 50% H_3PO_4 at 200 °C.

REMEDY Since the dealuminification itself did not cause the failure, no measures have been taken.

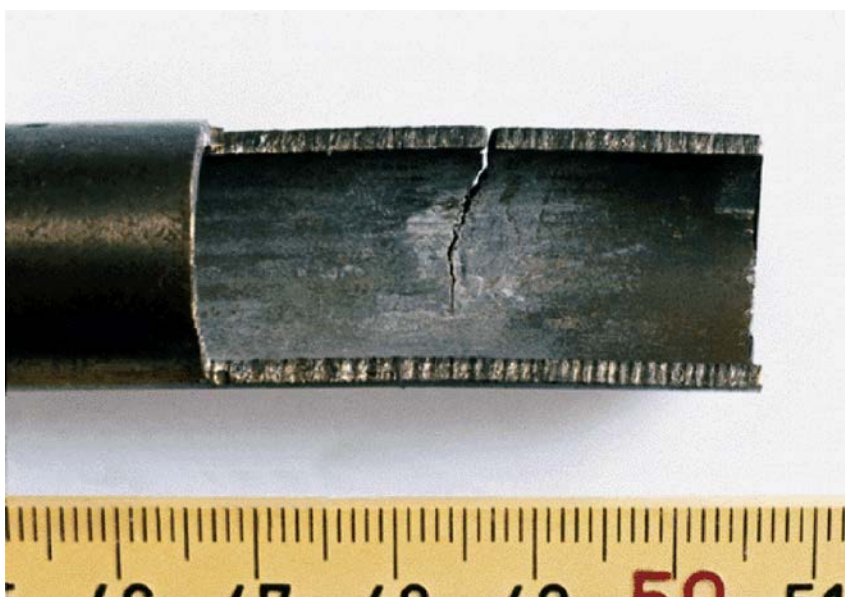
PART Pipe.

PHENOMENON Stress-corrosion cracking (transgranular).

APPEARANCE Transverse cracking.

CAUSE Traces of excess ammonia in the propylene in combination with stresses in the present material cause stress-corrosion cracking (see also Case History 06.06.18.01). Ammonia is added in order to neutralize acid residues in the propylene.

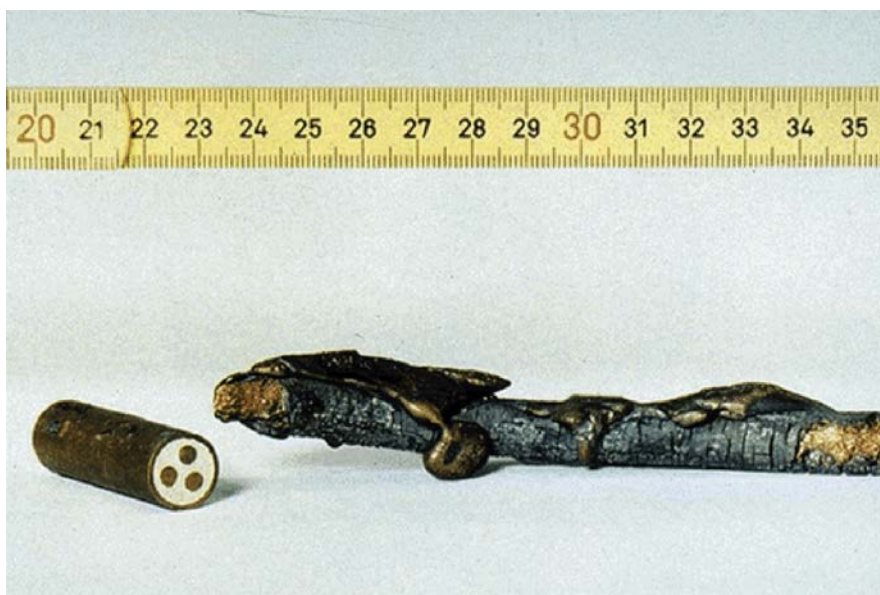
06.11.25.01

MATERIAL	Copper.
SYSTEM	Product transport pipe.
PART	Electric tracing.
PHENOMENON	Corrosion under insulation.

APPEARANCE	Local melting of copper sheathing.
TIME IN SERVICE	15 years.
ENVIRONMENT	Rainwater.
CAUSE	Rainwater penetrated into the insulation and attacked the copper sheathing, causing short-circuiting and the copper to melt.
REMEDY	Water-tight insulation of the system.

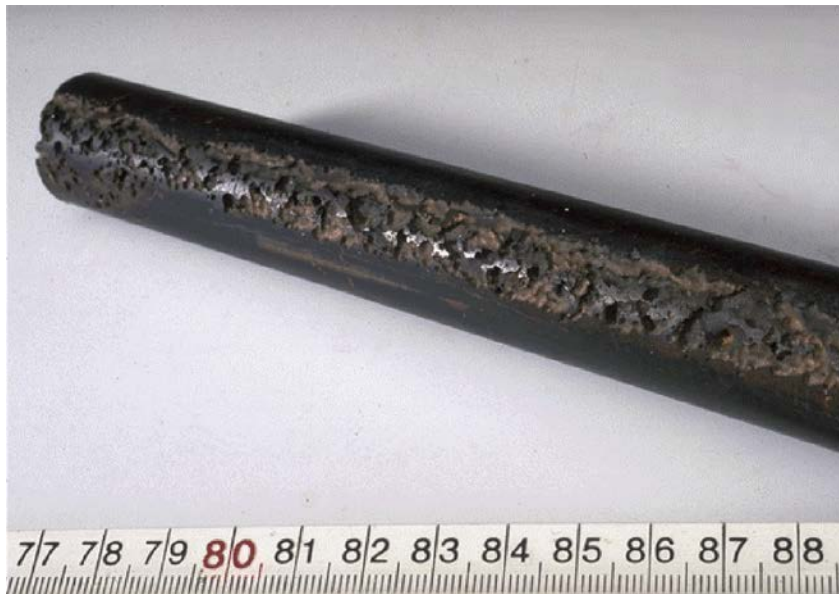
PART Pipe from the heating bundle in the vessel.

PHENOMENON Cavitation erosion.

APPEARANCE All along the upper part of the pipe, a strip of material 1.5–3 cm wide was worn away to the point of leakage.

CAUSE Flash-boiling occurred as a result of boiling point retardation, as a result of which the oxide skin was damaged. The damage occurred after the bundle had been chemically cleaned. Previously, the bundle had been in operation for years without any problems. Presumably, boiling point retardation was prevented in the past by dirt accumulation on the pipe.
