Corrosion Atlas

THIRD, EXPANDED AND REVISED EDITION

A Collection of Illustrated Case Histories

Evert D.D. During

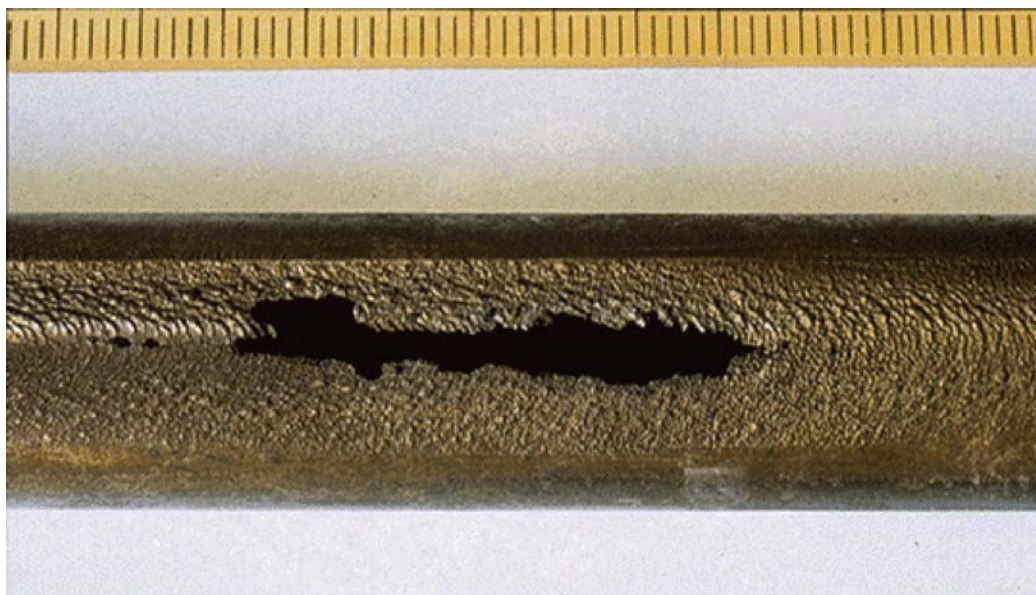
PART Pipe.

PHENOMENON Erosion corrosion.

APPEARANCE Severe attack, with flow pattern.

CAUSE High inflow velocity of the corrosive vapors (see also Case History 06.01.34.01).

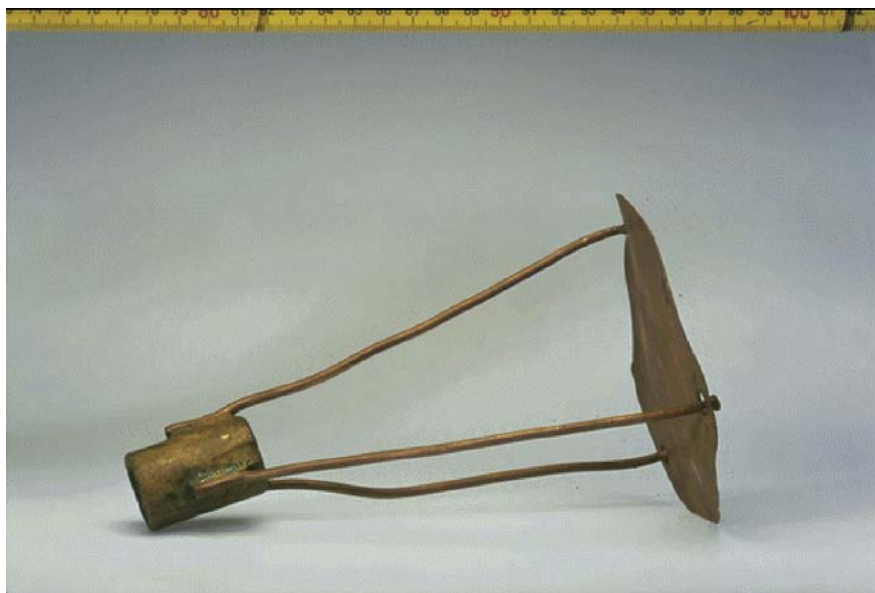
06.11.34.02

MATERIAL	Copper.
SYSTEM	Fatly acid manufacture.
PART	Spray plate of the sulfuric acid distributor from a fatty acid vessel (saponification).
PHENOMENON	Erosion corrosion.

APPEARANCE	Uniform attack over the entire surface (original thickness: 3 mm, remaining thickness <1 mm).
------------	---

CAUSE	At elevated temperature, copper is attacked by 96% sulfuric acid. In this case, the attack was of course accelerated by the continuous erosion caused by the sulfuric acid stream colliding against the surface of the spray plate.
-------	---

REMEDY	<ul style="list-style-type: none"> • Regular replacement, or • Make the spray plate of polyvinylidene fluoride.
--------	---

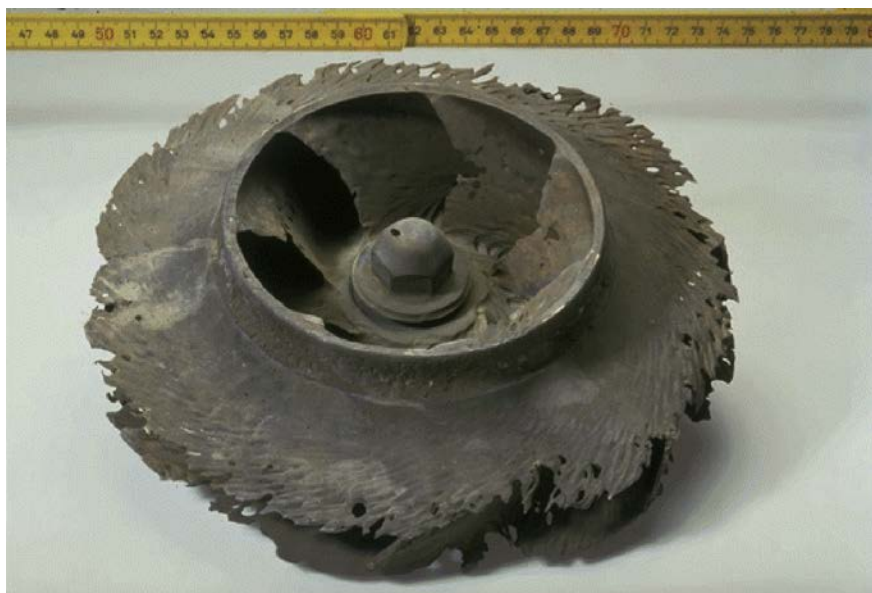
PART Impeller of centrifugal pump.

PHENOMENON Erosion corrosion.

APPEARANCE The entire surface of the impeller is attacked with a distinct flow pattern.

CAUSE At this temperature, sulfuric acid causes slight corrosion (< 0.5 mm/year) to the present bronze quality. The presence of solids contamination and the high velocity of the medium along the impeller, however, also cause erosion. The combination of erosion and corrosion leads to accelerated attack.

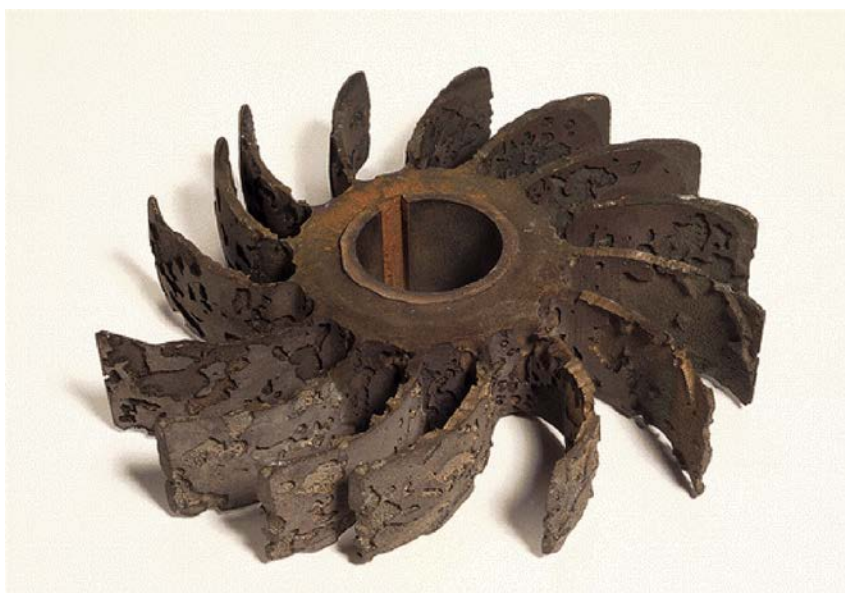
06.11.34.04

MATERIAL	Tin bronze.
SYSTEM	Process installation.
PART	Circulating pump impeller.
PHENOMENON	Erosion corrosion.

APPEARANCE	Severe local attack.
TIME IN SERVICE	2 years.
ENVIRONMENT	1–2% cyanide containing solution at 40–50 °C. Depoisoning by a batchwise reaction with sodium hypochlorite.
CAUSE	Bronze is not resistant to cyanide.
REMEDY	Use of stainless steel AISI 316.

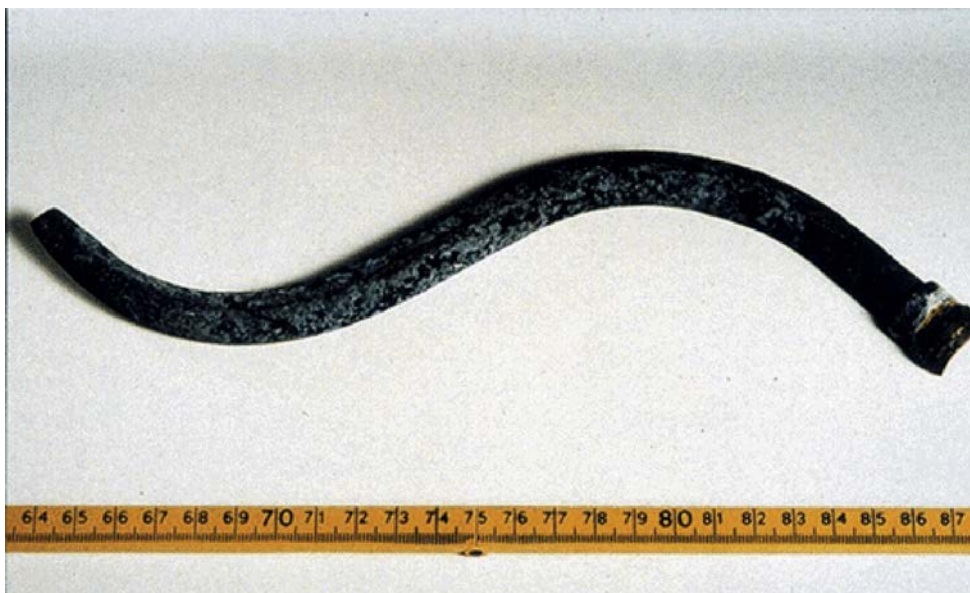
06.13.10.01

MATERIAL	Copper.
SYSTEM	Vacuum pump.
PART	Rejection water pipe.
PHENOMENON	Ammonia corrosion.

APPEARANCE External uniform attack, with blue-colored corrosion products.

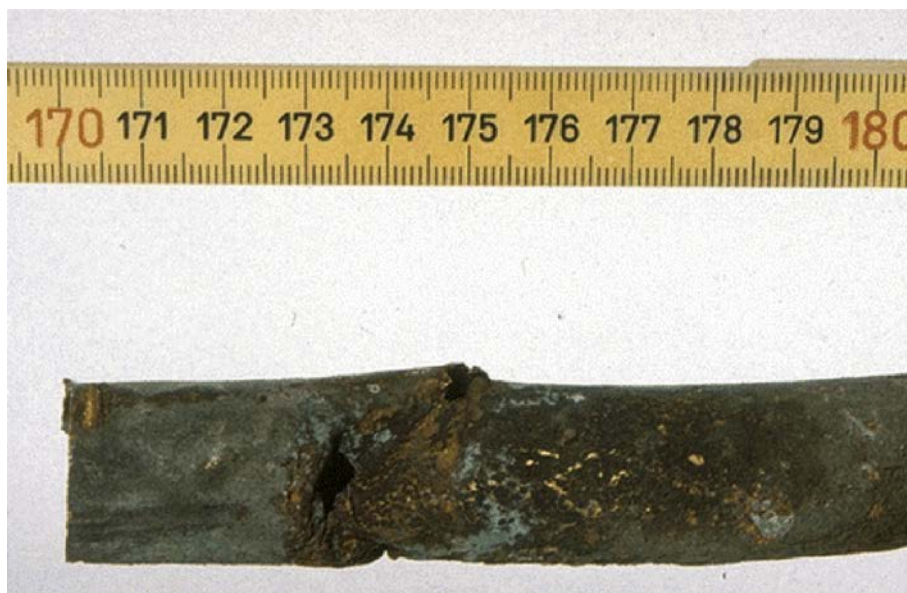
06.14.14.01

MATERIAL	Copper.
SYSTEM	Gas supply system.
PART	Underground pipeline.
PHENOMENON	Galvanic corrosion.

APPEARANCE	Local attack (mechanically deformed by digging up).
TIME IN SERVICE	16 years.
ENVIRONMENT	Soil with low soil resistance (<math><10 \text{ Ohm} \cdot \text{m}</math>); the pipeline lay in the groundwater.
CAUSE	Galvanic connection with concrete steel which, owing to the presence of an oxide skin, is more noble than copper at the prevailing high pH of the concrete.
REMEDY	Do not use an unprotected copper pipe in the soil, but protect it with a plastic jacket or polyethylene lining.

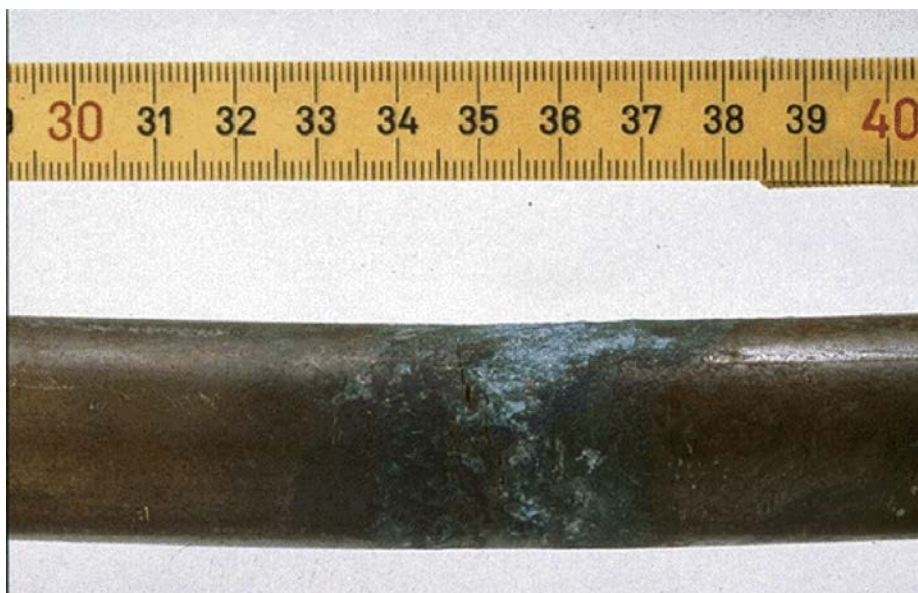
PART Underground pipeline.

PHENOMENON Stress-corrosion cracking.

APPEARANCE Fracture with blue corrosion products (pipe slightly distorted).

CAUSE Mechanical stress due to subsiding soil and ammonia from the soil. This type of copper is sensitive to stress-corrosion cracking.

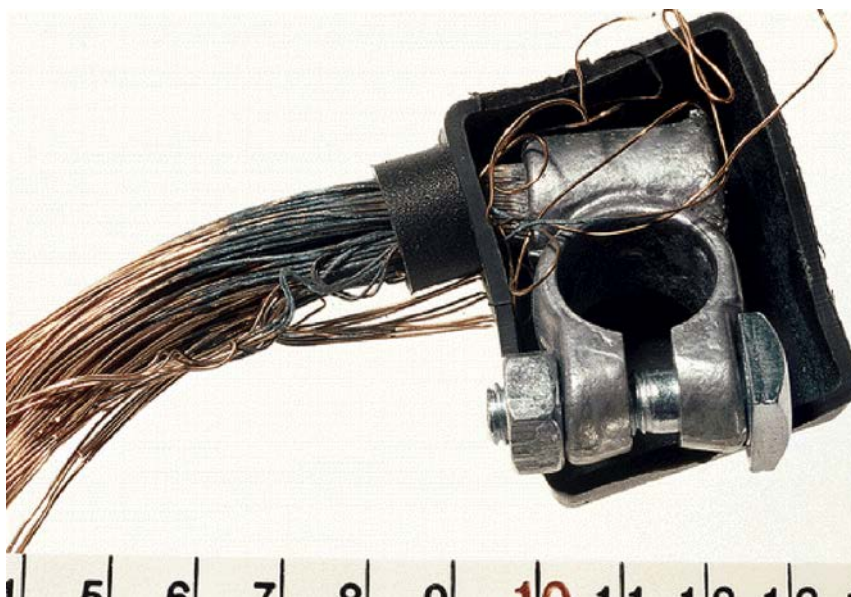
PART Battery cable.

PHENOMENON Corrosion caused by soldering process.

APPEARANCE Blue copper corrosion products on copper threads near soldered cable end.

CAUSE Insufficient cleaning after soldering. Corrosion caused by zinc chloride-based flux residues used for soldering (see also Case History 06.06.11.01).

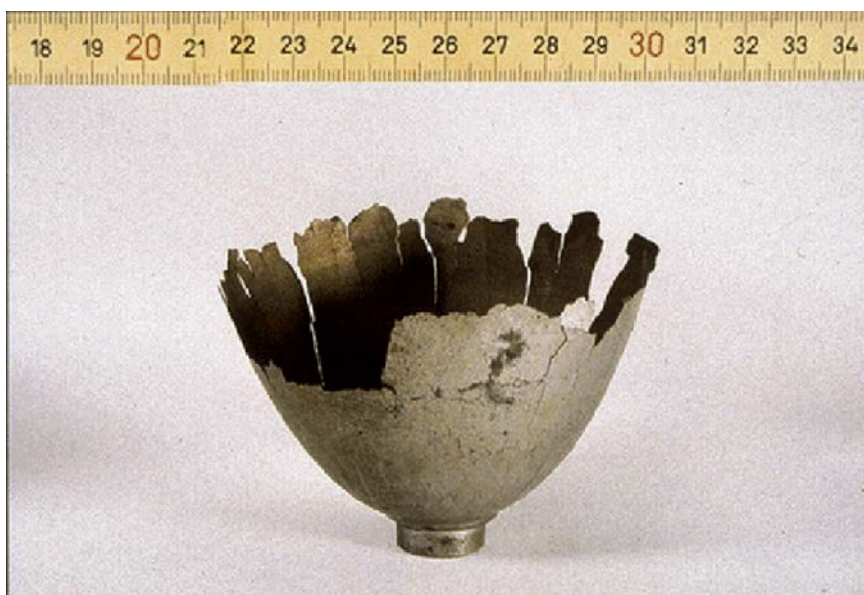
Stress corrosion cracking (season cracking).

Cracking.

In combination with stresses present in the brass cap, ammonia attack causes this stress corrosion (see also Case Histories 06.02.18.01, 06.06.18.01, and [06.25.18.01](#)).

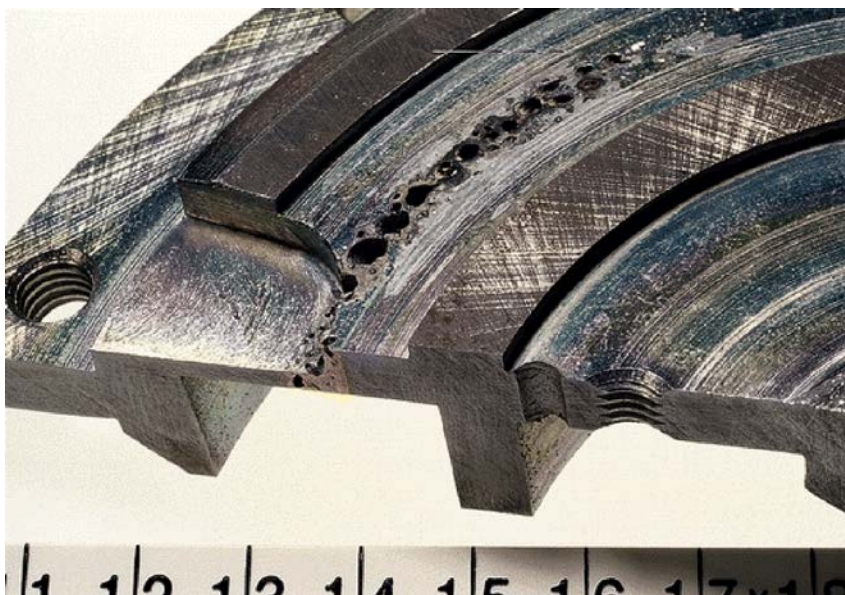
PART Electromagnetic induction wheel.

PHENOMENON Acid corrosion.

APPEARANCE Severe pitting and penetration of the (yellow-colored) brass segment.

CAUSE Brass is not resistant to the acidic chemicals used during pretreatment or during the plating process.

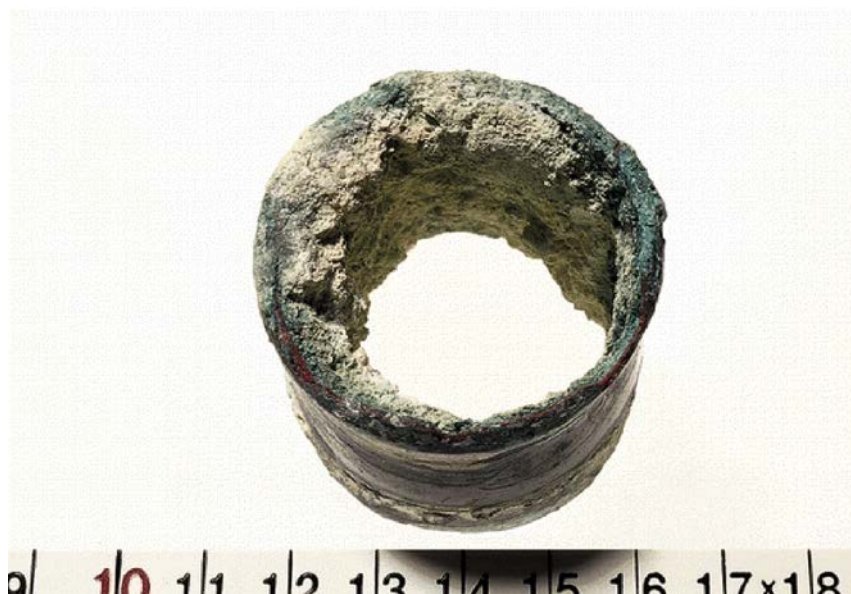
Selective leaching (layer-type dezincification).

Deposits and corrosion products, with the brass color fading from yellow to red.

Use of bad-quality water with high salt and chloride content caused layer-type dezincification. The remaining copper colored the hose pillar red.

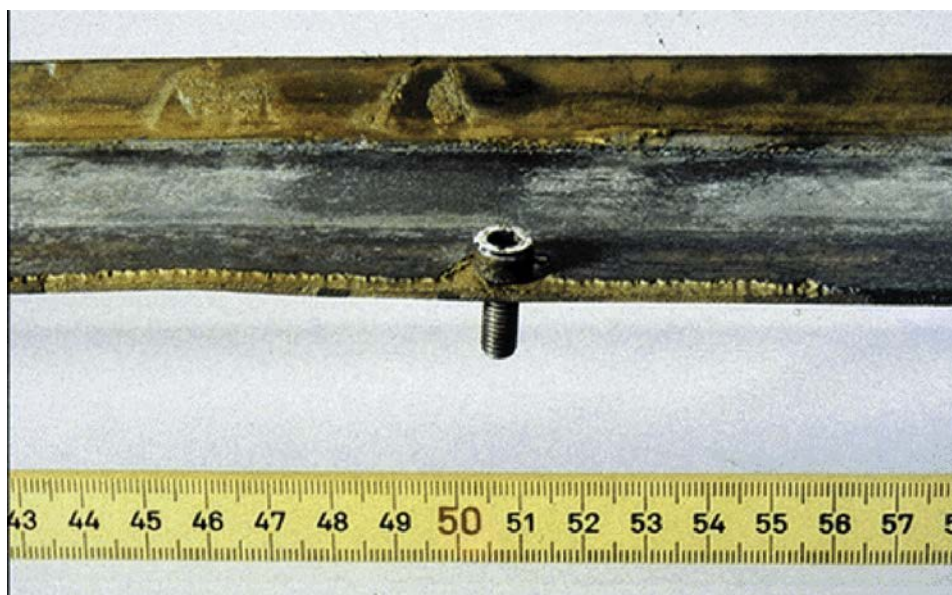
PART Protector cover of transmitter/receiver.

PHENOMENON Galvanic corrosion.

APPEARANCE Material worn away locally.

CAUSE The potential difference between the Nimonic bolts and the brass cover caused the less noble metal (the brass) to dissolve. This allowed the protective cover to detach. In spite of the favorable area ratio (large anode, small cathode), the brass cover was attacked due to the large potential difference and the high conductivity of the seawater.

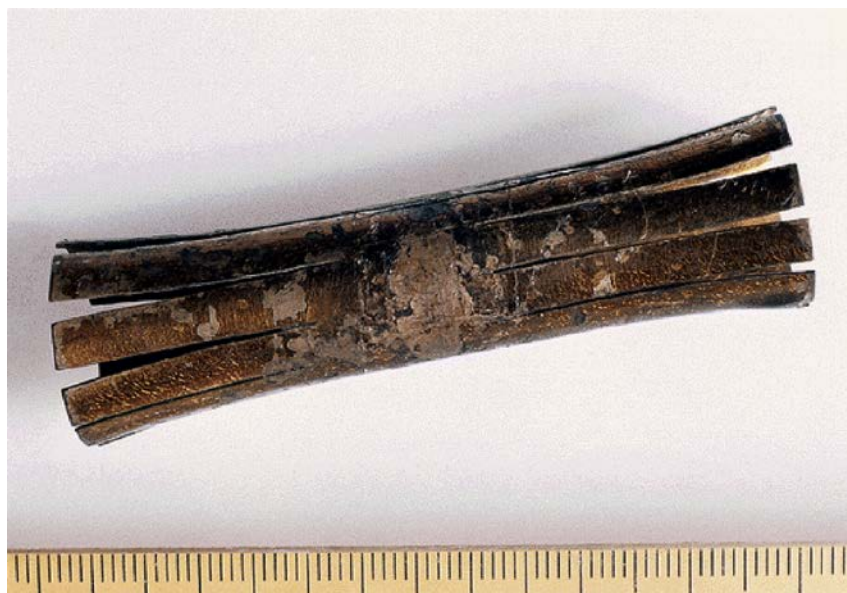
PART Condenser pipe.

PHENOMENON Stress-corrosion cracking.

APPEARANCE Numerous parallel longitudinal cracks.

CAUSE High stresses in the brass exposed in the above medium.

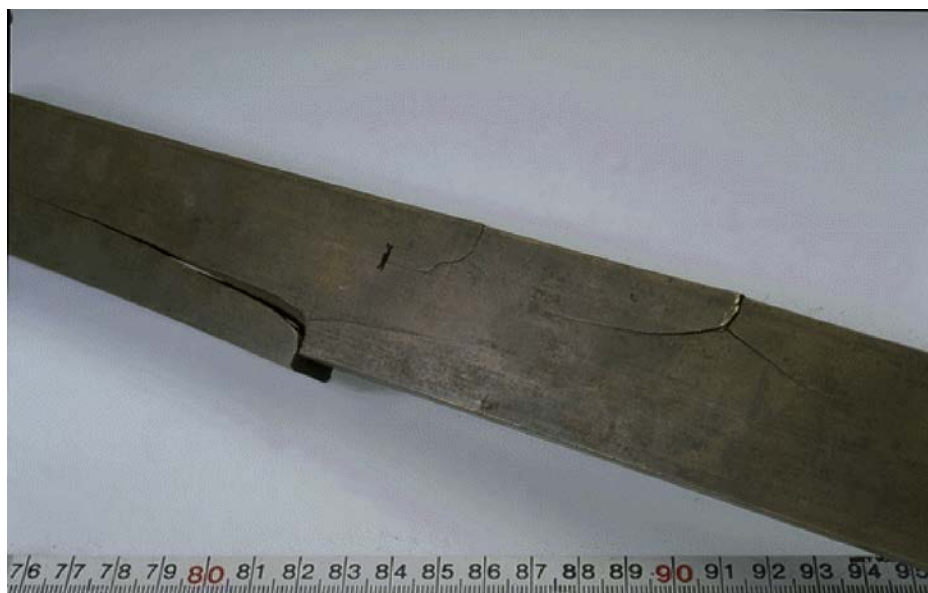
PART Rod.

PHENOMENON Stress corrosion cracking (season cracking).

APPEARANCE Fracturing.

ENVIRONMENT Moist atmosphere contaminated with ammonia originating from the storage of fertilizers (including ammonium salts) at a previous stage.

CAUSE Internal stresses and ammonia caused the occurrence of stress corrosion (see also Case Histories 06.02.18.01, 06.06.18.01, and [06.15.18.01](#)).

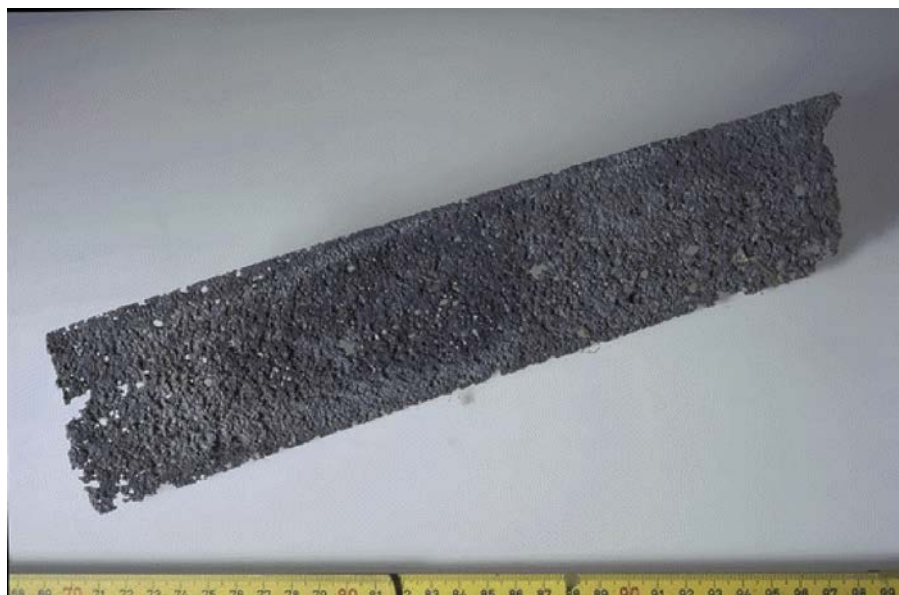
07.01.03.01

MATERIAL	Aluminum (99%).
SYSTEM	Steam consumer (granule press for preparing polystyrene blocks).
PART	Steam distributor plate.
PHENOMENON	Alkalinity corrosion.

APPEARANCE	Severe corrosion in the form of roughening over the entire surface, with perforation at various points.
TIME IN SERVICE	Unknown.
ENVIRONMENT	Saturated steam at 1 MPa, regularly contaminated with alkaline boiler water.
CAUSE	Switching on the presses at intervals caused sharp peaks in steam consumption, exceeding the boiler's capacity. As a result, pressure reduced and hence enlargement of the volume of steam occurred, allowing the boiler to prime. The steam regularly contained 40% of boiler water. The aluminum plate was attacked by the alkalinity of this boiler water (see also Case Histories 07.09.03.01 and 07.11.03.02).
REMEDY	<ul style="list-style-type: none"> • Construct the distributor plate of carbon steel, and • Install a back-up steam accumulator to supply peak consumption.

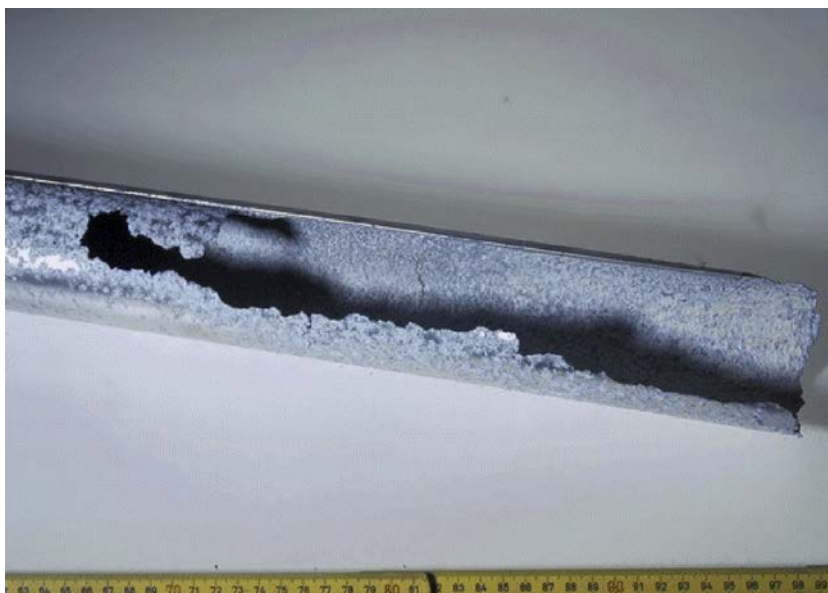
PART Flue gas discharge pipe.

PHENOMENON Acid corrosion.

APPEARANCE General attack with rough surface.

CAUSE The combustion air of the central heating boiler, which was installed in a hairdressing salon, was contaminated with chlorine-containing organic solvents. When these were combusted, HCl was formed which attacked the aluminum discharge flue when it condensed in the high-efficiency boiler (see also Case Histories 01.04.04.01 and 02.01.04.01).

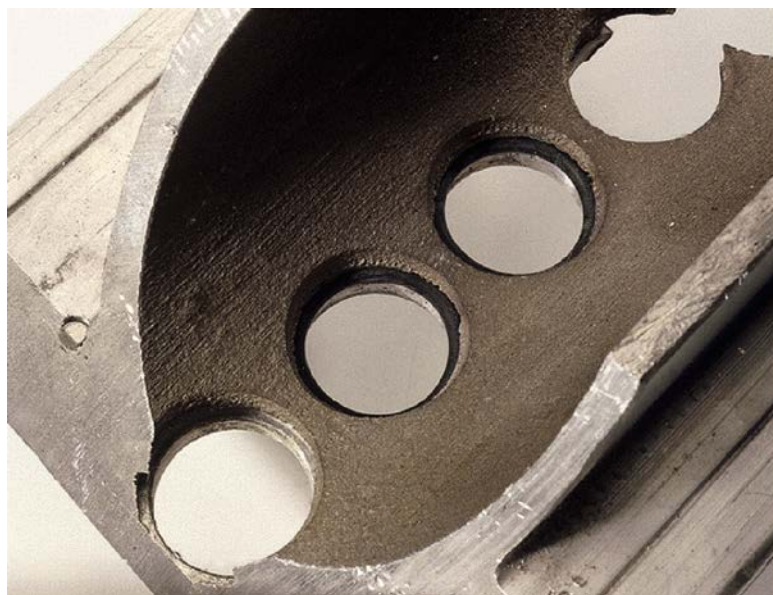
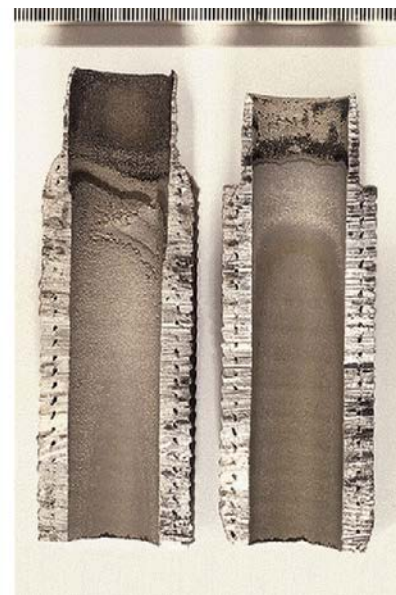
07.04.04.02

MATERIAL	Aluminum (AlMgSi 0.5).
SYSTEM	Central heating system.
PART	Header and finned pipes from heat exchanger.
PHENOMENON	Acid corrosion.

APPEARANCE	Uniform attack with pickled surface. Erosion corrosion caused by turbulence at the tube ends. The tube wall thickness is reduced from 2 to 0.1 mm.
TIME IN SERVICE	Total life span 2 months. Leakage took place 1 month after cleaning.
ENVIRONMENT	In service: heating water: temperature 70°C –90°C; pH 8.9–9.2; conductivity 88.6 mS/m; total hardness 2.3 ppm CaCO ₃ ; chloride 15 ppm; phosphate 45 ppm PO ₄ ³⁻ ; Fe 0.3 ppm; Al 25 ppm. During cleaning: uninhibited 3% HCl at room temperature.
CAUSE	The most important cause is acid corrosion during cleaning with uninhibited 3% HCl instead of inhibited citric acid. This illustrates poor workmanship by the cleaning firm. The high aluminum content in the heating water indicates corrosion also during service, probably caused by the high pH.
REMEDY	<ul style="list-style-type: none"> • Filling the system with demineralized water; • Cleaning with inhibited citric acid if necessary.

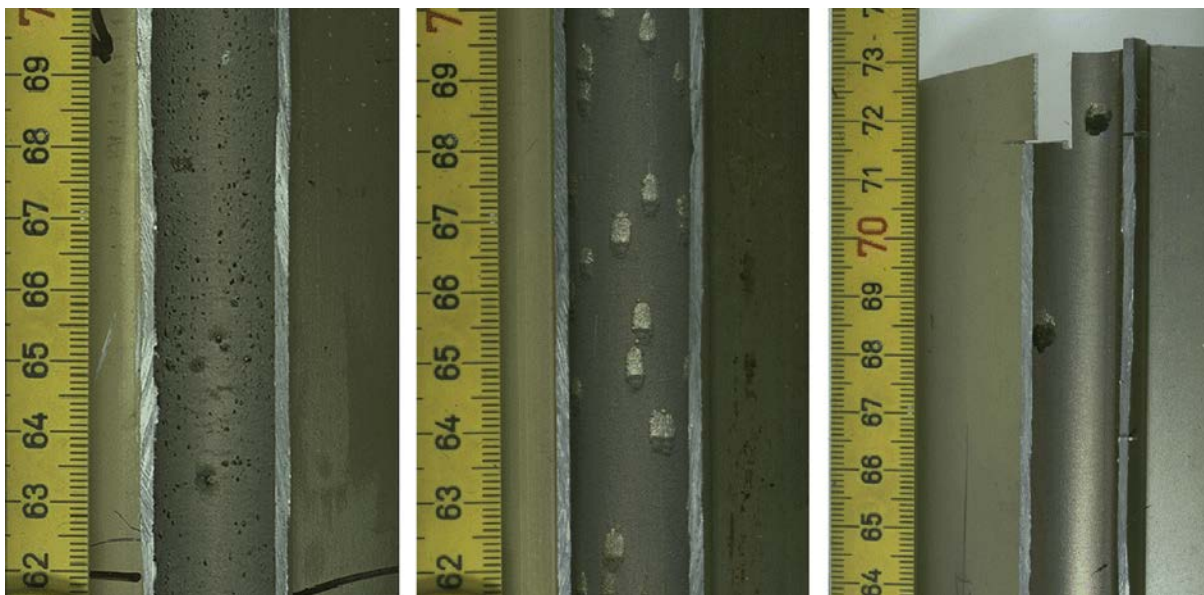
PART Radiant pipes.

PHENOMENON Chloride attack.

APPEARANCE Pitting attack.

CAUSE Pitting by chloride in the presence of oxygen, initiated by deposition of iron oxide (dispersed out of the old system) and promoted by the high pH (due to the dosing of sodium molybdate). The heating water contains 75 ppm. of Fe and 70 ppm of Al. Application of incorrect water treatment caused a loss of \$110,000 (poor workmanship by the water treatment firm).

- All the aluminum radiant pipes were replaced and incorporated in a secondary heating system which was heated by the old system by means of a stainless steel heat exchanger.
- The secondary system was filled with demineralized water without dosing of chemicals.

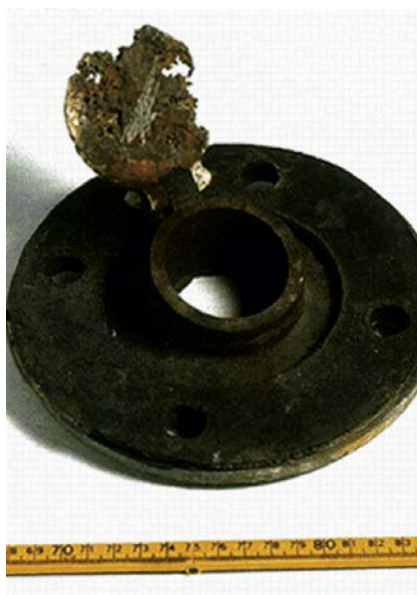
PART Check valve.

PHENOMENON Galvanic corrosion.

APPEARANCE Severe general corrosion.

CAUSE The corrosion took place because of the potential difference between aluminum and bronze in the presence of oxygen originating from the open expansion tank. Besides, aluminum is not resistant to alkaline water (pH > 8.5).

REMEDY Replacement of the open expansion tank by sealed expansion vessel(s) and construction of the valve from bronze.

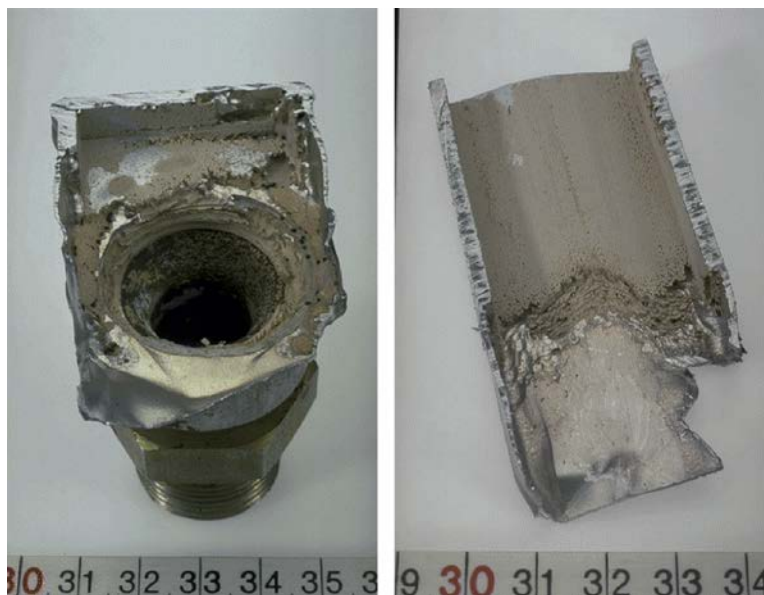
PART Aluminum tubes with cadmium-coated steel connecting piece.

PHENOMENON Galvanic corrosion.

APPEARANCE Severe uniform attack to aluminum, as a result of which wall thickness has reduced from 3 mm to <1 mm.

CAUSE The aerated heated water caused galvanic corrosion at the steel/aluminum connection. (Upon examination, the black grains were found to consist of calcium carbonate covered with iron oxide and therefore have nothing to do with the corrosion.)

- Construct the entire system of stainless steel and use softened make-up water to prevent chalk deposition, or
- If the present system is retained, fill the system and use low-salt make-up water (demineralized water, condensate or reversed osmosis water).

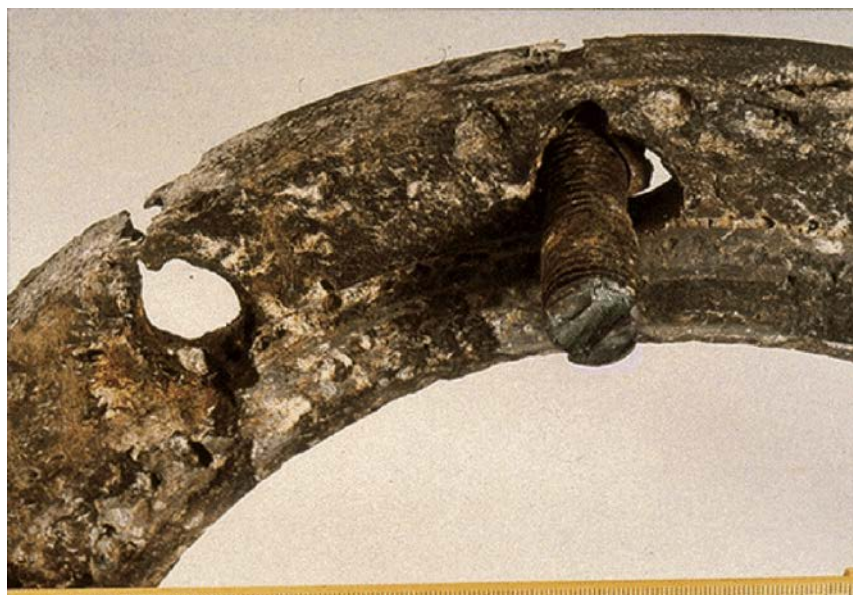
PART Push-on flange.

PHENOMENON Galvanic corrosion.

APPEARANCE Very severe attack over the entire surface.

CAUSE The couple between the stainless steel pipeline and the aluminum push-on flange; also between the steel bolts and the flange (see also next case). Poor workmanship by the installation firm.

REMEDY Use of stainless steel push-on flanges and bolts as well.

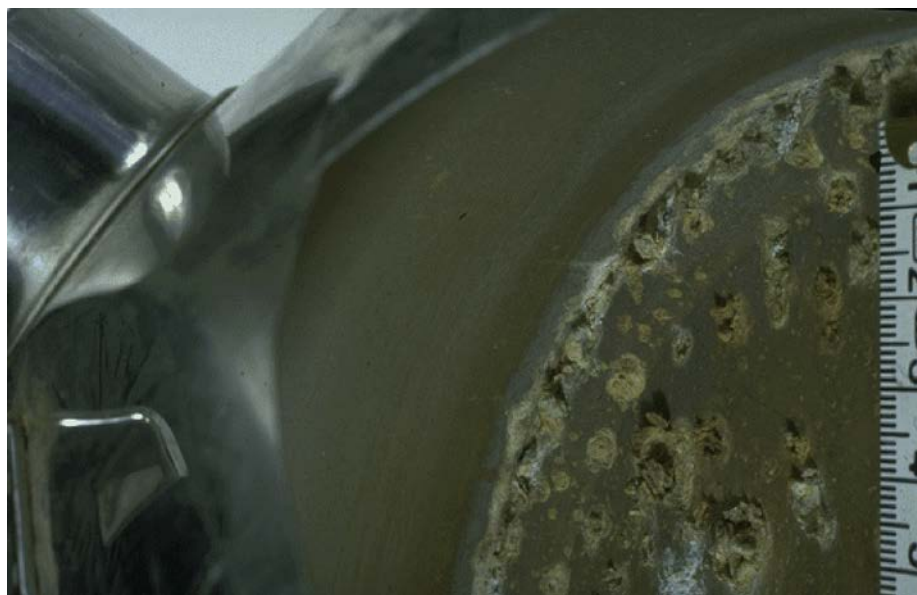
PART Base.

PHENOMENON Galvanic corrosion.

APPEARANCE Severe pitting corrosion on the base.

CAUSE Cell formation by the stainless steel jacket combined with the aluminum base, as a result of which galvanic corrosion occurred (see also former case).

REMEDY Manufacture the kettle either entirely of aluminum or entirely of stainless steel.

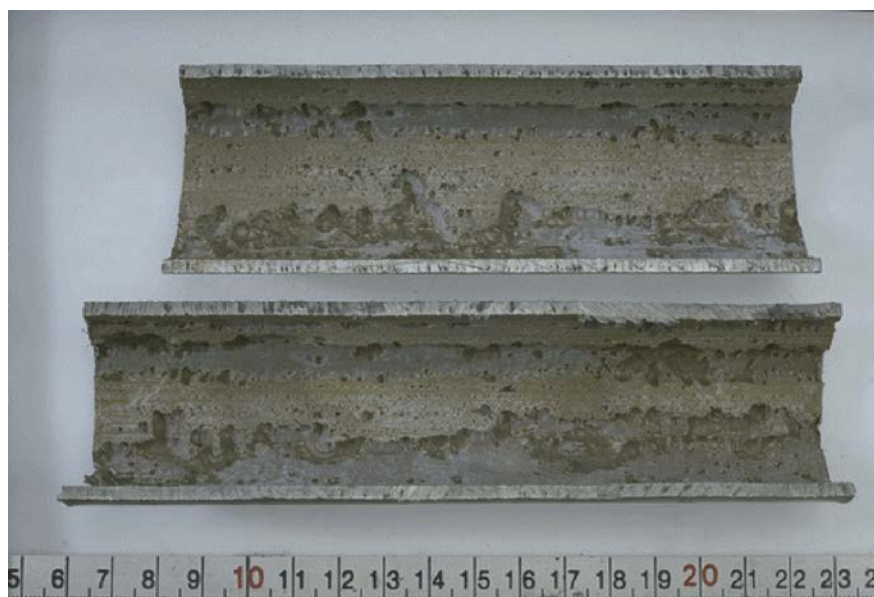
PART Water distributor pipes.

PHENOMENON Selective leaching (dezincification).

APPEARANCE Severe uniform attack with pitting to the point of leakage.

CAUSE Leaching out of the zinc-rich phase of the inhomogeneous alloy.

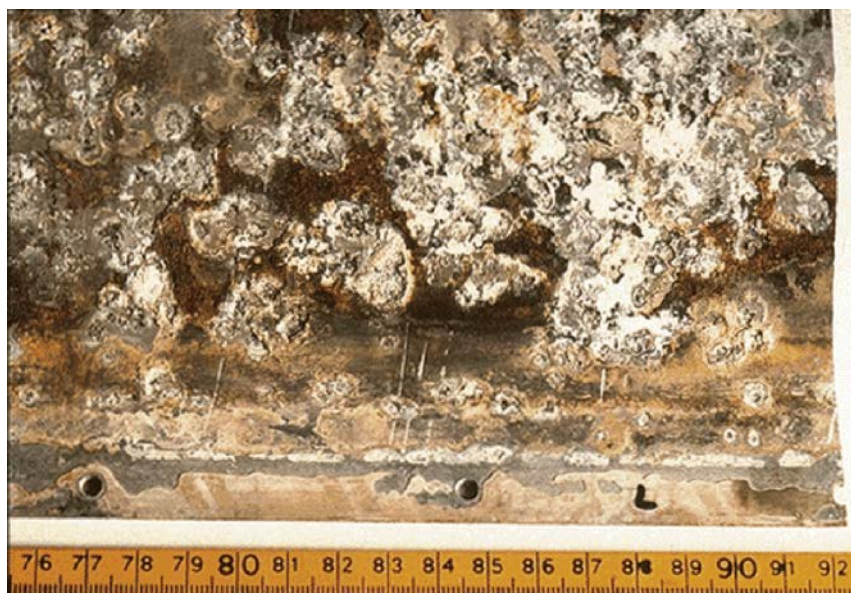
PART Heat exchanger plate.

PHENOMENON Sulfide corrosion.

APPEARANCE Pitting.

ENVIRONMENT Sulfide-containing corrosive well water with iron oxide deposition. Sulfide (S^{2-}) 0.8 ppm.; iron (Fe^{2+}) 31 ppm.; pH 6.3; wall temperature approximately 100°C.

CAUSE H_2S in the well water attacks the aluminum.

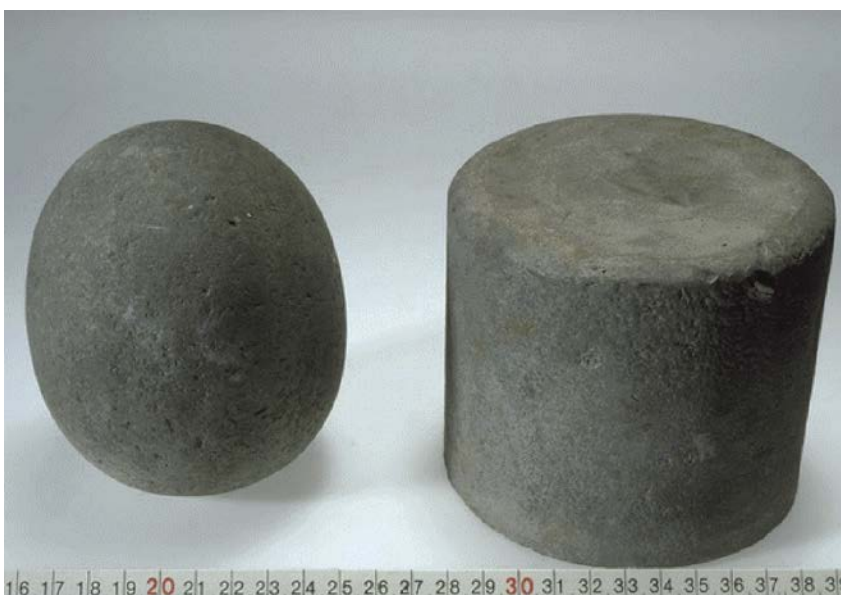
07.06.14.01

MATERIAL	Magnesium.
SYSTEM	Once-through cooling system.
PART	Sacrificial anode of the cathodic protection system of the carbon steel head of a cooler.
PHENOMENON	Galvanic corrosion.

APPEARANCE	Left: used anode. Right: new anode.
TIME IN SERVICE	4 years.
ENVIRONMENT	Brackish water.
CAUSE	The anode is mounted on the head plate by means of a carbon steel threaded bolt. The part of the anode touching the steel surface dissolves more rapidly, causing the anode to detach from the steel surface.
REMEDY	Use of a rubber slab between the magnesium anode and the steel plate to prevent direct contact and hence detachment of the anode.

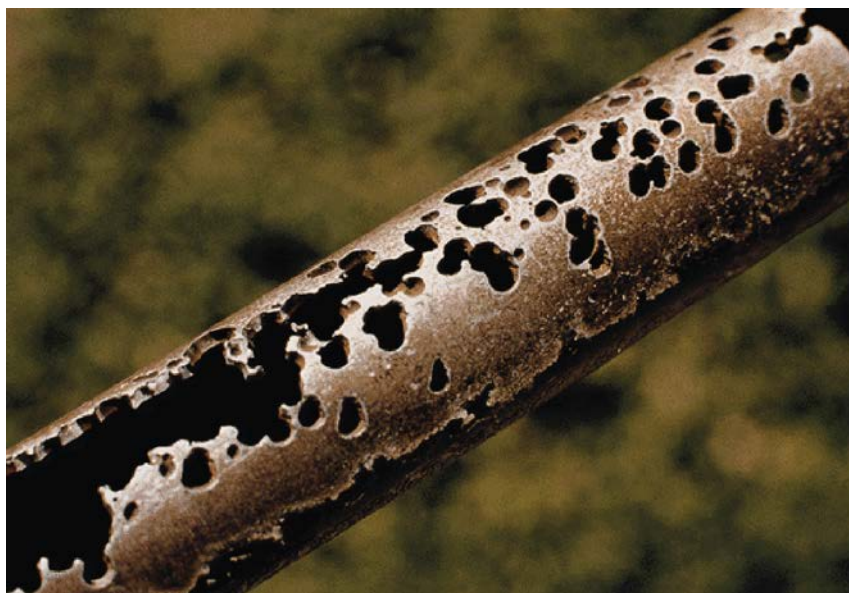
PART Horizontal heat exchanger tube (OD 2.22 cm).

PHENOMENON Microbiologically influenced corrosion.

APPEARANCE Severe pitting.

CAUSE Pits were caused by sulfate-reducing bacteria beneath a slime layer. No chemical treatment of this system was applied. The exchanger was plagued by low flow (0.6 m/sec). Total aerobic bacteria counts exceeded 10^7 in the bulk water, and anaerobic counts were as high as 100 (see also Case History 01.06.17.03).

REMEDY Biocide treatment involving maintenance of free chlorine residual level between 0.3 and 0.5 ppm. Before treatment, the exchanger was so severely damaged that it was replaced. No further failures were reported after treatment program was initiated.

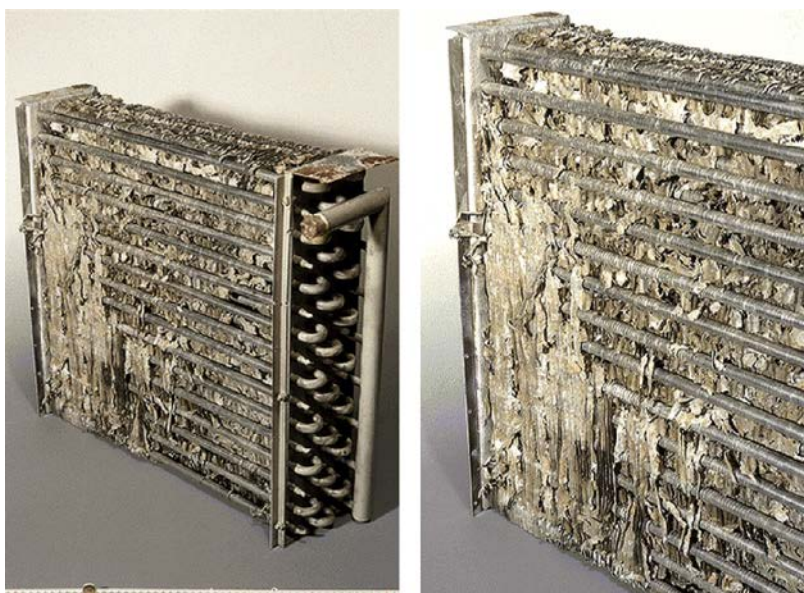
PART Freon evaporator.

PHENOMENON Acid corrosion.

APPEARANCE Severe deterioration of the aluminum lamellae.

CAUSE The condensing water and traces of acetic acid dissolved the aluminum. The collected condensate had a pH of 4.5–3.5 and contained 500–800 ppm of organic acids (mainly acetic acid). The corrosion was accelerated by the potential difference between aluminum and stainless steel.

REMEDY Use a more corrosion-resistant material (e.g., stainless steel, AISI 304 or 316).

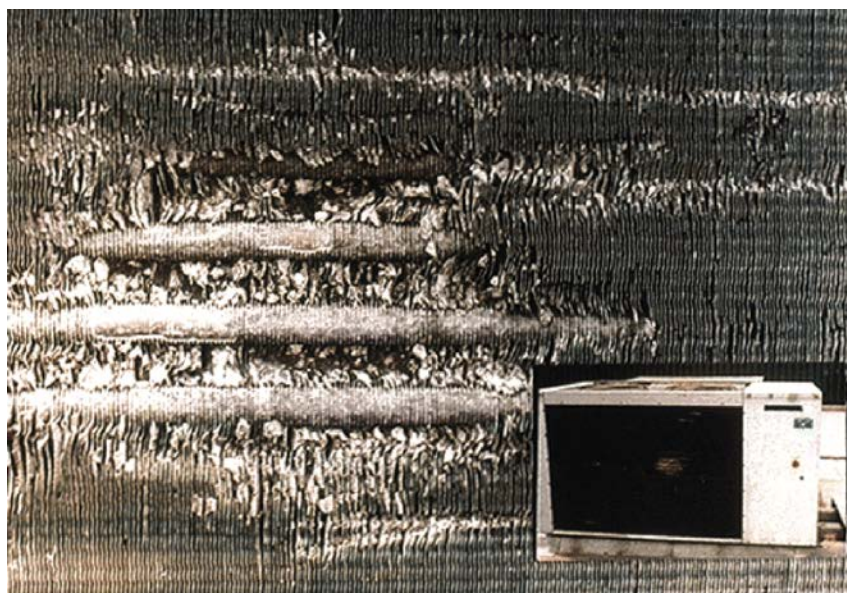
Atmospheric corrosion.

Cooling fins totally corroded away.

Aluminum is corroded by salt deposition. Vehicle exhaust fumes from a nearby motorway as well as aircraft exhaust fumes may also have played a contributory role. There is no explanation for the fact that the attack was so local. Probably, the fan did not function correctly.

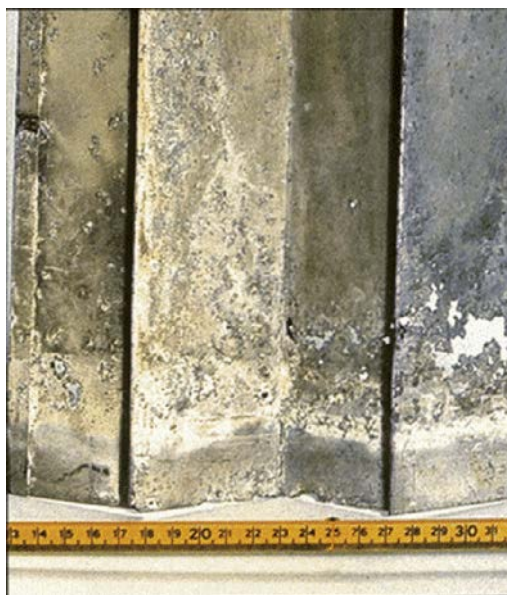
07.09.03.01

MATERIAL	Aluminum.
SYSTEM	Air conditioning plant.
PART	Drop catch of humidifier.
PHENOMENON	Alkalinity corrosion.

APPEARANCE	Uniform attack.
TIME IN SERVICE	Unknown.
ENVIRONMENT	Softened circulating water, pH 9.5.

CAUSE Atomization causes the formation of alkaline circulation water, and insufficient blowdown causes deposition of soda and sodium bicarbonate. This results in attack to the aluminum (see also Case History [07.06.03.01](#)).

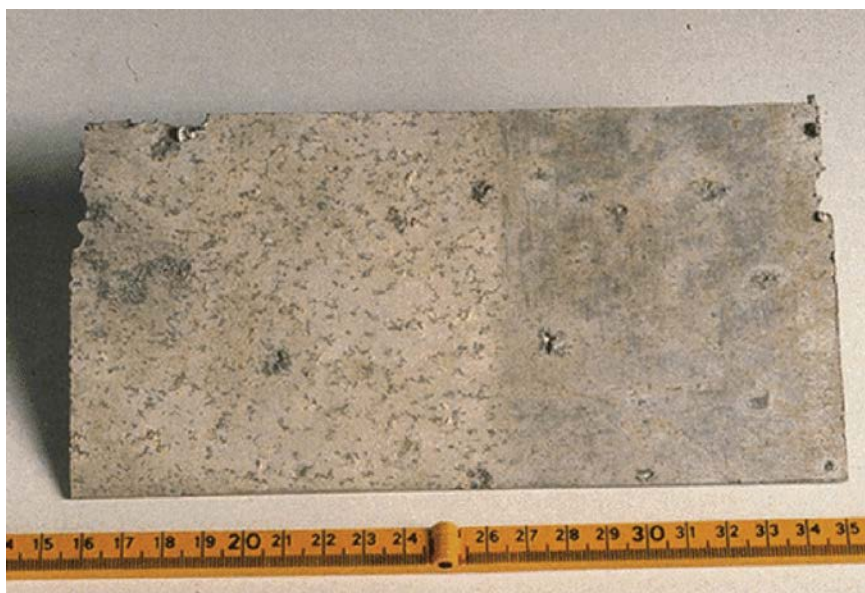
07.09.09.01

MATERIAL	Aluminum.
SYSTEM	Air conditioning plant.
PART	Part of an aluminum air duct.
PHENOMENON	Salt corrosion.

APPEARANCE	Pitting attack.
TIME IN SERVICE	Unknown.
ENVIRONMENT	Evaporated mains water.

CAUSE Water drops entrained with the air stream from the humidifier; after evaporation of these drops deposited in the ducts, alkalized salt deposits were formed which caused the attack to the aluminum.

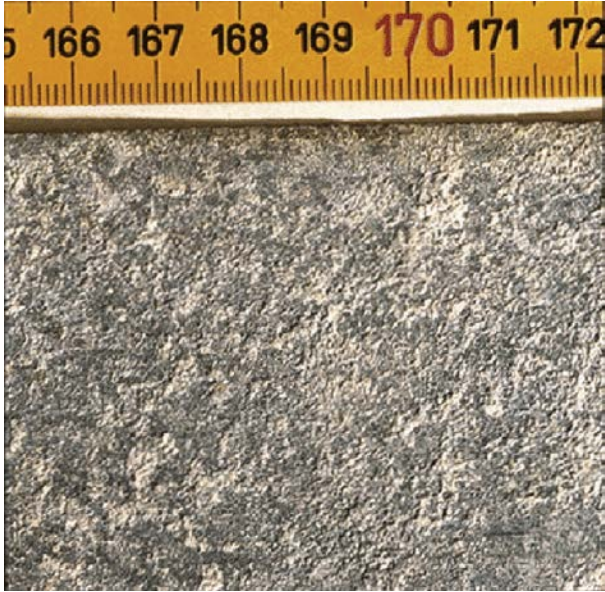
07.09.09.02

MATERIAL	Aluminum.
SYSTEM	Air conditioning plant.
PART	Floor of the plenum.
PHENOMENON	Salt corrosion.

APPEARANCE	Uniform attack.
TIME IN SERVICE	About 4 years.
ENVIRONMENT	Air with relative humidity reduced in the air conditioning system from 87% to 78%; the floor was dry. The air circulates from the plenum to a cheese store and back to the air conditioning plant.
CAUSE	The white deposit consists of $\text{Al}(\text{OH})_3$ in addition to some NaCl . In the past, the air was humidified with steam originating from a steam generator with poor separation of water. Accordingly, deposition of alkaline boiler water salts is the presumable cause.
REMEDY	The attack took place in the past (the new plenum—without steam humidification—exhibit no attack). As long as the floor remains dry, no further attack will take place. For added certainty, the deposits should be removed by brushing and vacuum cleaning, optionally followed by washing with demineralized water.

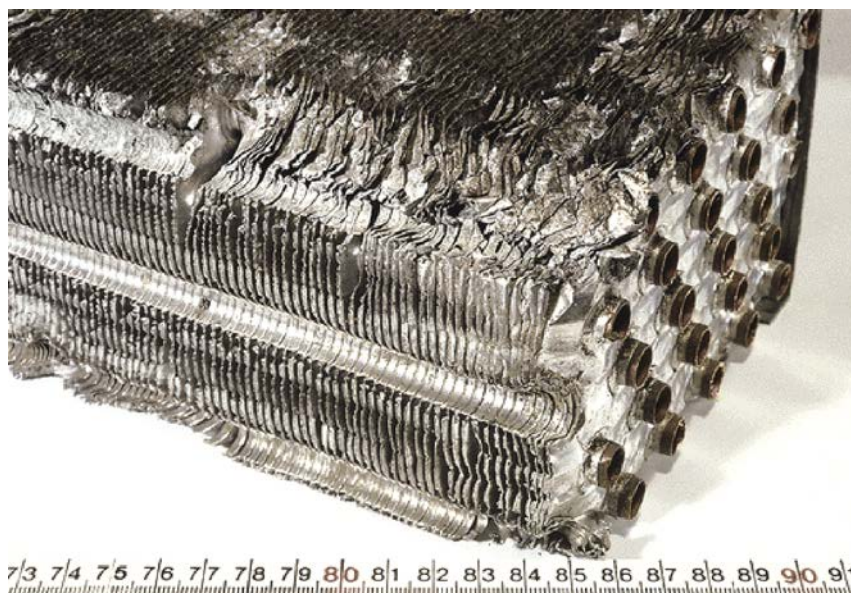
PART Heat exchanger.

PHENOMENON Galvanic corrosion.

APPEARANCE Severe deterioration of aluminum fins of copper tubes.

CAUSE Saline condensate enhanced galvanic corrosion of aluminum sheets, by the potential difference between copper and aluminum (see also Case History [07.16.14.01](#)).

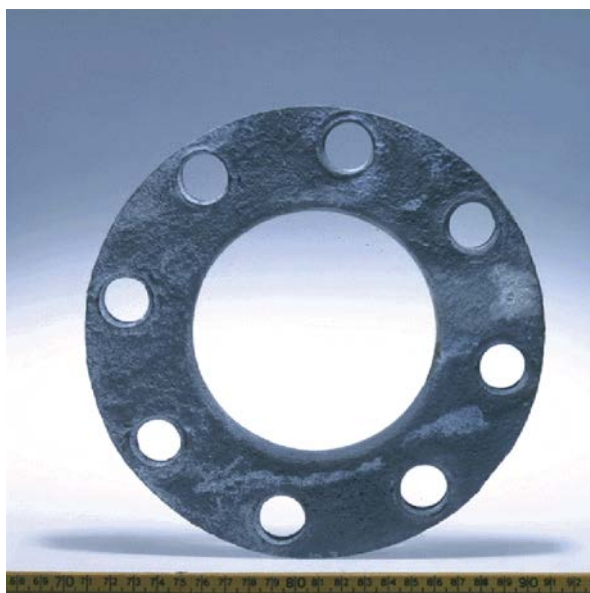
PART Push-on flange.

PHENOMENON Caustic corrosion.

APPEARANCE Uniform attack over the entire surface.

CAUSE Due to a leaking seal, the aluminum push-on flange came into contact with the caustic soda to which aluminum is not resistant.

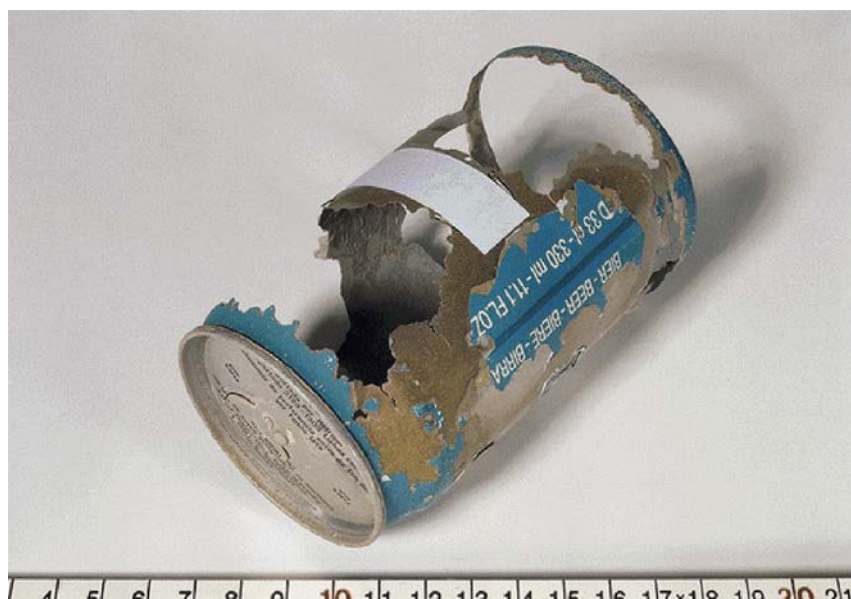
PART Beer can.

PHENOMENON Alkalinity attack.

APPEARANCE One half of the can is completely corroded away.

CAUSE The can had remained in a corner of the pasteurizer in contact with the medium. Aluminum is not resistant to the alkaline sodium hypochlorite (see also Case History [07.06.03.01](#)).

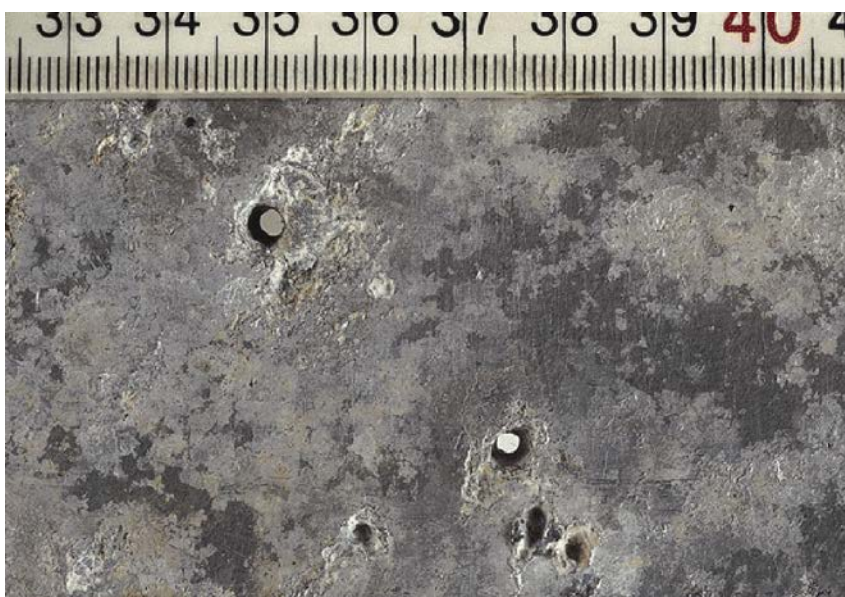
PART Bottom (6 mm thick).

PHENOMENON Under-deposit corrosion.

APPEARANCE Pits and holes and white corrosion products at the underside of the bottom.

CAUSE The presence of inhomogeneous soil allows the formation of aeration cells. The oxygen lean parts of the bedding (above the lumps of earth) are attacked by the presence of moisture and chlorides. In this situation, aluminum exhibits the same sensitivity as stainless steel (see Case History 04.10.15.01) and galvanized steel (see Case History 02.08.15.01).

- Jack up the tank and grit-blast the bottom, repair any sites attacked deeper than 2 mm with new aluminum plate sections. Then coat the tank bottom (three coats of two-component epoxy coating).
- Replace the tank bedding with homogeneous clean sand.
