Corrosion Atlas

THIRD, EXPANDED AND REVISED EDITION

A Collection of Illustrated Case Histories

Evert D.D. During

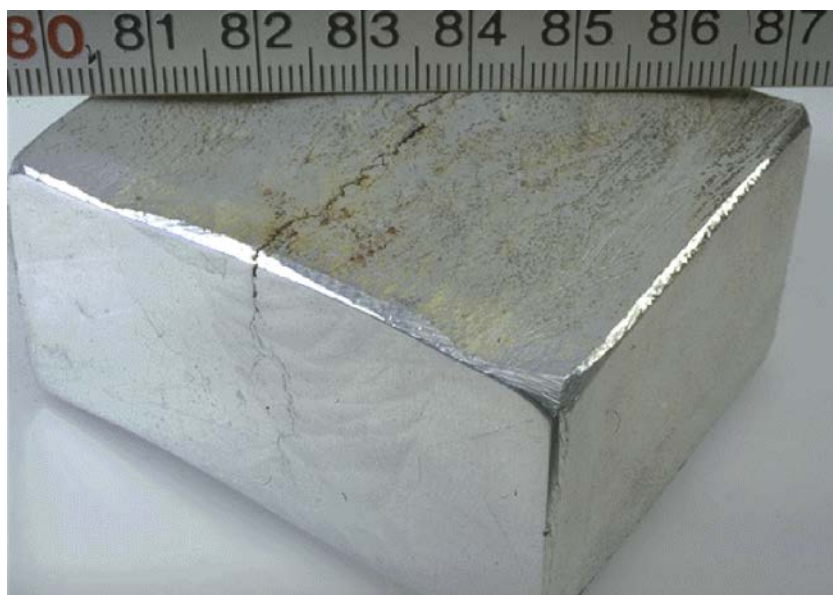
PART Base plate.

PHENOMENON Stress corrosion cracking (transgranular).

APPEARANCE Fracture at the center of the weld, in the longitudinal direction of the weld.

CAUSE During welding of the thick aluminum plates, shrinkage cracks were formed due to excessive cooling rate. As a result of the presence of residual stresses in the vicinity of the crack tip, that area is exposed to attack by acetic acid and thereby to crack propagation resulting from the combination of stress and corrosion.

REMEDY Shrinkage cracks during welding of thick wall plates can be prevented by prewarming of the plates and gradual cooling after welding. Shrinkage cracks present can be removed by remelting Gas Tungsten Arc Welding (GTAW).

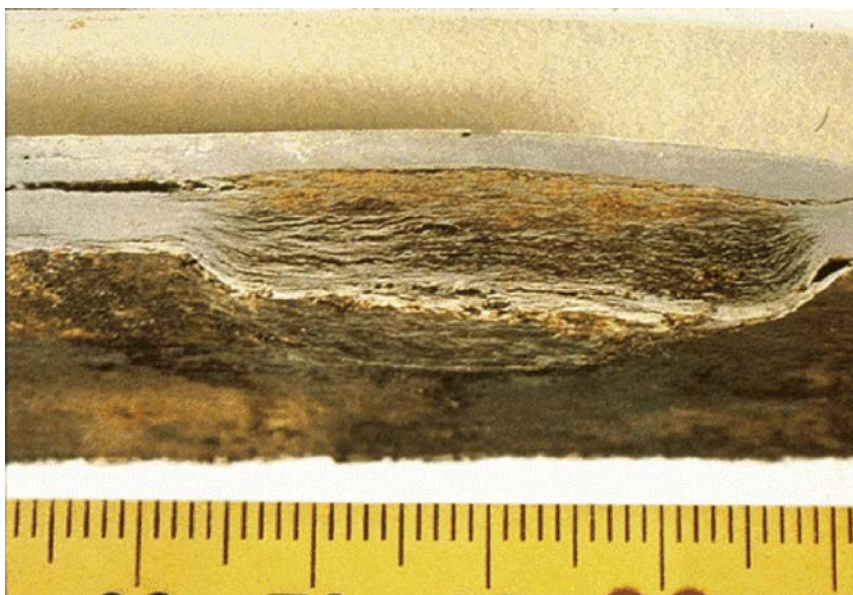
PART Bottom plate.

PHENOMENON Intergranular corrosion (exfoliation).

APPEARANCE Local layered swelling of the material.

CAUSE Moisture between the tank bottom and pad led to slight corrosion, which in the long term led to this form of intergranular stress corrosion parallel to the surface. The lamellar build-up of relatively noncorroded material is caused by the expansive force of the corrosion products (see also Case Histories [07.19.19.01/02/03/04](#) and [07.20.19.01/02](#)).

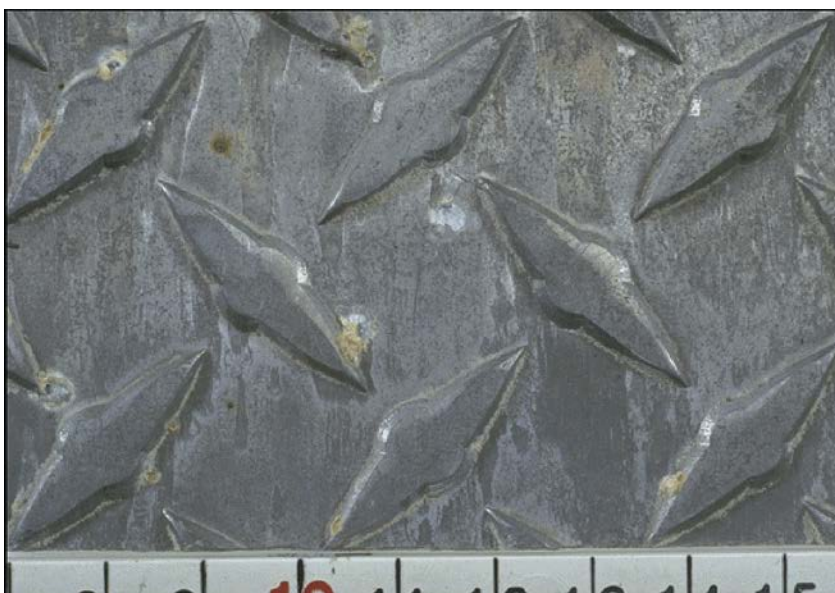
07.16.12.01

MATERIAL	Anodized aluminum.
SYSTEM	Swimming pool.
PART	Section of movable intermediate floor.
PHENOMENON	Chloride pitting.

APPEARANCE	Pitting.
TIME IN SERVICE	During laboratory investigation of the material to establish the cause of damage in practice.
ENVIRONMENT	Swimming water with addition of sodium hypochlorite for disinfection. pH 8.
CAUSE	Presence of pores in the oxide layer due to insufficient sealing. The sealing failed as a result of the profile inserted in the flat sheet material, which had angles having too small a curvature radius.
REMEDY	Make the profile angles with a larger curvature radius.

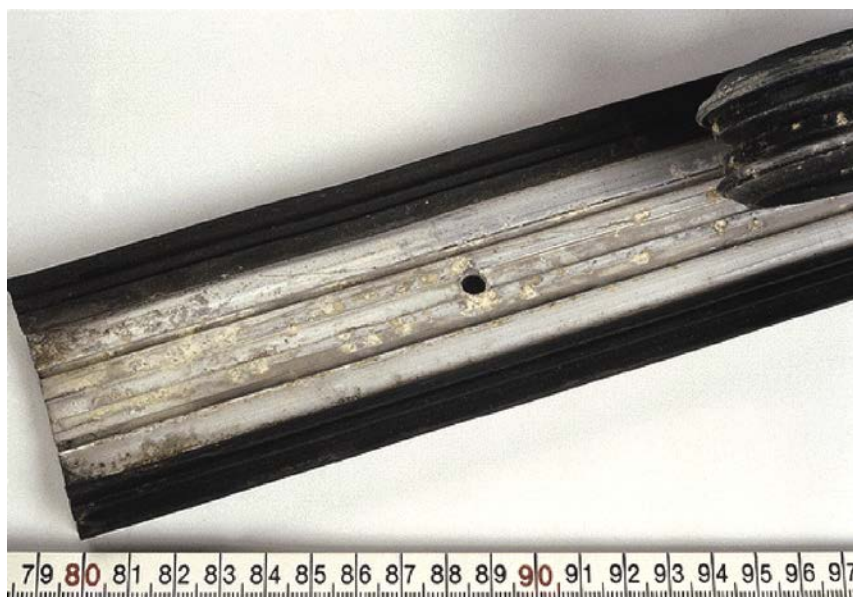
07.16.13.01

MATERIAL	Aluminum alloy.
SYSTEM	Civil engineering structure.
PART	Facade element of a window frame.
PHENOMENON	Crevice corrosion.

APPEARANCE	Slight pitting underneath whitish/beige-colored corrosion products immediately below the rubber strip seal.
TIME IN SERVICE	1.5 years.
ENVIRONMENT	Urban atmosphere.
CAUSE	Failure of the rubber strip seal, allowing rainwater to enter underneath the rubber strips. Differential aeration underneath and beside the strips allows corrosion to occur at the least aerated site. Aluminum exhibits the same sensitivity to crevice corrosion as stainless steel (see also Case Histories 07.19.13.01 and 07.25.13.01).
REMEDY	<ul style="list-style-type: none"> • Regular cleaning. • Modify window construction to improve the seal.

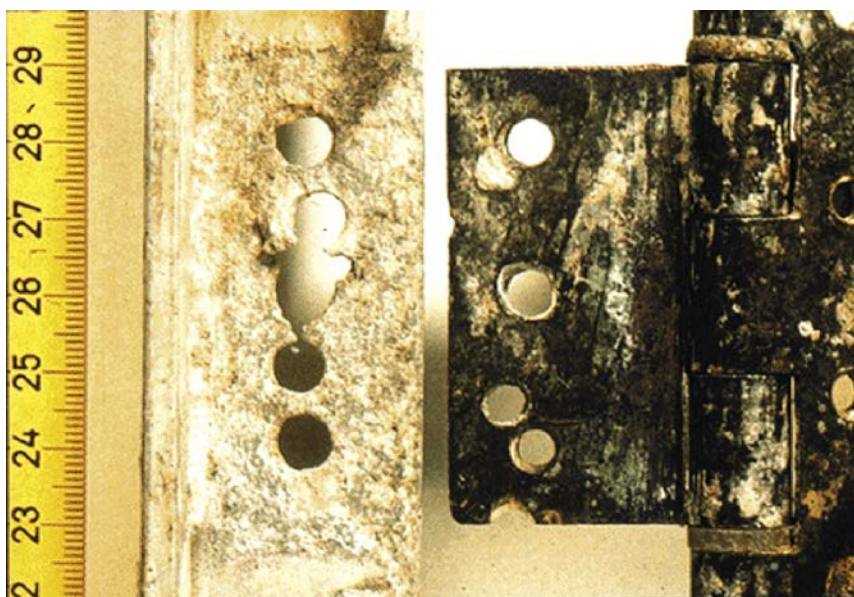
PART Factory door frame with hinge.

PHENOMENON Galvanic corrosion.

APPEARANCE Uniform attack of the frame on contact surface with hinge.

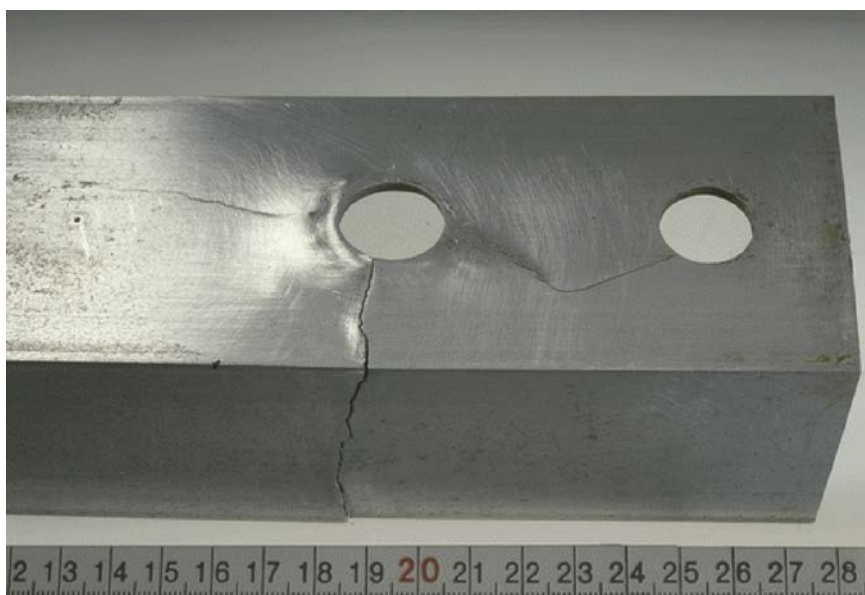
PART Roof truss.

PHENOMENON Stress corrosion cracking (intergranular).

APPEARANCE Fracturing.

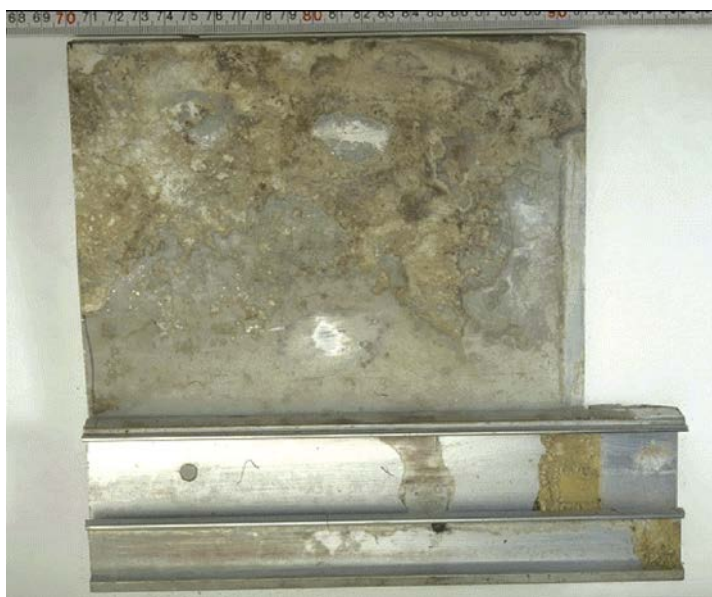
PART Windowsill.

PHENOMENON Blooming.

APPEARANCE White bloom on the surface.

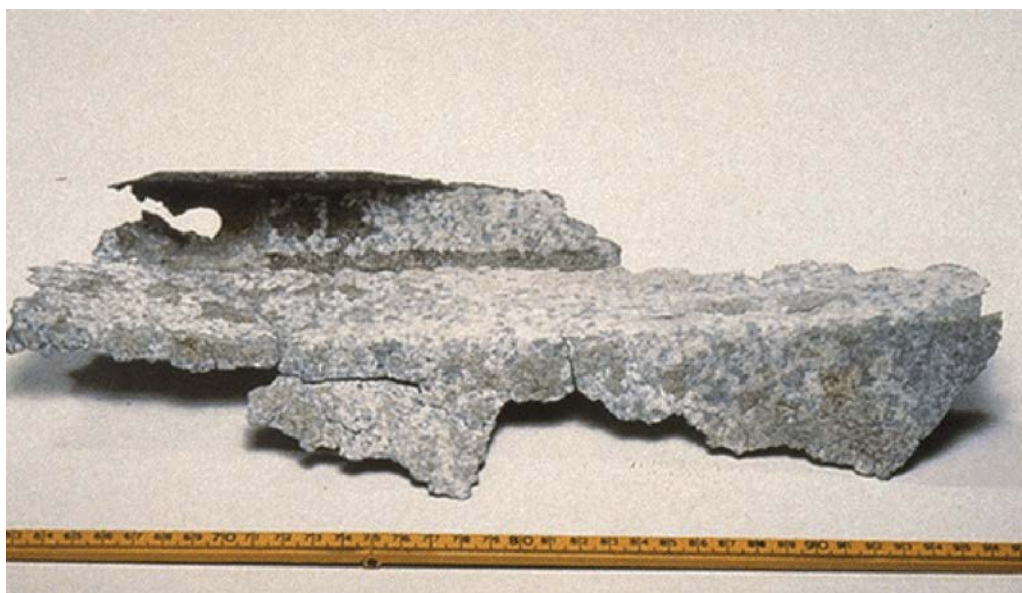
Atmospheric corrosion.

Uniform attack.

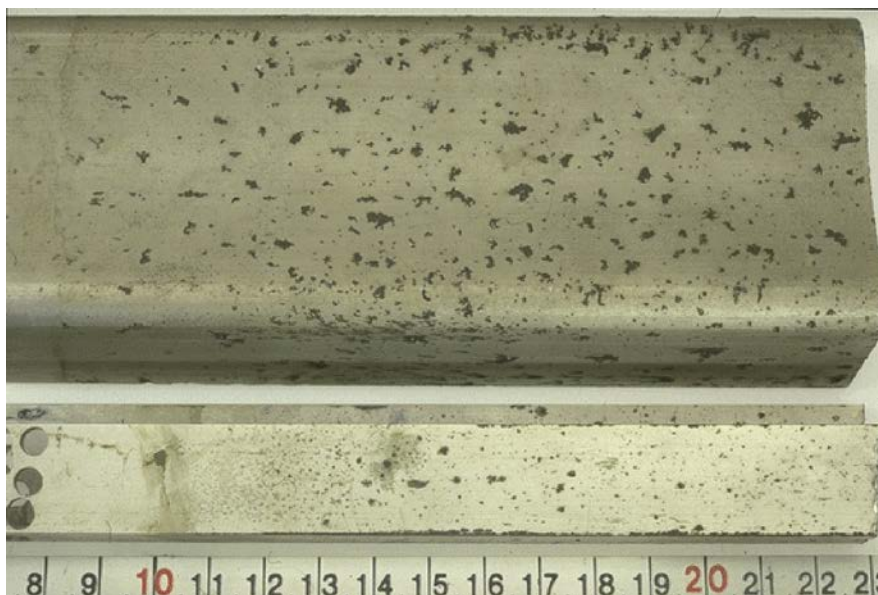
PART Part of outer wall.

PHENOMENON Atmospheric corrosion.

APPEARANCE Pitting.

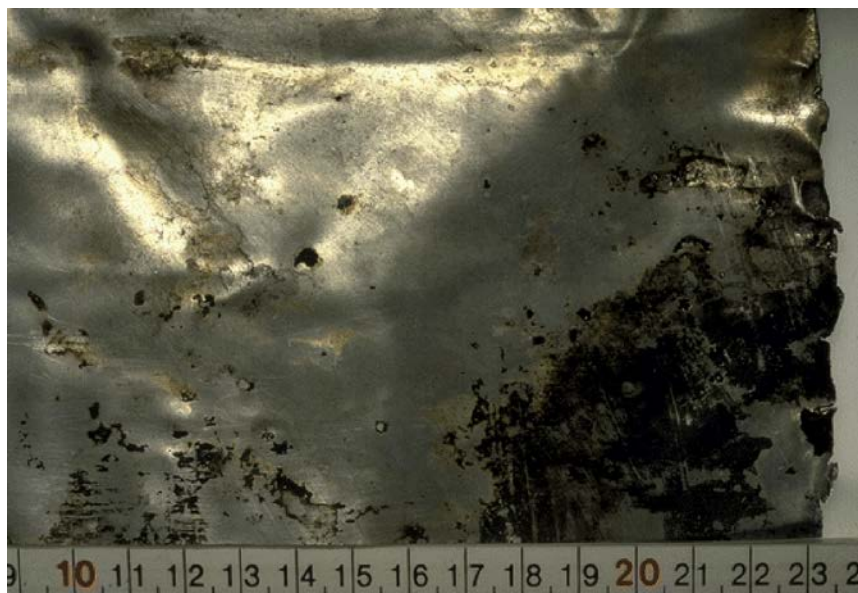
PART Roof cover.

PHENOMENON Stray current corrosion.

APPEARANCE Pits and perforations around the antenna cable attachment sites.

CAUSE Stray current corrosion of the roof covering occurred as a result of defective earthing of the antenna motor.

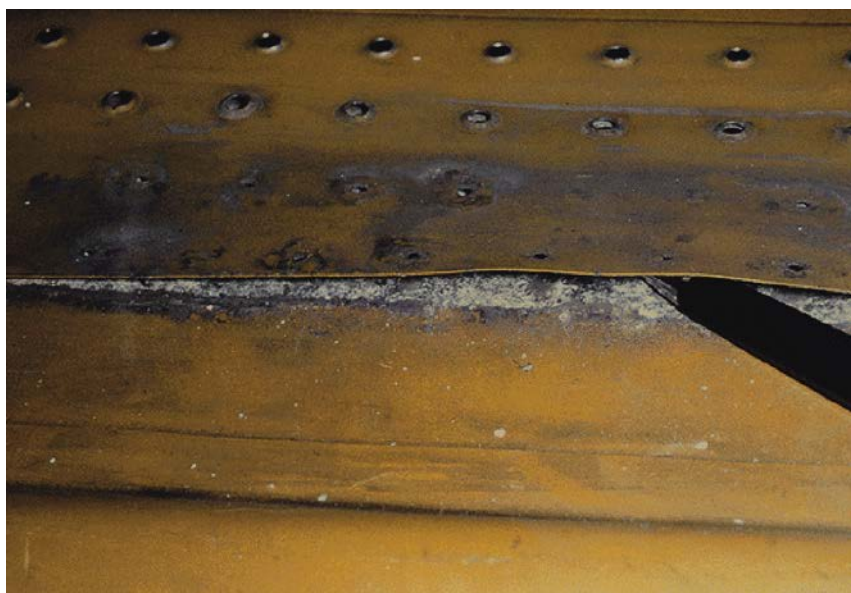
PART Elevator panel.

PHENOMENON Crevice corrosion.

APPEARANCE Sheet material in lap joint is severely attacked.

CAUSE The spot-welded lap joint of two sheets remained unsealed. Hence, (salt) water was able to penetrate into the joint (see also Case Histories [07.16.13.01](#) and [07.25.13.01](#)).

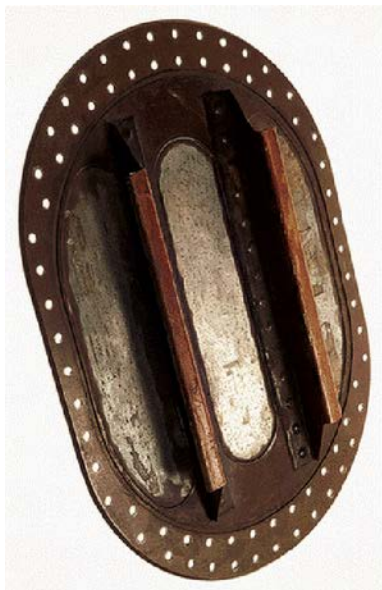
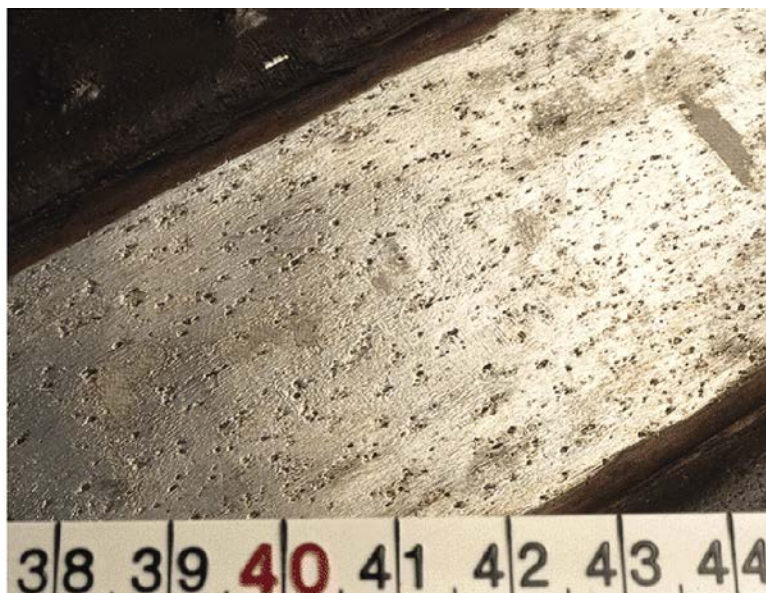
PART Tank hatch.

PHENOMENON Microbiologically influenced corrosion.

APPEARANCE Pitting attack.

CAUSE Microbiological activity of bacteria (*Pseudomonas fluoresces*, *micrococcus*), yeast (*Rhodoturula*), and fungi (*Cladosporium resinae*, *Penicillium chrysogonium*, *Aspergillus niger*) in fuel tanks resulted in the formation of sludge and metabolism products which induced severe pitting attack.

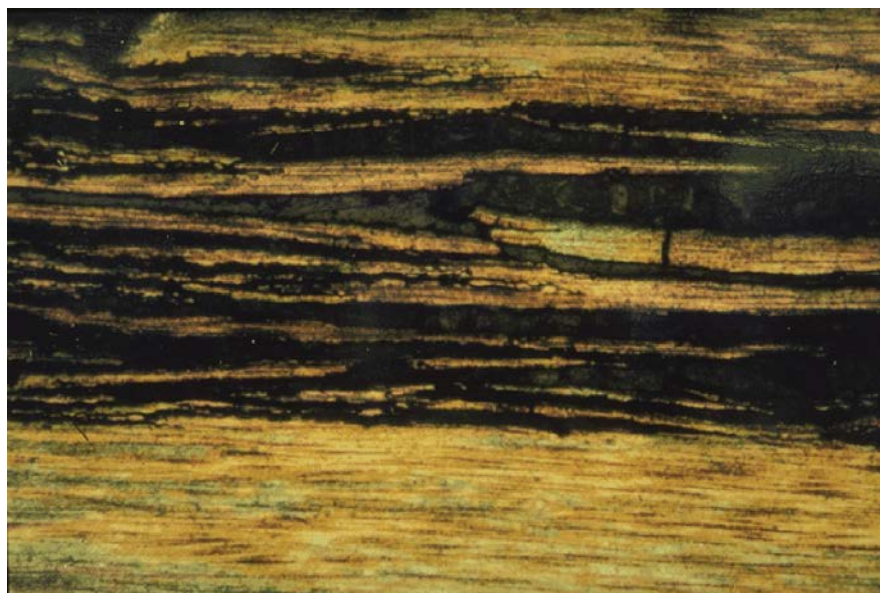
PART Sample from the horizontal tailplane.

PHENOMENON Intergranular corrosion (exfoliation).

APPEARANCE Micro photo of layered corrosion, invariably initiating from a rivet hole.

CAUSE Because of the highly pronounced, extended grain structure (typical of exclusions), which unfortunately intersects the surface, this material is sensitive to exfoliation corrosion (see also next three cases). Corrosive electrolytes have initiated the exfoliation by penetration in the space between rivet and hole.

REMEDY The damage can cause the component to fail; therefore, measures must be taken. These could be:

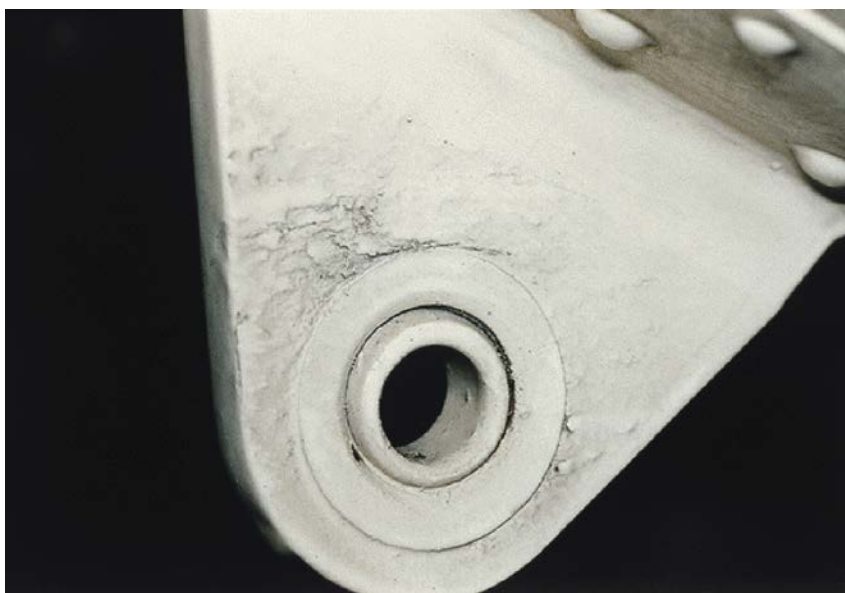
PART Attached fitting.

PHENOMENON Intergranular corrosion (exfoliation).

APPEARANCE Selective corrosion along subsurface paths parallel to the surface. The voluminous corrosion products force the uncorroded metal layers away, giving rise to a layered appearance.

CAUSE Insufficient protection.

REMEDY Remove corrosion, check if remaining cross-section is sufficient and apply protective coating.

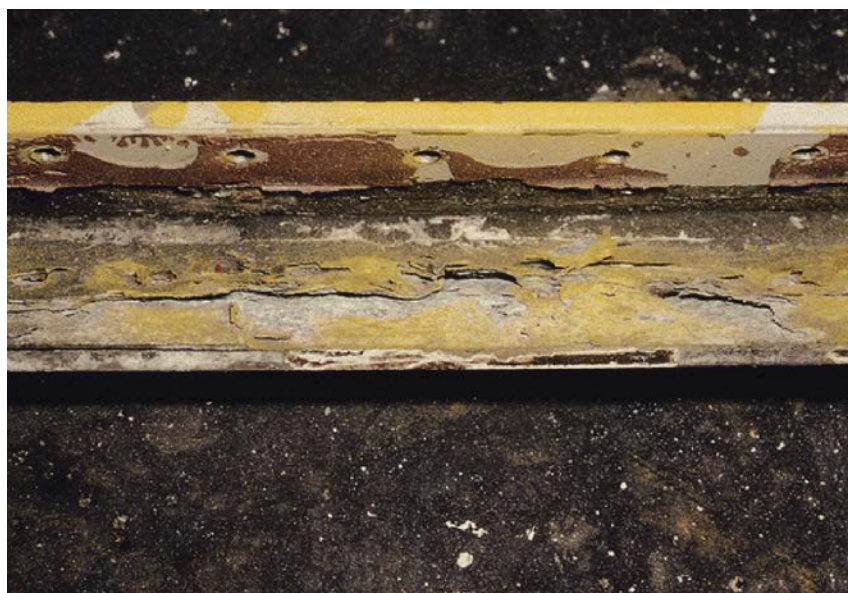
PART Longeron in fuselage.

PHENOMENON Intergranular corrosion (exfoliation).

APPEARANCE Partly corroded away.

CAUSE Water accumulated at this site and was able to cause exfoliation corrosion, since alloy 7075 in the T6(51) (= peak-aged) condition is prone to exfoliation corrosion.

REMEDY Use aluminum alloy 7075 in the over-aged (T7) heat treatment condition.

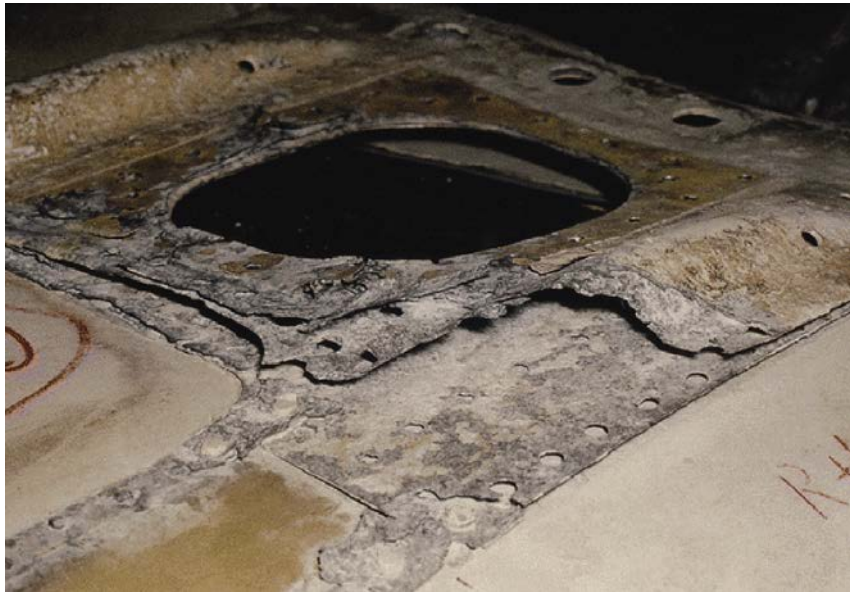
PART Fairing (wing fuselage).

PHENOMENON Intergranular corrosion (exfoliation).

APPEARANCE Partly corroded away.

CAUSE Aluminum alloy 7075 in the T6(51) (= peak-aged) condition is prone to exfoliation corrosion (see also Case Histories [07.11.19.01](#) and [07.20.19.01](#)).

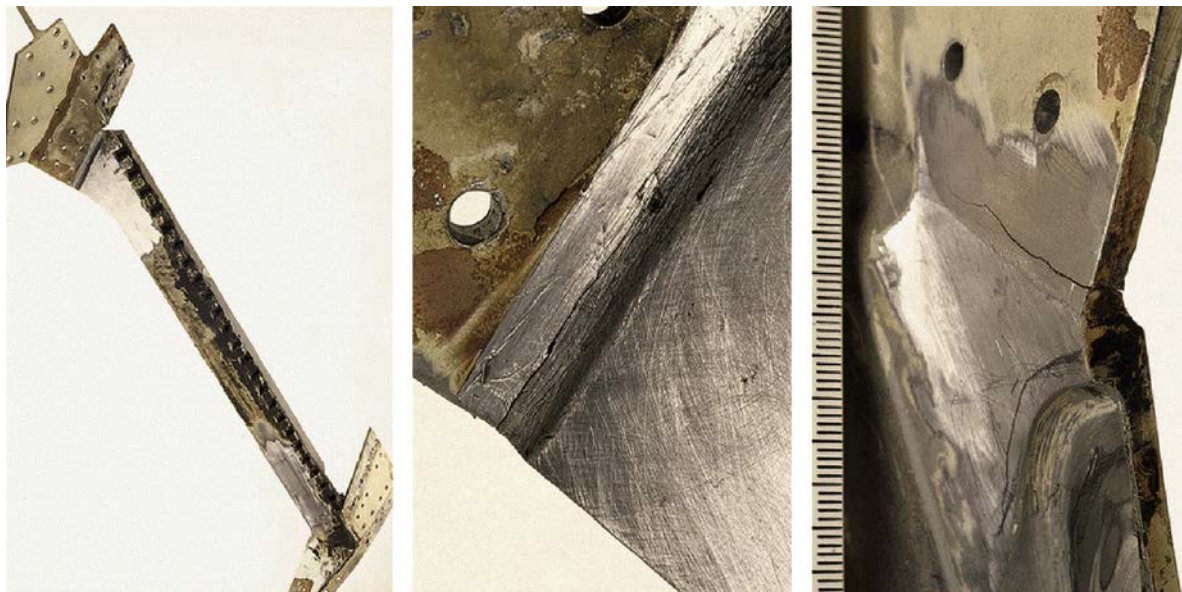
PART Window post.

PHENOMENON Fatigue.

APPEARANCE Surface flaw in radius of the window post.

CAUSE The cabin pressurization cycle generated fretting between skin edge and window post. Multiple fatigue sites, originating in the radius at the transition of the post-to-flange, form one primary crack front which proceeds through the cross-section.

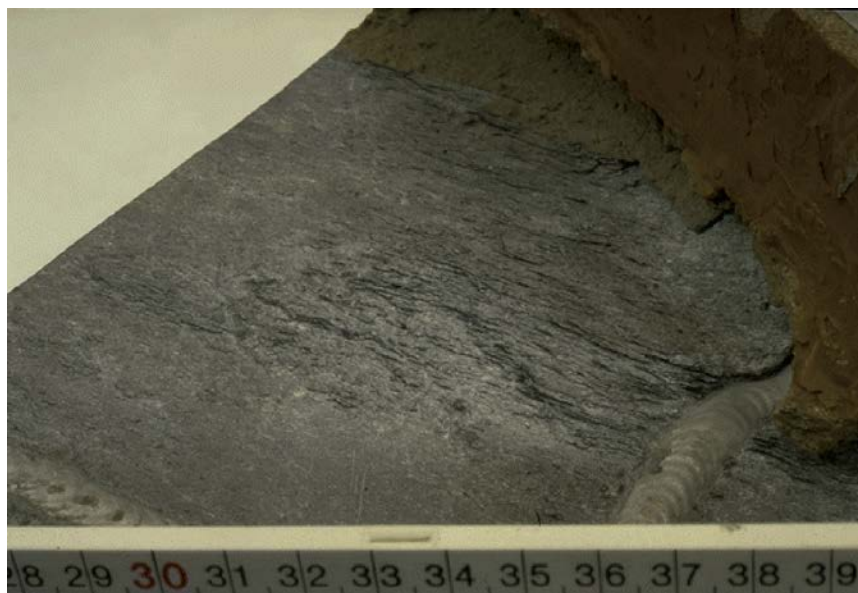
07.20.19.01

MATERIAL	Aluminum 99%.
SYSTEM	Army tank.
PART	Part of the outside of the asbestos-insulated oil reservoir.
PHENOMENON	Intergranular corrosion (exfoliation).

APPEARANCE Layered corrosion.

CAUSE As a result of the regular wetting of the insulation and the direct contact with the asbestos, the aluminum is subject to layered attack so that more and more new aluminum oxide layers are formed (see also Case Histories [07.11.19.01](#) and [07.19.19.01/02/03/04](#)).

REMEDY It was possible to prevent the corrosion by applying a plastic film between the aluminum and the asbestos (nowadays the use of asbestos as insulation material is prohibited because of its carcinogenic effect).

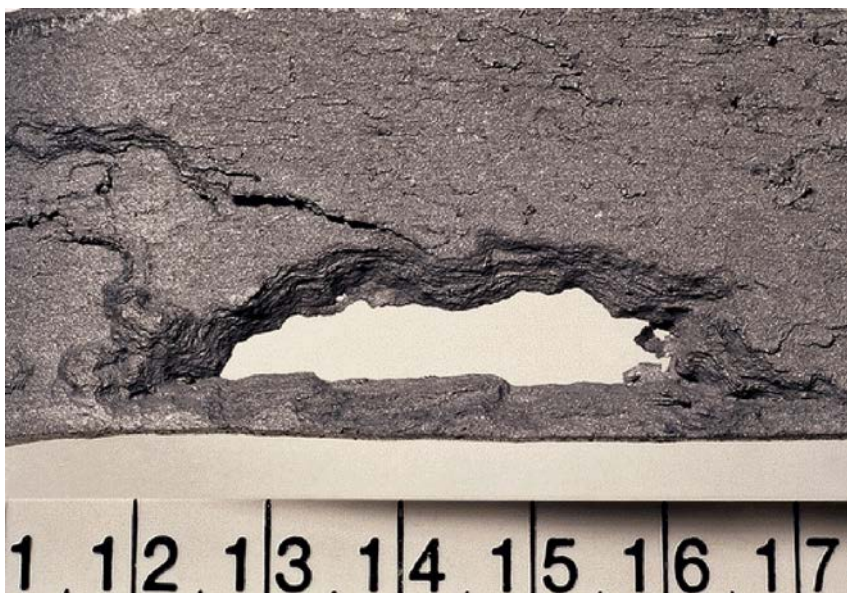
PART Fuel tank.

PHENOMENON Intergranular corrosion (exfoliation).

APPEARANCE Loss of material by layered attack resulting in flaking-off.

CAUSE During the polycondensation, water was formed and liberated. Wetting of the insulation caused a humid chloride-containing atmosphere to form on the surface of the aluminum fuel tank, resulting in exfoliation corrosion of the aluminum alloy (see also former case).

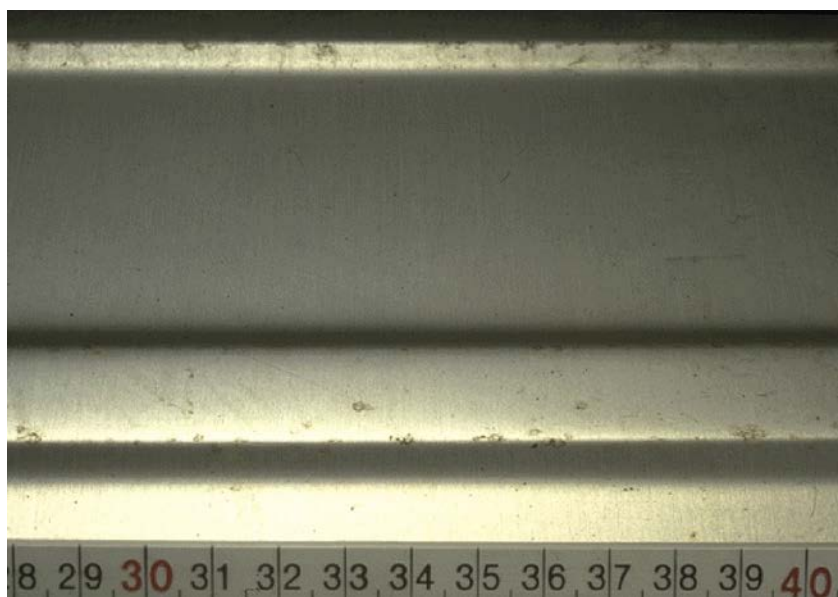
PART Exterior wall.

PHENOMENON Atmospheric corrosion.

APPEARANCE Pitting of the profiled edges.

CAUSE Damage to the anodizing layer due to shaping of the aluminum plates after anodizing.

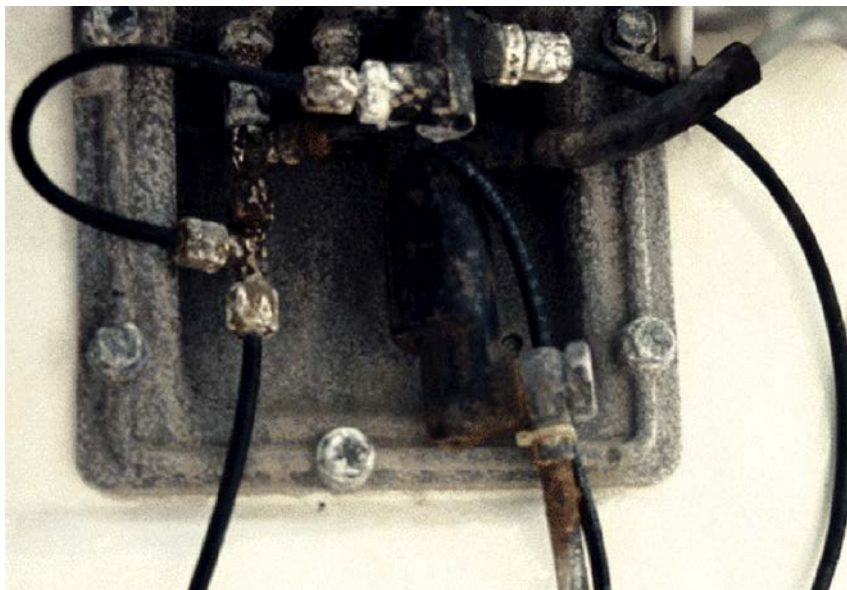
07.20.24.02

MATERIAL	-Aluminum G-AlSi12(Cu). -Zinc-plated steel.
SYSTEM	Automotive system.
PART	Aluminum-mounting panel with various zinc-plated parts.
PHENOMENON	Atmospheric corrosion.

APPEARANCE	Various white corrosion products and some red rust.
TIME IN SERVICE	Estimated: about 2 years under normal road conditions.
ENVIRONMENT	Very severe road conditions (vehicle corrosion test).
CAUSE	“Overall corrosion” caused by a combination of dirt, road salts, and humidity.
REMEDY	<ul style="list-style-type: none"> • Complementary protection by coating or shielding. • Electrocoating on aluminum parts.

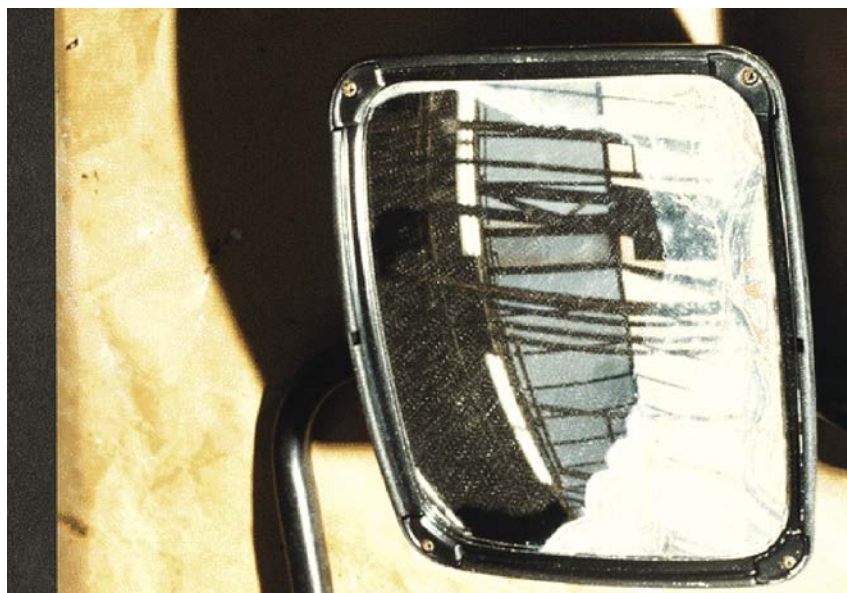
PART Exterior vehicle mirror.

PHENOMENON Atmospheric corrosion.

APPEARANCE A dull, nonreflecting mirror surface.

ENVIRONMENT Very severe road conditions (vehicle corrosion test): combination of dirt, road salts, and humidity.

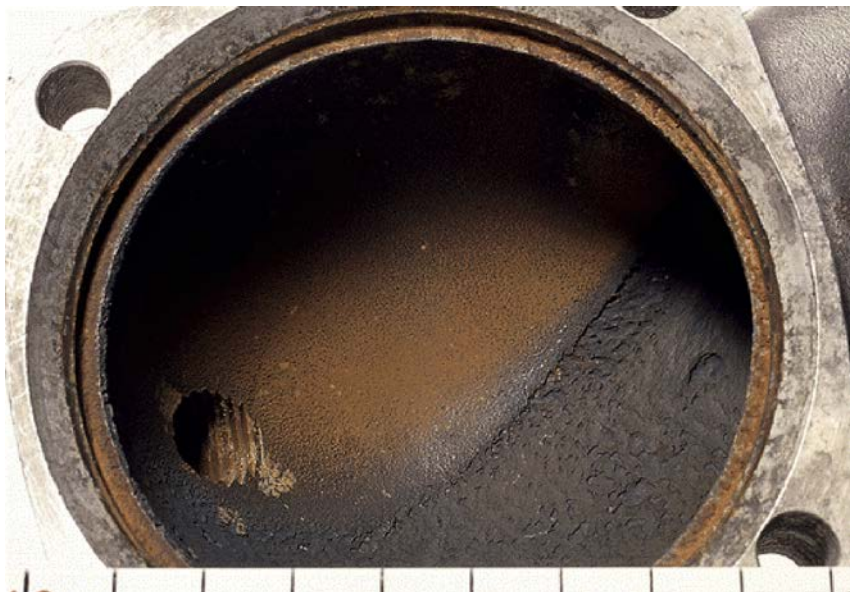
PART Water-cooler lid.

PHENOMENON Cavitation corrosion.

APPEARANCE Inside: flow pattern with pitting.
Outside: perforation of one of the hose pillars.

CAUSE Excessive velocity and turbulence of the water flow in combination with corrosion.
Strong vibration of hose near hose pillar (see also next case).

REMEDY Use appropriate flow and vibration conditions and an inhibited water-antifreeze mix.

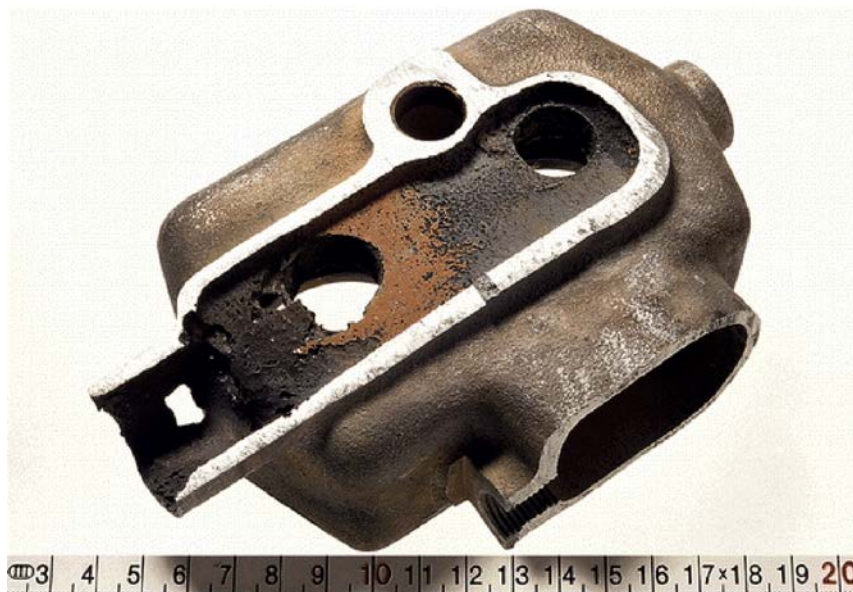
PART Thermostat housing of cooling system.

PHENOMENON Cavitation corrosion.

APPEARANCE Material partly worn away; many sharp-edged pits and holes.

CAUSE Part opening of the ineffective thermostat-caused cavitation of the aluminum housing by high velocity, turbulent, liquid flow (see also former case).

REMEDY Replace by an effective thermostat.

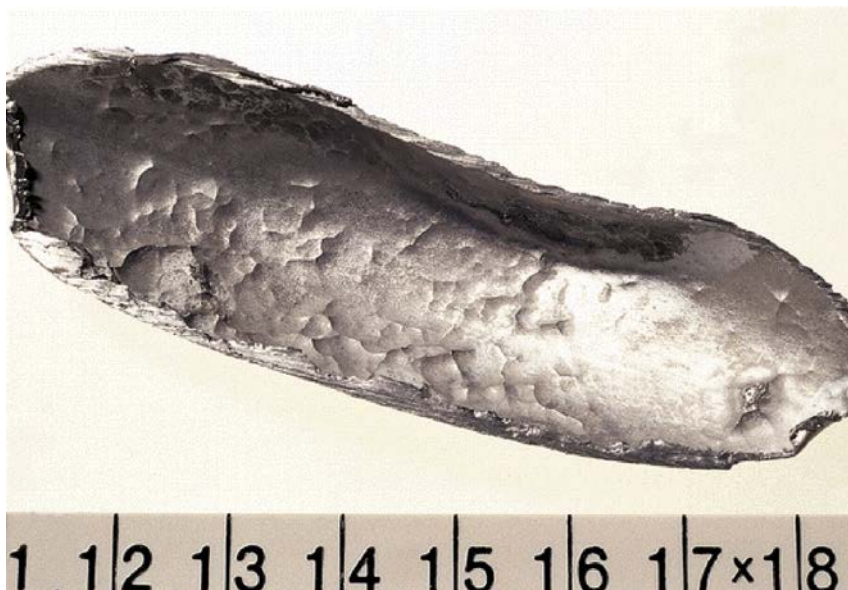
PART Pipe from cooling system.

PHENOMENON Erosion corrosion.

APPEARANCE Thinning with horseshoe pattern.

CAUSE Excessive velocity resulting in turbulent flow pattern.

- Create better, less turbulent, flow conditions.
- Use inhibited antifreeze–water mixes.

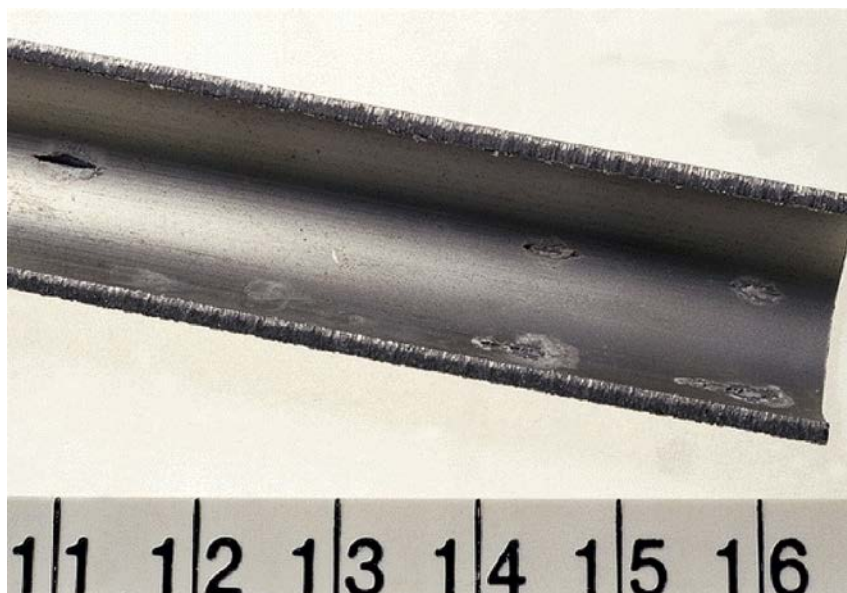
PART Pipe from cooling system.

PHENOMENON Material defects.

APPEARANCE Line pitting attack to inner pipe surface.

CAUSE Defects in pipe surface caused by extrusion process: material overlaps (“doublings”) as shown by metallographic examination.

REMEDY Use better-quality pipe, without defects.

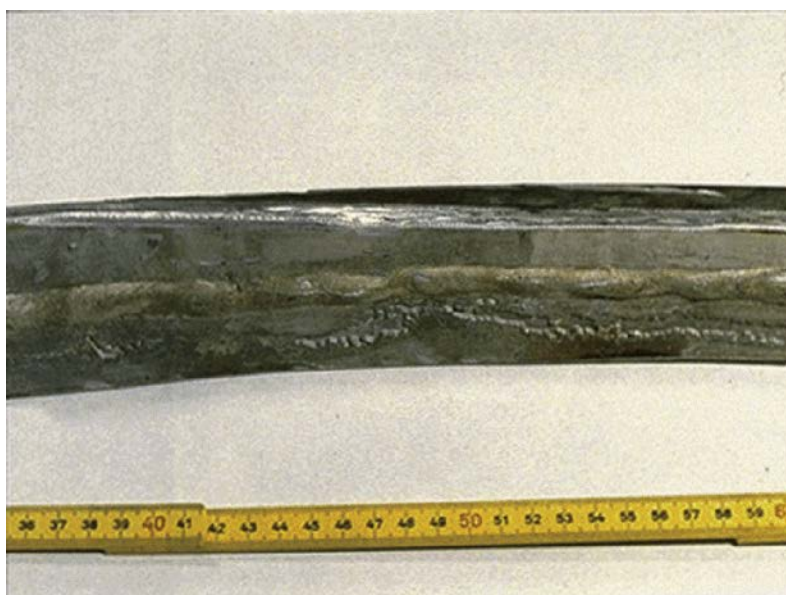
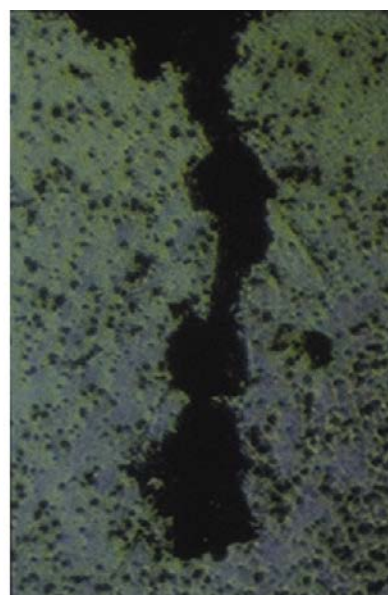
PART Air discharge pipeline.

PHENOMENON Intergranular corrosion (weld decay).

APPEARANCE Severe attack beside the weld.

ENVIRONMENT Air with a relative humidity of 100%, temperature 25°C, contaminated with traces of H₂S and CS₂, sometimes with NaOH. pH of condensate normally 7.5, occasionally rising to 10.

CAUSE Excessive heat application on welding: not properly cooled. This has led to demonstrable structural changes, as disclosed by the microscopic examination, as a result of which the material has become locally sensitive to corrosion. At each side (at 2 cm) of the weld, the hardness of the material has decreased by 25%.

REMEDY Weld decay can be restricted by sufficient cooling during the welding process. In the present case, the discharge pipeline is constructed as a glass-fiber-reinforced polyester pipe with PVC liner.

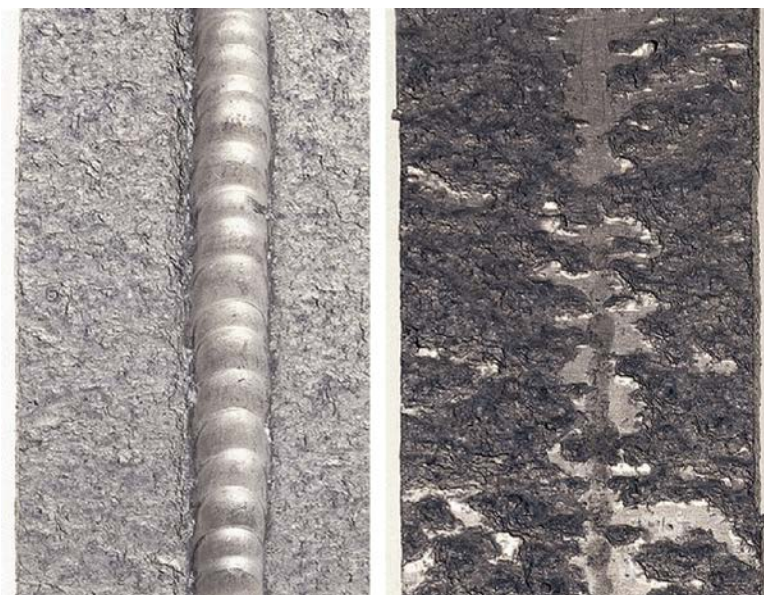
07.24.12.01

MATERIAL	Aluminum (S 57).
SYSTEM	Test rig.
PART	Welded aluminum test plate (weld: AlMn).
PHENOMENON	Chloride attack.

APPEARANCE General corrosion of the sheet material, the weld itself was not corroded.

CAUSE The aluminum sheet is not resistant to seawater, in contrast to the weld with a different composition and structure.

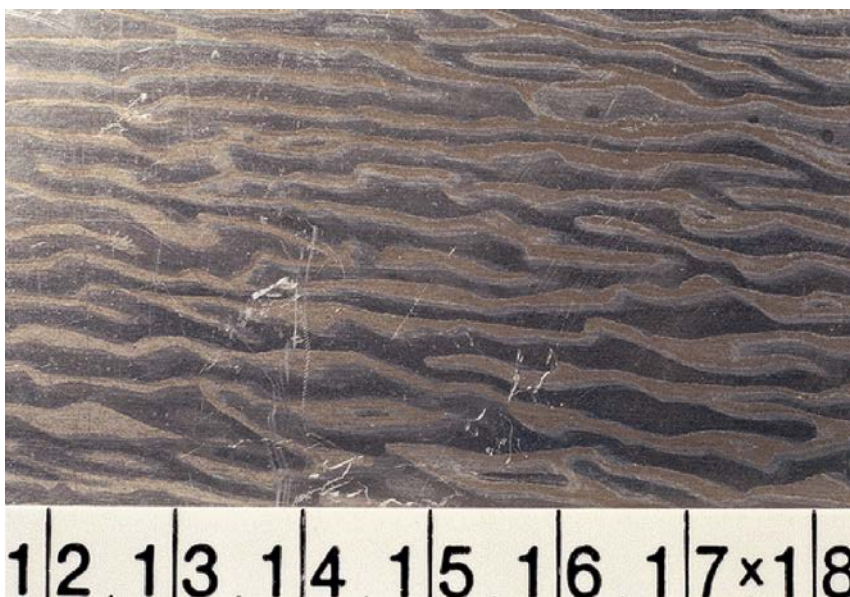
PART Aluminum sheet material.

PHENOMENON Crevice corrosion.

APPEARANCE Stripe-like discolorations (with scratches caused by mechanical damage).

CAUSE Forming of differential aeration cells by the aluminum being in close contact with the wet corrugated cardboard. The photo shows the very beginning of crevice corrosion.

REMEDY Storage under dry conditions.

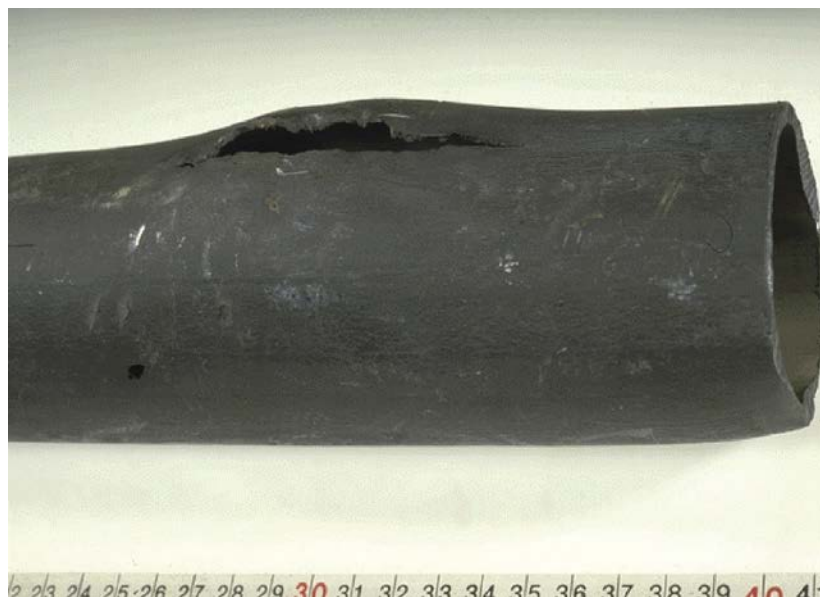
Erosion (deformation by water hammer).

Pipe fractured.

The yield stress of the material was exceeded due to pressure peaks (water hammer) caused by the sudden closing of a valve (see also Case History 06.02.32.01).

Replace the valve by a slow-closing valve or provide the system with an expansion vessel to absorb the pressure peaks.

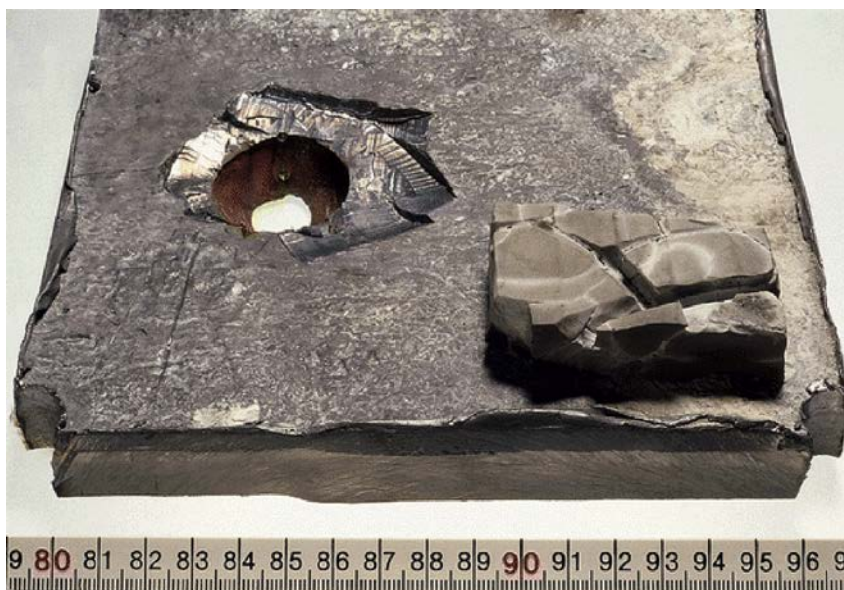
PART Stripping column.

PHENOMENON Acid corrosion.

APPEARANCE Spalling porcelain, mechanical damage/corrosion lead, uniform corrosion carbon steel. For the purpose of the photograph, part of the porcelain liner is placed loose on the lead membrane.

CAUSE Porcelain spalled due to temperature changes, 50% H_2SO_4 touches the lead and above 90°C lead corrodes, after which carbon steel corrodes severely. Lead was also locally damaged by the mechanical force needed to remove the porcelain. As a result, the corroded lead surface is no longer visible.

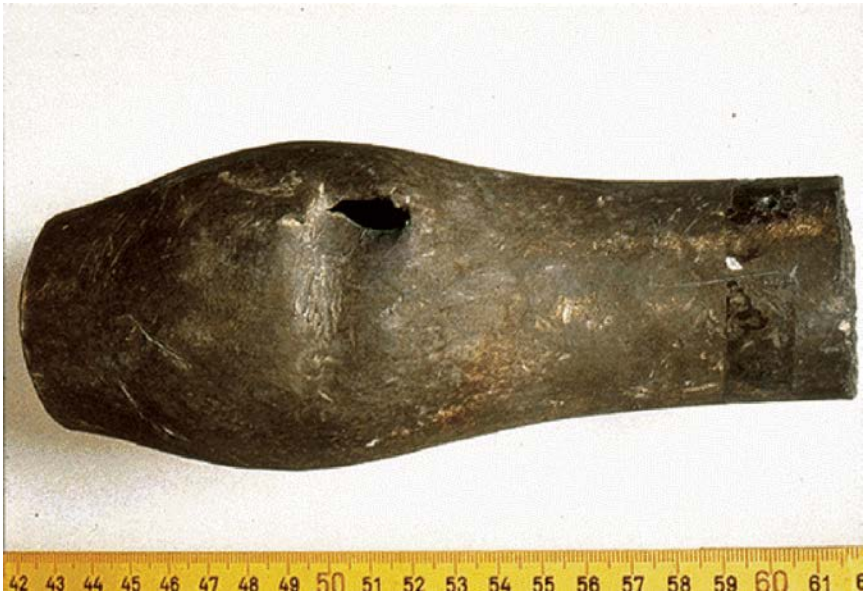
APPEARANCE	Pipe locally swollen and burst open.
TIME IN SERVICE	Unknown.
ENVIRONMENT	Flue gases at approximately 80°C through the pipe; sulfuric acid around the pipe.
CAUSE	The temperature of the flue gases caused accelerated creep of the material (see also Case History 01.01.30.02).
REMEDY	<ul style="list-style-type: none"> • Change material by taking a copper pipe and sheathing it in lead, or • Construct the heating pipe from Hastelloy C.

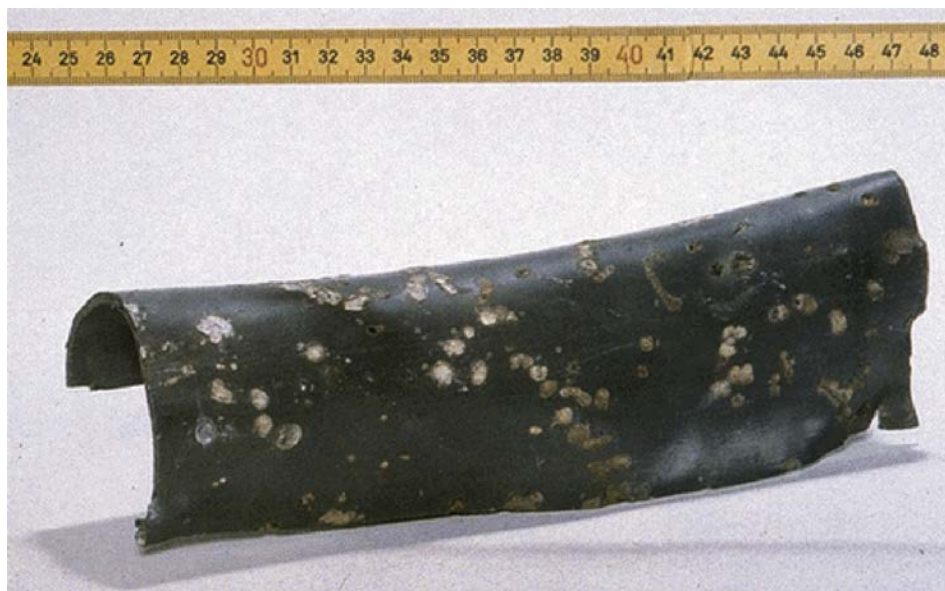
08.15.26.01

MATERIAL	Lead.
SYSTEM	Energy transmission system.
PART	The jacket of an underground 10 kV cable.
PHENOMENON	Stray-current corrosion.

APPEARANCE	Pitting attack, characteristic of this phenomenon in lead.
TIME IN SERVICE	19 years.
ENVIRONMENT	Soil (no sulfide present); pH 8.3; not corrosive to lead; corrosion products: PbO_2 , PbSO_4 , PbCl_2 .
CAUSE	Stray currents leaving the cable locally owing to its siting at a railway station. The pitting attack is typical of stray-current corrosion in lead.
REMEDY	The cable should be moved to a more favorable location, and for added certainty, the lead jacket should be replaced by a plastic jacket.

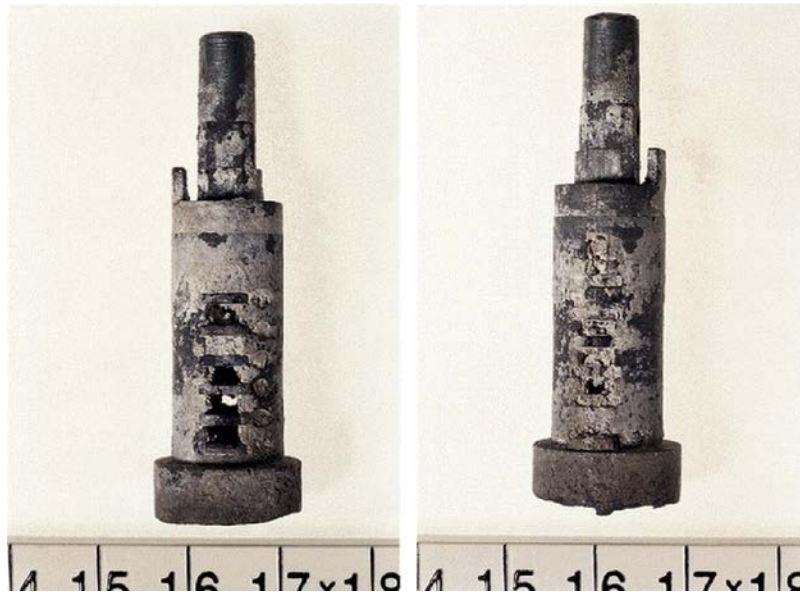
PART Door lock.

PHENOMENON Atmospheric corrosion.

APPEARANCE Blocking of slides by zinc-corrosion products.

ENVIRONMENT Moist from atmosphere with road-salts and road dirt.

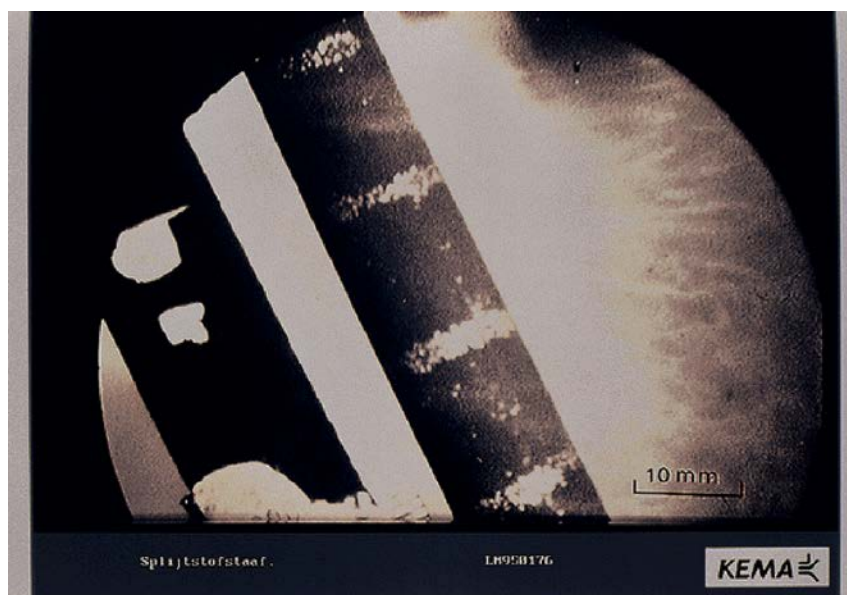
09.01.07.01

MATERIAL	Zircalloy.
SYSTEM	Boiling water reactor (pressure: 5.4 MPa).
PART	Fuel element filled with uranium oxide pellets.
PHENOMENON	Heat-flux corrosion (nodular corrosion).

APPEARANCE	On the interfaces of the pellets, small rings of pitting corrosion were present at the cooling side of the element. The corrosion product is still present as hard pustules.
TIME IN SERVICE	Unknown.
ENVIRONMENT	Pure water.
CAUSE	The water–steam mixture runs along the outside of the Zircalloy cannings. The heat flux varies over the length of the element. On the interface of the tablets, the heat flux is critical for local boiling of the water, a process known as nucleate boiling or columnar boiling. This boiling process on nucleates causes pitting corrosion (see also Case Histories 01.01.07.03/04). In nuclear technology, this type of corrosion is called nodular corrosion.
REMEDY	Removal of the fuel elements before leakages occur. There is no remedy for nodular corrosion.

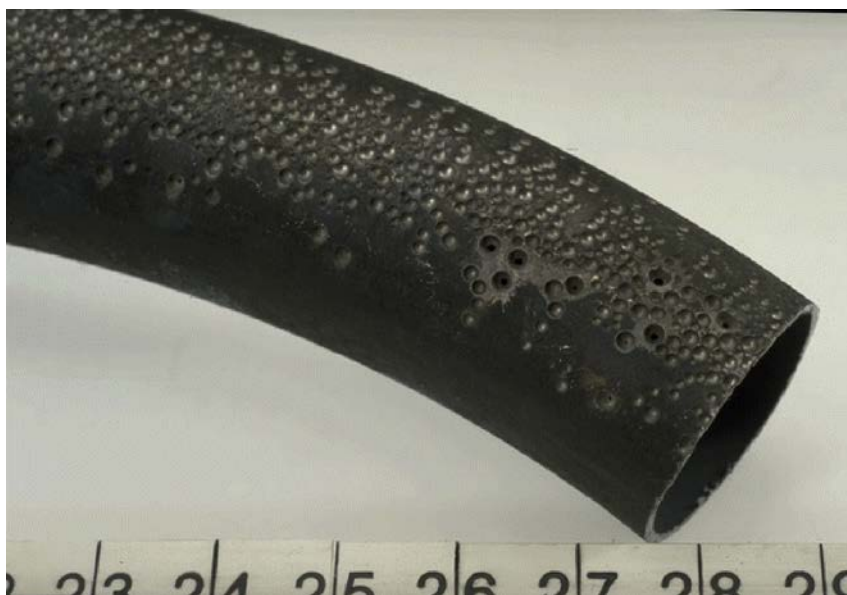
PART Heating coil.

PHENOMENON Cavitation corrosion.

APPEARANCE Pitting corrosion in the form of numerous small cavities, the pipe being perforated at various places.
