Corrosion Atlas

THIRD, EXPANDED AND REVISED EDITION

A Collection of Illustrated Case Histories

Evert D.D. During

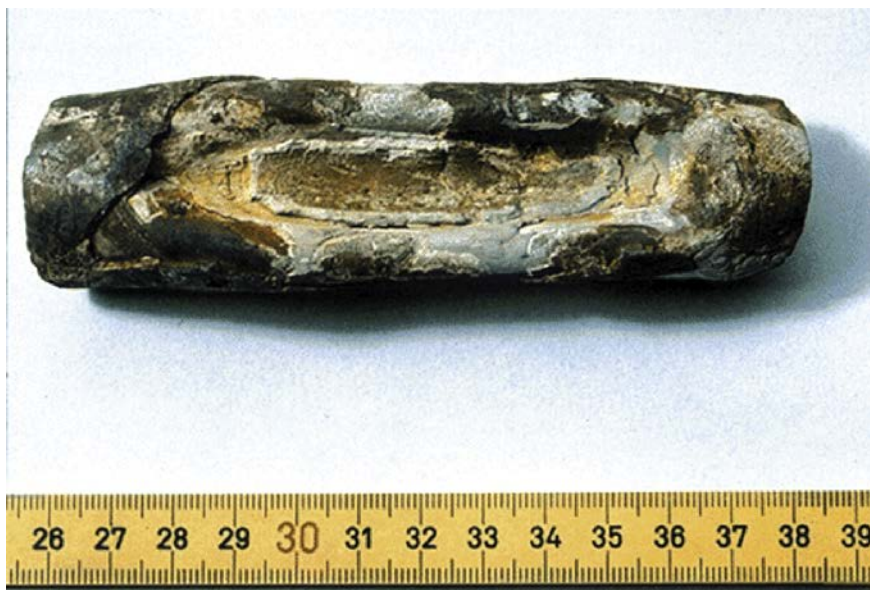
PART Gas inlet pipe.

PHENOMENON Chlorine corrosion.

APPEARANCE Uniform attack, with brittle silver chloride layer being formed.

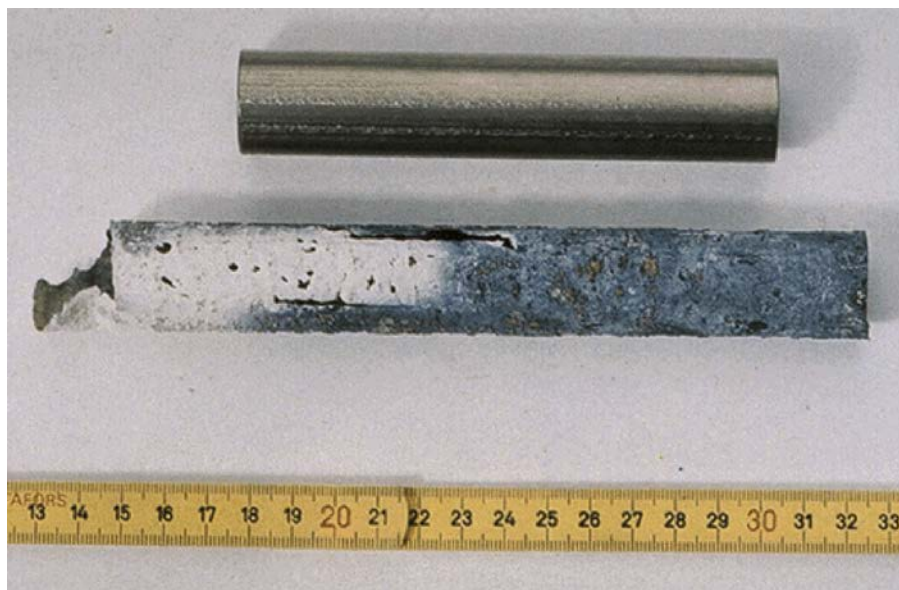
09.11.08.02

MATERIAL	Zirconium.
SYSTEM	Heat exchanger in chlorine manufacturing plant (chlorine through and cooling water around the pipes).
PART	Pipe in pipe bundle. Above: constructed of titanium; below: constructed of zirconium.
PHENOMENON	Chlorine corrosion.

APPEARANCE	Uniform attack with white oxides and annealing colors.
TIME IN SERVICE	1 week.
ENVIRONMENT	Chlorine-containing condensate; temperature approximately 25°C.

CAUSE Error in choice of material: one of the pipes was of zirconium instead of titanium. Zirconium is not resistant to this medium; on disassembly, spontaneous chlorine combustion occurred.

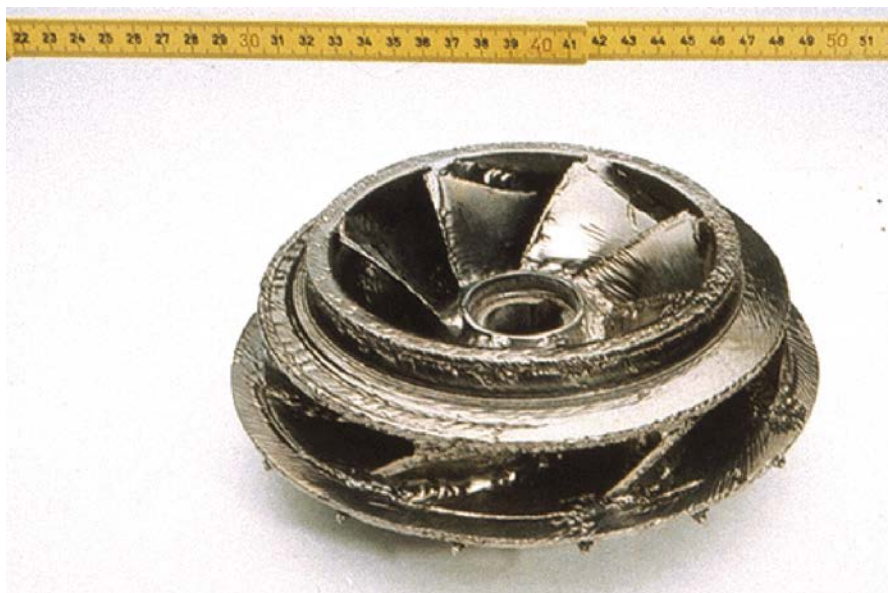
PART Impeller.

PHENOMENON Erosion corrosion and cavitation.

APPEARANCE Attack to impeller, with a distinct flow pattern.

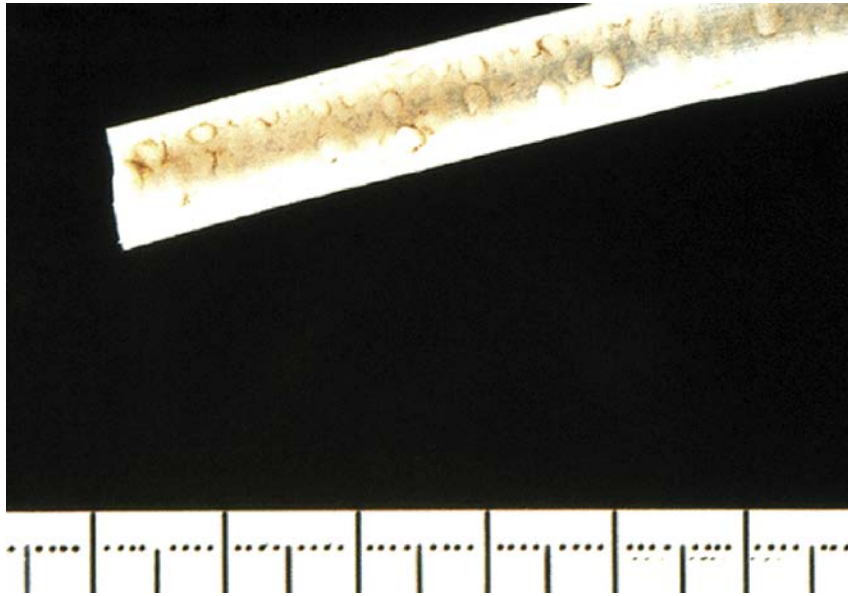
PART Cooling pipe.

PHENOMENON Diffusion.

APPEARANCE Blistering.

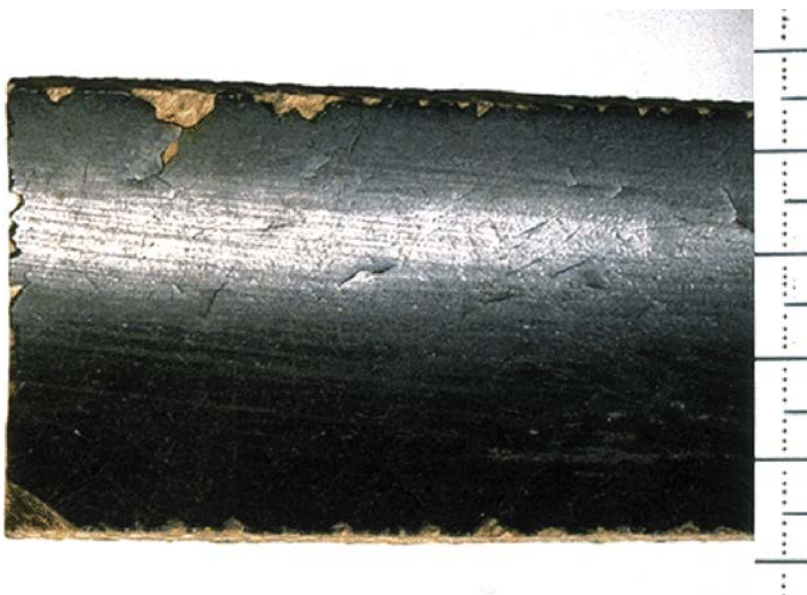
10.02.37.02

MATERIAL	Glass-fiber-reinforced epoxy.
SYSTEM	Steam condensate transport pipe.
PART	Pipe section.
PHENOMENON	Diffusion.

APPEARANCE	Flaking-off of the gel coat.
TIME IN SERVICE	5 years.
ENVIRONMENT	Condensate; temperature 95°C.

CAUSE The diffusion velocity through the gel coat is higher than that through the glass-fiber-reinforced sheeting. As a result, liquid collects at the boundary plane, causing the gel coat to flake off.

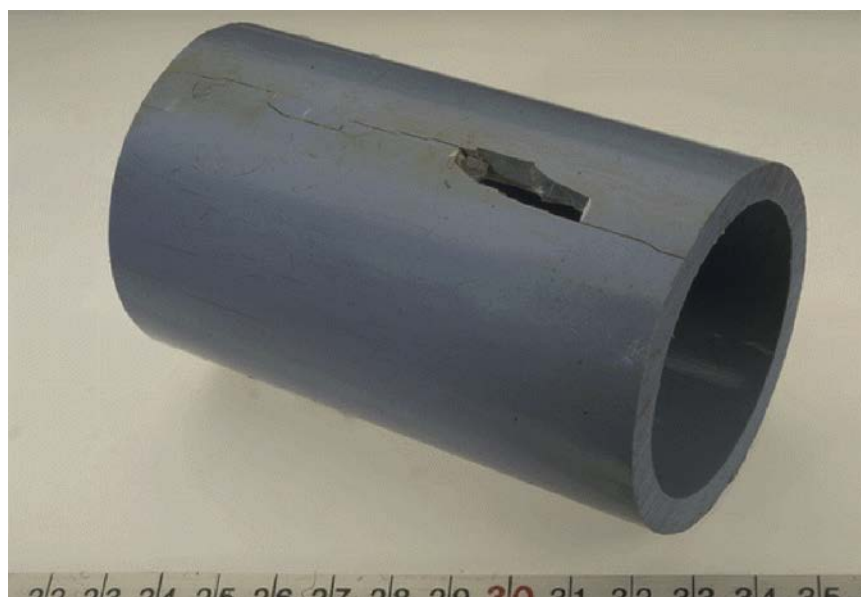
PART Outdoor pipe.

PHENOMENON Stress cracking (embrittlement).

APPEARANCE Longitudinal cracking, with a piece broken out.

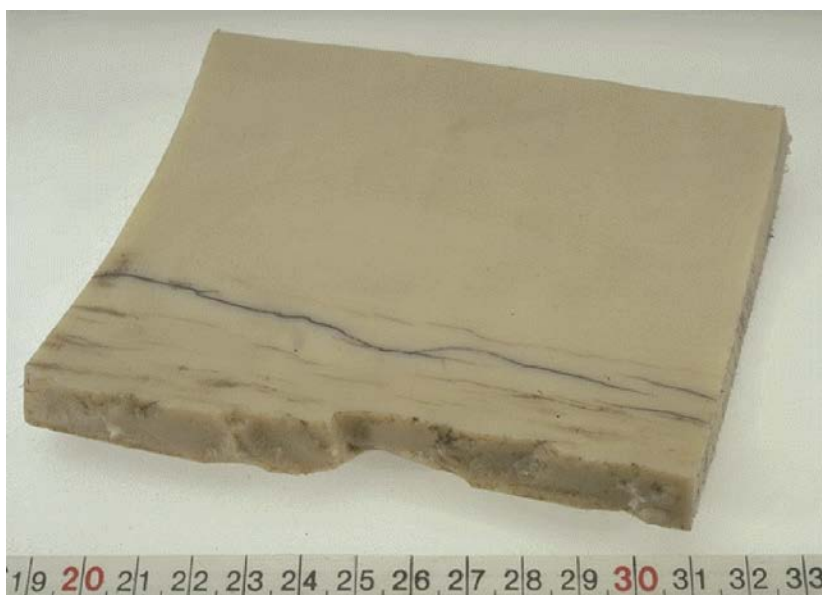
PART Sewer.

PHENOMENON Stress cracking (embrittlement).

APPEARANCE Parallel cracking.

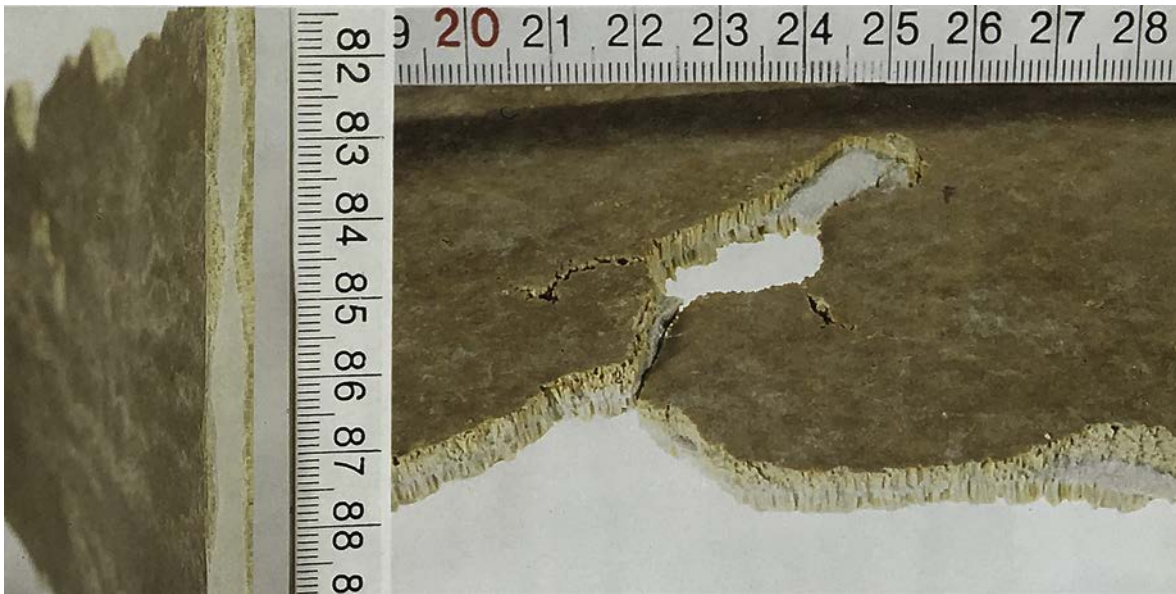
PART Upper part of cap.

PHENOMENON Aging.

APPEARANCE Material exhibits two-sided discoloration from gray to yellow, with needle structure.

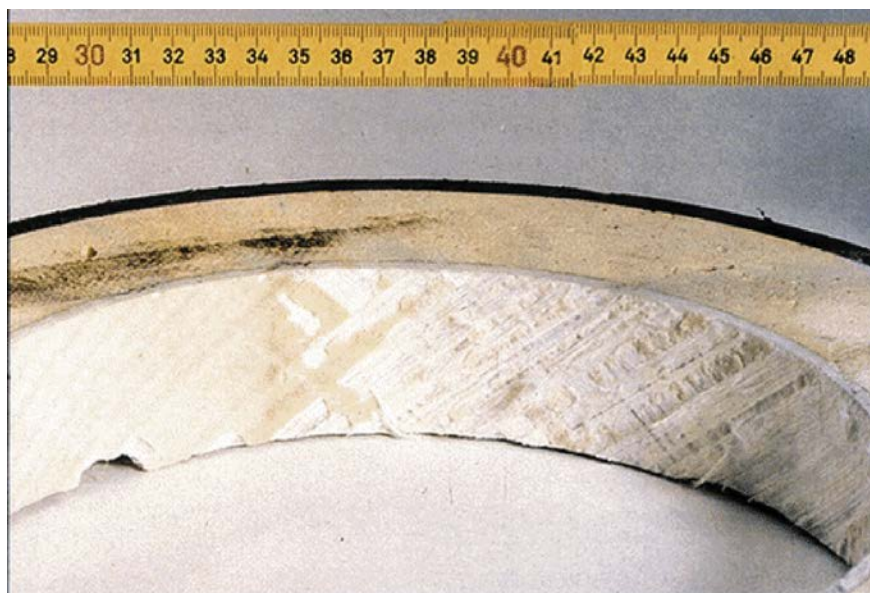
10.11.03.01

MATERIAL	Glass-fiber-reinforced vinyl ester (Fibercast, type F 1222).
SYSTEM	Caustic transport pipeline.
PART	Pipe section (provided with thermal insulation with electric tracing).
PHENOMENON	Caustic attack.

APPEARANCE	Resin layer partly disappeared, glass fibers frayed.
TIME IN SERVICE	2½ years.
ENVIRONMENT	50% NaOH; temperature 50°C–60°C; flowing and standing.
CAUSE	Diffusion of caustic through the resinous inner layer to the glass-fiber reinforcement, which was attacked. According to the supplier, the material was resistant to 50% caustic soda at 65°C.
REMEDY	Construction of the pipeline from epoxy or AISI 316 Ti stainless steel (W.-Nr. 1.4571).

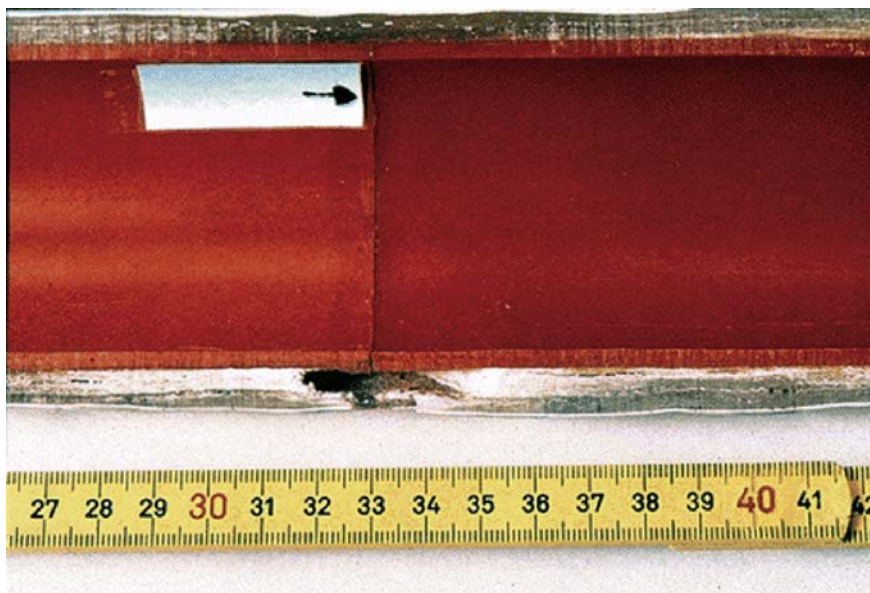
PART Pipe section.

PHENOMENON Caustic attack.

APPEARANCE Attack to the polyester at the weld.

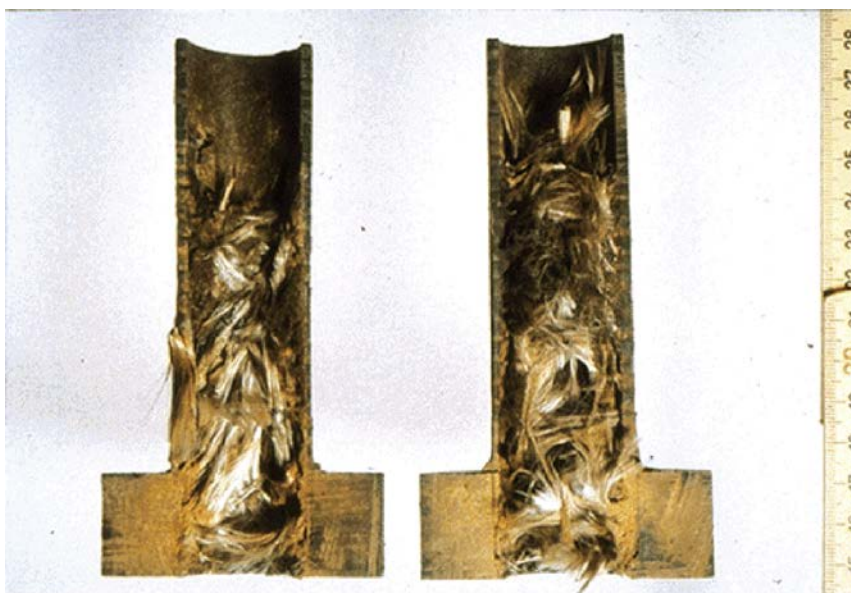
10.11.04.01

MATERIAL	Glass-fiber-reinforced epoxy.
SYSTEM	Formic acid transport system.
PART	Pipe with bonded connection flange.
PHENOMENON	Acid attack.

APPEARANCE Total disintegration of the reinforcement.

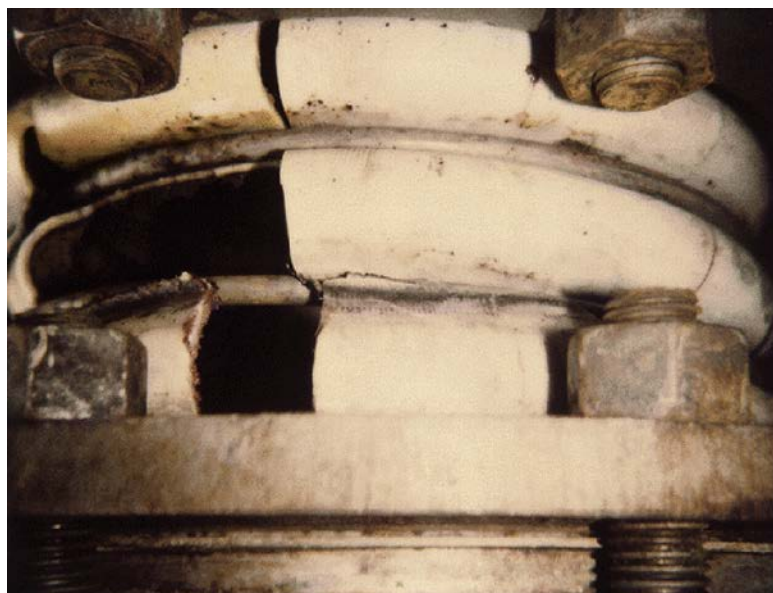
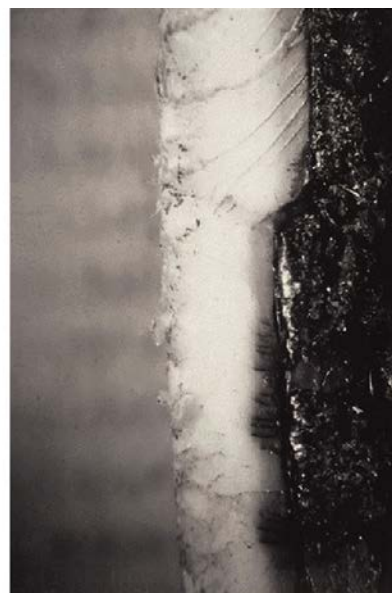
APPEARANCE Black brittle layer of corrosion products.

CAUSE Chemical attack of PTFE by HCl and aniline (see also Case History [10.11.28.01](#)).

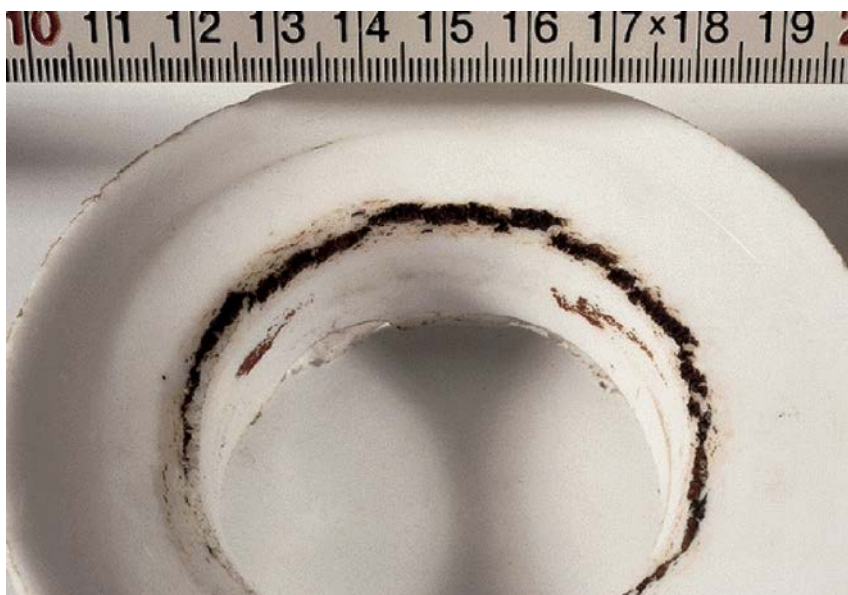
APPEARANCE Cracked lining.

CAUSE Corrosion fatigue due to temperature fluctuations and aniline in the medium (see also Case History [10.11.04.02](#)).

REMEDY Select Hastelloy C276 with corrosion allowance instead of PTFE-lined steel.

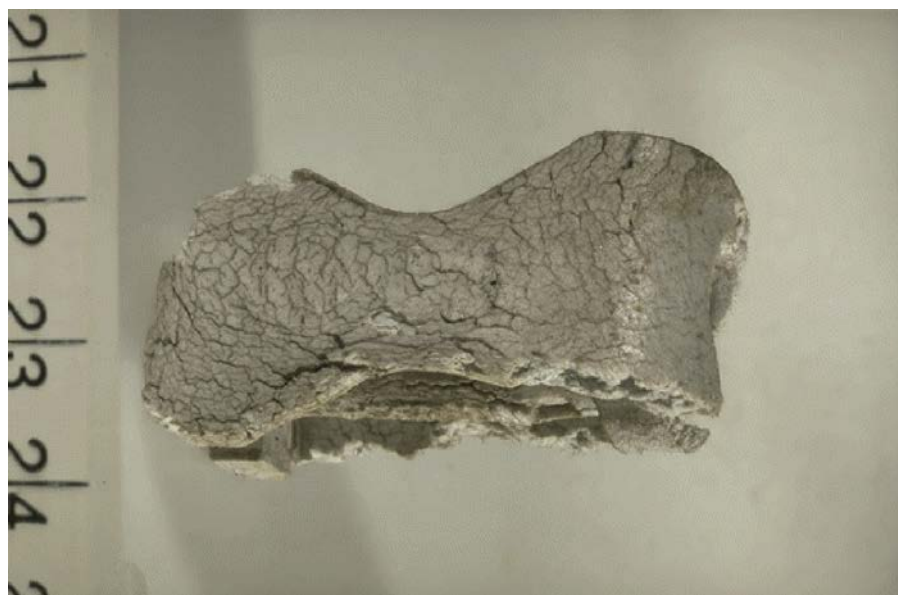
APPEARANCE Network of cracks and brittle fracture.

CAUSE Insufficient hardening of the melamine resin and use of inappropriate fillers led to accelerated aging.

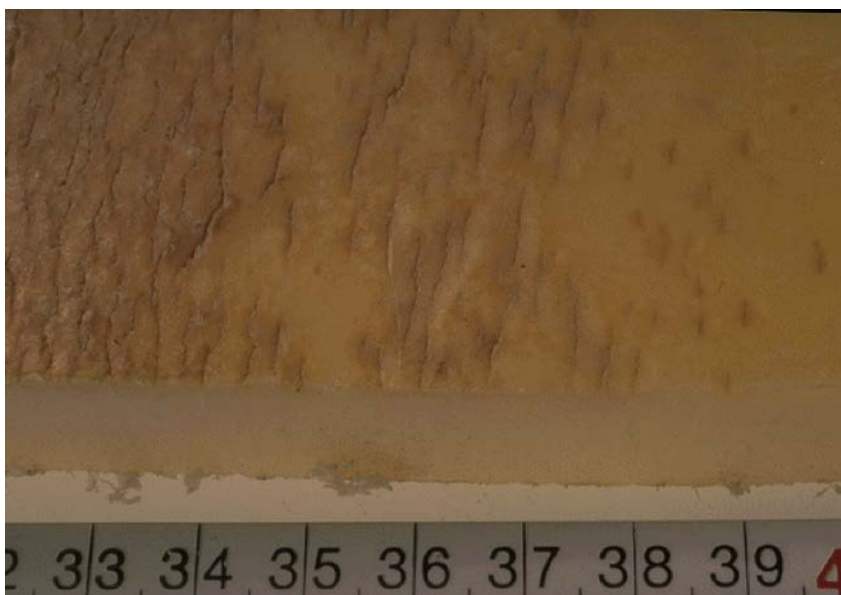
APPEARANCE Discolouration with cracking.

CAUSE Abnormal operating conditions. The design temperature was 90°C. Above 100°C, in the presence of oxygen, rapid aging takes place due to oxidation of the polyethylene.

REMEDY Use wearing plates made of ceramic tiles.

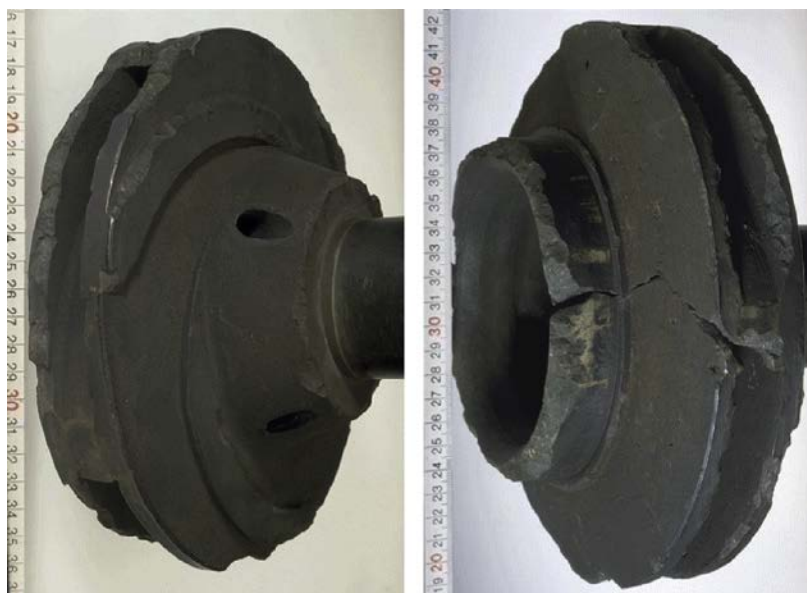
APPEARANCE Cracking.

CAUSE Cracking due to excessively high alkalinity and temperature.

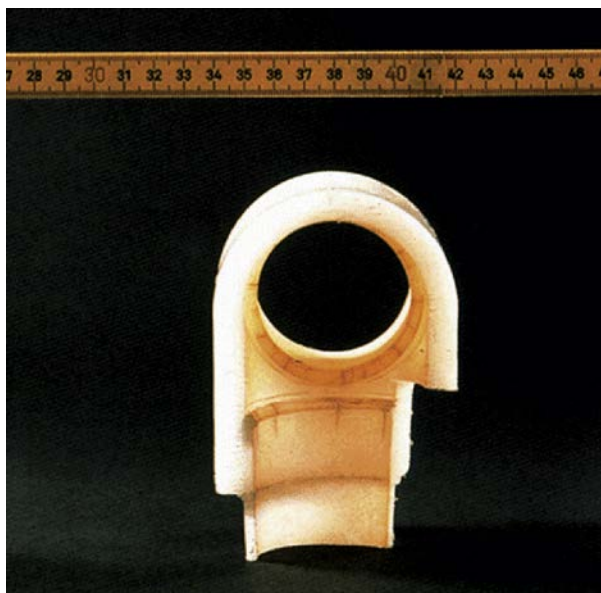
10.11.36.03

APPEARANCE	Cracking and uniform thickness reduction, respectively.
TIME IN SERVICE	About 4 months.
ENVIRONMENT	Chlorine-containing brine (NaCl); temperature 50°C–60°C.
CAUSE	The chlorine oxidizes the polypropylene; that part subject to stress begins to crack.
REMEDY	Use of PVDF filter.

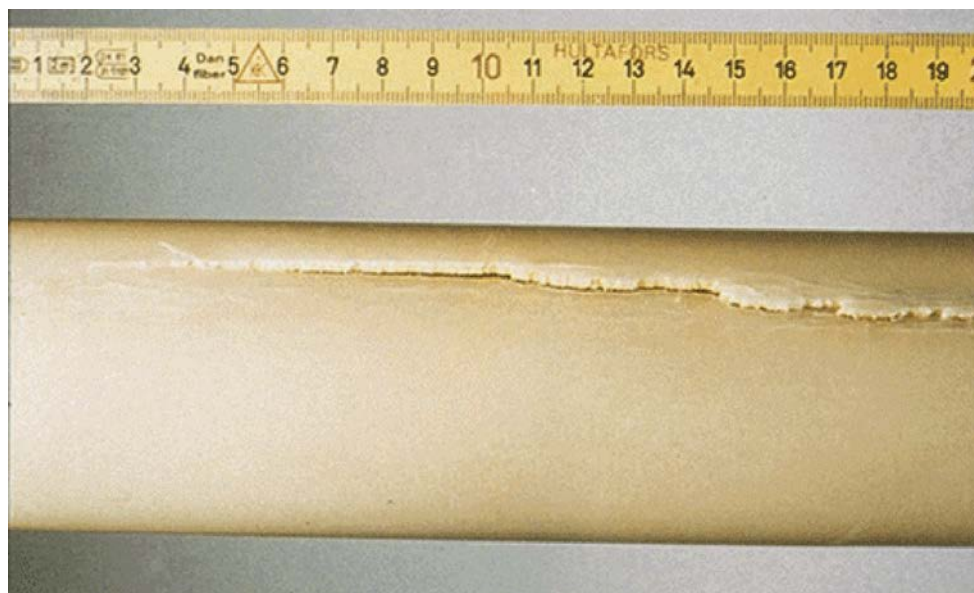
APPEARANCE Cracking.

CAUSE PSU is sensitive to the formation of stress cracking by combination of stresses with MIBK (but also by contact with acetone, benzene, butanol, ether, carbon tetrachloride, isopropanol, ethylbenzene, ethyl benzoate, methyl ethyl ketone, cyclohexanone, carbon disulfide, and nitromethane).

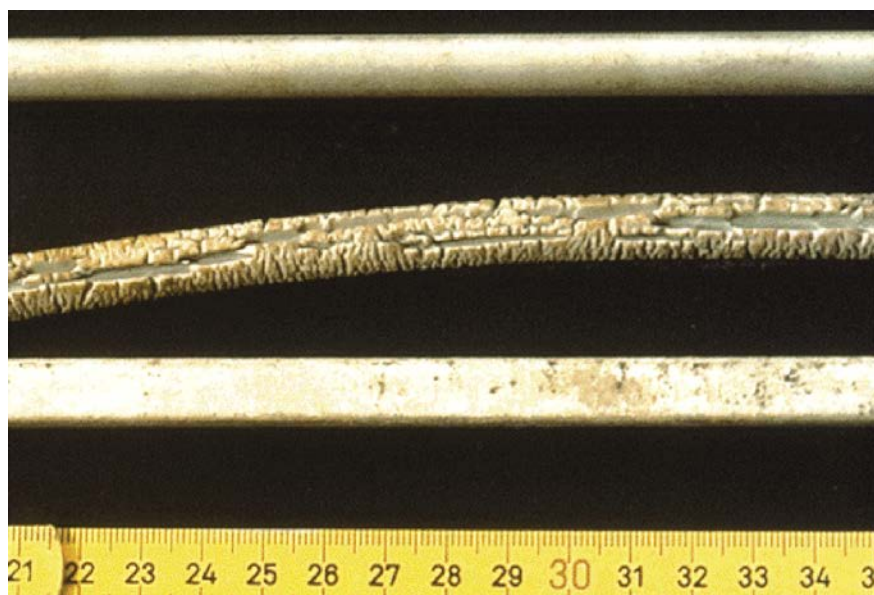
APPEARANCE Blistering.

CAUSE Internal condensation and pressure build-up due to diffusion of water and HCl.

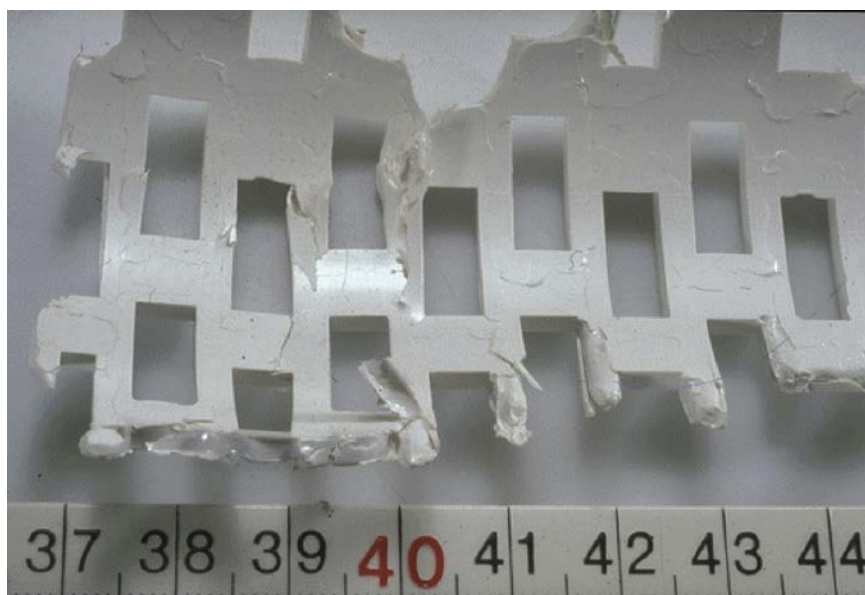
APPEARANCE Blistering.

CAUSE Diffusion and condensation of benzaldehyde in the lining (see also preceding case).

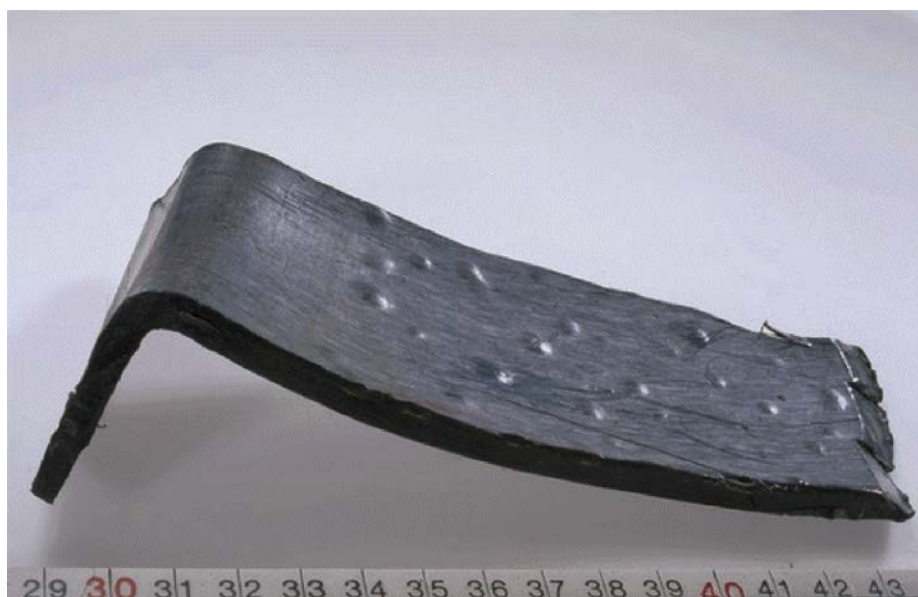
APPEARANCE Local damage.

CAUSE Manufacturing error: because of the porosity in the coating, the liquid was able to penetrate to the steel core, and owing to formation of corrosion products, the coating was pushed up locally. This caused the plug to seize.

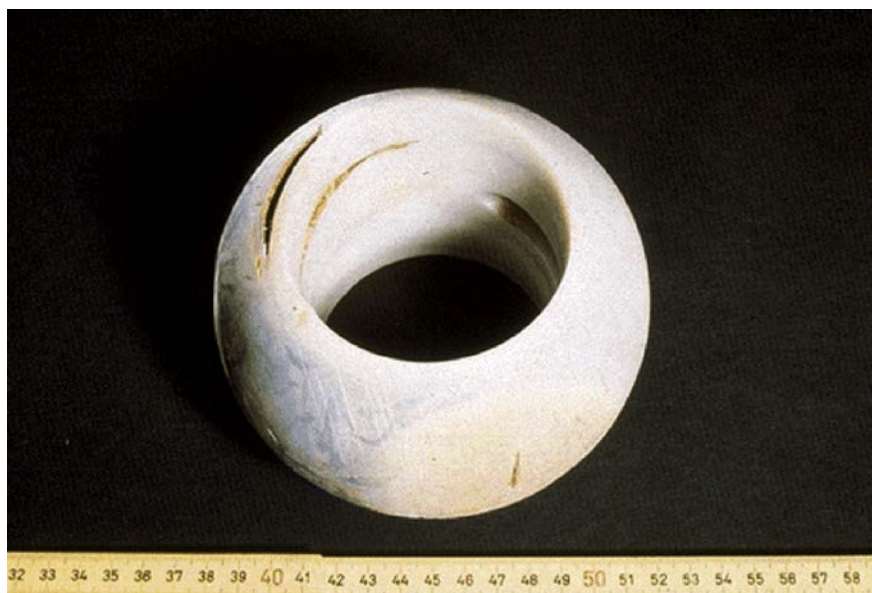
APPEARANCE Cracking (brittle fracture).

CAUSE Poorly sintered PTFE. Cracking occurred owing to temperature fluctuations.

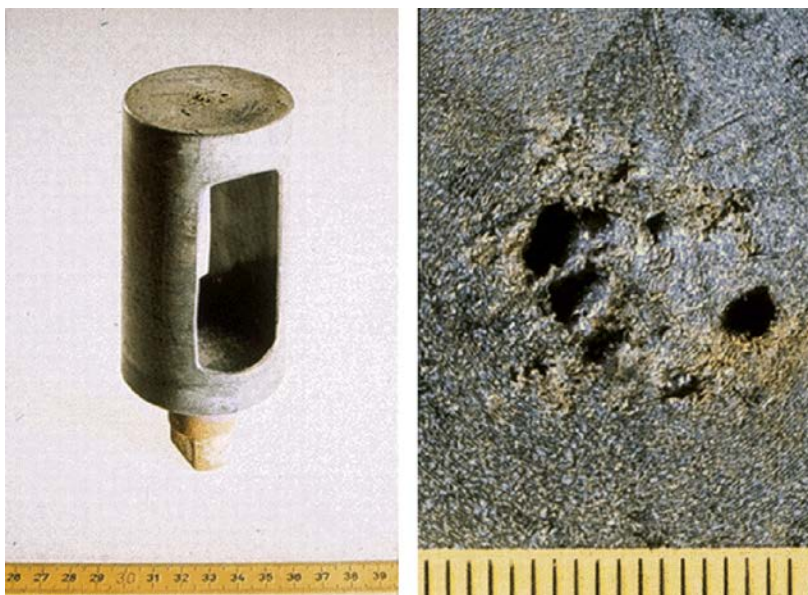
APPEARANCE Granular fracture face.

CAUSE Insufficient fusing of the grains due to incorrect extruder setting.

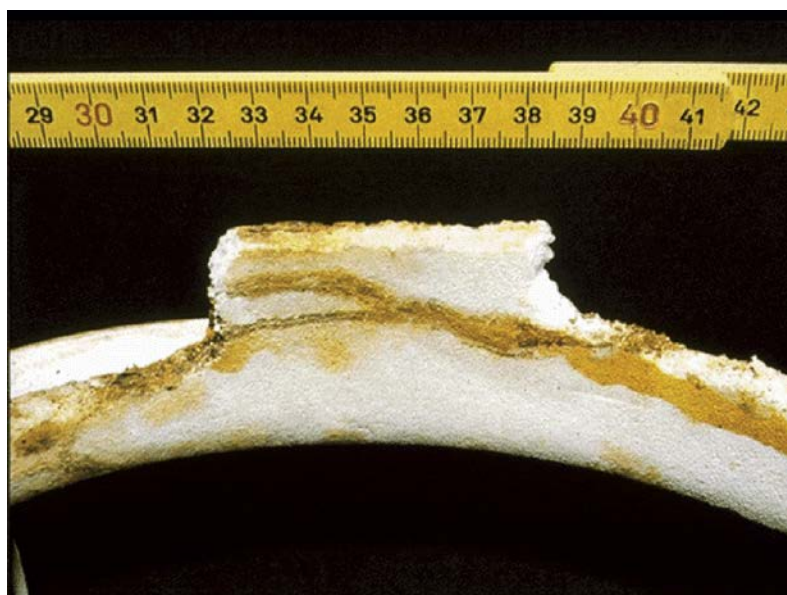
APPEARANCE Rubber is swollen and exhibits cracks.

CAUSE The solvents present caused strong swelling of the rubber, and finally notches and cracks occur.

REMEDY Replacement by a fluorinated elastomer seal.

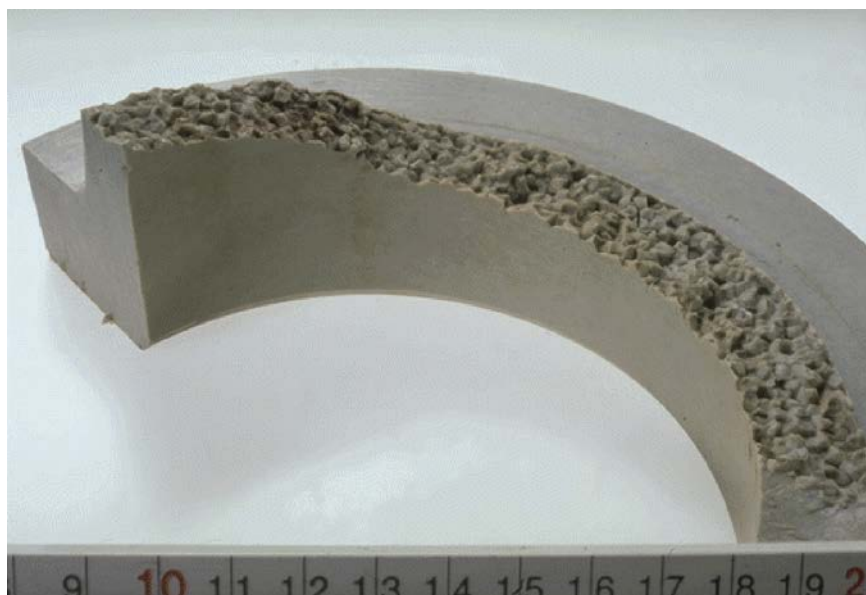
10.11.39.02

APPEARANCE The formation of globules in the PTFE caused severe swelling of the heat of the support.

CAUSE Polymerization of styrene in the microcavities of the PTFE.

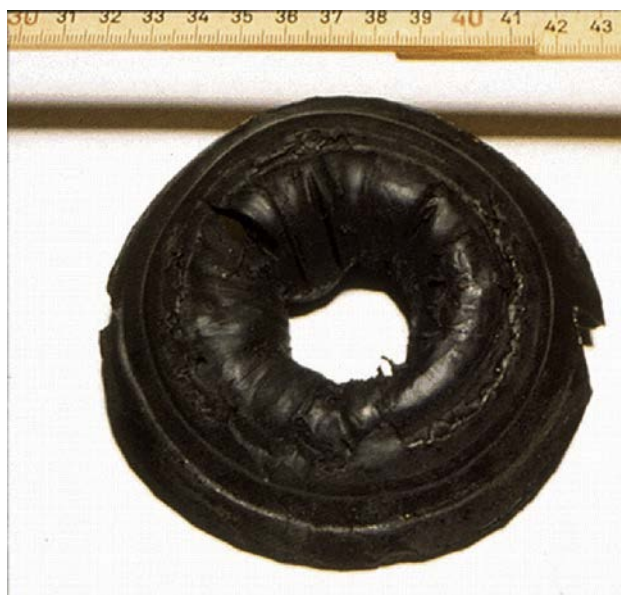
Extensive swelling and softening.

Use polypropylene (PP) or Polyester (PE) (not stainless steel to prevent damage to the glass equipment).

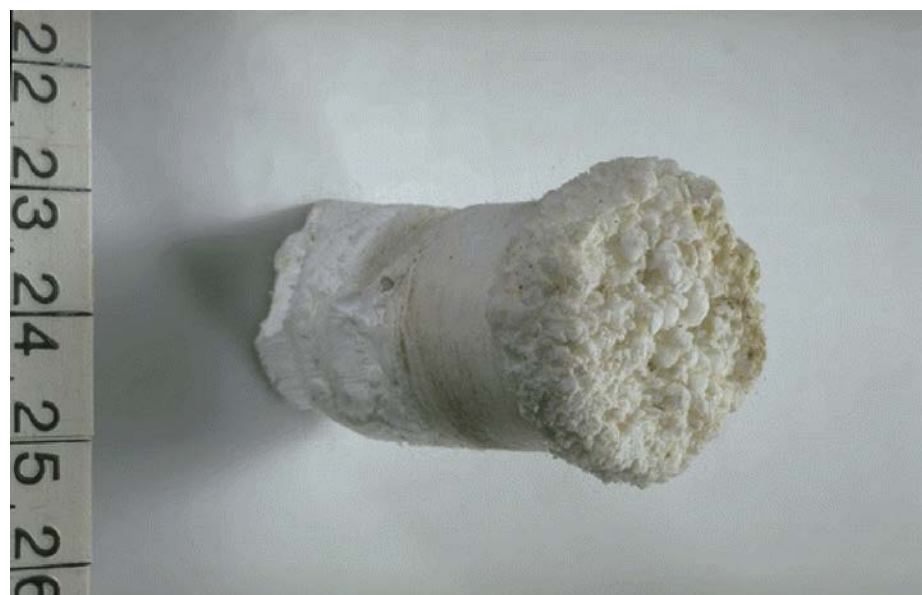
APPEARANCE Cracking at sites subject to highest loads.

CAUSE The chlorine in the liquid attacks polypropylene, with cracking at sites subject to the highest stress.

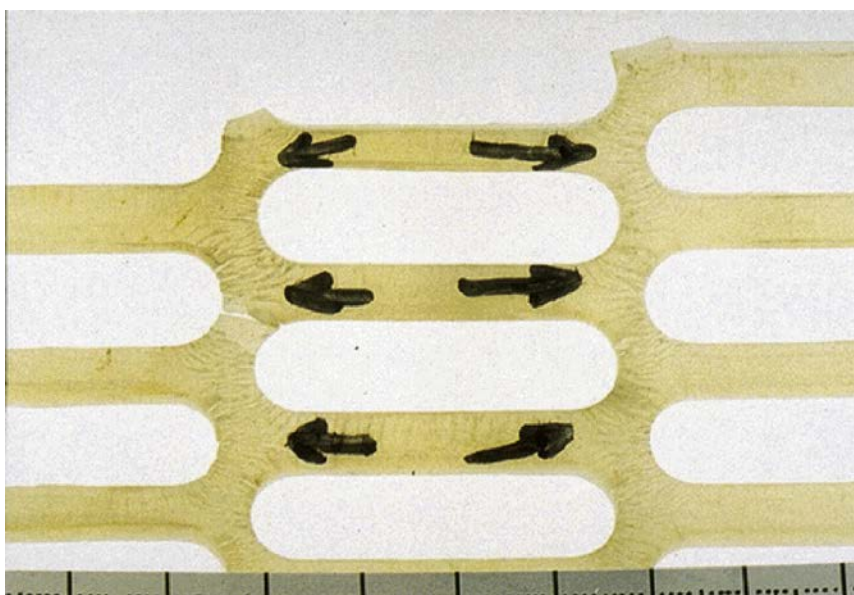
10.11.30.01

APPEARANCE	Material began to yield and then cracked.
TIME IN SERVICE	5 years.
ENVIRONMENT	Dibutyl chloride; steam at 0.3 MPa and 130°C.

CAUSE Overloading due to excessively high pressure and temperature while blowing down the pipe. The blisters were caused by the effect of the dibutyl chloride.

REMEDY When installing a new pipeline, its service life should be determined in advance and replaced in good time, or. Better material should be selected.

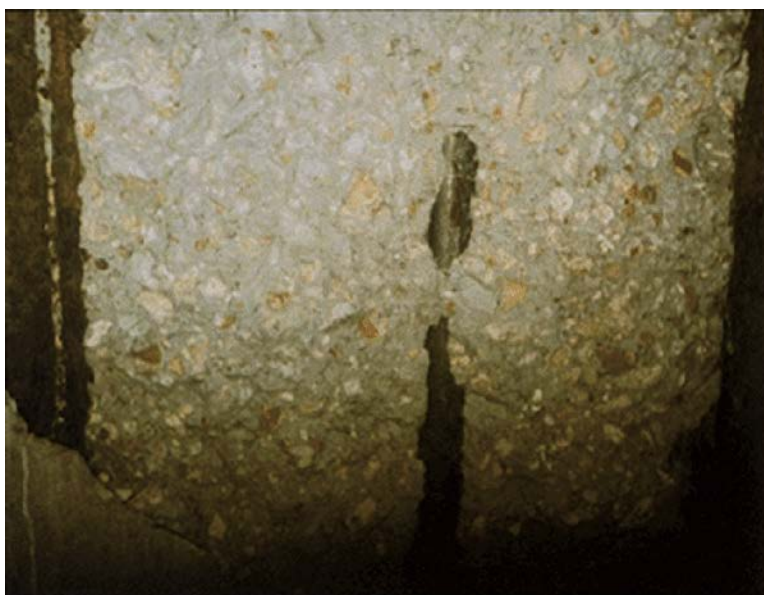
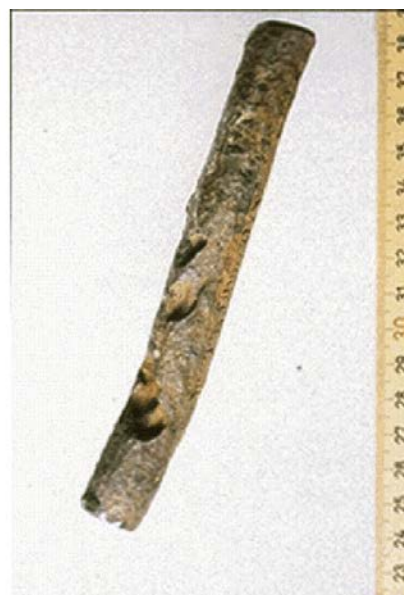
11.16.12.01

APPEARANCE	Locally very severe pitting corrosion to the reinforcement.
TIME IN SERVICE	11 years.
ENVIRONMENT	Damp concrete with 1% chloride (based on dry matter). Brackish water at the outside of the tunnel.

CAUSE Chloride penetration into the concrete from the ambient water. Galvanic corrosion occurs owing to local differences in chloride content, while certain rods act as a cathode and are therefore not attacked due to formation of a so-called concentration cell (center of left photo).

Remedy Remove concrete, grit-blast, and coat the corroded rods, then apply fresh concrete.

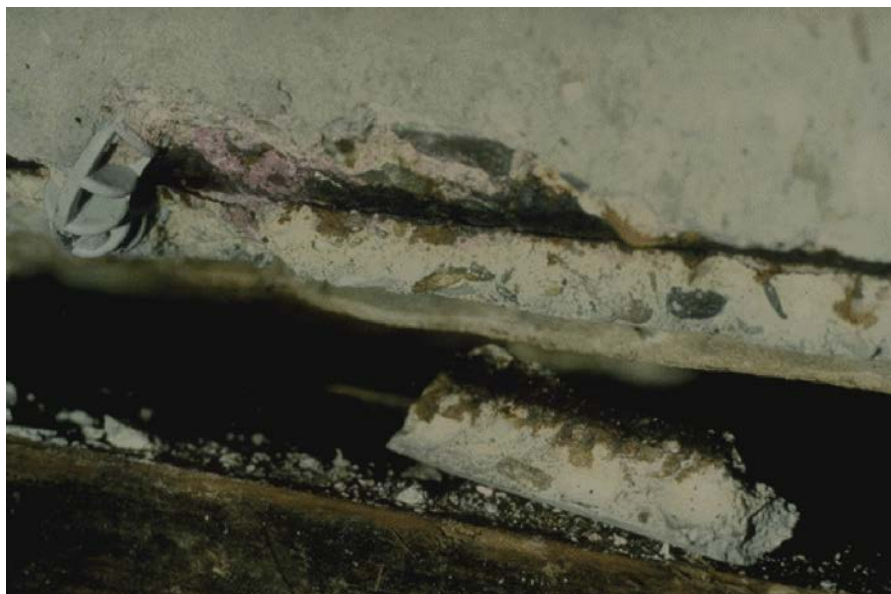
11.16.12.02

APPEARANCE Cracking of the concrete cover reveals severe rebar corrosion.

CAUSE Chloride ions mixed in as setting accelerator (about 1% Cl^- to cement mass). In the case of damp concrete, the conditions are then ideal for corrosion and the corrosion products of the rebars force off the covering layer.

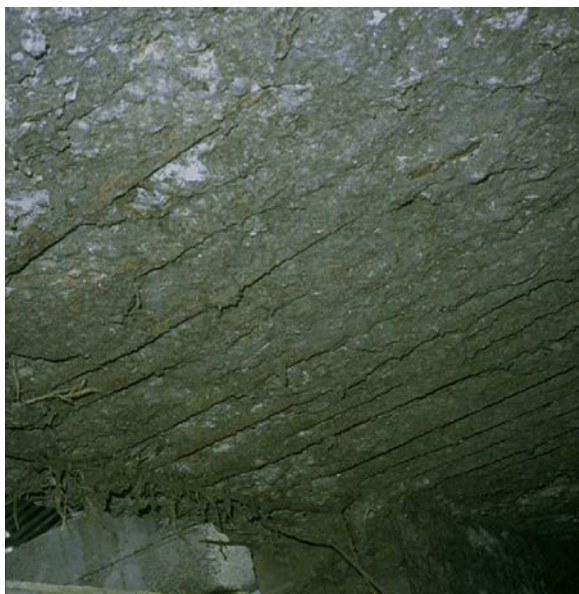
APPEARANCE Concrete cover dissolved; reinforcement severely attacked.

CAUSE Sulfur compounds in the manure are converted anaerobically by sulfate-reducing bacteria into H_2S which escapes in the gaseous form from the liquid slurry and subsequently dissolves in the condensation layer on the walls and the ceiling above the manure surface. There, H_2S is then aerobically converted by sulfur bacteria into sulfuric acid, which attacks the concrete and subsequently the reinforcement (see also Case History 11.08.17.01).

REMEDY Preventive: use high-density concrete and apply an extra cover (sacrificial layer).
Repair: chip away the attacked concrete, blast the corroded rods, if necessary lay extra reinforcement, and then apply new high-density concrete (with extra cover).
Alternative to extra cover: use epoxy resin-based two-component coating.

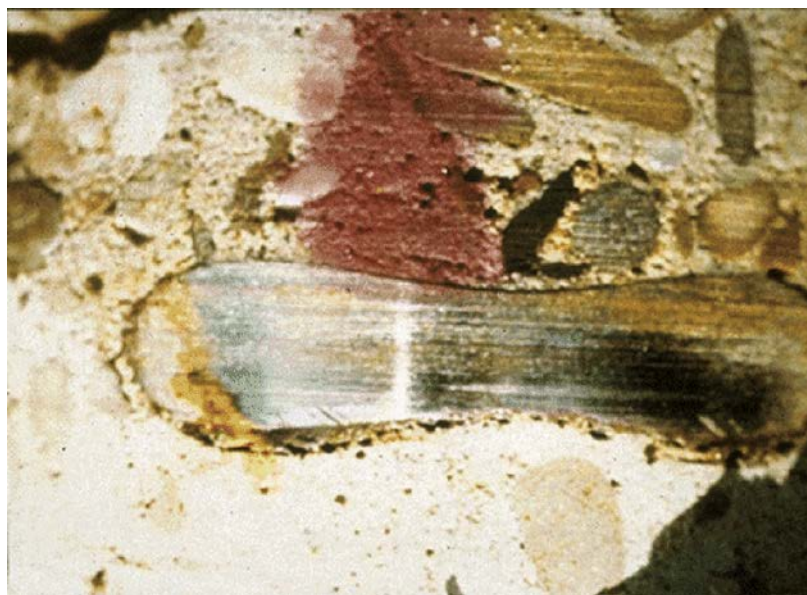
APPEARANCE Uniform rust layer on exterior of structure.

CAUSE Reaction of carbon dioxide (CO_2) penetrated from the air together with the calcium hydroxide ($\text{CA}(\text{OH})_2$) present in the concrete. The reinforcement steel is attacked in the consequently acidifying environment. The exterior of the core is carbonated, while behind the reinforcement, the concrete is still sufficiently alkaline (red indicator color; see also Case History [11.16.24.03](#)).

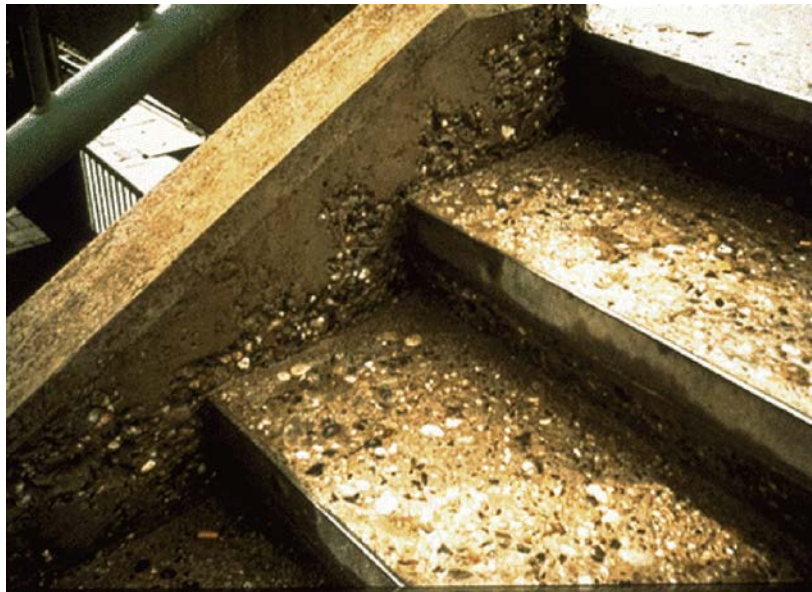
APPEARANCE Flaked-off cement coating, gravel visible.

CAUSE Road salt caused a diminishing reduction in freezing point in an inward direction, as a result of which a frozen layer first occurs inside the concrete after which the surface freezes as the temperature falls further. Subsequently, the water in an as yet unfrozen intermediate layer will not be able to expand as the temperature falls further, and thereby (at sufficient degree of hydration) will be able to force off the top layer.

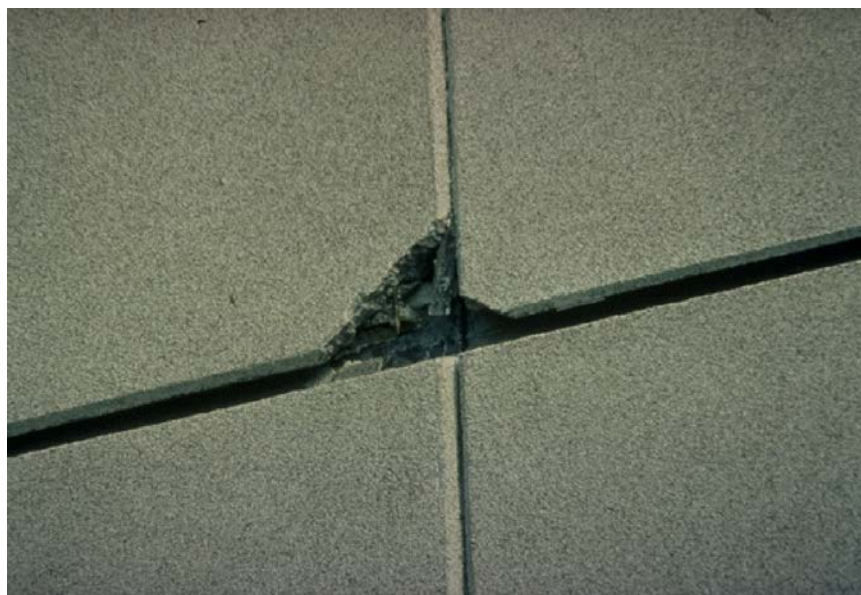
APPEARANCE Pieces detached along the edges of the panels.

CAUSE Corrosion of the reinforcement caused by penetration of moisture, CO₂, and SO₂. As a result of this diffusion, the pH of the concrete is reduced to below 7 and causes corrosion of the steel surface. The large volume of the corrosion products locally forces off the concrete cover (see also Case History [11.16.24.01](#)). This phenomenon is also known as rebar corrosion.

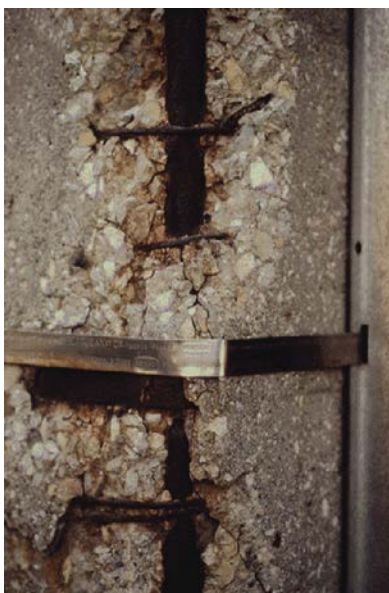
APPEARANCE Local wearing away of the concrete, with uniform corrosion of the reinforcement.

CAUSE Diffusion of salt water through the insufficiently thick concrete cover caused a high chloride concentration and a low pH at the steel surface, as a result of which rebar corrosion took place, after which the concrete cover was forced off (see also Case History [11.16.12.01](#)). In order to prevent accidents, a galvanized steel profile had been secured to the post by means of stainless-steel strips (see also Case History [02.17.24.03](#)).

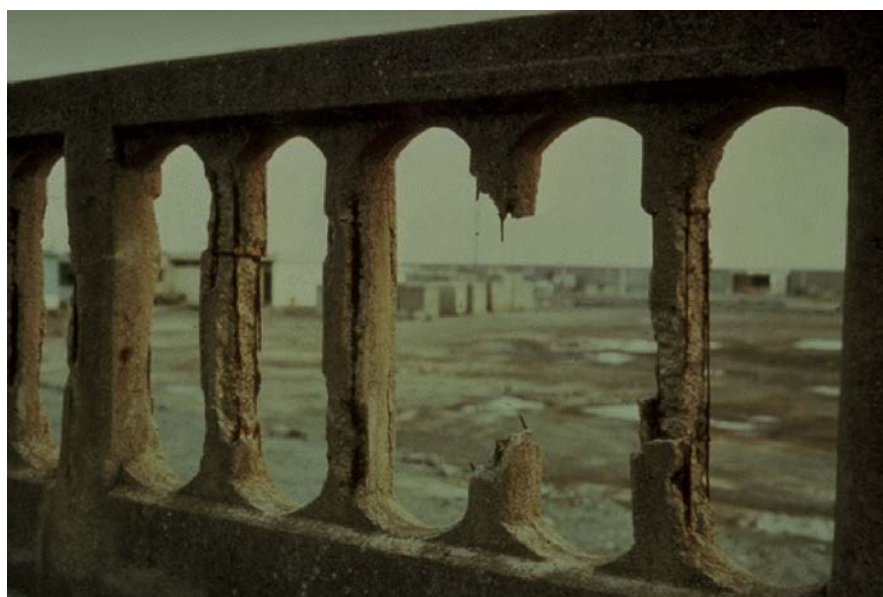
APPEARANCE Totally or partly decayed concrete structure, with uniform corrosion of the reinforcement.

CAUSE Corrosion of the reinforcement by very strong salt attack, after which the concrete cover was forced off (see also Case History [11.16.24.04](#)).

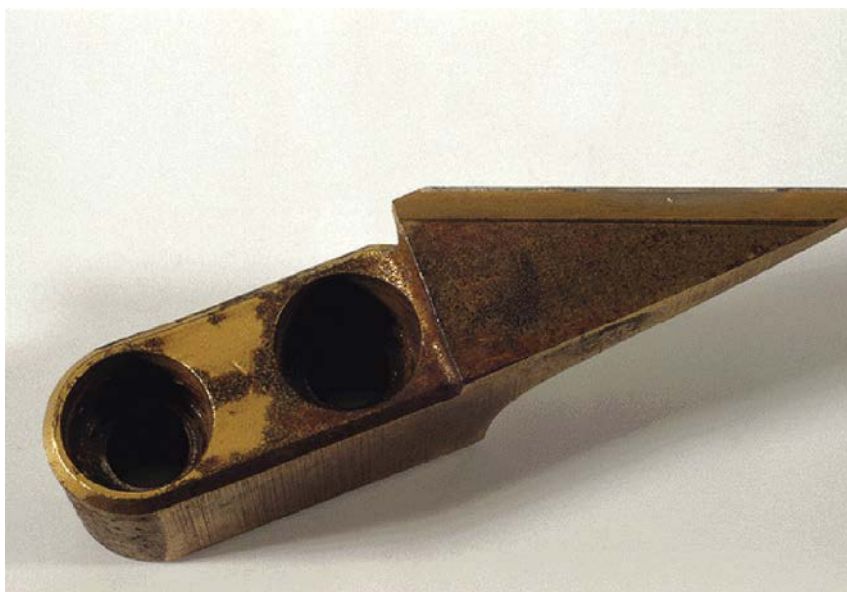
APPEARANCE Rusty.

CAUSE Galvanic corrosion of martensitic stainless steel in contact with tin PVD coating in moist air.

REMEDY Use uncoated martensitic stainless steel.

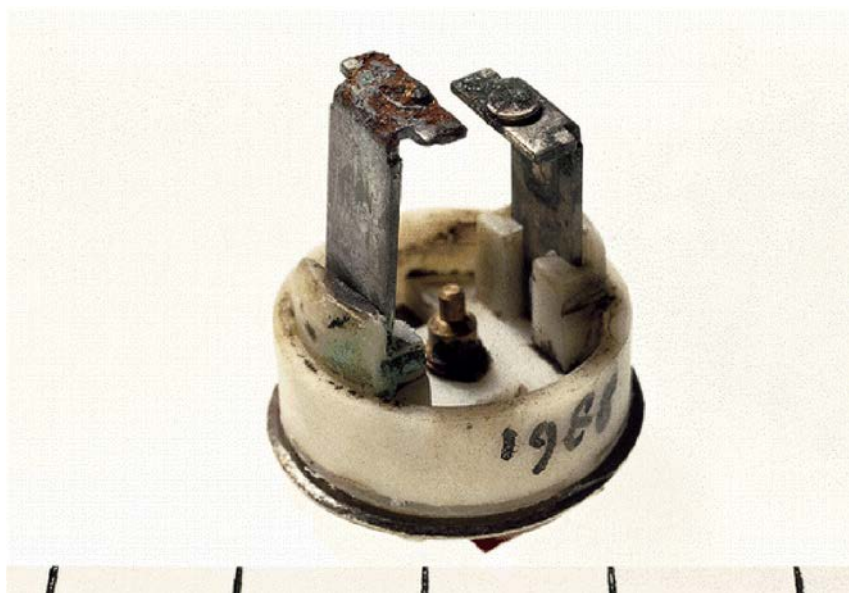
APPEARANCE Heavily corroded anode with blue copper corrosion products leaking out of the switch.

CAUSE Leakage of water and road salts into the switch along the connectors by capillary activity. The potential difference of 24V between the poles created an electrochemical cell. This resulted in corrosion of the anode. Removal of the silver coating took place, followed by dezincification of the brass. As a result, the switch failed.

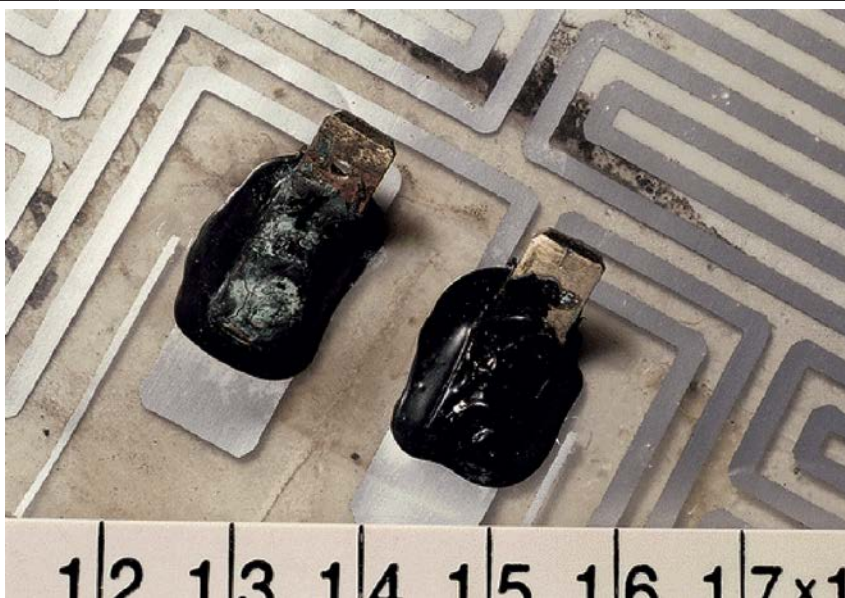
12.15.24.02

APPEARANCE	Anodic contact (left) heavily corroded with blue copper corrosion products. Aluminium thread partly broken.
TIME IN SERVICE	1–2 years.
ENVIRONMENT	Humid atmosphere around contacts in combination with road salts.
CAUSE	Wetting of the contacts by capillary activity caused corrosion of the anodic contact, resulting in heating element failure.
REMEDY	<ul style="list-style-type: none"> • Improved contact between mirror rear and heating foil. • Improved positioning of contacts; more to the inward side of the mirror. • Coat the contact area for protection.
