Corrosion Atlas

THIRD, EXPANDED AND REVISED EDITION

A Collection of Illustrated Case Histories

Evert D.D. During

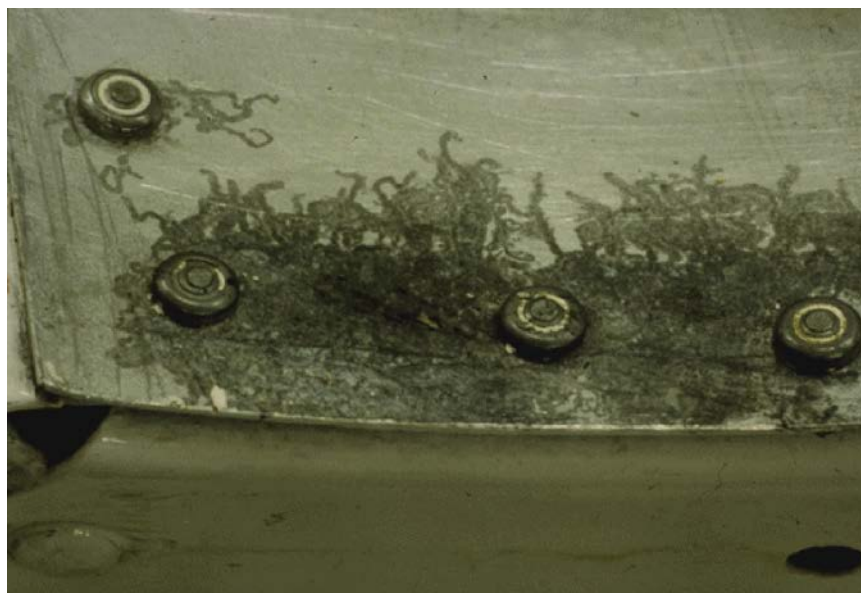
APPEARANCE Randomly distributed thread-like filaments under the coating.

CAUSE The discontinuity of the coating system at the rivets, allowing moisture to diffuse underneath coating, resulting in a filiform, fanning-out corrosion picture (see also Case Histories [03.20.41.01](#) and [03.24.21.01](#)).

REMEDY Improvement of the coating system by applying a corrosion inhibitor at the holes (incidentally, the filiform corrosion in itself is not critical; the dangerous thing is that the coating system has been attacked so that other forms of corrosion can occur).

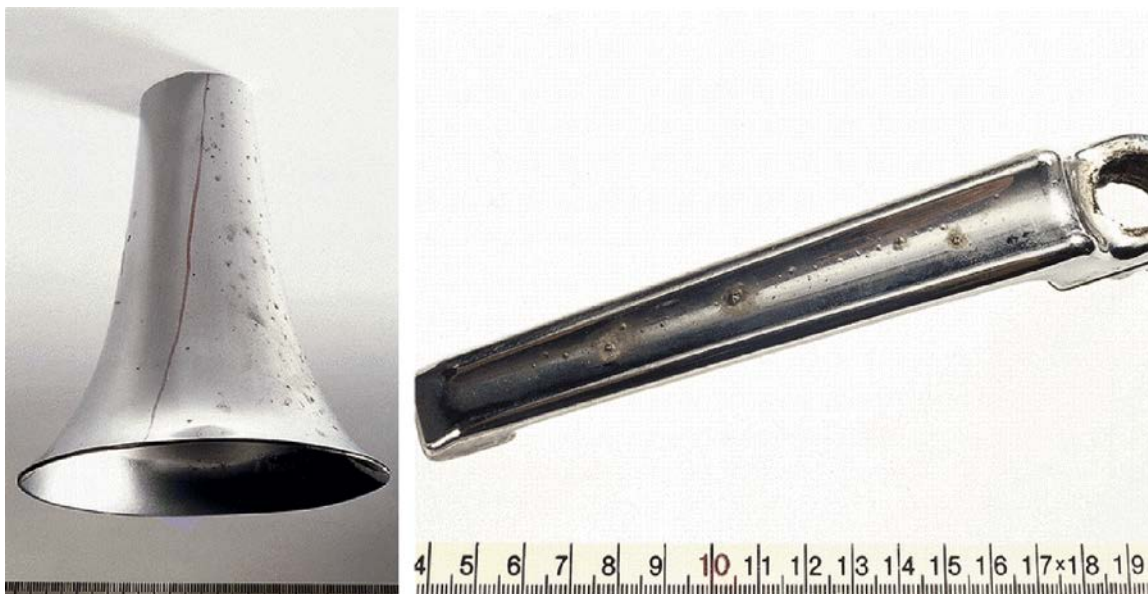
APPEARANCE The coating is blistered; the base metal is corroded. The red line is not important.

CAUSE Pores in the coating caused base metal corrosion followed by blistering of the coating system.

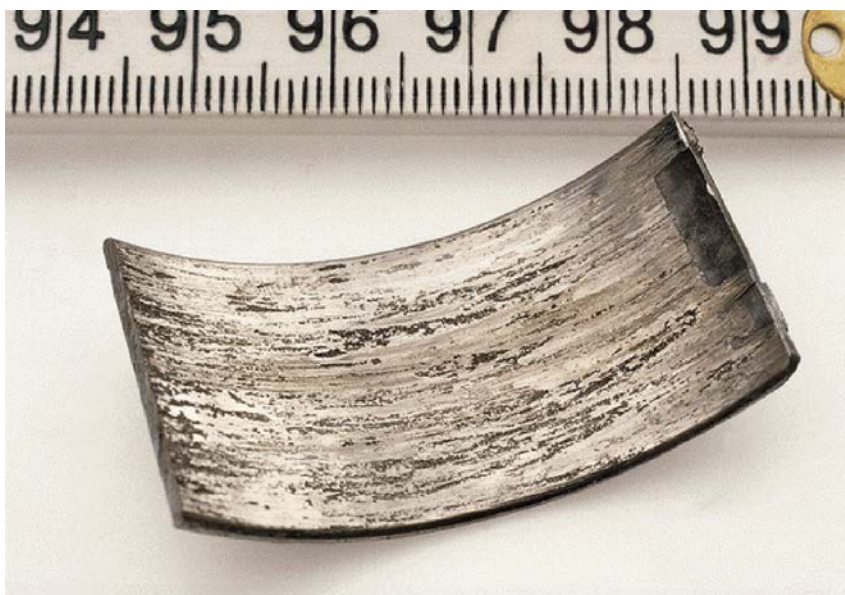
APPEARANCE Babbit metal crumbled out.

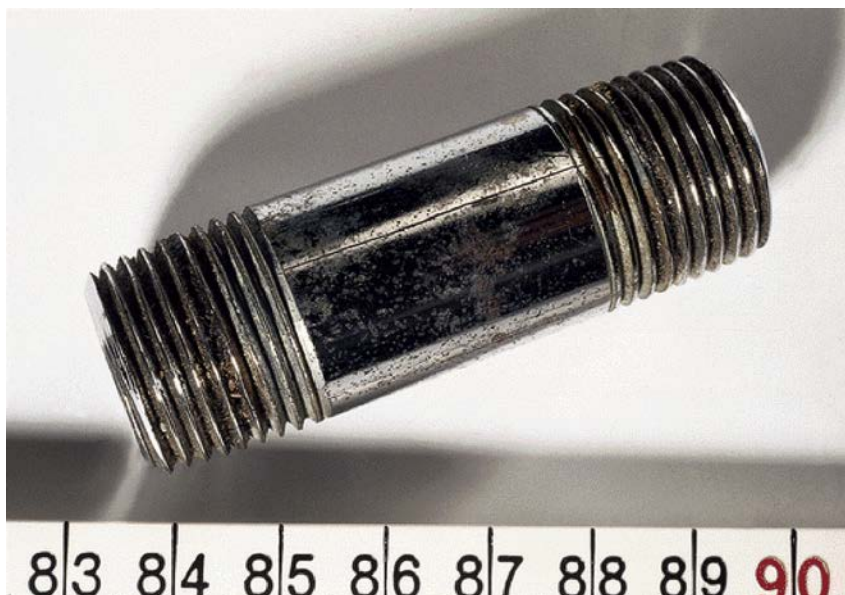
APPEARANCE Pitting attack of this chromium layer with cracking of the brass.

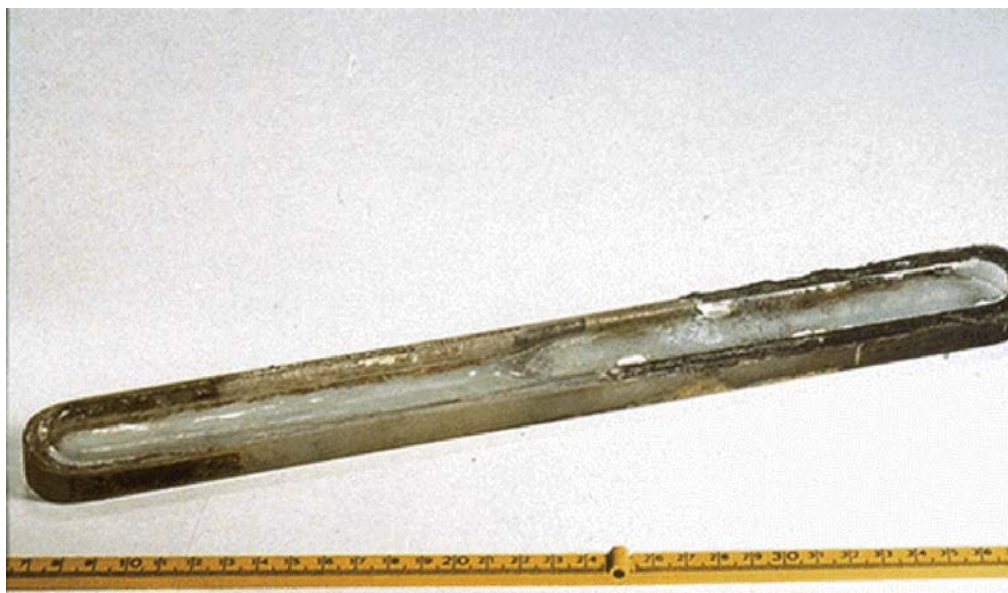
APPEARANCE Uniform attack at the lower part (left side).

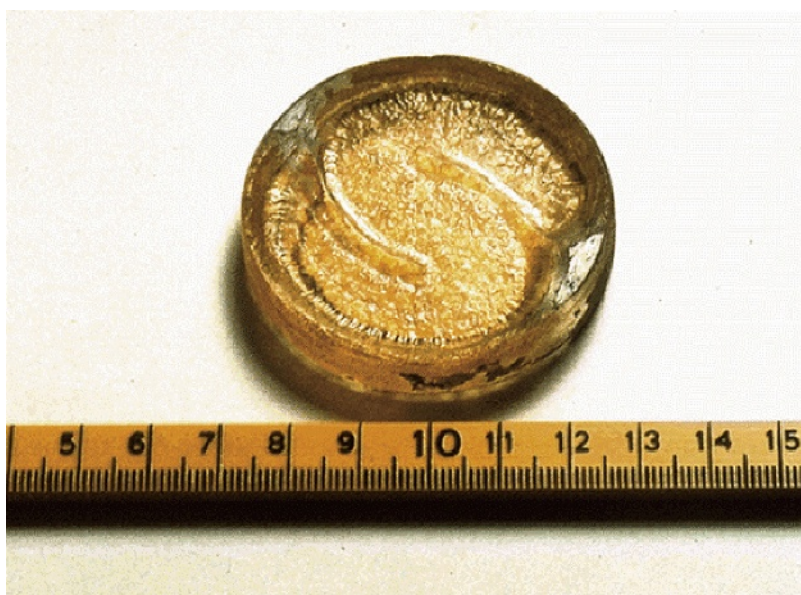
13.02.02.01

MATERIAL	Glass.
SYSTEM	Steam condensate system.
PART	Steam trap inspection glass.
PHENOMENON	Carbonic acid corrosion.

APPEARANCE	Uniform etching.
TIME IN SERVICE	6 months to 1 year.
ENVIRONMENT	Corrosive condensate; temperature 90–100°C.
CAUSE	The glass used is not resistant to the corrosive condensate.
REMEDY	Fitting a mica shield over the glass, thereby avoiding direct contact with the condensate.

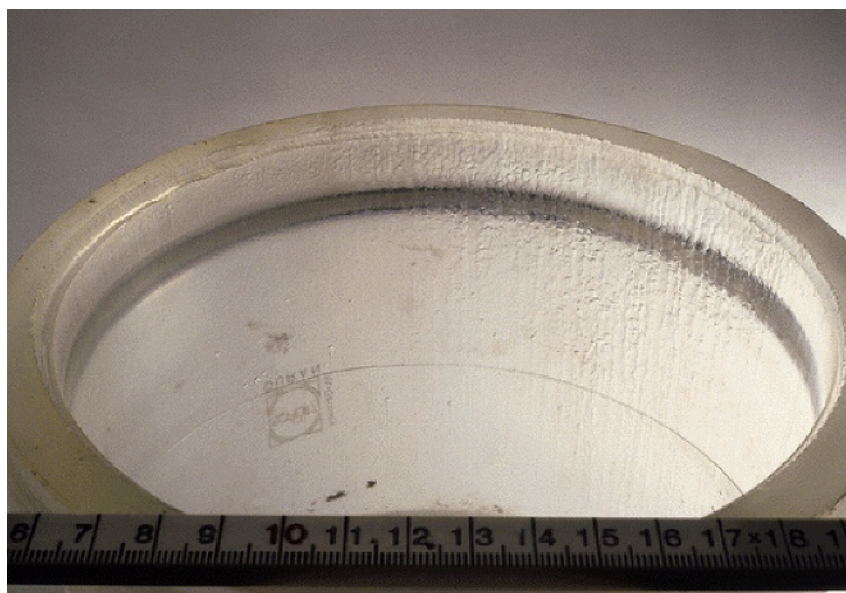
PART Pipe.

PHENOMENON Halide corrosion (fluoride attack).

APPEARANCE Severe overall attack of the system parts (both in the liquid and vapor phases). The surface roughness has increased strongly.

TIME IN SERVICE 5 months.

CAUSE Glass is not resistant to environments containing F^- at elevated temperatures. Even at room temperature, glassy materials are attacked in a diluted HF^- solution.

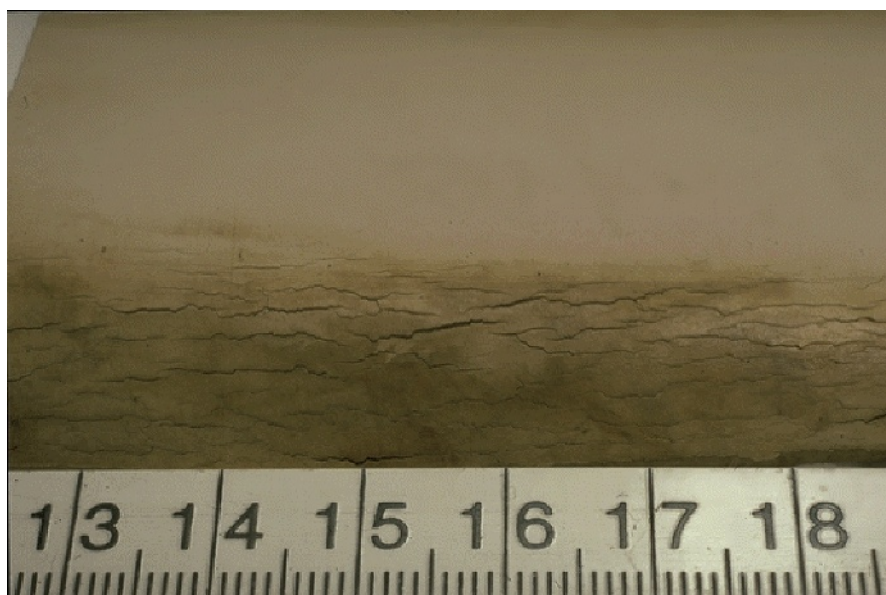
PART Sealing sleeve.

PHENOMENON Aging.

APPEARANCE Parallel cracks.

TIME IN SERVICE $\frac{1}{2}$ year.

CAUSE Natural rubber is readily degraded by light, in particular, ultraviolet light. In the presence of oxygen, rubber is also degraded by visible light (photo-oxidation), which causes cracking.
